## Stone replacement on north side of chimney CS18

**OTH-PUR-TH-RF-SKE-A-3669**

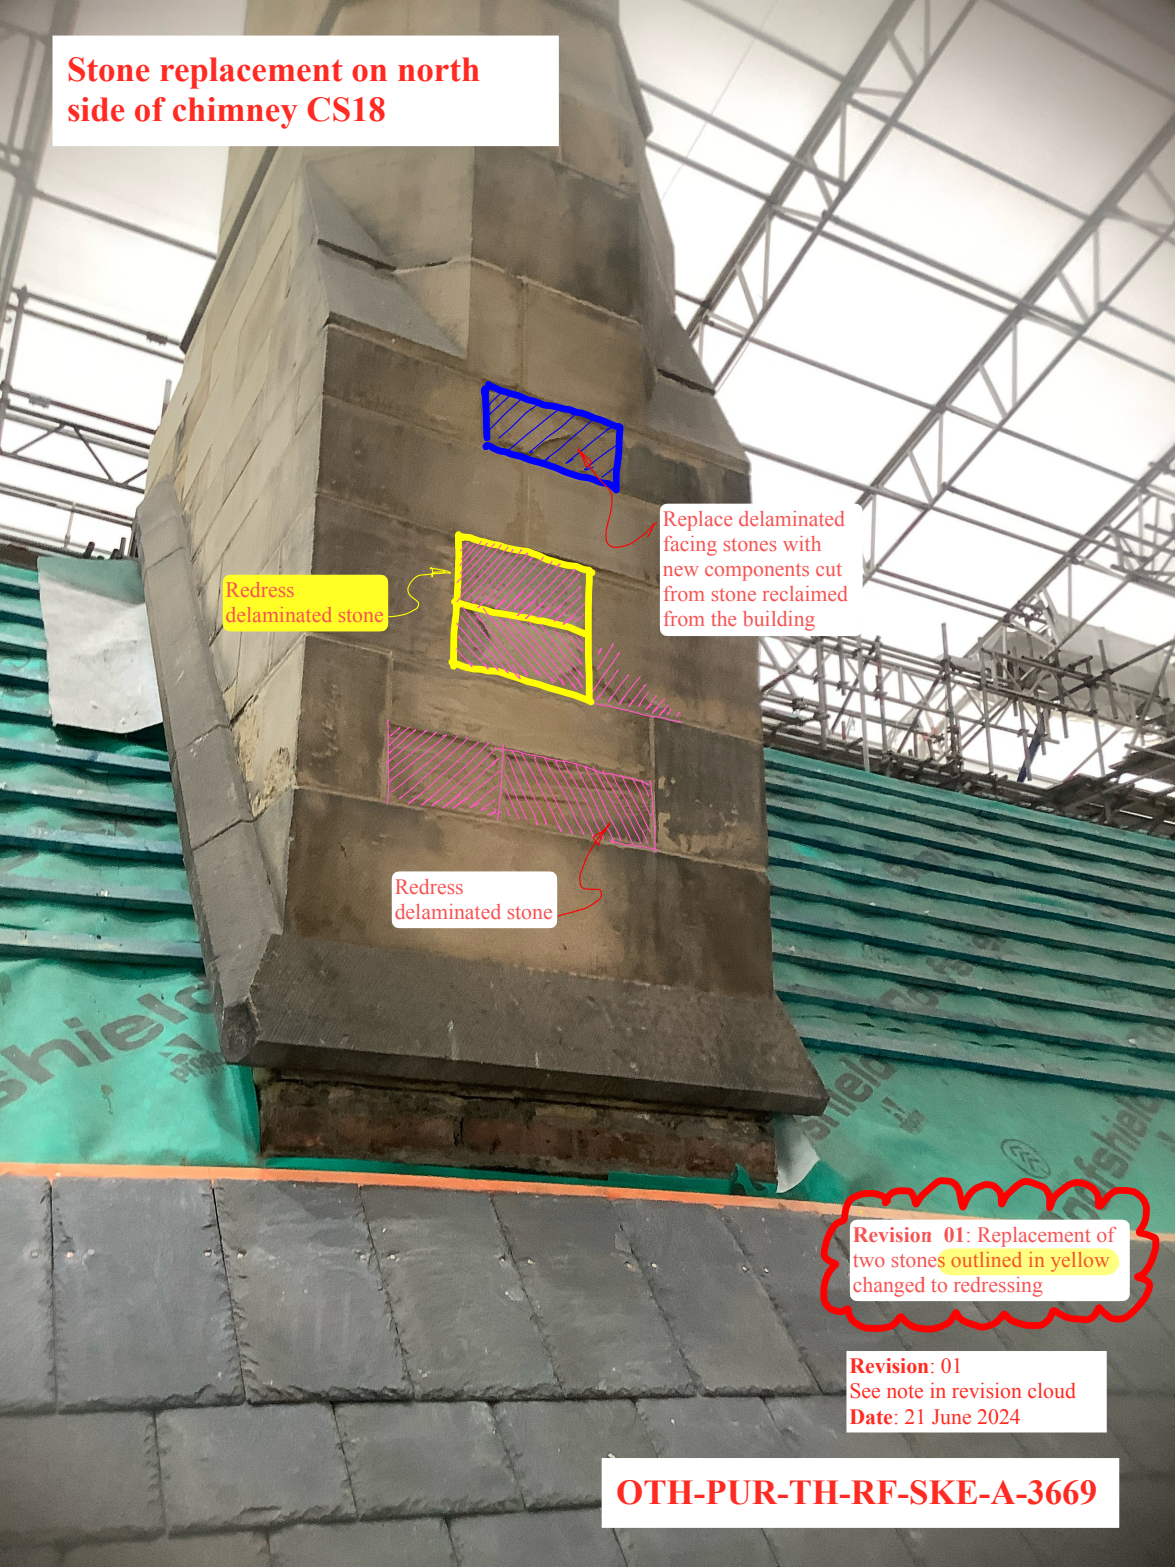
Redress  
delaminated stone

**Revision 01:** Replacement of  
two stones outlined in yellow  
changed to redressing

Replace delaminated  
facing stones with  
new components cut  
from stone reclaimed  
from the building
