# Chimney CS17 repairs to bottom

OTH-PUR-TH-RF-SKE-A-3746

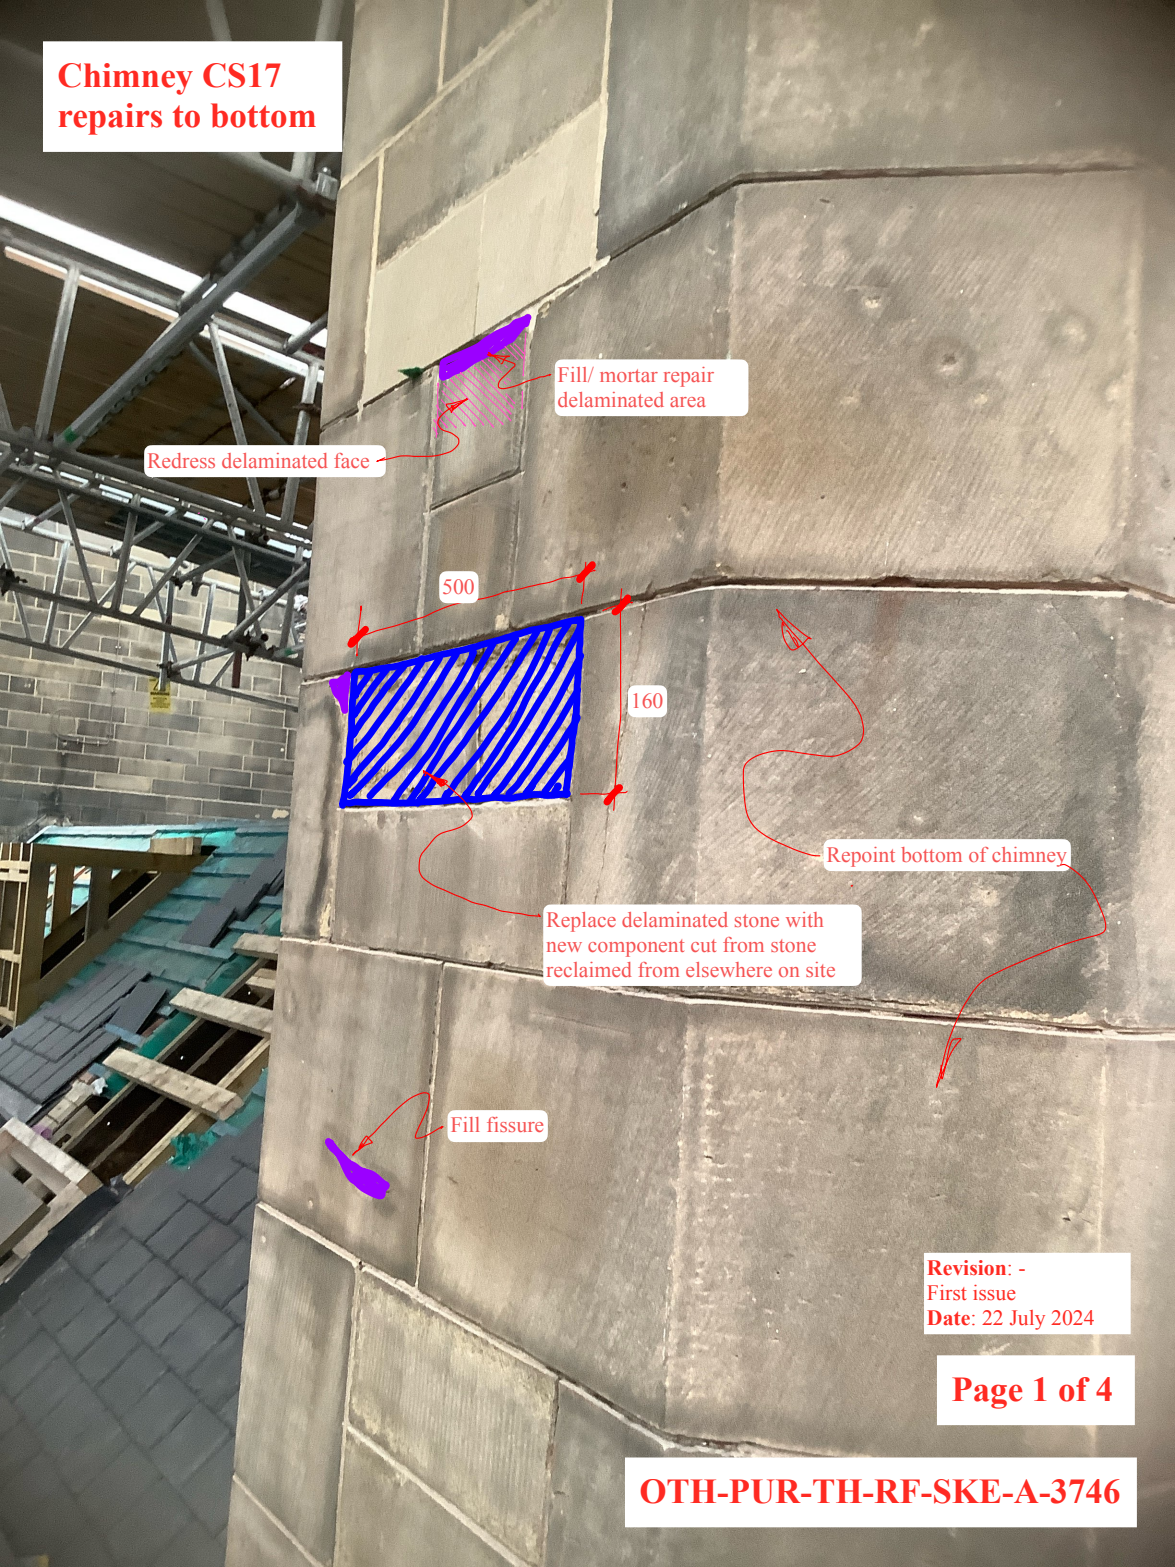
Fill/ mortar repair  
delaminated area

Redress delaminated face

Repoint bottom of chimney

Fill fissure

Replace delaminated stone with  
new component cut from stone  
reclaimed from elsewhere on site
