**RWP 86**

**Lloyd Street courtyard  
Repairs behind rainwater  
pipes at mosaic locations**

**OTH-PUR-TH-RF-SKE-A-3753**

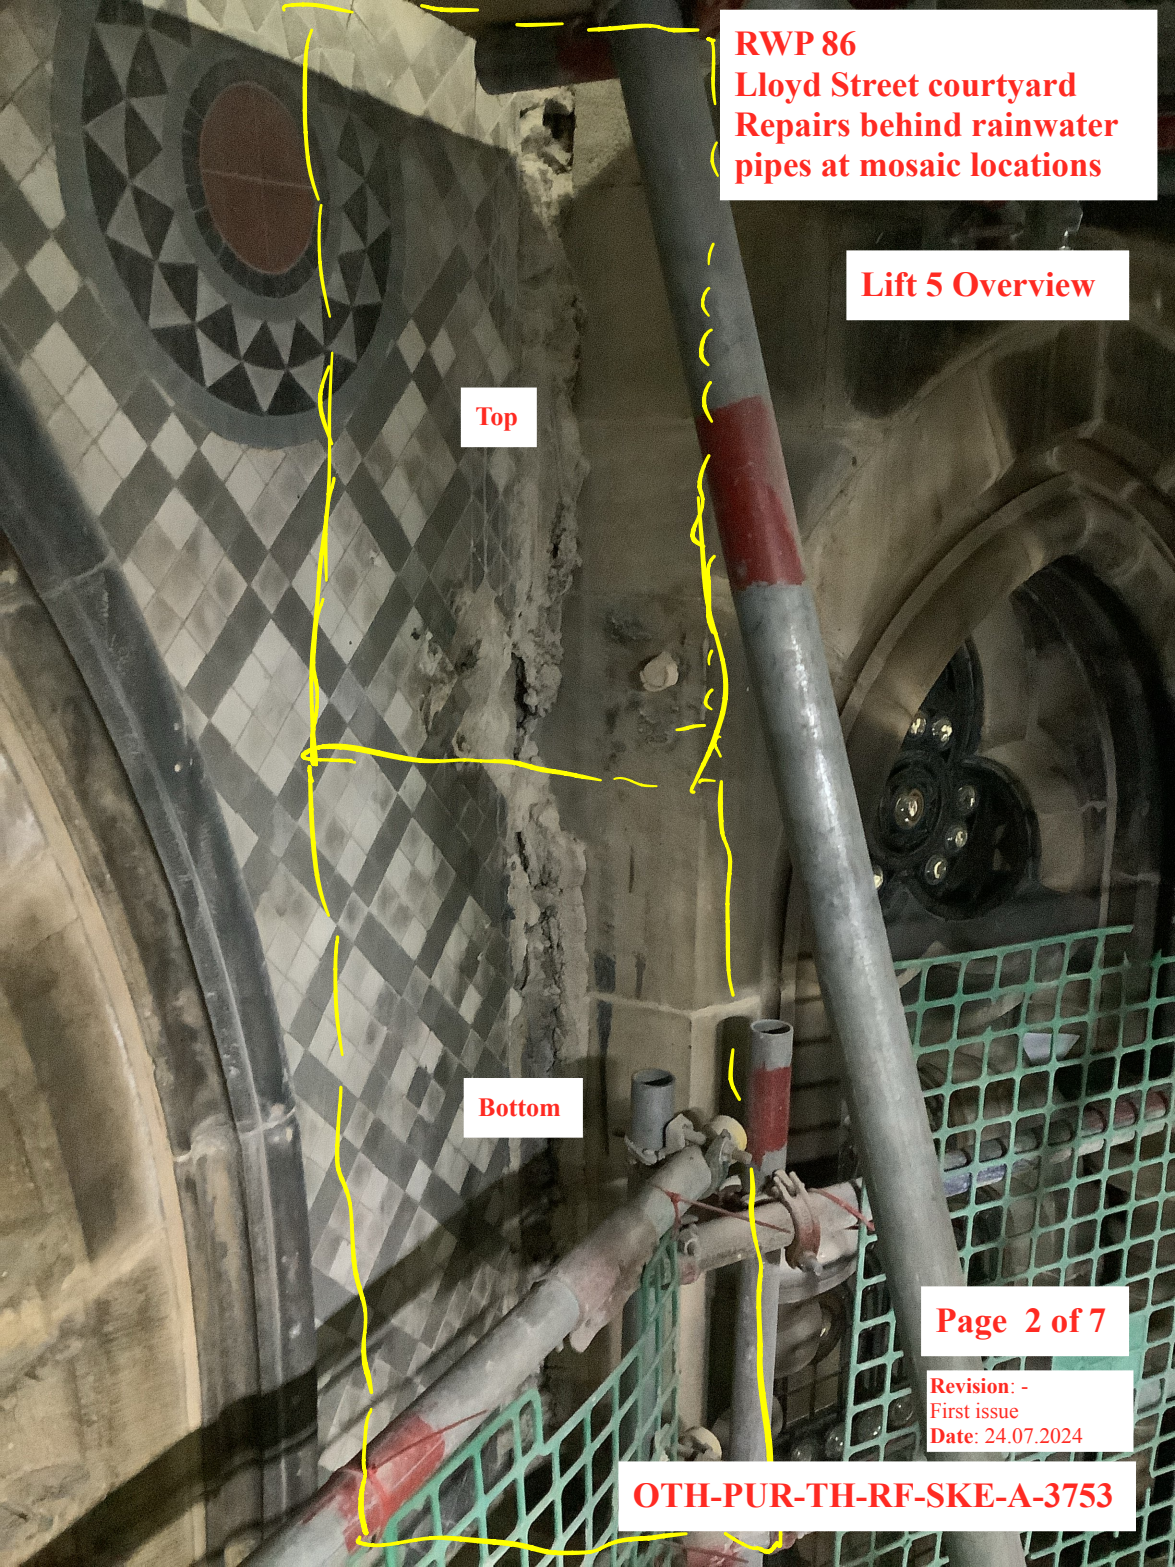
**Lift 6**

Carefully remove damaged  
mosaic tile. Area to be reviewed  
when all loose tiles have been  
removed

Replacement tiles to be re-fixed  
and grouted using Sencil Tek  
Adhere Cal NHL fixing mortar

Replacement mosaic tiles  
matching original as NBS  
specification reference C41.278

Replace missing render immediately behind  
rainwater pipe  
**Mix:** 1 part NHL lime : 2 parts aggregate  
**Lime:** St Astier NHL 3.5  
**Aggregate:** Washed Sharp sand  
**Reinforcement:** Bellmix flock polypropylene  
fibres 18mm - 500g to 2 kg per tonne

Fill hole

**Mix:** 1 part NHL lime : 2 parts aggregate  
**Lime:** St Astier NHL 3.5  
**Aggregate:** Washed Sharp sand  
**Reinforcement:** Bellmix flock polypropylene  
fibres 18mm - 500g to 2 kg per tonne
