**RWP 87**  
**Lloyd Street courtyard**  
**Repairs behind rainwater**  
**pipes at mosaic locations**

**OTH-PUR-TH-RF-SKE-A- 3754**

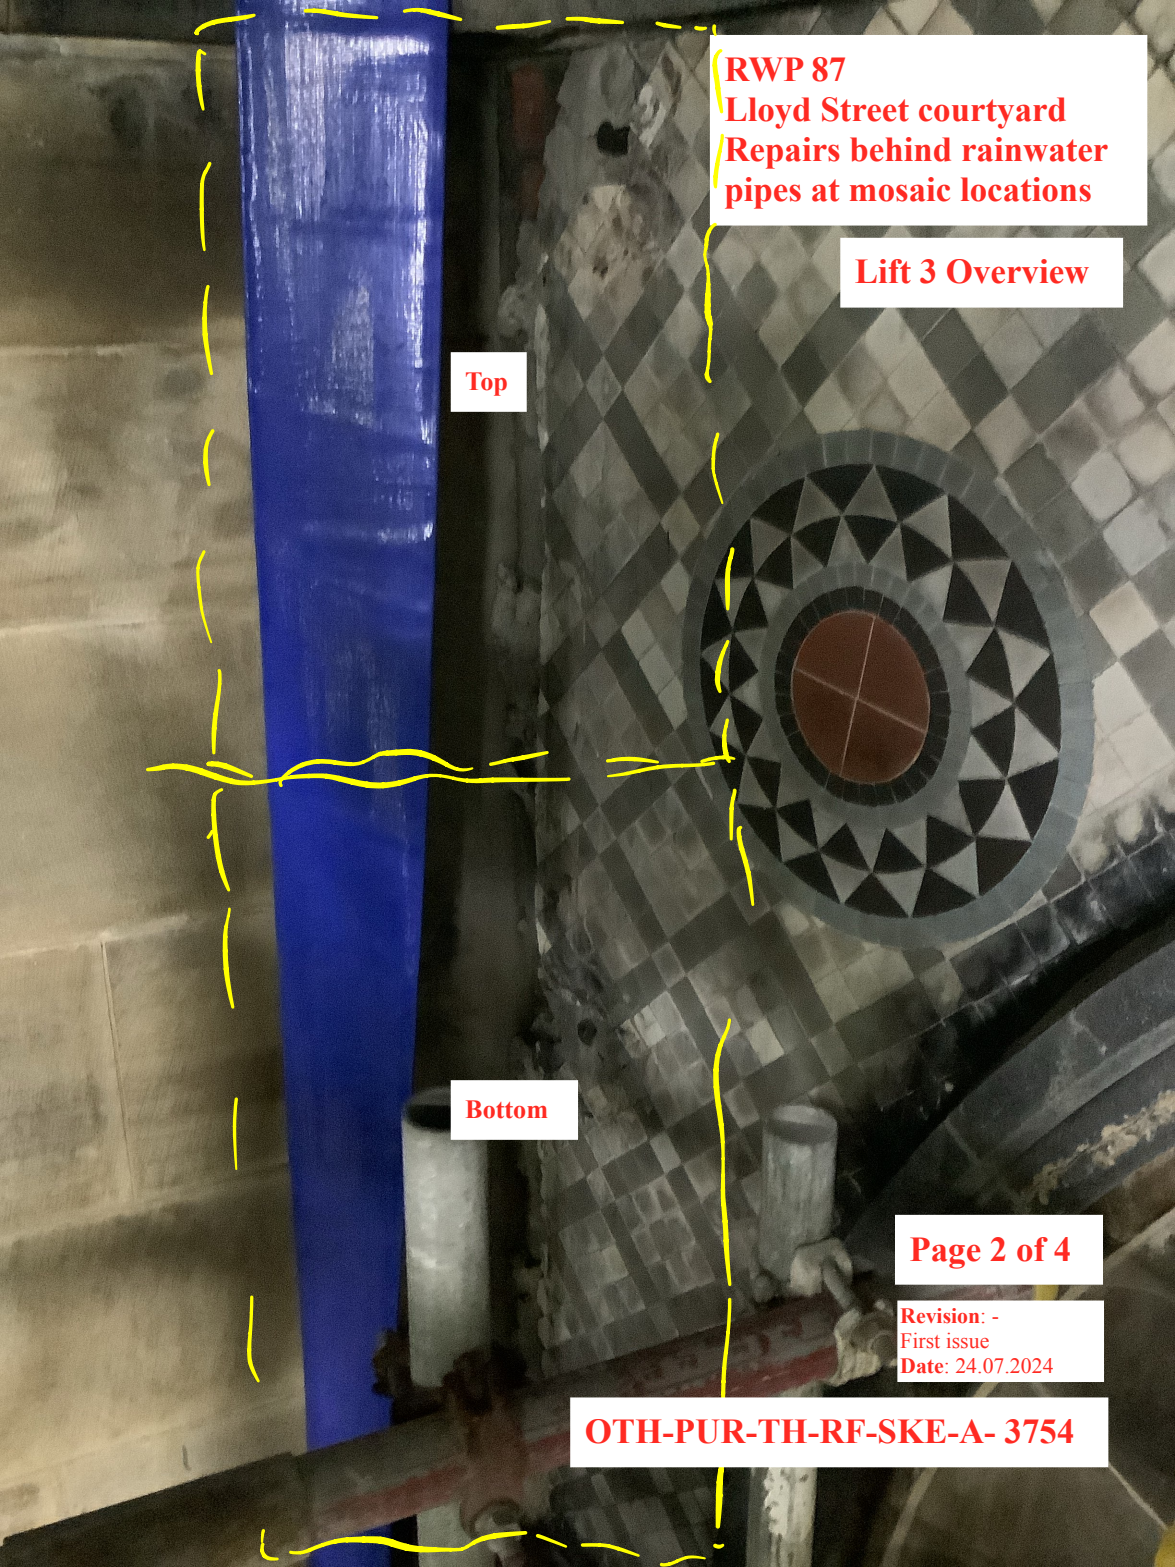
**Lift 3 Overview**

**Top**

**Bottom**
