## Asbestos Demolition Survey

**Block D8 Boiler House No1  
North Manchester General Hospital  
Delaunays Road  
Crumpsall  
Manchester  
M8 5RB**

**Manchester Foundation Trust**

| Project Number: | Survey Date: | Issue Date: |
|---|---|---|
| B-31336s2 | 26 May 2021 | 21 October 2021 |

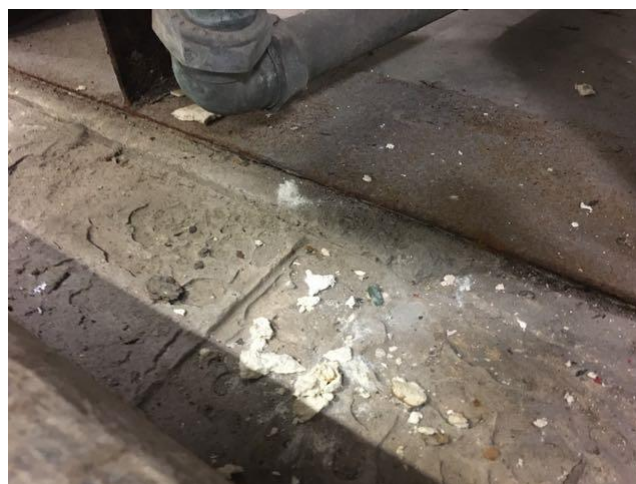
| Analysis Result | No Asbestos Detected | 0 |
| Condition | High Damage | 3 |

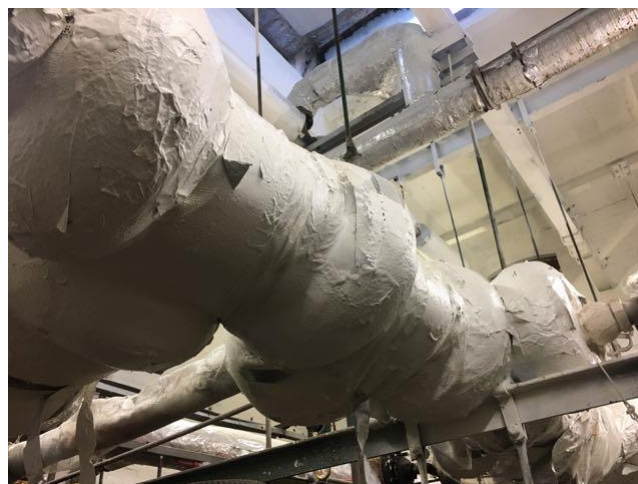
| <b>Analysis Result</b> | No Asbestos Detected | 0 |
| <b>Condition</b> | High Damage | 3 |

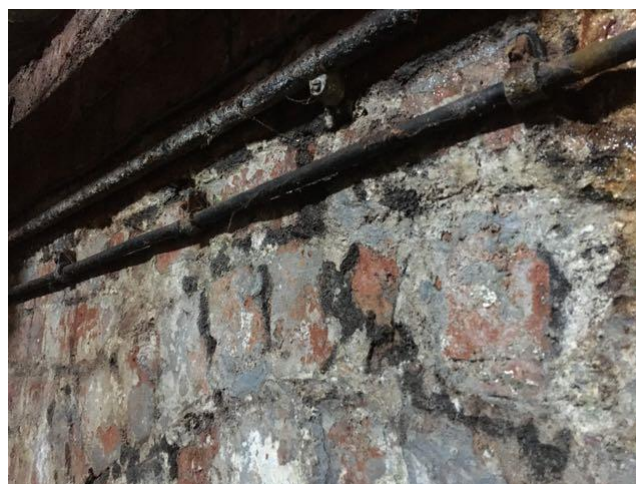
| <b>Analysis Result</b> | No Asbestos Detected | 0 |
| <b>Condition</b> | High Damage | 3 |

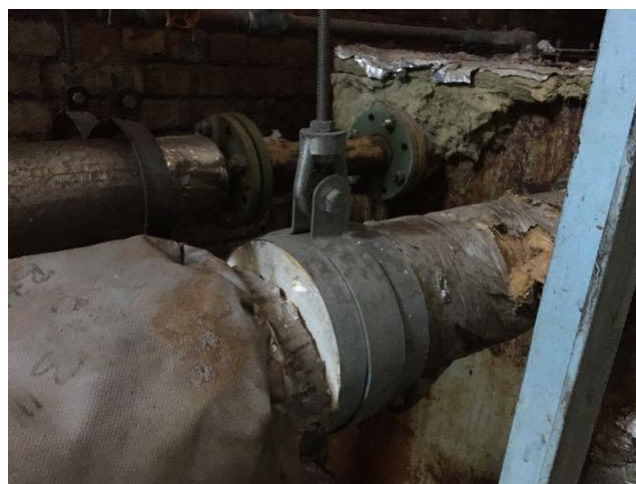
| <b>Analysis Result</b> | No Asbestos Detected | 0 |
| <b>Condition</b> | High Damage | 3 |

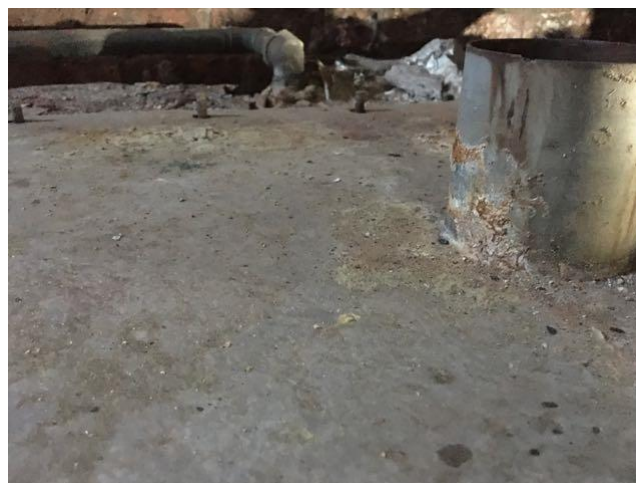
| Analysis Result | Chrysotile, Amosite, Crocidolite | 3 |
| Condition | High Damage | 3 |

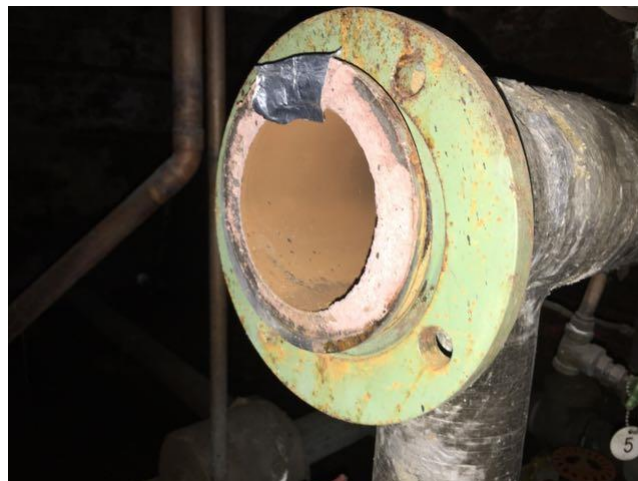
| <b>Analysis Result</b> | Chrysotile | 1 |
| <b>Condition</b> | Low Damage | 1 |

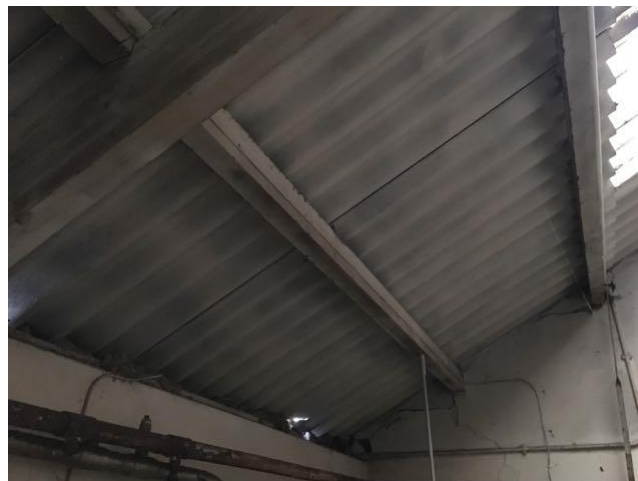
| <b>Analysis Result</b> | Chrysotile | 1 |
| <b>Condition</b> | Low Damage | 1 |

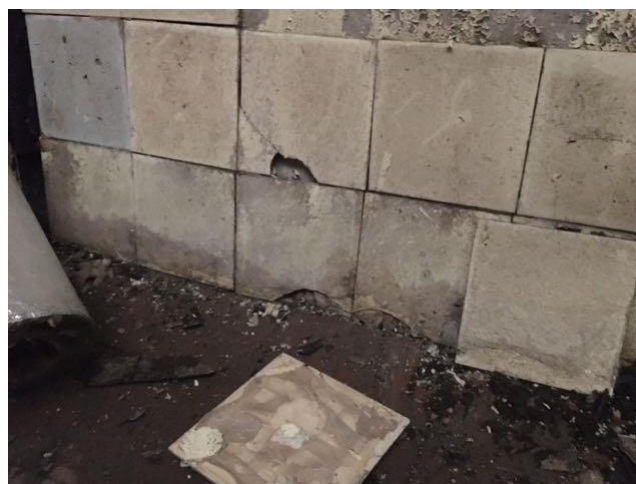
| <b>Analysis Result</b> | No Asbestos Detected | 0 |
| <b>Condition</b> | Low Damage | 1 |

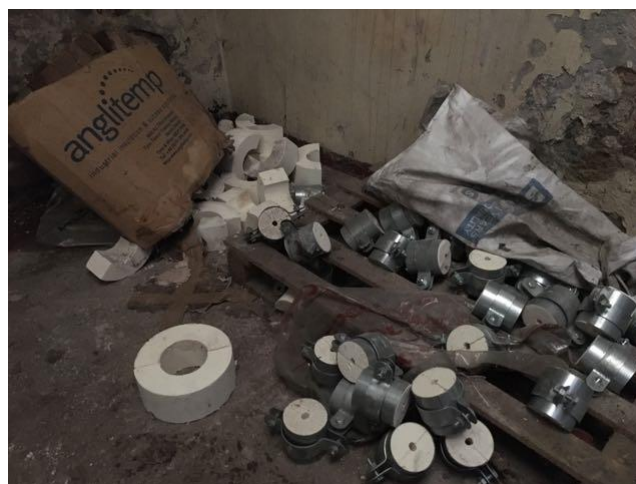
| <b>Analysis Result</b> | No Asbestos Detected | 0 |
| <b>Condition</b> | Medium Damage | 2 |

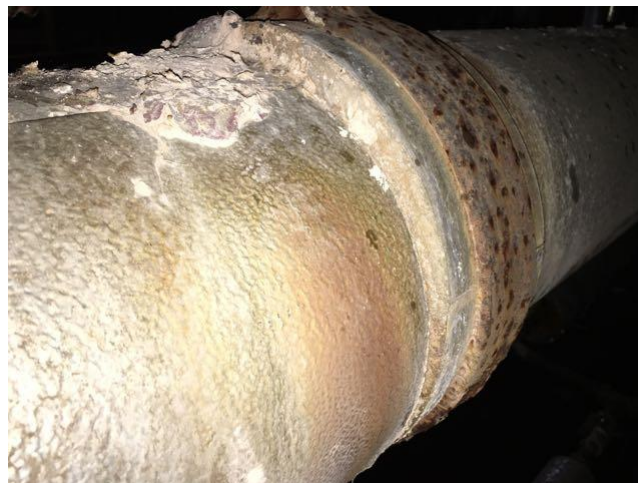
| <b>Analysis Result</b> | No Asbestos Detected | 0 |
| <b>Condition</b> | Low Damage | 1 |

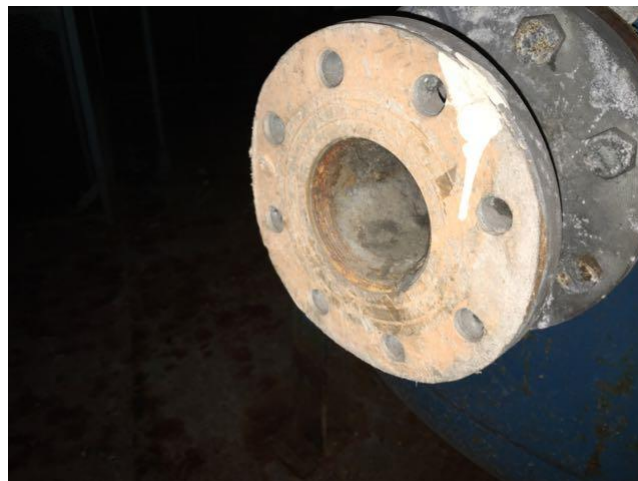
| <b>Analysis Result</b> | Chrysotile | 1 |
| <b>Condition</b> | Low Damage | 1 |

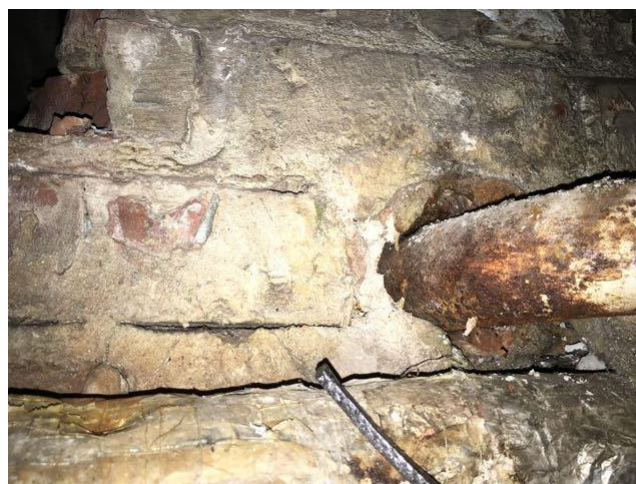
| <b>Analysis Result</b> | No Asbestos Detected | 0 |
| <b>Condition</b> | High Damage | 3 |

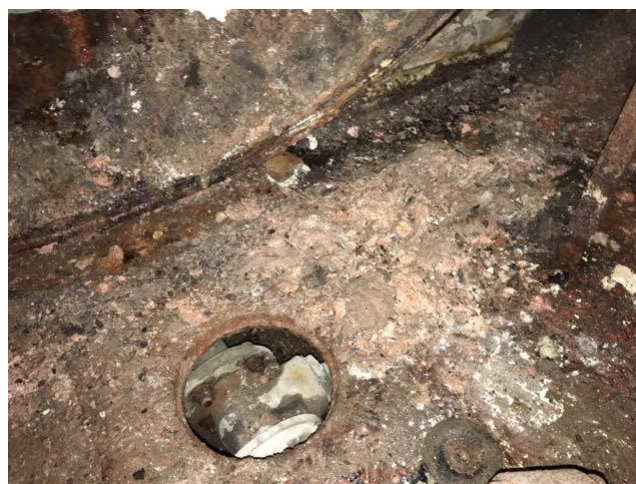
| Analysis Result | No Asbestos Detected | 0 |
| Condition | High Damage | 3 |

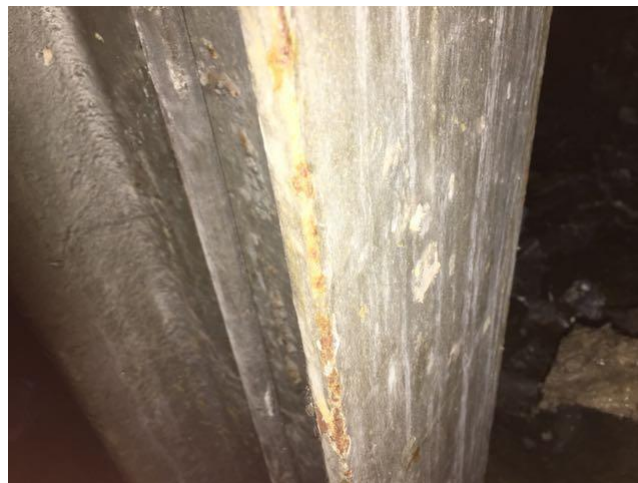
| <b>Analysis Result</b> | No Asbestos Detected | 0 |
| <b>Condition</b> | High Damage | 3 |

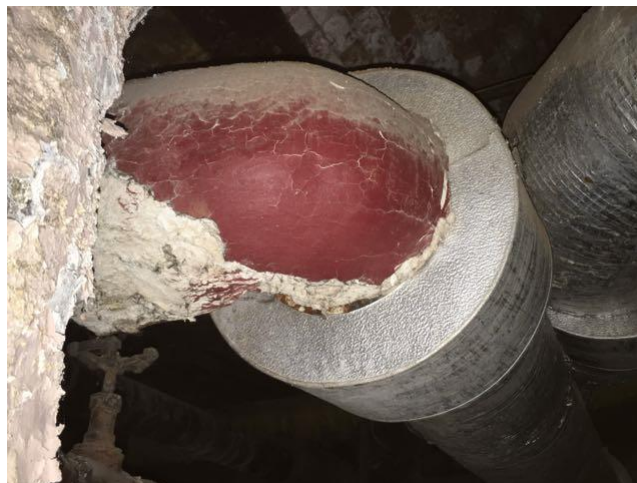
| <b>Analysis Result</b> | No Asbestos Detected | 0 |
| <b>Condition</b> | High Damage | 3 |

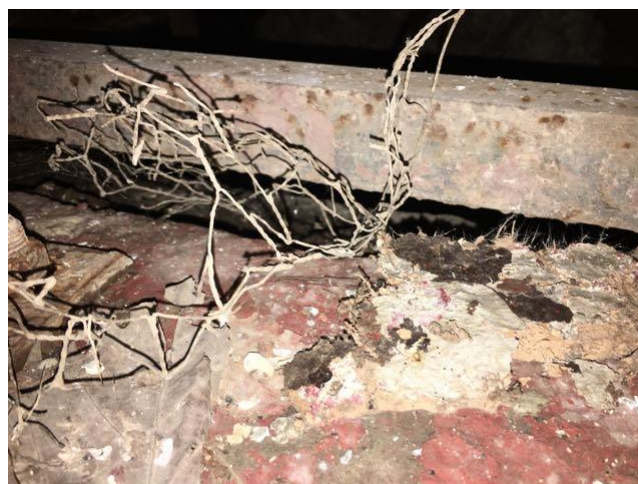
| Analysis Result | No Asbestos Detected | 0 |
| Condition | High Damage | 3 |

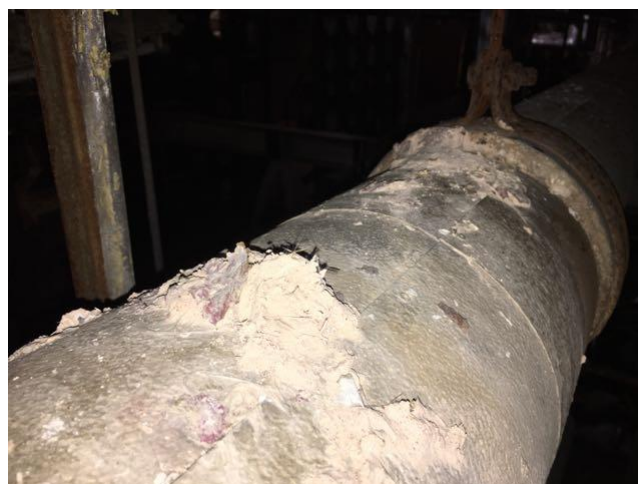
| Analysis Result | No Asbestos Detected | 0 |
| Condition | High Damage | 3 |

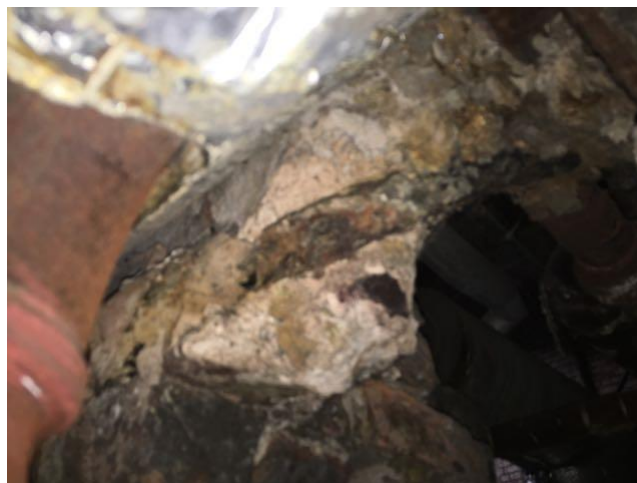
| <b>Analysis Result</b> | Chrysotile, Amosite, Crocidolite | 3 |
| <b>Condition</b> | High Damage | 3 |

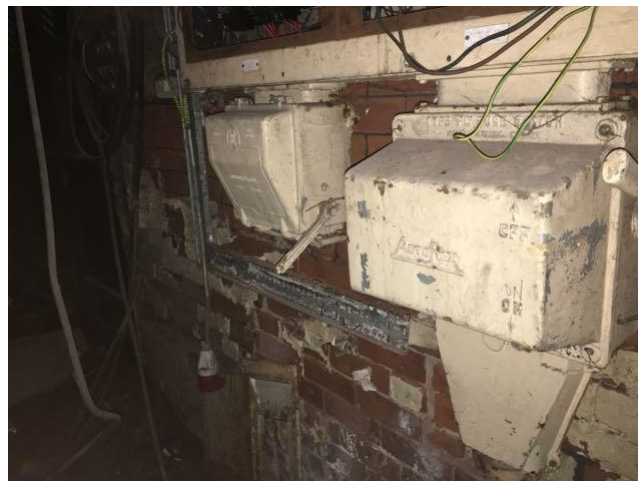
| <b>Analysis Result</b> | Chrysotile | 1 |

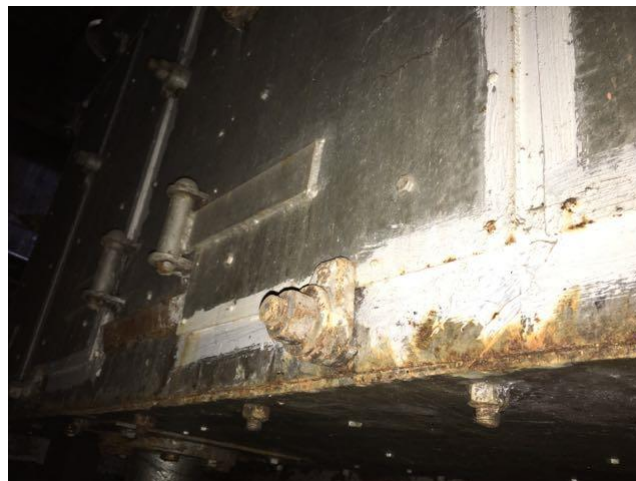
| <b>Analysis Result</b> | Chrysotile | 1 |

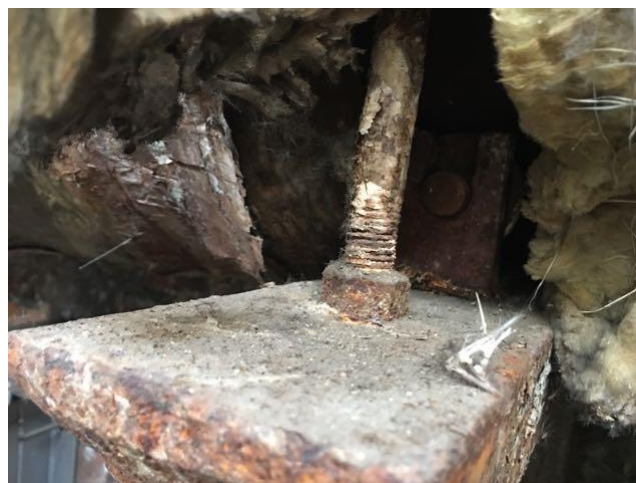
| Analysis Result | Chrysotile | 1 |

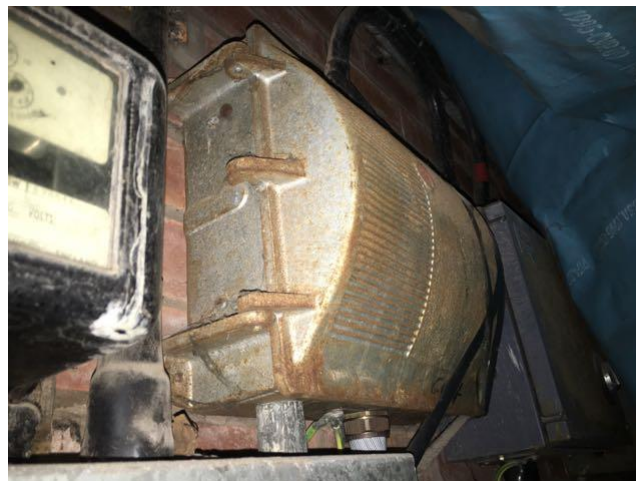
| <b>Analysis Result</b> | Chrysotile | 1 |

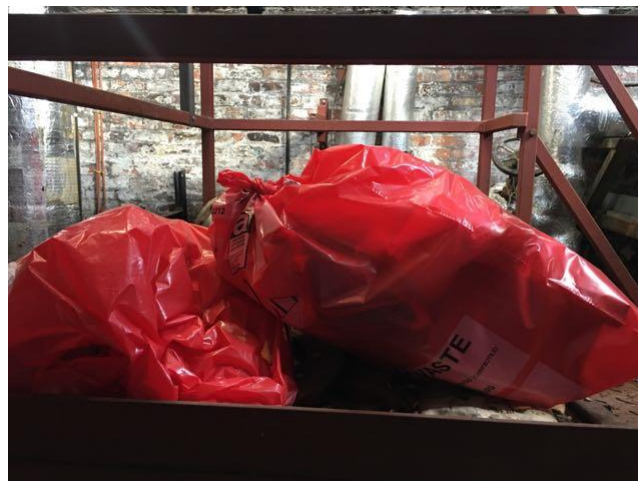
| <b>Analysis Result</b> | Chrysotile, Amosite, Crocidolite | 3 |

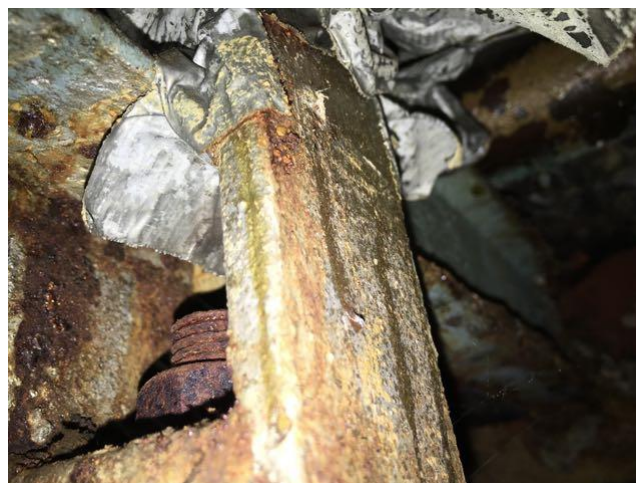
| Analysis Result | Amosite, Chrysotile | 2 |

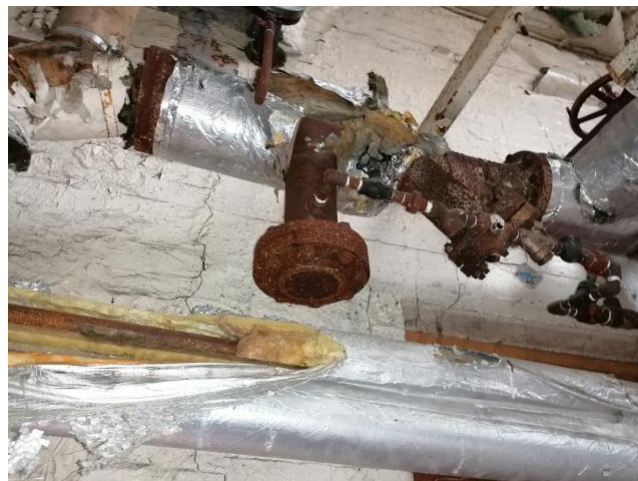
| <b>Analysis Result</b> | Chrysotile | 1 |

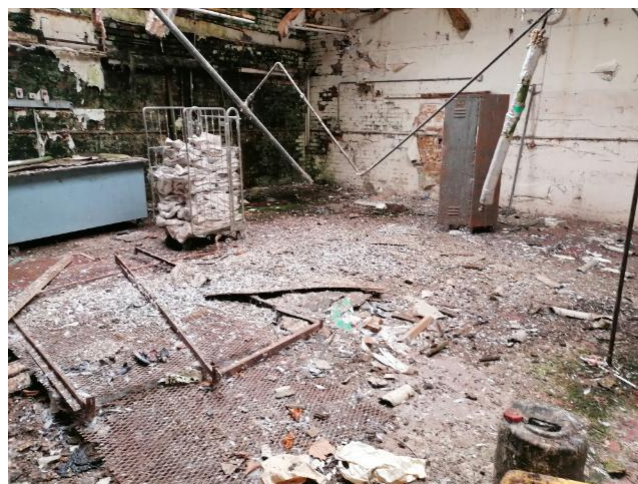
| Quantity | 70 m <sup>2</sup> |

| Analysis Result | No Asbestos Detected | 0 |
| Condition | High Damage | 3 |

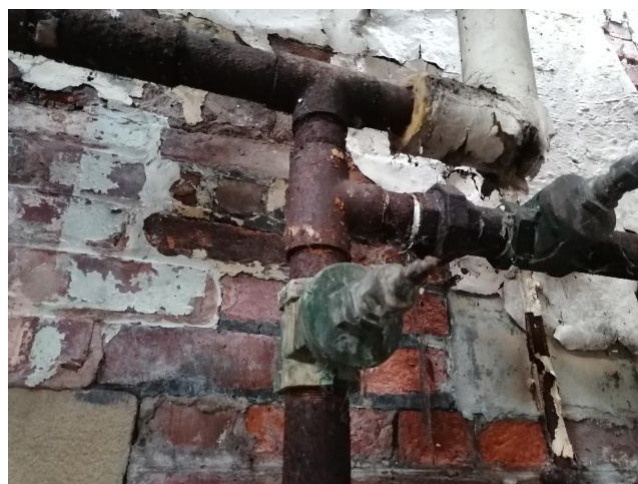
| Quantity | 20 m <sup>2</sup> |

| Analysis Result | No Asbestos Detected | 0 |
| Condition | High Damage | 3 |

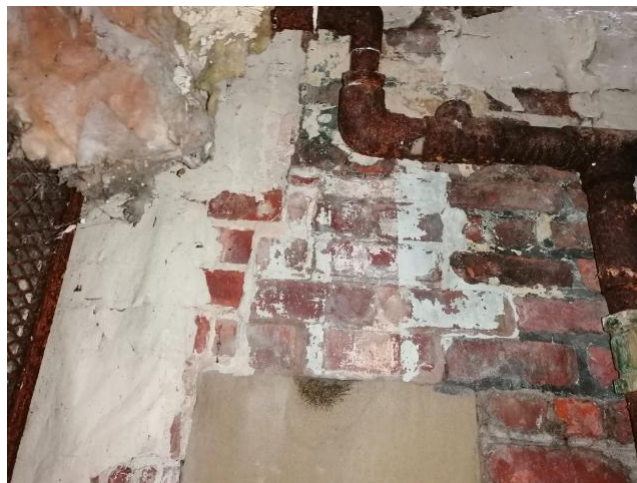
| <b>Quantity</b> | 20 m <sup>2</sup> |

| <b>Analysis Result</b> | No Asbestos Detected | 0 |
| <b>Condition</b> | High Damage | 3 |

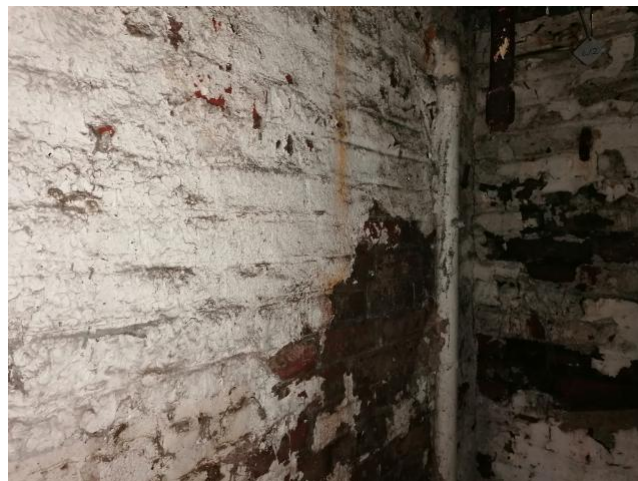
| <b>Quantity</b> | 20 m <sup>2</sup> |

| <b>Analysis Result</b> | No Asbestos Detected | 0 |
| <b>Condition</b> | High Damage | 3 |

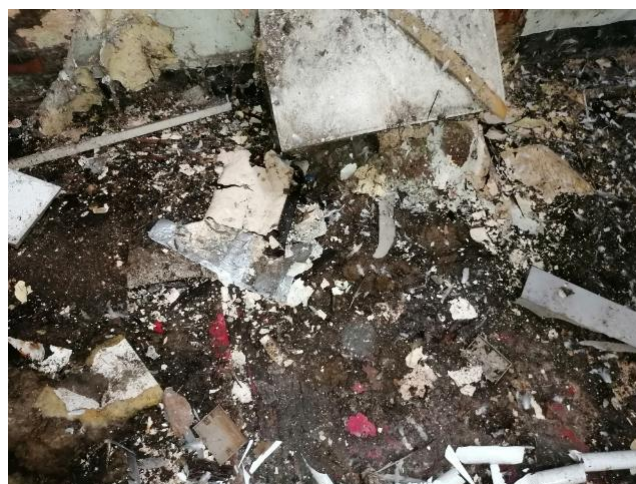
| Quantity | 20 m <sup>2</sup> |

| Analysis Result | No Asbestos Detected | 0 |
| Condition | Low Damage | 1 |

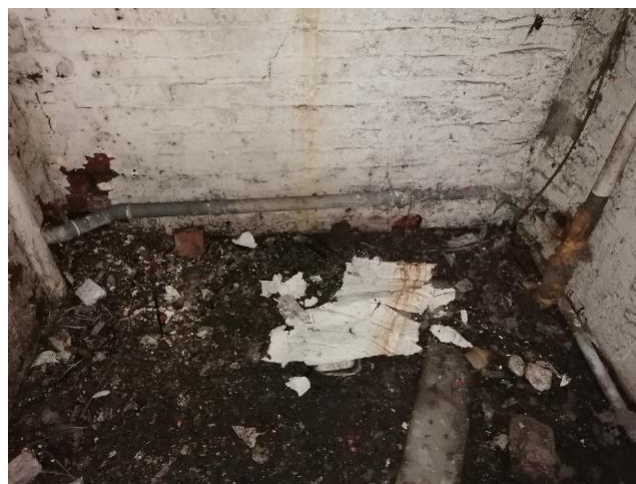
| <b>Quantity</b> | 20 m <sup>2</sup> |

| <b>Analysis Result</b> | No Asbestos Detected | 0 |
| <b>Condition</b> | High Damage | 3 |

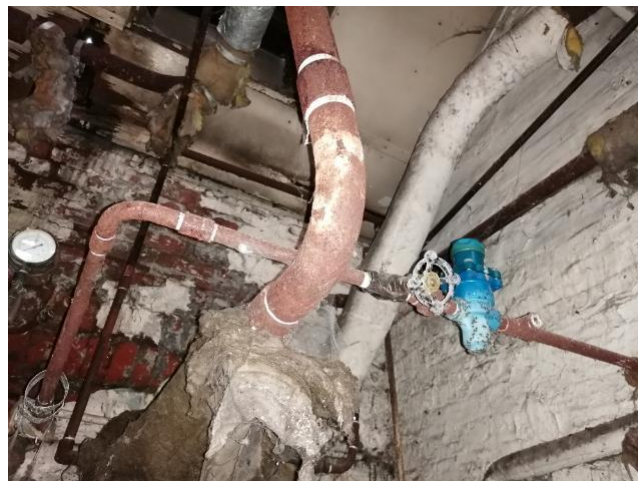
| <b>Quantity</b> | 20 m <sup>2</sup> |

| <b>Analysis Result</b> | Chrysotile | 1 |
| <b>Condition</b> | Low Damage | 1 |

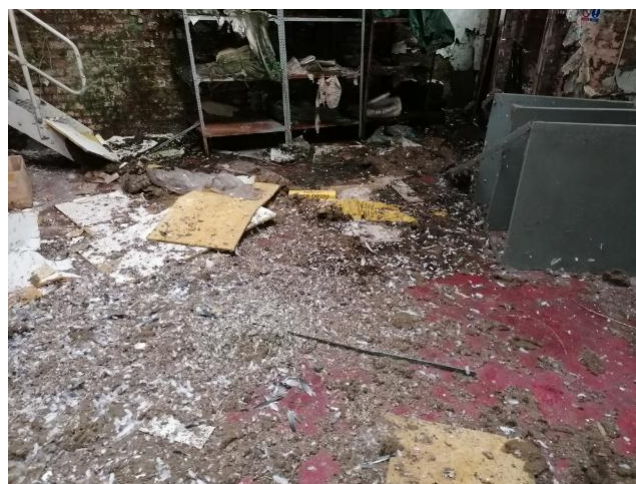
| Quantity | 50 m <sup>2</sup> |

| Analysis Result | No Asbestos Detected | 0 |
| Condition | Low Damage | 1 |

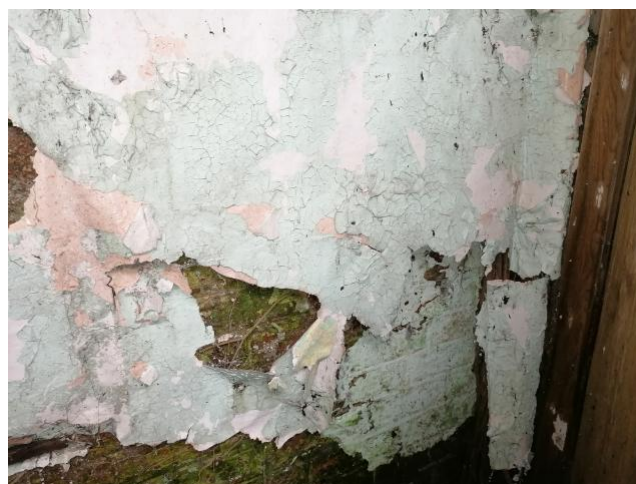
| <b>Quantity</b> | 50 m <sup>2</sup> |

| <b>Analysis Result</b> | No Asbestos Detected | 0 |
| <b>Condition</b> | High Damage | 3 |

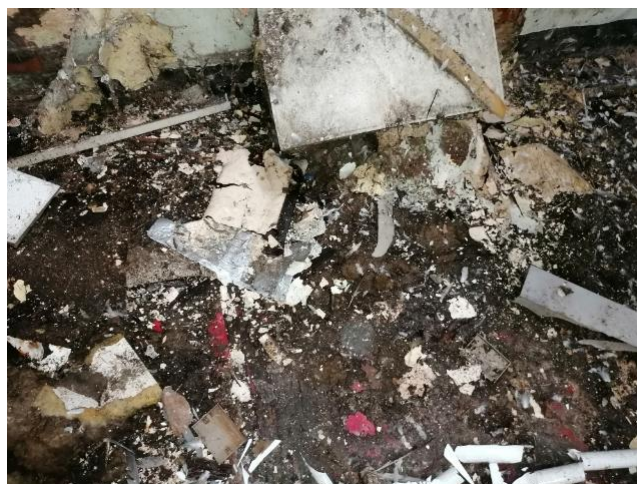
| <b>Quantity</b> | 50 m <sup>2</sup> |

| <b>Analysis Result</b> | No Asbestos Detected | 0 |
| <b>Condition</b> | High Damage | 3 |

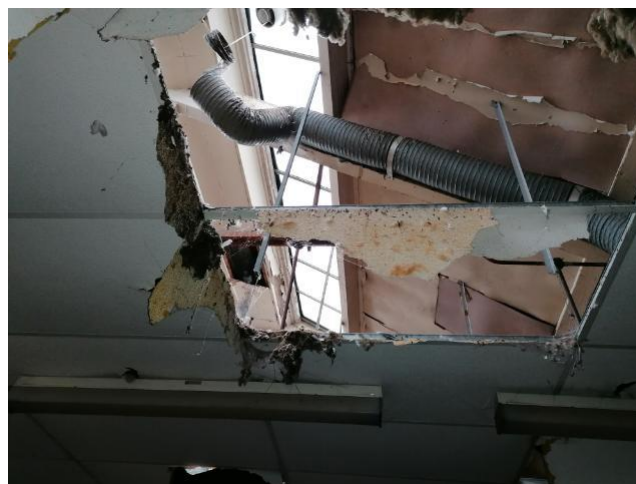
| Quantity | 10 m <sup>2</sup> |

| Analysis Result | Chrysotile | 1 |
| Condition | Good Condition | 0 |

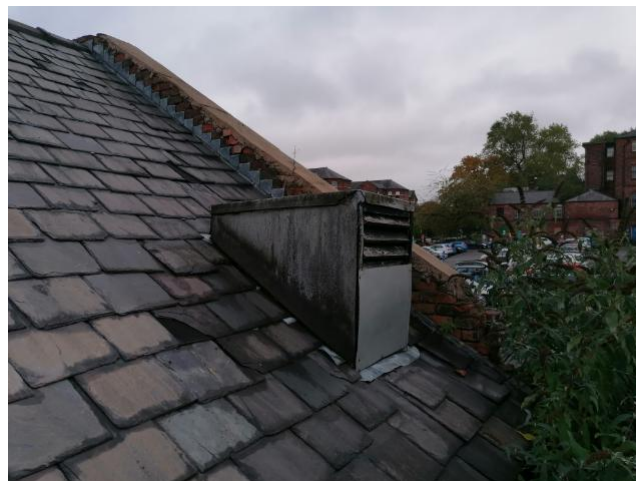
| <b>Quantity</b> | 1 m <sup>2</sup> |

| <b>Analysis Result</b> | Chrysotile | 1 |
| <b>Condition</b> | Good Condition | 0 |

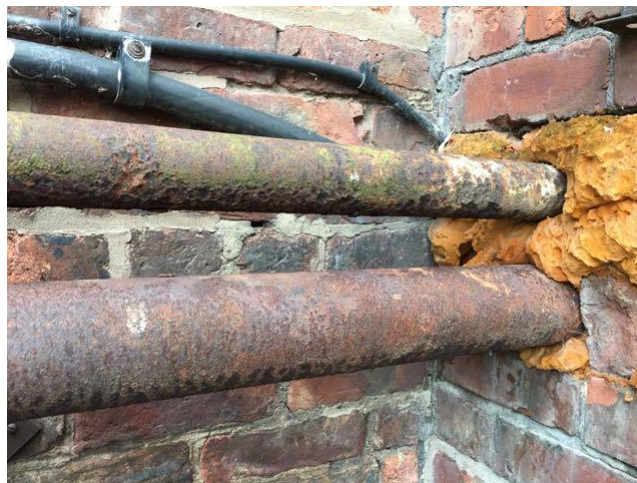
| <b>Quantity</b> | 15 Lin M |

| <b>Analysis Result</b> | Amosite, Chrysotile | 2 |
| <b>Condition</b> | High Damage | 3 |

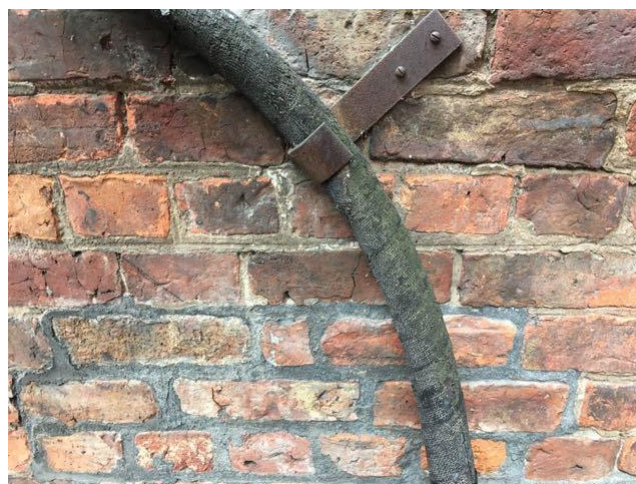
| <b>Quantity</b> | 5 Lin M |

| <b>Analysis Result</b> | No Asbestos Detected | 0 |
| <b>Condition</b> | Low Damage | 1 |

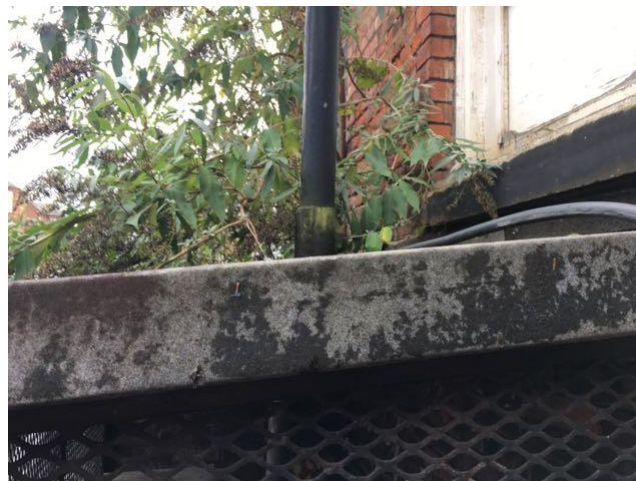
| <b>Quantity</b> | 4 m <sup>2</sup> |

| <b>Analysis Result</b> | Chrysotile | 1 |
| <b>Condition</b> | Low Damage | 1 |

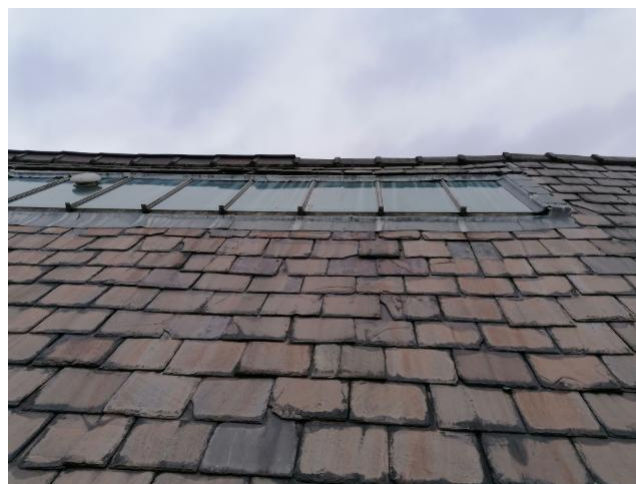
| <b>Quantity</b> | 10 m <sup>2</sup> |

| <b>Analysis Result</b> | Chrysotile | 1 |
| <b>Condition</b> | Good Condition | 0 |
