Validation Completion Report  
Plots 1-54  
Bowes Street, Manchester

Reference:11-813-R5-1  
Date: March 2022

Plots 1-54  
Former Stagecoach Bus Depot  
Land off Bowes Street  
Manchester

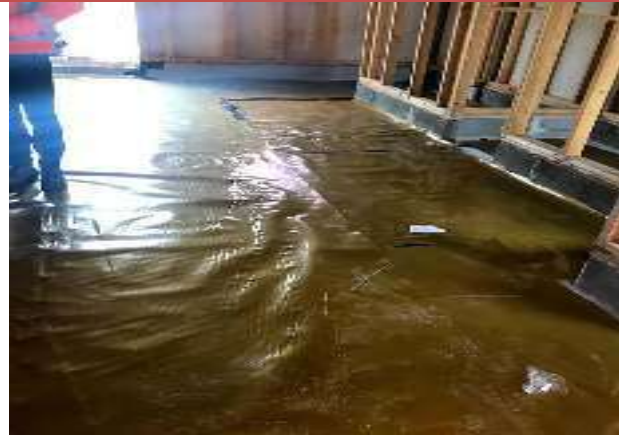
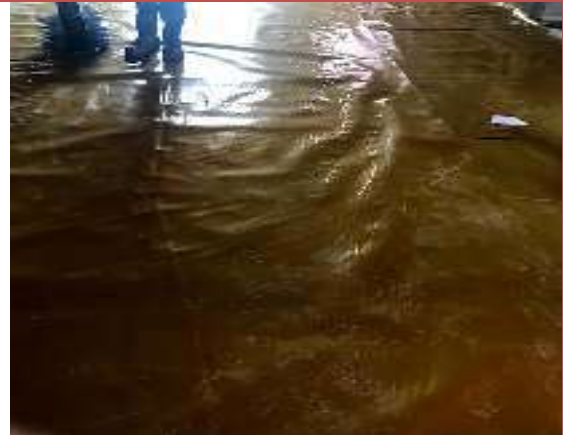
**Plot – 1**

**General Condition of Membrane-Good Condition**

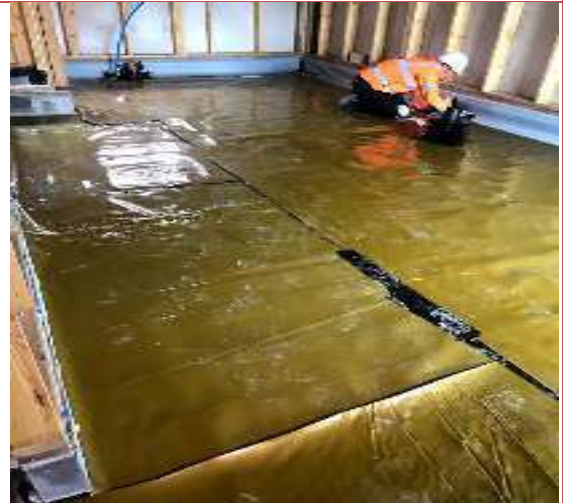
**Verification of Joints and Seals-Good Condition**

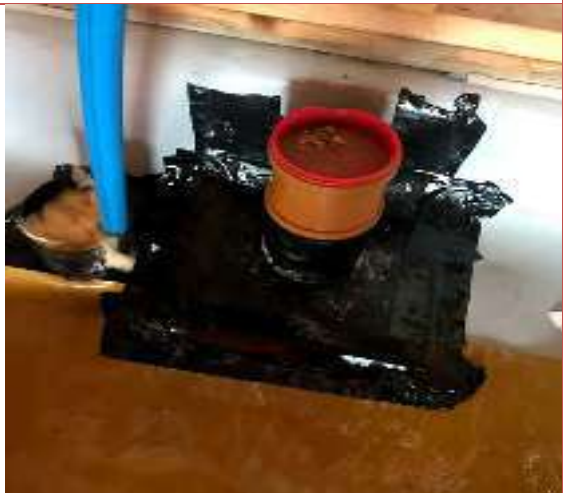
**Verification of Service Penetrations-Good Condition**

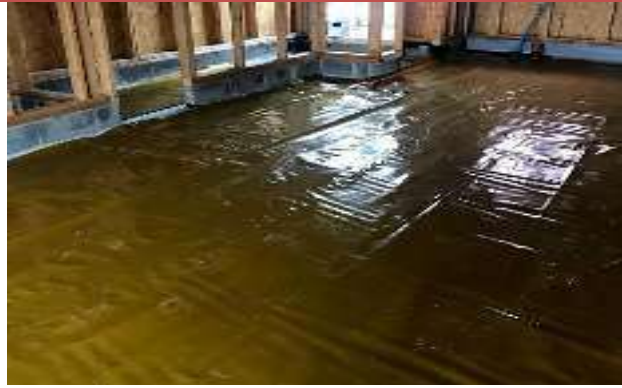
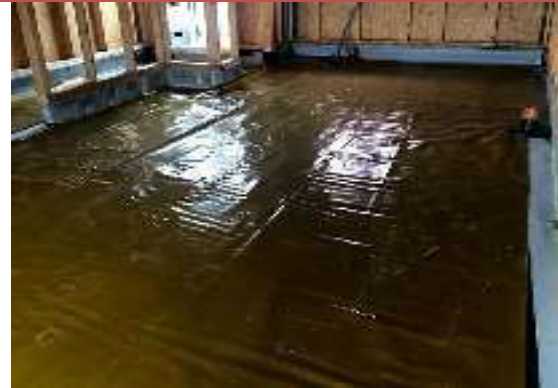
**Plot - 2**

**General Condition of Membrane-Good Condition**

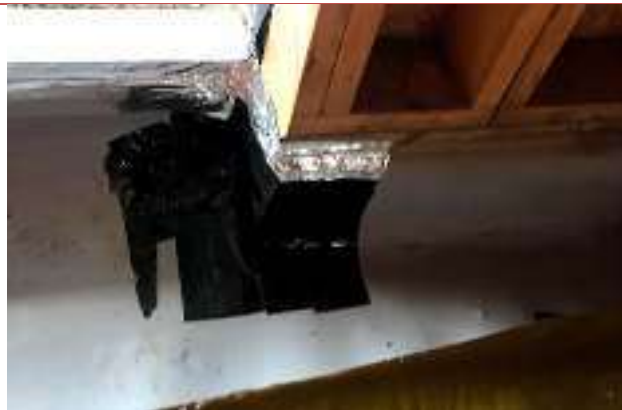
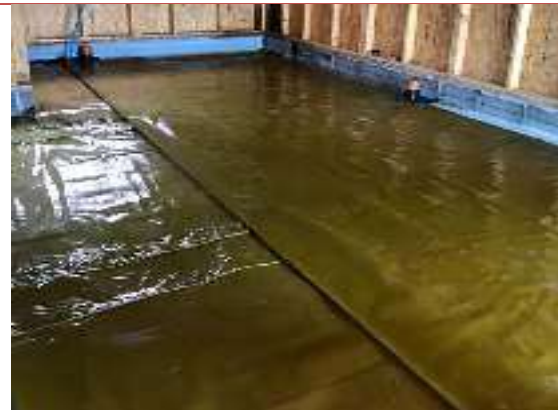
**Verification of Joints and Seals-Good Condition**

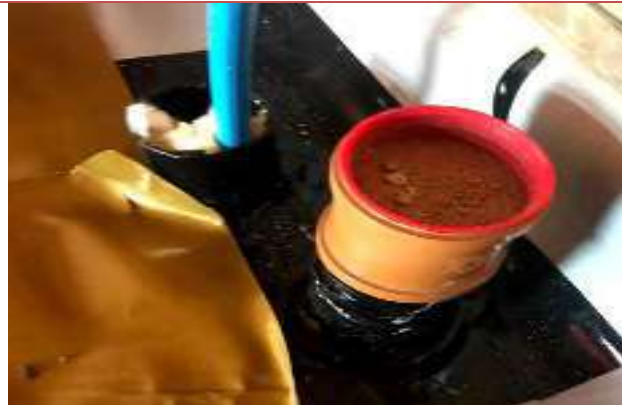
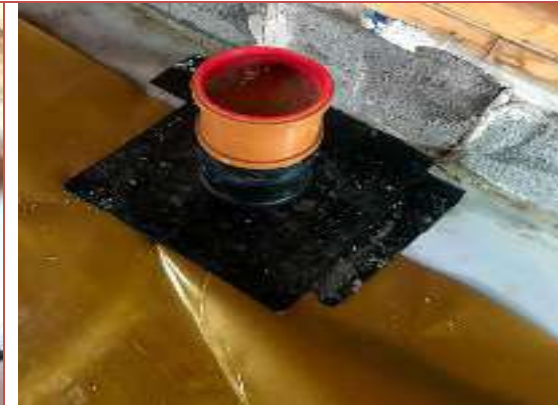
**Verification of Service Penetrations-Good Condition**

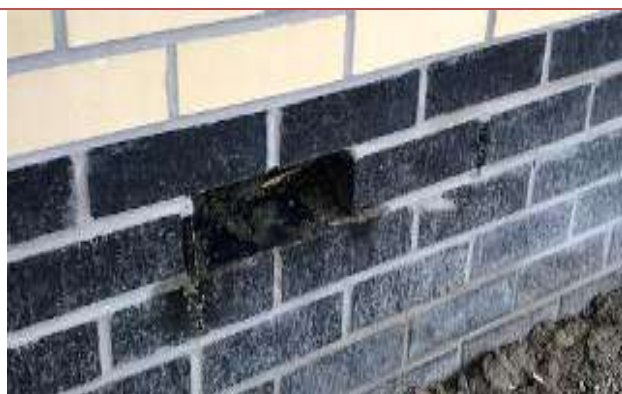
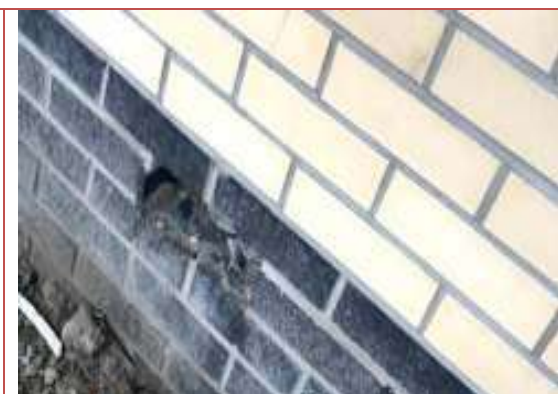
**Verification of ventilation-Good Condition**

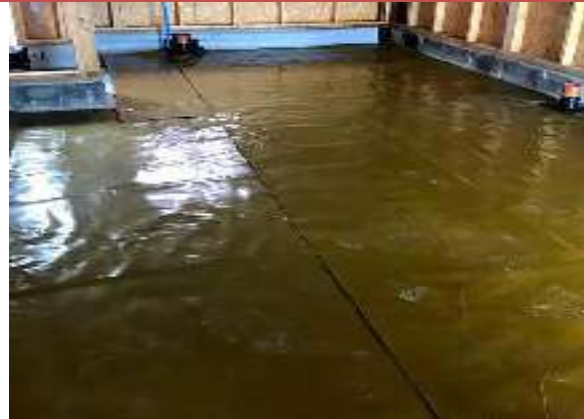
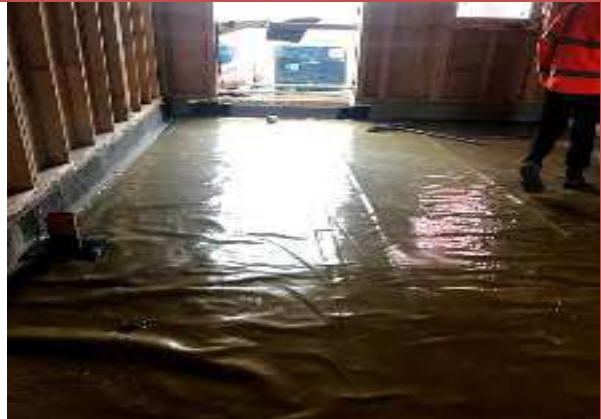
**Plot - 3**

**General Condition of Membrane-Good Condition**

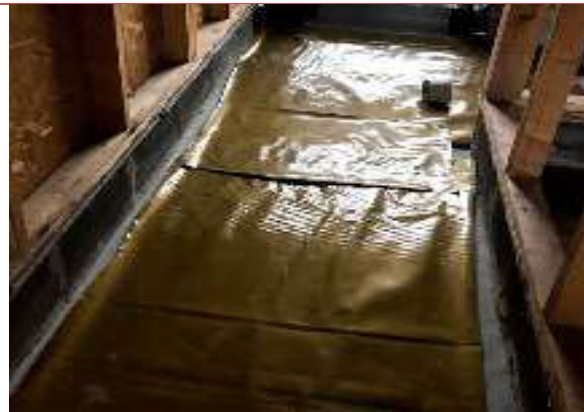
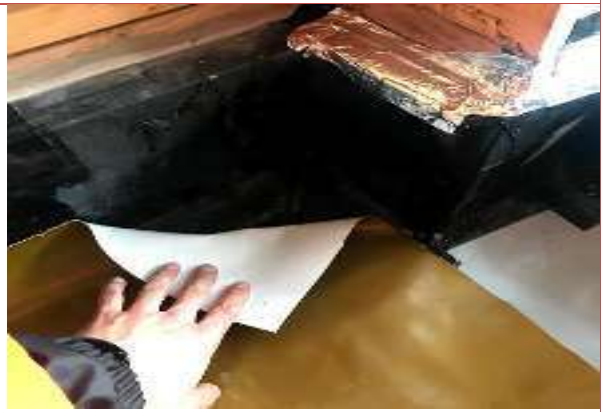
**Verification of Joints and Seals-Good Condition**

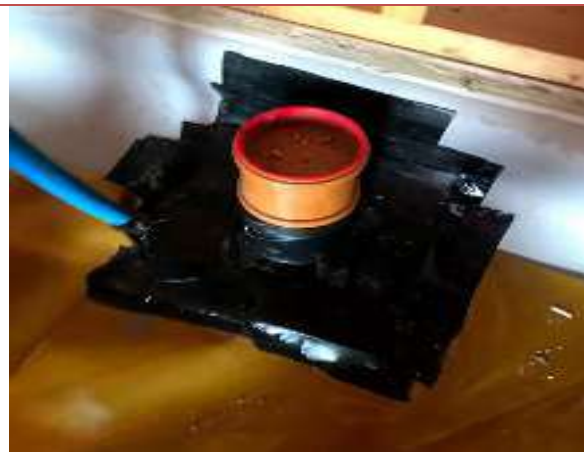
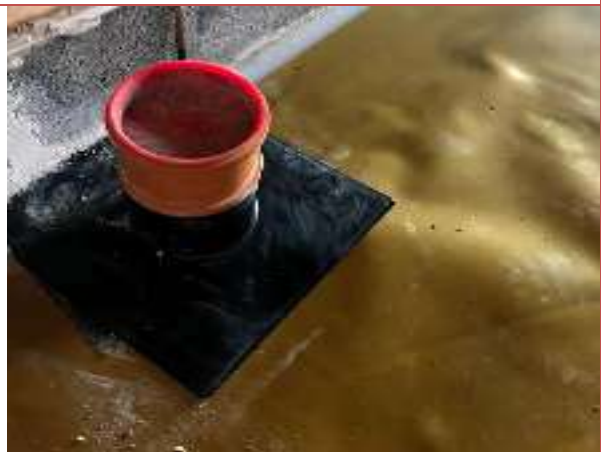
**Verification of Service Penetrations-Good Condition**

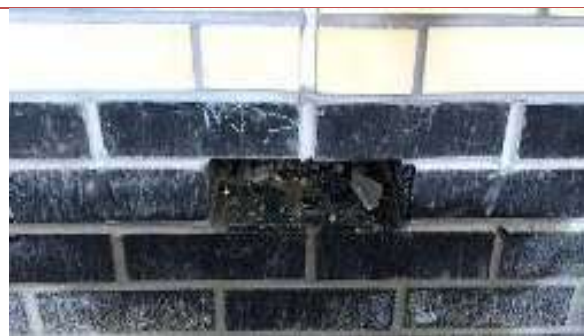
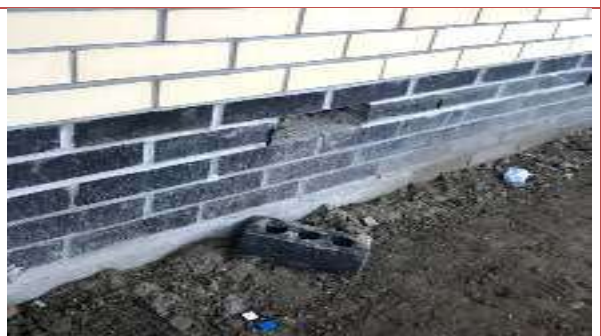
**Verification of ventilation-Good Condition**

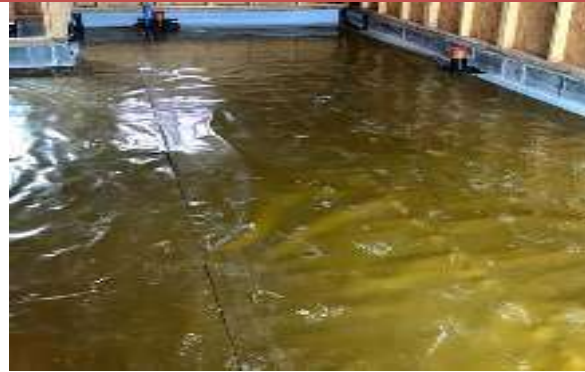
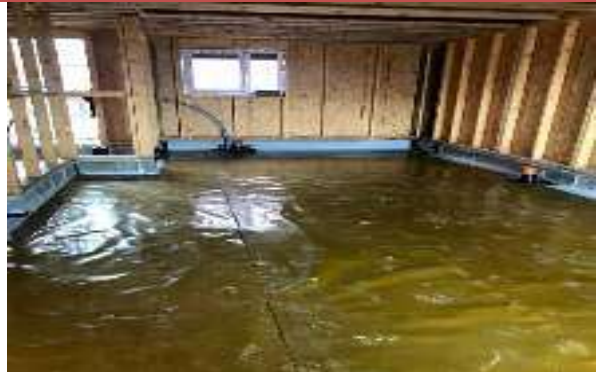
**Plot - 4**

**General Condition of Membrane-Good Condition**

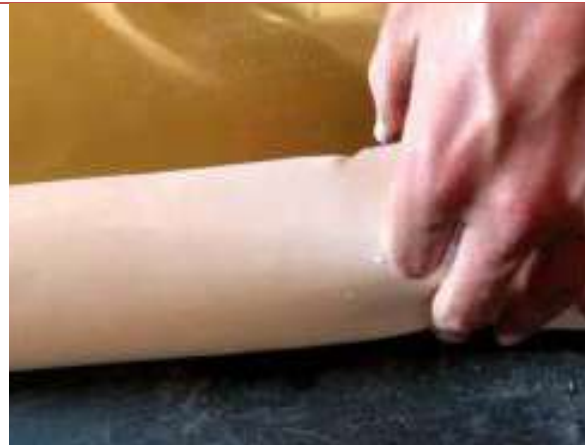
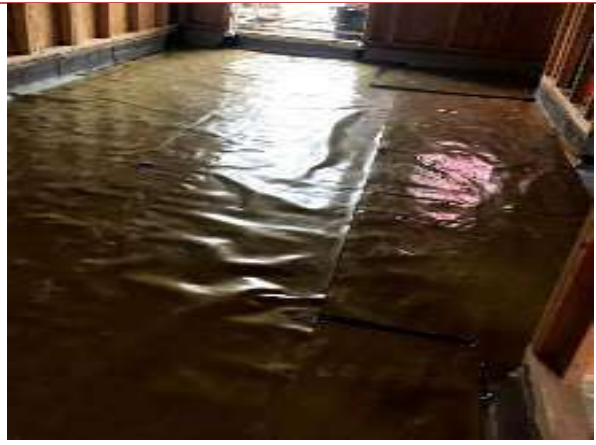
**Verification of Joints and Seals-Good Condition**

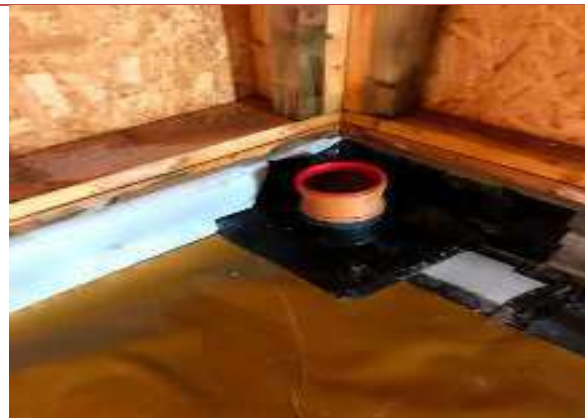
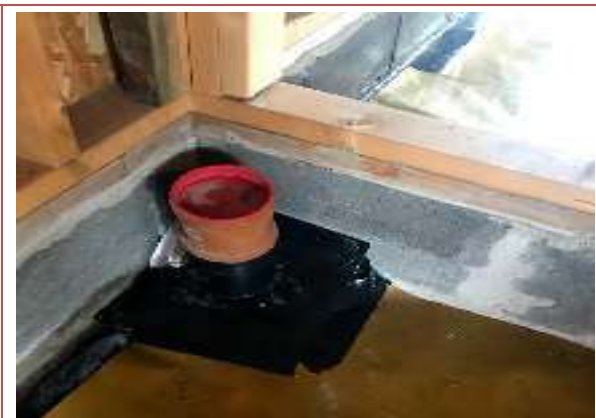
**Verification of Service Penetrations-Good Condition**

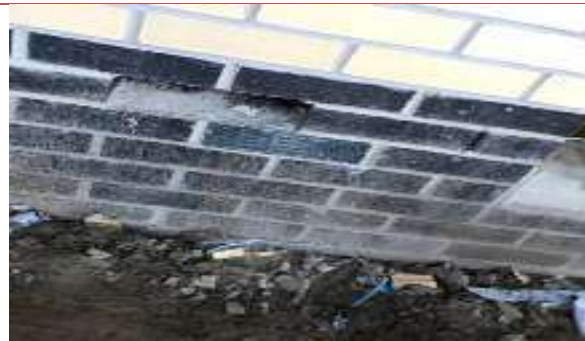
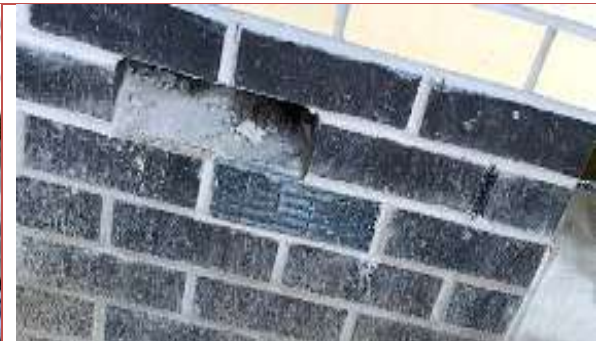
**Verification of ventilation-Good Condition**

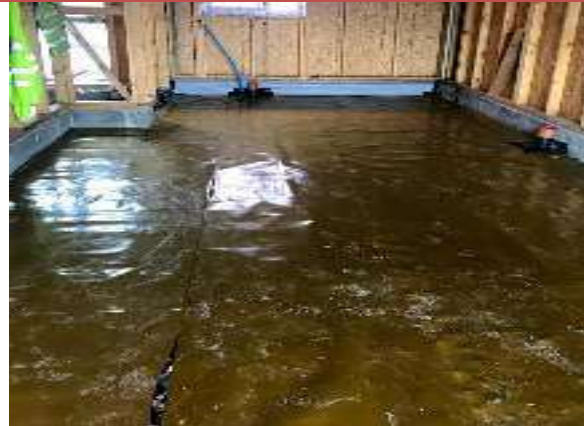
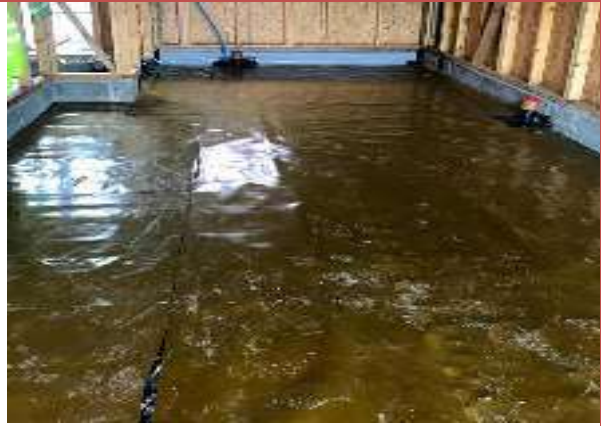
**Plot - 5**

**General Condition of Membrane-Good Condition**

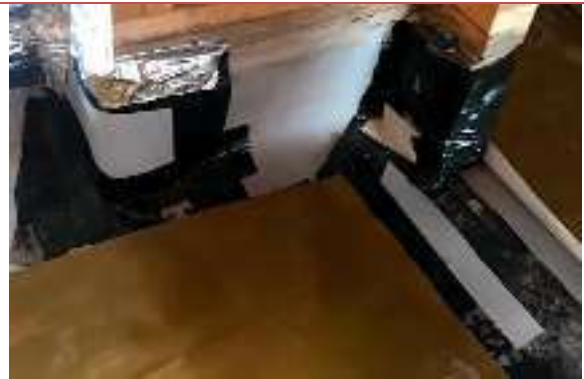
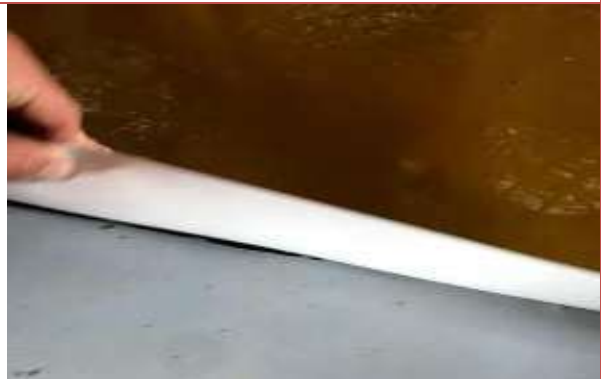
**Verification of Joints and Seals-Good Condition**

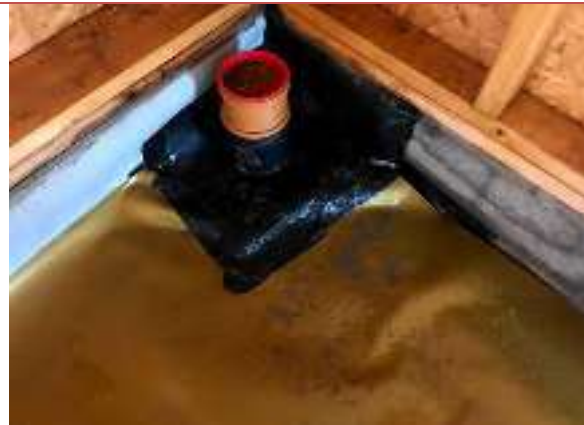
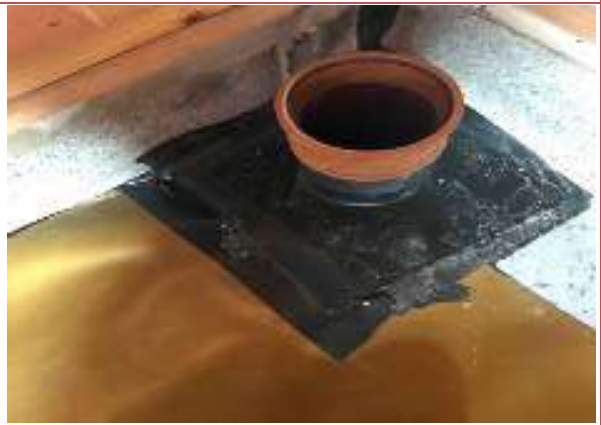
**Verification of Service Penetrations-Good Condition**

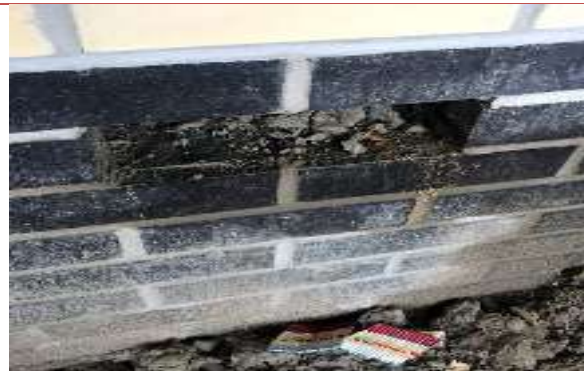
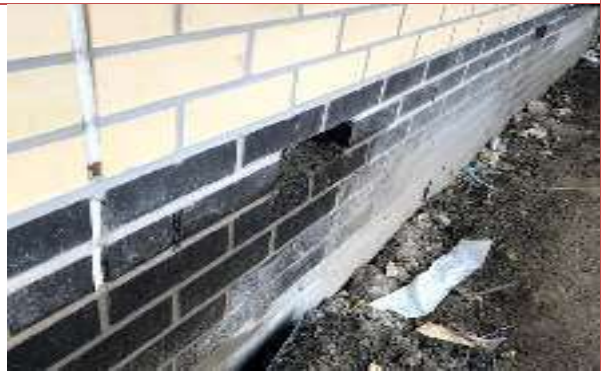
**Verification of ventilation-Good Condition**

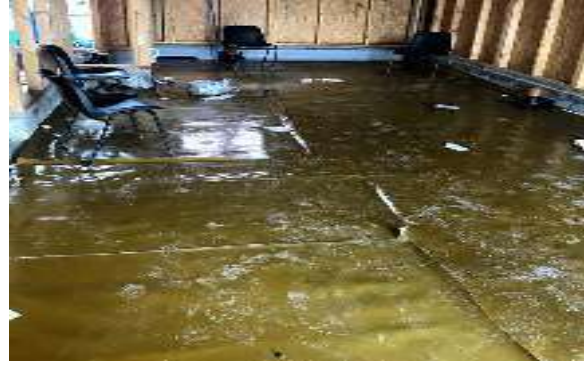
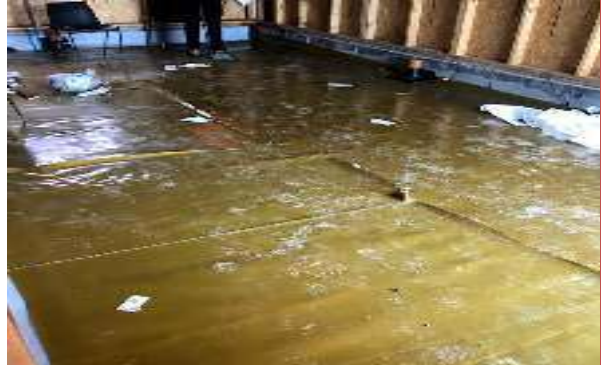
**Plot - 6**

**General Condition of Membrane-Good Condition**

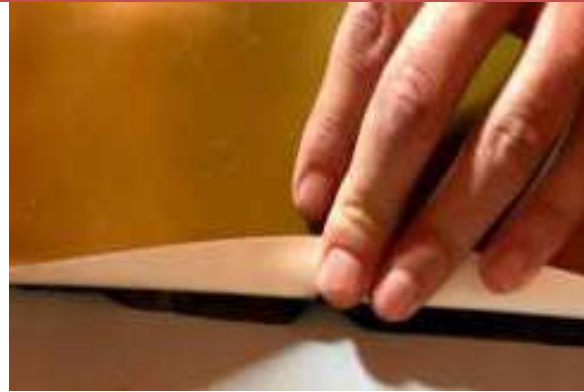
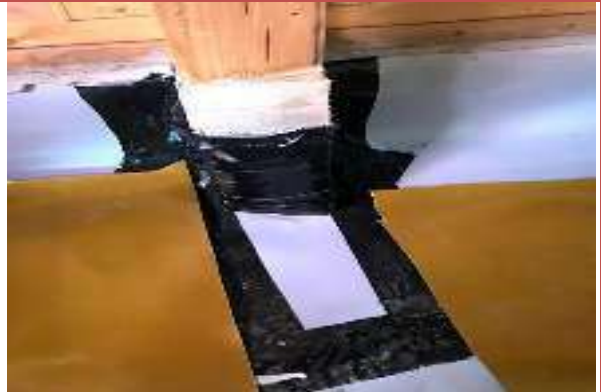
**Verification of Joints and Seals-Good Condition**

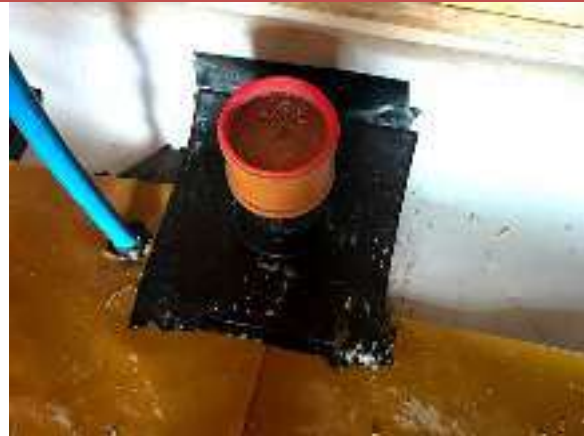
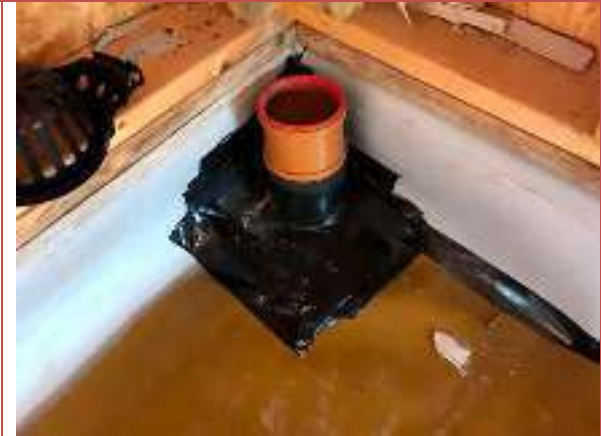
**Verification of Service Penetrations-Good Condition**

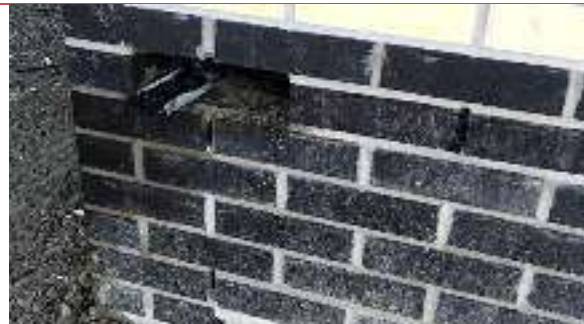
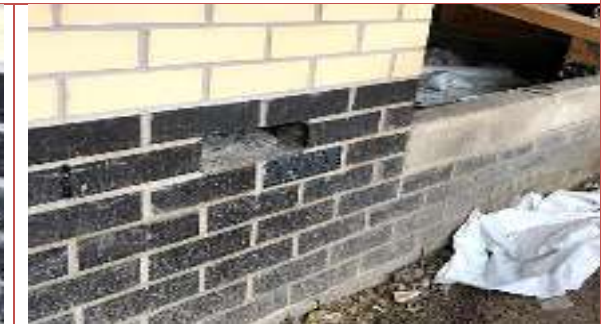
**Verification of Ventilation-Good Condition**

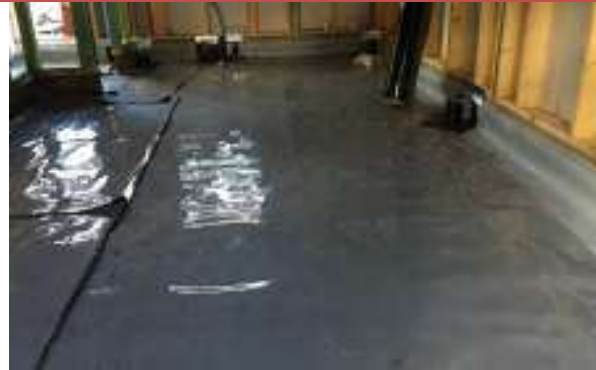
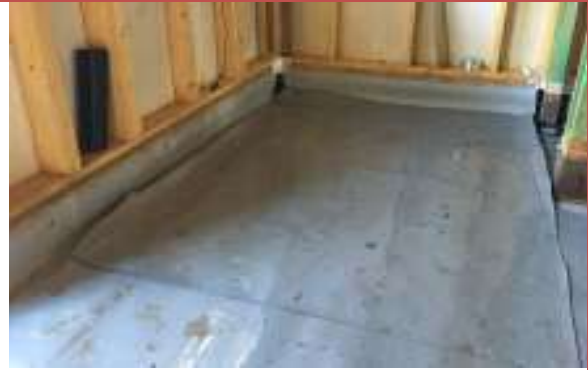
**Plot – 7**

**General Condition of Membrane-Good Condition**

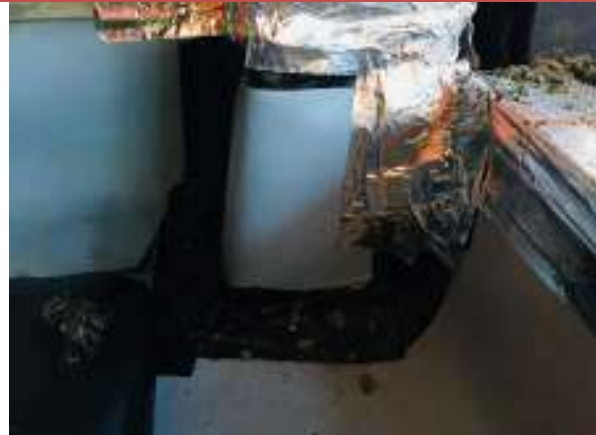
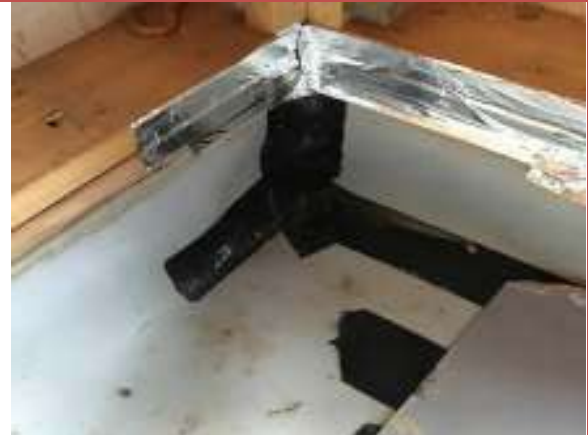
**Verification of Joints and Seals-Good Condition**

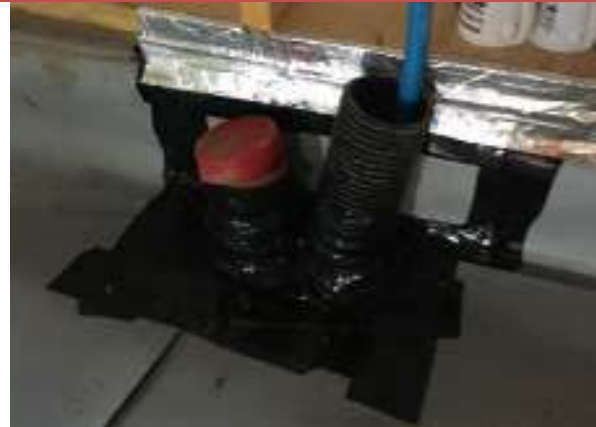
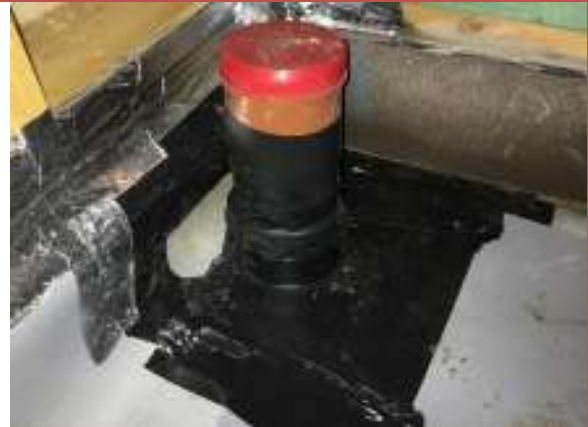
**Verification of Service Penetrations-Good Condition**

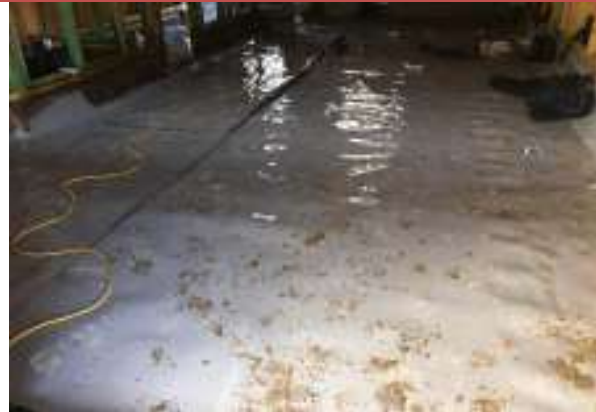
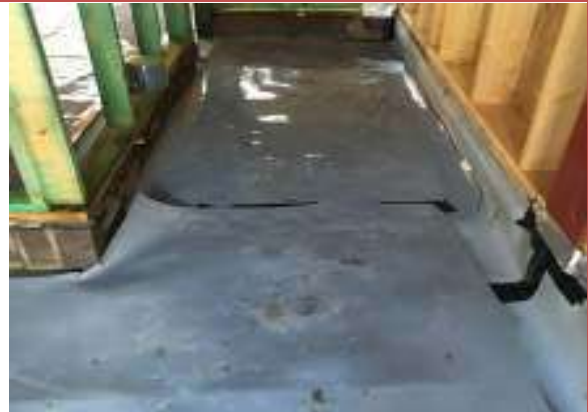
**Plot – 8**

**General Condition of Membrane-Good Condition**

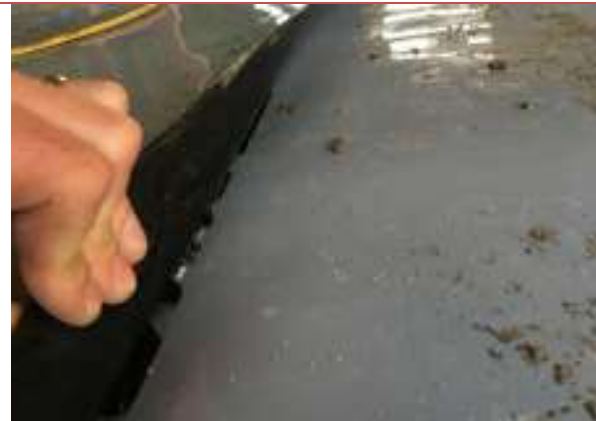
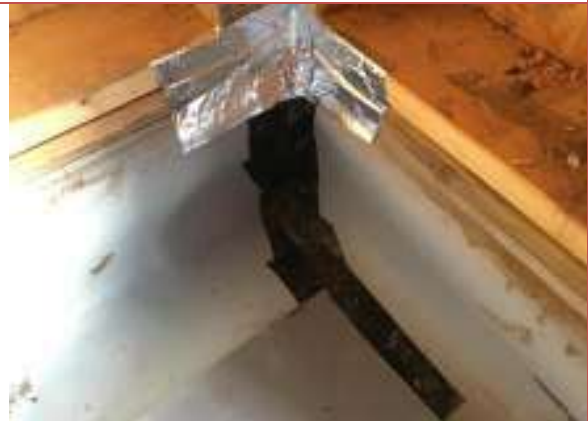
**Verification of Joints and Seals-Good Condition**

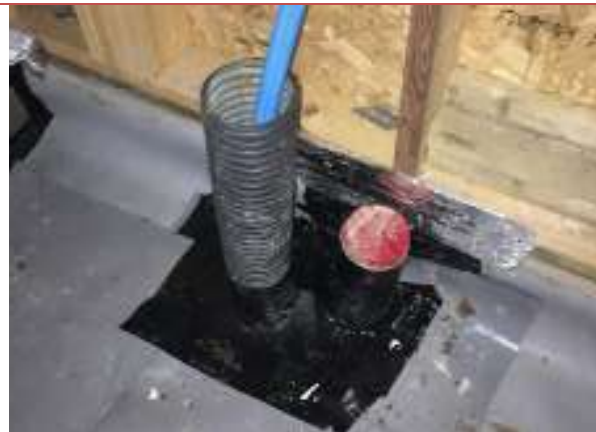
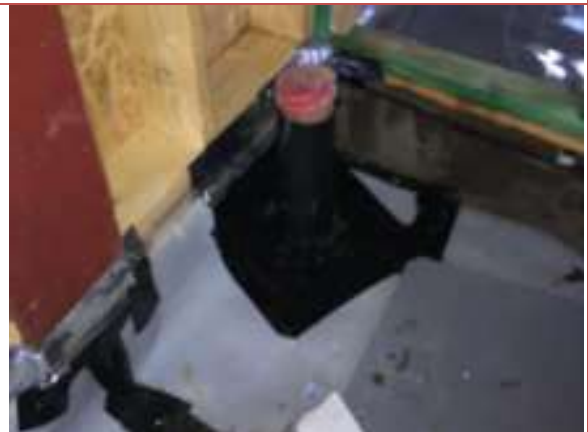
**Verification of Service Penetrations-Good Condition**

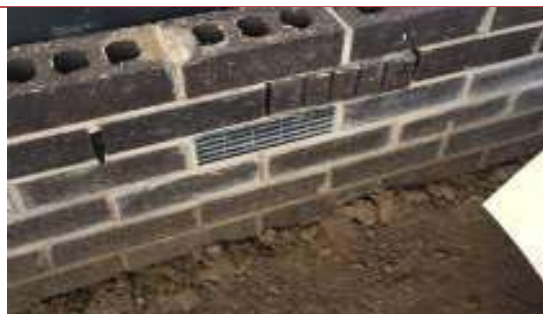
**Verification of Ventilation- Good Condition**

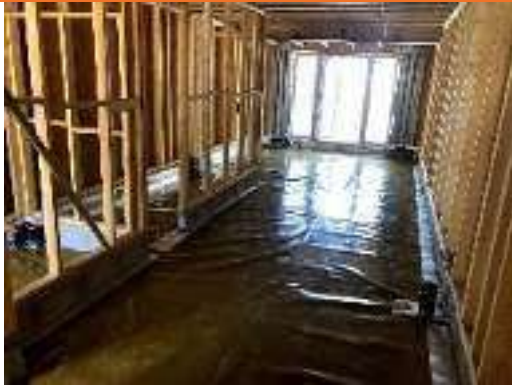
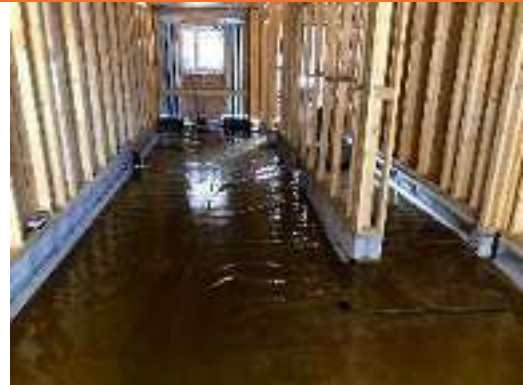
**Plot – 9**

**General Condition of Membrane-Good Condition**

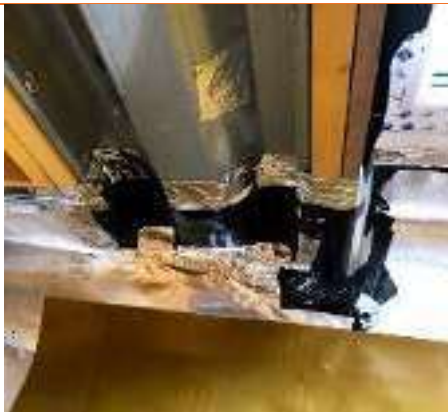
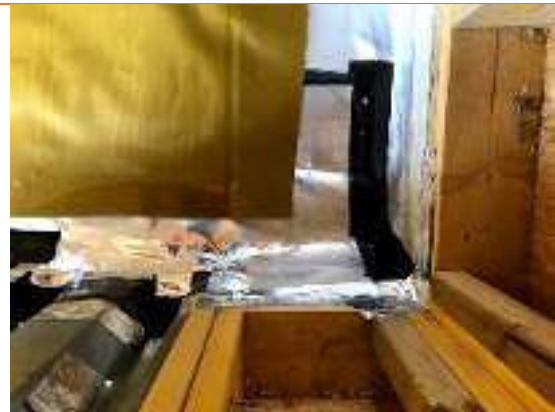
**Verification of Joints and Seals-Good Condition**

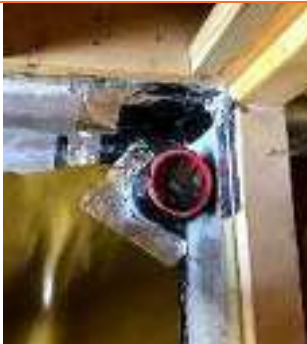
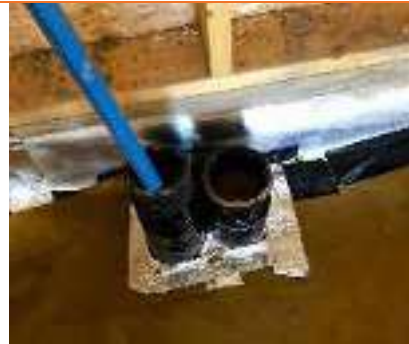
**Verification of Service Penetrations-Good Condition**

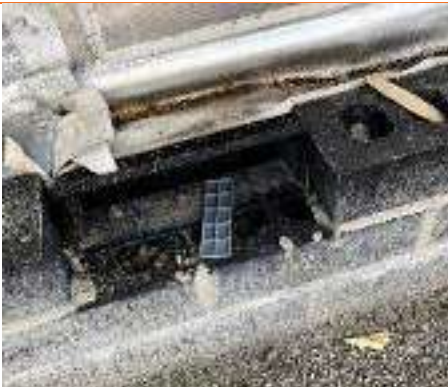
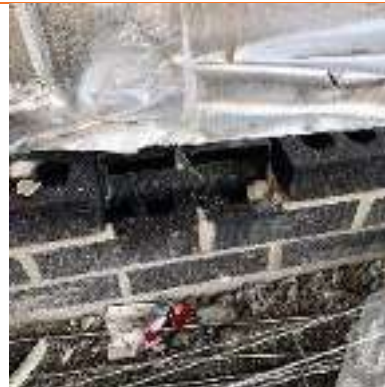
**Verification of Ventilation- Good Condition**

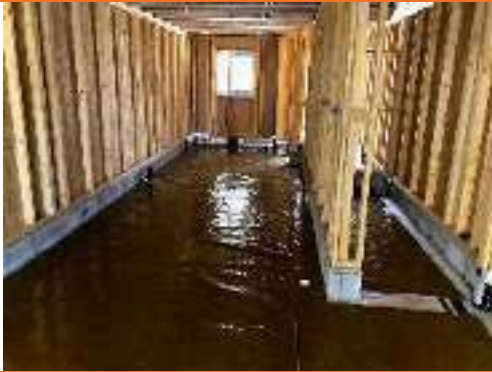
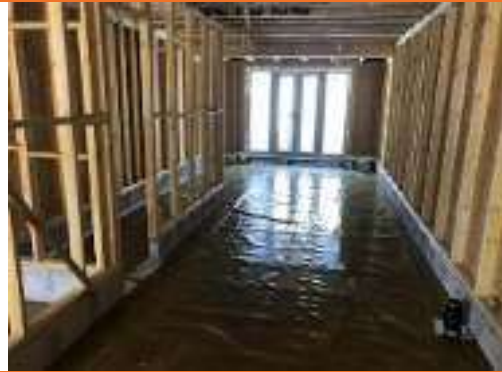
**Plot – 10**

**General Condition of Membrane-Good Condition**

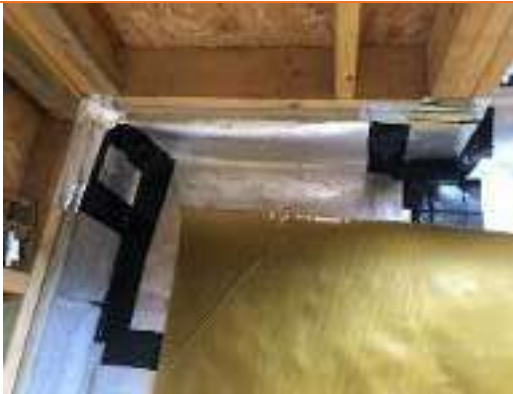
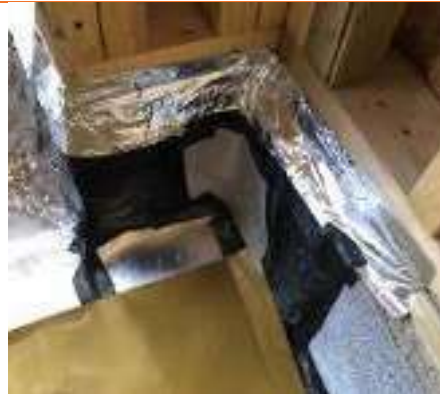
**Verification of Joints and Seals-Good Condition**

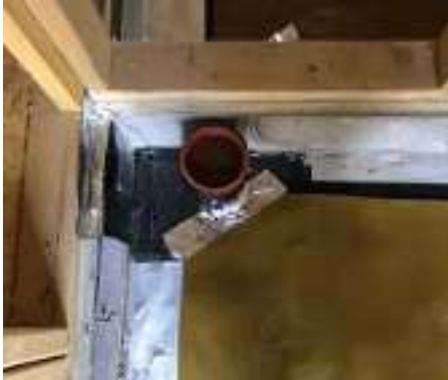
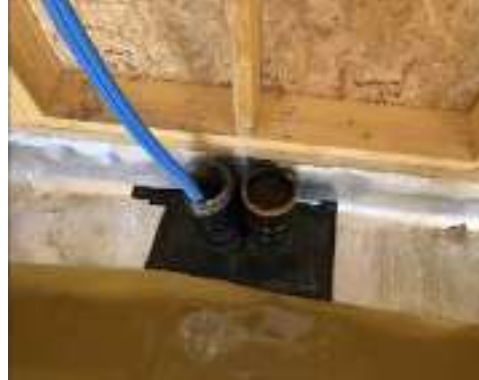
**Verification of Service Penetrations-Good Condition**

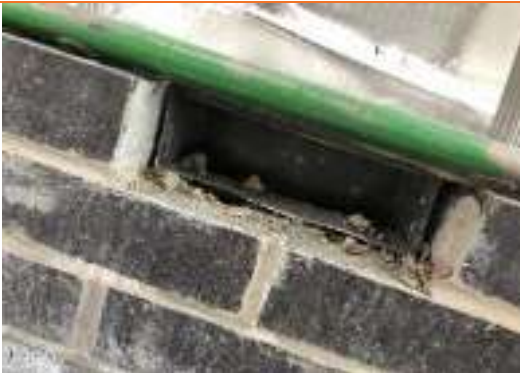
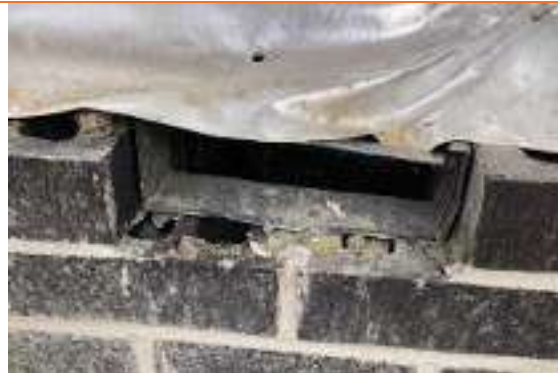
**Verification of Ventilation- Good Condition**

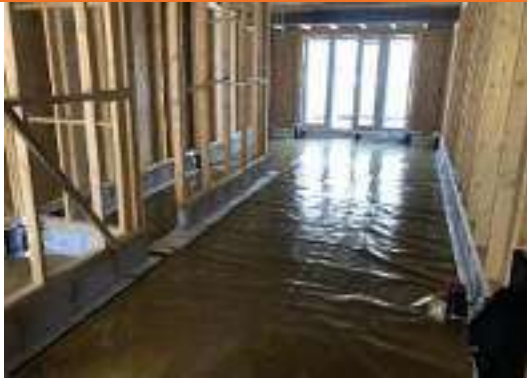
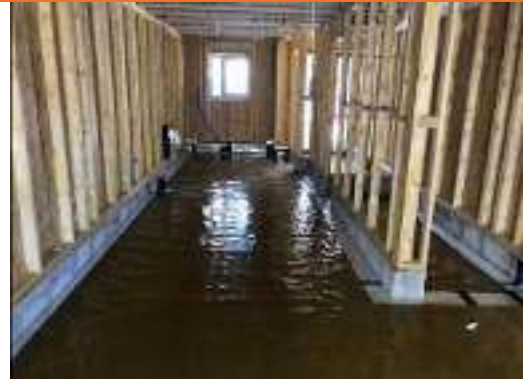
**Plot – 11**

**General Condition of Membrane-Good Condition**

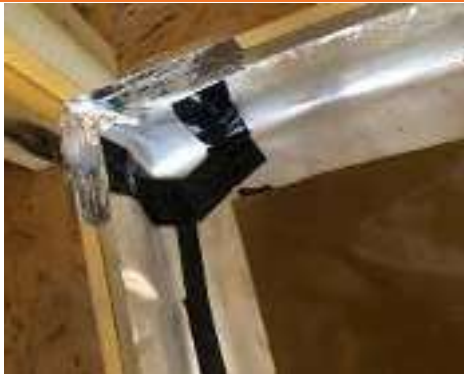
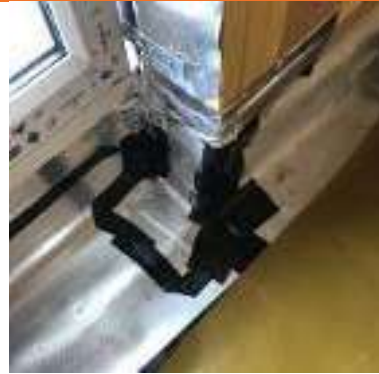
**Verification of Joints and Seals-Good Condition**

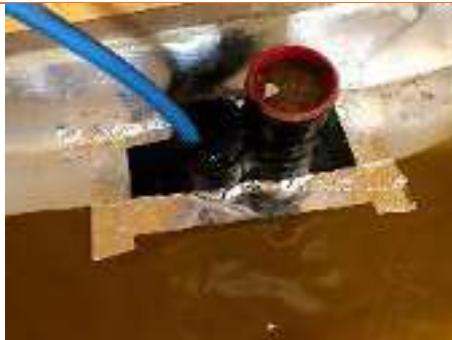
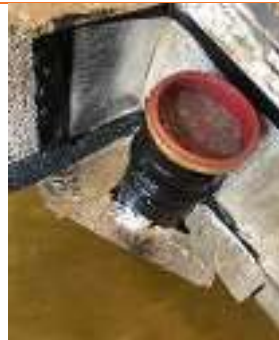
**Verification of Service Penetrations-Good Condition**

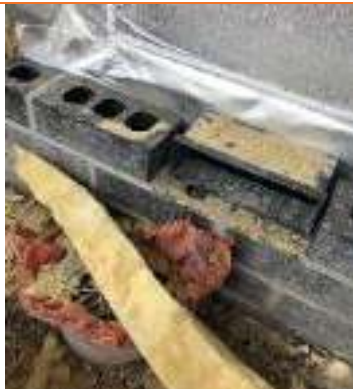
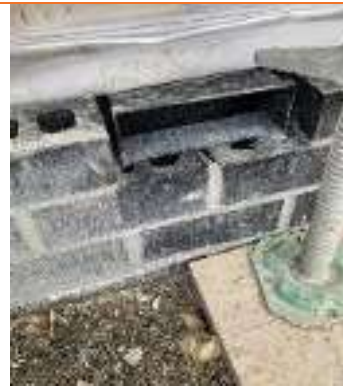
**Verification of Ventilation- Good Condition**

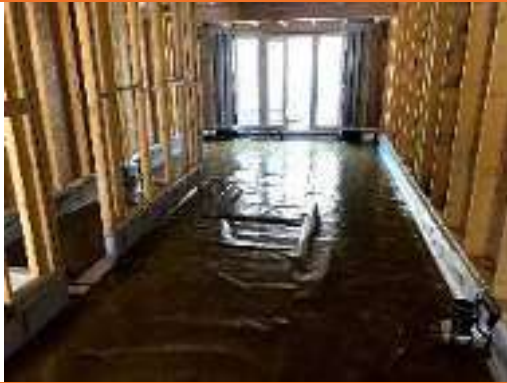
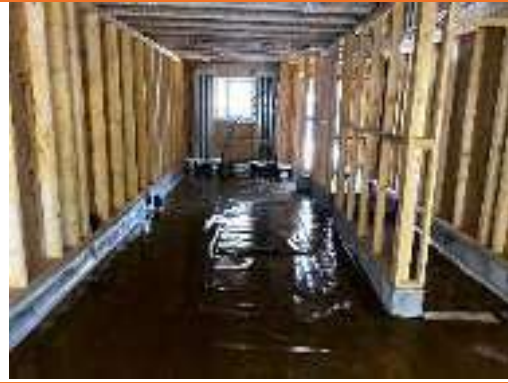
**Plot – 12**

**General Condition of Membrane-Good Condition**

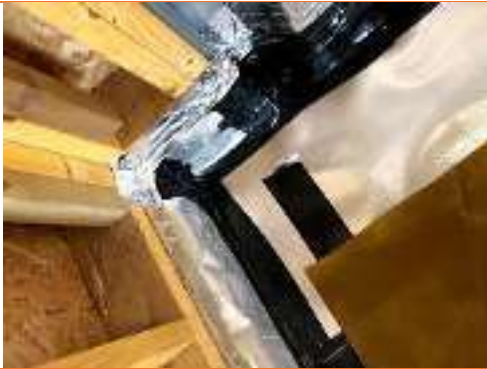
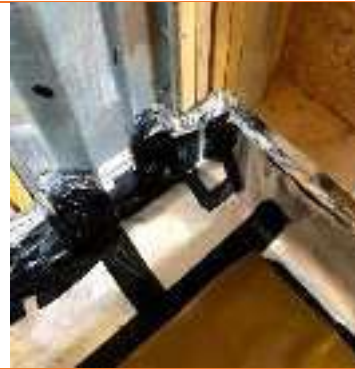
**Verification of Joints and Seals-Good Condition**

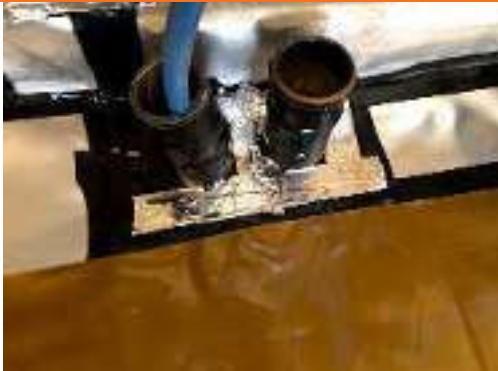
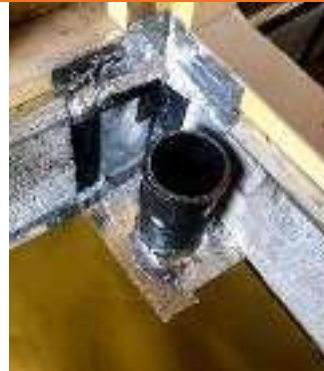
**Verification of Service Penetrations-Good Condition**

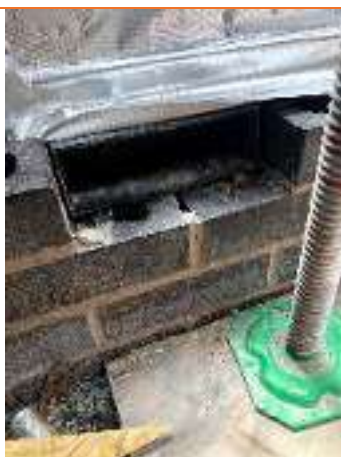
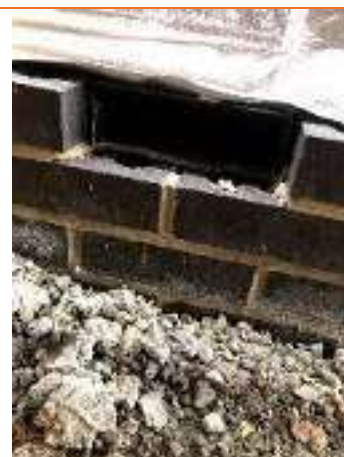
**Verification of Ventilation- Good Condition**

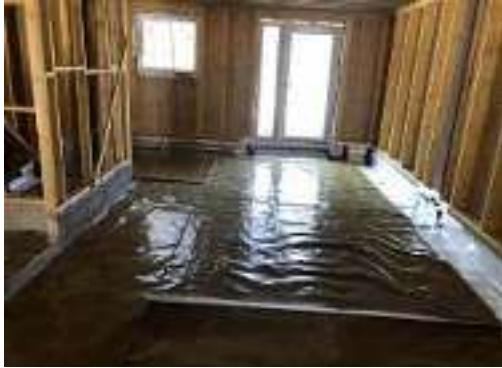
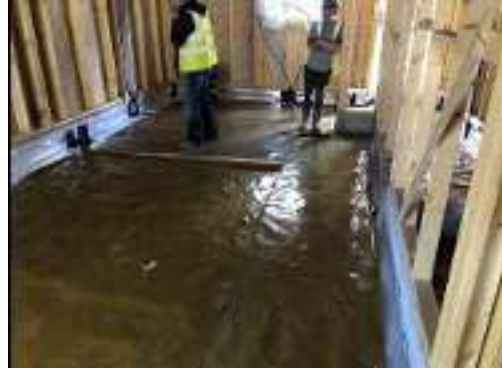
**Plot – 17**

**General Condition of Membrane-Good Condition**

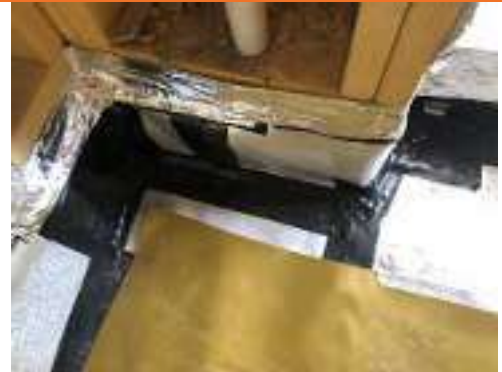
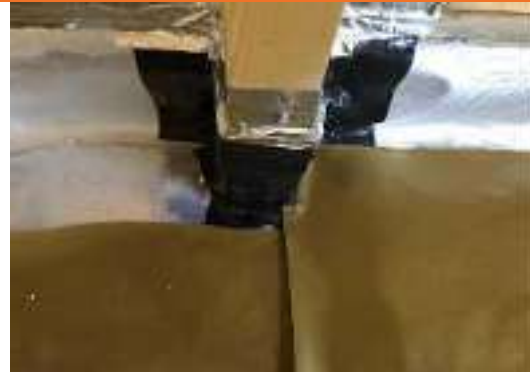
**Verification of Joints and Seals-Good Condition**

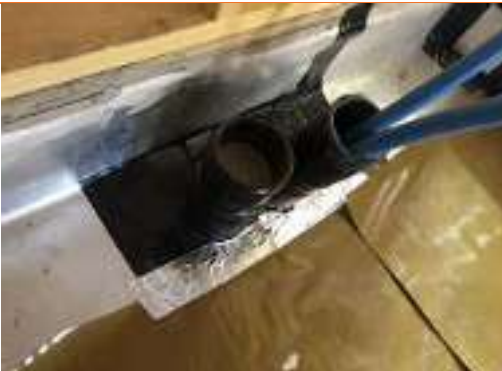
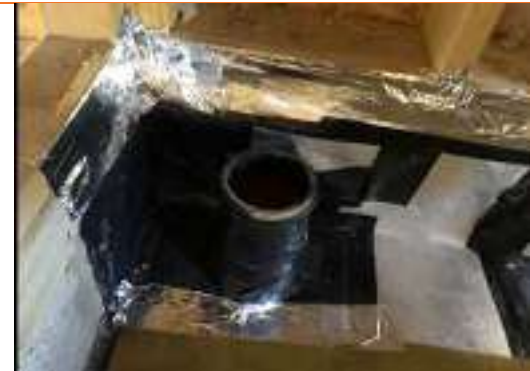
**Verification of Service Penetrations-Good Condition**

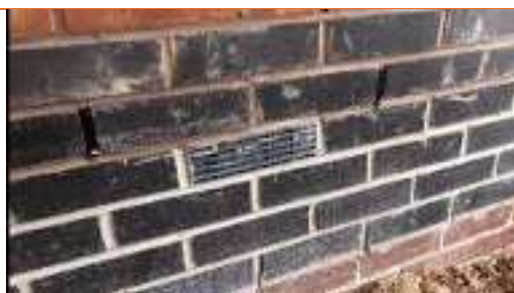
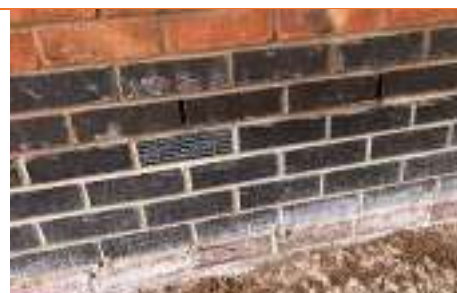
**Verification of Ventilation- Good Condition**

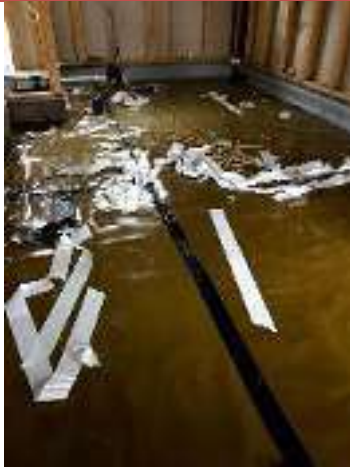
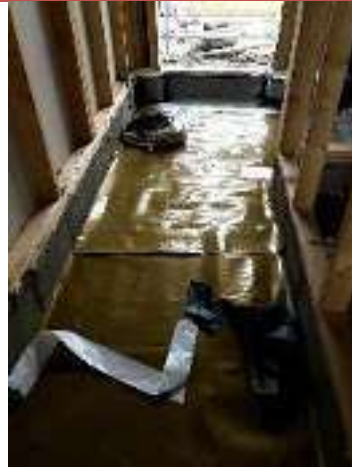
**Plot – 13**

**General Condition of Membrane-Good Condition**

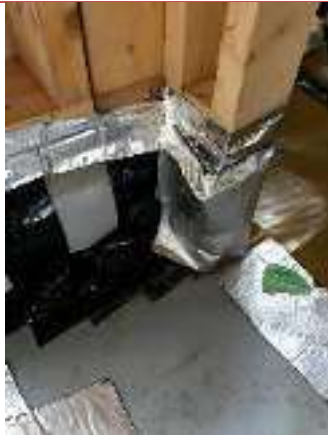
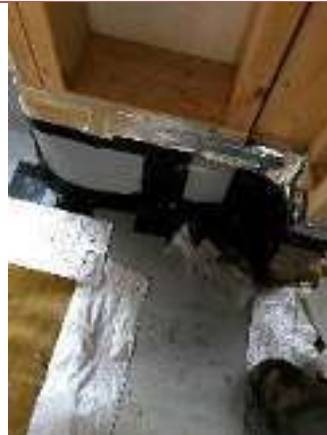
**Verification of Joints and Seals-Good Condition**

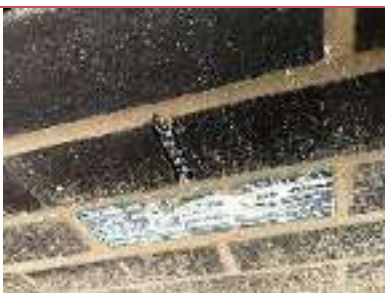
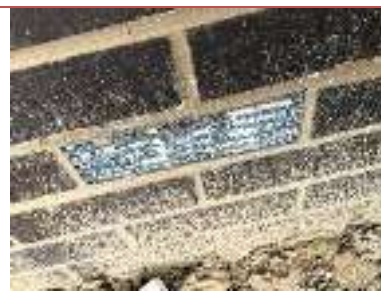
**Verification of Ventilation- Good Condition**

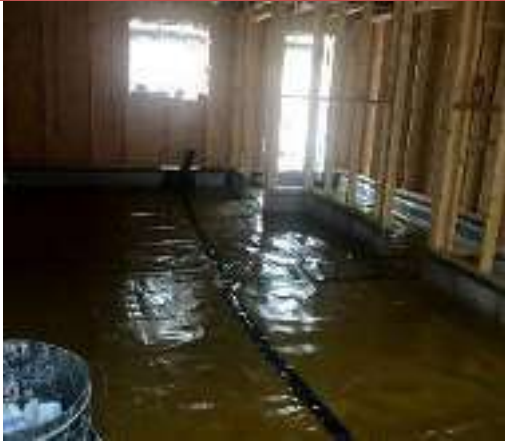
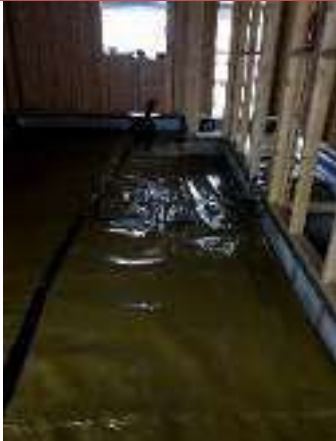
| Plot – 18 | |

| Plot – 18 | |
|---|---|
| General Condition of Membrane-Good Condition | |

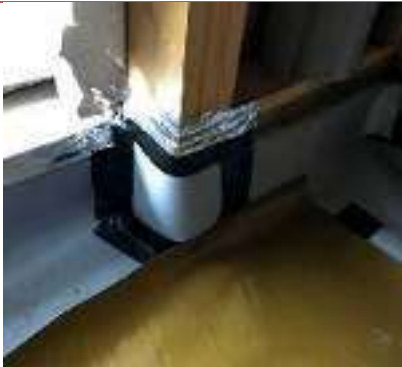
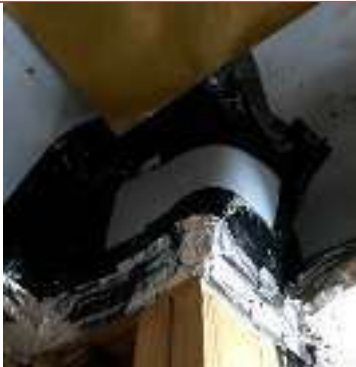
| Plot – 18 | |
|---|---|
| Verification of Joints and Seals-Good Condition | |

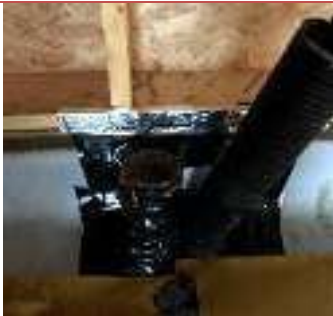
| Plot – 18 | |
|---|---|
| Verification of Service Penetrations-Good Condition | |

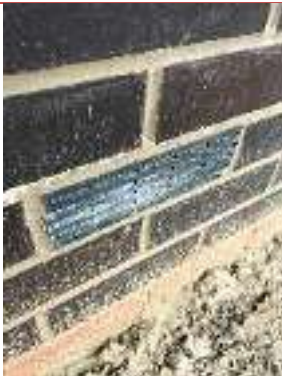
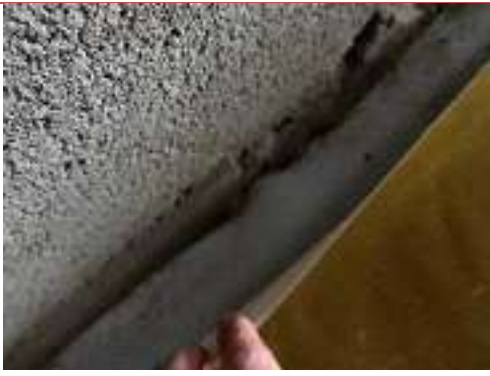
| Plot – 18 | |
|---|---|
| Verification of Ventilation- Good Condition | |
