Validation Completion Report  
Plots 1-54  
Bowes Street, Manchester

Reference:11-813-R5-1  
Date: March 2022

Plots 1-54  
Former Stagecoach Bus Depot  
Land off Bowes Street  
Manchester

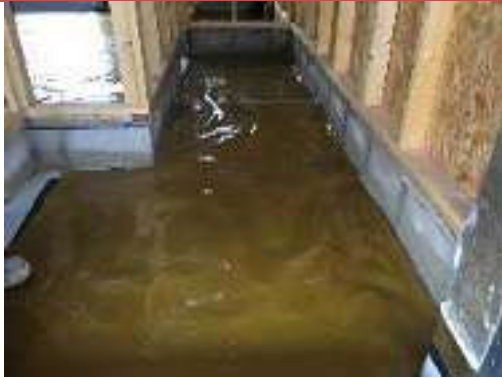
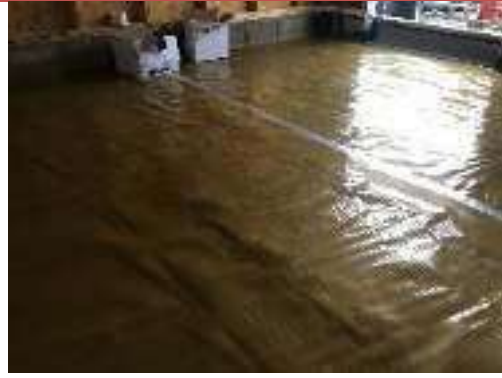
**Plot – 14**

**General Condition of Membrane-Good Condition**

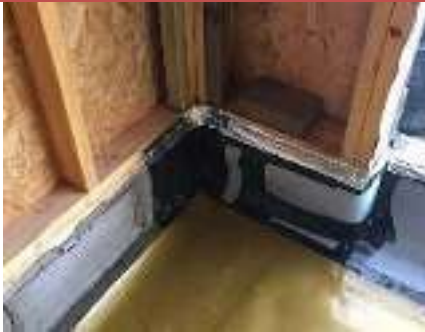
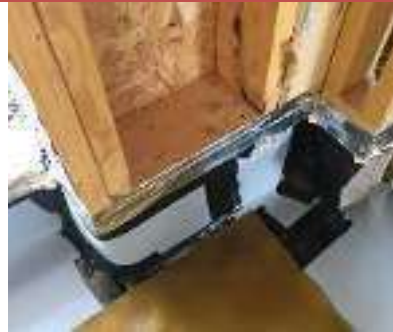
**Verification of Joints and Seals-Good Condition**

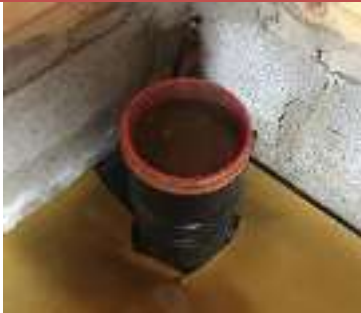
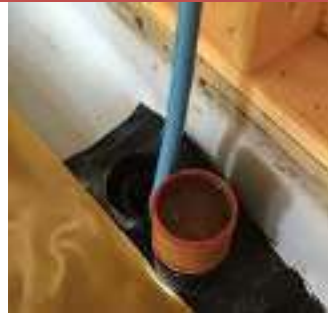
**Verification of Service Penetrations-Good Condition**

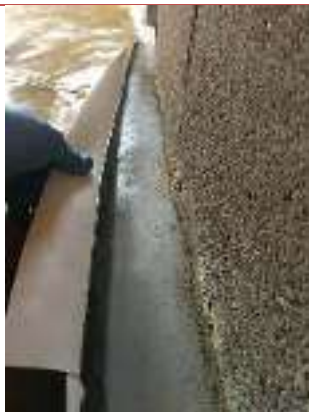
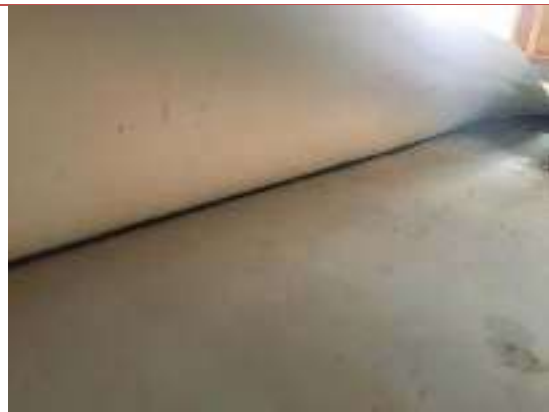
**Verification of Ventilation- Good Condition**

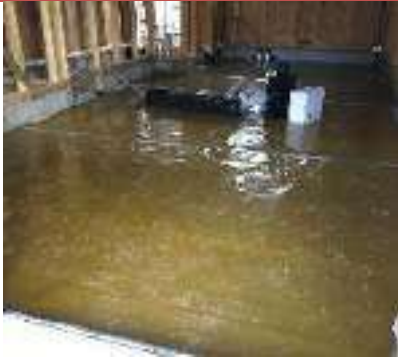
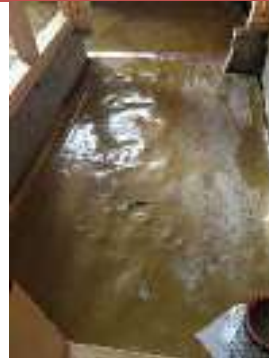
**Plot – 15**

**General Condition of Membrane-Good Condition**

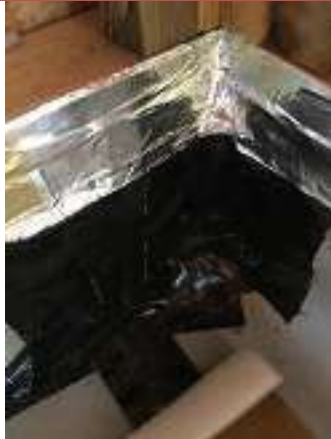
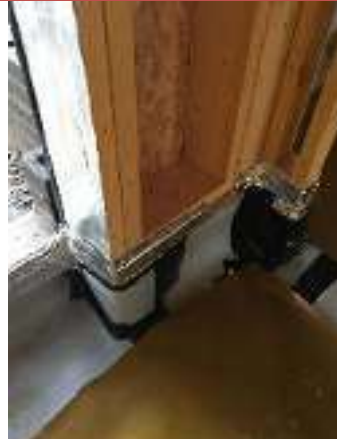
**Verification of Joints and Seals-Good Condition**

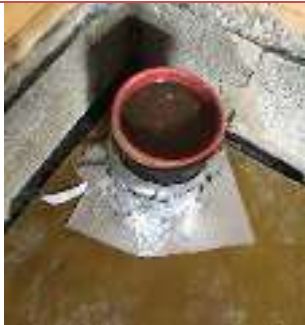
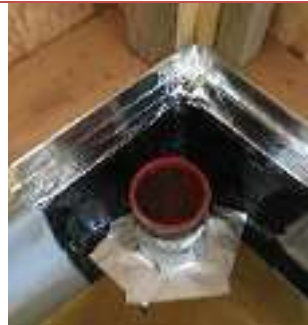
**Verification of Service Penetrations-Good Condition**

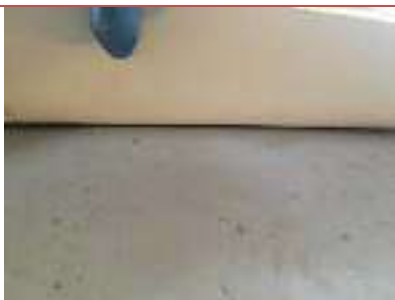
**Verification of Ventilation- Good Condition**

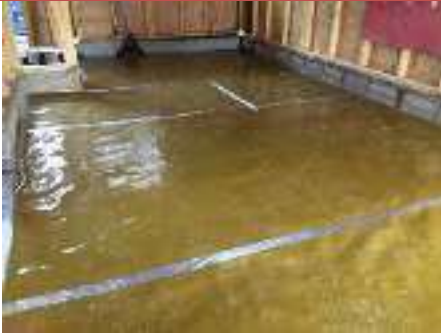
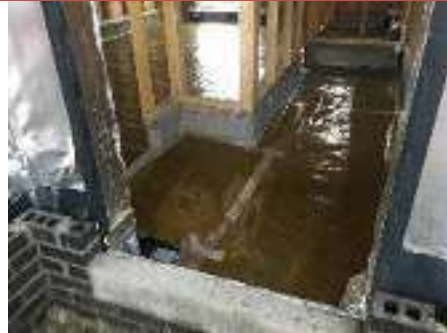
**Plot – 16**

**General Condition of Membrane-Good Condition**

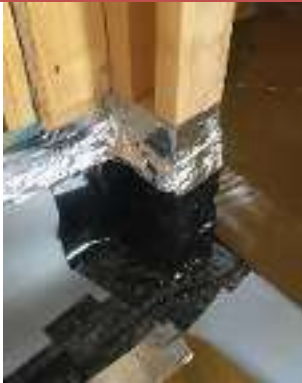
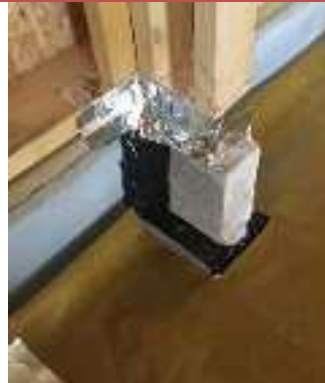
**Verification of Joints and Seals-Good Condition**

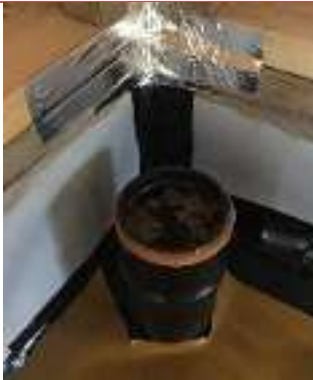
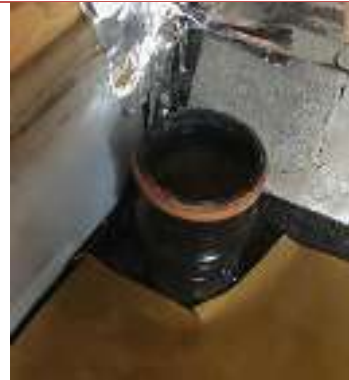
**Verification of Service Penetrations-Good Condition**

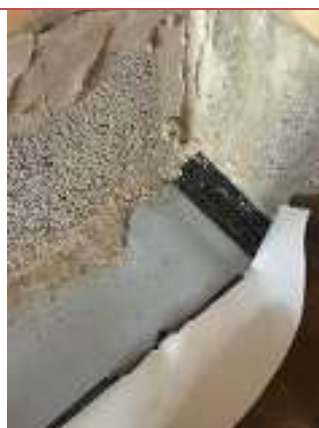
**Verification of Ventilation- Good Condition**

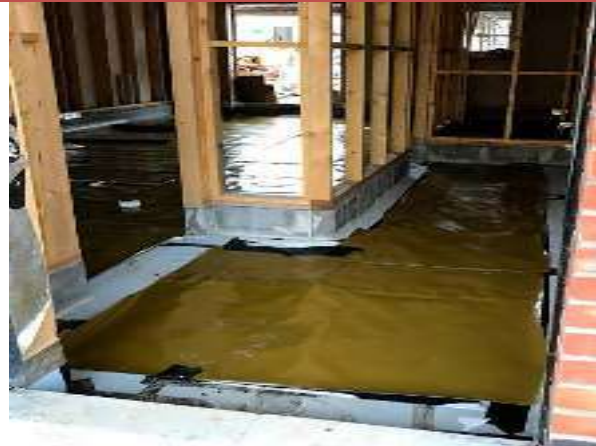
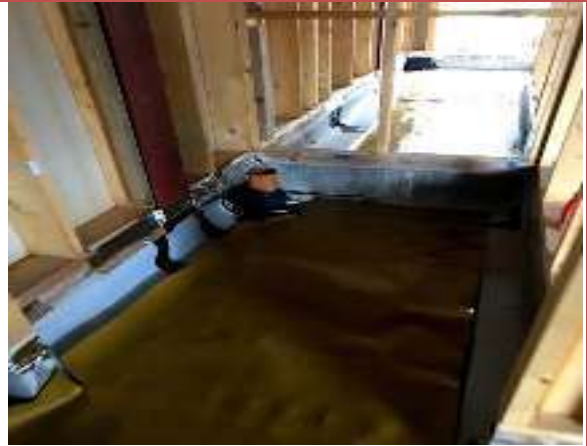
**Plot – 19**

**General Condition of Membrane-Good Condition**

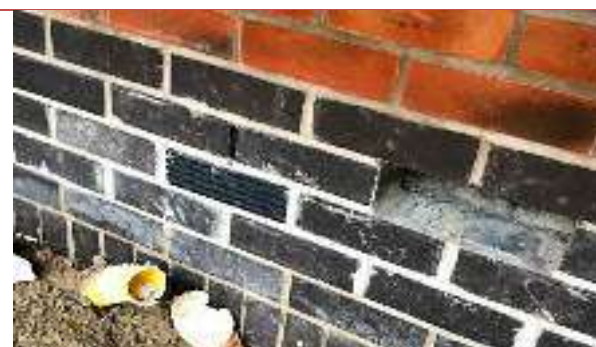
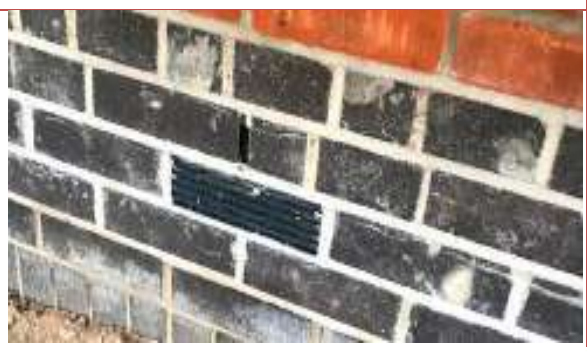
**Verification of Ventilation- Good Condition**

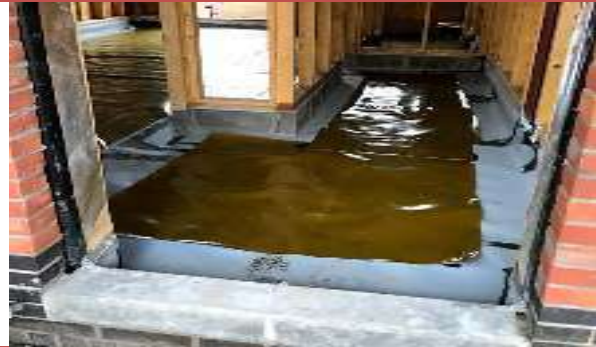
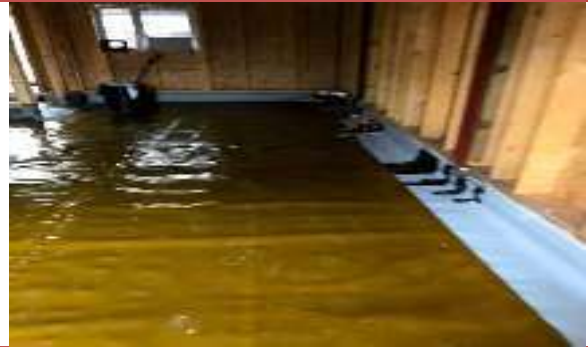
**Plot - 20**

**General Condition of Membrane-Good Condition**

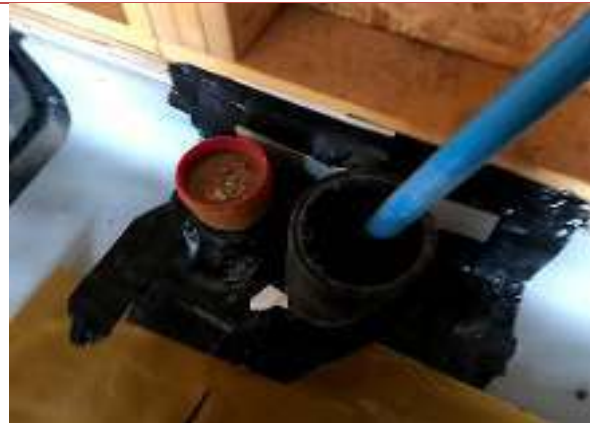
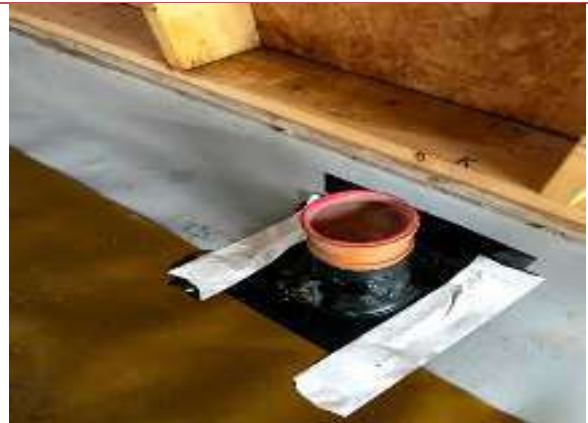
**Verification of Service Penetrations-Good Condition**

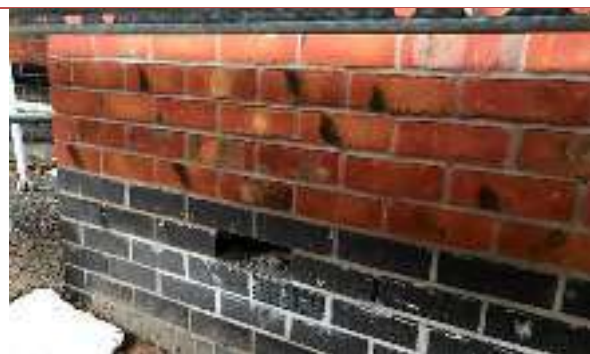
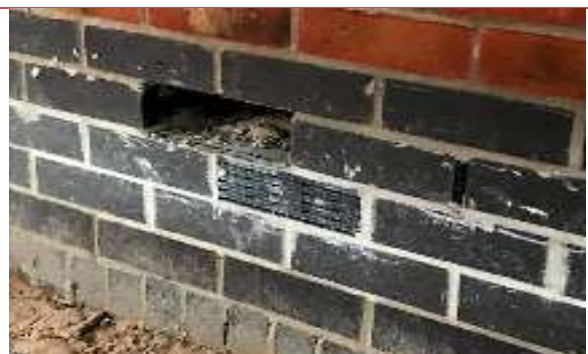
**Verification of ventilation-Good Condition**

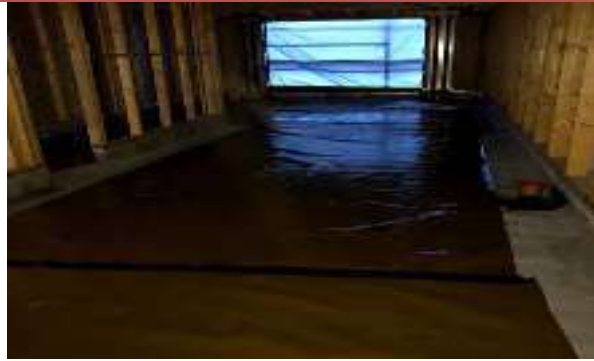
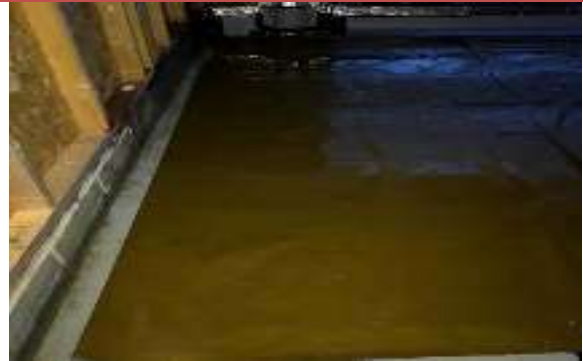
**Plot – 21**

**General Condition of Membrane-Good Condition**

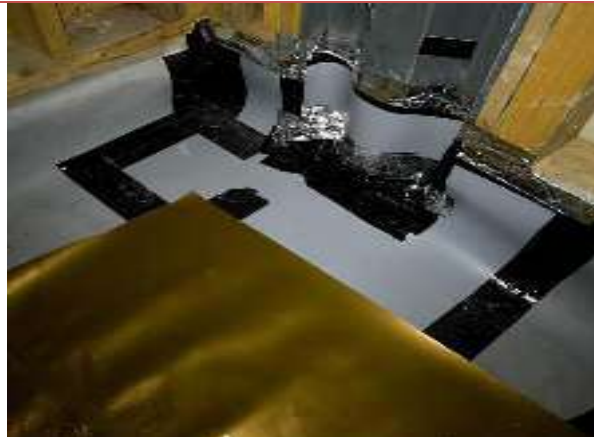
**Verification of Joints and Seals-Good Condition**

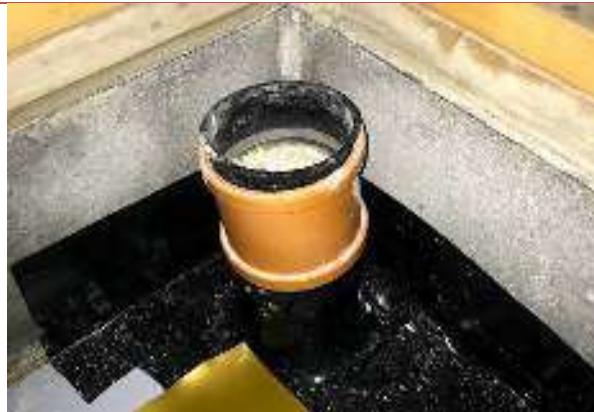
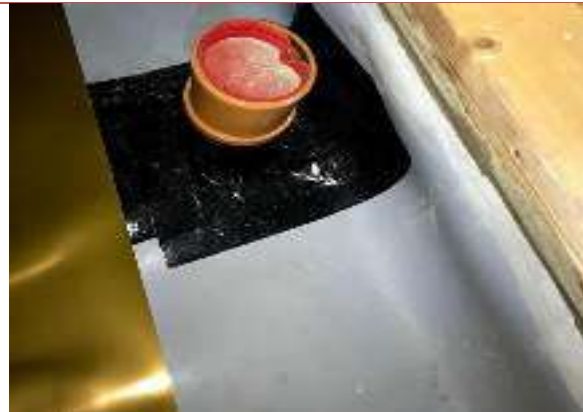
**Verification of Service Penetrations-Good Condition**

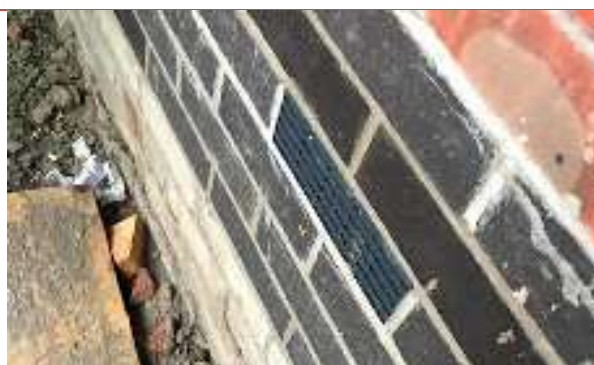
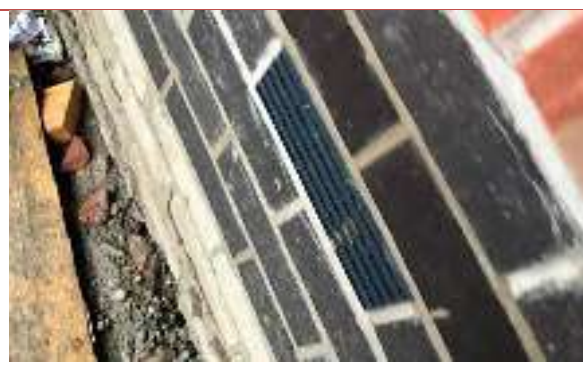
**Verification of Ventilation- Good Condition**

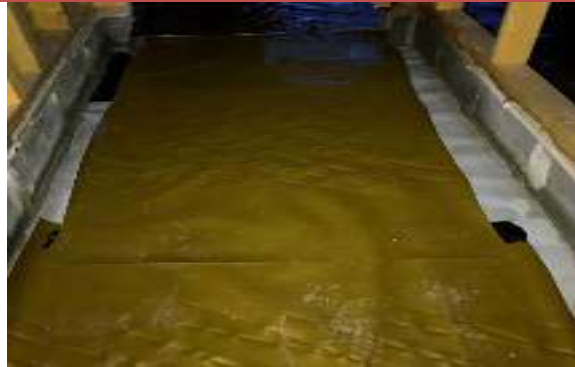
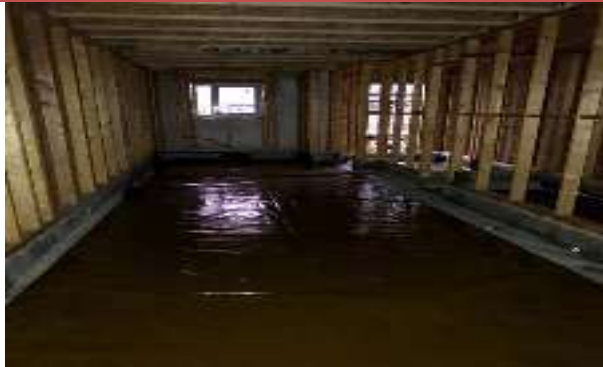
**Plot - 22**

**General Condition of Membrane-Good Condition**

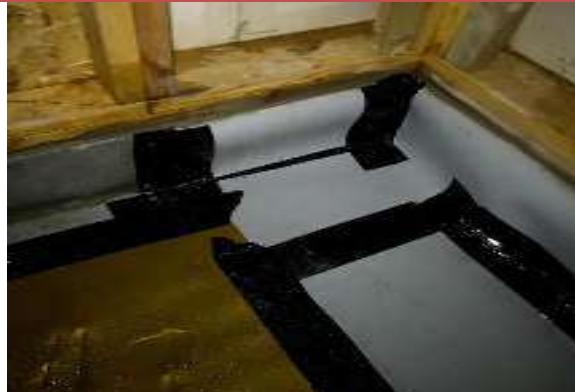
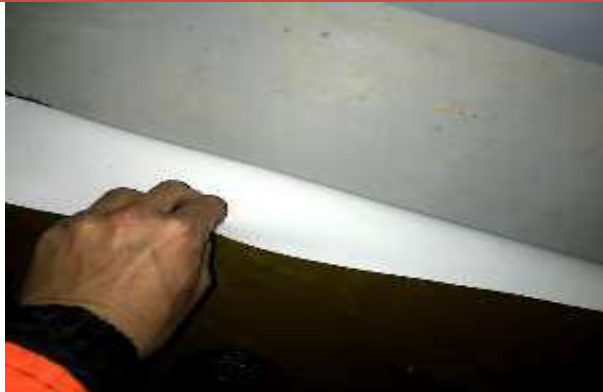
**Verification of Joints and Seals-Good Condition**

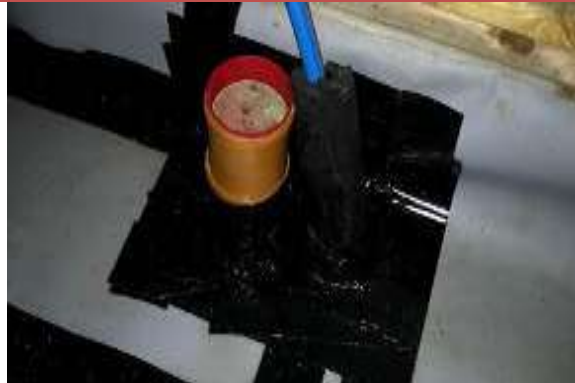
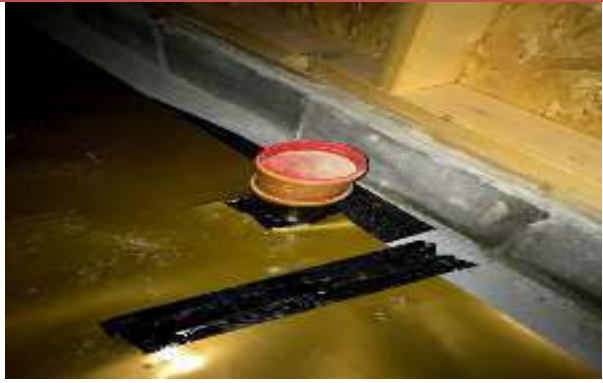
**Verification of Service Penetrations-Good Condition**

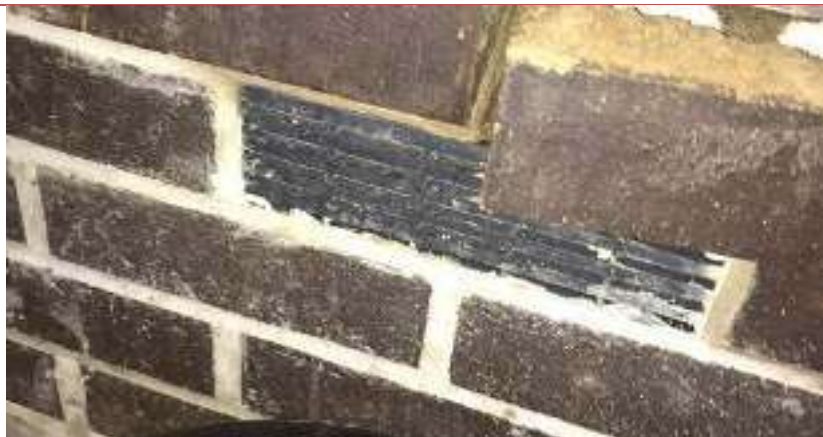
**Verification of ventilation-Good Condition**

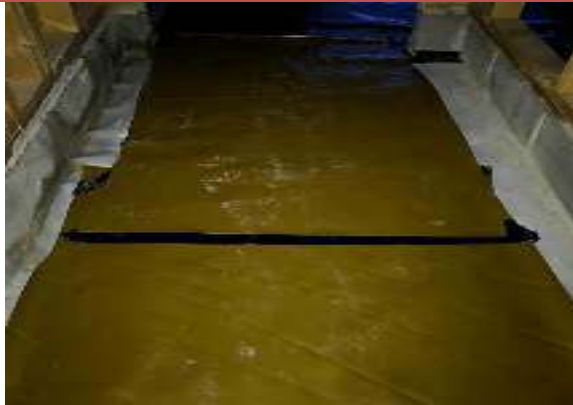
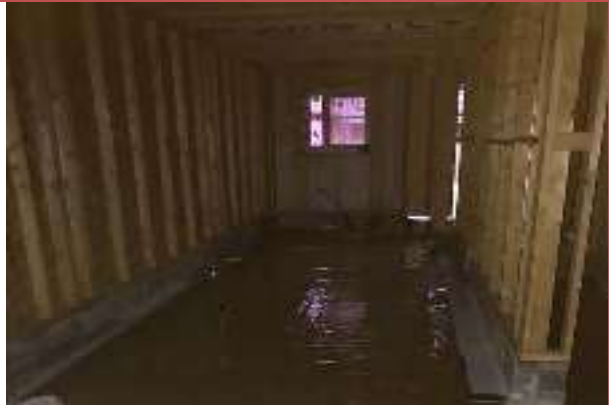
**Plot -23**

**General Condition of Membrane-Good Condition**

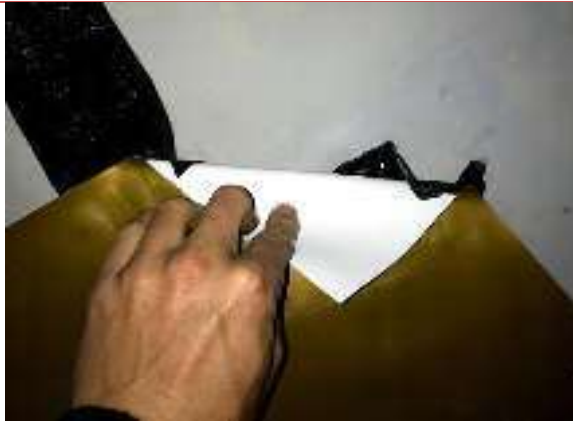
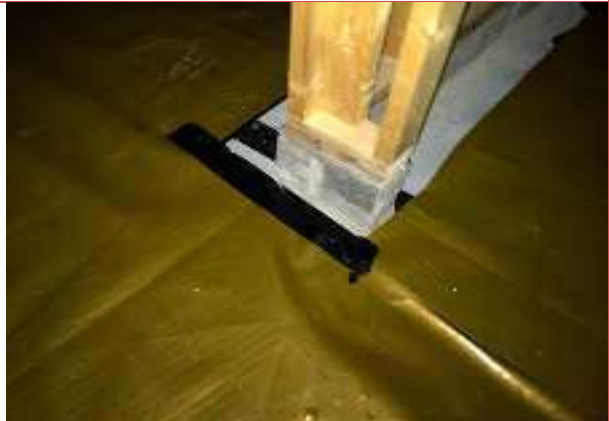
**Verification of Joints and Seals-Good Condition**

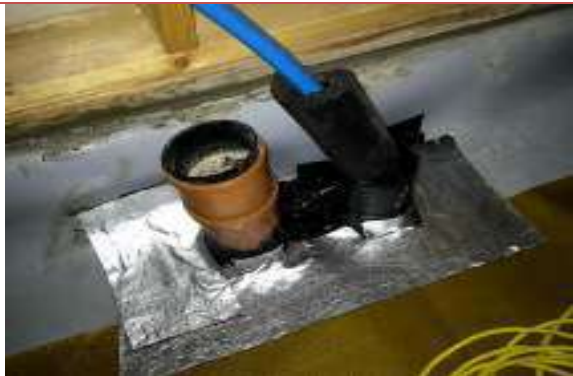
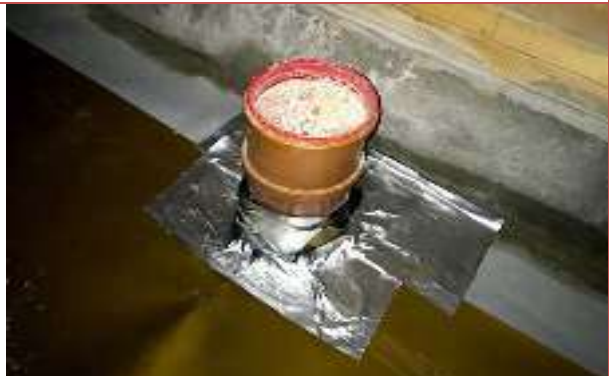
**Verification of Service Penetrations-Good Condition**

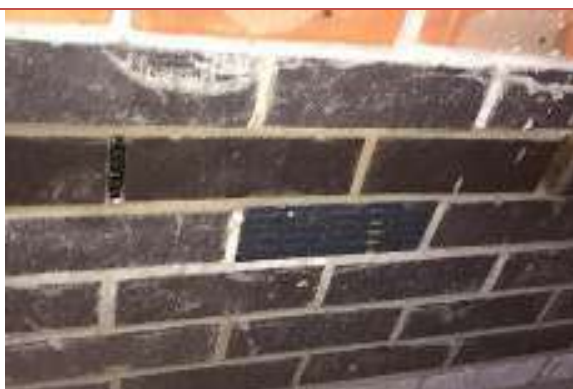
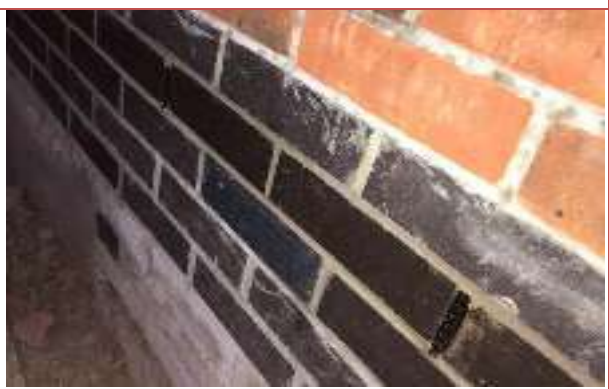
**Verification of ventilation-Good Condition**

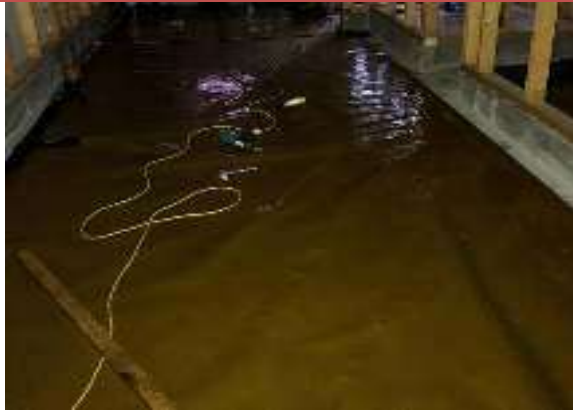
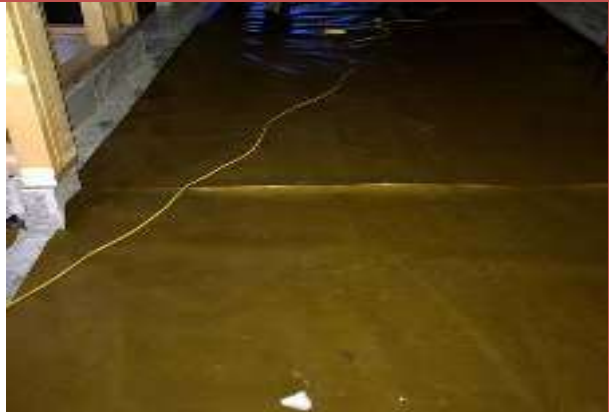
**Plot - 24**

**General Condition of Membrane-Good Condition**

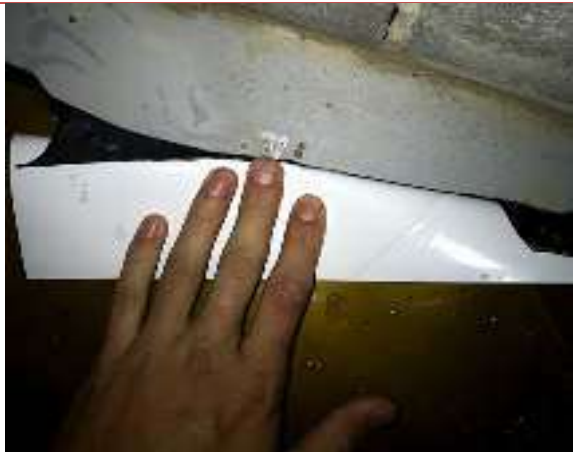
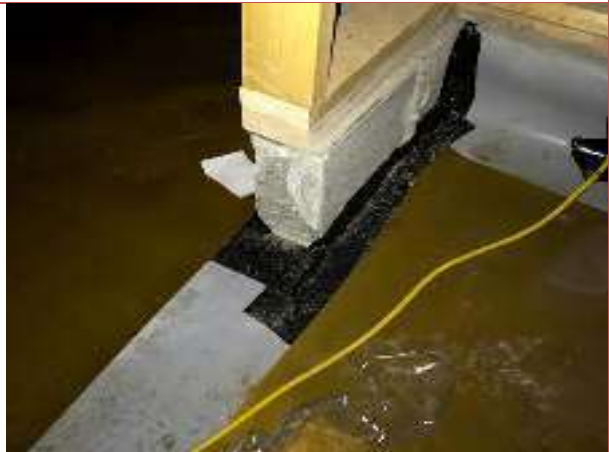
**Verification of Joints and Seals-Good Condition**

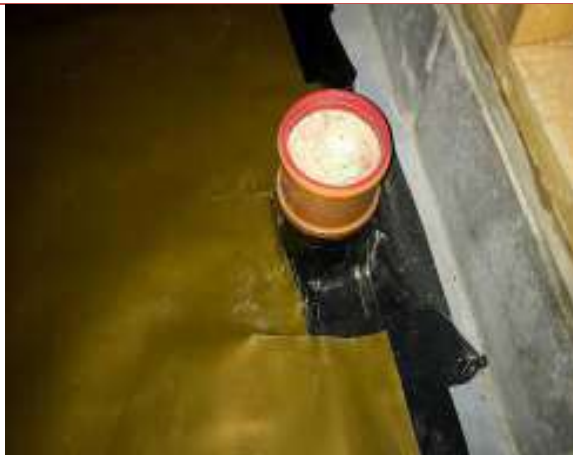
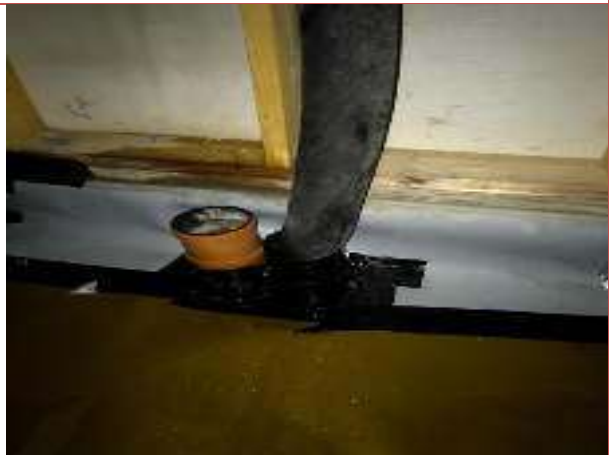
**Verification of Service Penetrations-Good Condition**

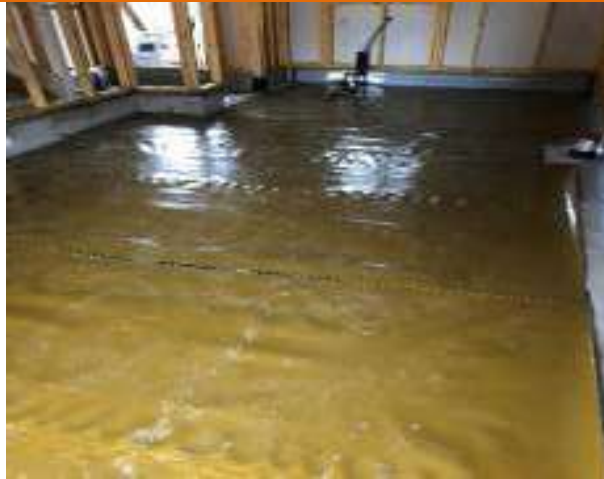
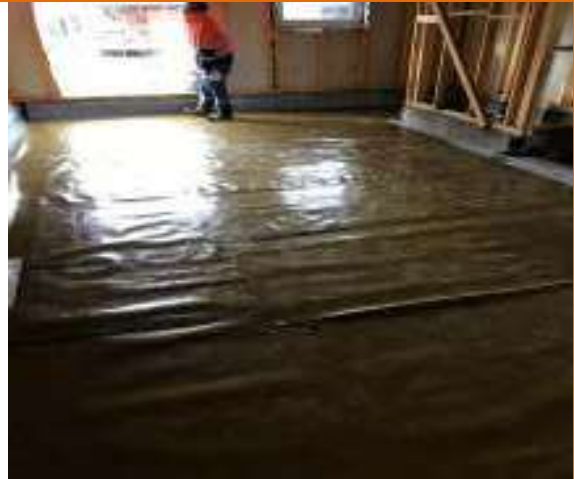
**Plot – 25**

**General Condition of Membrane-Good Condition**

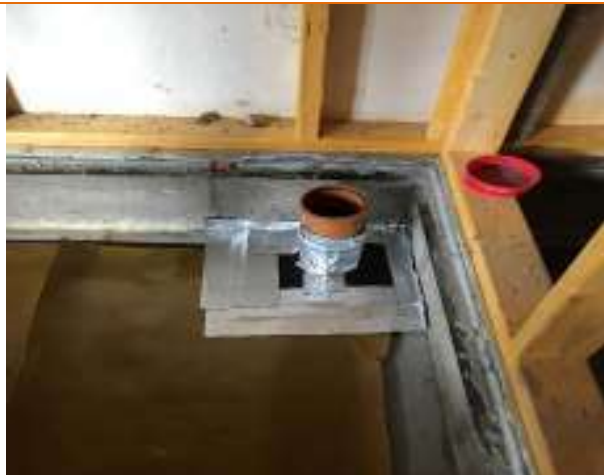
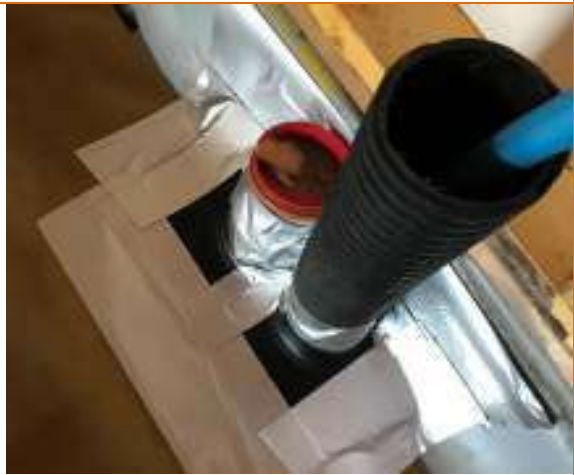
**Verification of Service Penetrations-Good Condition**

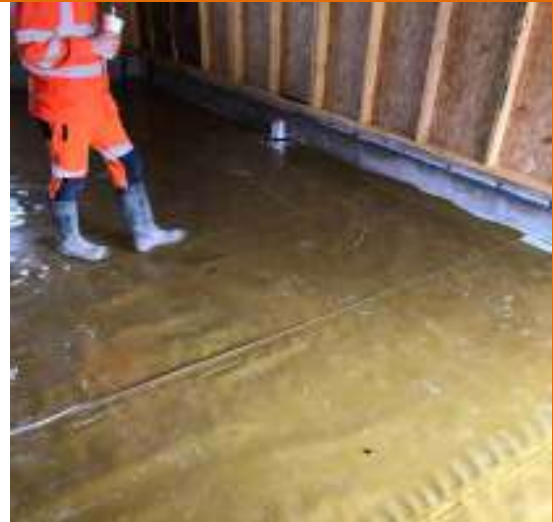
**Plot – 26**

**General Condition of Membrane-Good Condition**

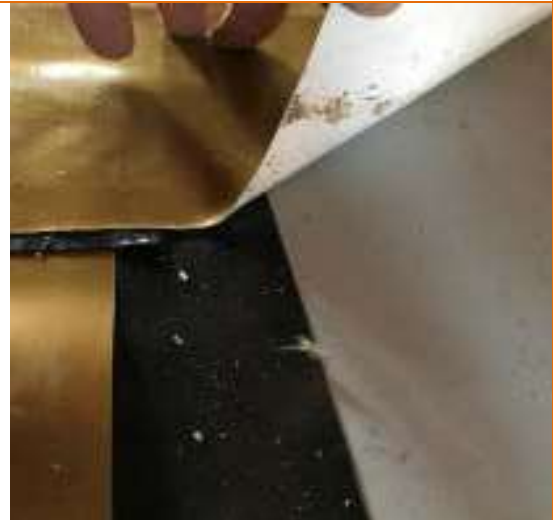
**Verification of Joints and Seals-Good Condition**

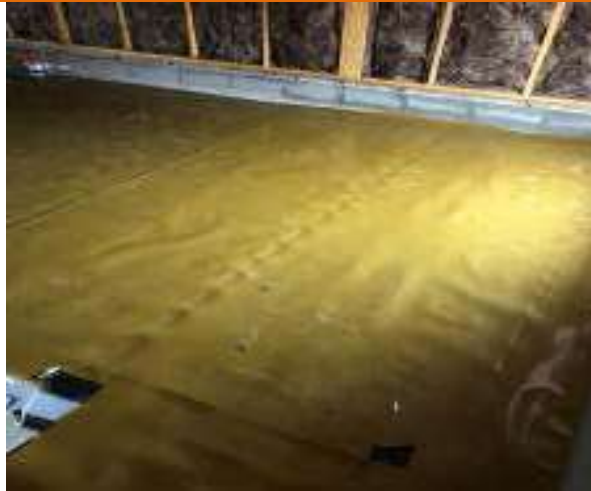
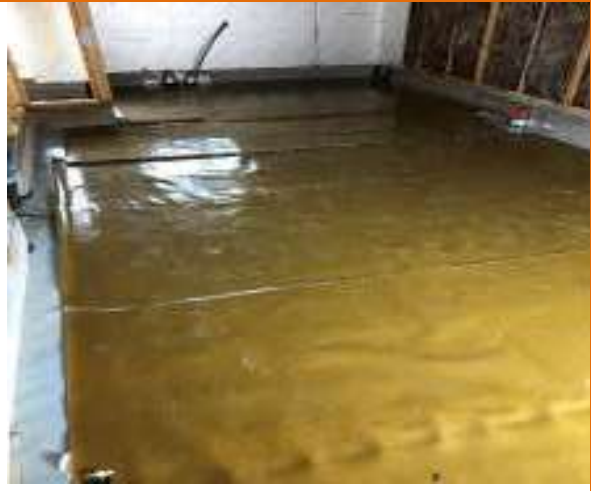
**Plot – 27**

**General Condition of Membrane-Good Condition**

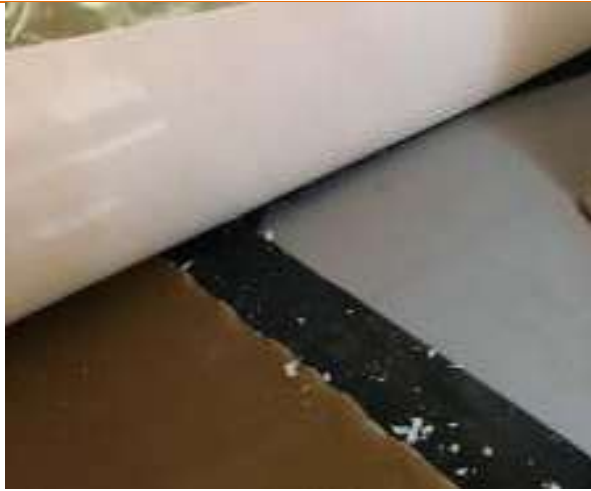
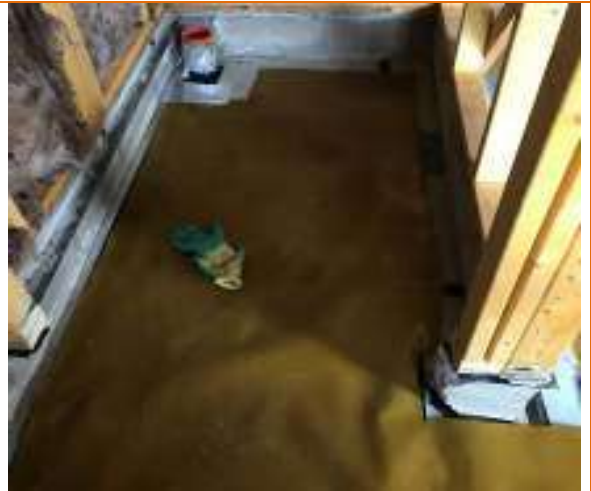
**Verification of Joints and Seals-Good Condition**

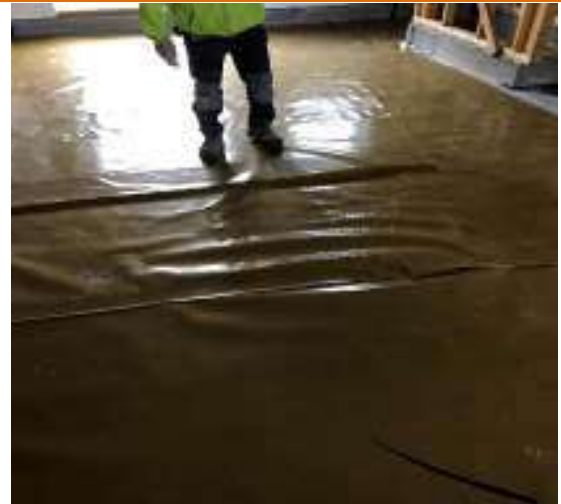
**Plot – 28**

**General Condition of Membrane-Good Condition**

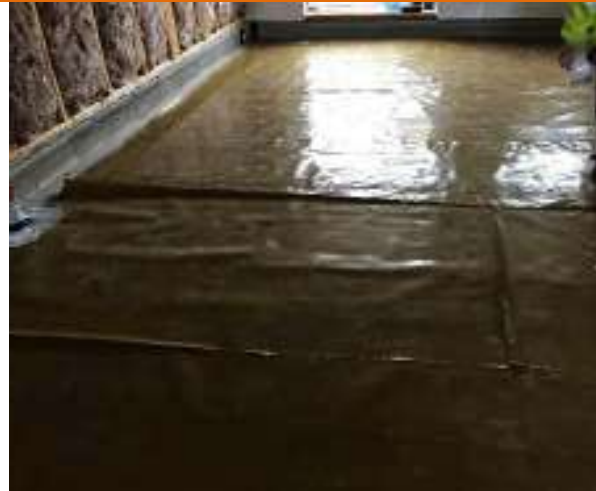
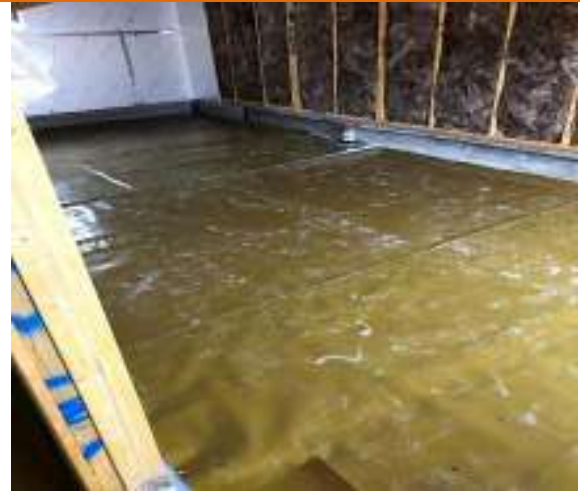
**Plot – 29**

**General Condition of Membrane-Good Condition**

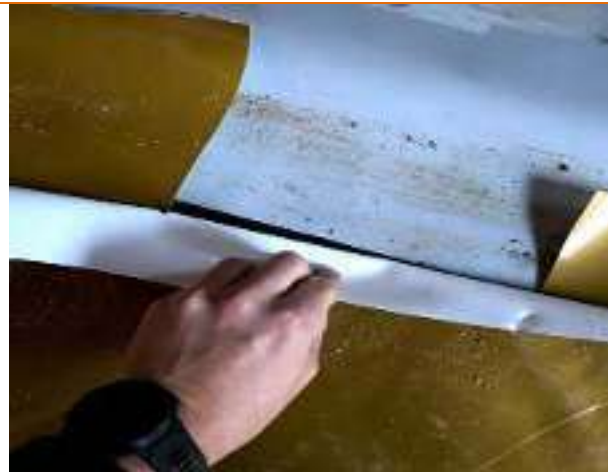
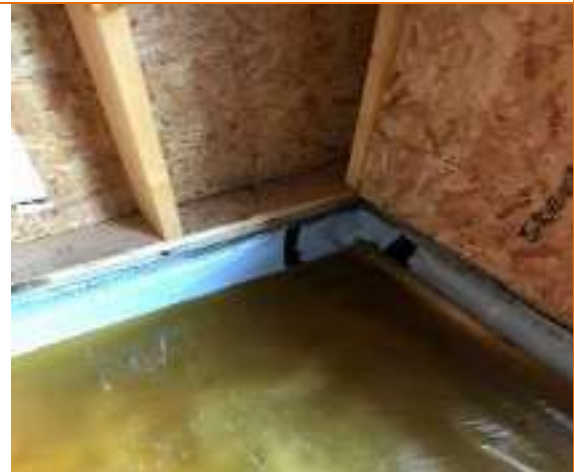
**Verification of Joints and Seals-Good Condition**

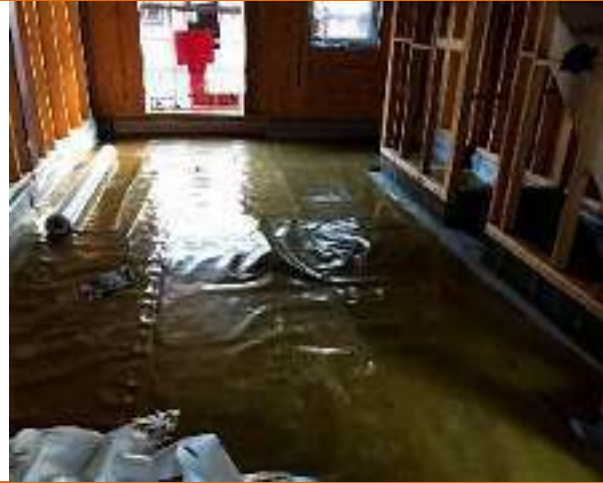
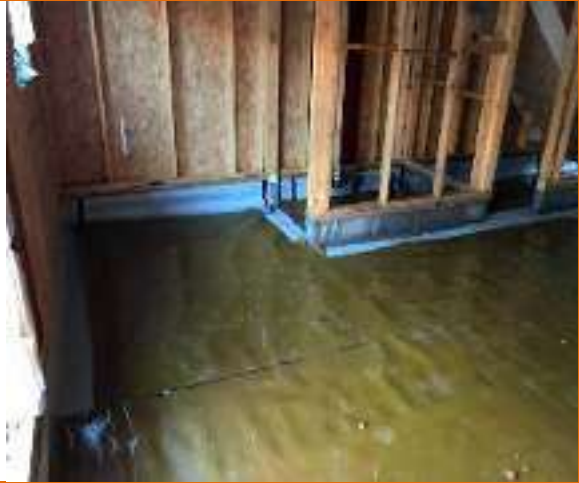
**Plot - 49**

**General Condition of Membrane-Good Condition**

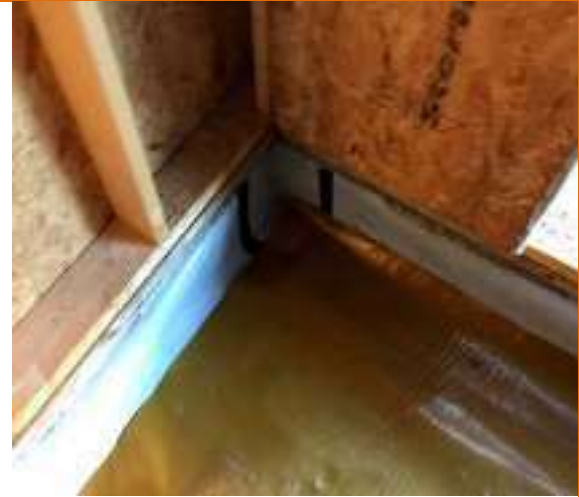
**Verification of Joints and Seals-Good Condition**

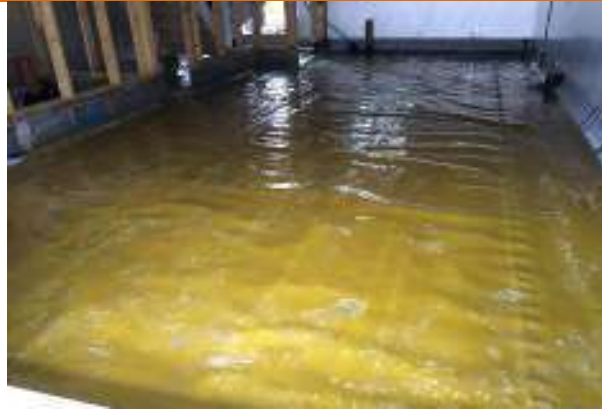
**Plot – 32**

**General Condition of Membrane-Good Condition**

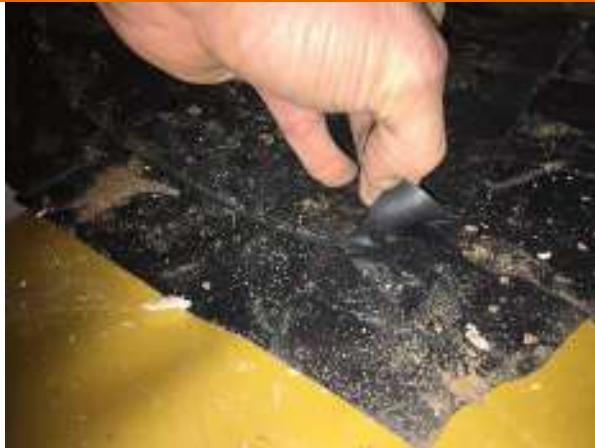
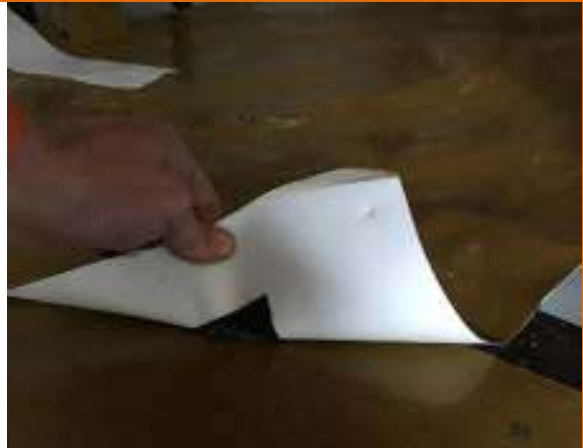
**Verification of Joints and Seals-Good Condition**

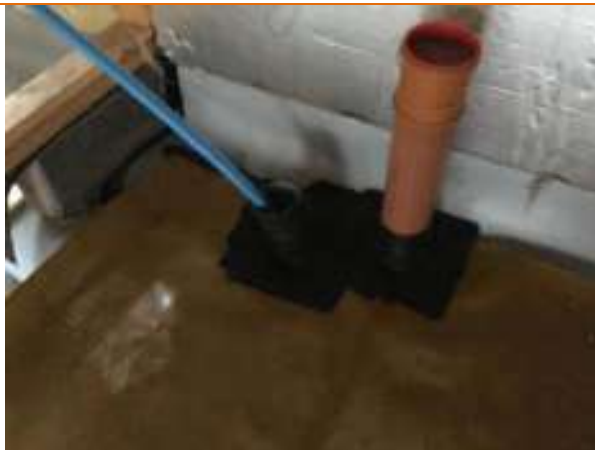
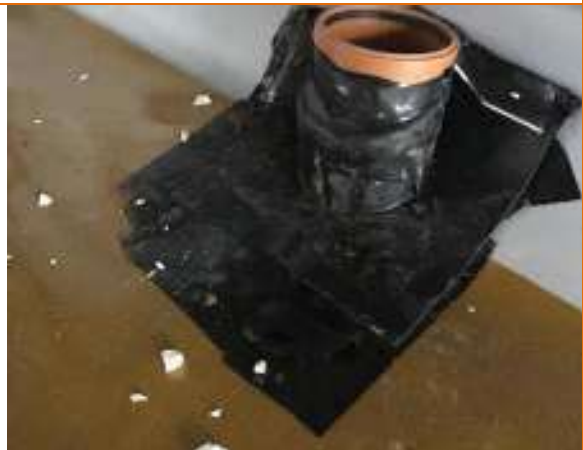
**Verification of Service Penetrations-Good Condition**

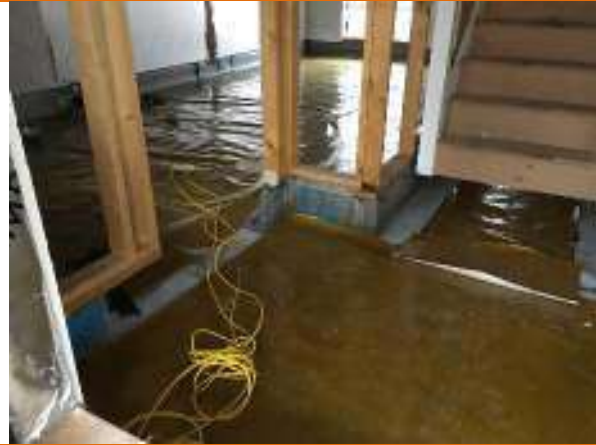
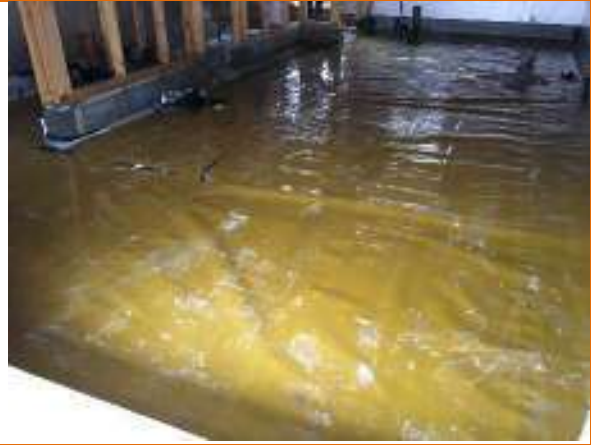
**Plot – 33**

**General Condition of Membrane-Good Condition**

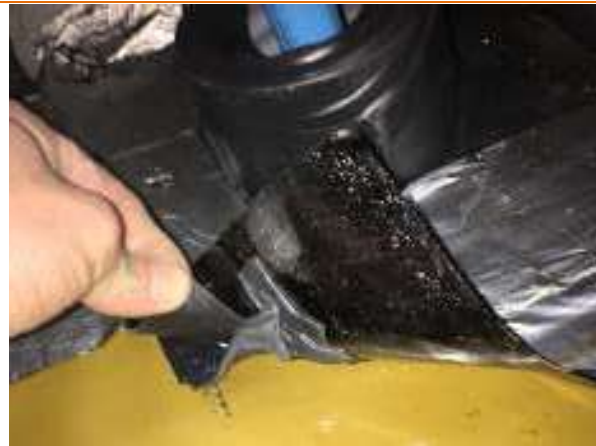
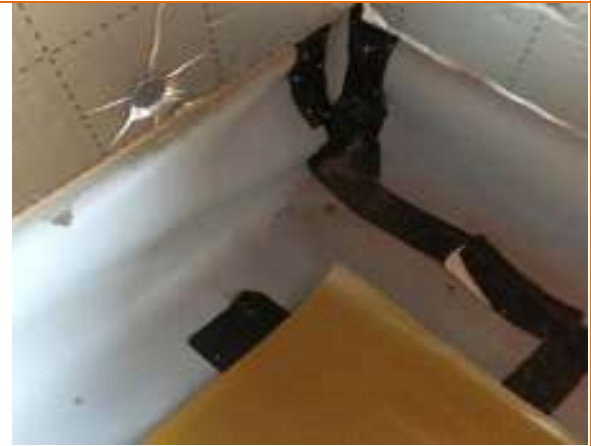
**Verification of Joints and Seals-Good Condition**

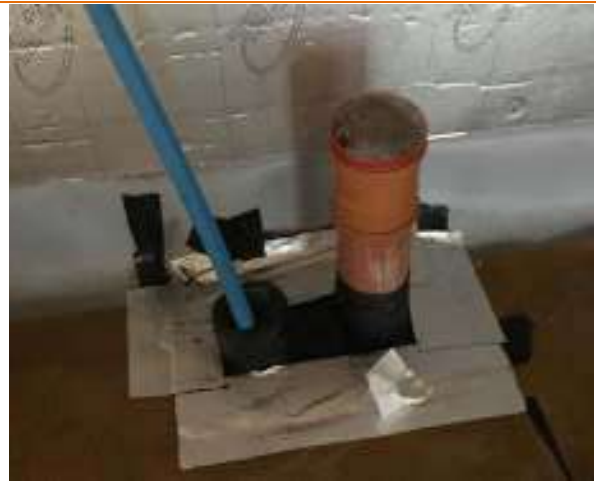
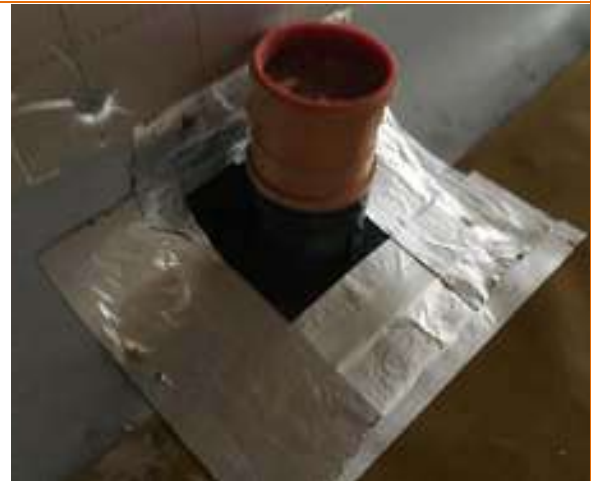
**Verification of Service Penetrations-Good Condition**

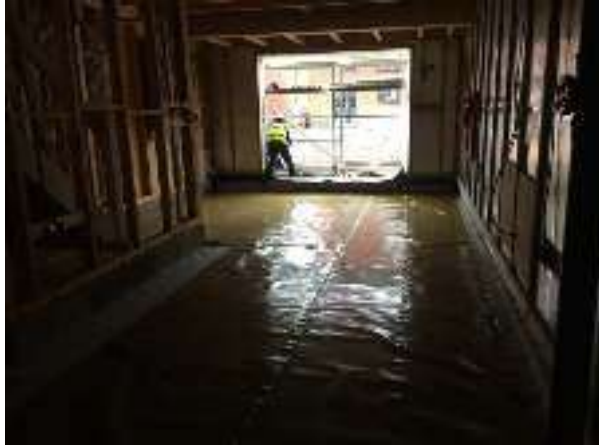
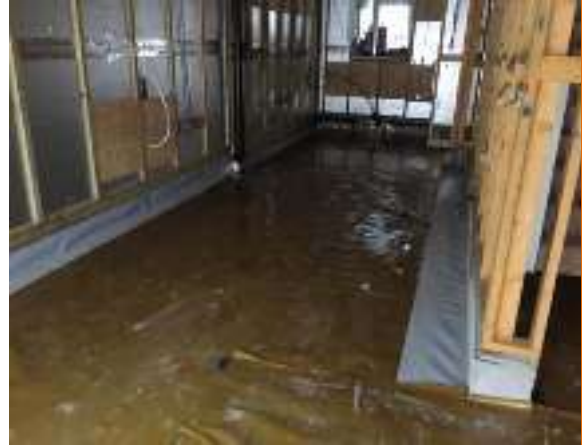
**Plot – 35**

**General Condition of Membrane-Good Condition**

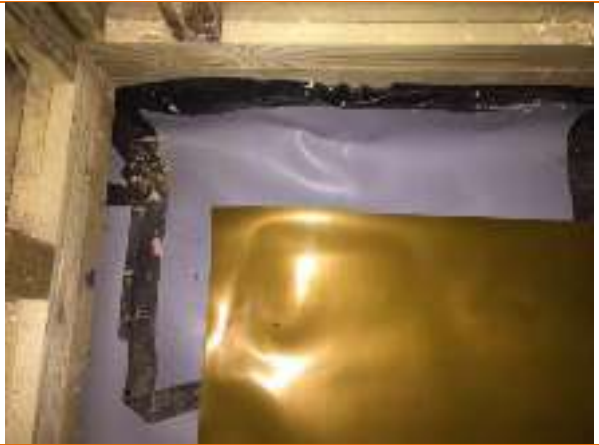
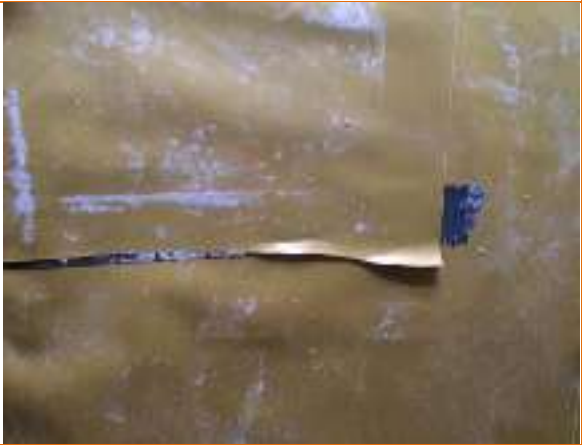
**Verification of Joints and Seals-Good Condition**

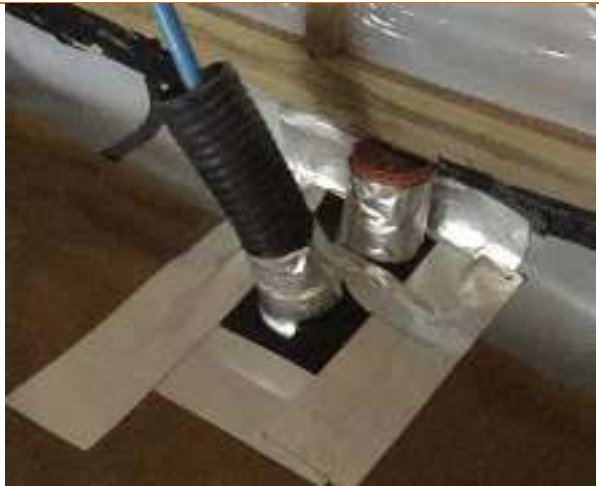
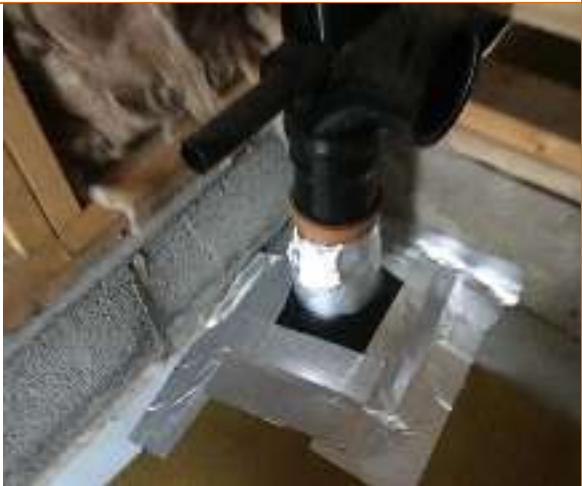
**Verification of Service Penetrations-Good Condition**

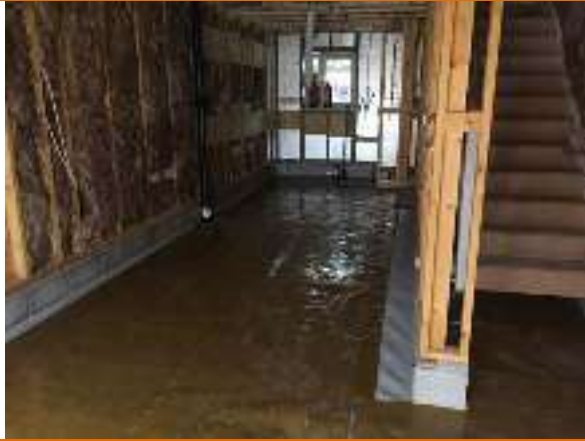
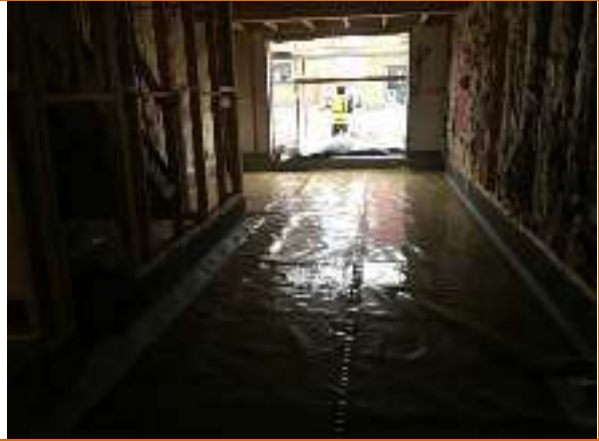
**Plot – 36**

**General Condition of Membrane-Good Condition**
