Validation Completion Report  
Plots 1-54  
Bowes Street, Manchester

Reference:11-813-R5-1  
Date: March 2022

Plots 1-54  
Former Stagecoach Bus Depot  
Land off Bowes Street  
Manchester

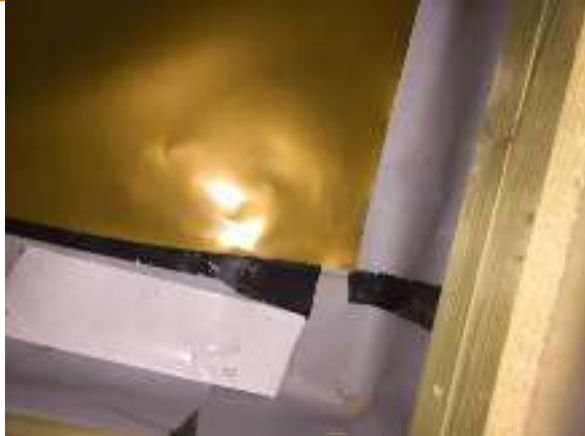
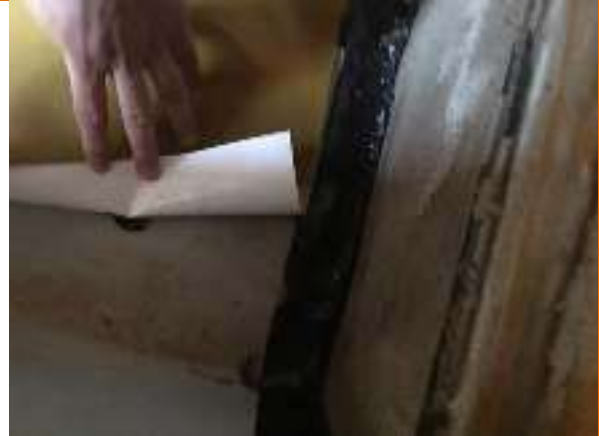
**Plot – 36**

**Verification of Joints and Seals-Good Condition**

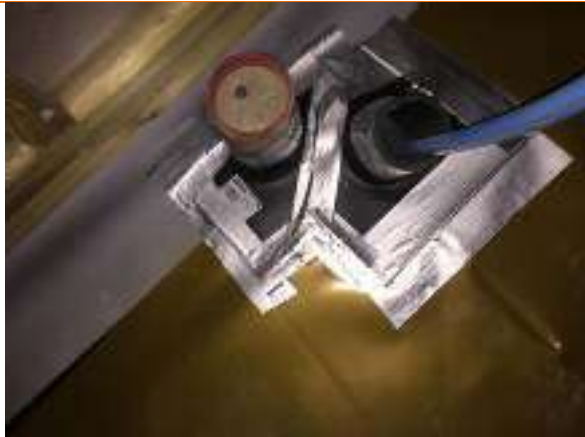
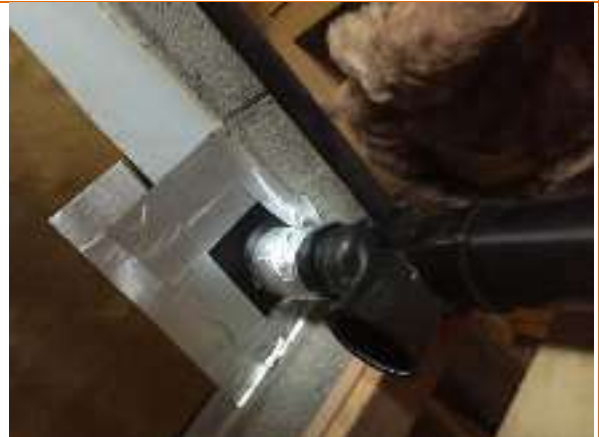
**Verification of Service Penetrations-Good Condition**

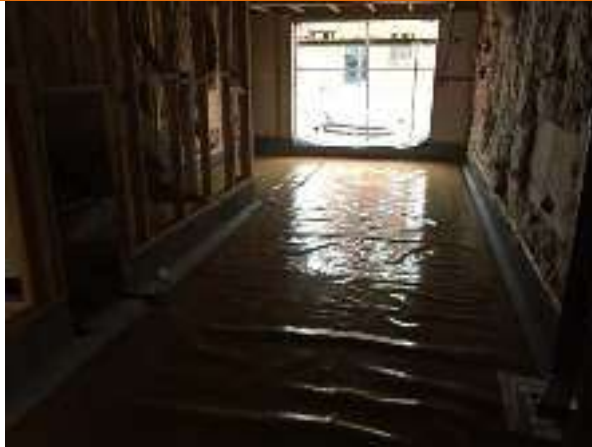
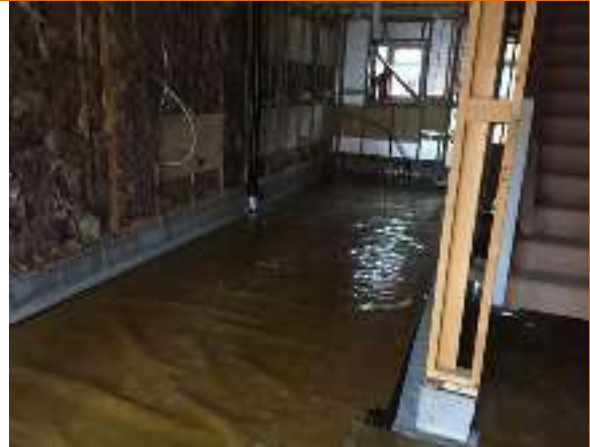
**Plot – 37**

**General Condition of Membrane-Good Condition**

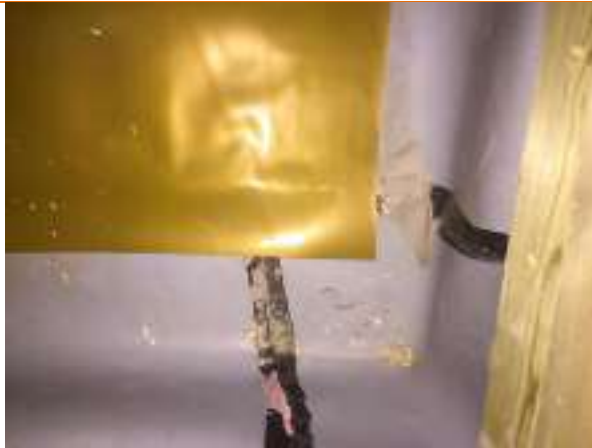
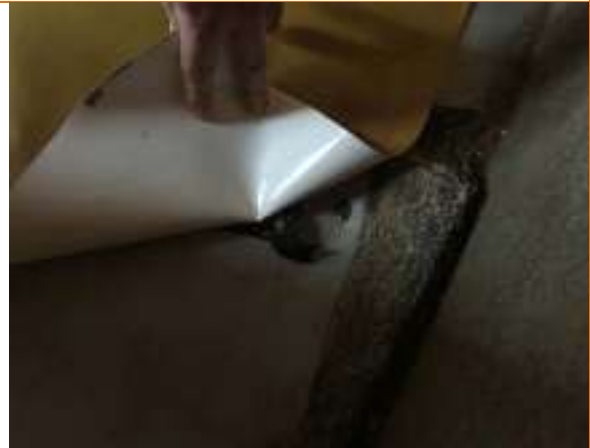
**Verification of Joints and Seals-Good Condition**

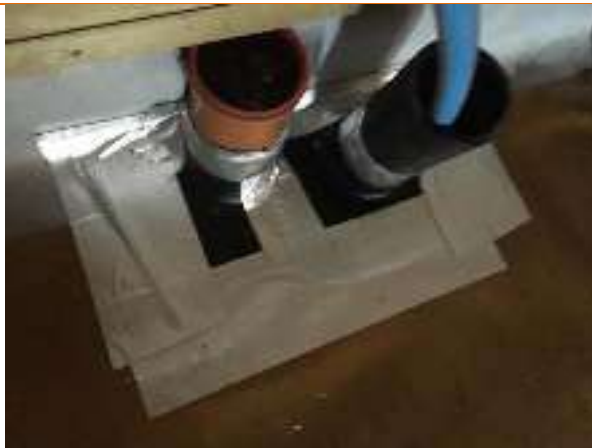
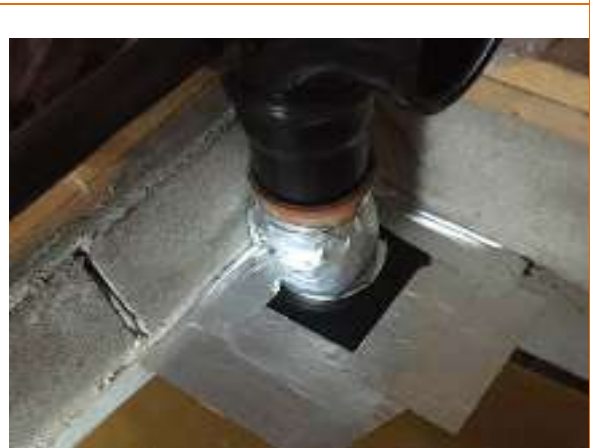
**Verification of Service Penetrations-Good Condition**

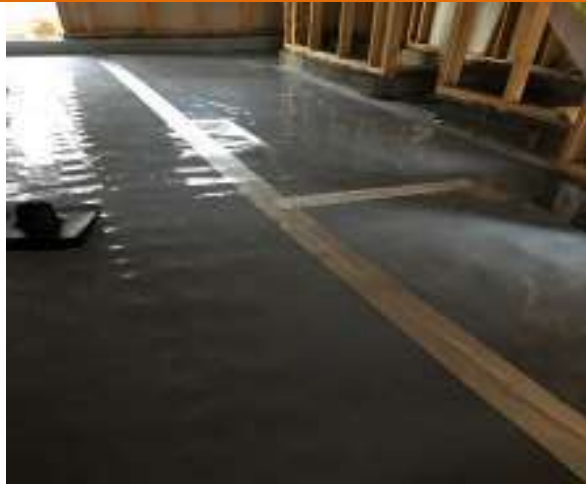
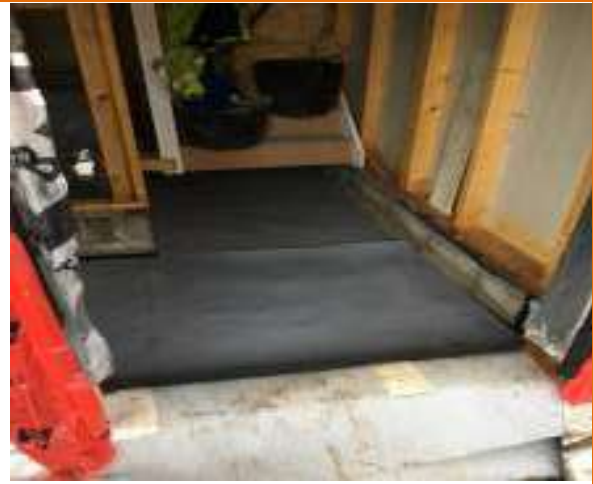
**Plot – 39**

**General Condition of Membrane-Good Condition**

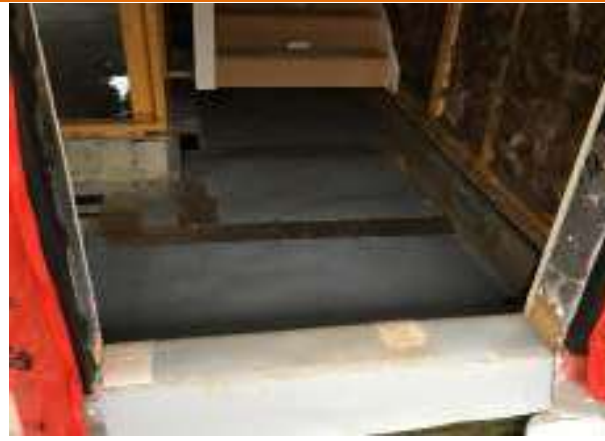
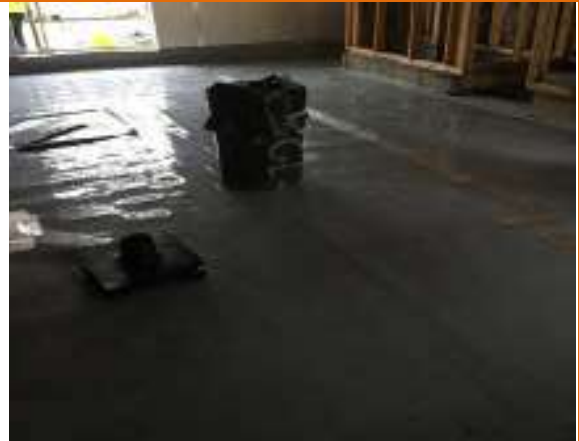
**Plot – 40**

**General Condition of Membrane-Good Condition**

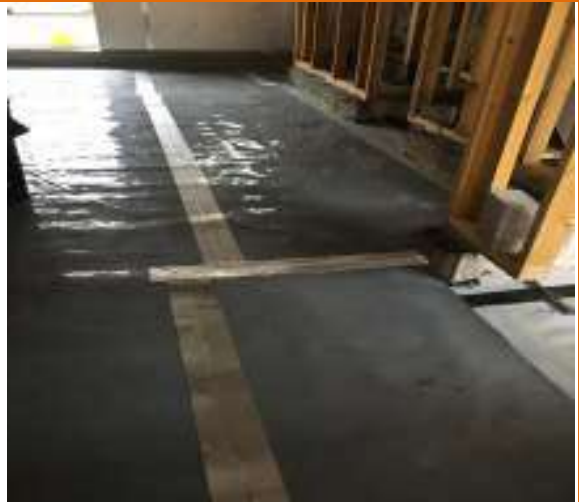
**Verification of Joints and Seals-Good Condition**

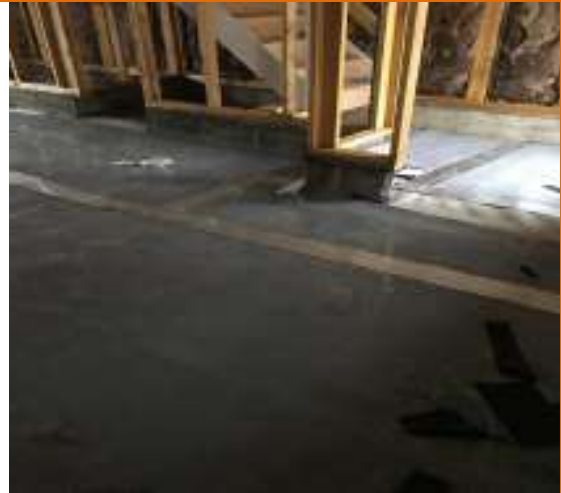
**Plot – 41**

**General Condition of Membrane-Good Condition**

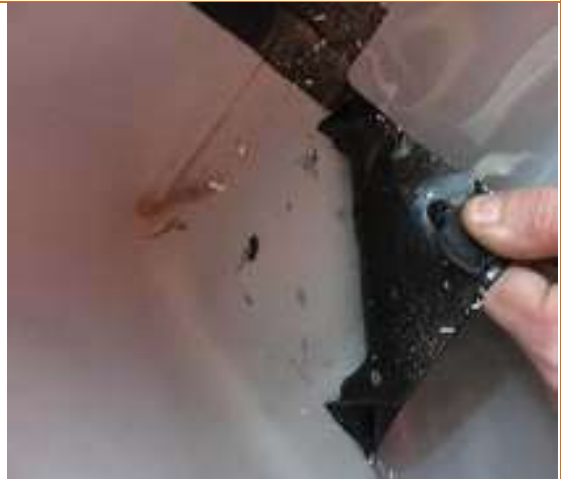
**Verification of Joints and Seals-Good Condition**

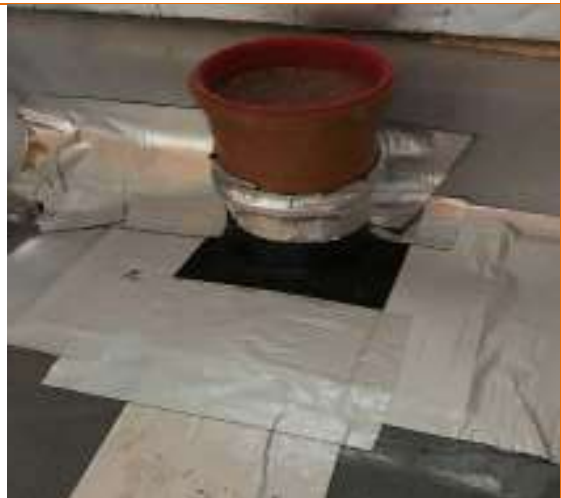
**Verification of Service Penetrations-Good Condition**

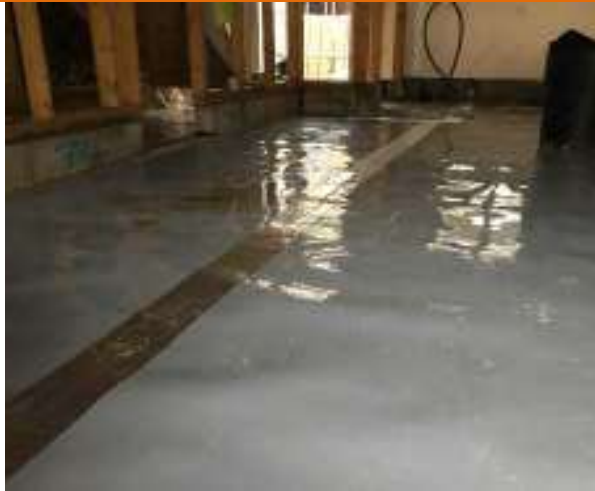
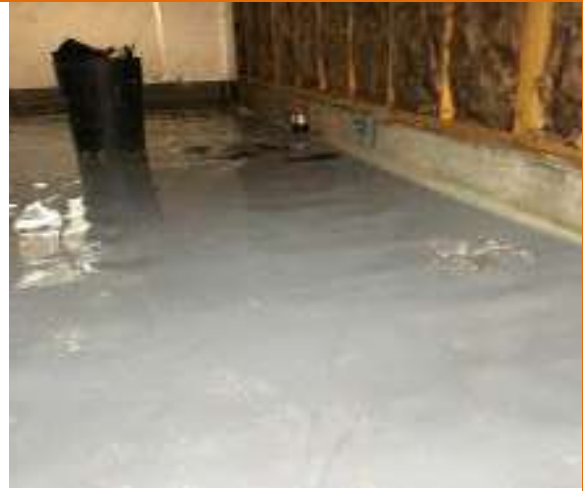
**Plot – 42**

**General Condition of Membrane-Good Condition**

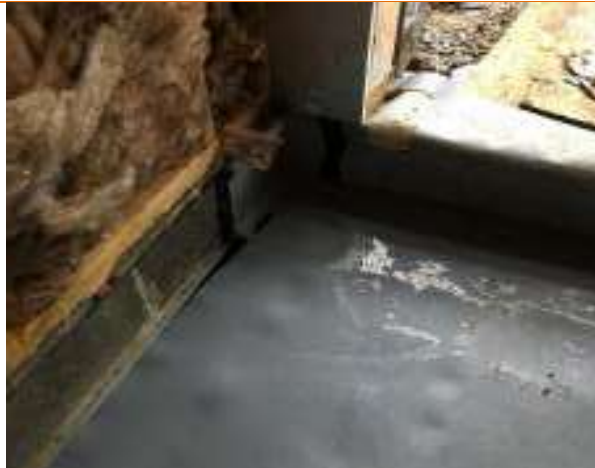
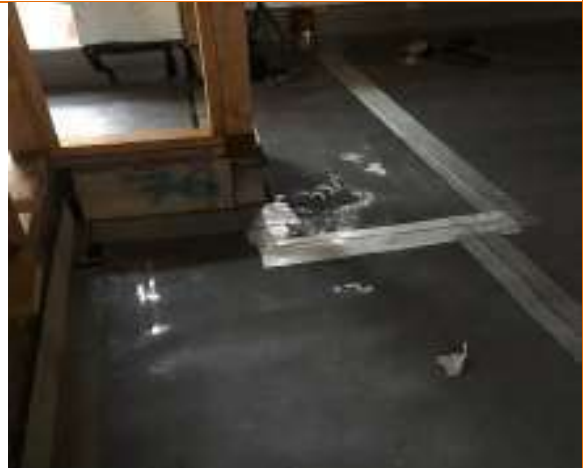
**Verification of Joints and Seals-Good Condition**

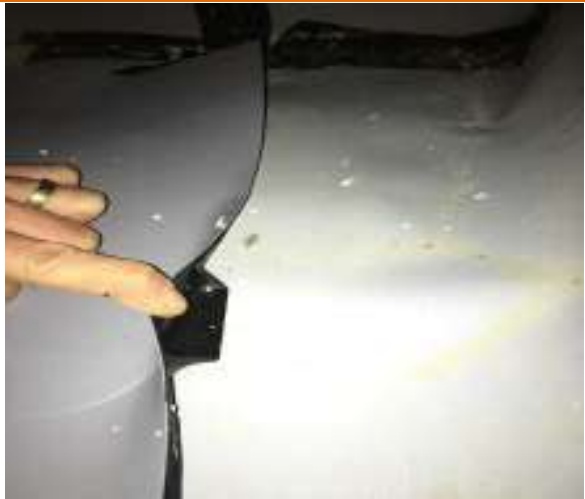
**Verification of Joints and Seals-Good Condition**

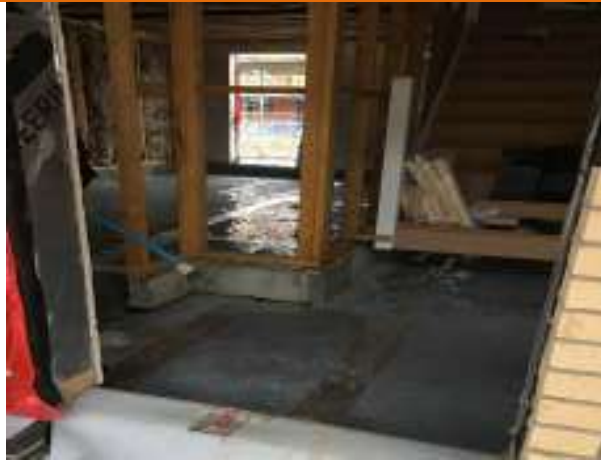
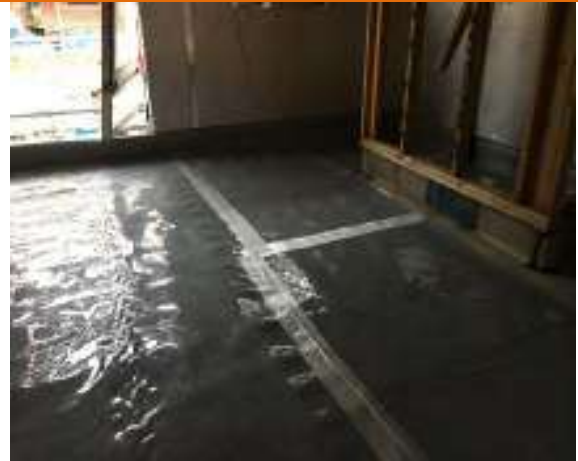
**Plot – 44**

**General Condition of Membrane-Good Condition**

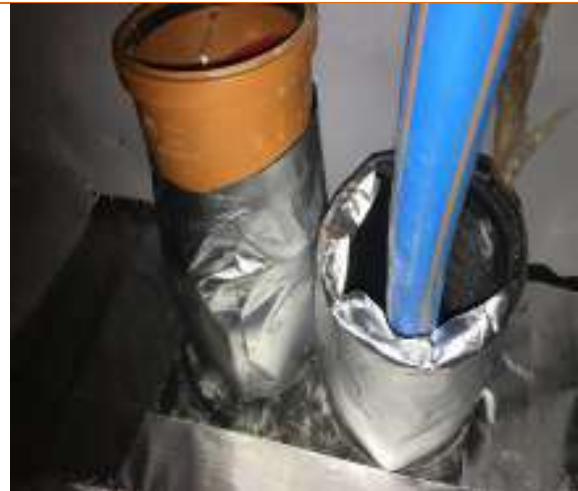
**Verification of Service Penetrations-Good Condition**

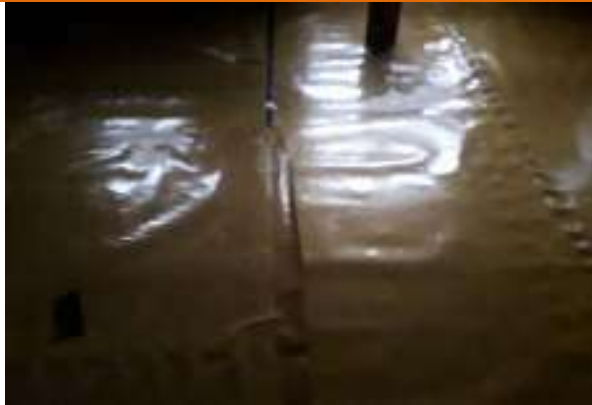
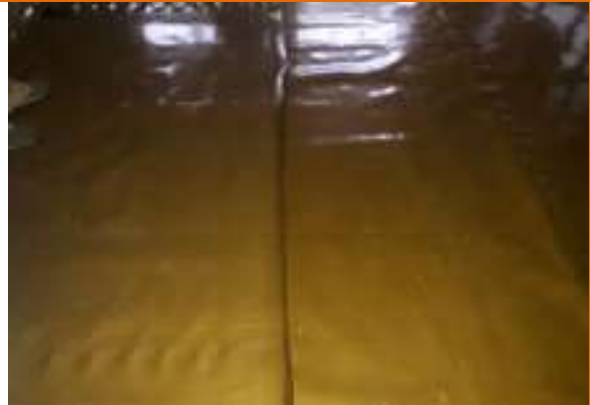
**Plot - 45**

**General Condition of Membrane-Good Condition**

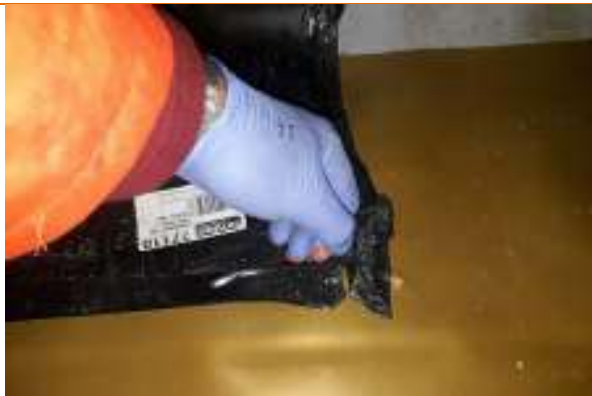
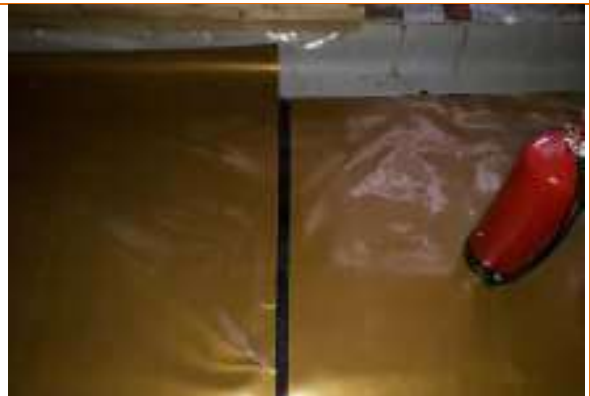
**Verification of Joints and Seals-Good Condition**

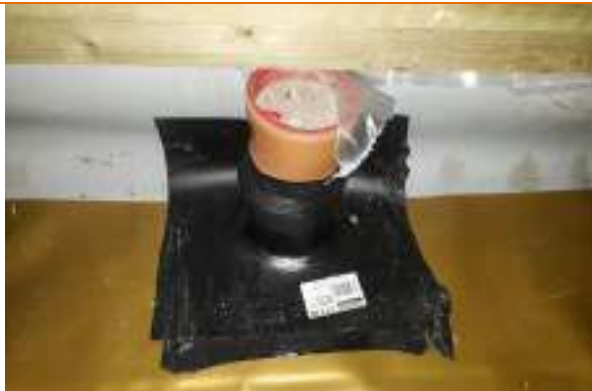
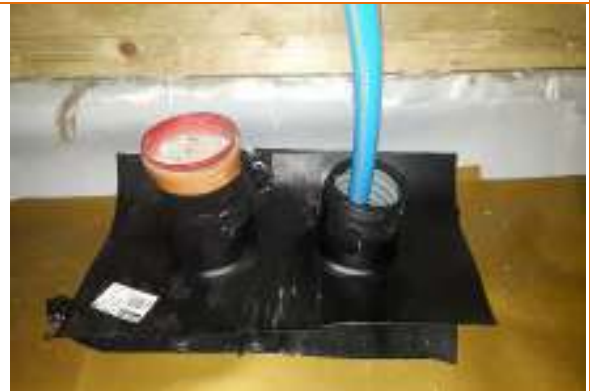
**Verification of Service Penetrations-Good Condition**

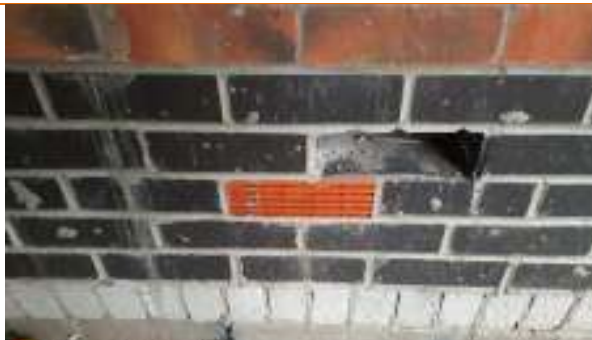
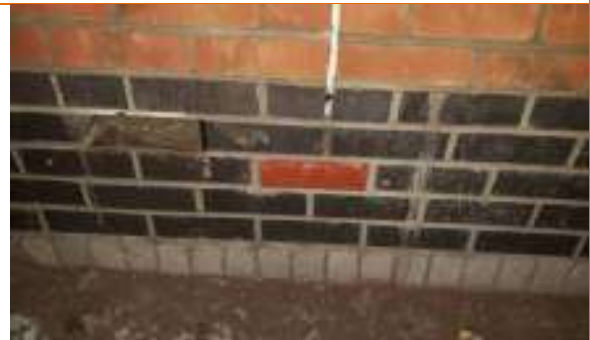
**Verification of Ventilation-Good Condition**

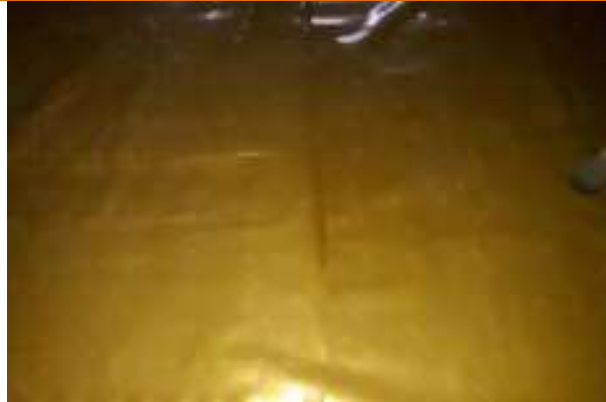
**Plot - 46**

**General Condition of Membrane-Good Condition**

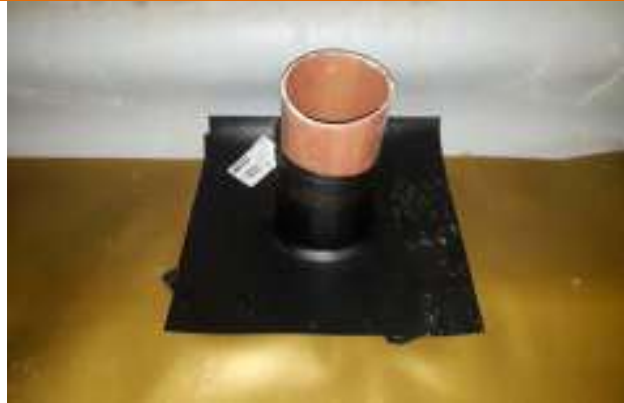
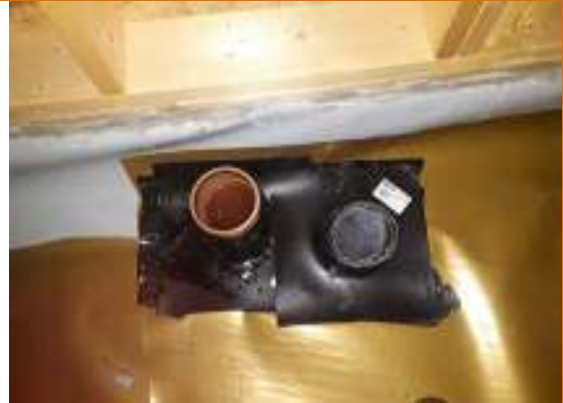
**Verification of Joints and Seals-Good Condition**

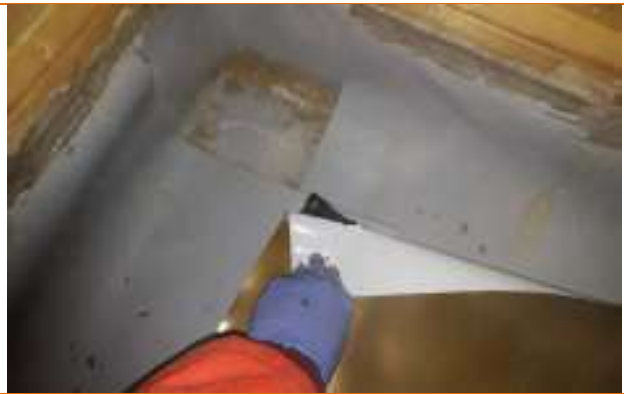
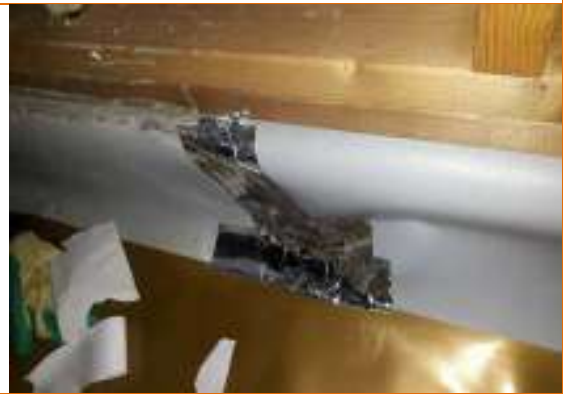
**Verification of Service Penetrations-Good Condition**

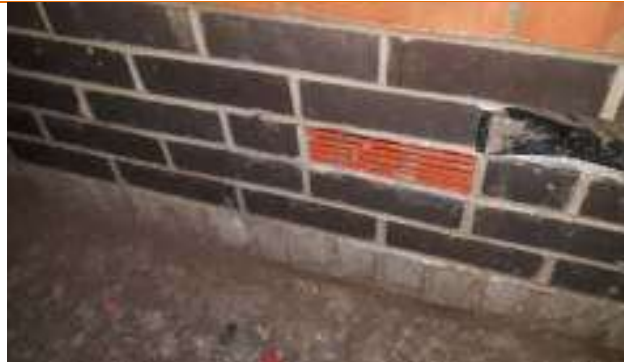
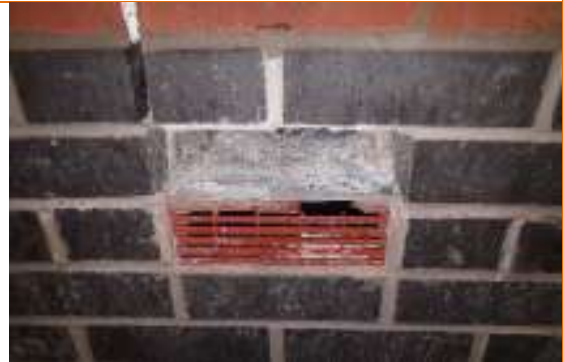
**Verification of Ventilation-Good Condition**

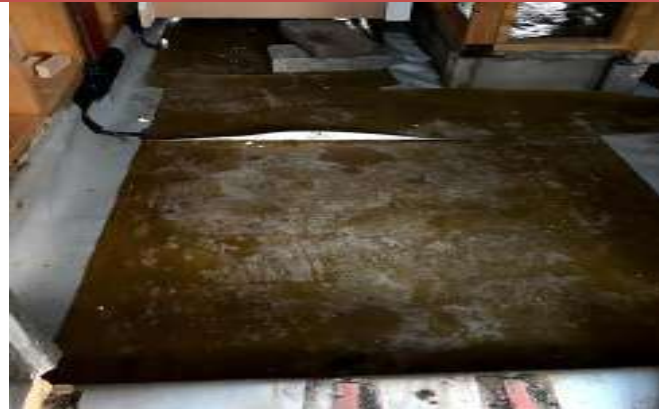
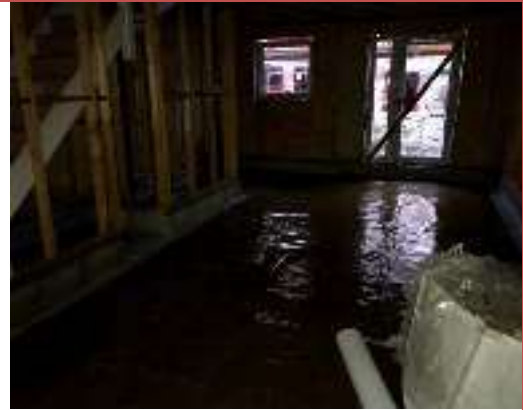
**Plot – 47**

**General Condition of Membrane-Good Condition**

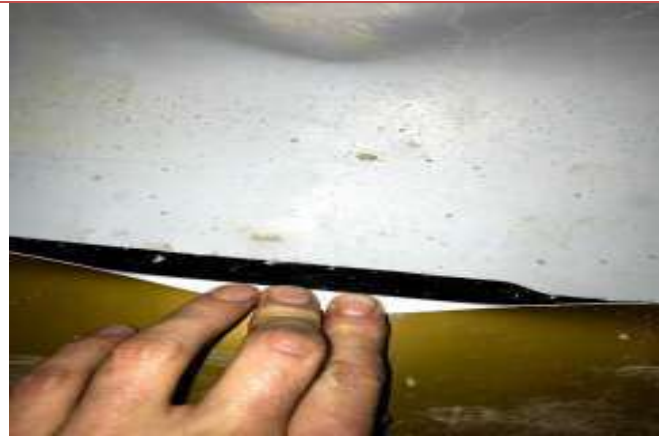
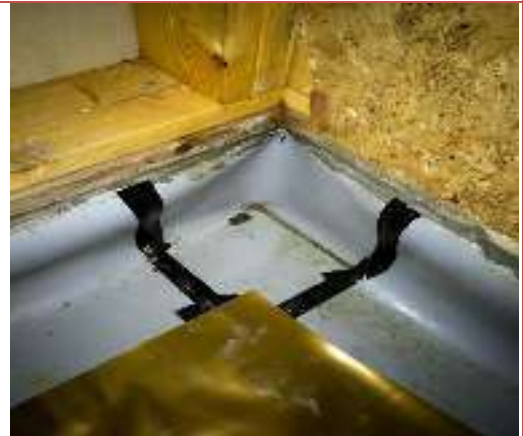
**Verification of Joints and Seals-Good Condition**

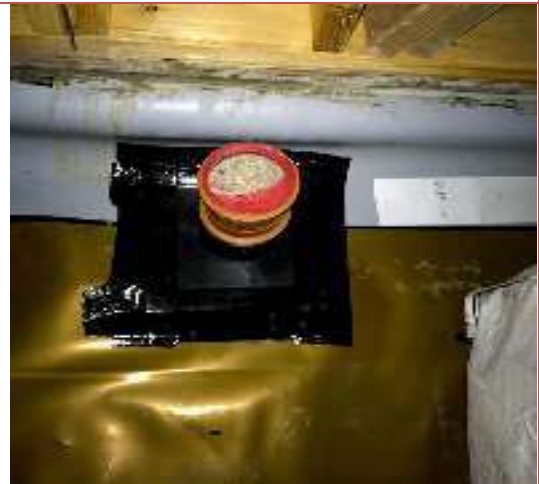
**Verification of Service Penetrations-Good Condition**

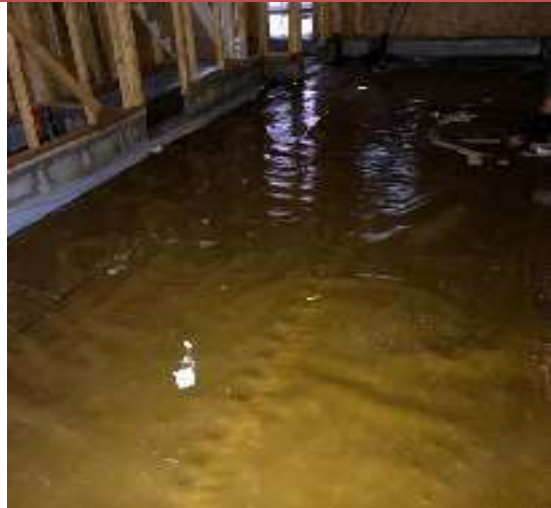
**Plot - 50**

**General Condition of Membrane-Good Condition**

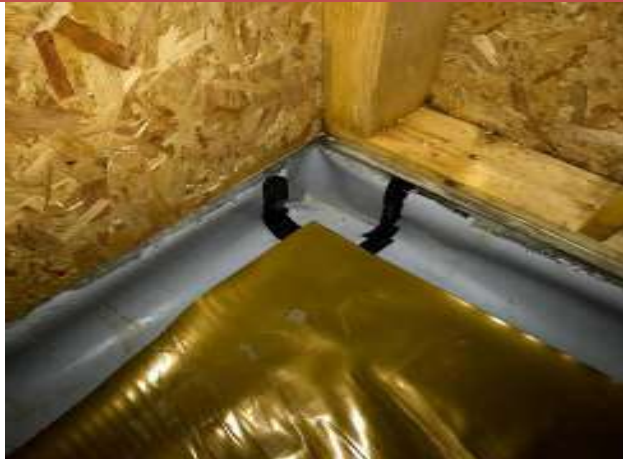
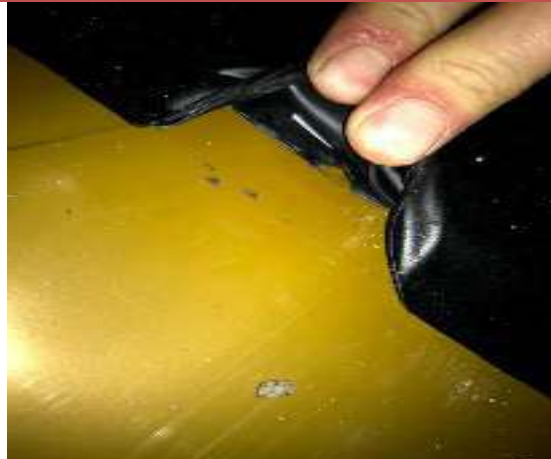
**Verification of Joints and Seals-Good Condition**

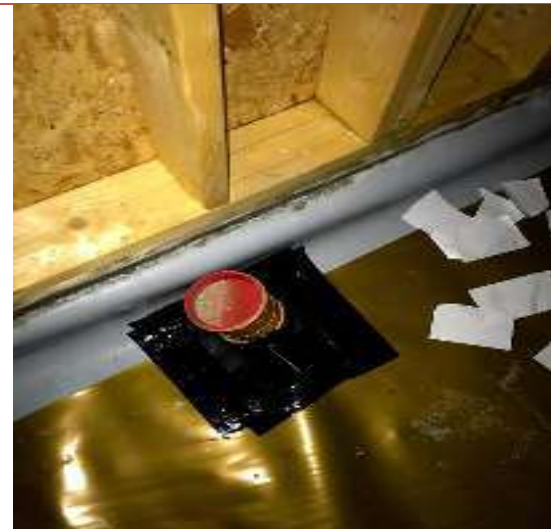
**Verification of Service Penetrations-Good Condition**

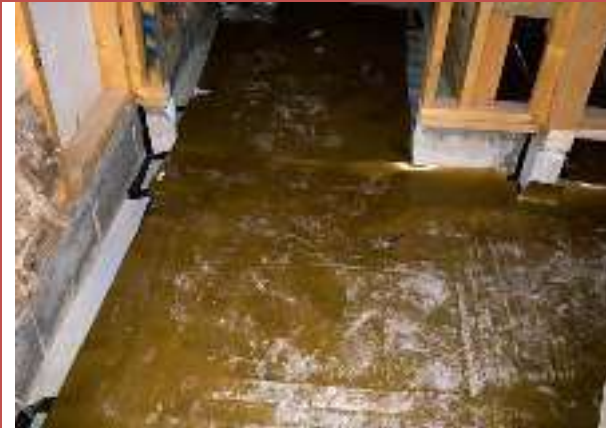
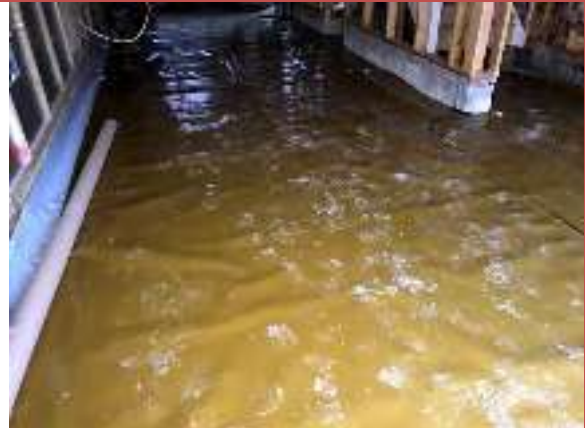
**Plot - 51**

**General Condition of Membrane-Good Condition**

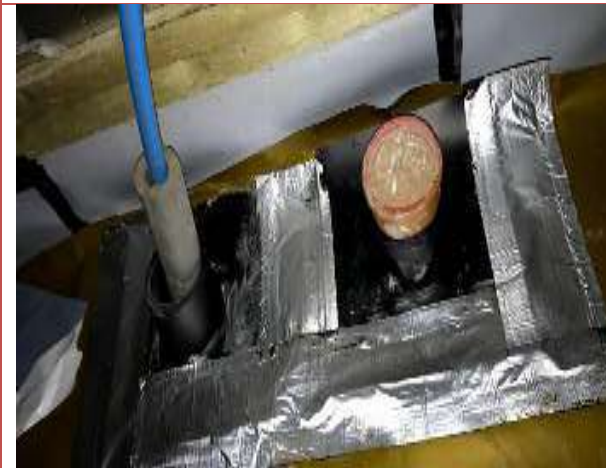
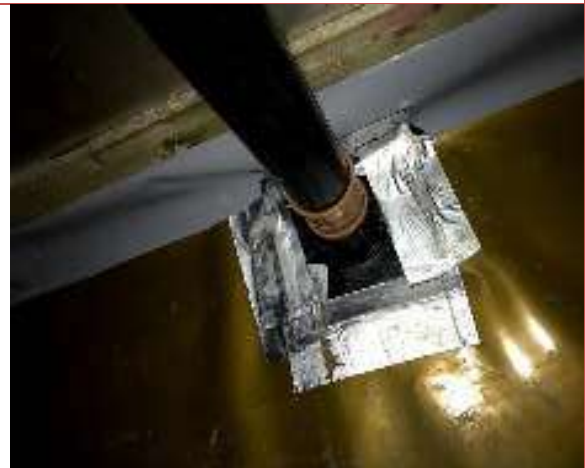
**Verification of Service Penetrations-Good Condition**

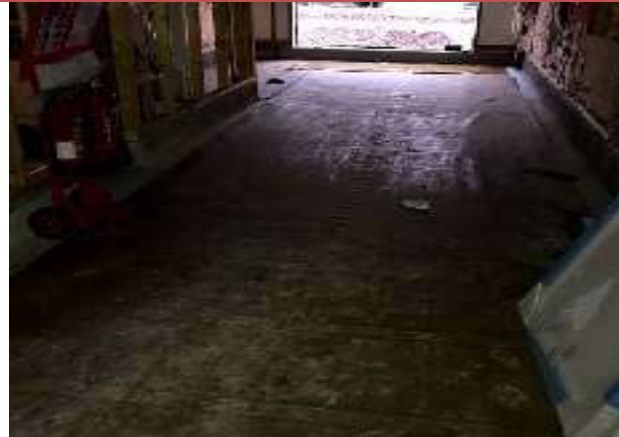
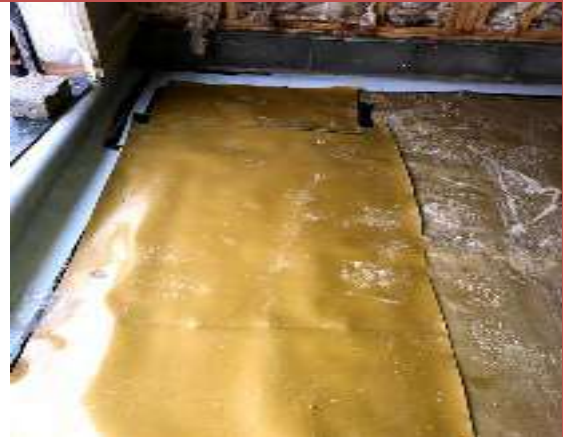
**Plot - 52**

**General Condition of Membrane-Good Condition**

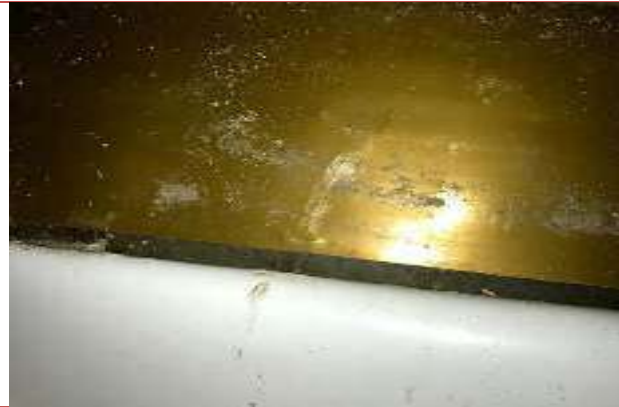
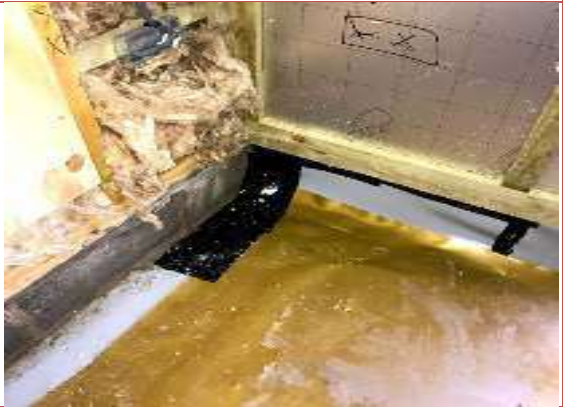
**Verification of Joints and Seals-Good Condition**

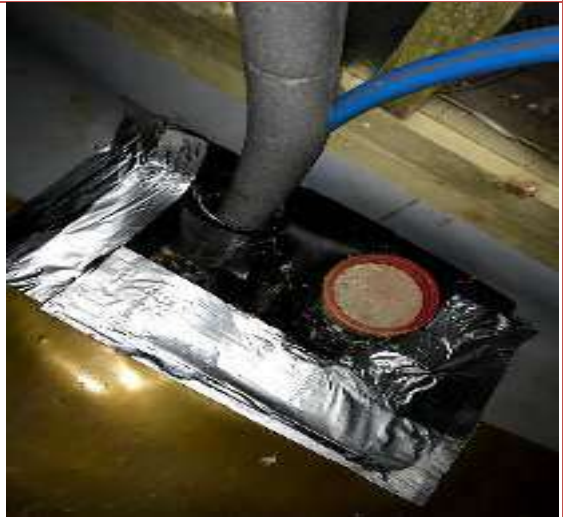
**Verification of Service Penetrations-Good Condition**

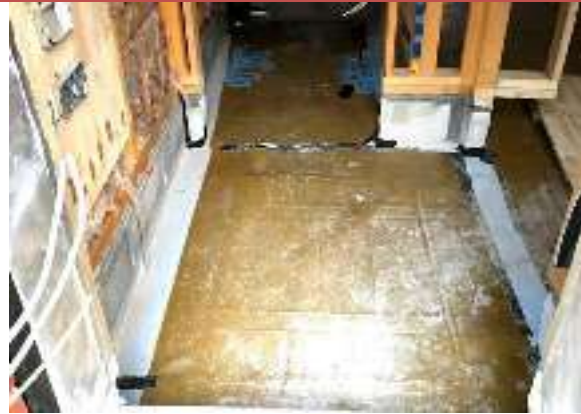
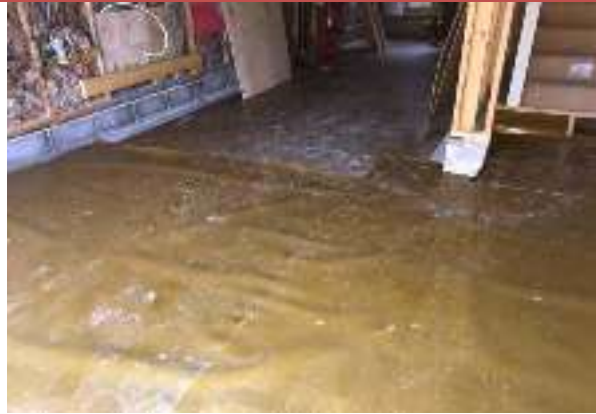
**Plot - 53**

**General Condition of Membrane-Good Condition**

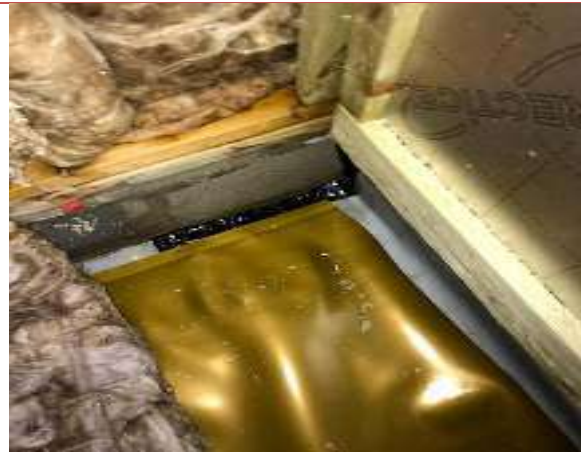
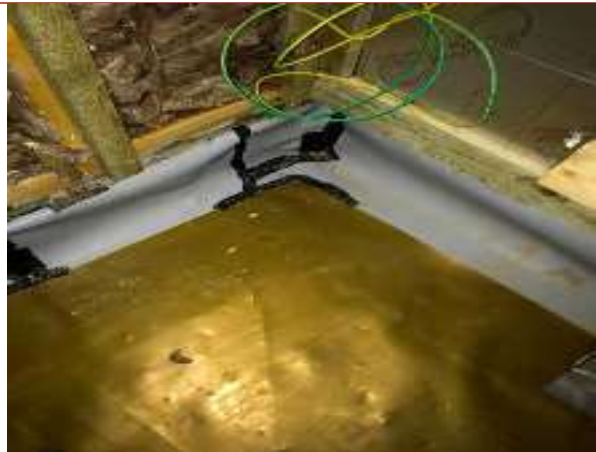
**Verification of Joints and Seals-Good Condition**

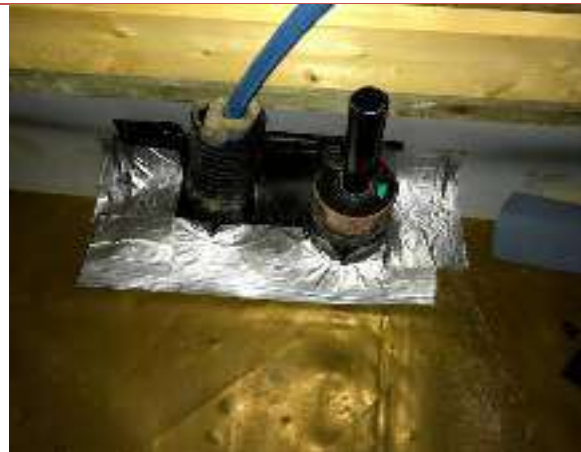
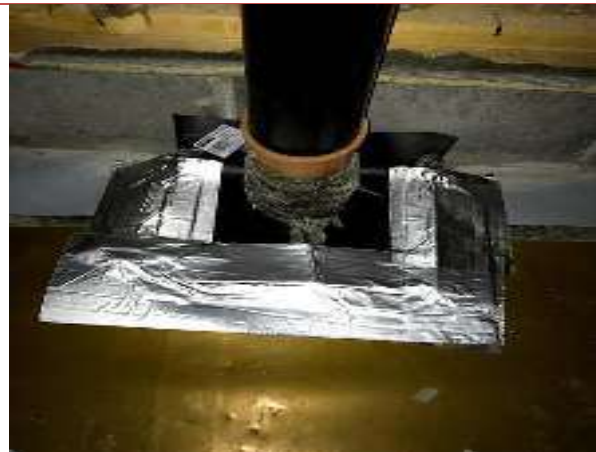
**Verification of Service Penetrations-Good Condition**

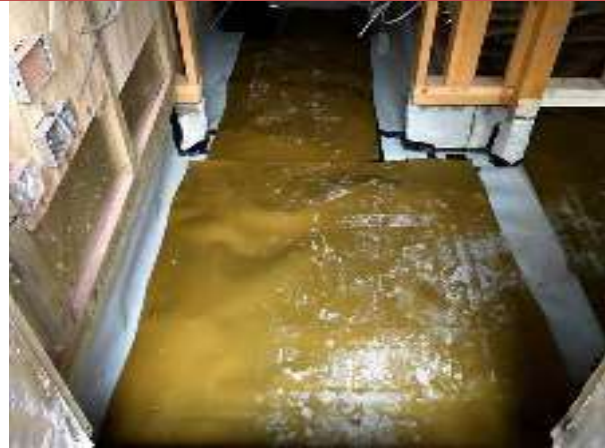
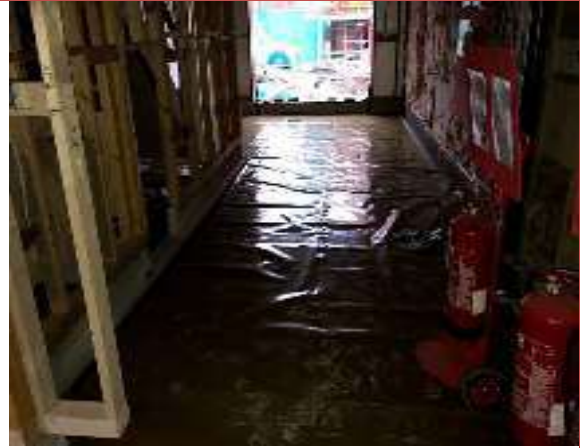
**Plot - 54**

**General Condition of Membrane-Good Condition**

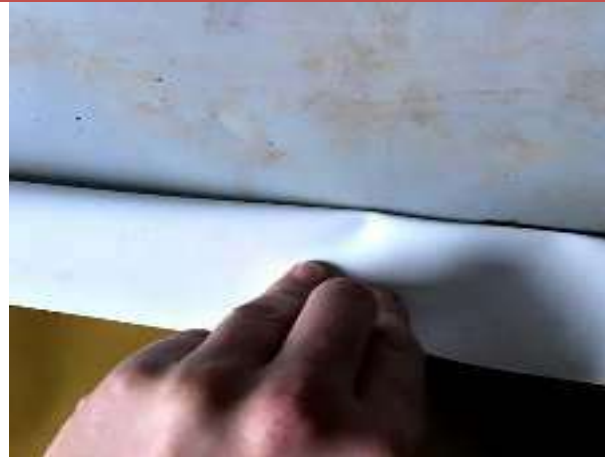
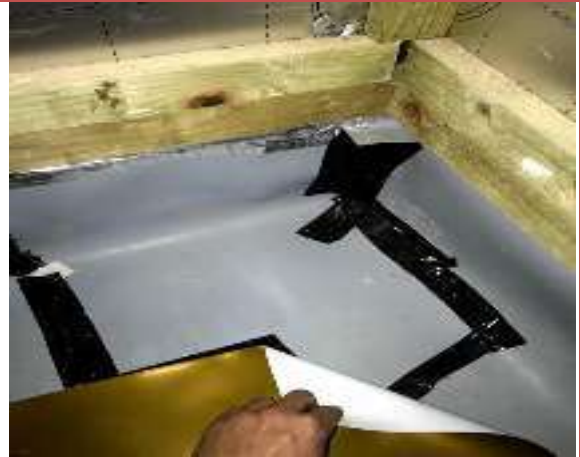
**Verification of Joints and Seals-Good Condition**

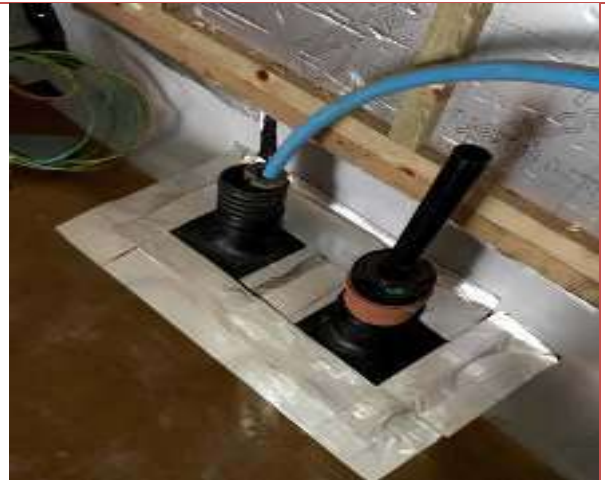
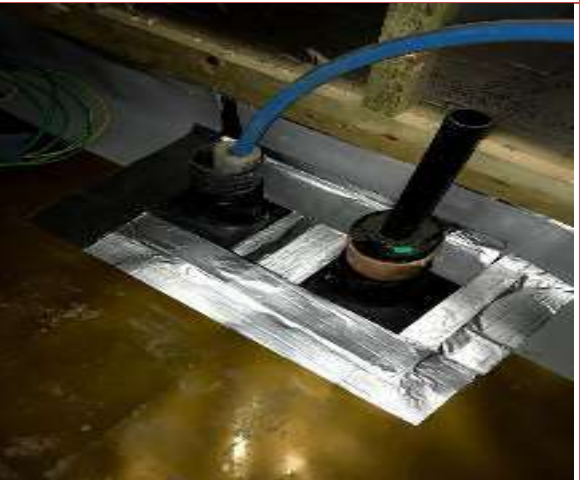
**Verification of Service Penetrations-Good Condition**
