## Phase IV Validation Completion Report

Prospect House School  
Blackley

Reference: 30186-SUT-ZZ-00-RP-G-704-0001

Date: January 2022

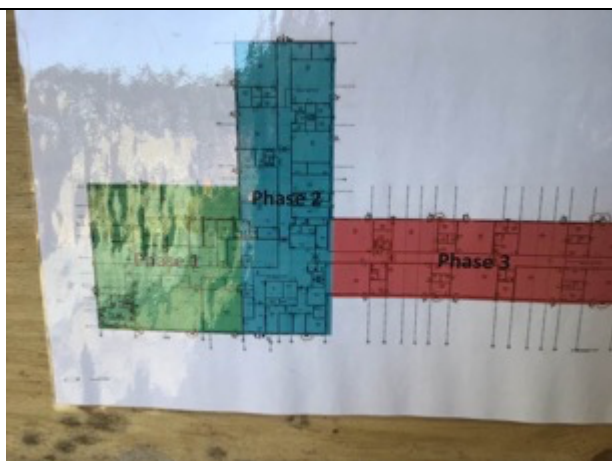
Overview

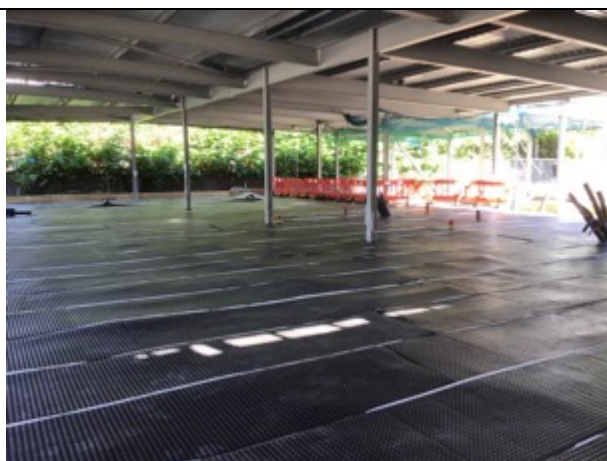
Vent into slotted collection pipe

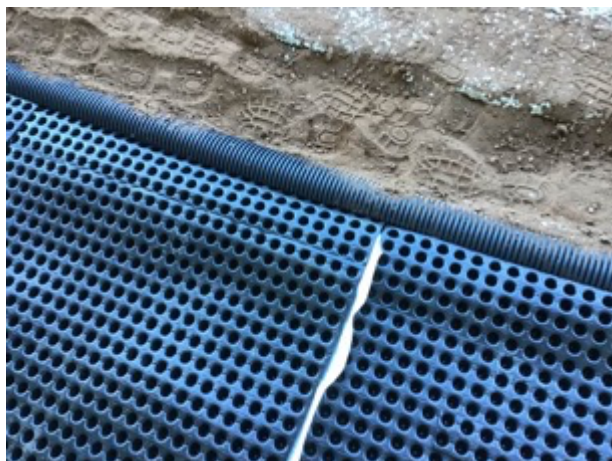
Vent mat around pipe

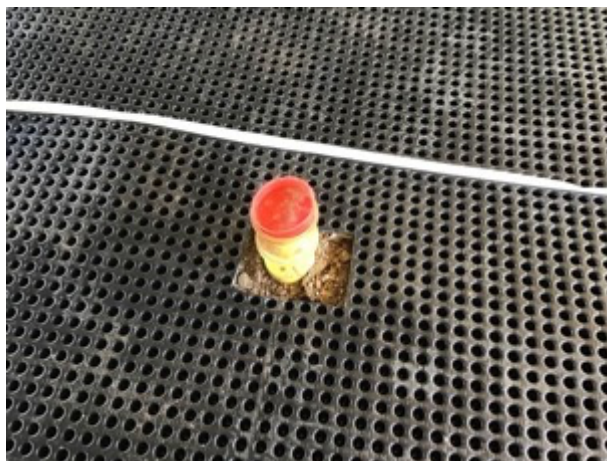
Vent mat around stanchion

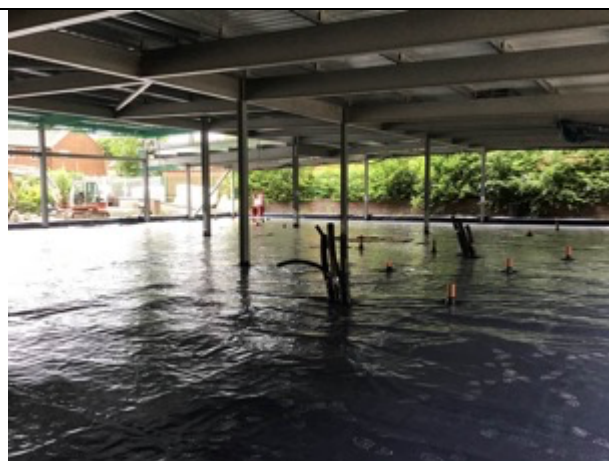
Multiple pipe seals using SAGM

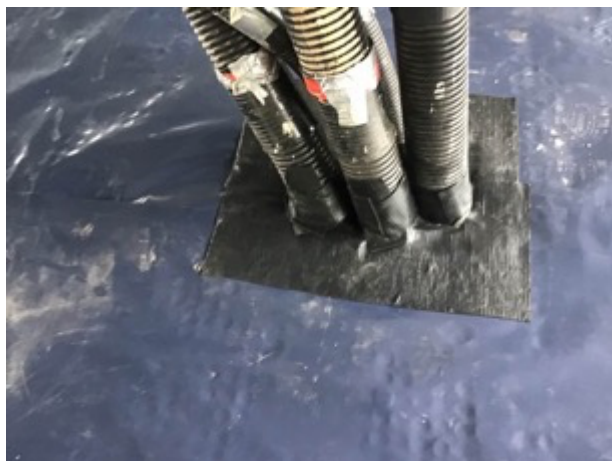
Tape joint

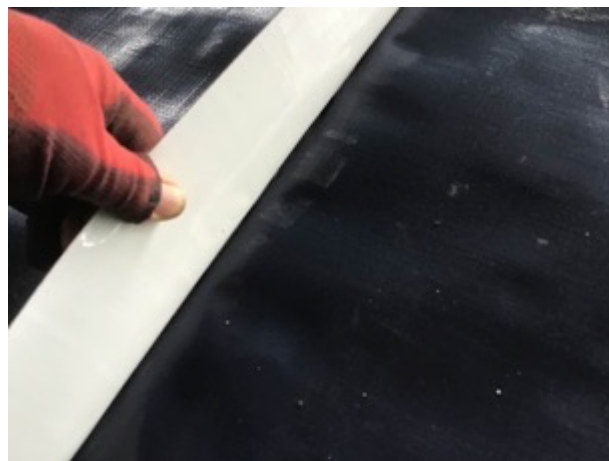
Perimeter edge

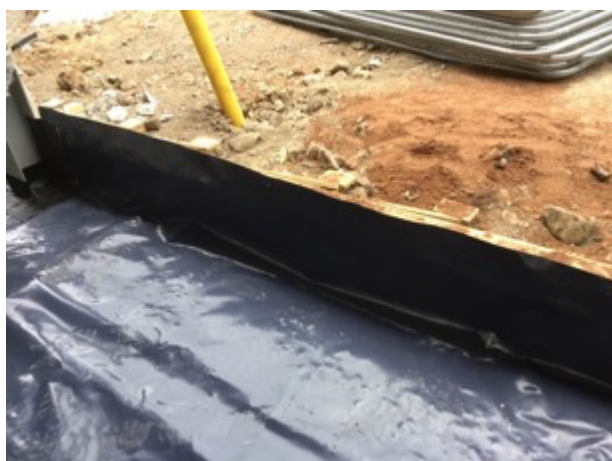
Stanchion seal using SAGM

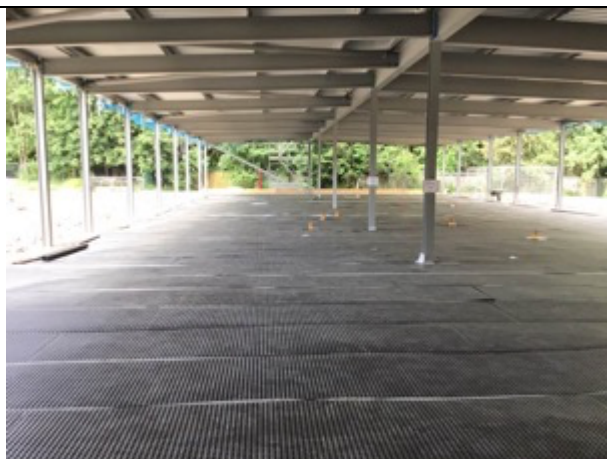
Vent mat around stanchion

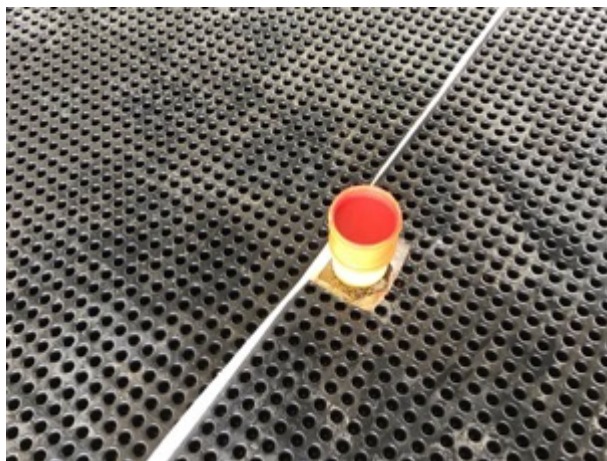
Vent mat inserted into slotted collection pipe

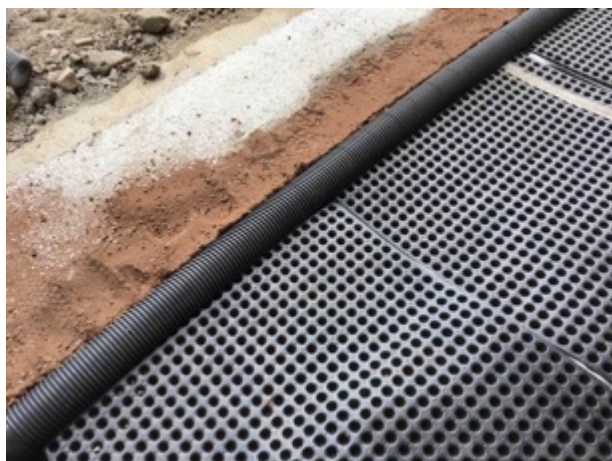
Perimeter edge beam

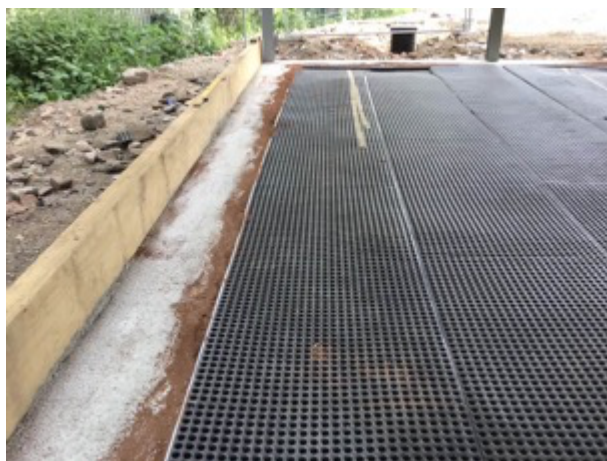
Vent mat inserted into slotted collection pipe

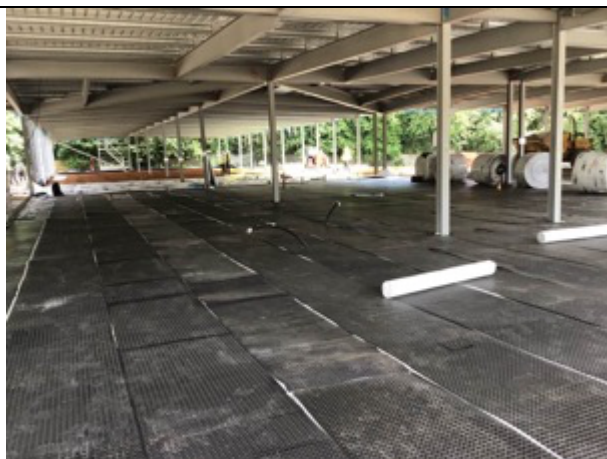
Vent mat inserted into slotted collection pipe

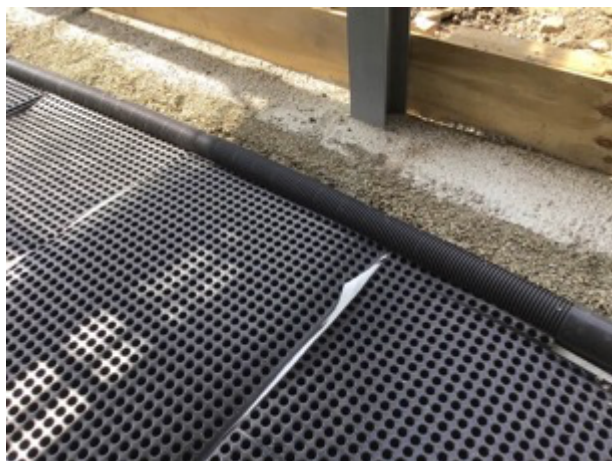
Vent mat around stanchion

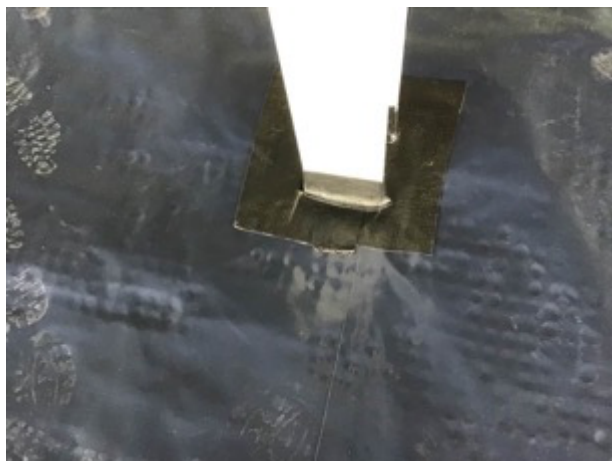
Pipe seal being pick tested

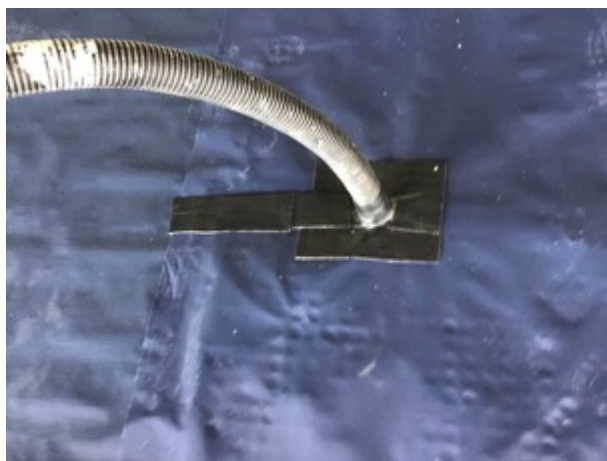
Pipe seal using SAGM

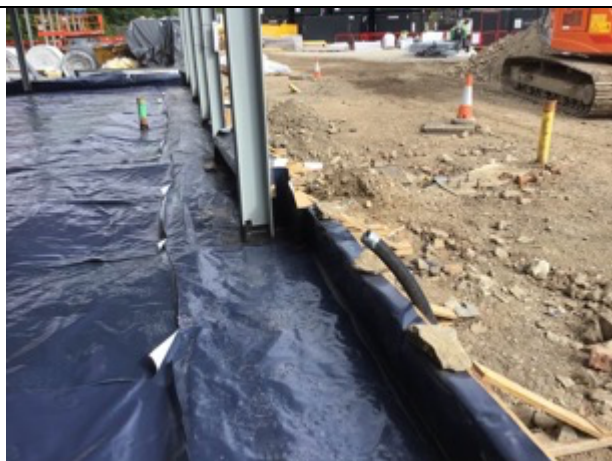
Perimeter edge

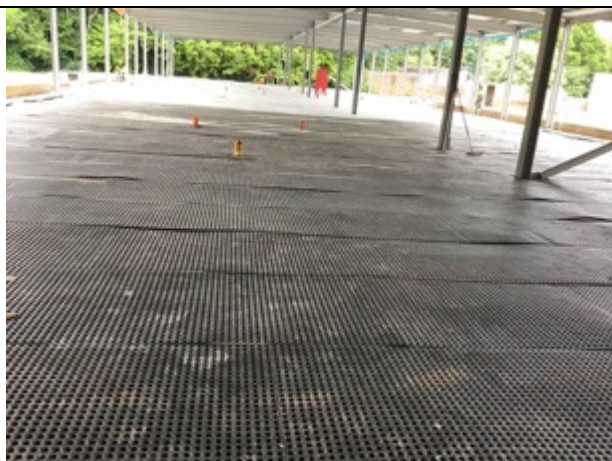
Full venting installation

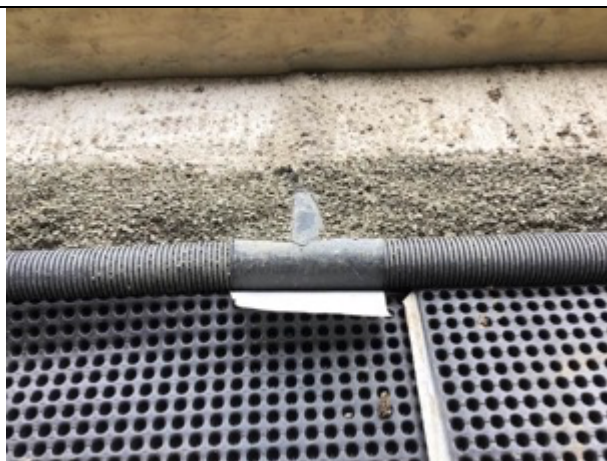
Vent mat joining to perimeter T piece

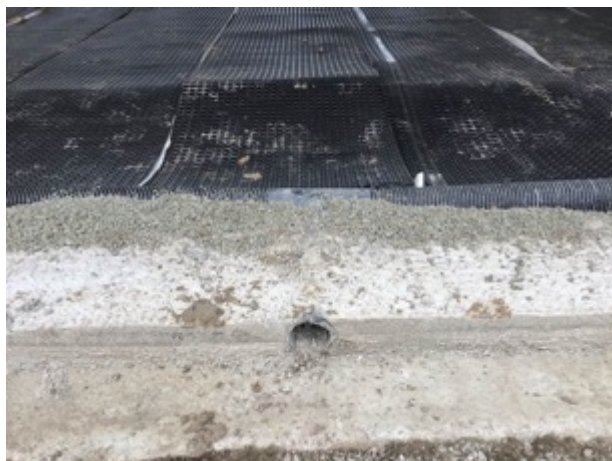
T piece coming through the perimeter concrete beam

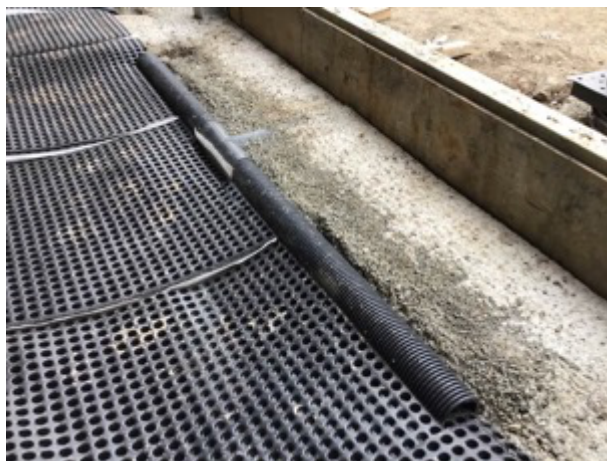
Vent mat connected to perimeter T piece

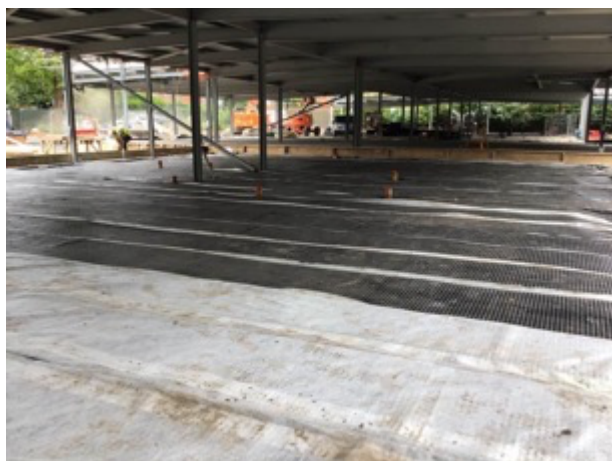
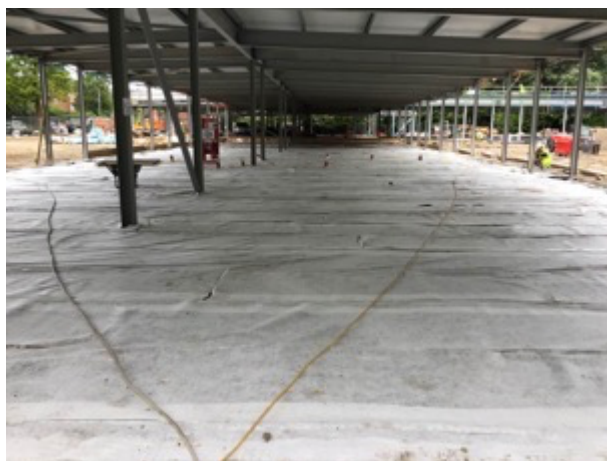
Full venting installation gridlines L-U / 2-7

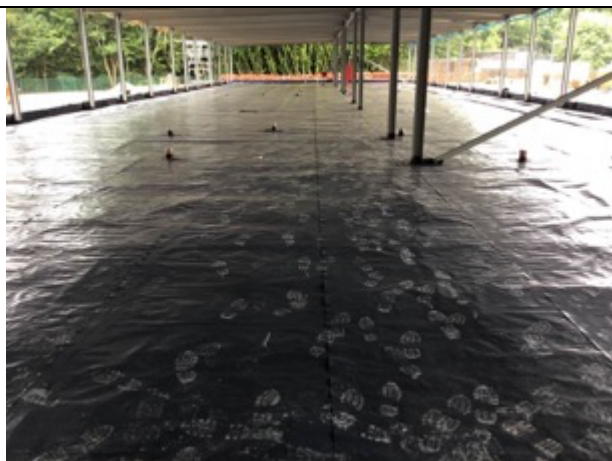
Full line out installation gridlines L-U / 2-7

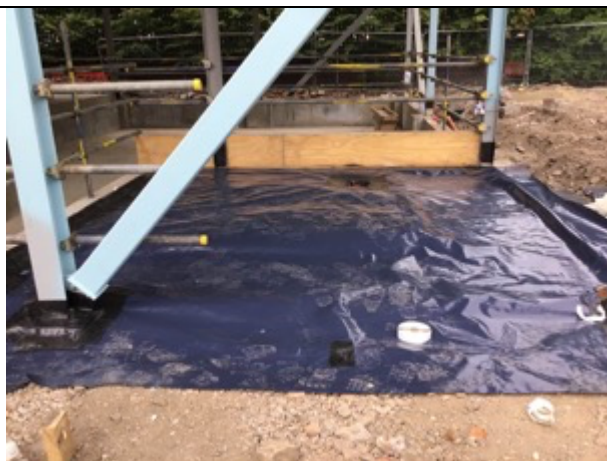
Full line out installation gridlines D-E / 8-9

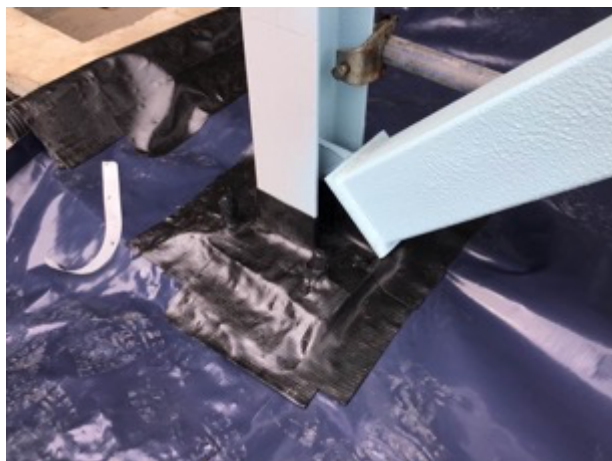
Sealed stanchion detail

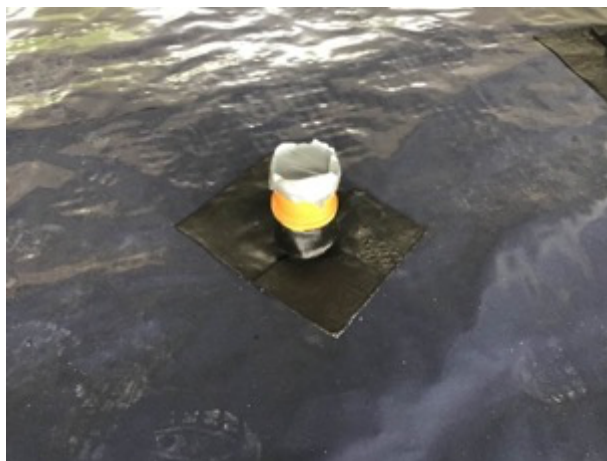
Sealed pipe penetration

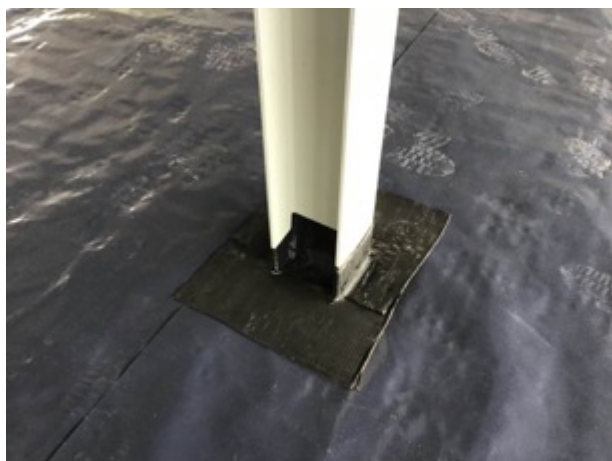
Sealed stanchion detail

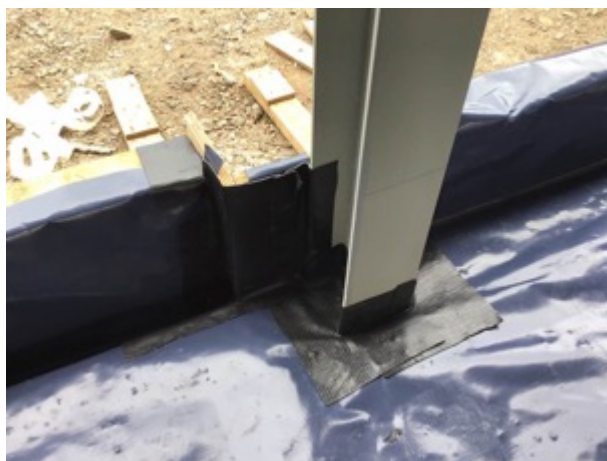
Sealed perimeter stanchion and corner detailing

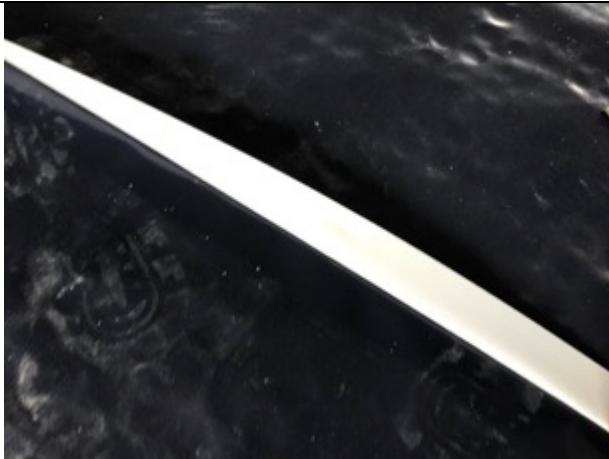
Sealed double sided butyl tape membrane joint

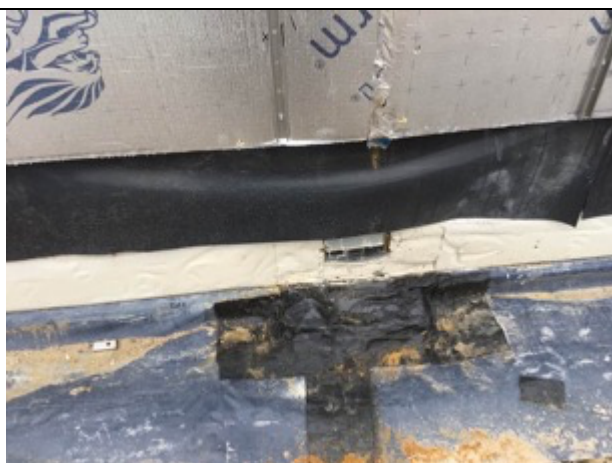
Stanchion seal using SAGM

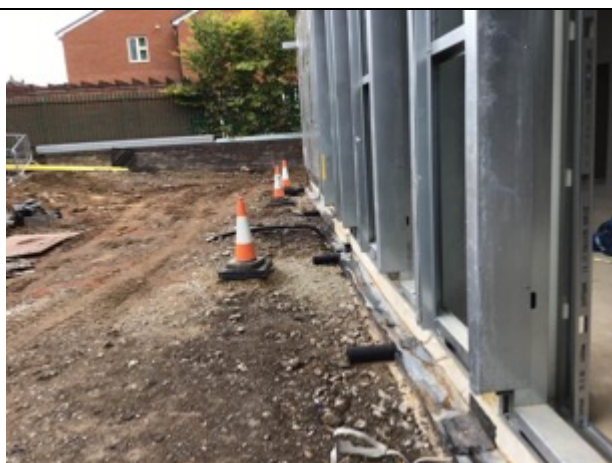
Perimeter edge

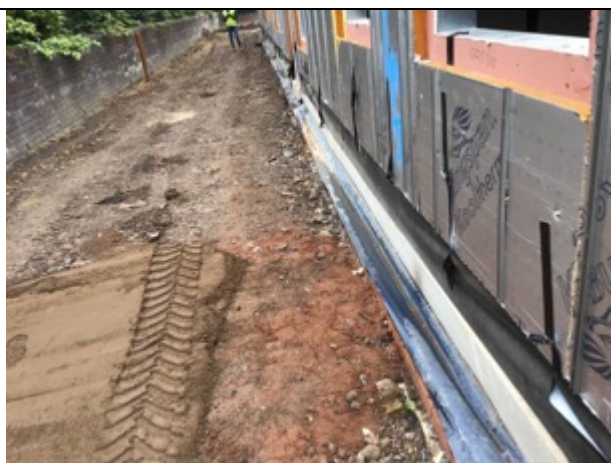
Perimeter edge

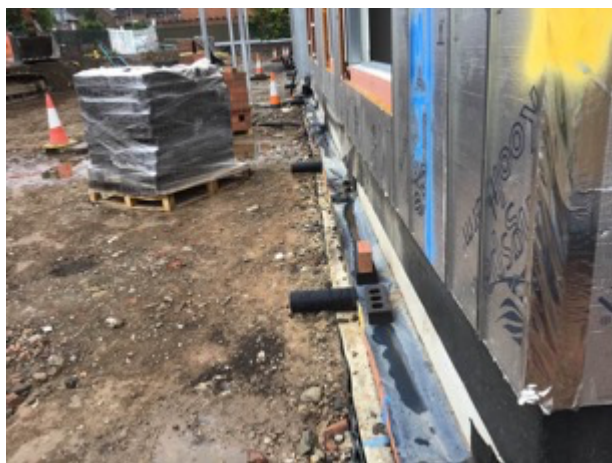
Perimeter edge
