| ELR: MAJ | Structure No: 289 | Mileage: | Examination date: 07/09/2020 |
| Name: Castlefield Viaduct | | | Type: Viaduct |
| Carrying/Over: Disused rail / Canal, rail, road & land | | | No. of spans: 8 |

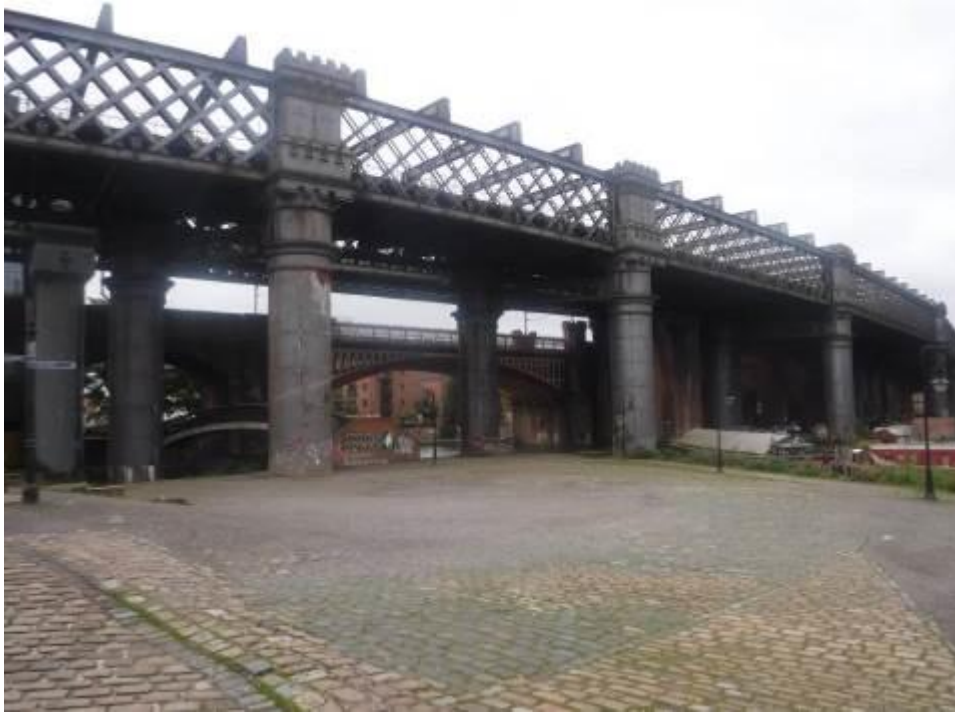
Photograph 1: North elevation

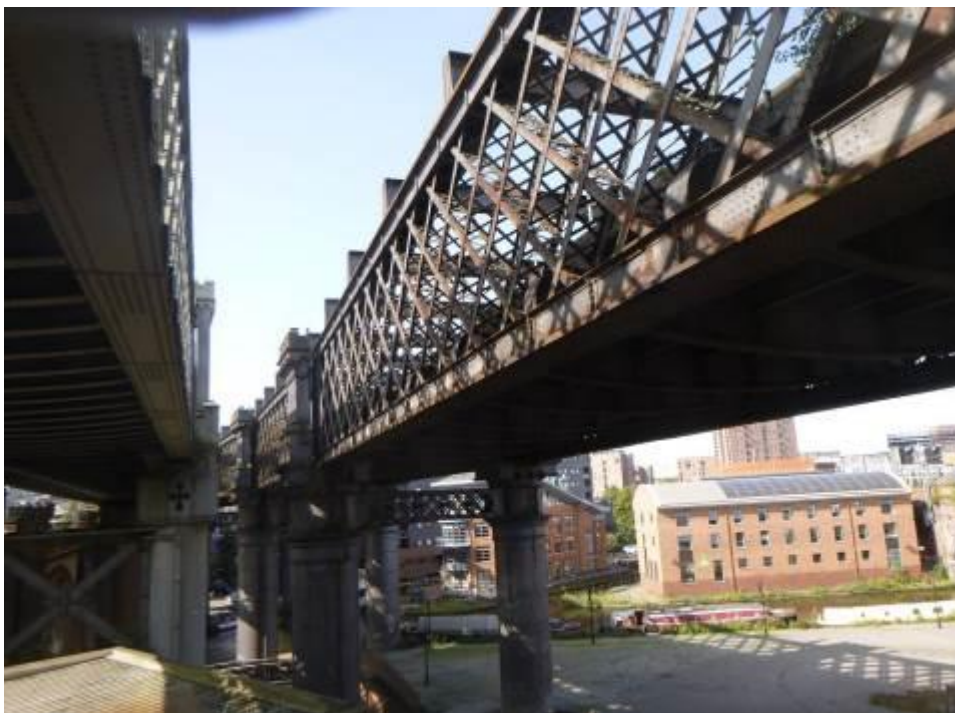
Photograph 2: South elevation

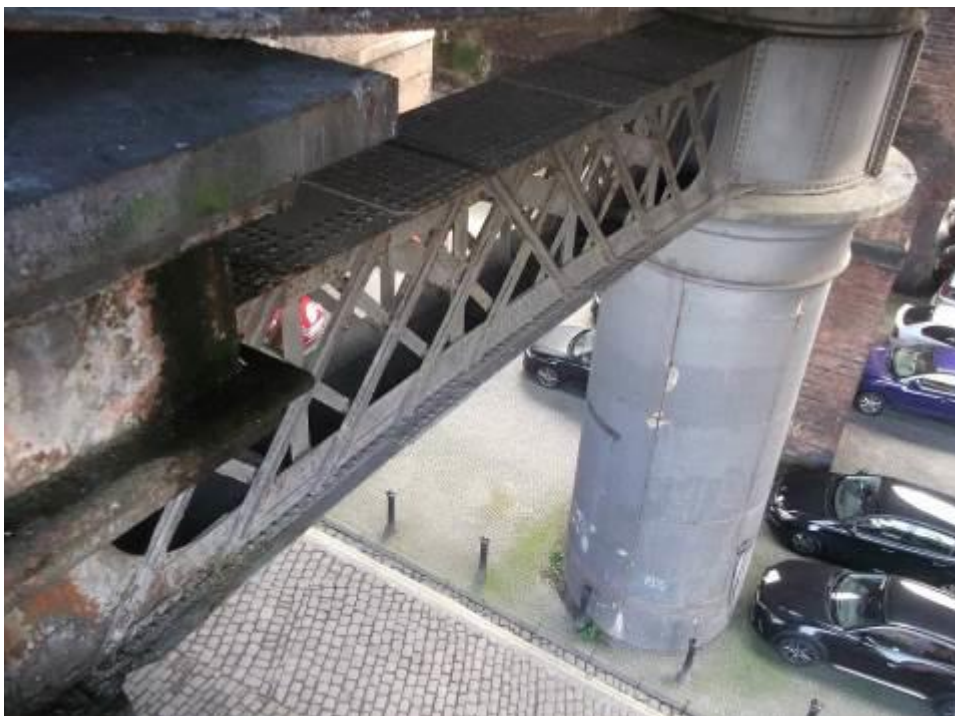
**South column: (photo 36)** There were areas of hairline map cracking to paintwork, paint loss and surface corrosion throughout, especially to the panel joints.

**Interconnecting truss: (photo 36)** The truss was in fair condition with spot areas of paint loss and surface corrosion. There was an area of loss of section to the north end of the lower west flange, 30 x 10mm. (photo 37)

Photograph 36: General view of pier 1, south column and interconnecting truss of pier 1

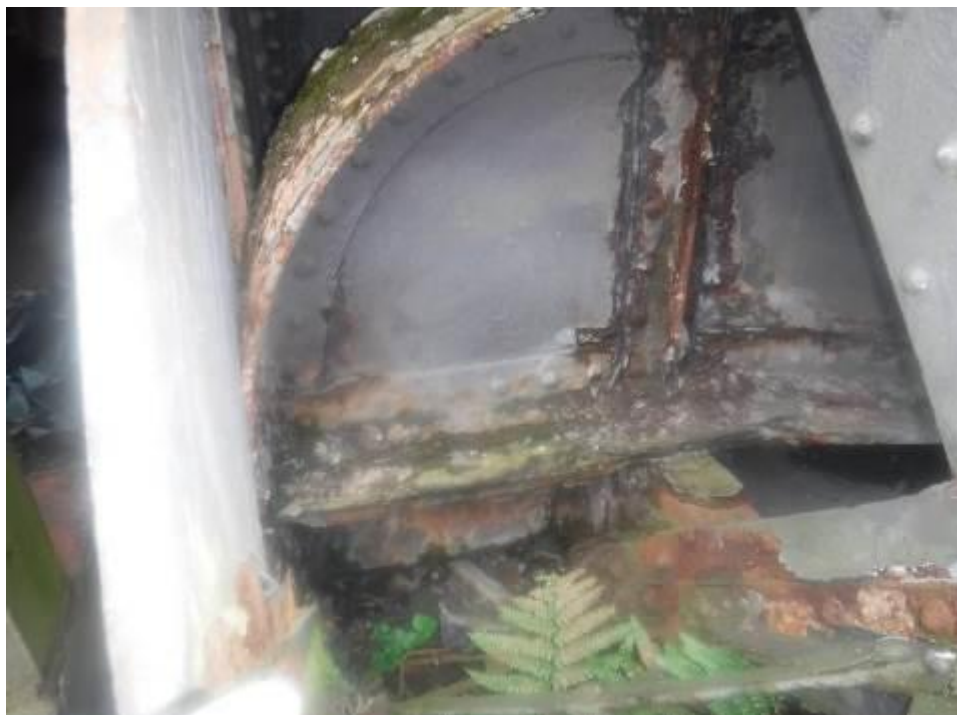
Photograph 157: Typical loss of thickness to bottom boom connections with transverse girders of north truss of span 7

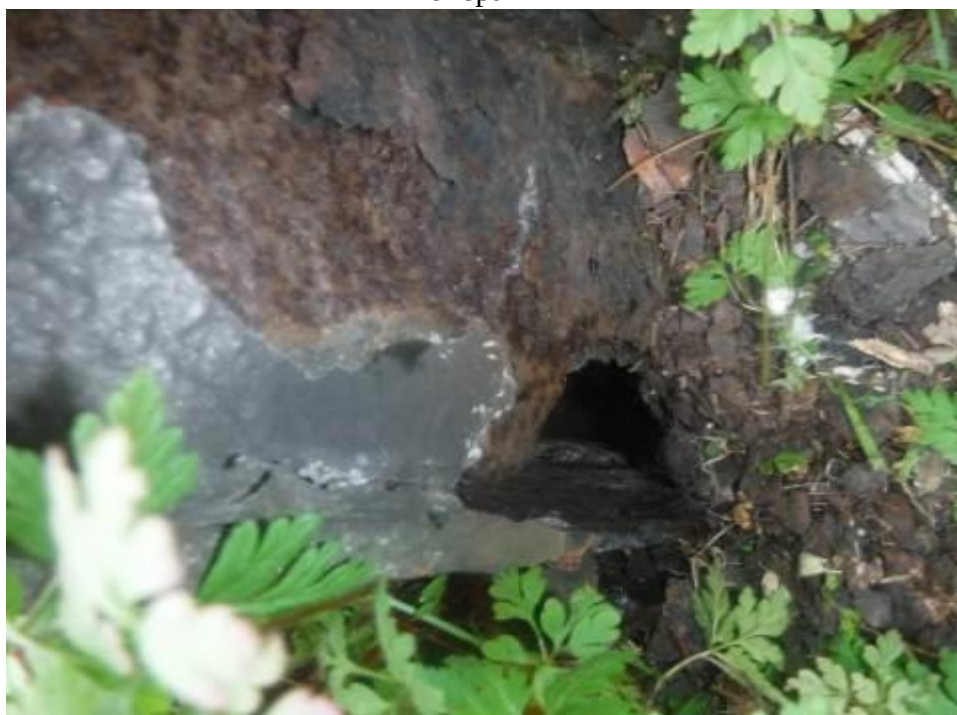
Photograph 158: Loss of section to end section middle vertical stiffener of south truss of span 7

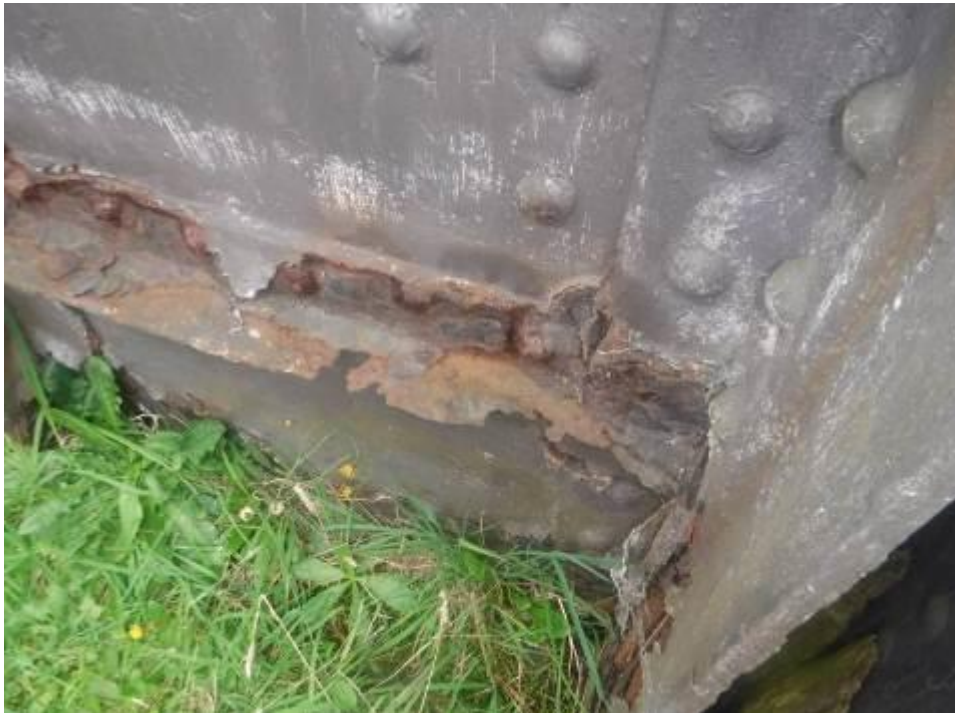
Photograph 161: Loss of thickness & section to end section lowest horizontal stiffener of south truss of span 7

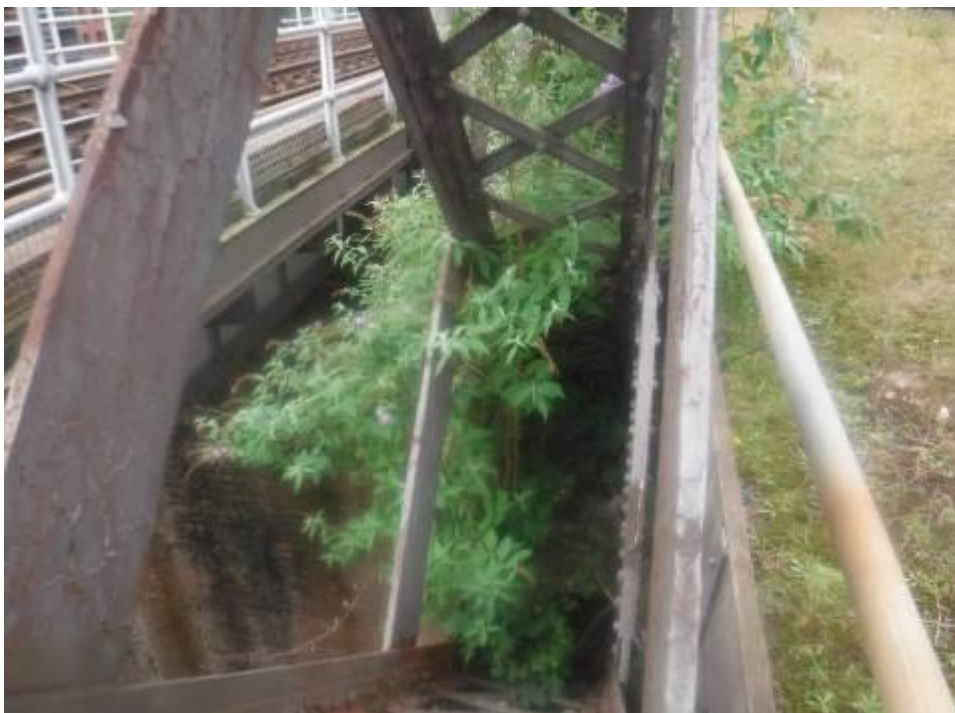
Photograph 162: Vegetation growth to bottom boom of south truss of span 7

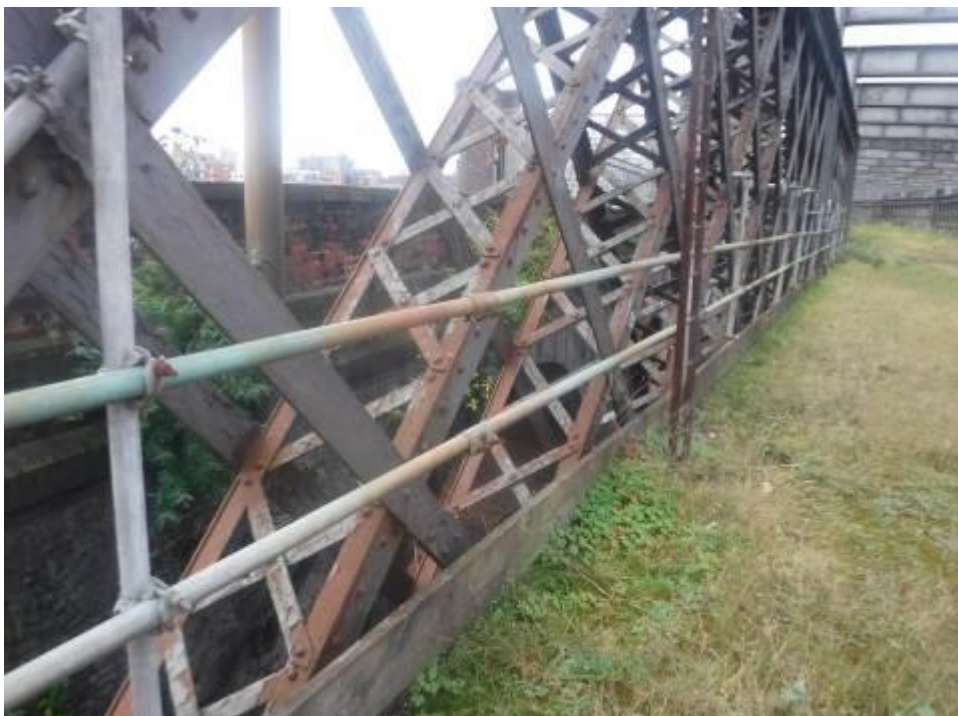
The top of the bridge (formerly the track top) was vegetated throughout, mainly with grass and weeds growing from the deck. **(photos 228 & 229)** Ballast boards along each edge of the deck held in place with scaffold bars were in fair condition although fixings were generally in poor condition. **(photos 230, 231 & 232)** There were no ballast boards in place over span 8. **(photo 233)**

Photograph 230: General view of ballast boards held in place with scaffold bars to top of deck
