## VALIDATION COMPLETION REPORT

Former Withington Hospital  
Cavendish Road  
Manchester  
M20 1LB

Prepared for:  
Bellway Homes Manchester

**Report Ref: 10-933-R4-1**  
**Date Issued: 30/07/2020**

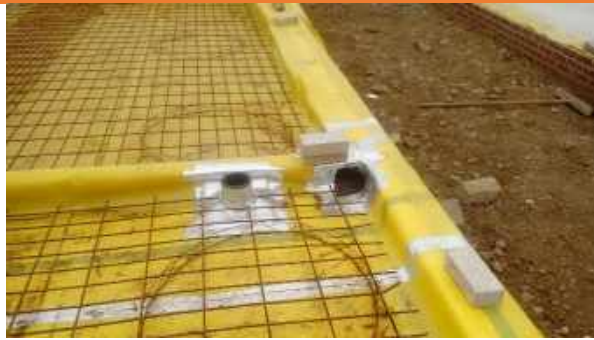
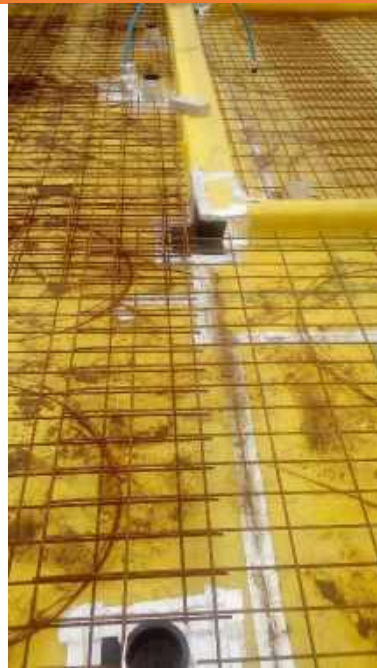
**Plots 25 & 26**

**General Condition of Membrane-Good Condition**

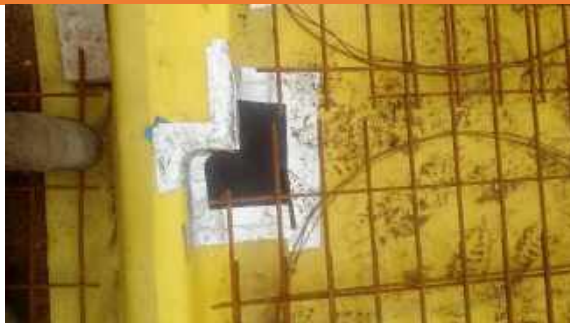
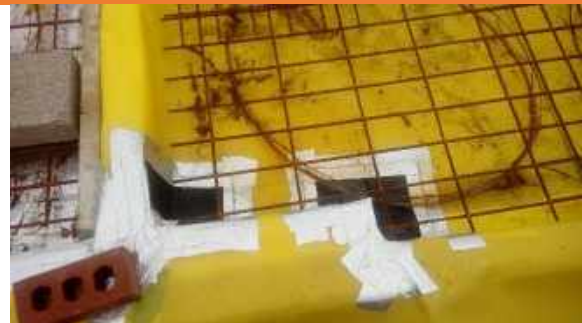
**Verification of Joints and Seals-Good Condition**

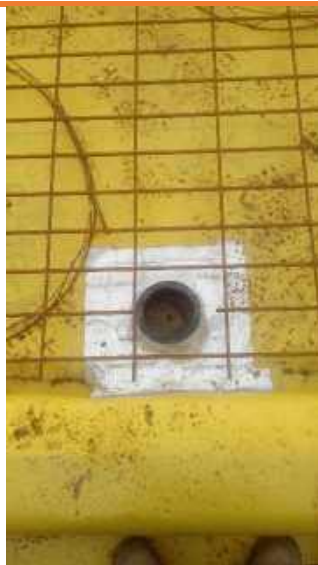
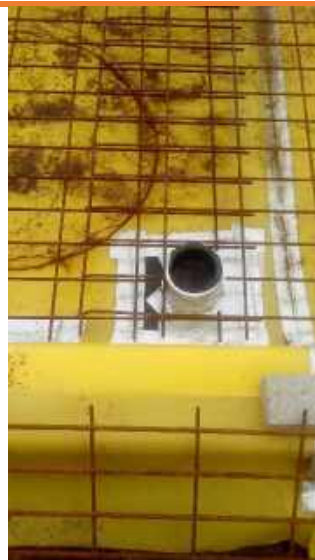
**Verification of Service Penetrations-Good Condition**

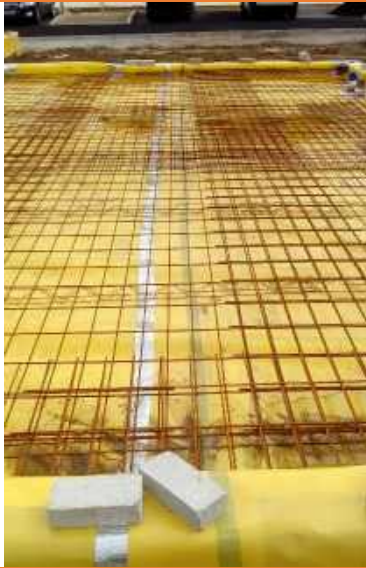
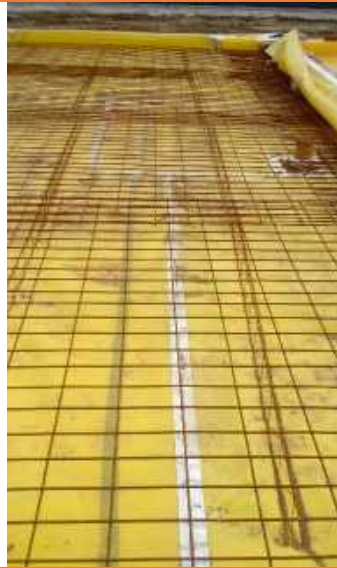
**Plot 27**

**General Condition of Membrane-Good Condition**

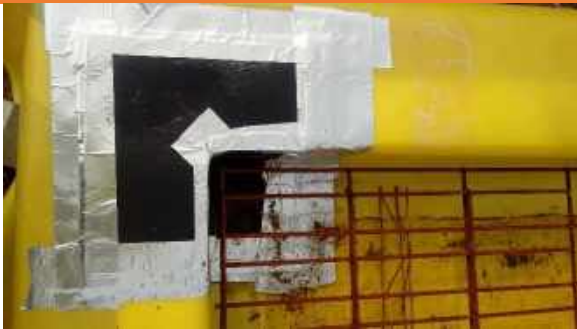
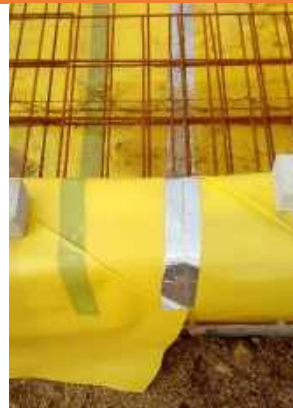
**Verification of Joints and Seals-Good Condition**

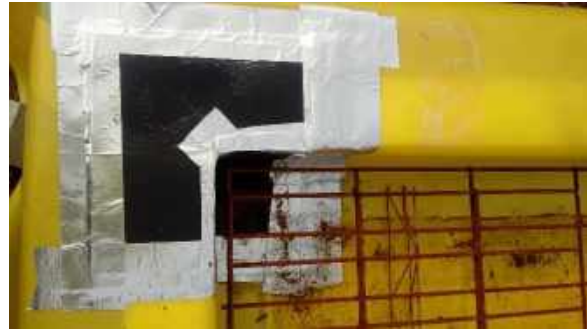
**Plot – 33**

**General Condition of Membrane-Good Condition**

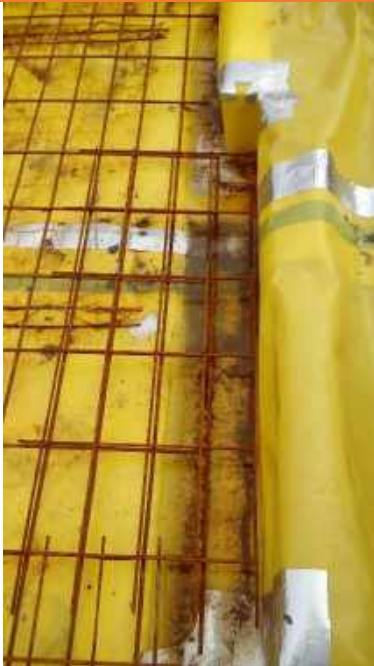
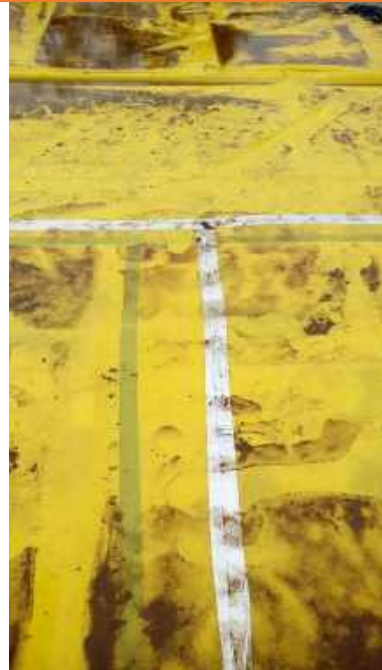
**Plots 34 & 35****General Condition of Membrane-Good Condition**

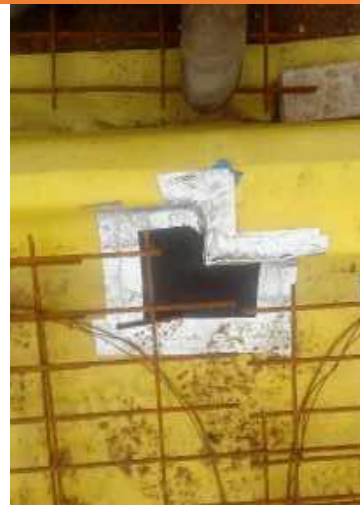
**Verification of Joints and Seals-Good Condition**

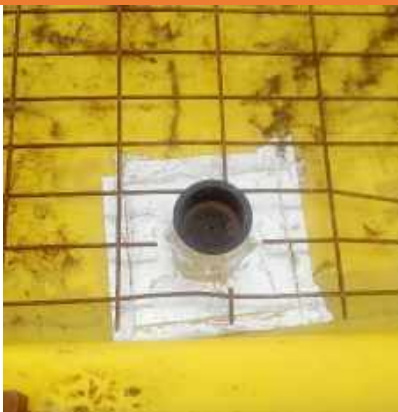
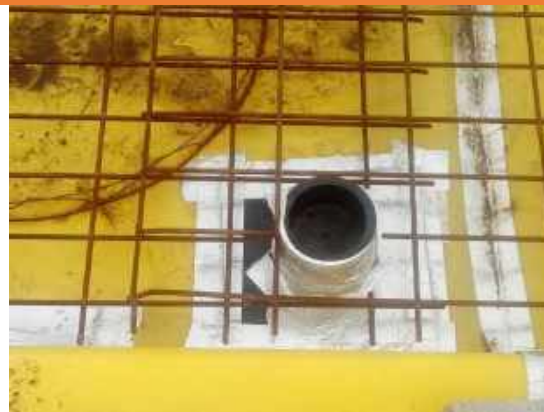
**Verification of Service Penetrations- Good Condition**

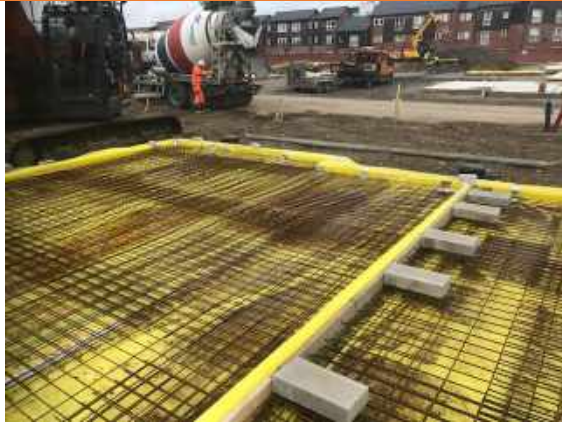
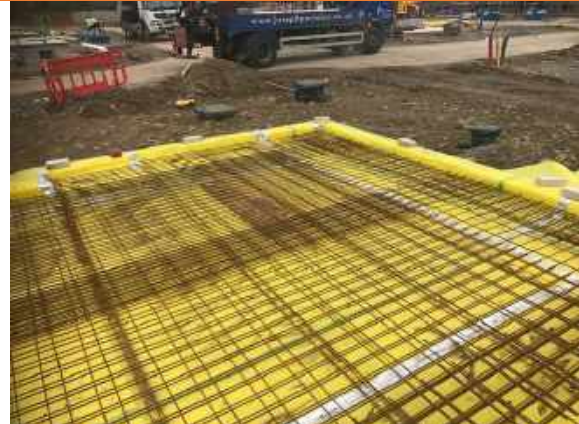
**Plots 36 & 37**

**General Condition of Membrane-Good Condition**

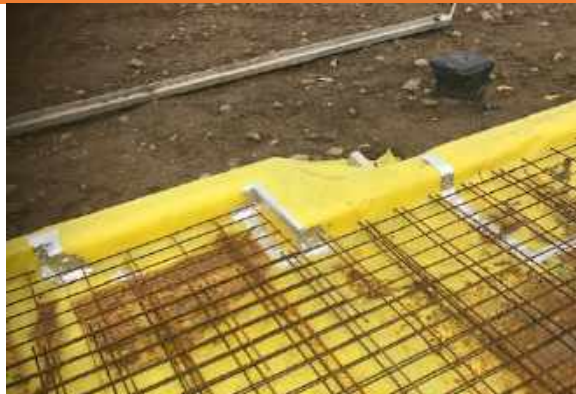
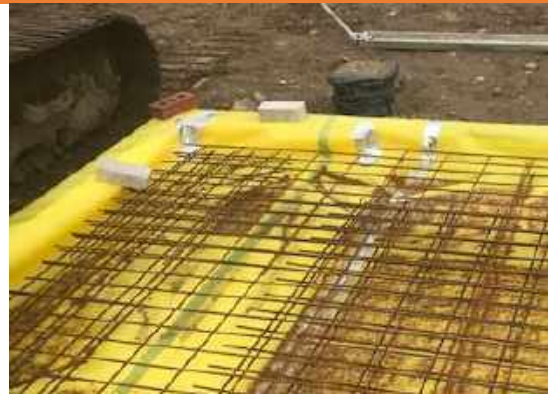
**Verification of Joints and Seals-Good Condition**

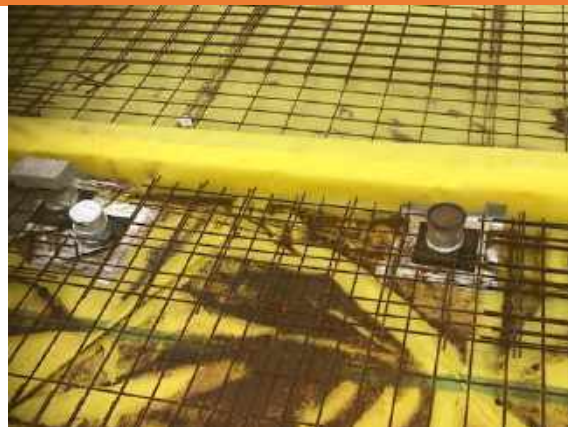
**Verification of Service Penetrations- Good Condition**

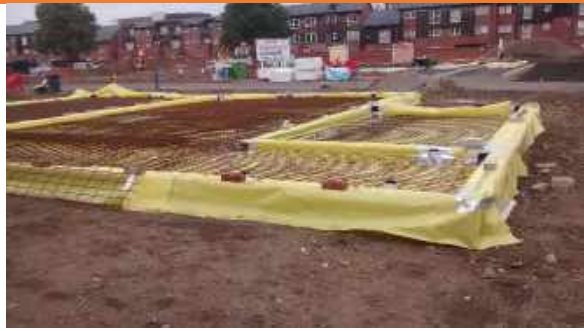
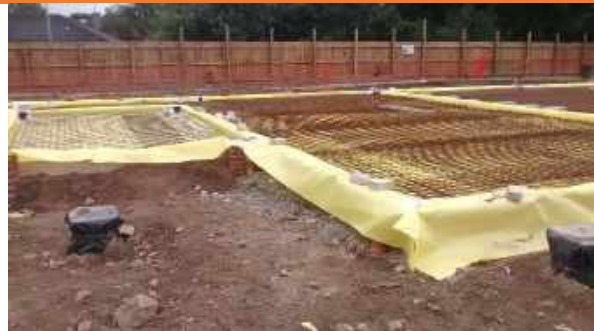
**Plot - 38**

**General Condition of Membrane-Good Condition**

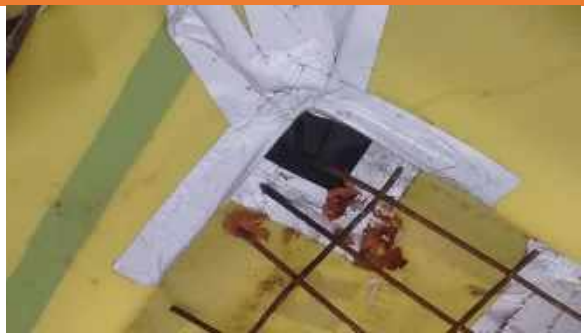
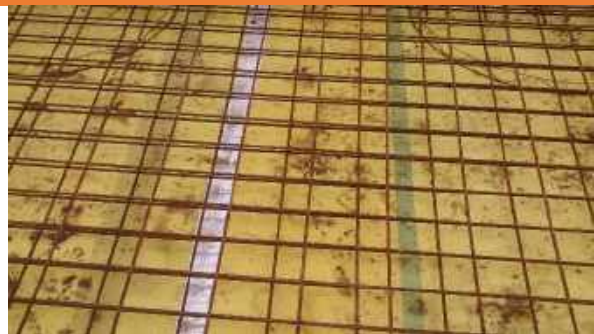
**Verification of Joints and Seals-Good Condition**

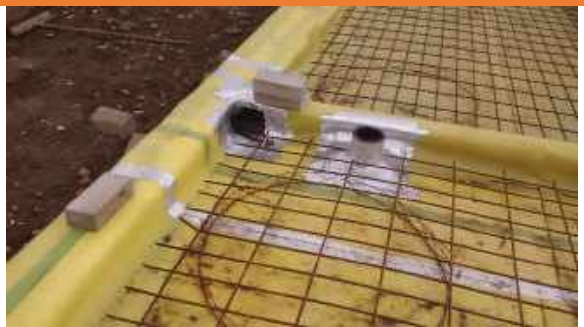
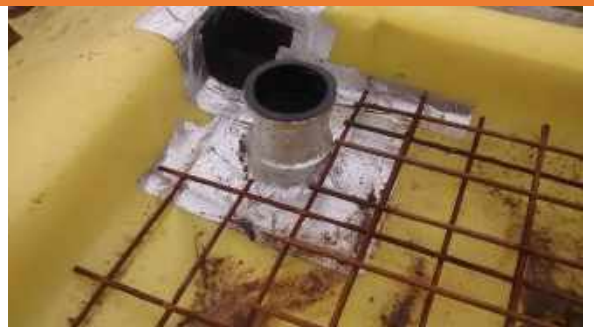
**Verification of Service Penetrations-Good Condition**

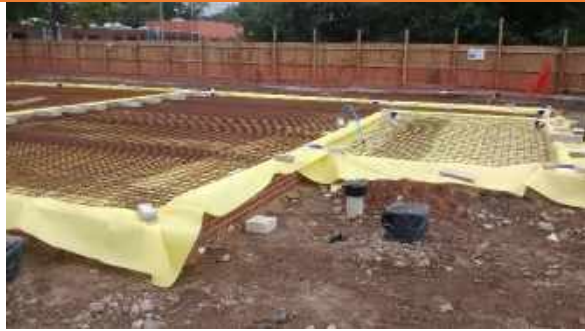
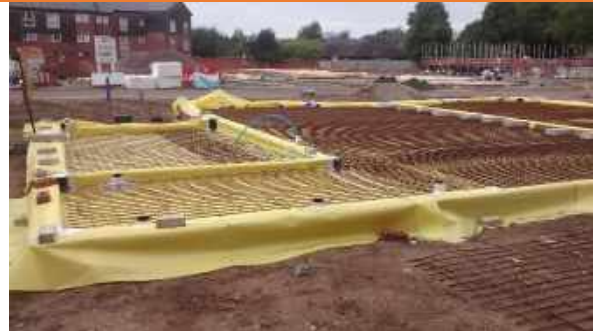
**Plot - 39**

**General Condition of Membrane-Good Condition**

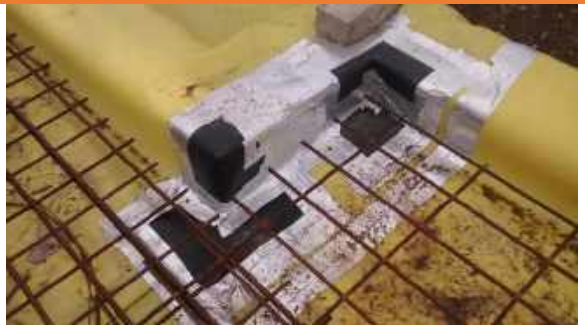
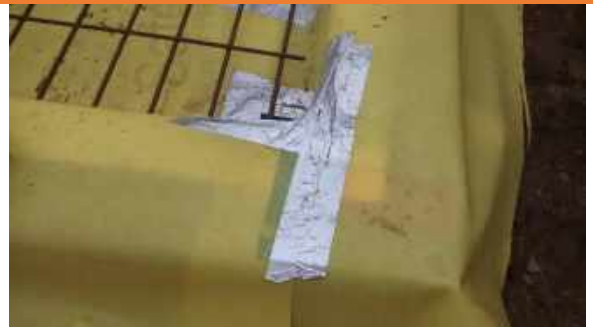
**Verification of Joints and Seals-Good Condition**

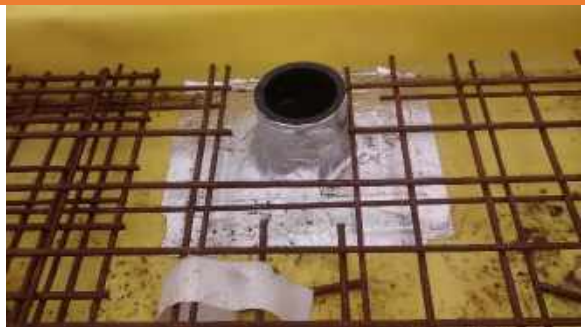
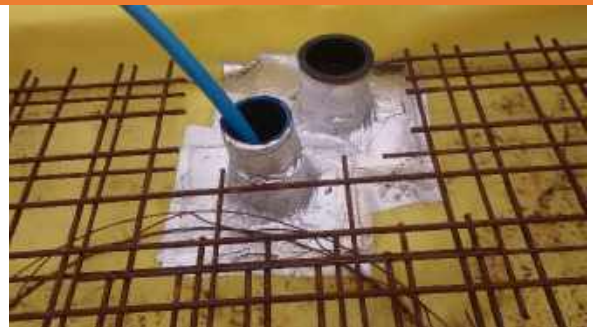
**Verification of Service Penetrations-Good Condition**

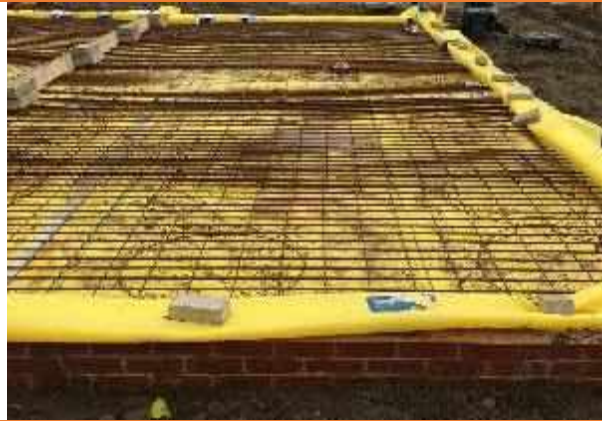
**Plot - 40**

**General Condition of Membrane-Good Condition**

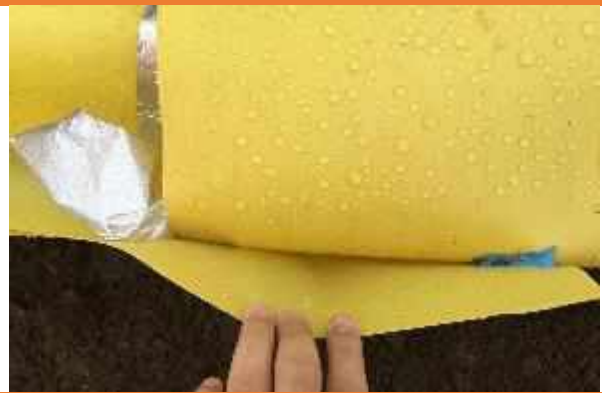
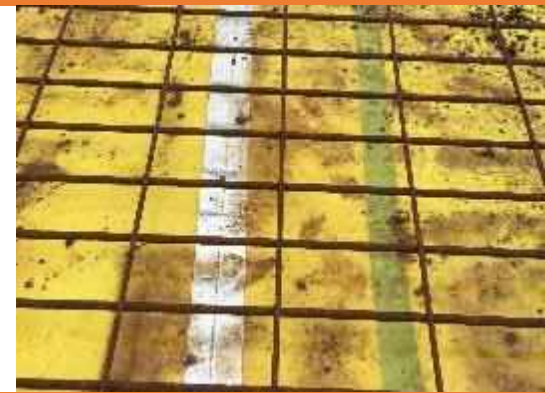
**Verification of Joints and Seals-Good Condition**

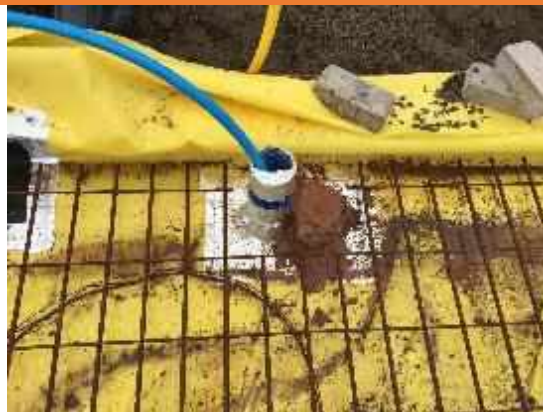
**Verification of Service Penetrations-Good Condition**

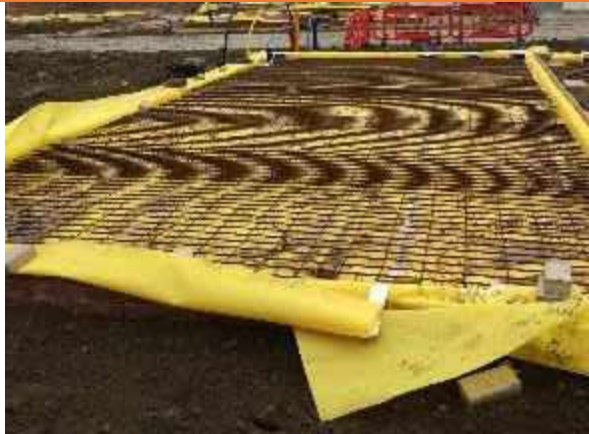
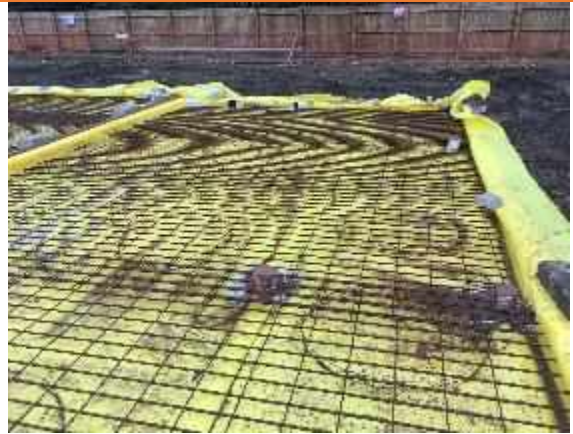
**Plot - 41**

**General Condition of Membrane-Good Condition**

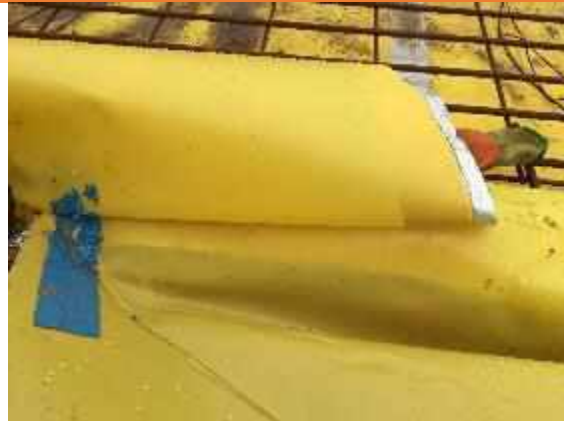
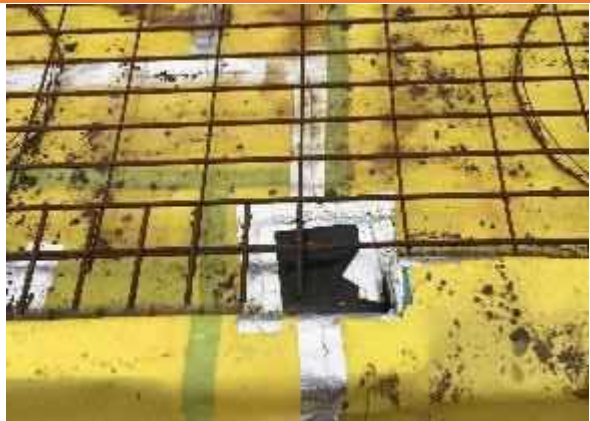
**Verification of Joints and Seals-Good Condition**

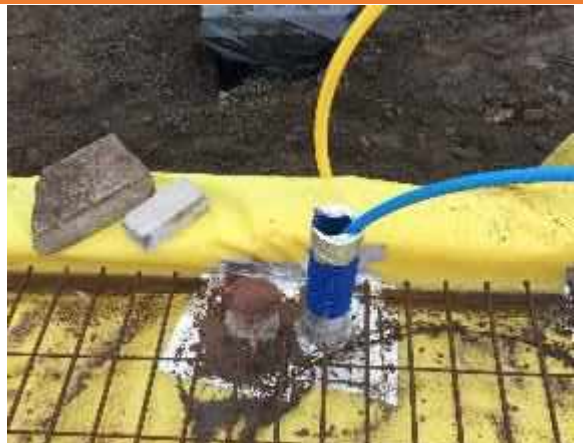
**Verification of Service Penetrations-Good Condition**

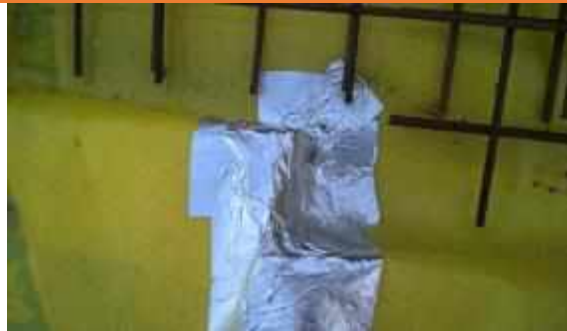
**Verification of Joints and Seals-Good Condition**

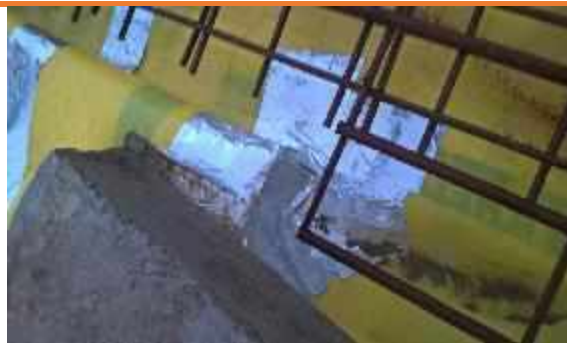
**Verification of Joints and Seals-Good Condition**

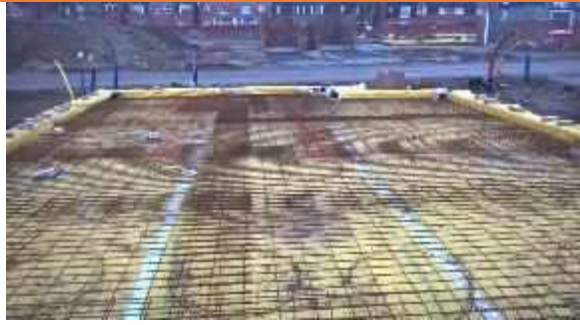
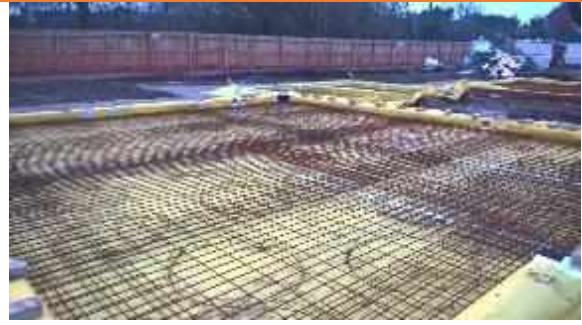
**Plot - 44**

**General Condition of Membrane-Good Condition**

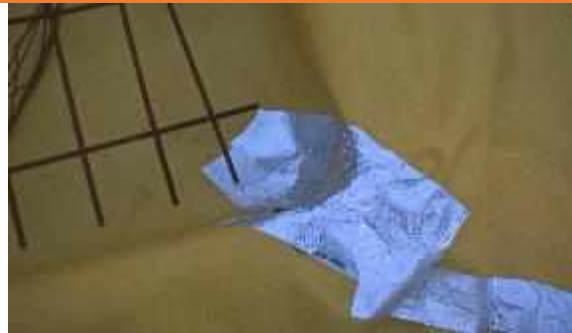
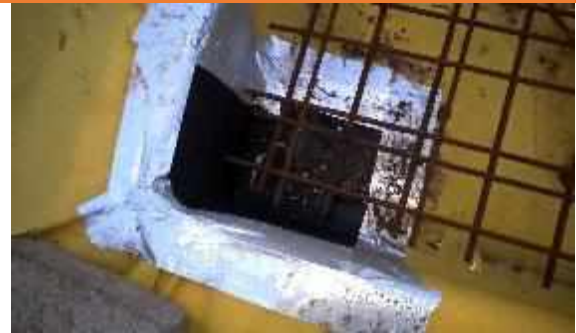
**Verification of Joints and Seals-Good Condition**

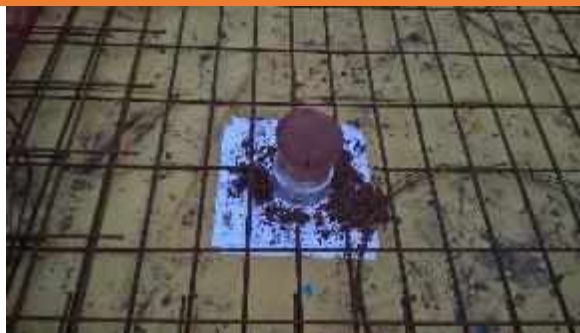
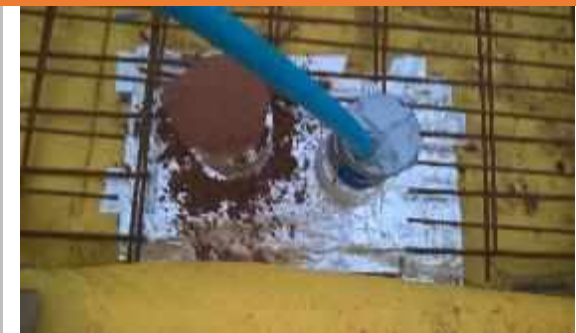
**Verification of Service Penetrations-Good Condition**

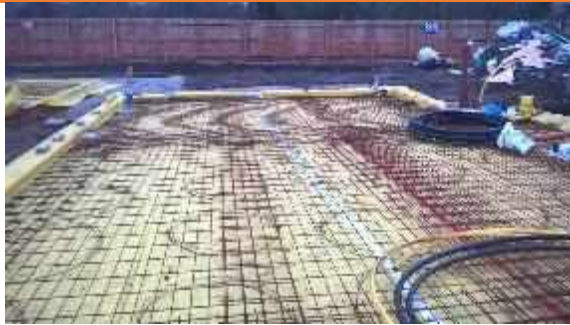
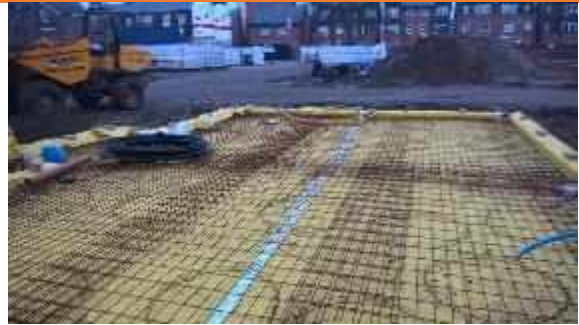
**Plot - 45**

**General Condition of Membrane-Good Condition**

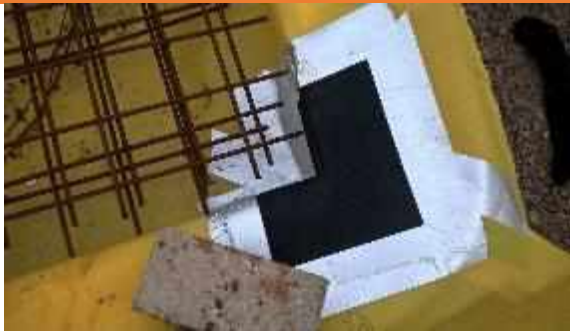
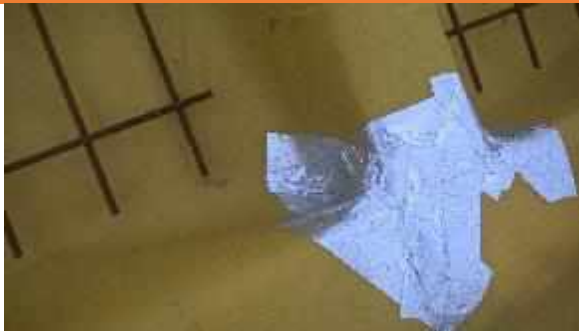
**Verification of Joints and Seals-Good Condition**

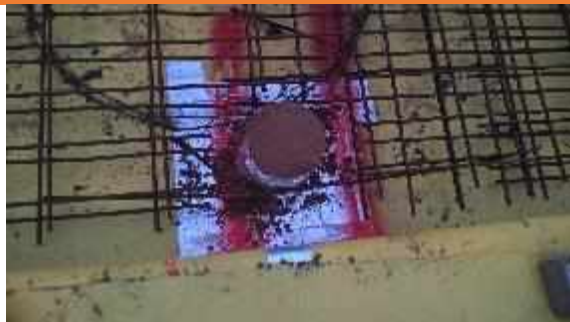
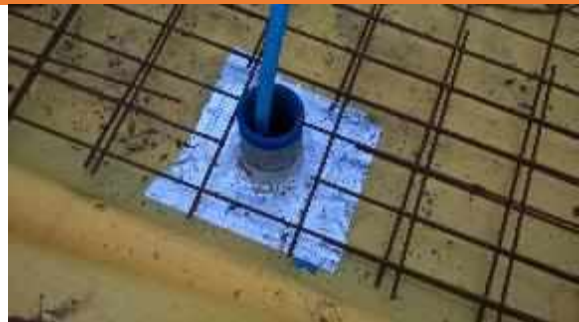
**Verification of Service Penetrations-Good Condition**

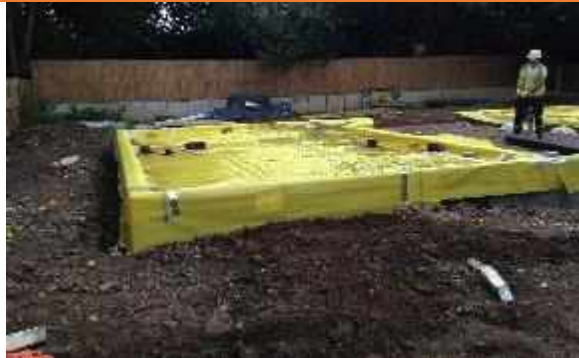
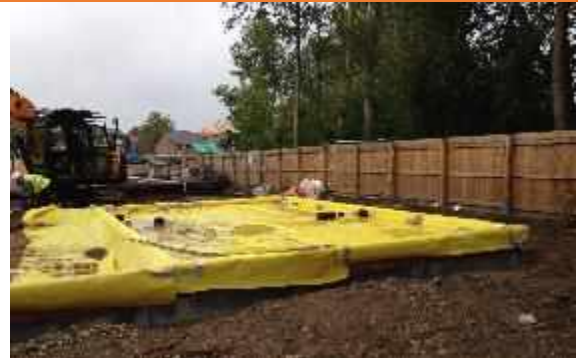
**Plots 46**

**General Condition of Membrane-Good Condition**

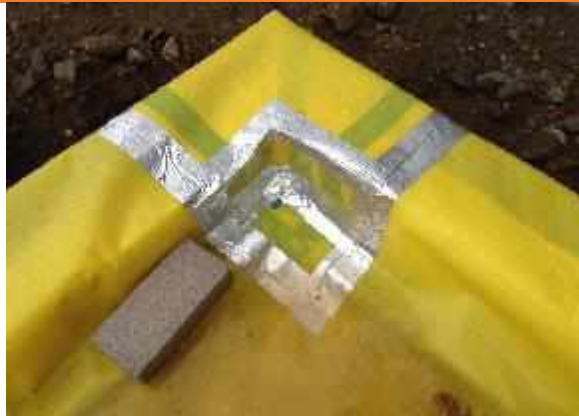
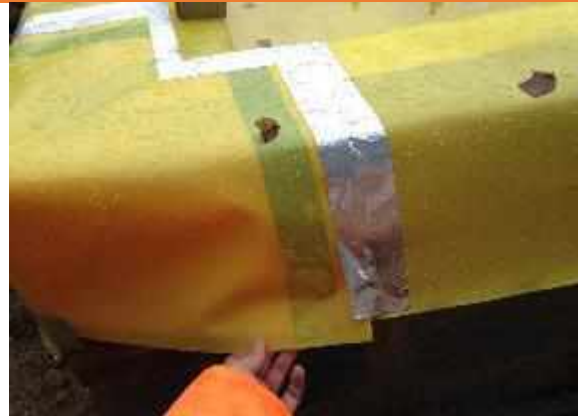
**Verification of Joints and Seals-Good Condition**

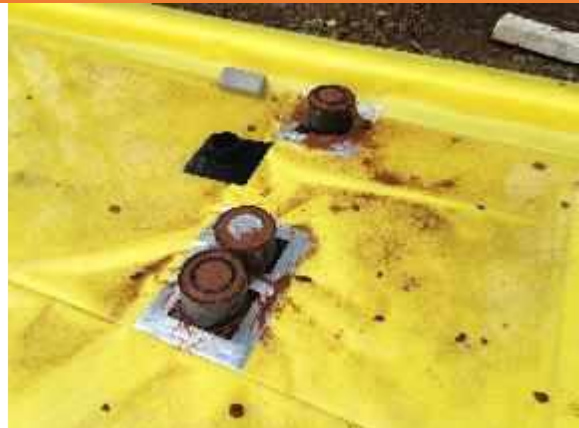
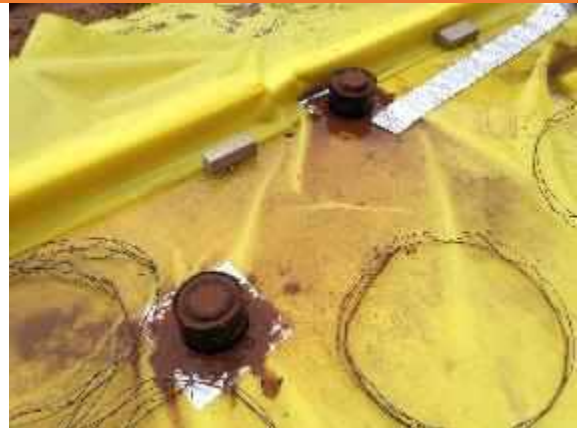
**Verification of Service Penetrations- Good Condition**

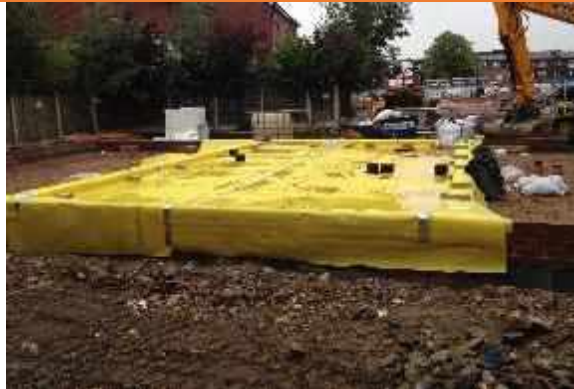
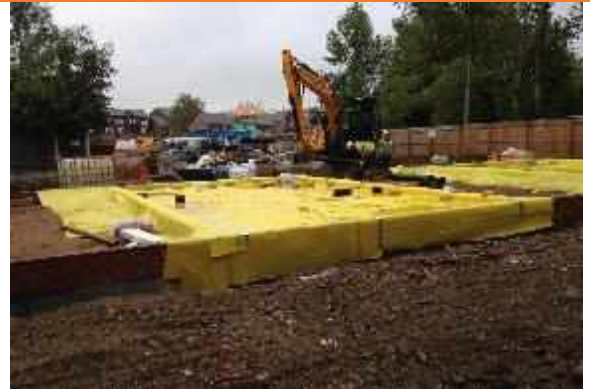
**Plots 48**

**General Condition of Membrane-Good Condition**

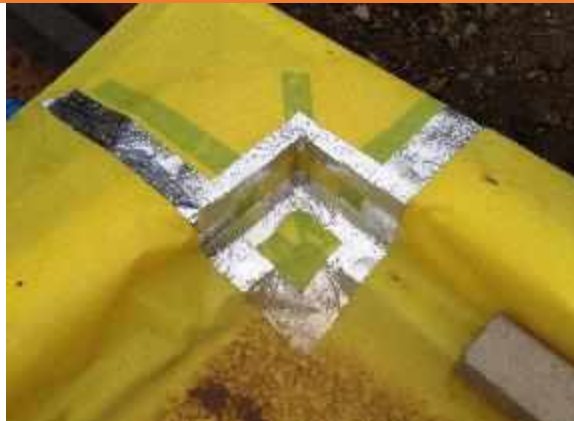
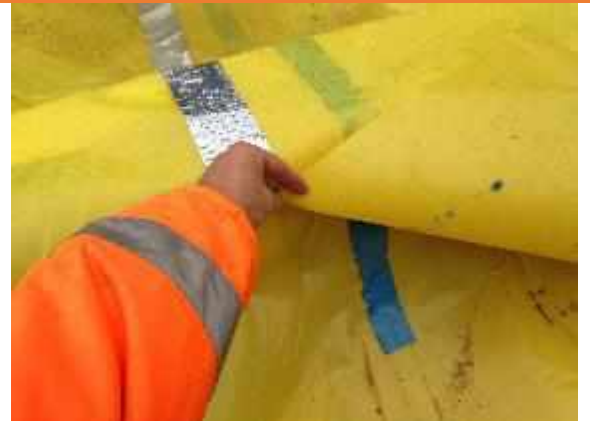
**Verification of Joints and Seals-Good Condition**

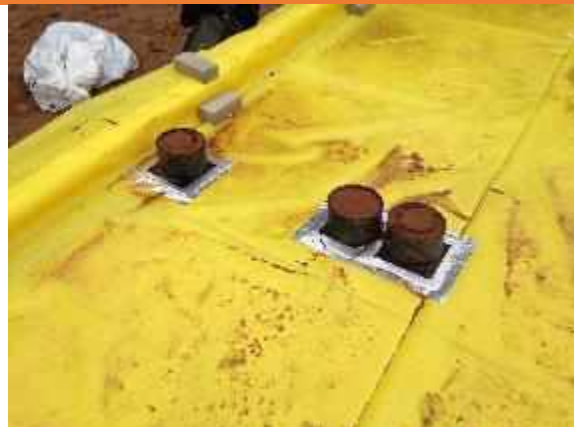
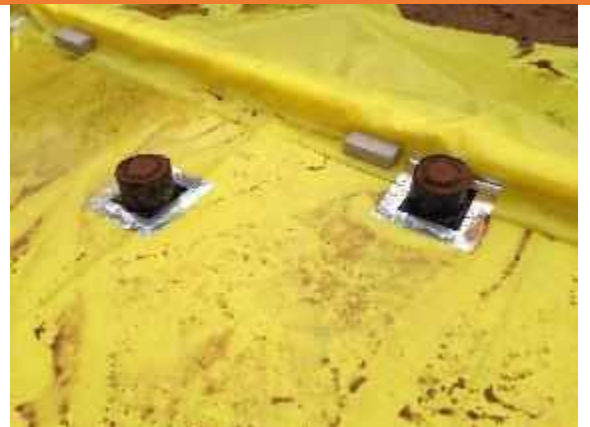
**Verification of Service Penetrations- Good Condition**

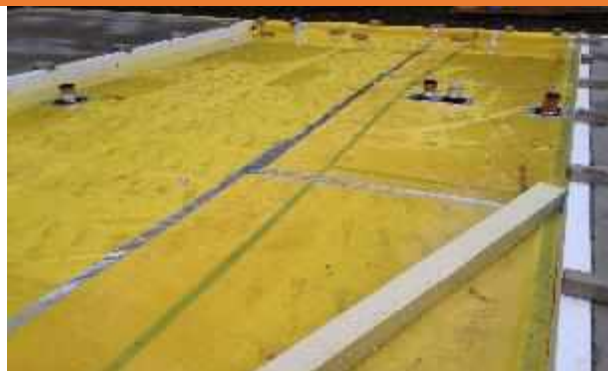
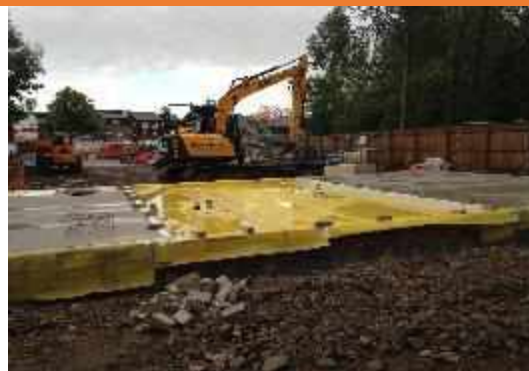
## Plots 47

### General Condition of Membrane-Good Condition

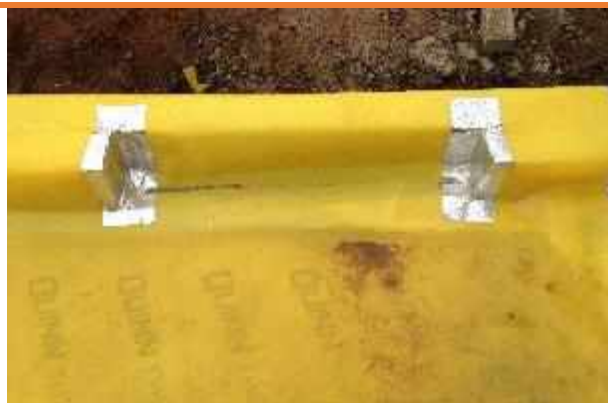
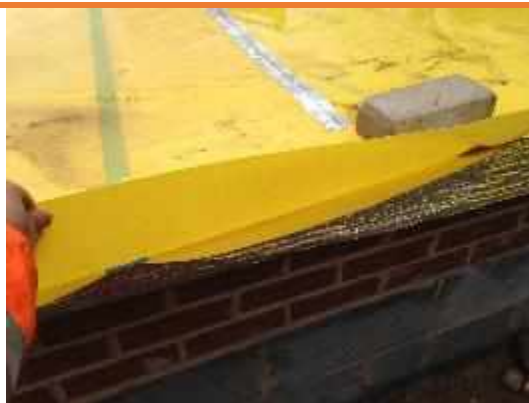
### Verification of Joints and Seals-Good Condition

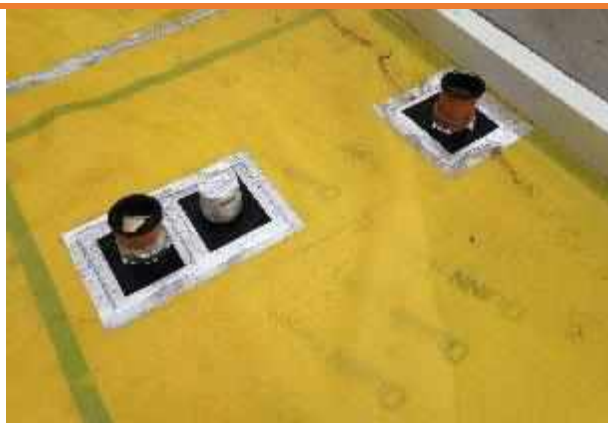
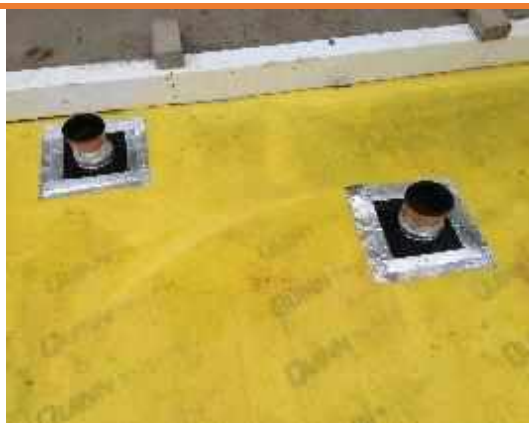
### Verification of Service Penetrations- Good Condition

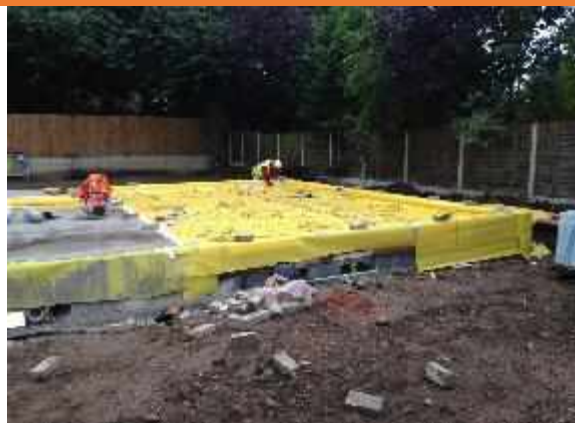
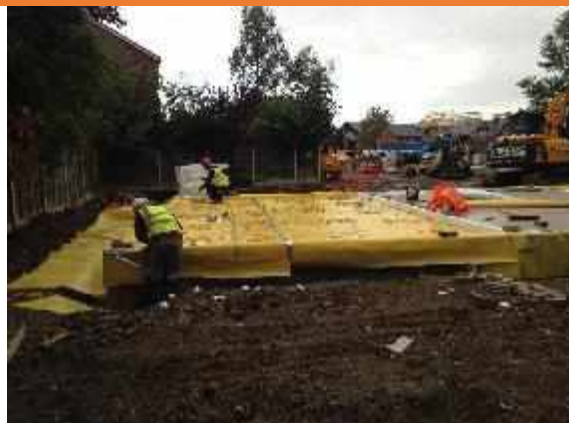
## Plots 49

### General Condition of Membrane-Good Condition

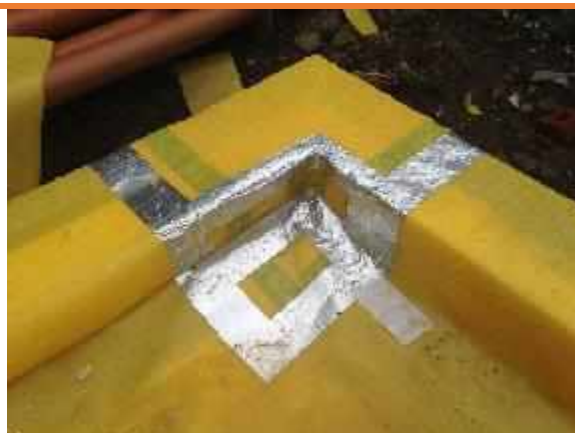
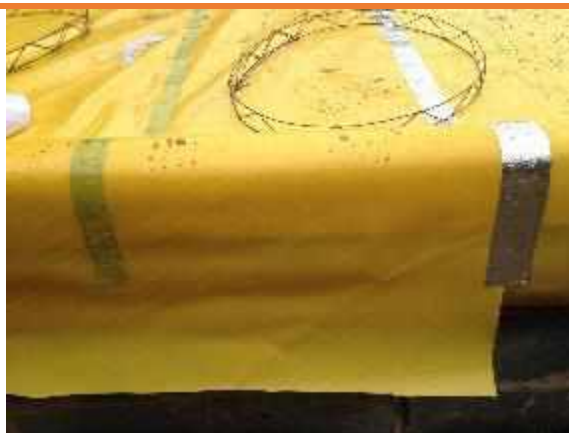
### Verification of Joints and Seals-Good Condition

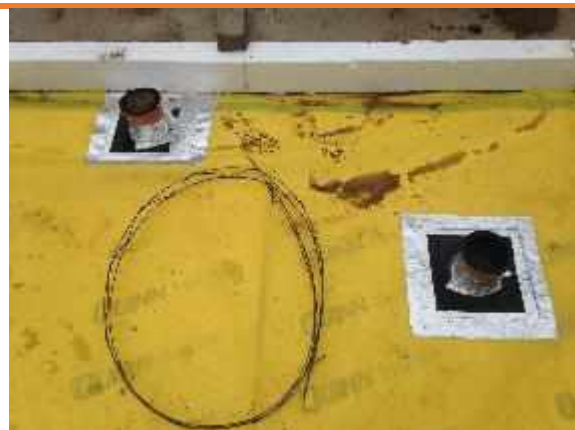
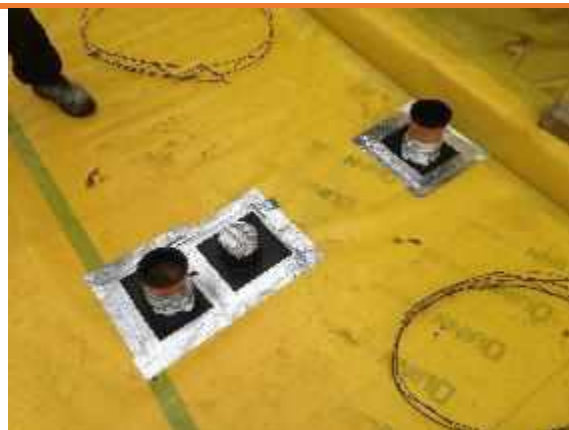
### Verification of Service Penetrations- Good Condition

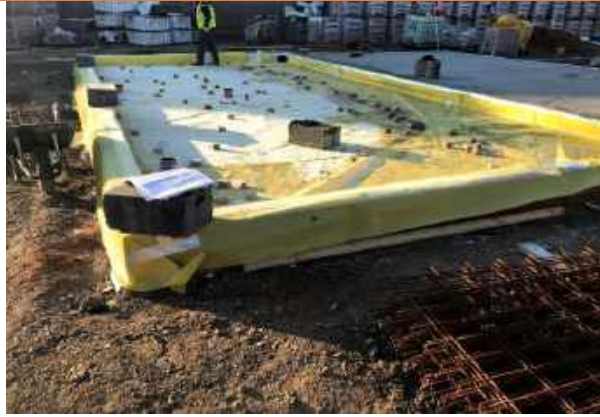
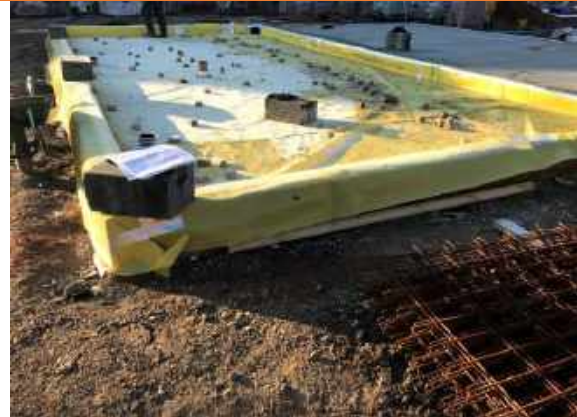
**Plot 51**

**General Condition of Membrane-Good Condition**

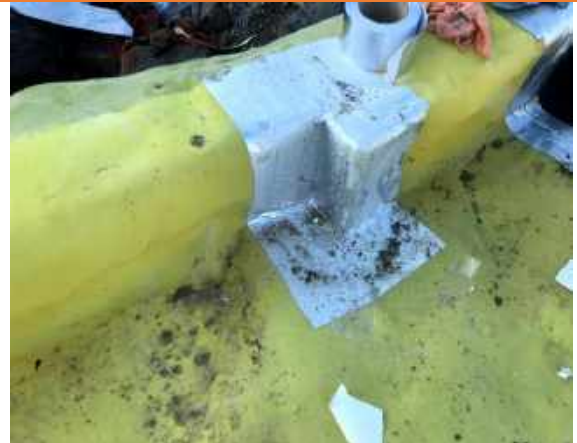
**Verification of Joints and Seals-Good Condition**

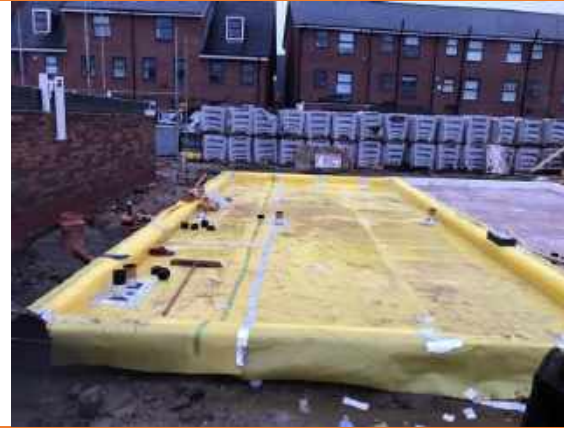
**Plot 53**

**General Condition of Membrane-Good Condition**

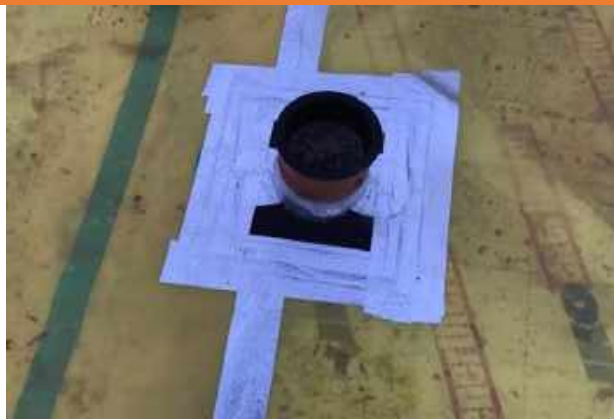
**Verification of Service Penetrations- Good Condition**

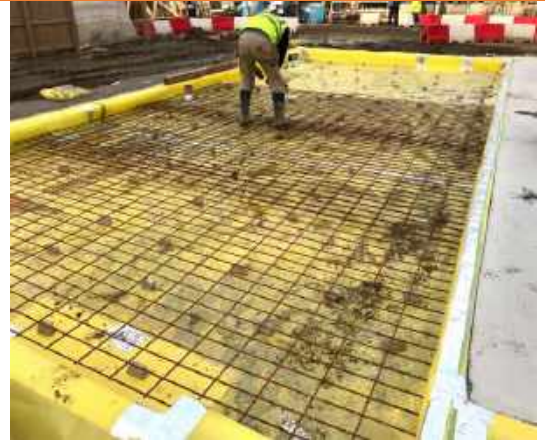
**Plot 54**

**General Condition of Membrane-Good Condition**

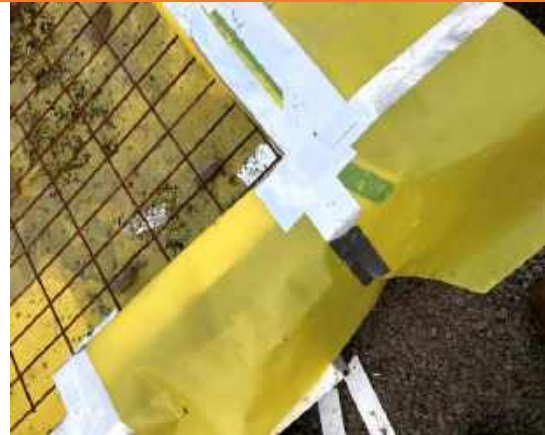
**Verification of Joints and Seals-Good Condition**

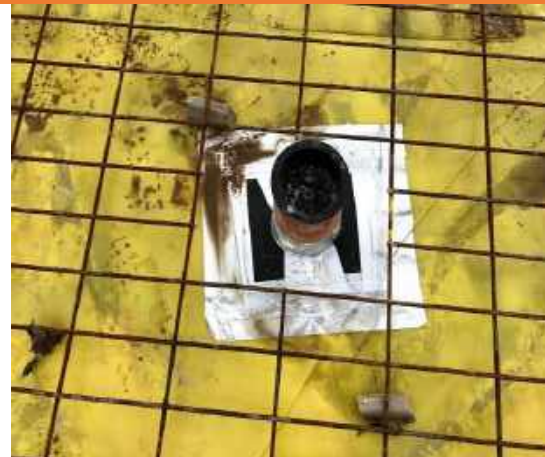
**Verification of Service Penetrations- Good Condition**

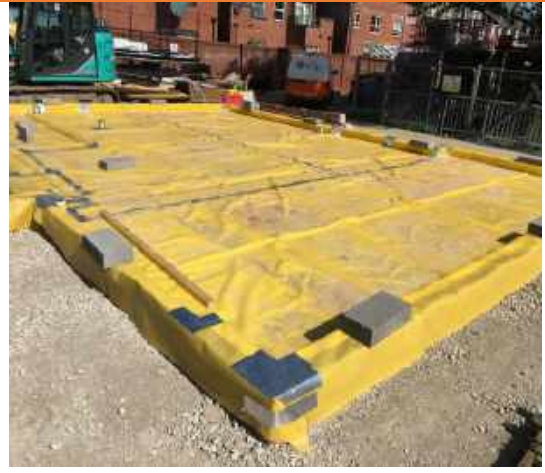
**Plot 56**

**General Condition of Membrane-Good Condition**

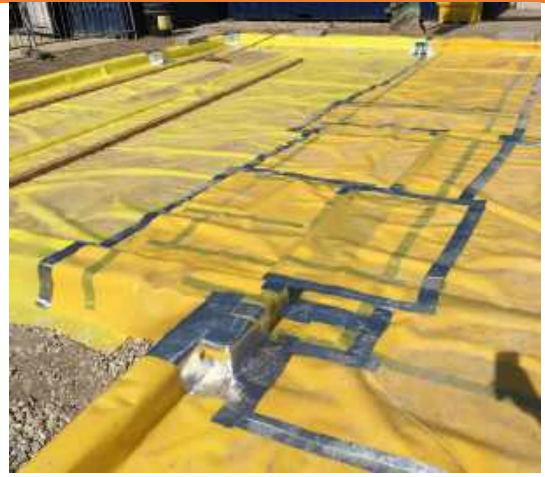
**Verification of Joints and Seals-Good Condition**

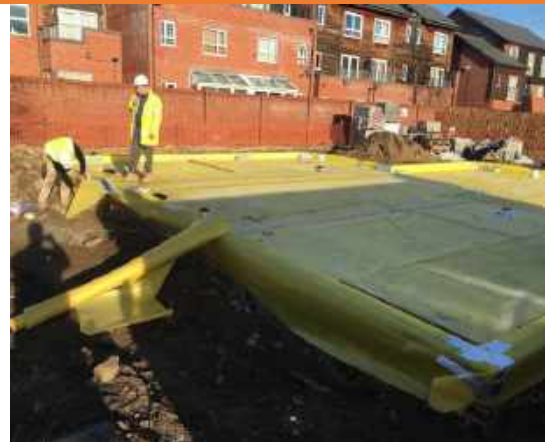
**Plot 57**

**General Condition of Membrane-Good Condition**

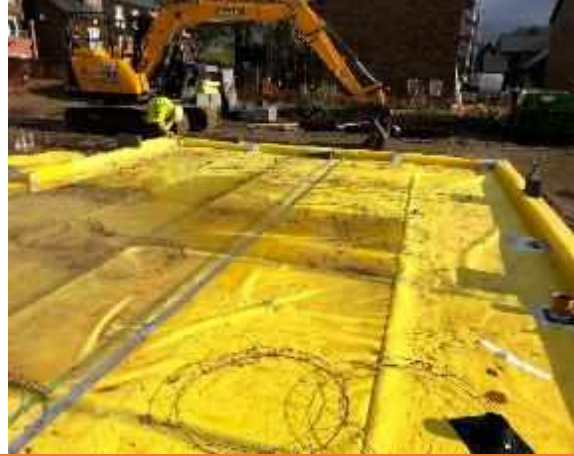
**Plot 58**

**General Condition of Membrane-Good Condition**

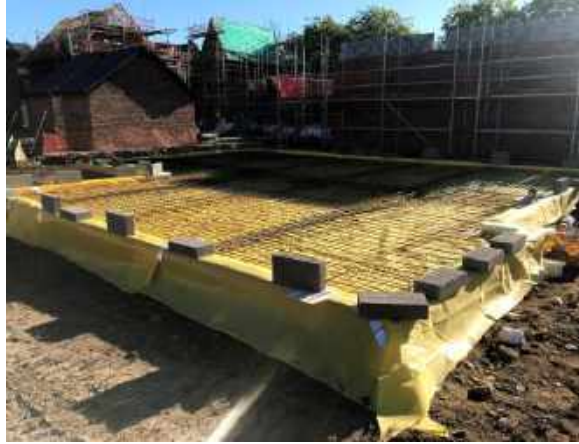
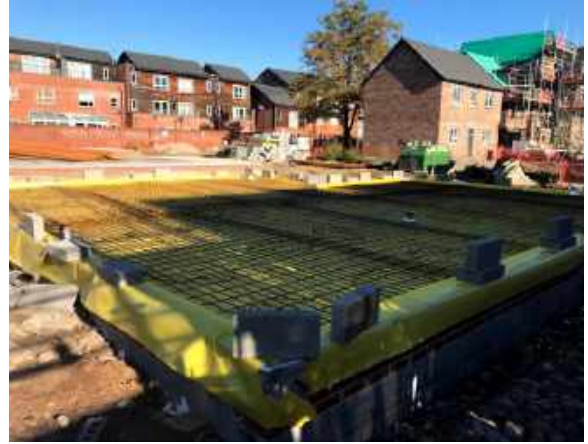
**Plot 59**

**General Condition of Membrane-Good Condition**

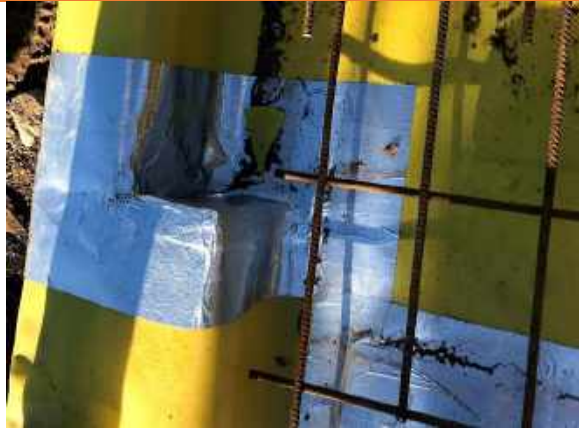
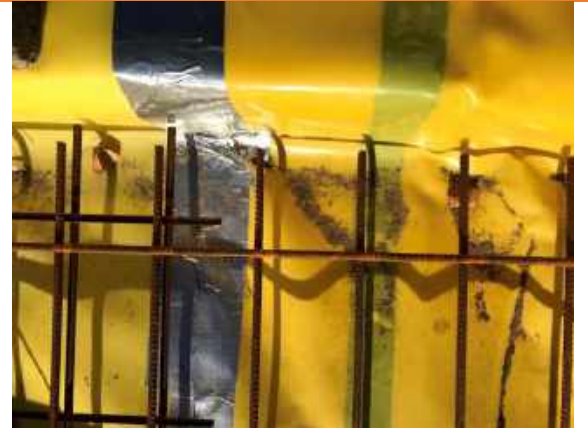
**Verification of Joints and Seals-Good Condition**

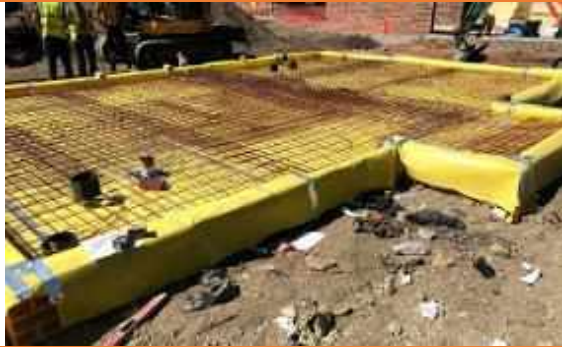
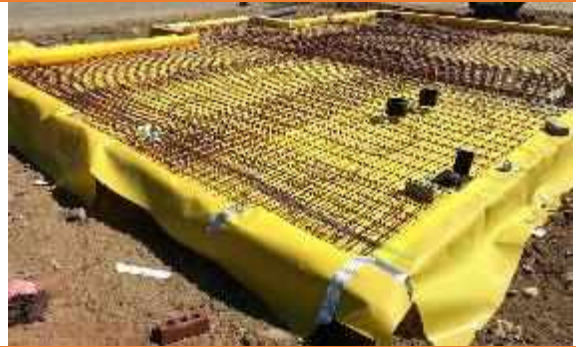
**Plot 60**

**General Condition of Membrane-Good Condition**

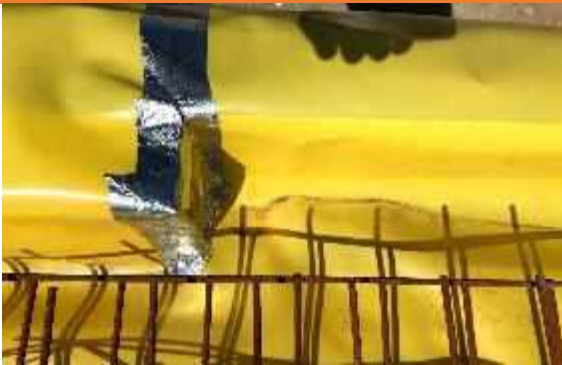
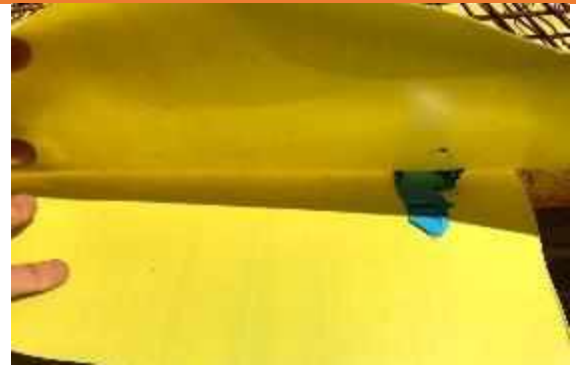
**Verification of Joints and Seals-Good Condition**

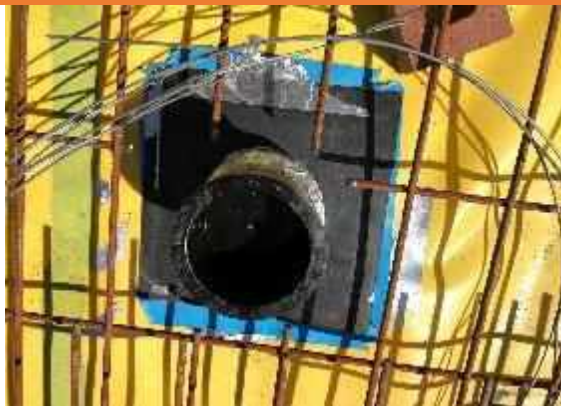
**Verification of Service Penetrations- Good Condition**
