## VALIDATION COMPLETION REPORT

Former Withington Hospital  
Cavendish Road  
Manchester  
M20 1LB

Prepared for:  
Bellway Homes Manchester

**Report Ref: 10-933-R4-1**  
**Date Issued: 30/07/2020**

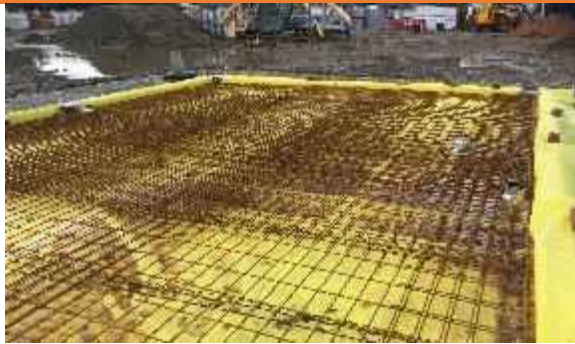
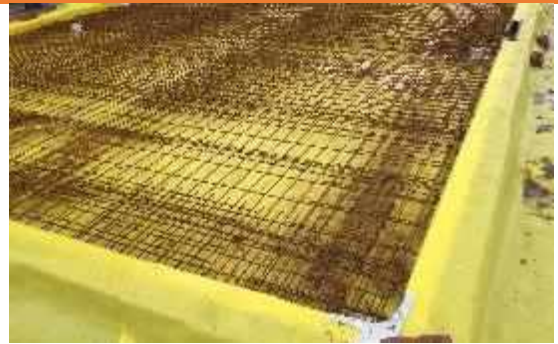
**Plot - 63**

**General Condition of Membrane-Good Condition**

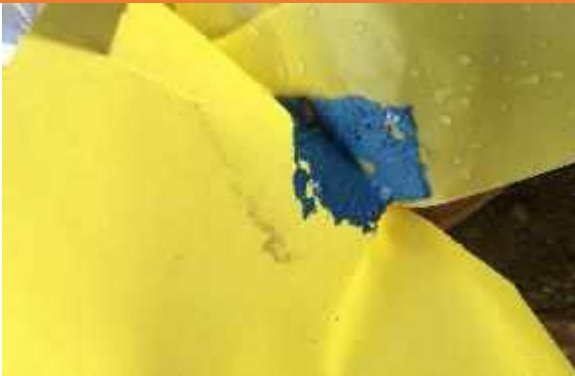
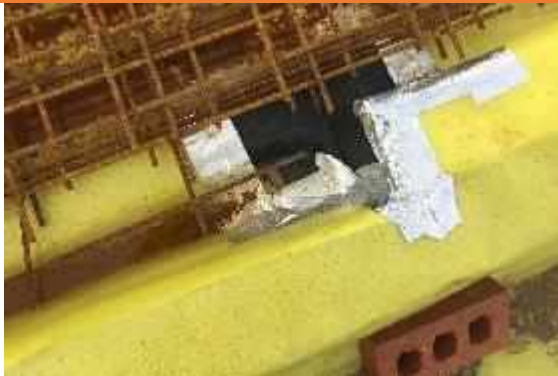
**Verification of Joints and Seals-Good Condition**

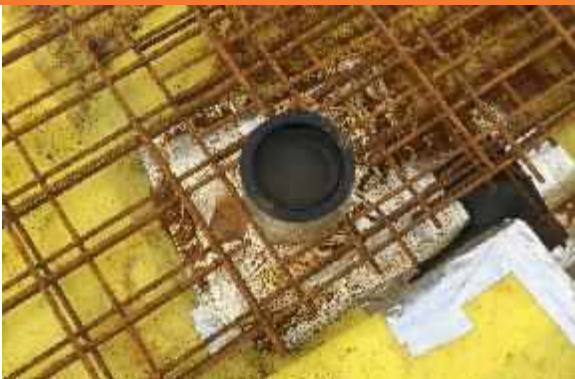
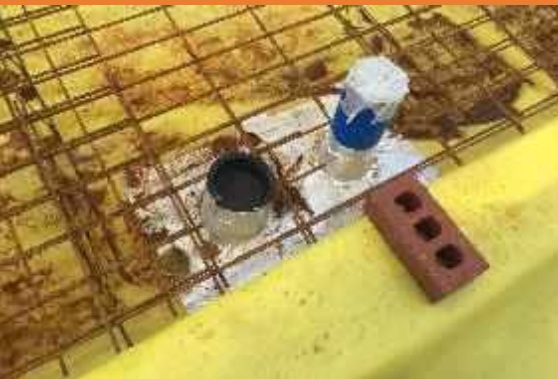
**Verification of Service Penetrations-Good Condition**

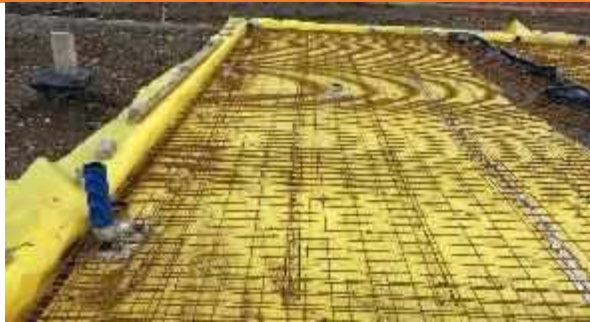
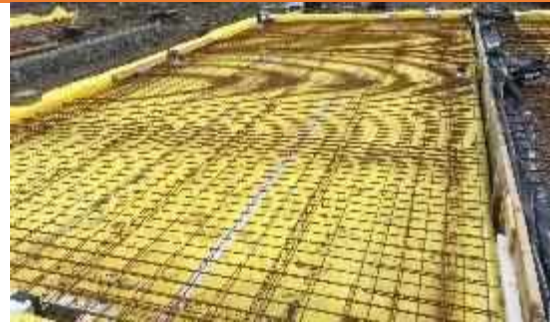
**Plot - 64**

**General Condition of Membrane-Good Condition**

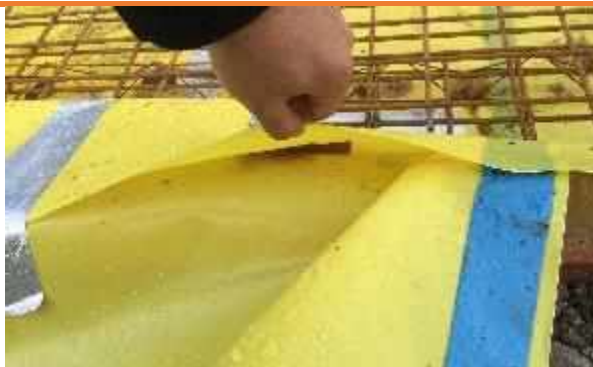
**Verification of Joints and Seals-Good Condition**

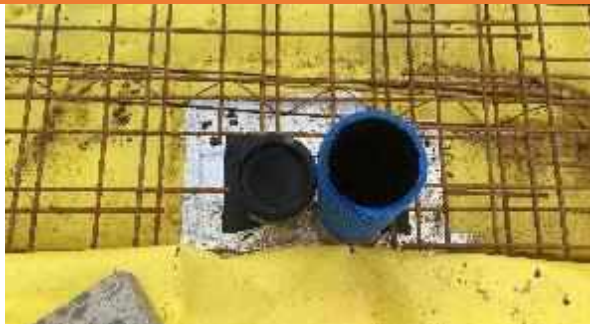
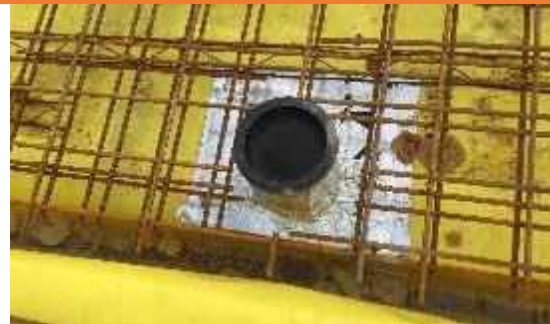
**Verification of Service Penetrations-Good Condition**

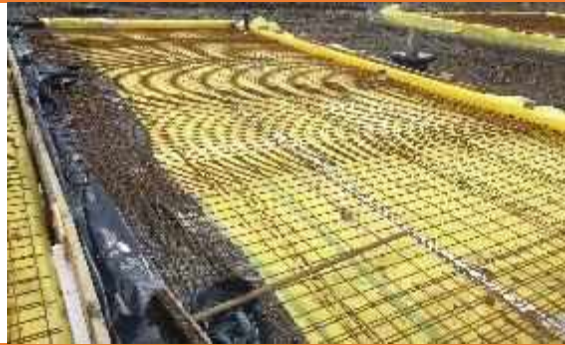
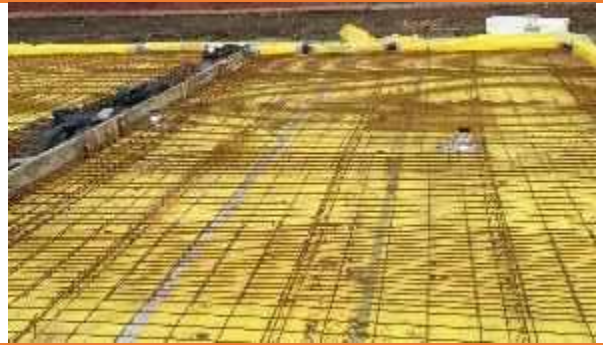
**Plot - 65**

**General Condition of Membrane-Good Condition**

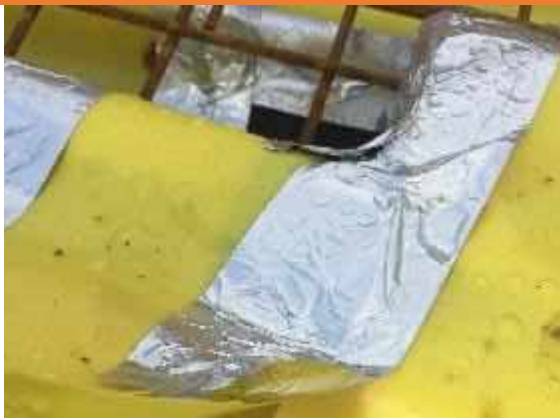
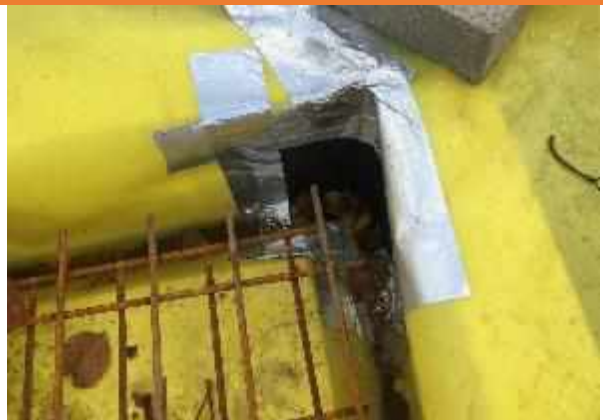
**Verification of Joints and Seals-Good Condition**

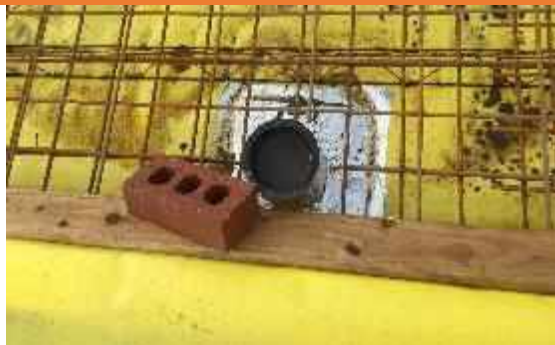
**Verification of Service Penetrations-Good Condition**

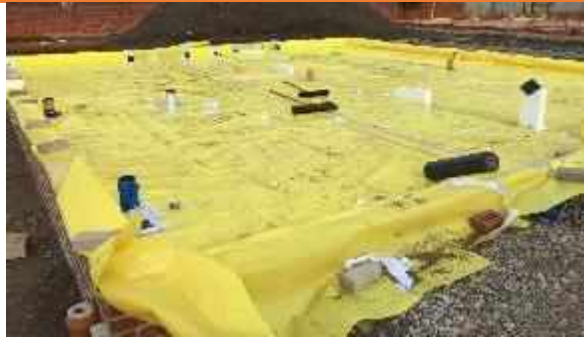
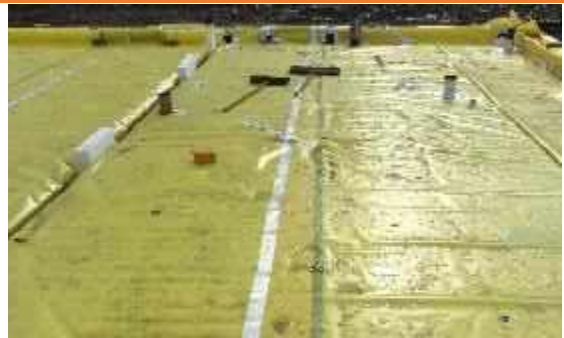
**Plot - 66**

**General Condition of Membrane-Good Condition**

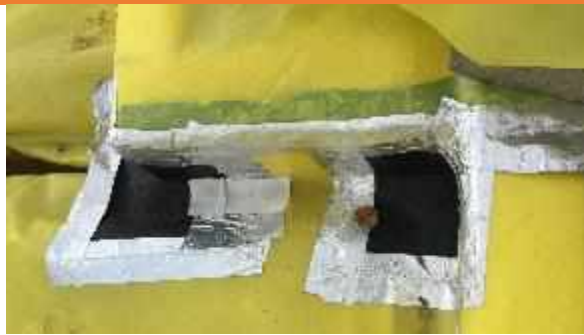
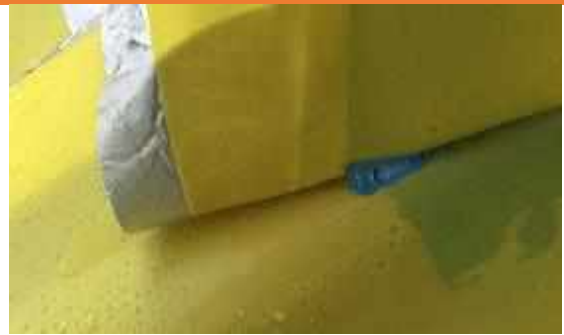
**Verification of Joints and Seals-Good Condition**

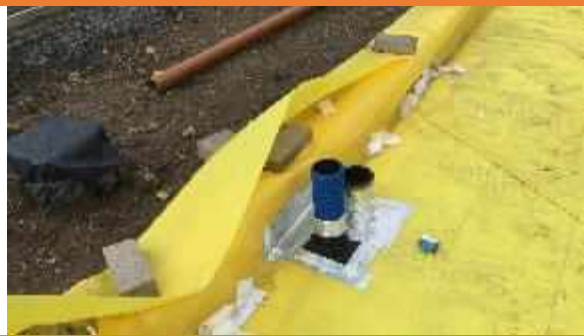
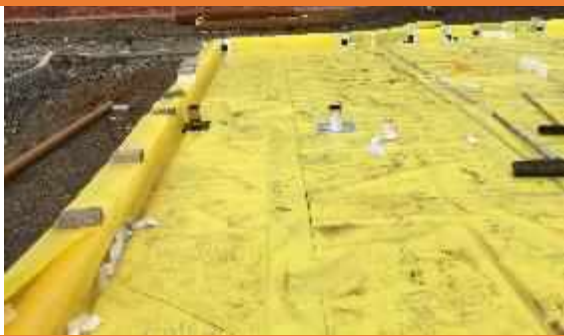
**Verification of Service Penetrations-Good Condition**

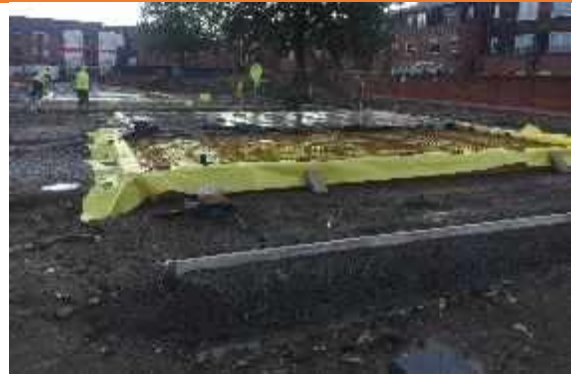
**Plot - 67**

**General Condition of Membrane-Good Condition**

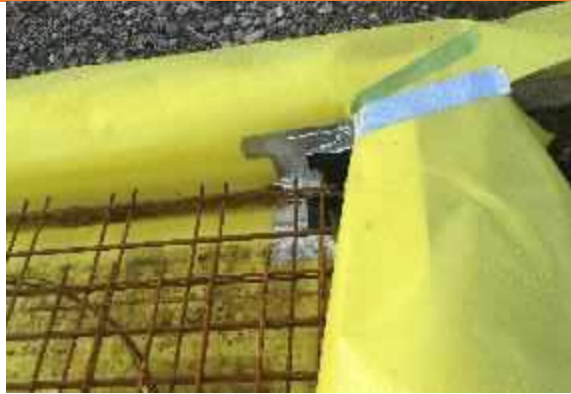
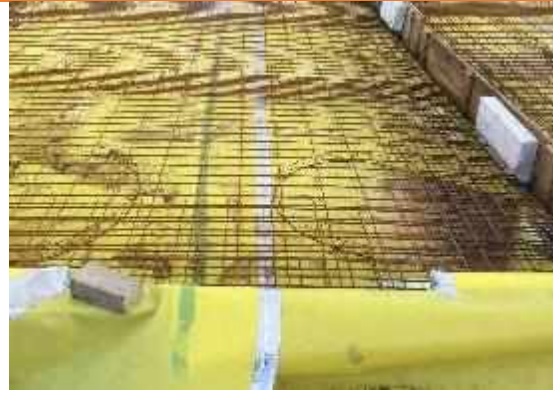
**Verification of Joints and Seals-Good Condition**

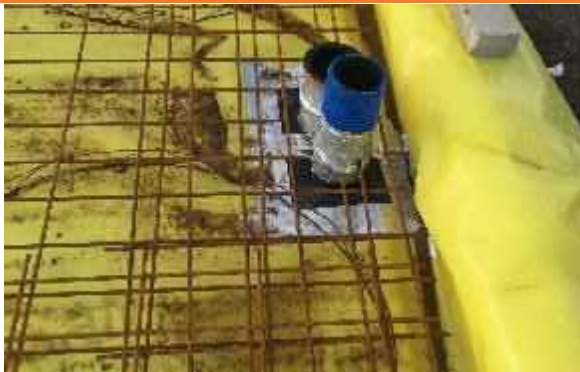
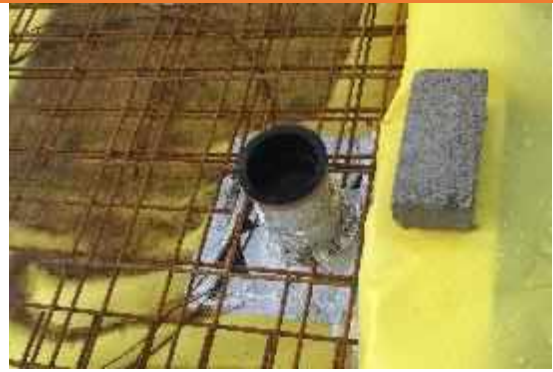
**Verification of Service Penetrations-Good Condition**
