Validation Completion Report  
Plots 1-54  
Bowes Street, Manchester

Reference:11-813-R5-2  
Date: May 2022

Plots 1-54  
Former Stagecoach Bus Depot  
Land off Bowes Street  
Manchester

Prepared for:  
**Rowlinson Construction**

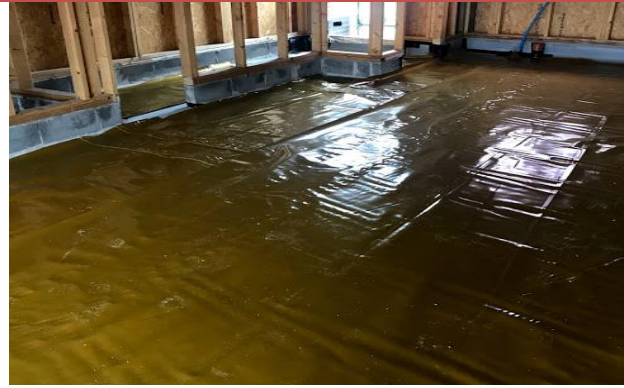
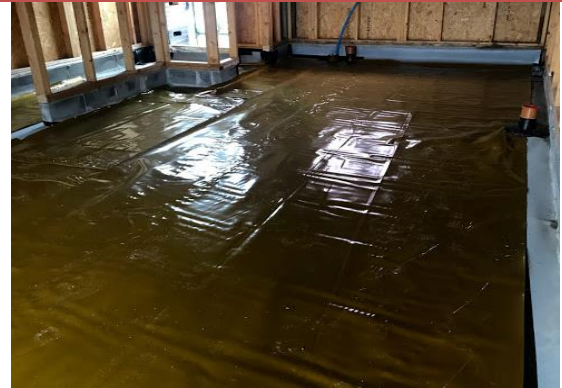
**Plot - 2**

**General Condition of Membrane-Good Condition**

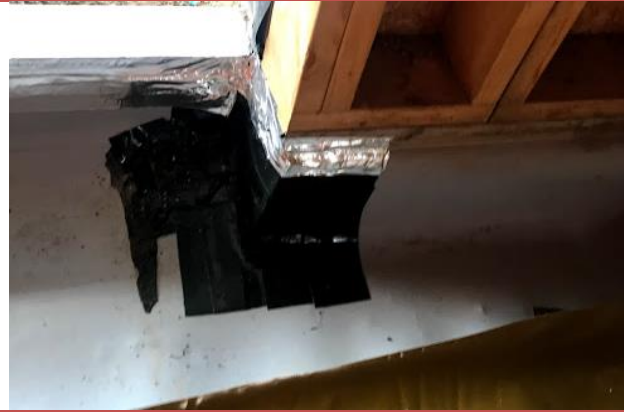
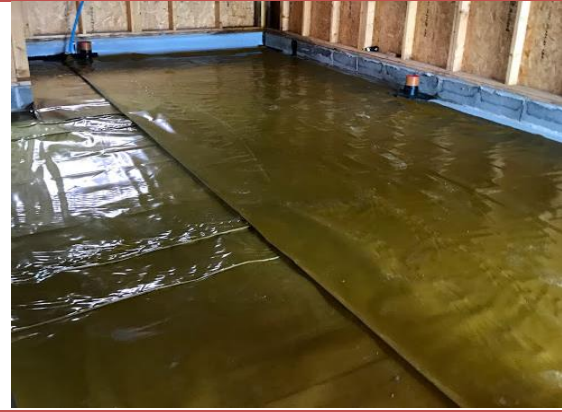
**Verification of Joints and Seals-Good Condition**

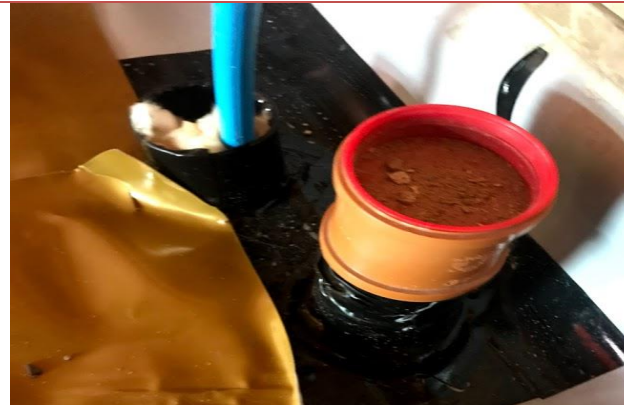
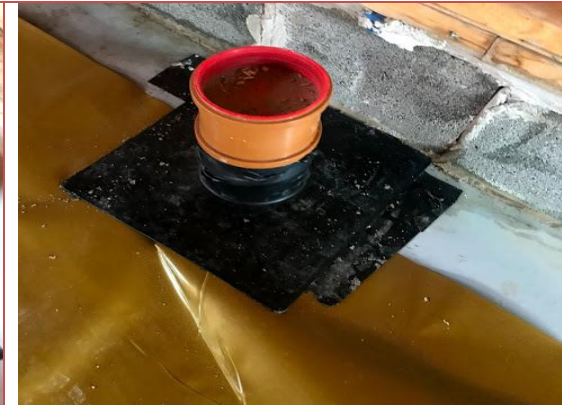
**Verification of Service Penetrations-Good Condition**

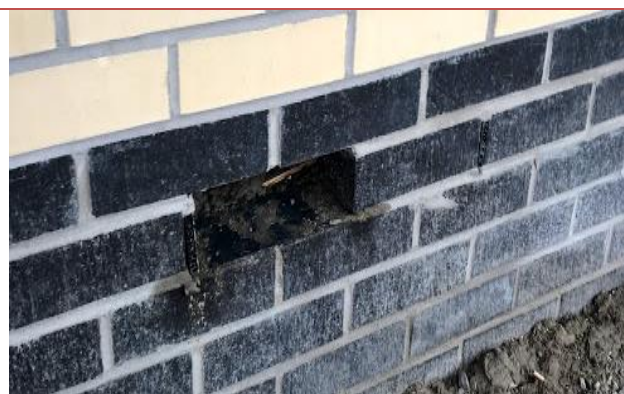
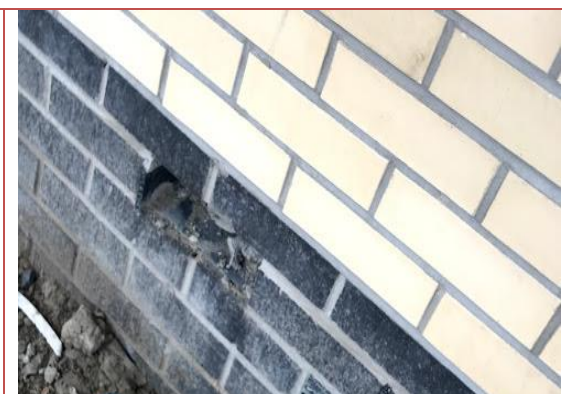
**Verification of ventilation-Good Condition**

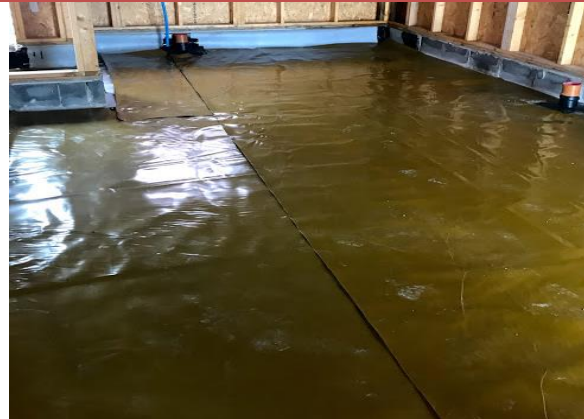
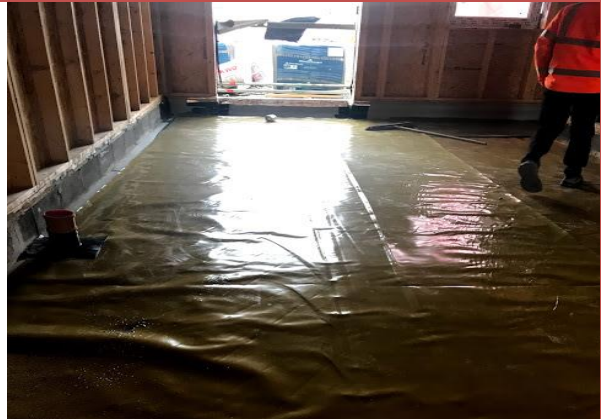
**Plot - 3**

**General Condition of Membrane-Good Condition**

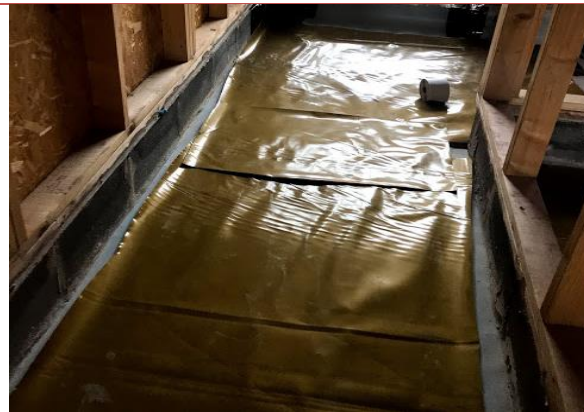
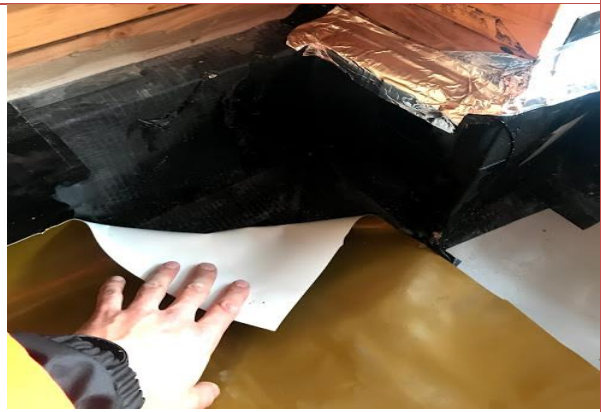
**Verification of Joints and Seals-Good Condition**

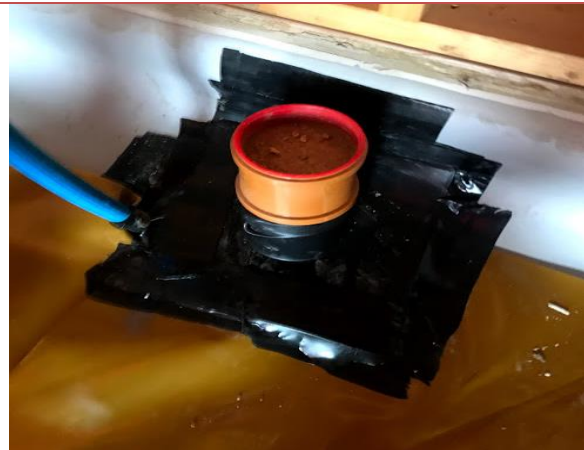
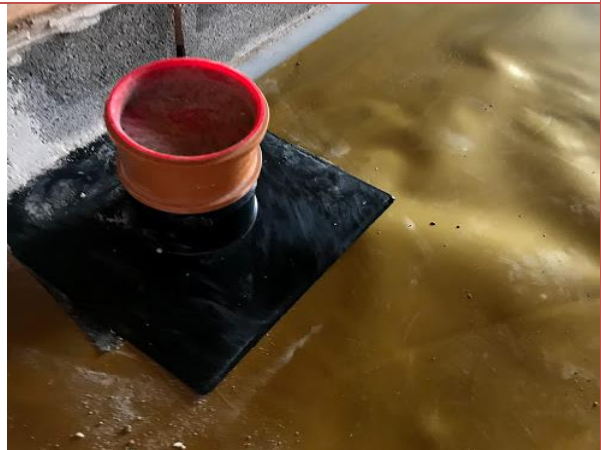
**Verification of Service Penetrations-Good Condition**

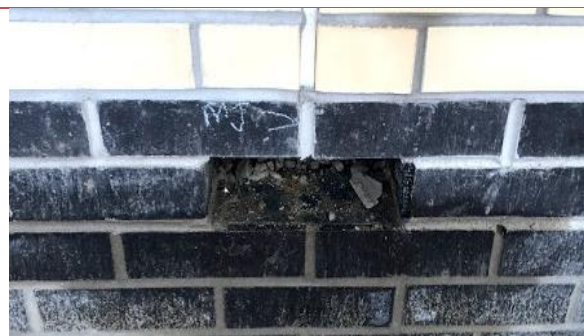
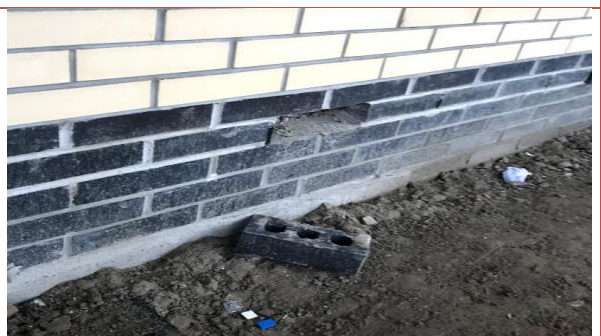
**Verification of ventilation-Good Condition**

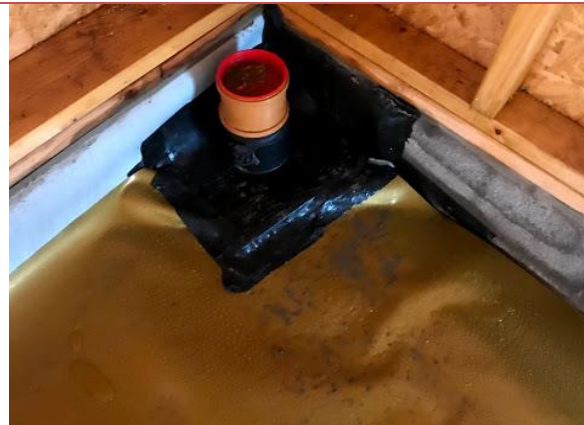
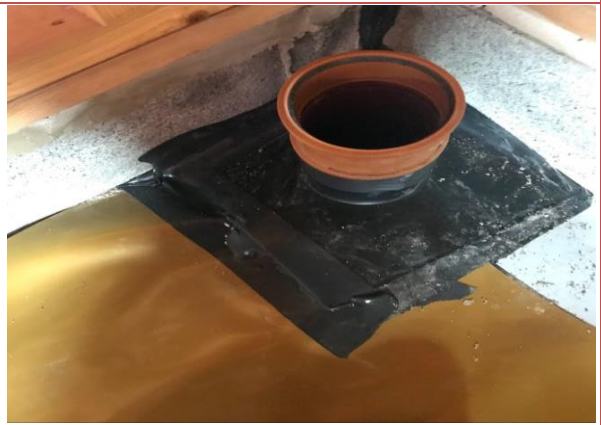
**Verification of Service Penetrations-Good Condition**

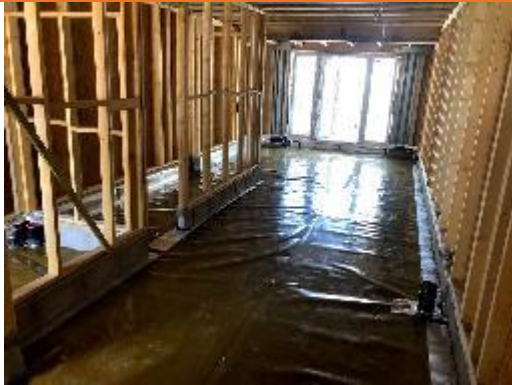
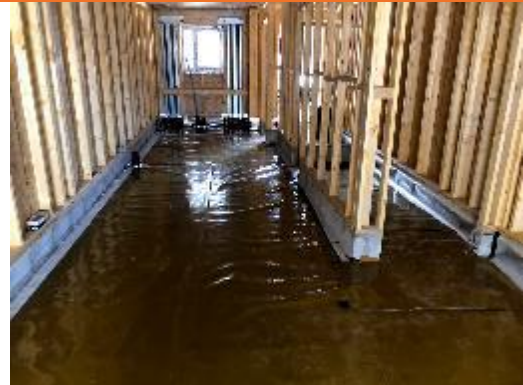
**Plot – 9**

**General Condition of Membrane-Good Condition**

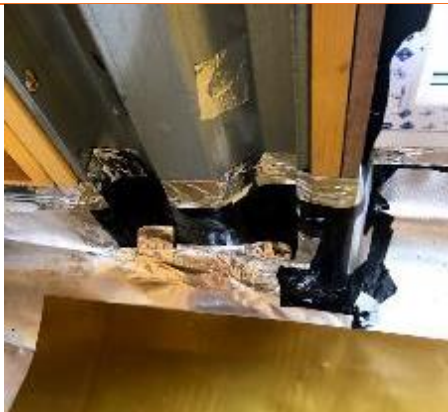
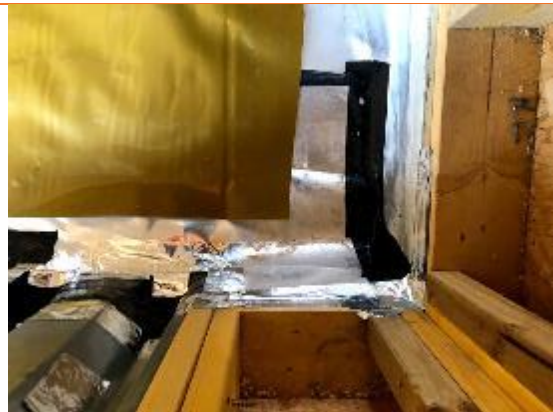
**Verification of Joints and Seals-Good Condition**

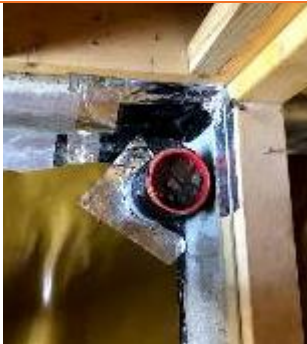
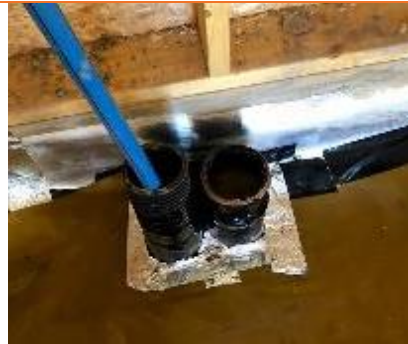
**Verification of Service Penetrations-Good Condition**

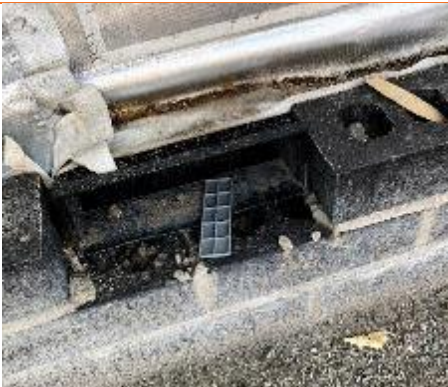
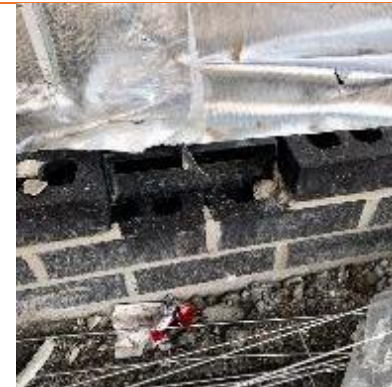
**Verification of Ventilation- Good Condition**

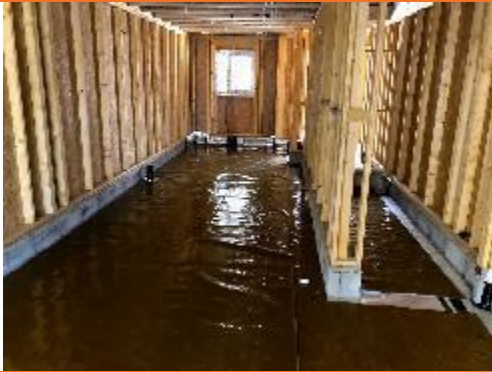
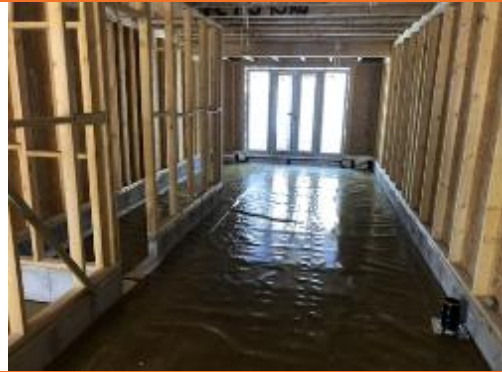
**Plot – 10**

**General Condition of Membrane-Good Condition**

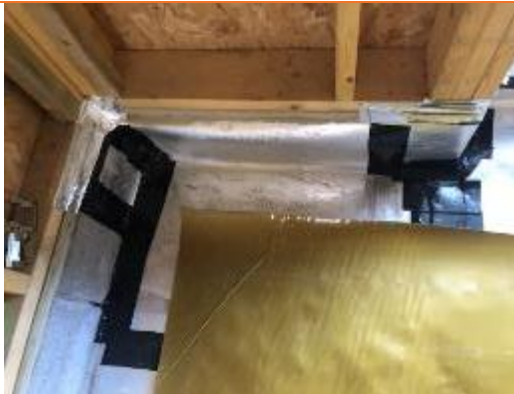
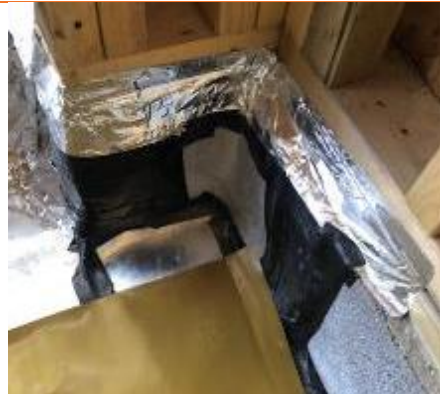
**Verification of Joints and Seals-Good Condition**

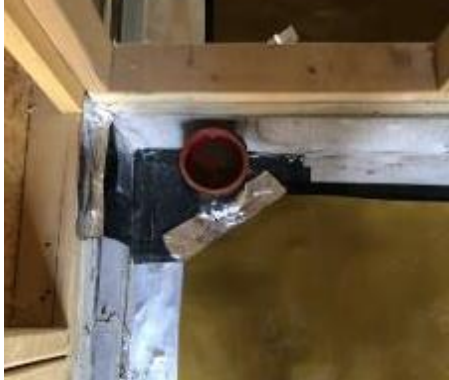
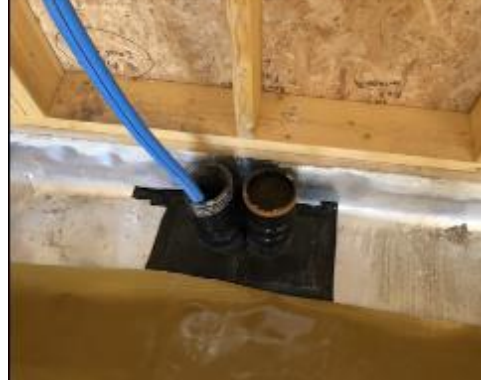
**Verification of Service Penetrations-Good Condition**

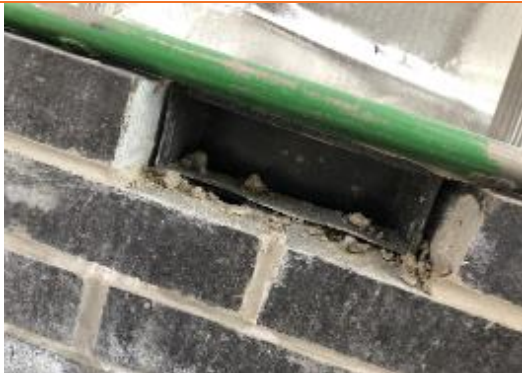
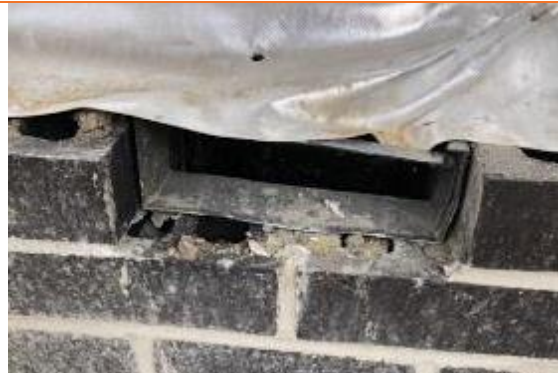
**Verification of Ventilation- Good Condition**

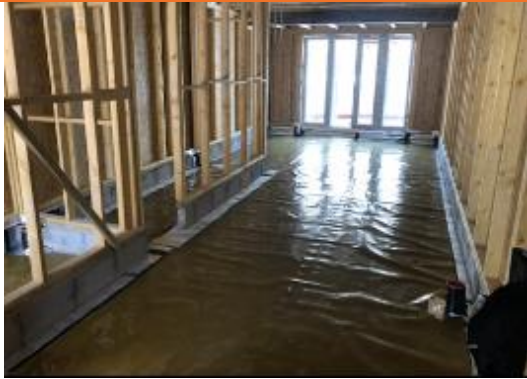
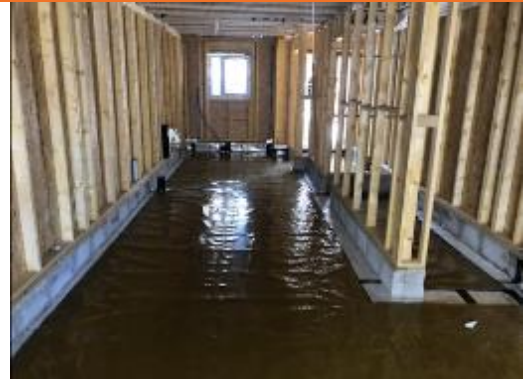
**Plot – 11**

**General Condition of Membrane-Good Condition**

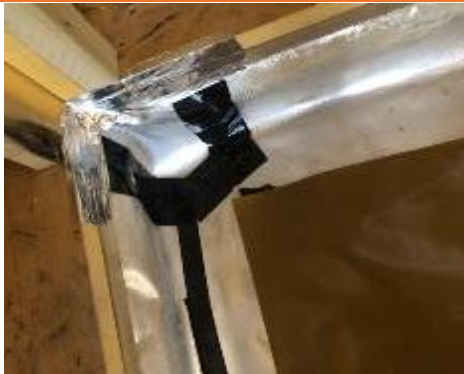
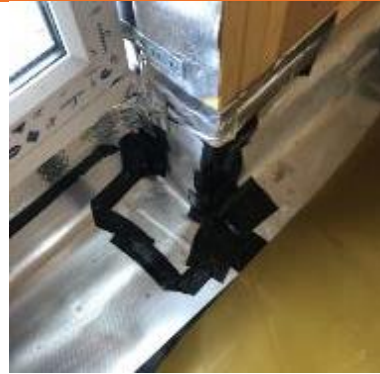
**Verification of Joints and Seals-Good Condition**

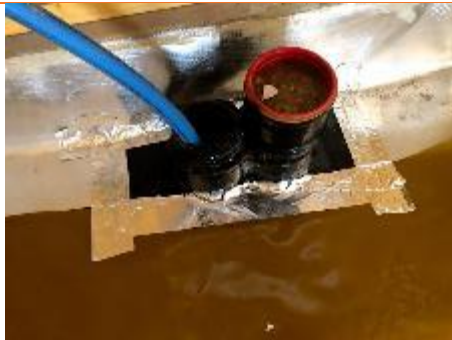
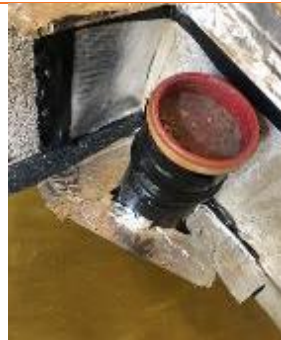
**Verification of Service Penetrations-Good Condition**

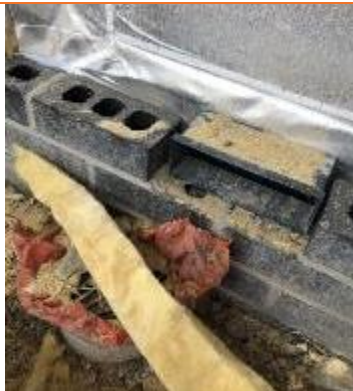
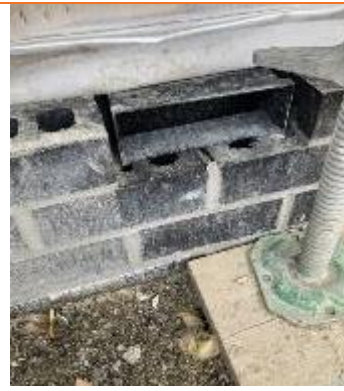
**Verification of Ventilation- Good Condition**

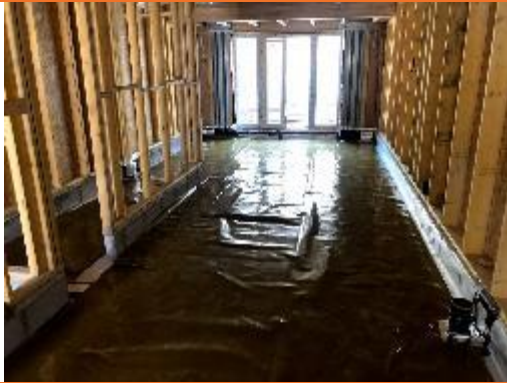
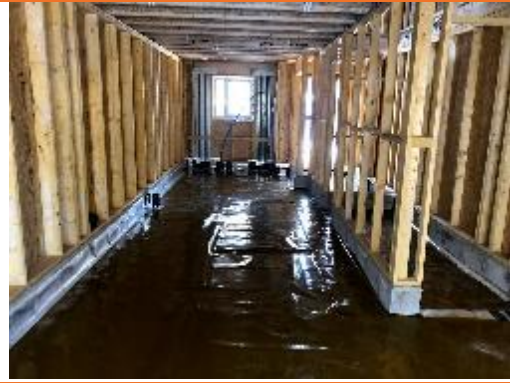
**Plot – 12**

**General Condition of Membrane-Good Condition**

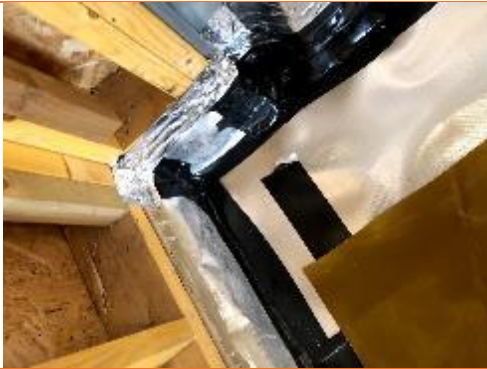
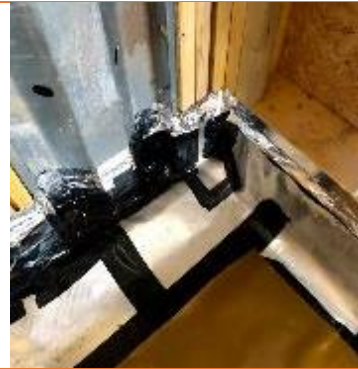
**Verification of Joints and Seals-Good Condition**

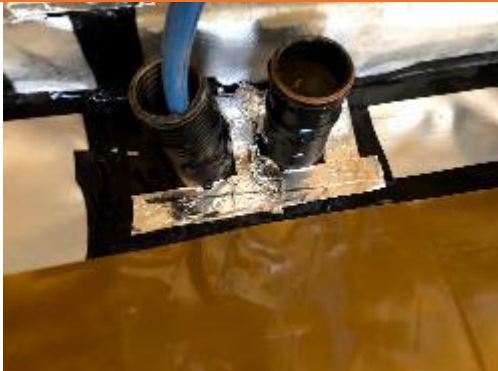
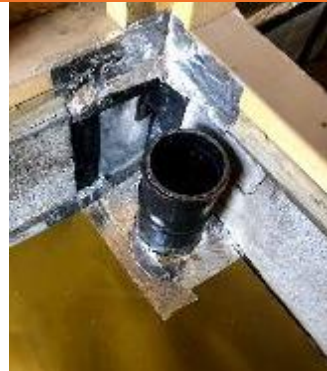
**Verification of Service Penetrations-Good Condition**

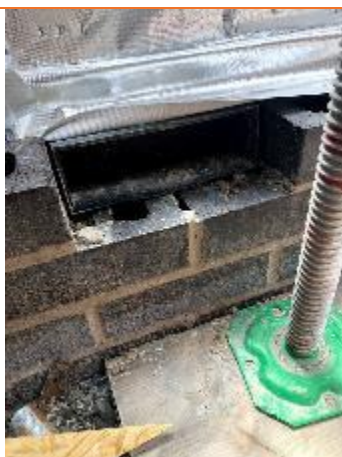
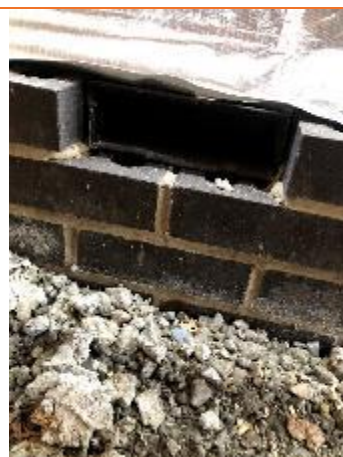
**Verification of Ventilation- Good Condition**

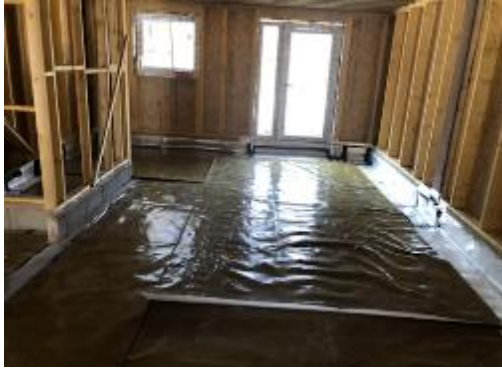
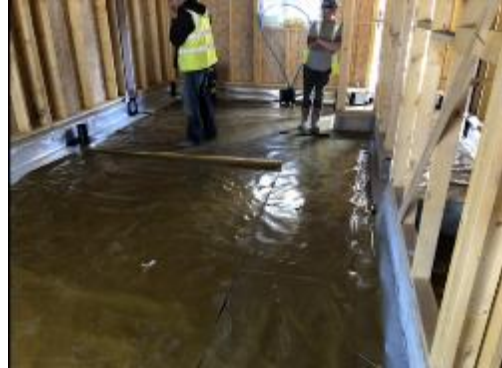
**Plot – 17**

**General Condition of Membrane-Good Condition**

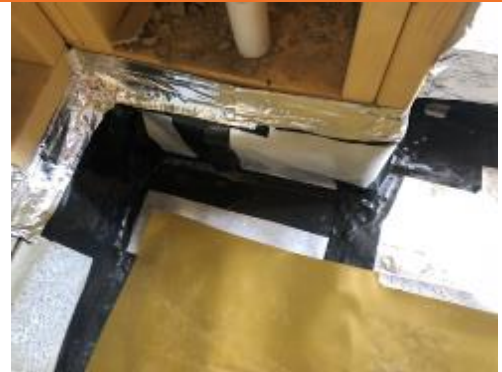
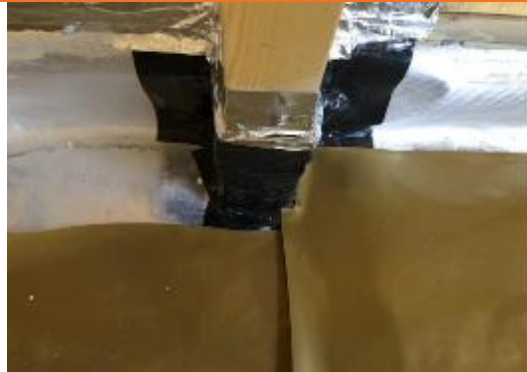
**Verification of Joints and Seals-Good Condition**

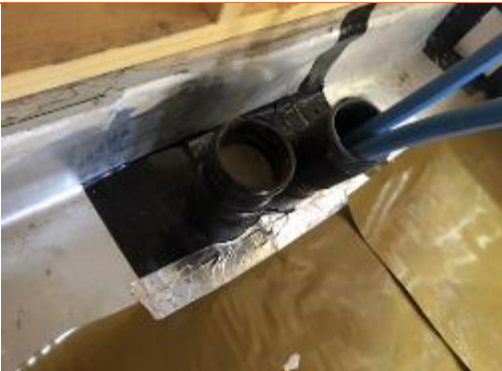
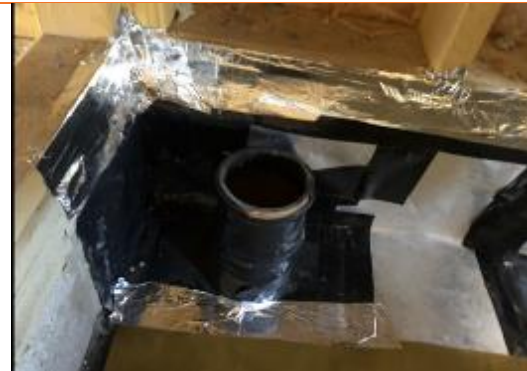
**Verification of Service Penetrations-Good Condition**

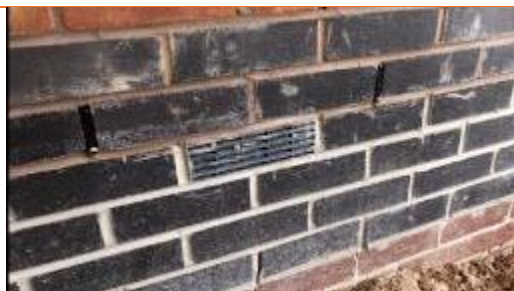
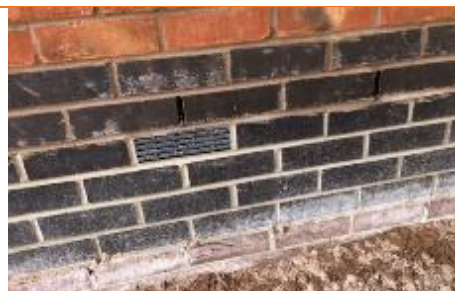
**Verification of Ventilation- Good Condition**

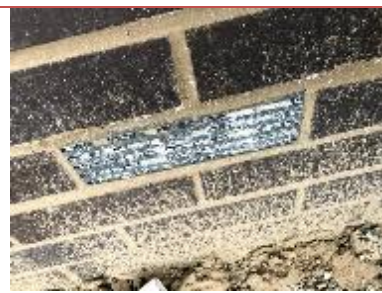
**Verification of Ventilation- Good Condition**

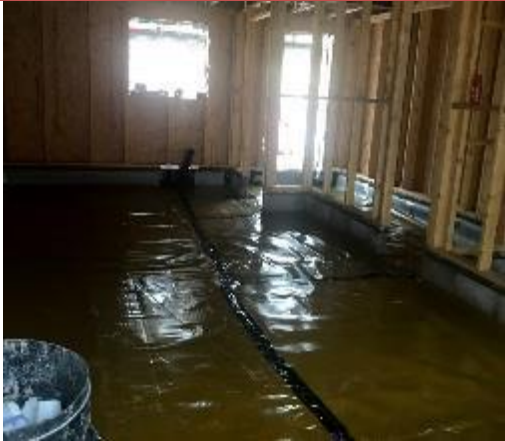
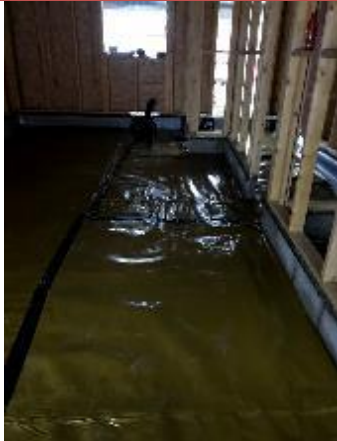
| Plot – 18 | |

| Plot – 18 | |
|---|---|
| General Condition of Membrane-Good Condition | |

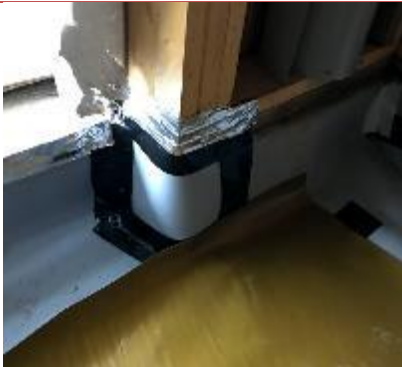
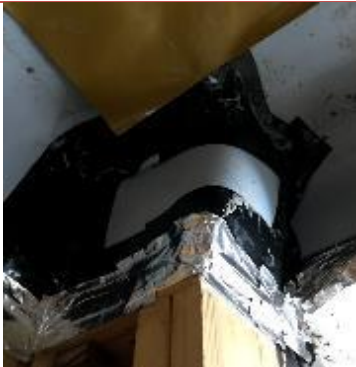
| Plot – 18 | |
|---|---|
| Verification of Joints and Seals-Good Condition | |

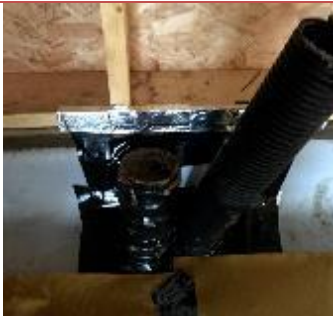
| Plot – 18 | |
|---|---|
| Verification of Service Penetrations-Good Condition | |

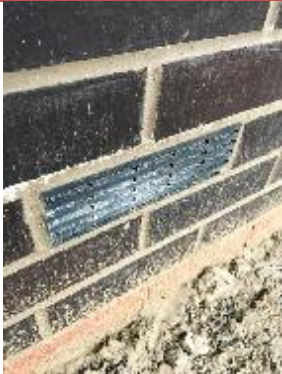
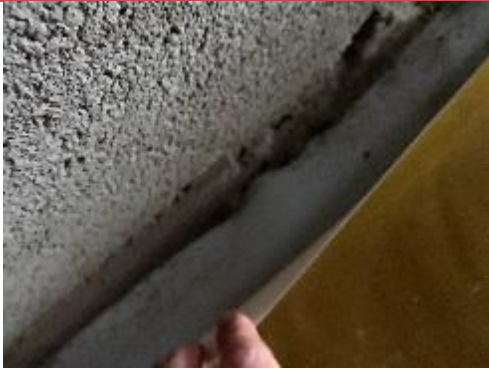
| Plot – 18 | |
|---|---|
| Verification of Ventilation- Good Condition | |

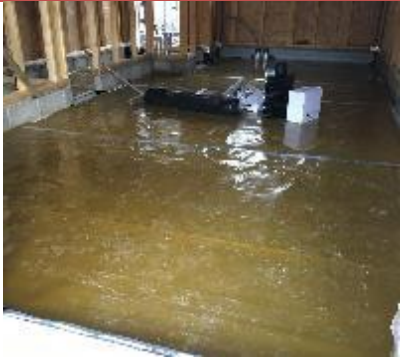
**Plot – 15**

**General Condition of Membrane-Good Condition**

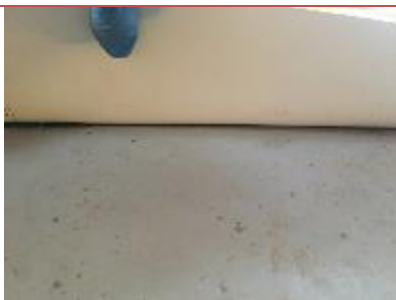
**Verification of Ventilation- Good Condition**

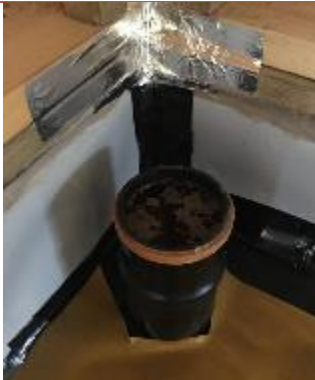
**Plot – 16**

**Verification of Service Penetrations-Good Condition**

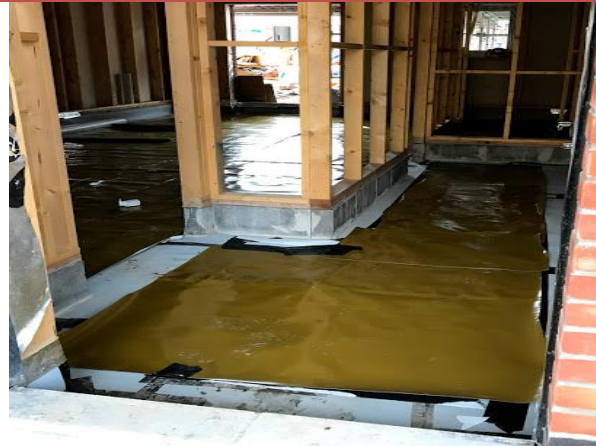
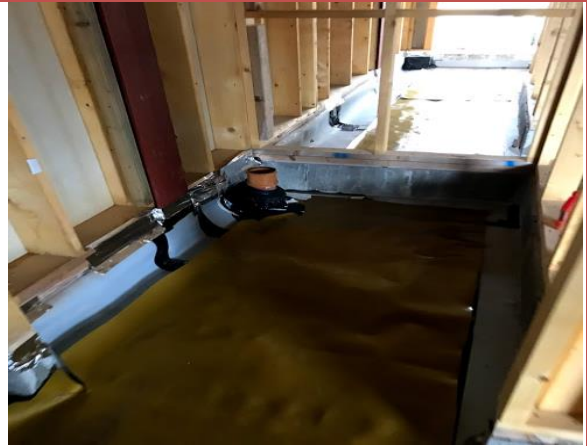
**Plot – 19**

**General Condition of Membrane-Good Condition**

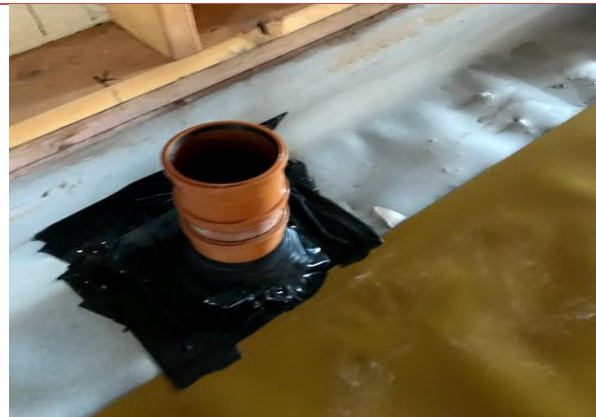
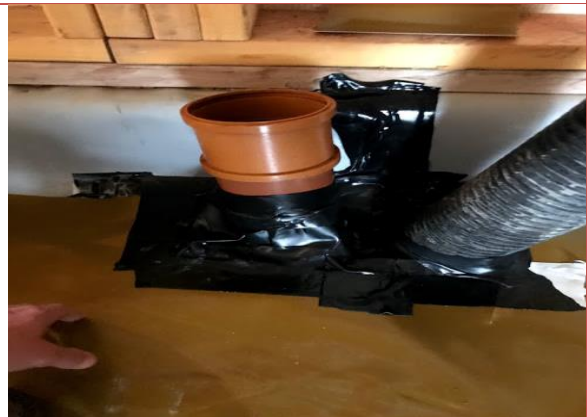
**Verification of Joints and Seals-Good Condition**

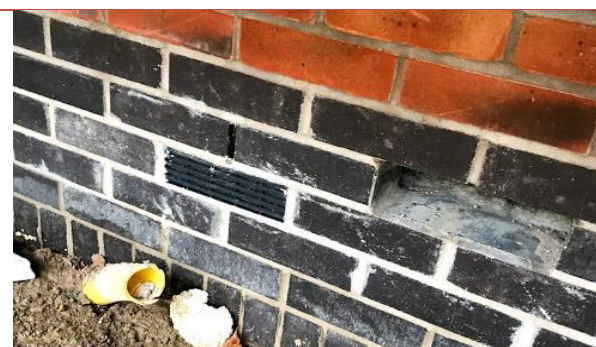
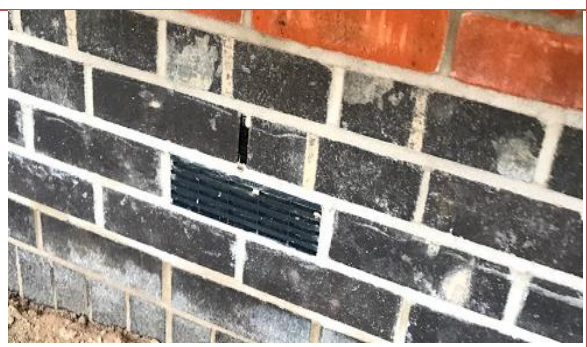
**Verification of Ventilation- Good Condition**

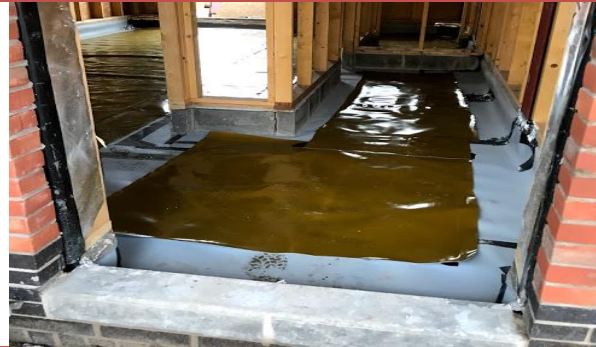
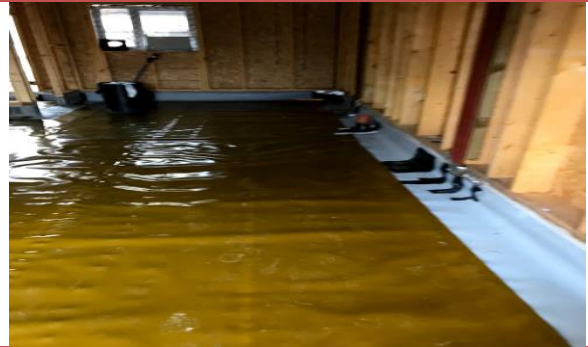
Plot - 20

General Condition of Membrane-Good Condition

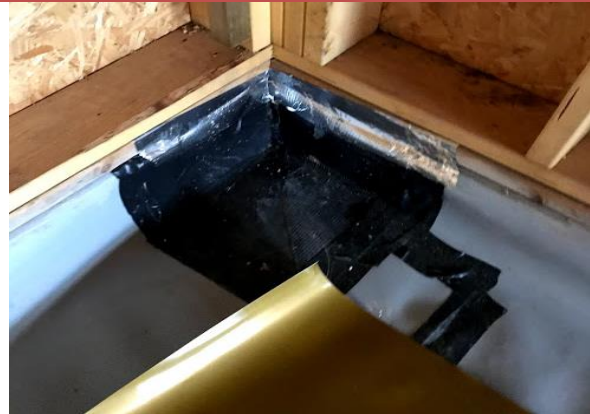
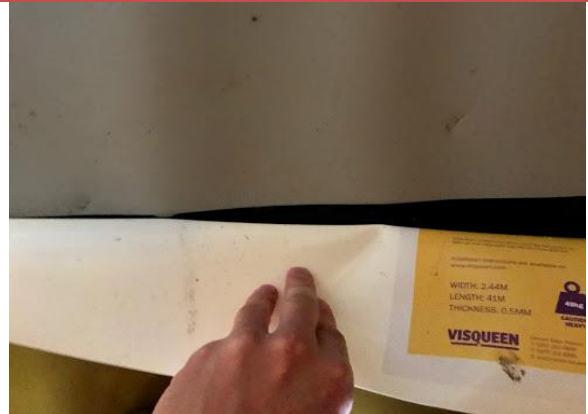
Verification of Joints and Seals-Good Condition

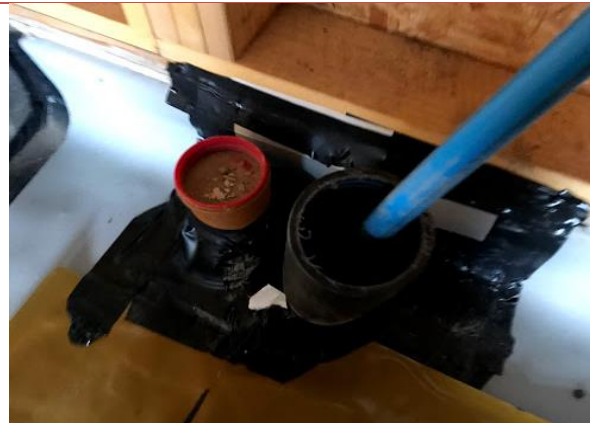
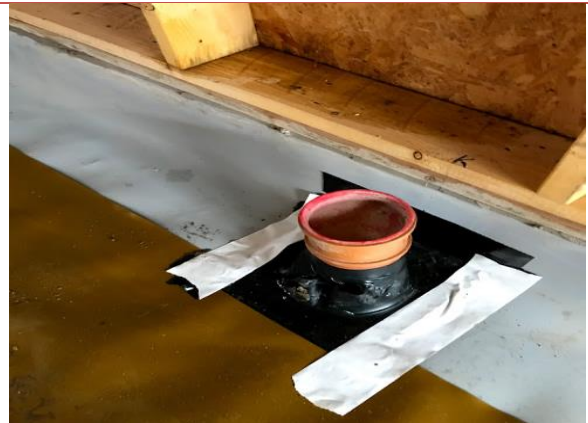
Verification of Service Penetrations-Good Condition

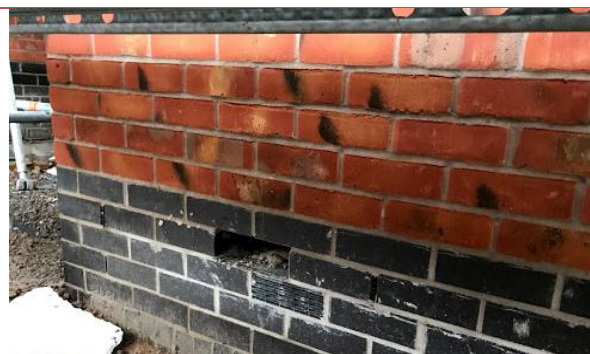
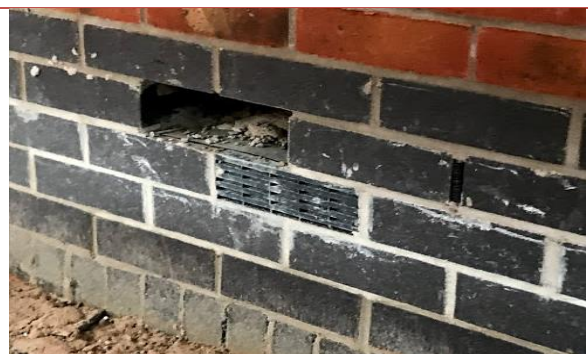
Verification of ventilation-Good Condition

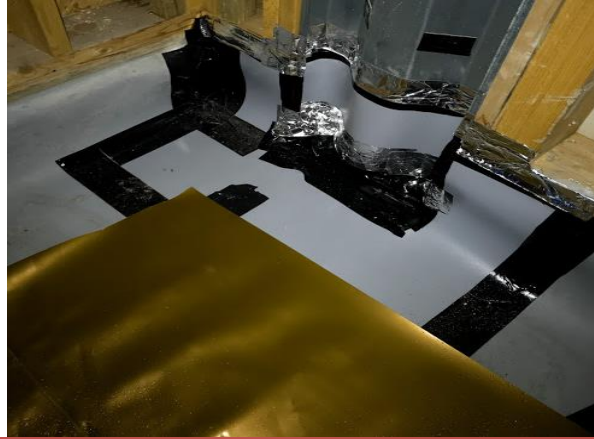
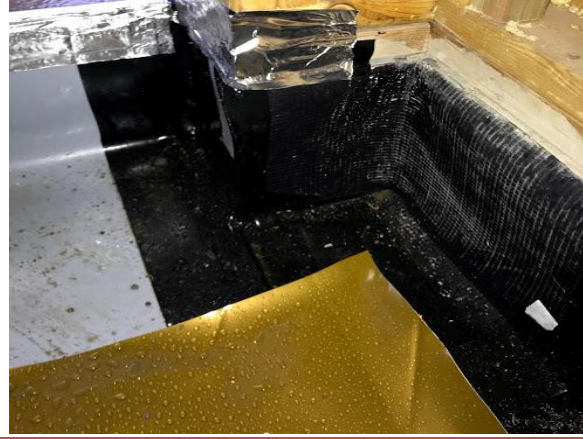
**Verification of Joints and Seals-Good Condition**

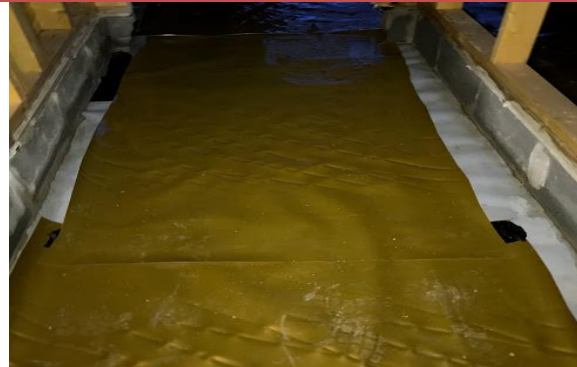
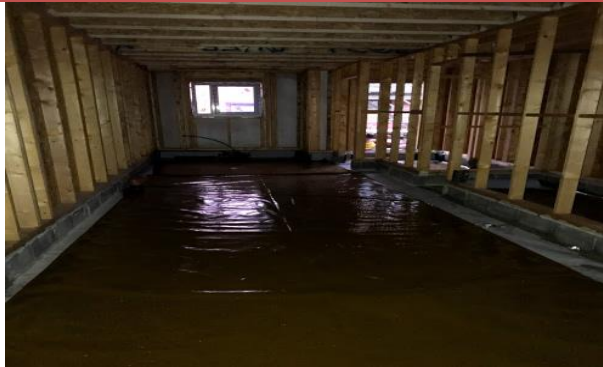
**Plot - 22**

**General Condition of Membrane-Good Condition**

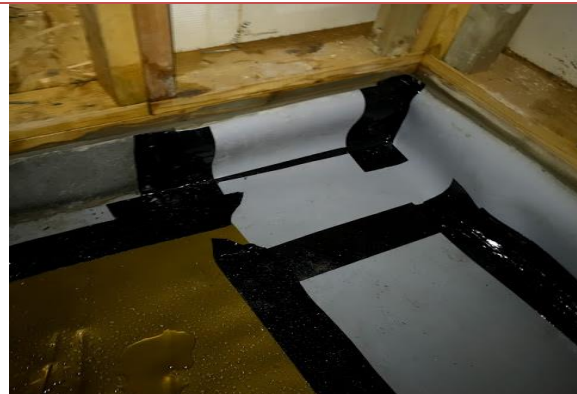
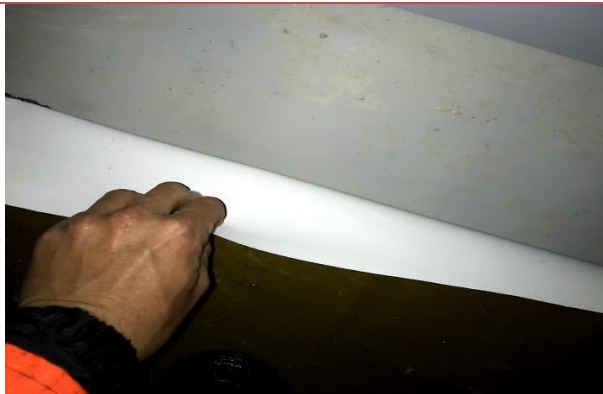
**Verification of Joints and Seals-Good Condition**

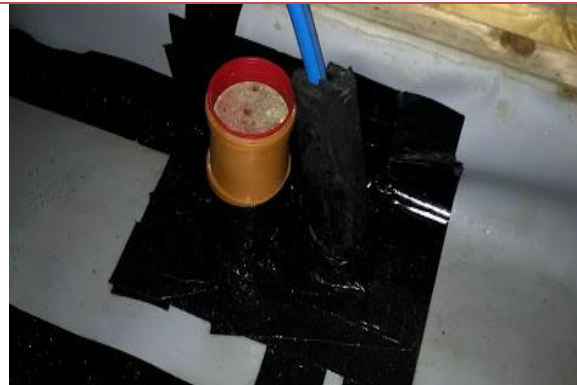
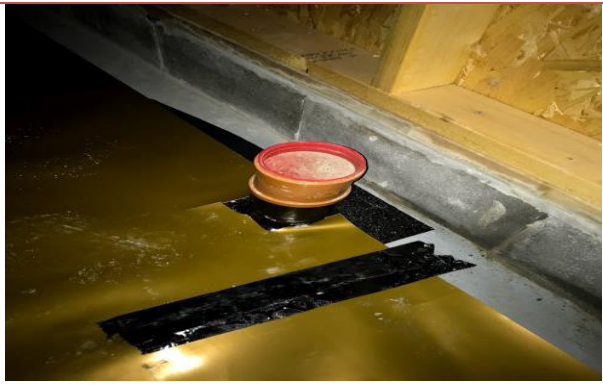
**Verification of Service Penetrations-Good Condition**

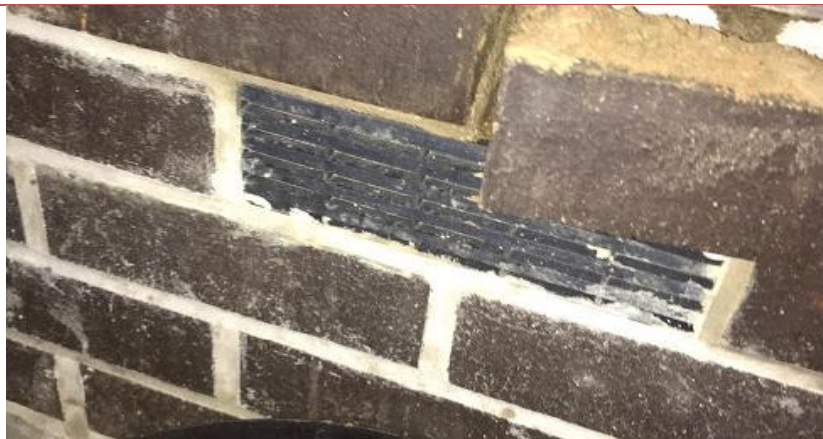
**Verification of ventilation-Good Condition**

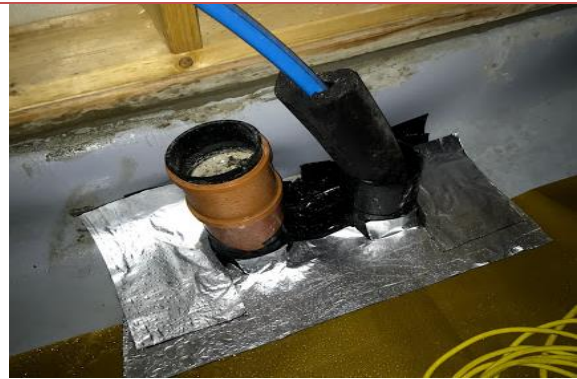
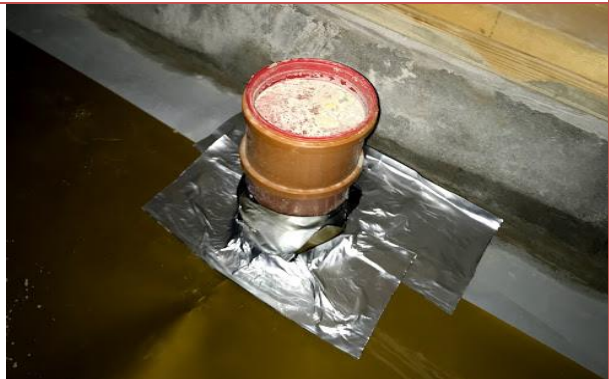
**Verification of Service Penetrations-Good Condition**

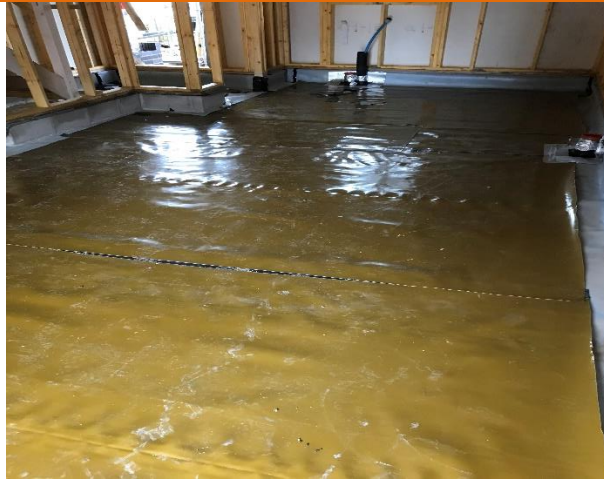
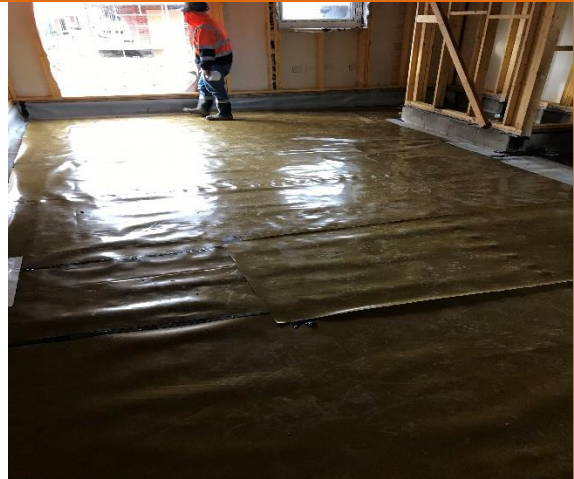
**Plot – 25**

**General Condition of Membrane-Good Condition**

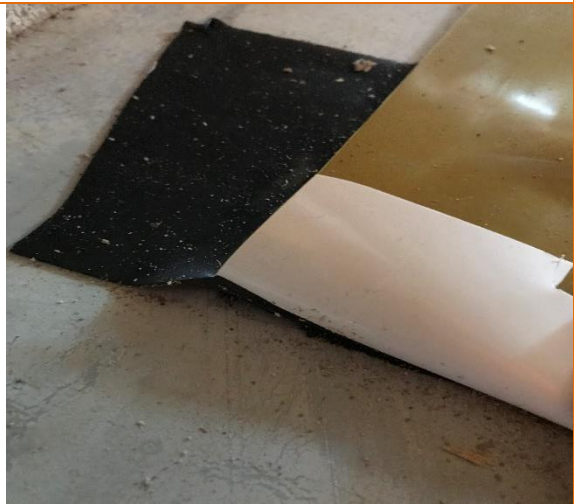
**Verification of Joints and Seals-Good Condition**

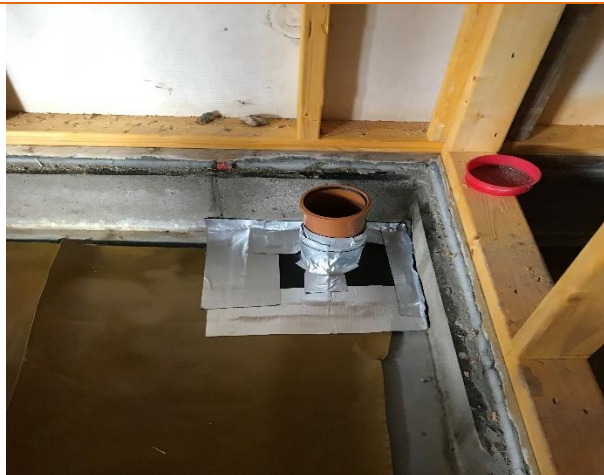
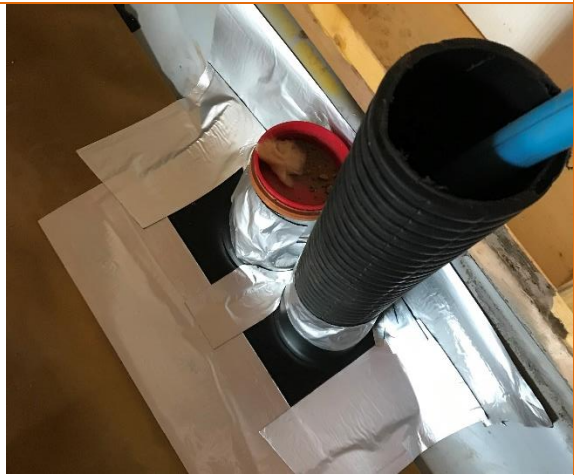
**Verification of Service Penetrations-Good Condition**

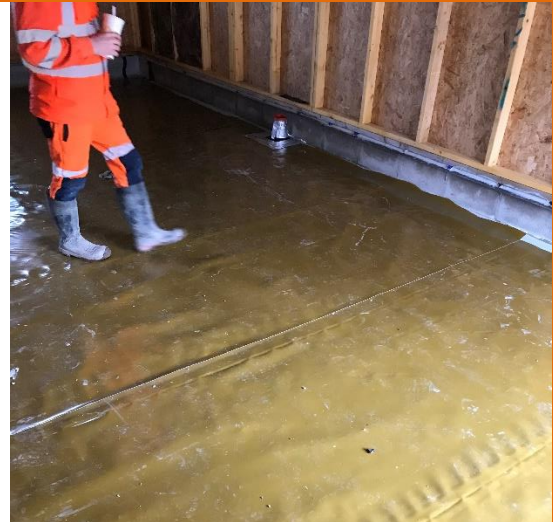
**Plot – 26**

**General Condition of Membrane-Good Condition**

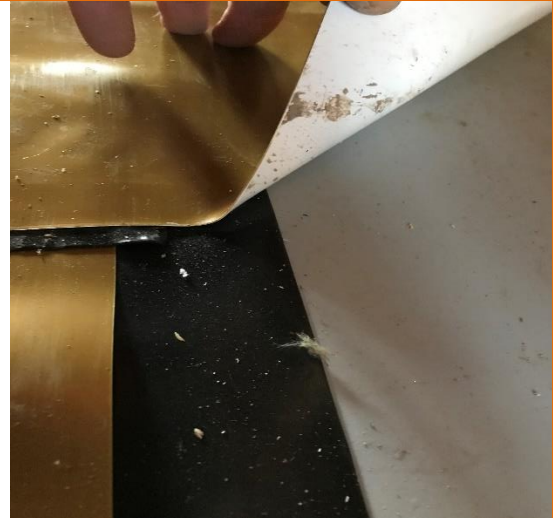
**Verification of Joints and Seals-Good Condition**

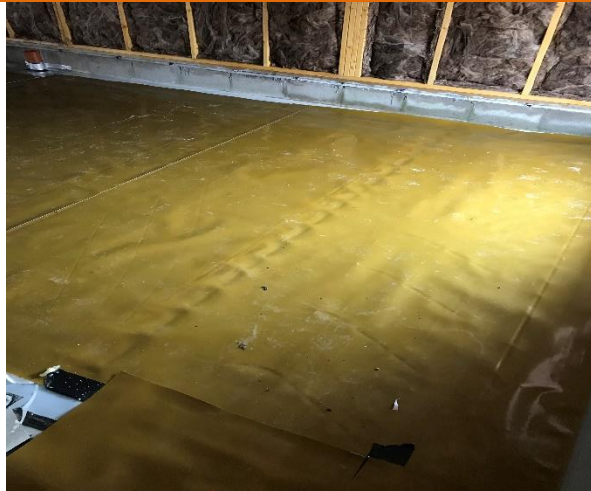
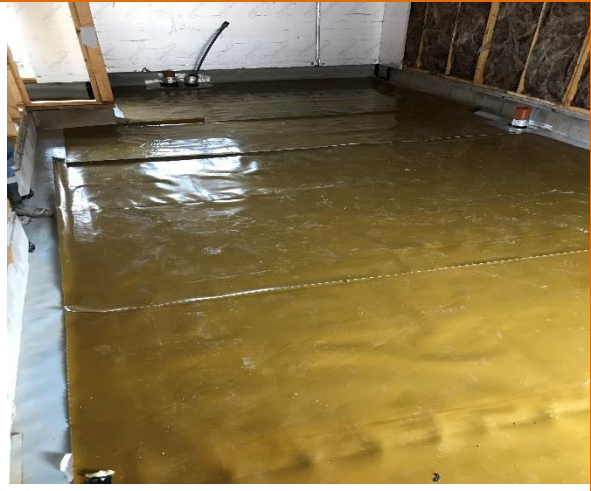
**Plot – 27**

**General Condition of Membrane-Good Condition**

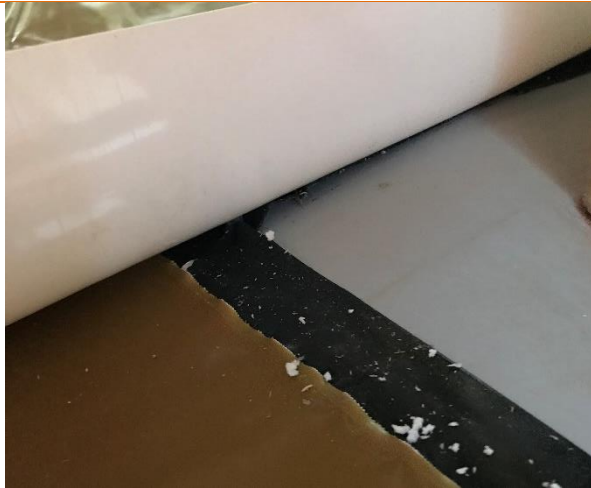
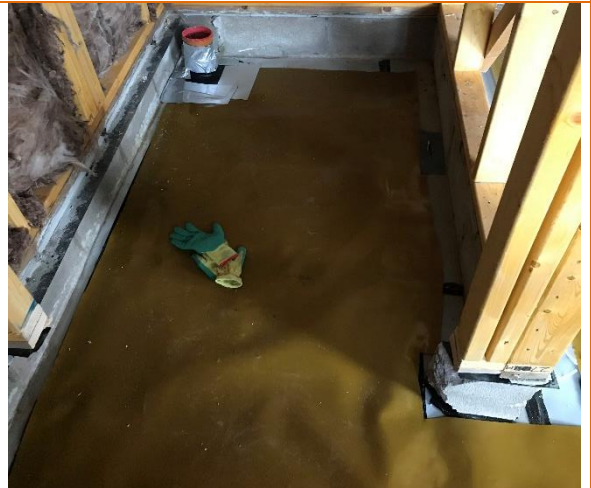
**Verification of Joints and Seals-Good Condition**

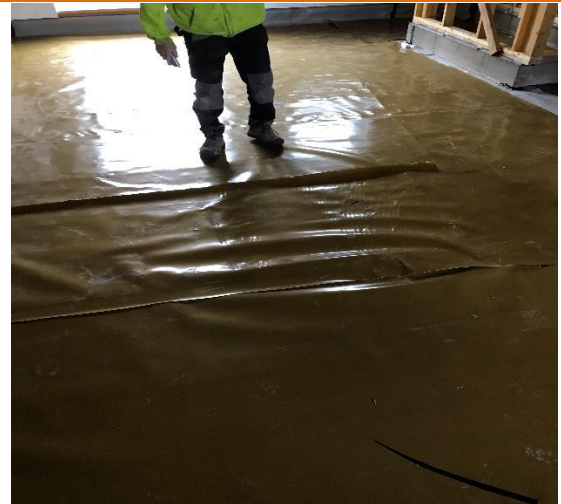
**Plot – 28**

**General Condition of Membrane-Good Condition**
