Validation Completion Report  
Plots 1-54  
Bowes Street, Manchester

Reference:11-813-R5-2  
Date: May 2022

Plots 1-54  
Former Stagecoach Bus Depot  
Land off Bowes Street  
Manchester

Prepared for:  
**Rowlinson Construction**

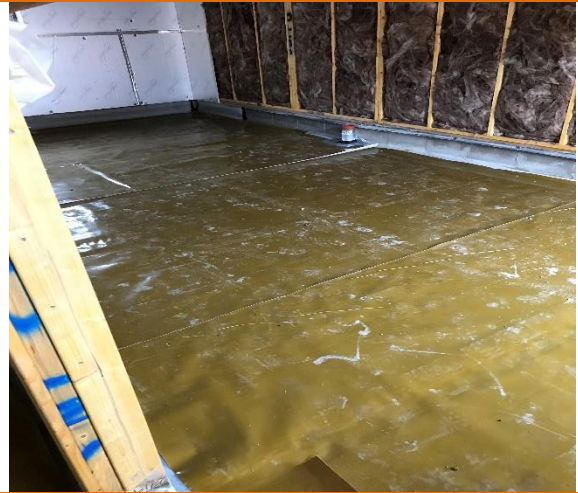
**Plot – 29**

**General Condition of Membrane-Good Condition**

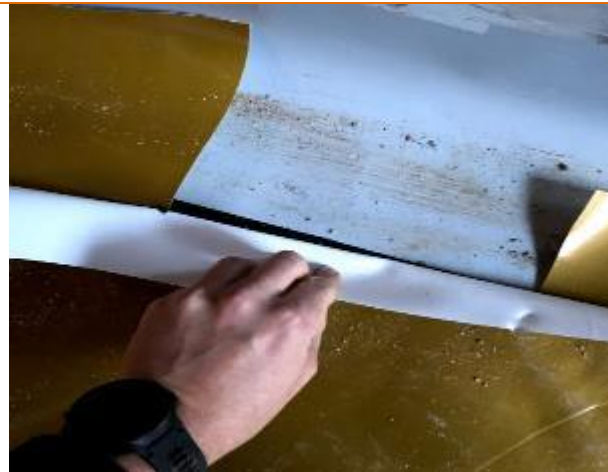
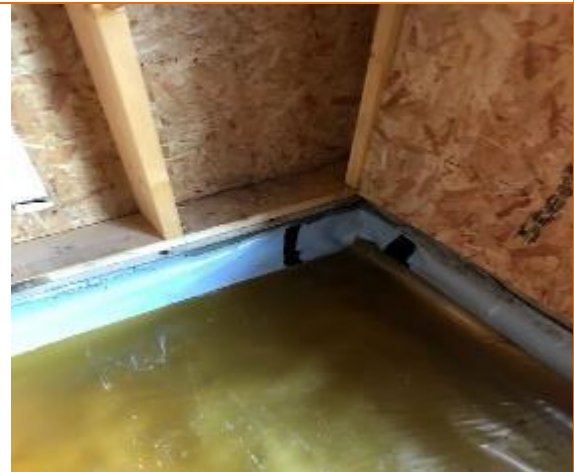
**Verification of Joints and Seals-Good Condition**

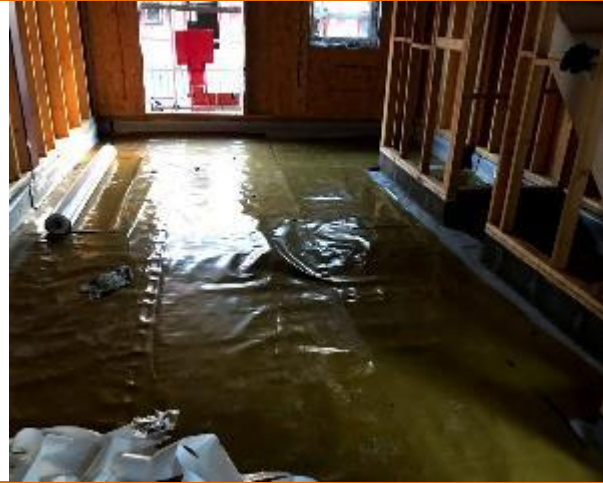
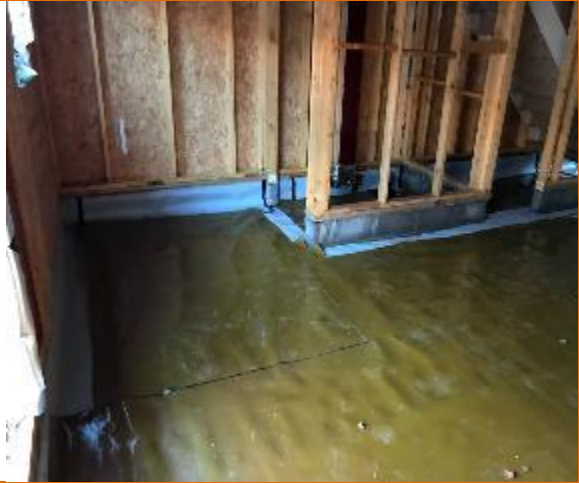
**Plot - 49**

**General Condition of Membrane-Good Condition**

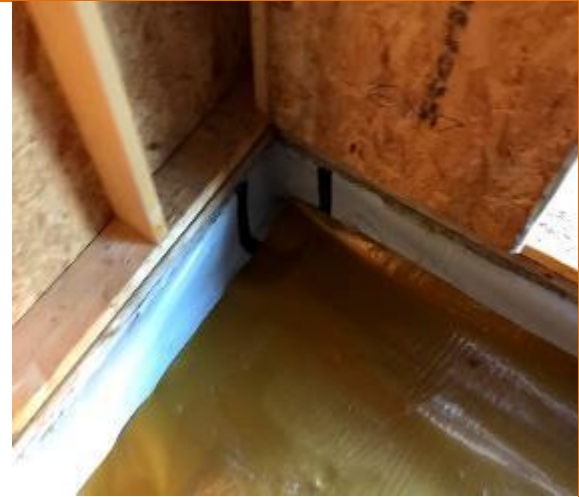
**Verification of Joints and Seals-Good Condition**

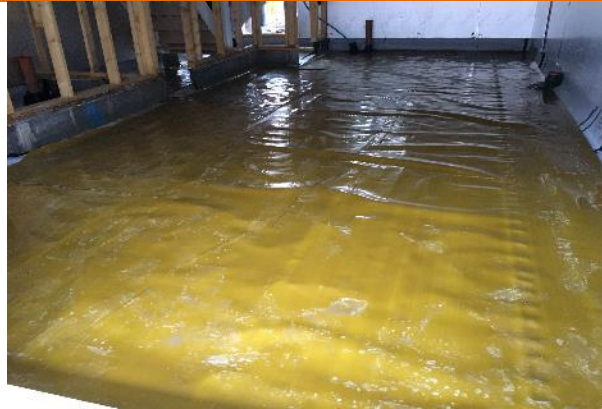
**Plot – 32**

**General Condition of Membrane-Good Condition**

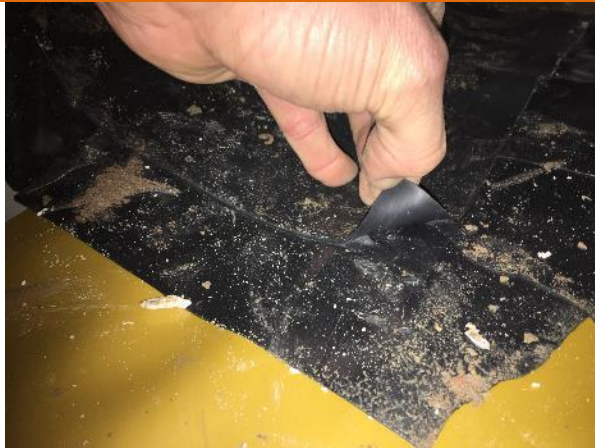
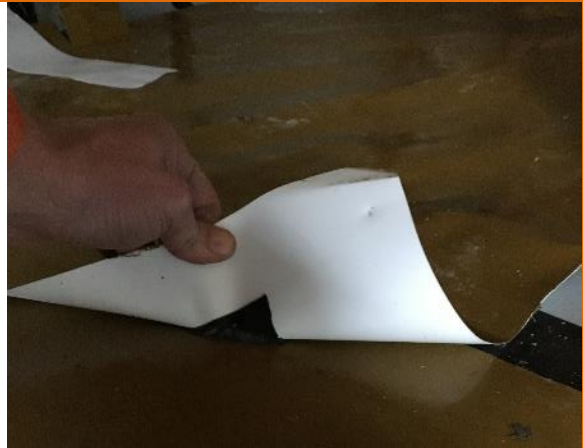
**Verification of Joints and Seals-Good Condition**

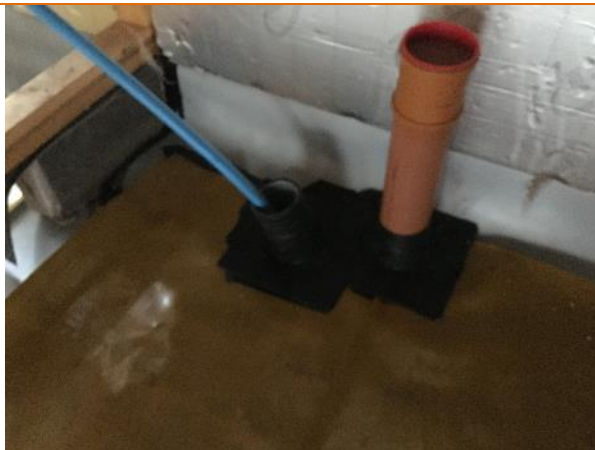
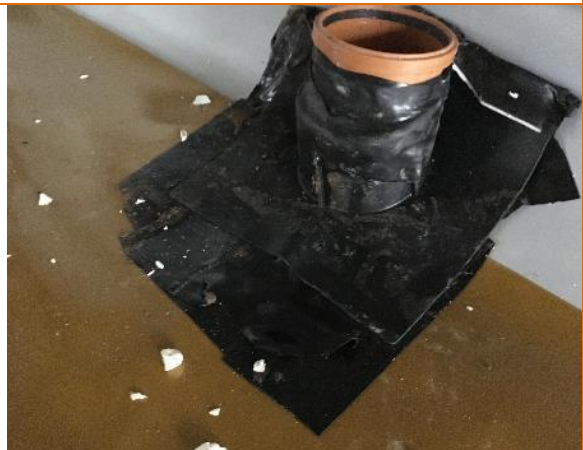
**Verification of Service Penetrations-Good Condition**

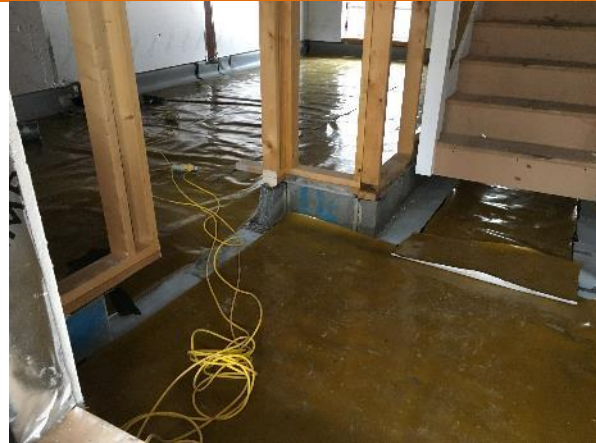
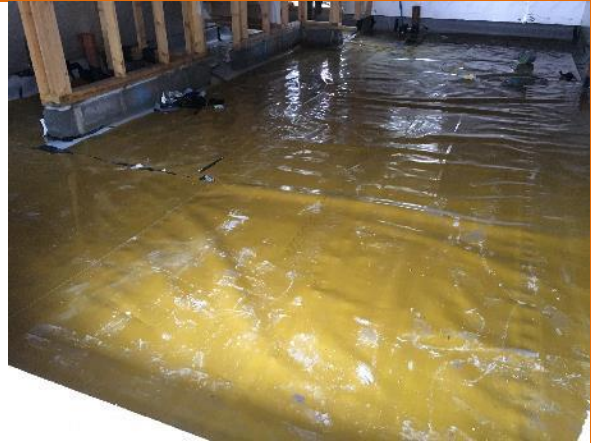
**Plot – 33**

**General Condition of Membrane-Good Condition**

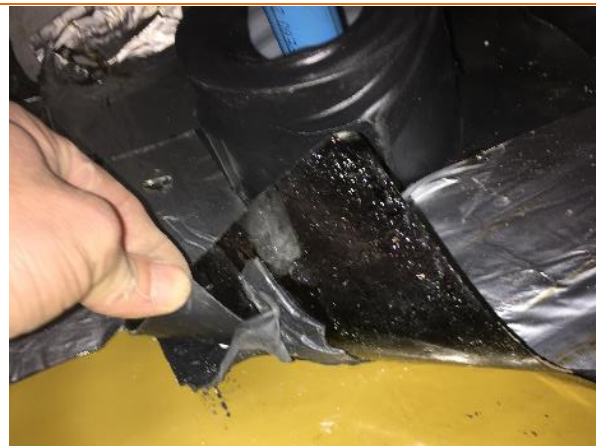
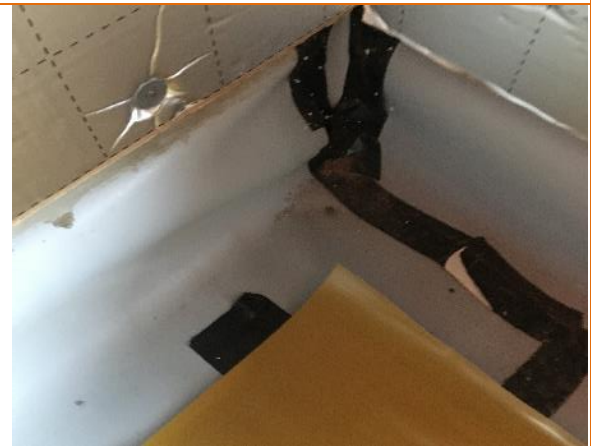
**Verification of Joints and Seals-Good Condition**

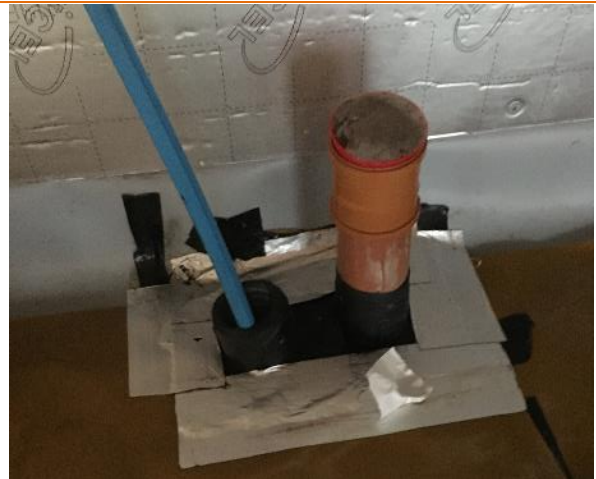
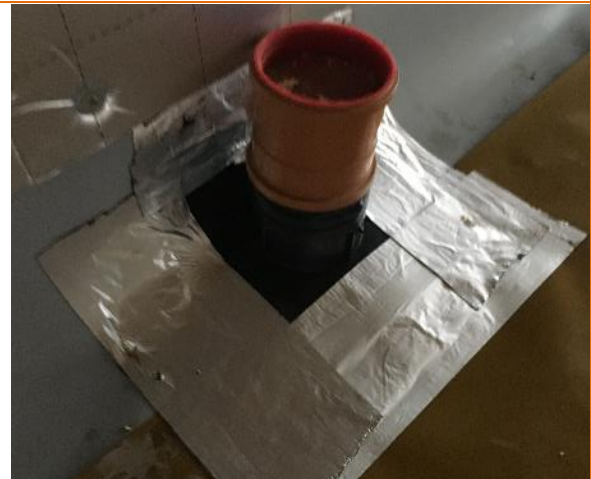
**Verification of Service Penetrations-Good Condition**

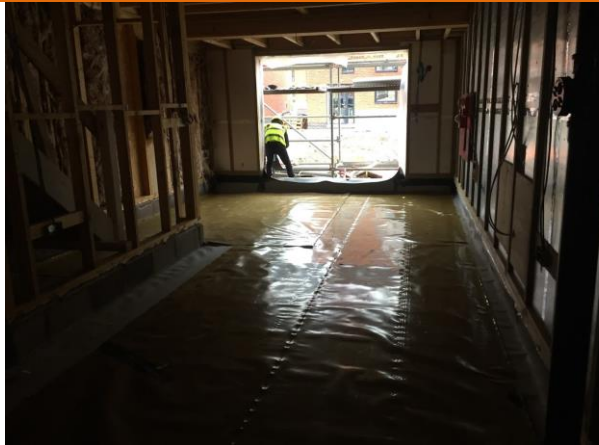
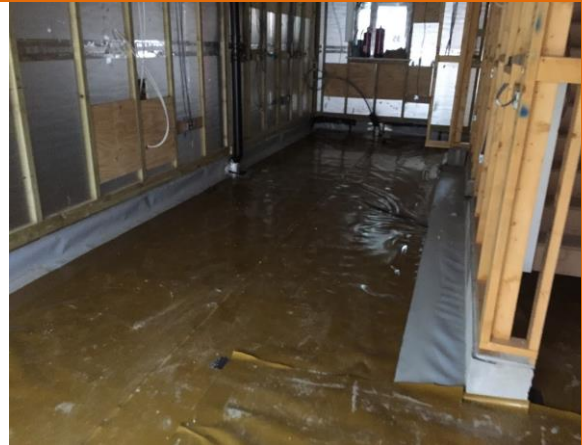
**Plot – 35**

**General Condition of Membrane-Good Condition**

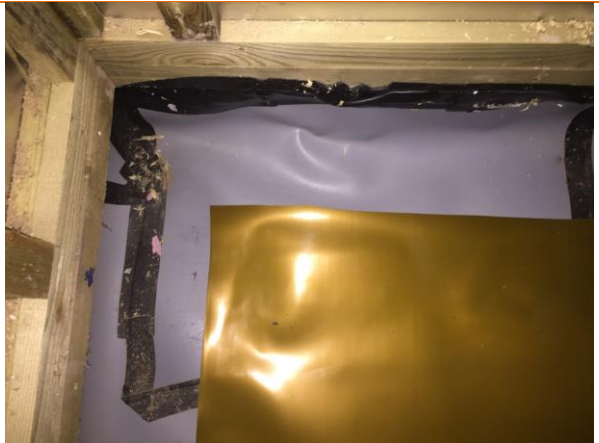
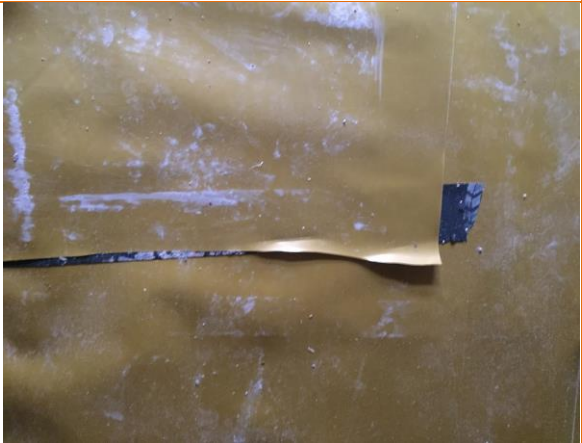
**Verification of Joints and Seals-Good Condition**

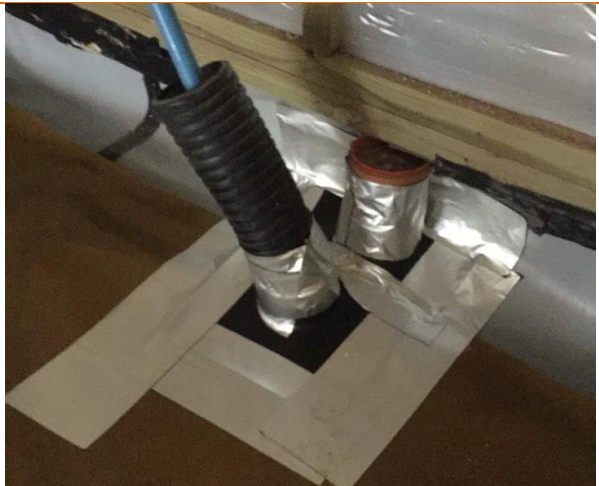
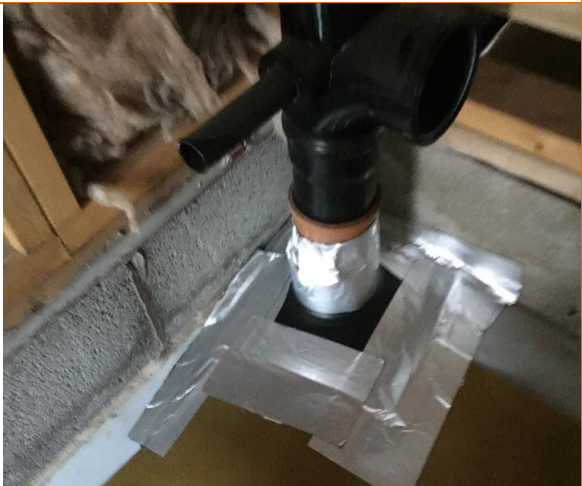
**Verification of Service Penetrations-Good Condition**

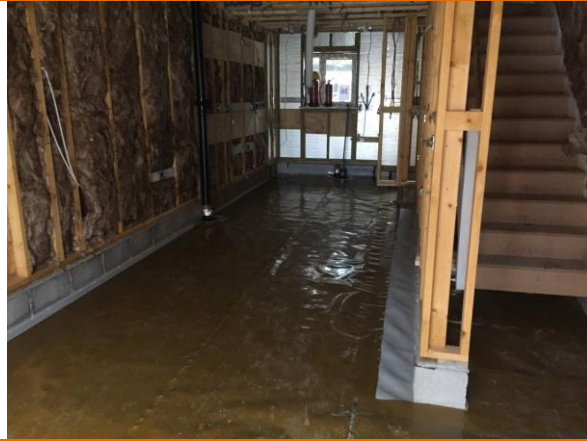
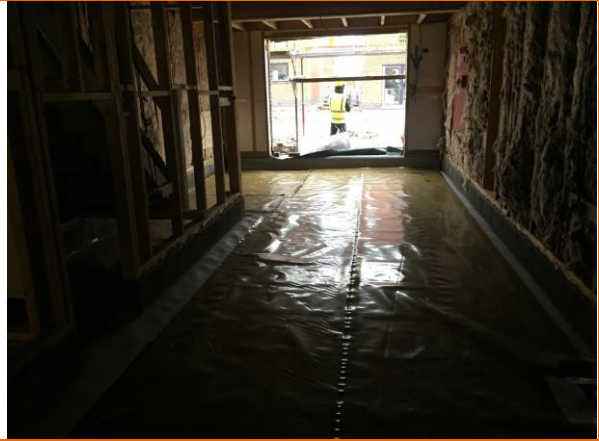
**Plot – 36**

**General Condition of Membrane-Good Condition**

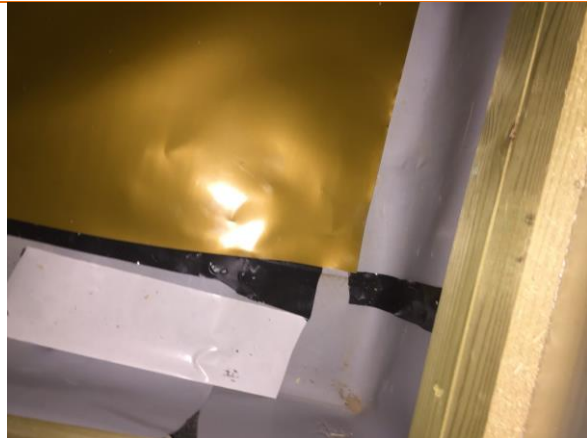
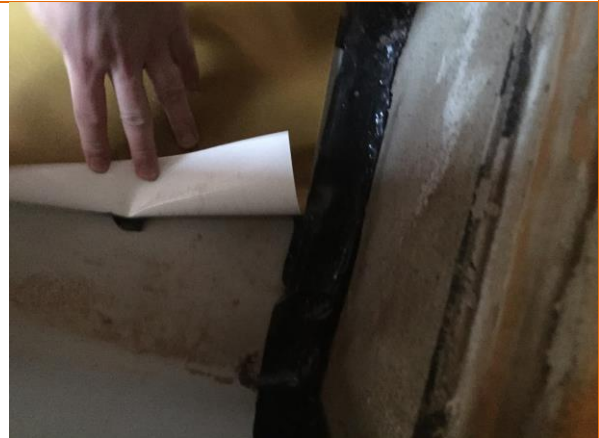
**Verification of Joints and Seals-Good Condition**

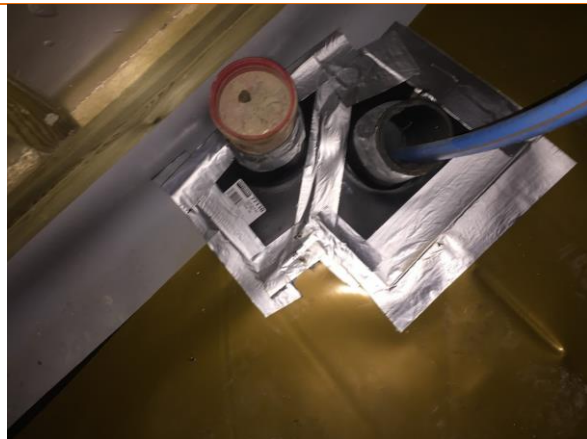
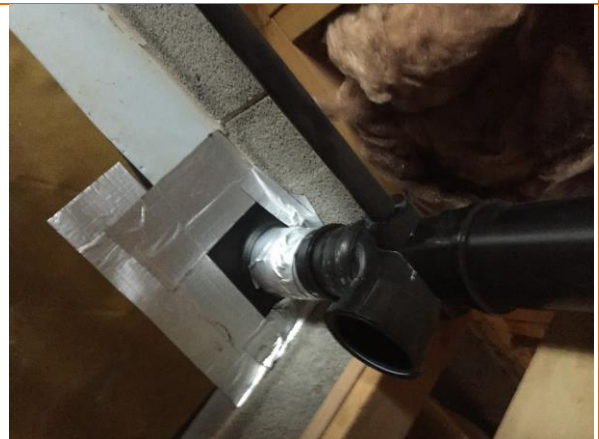
**Verification of Service Penetrations-Good Condition**

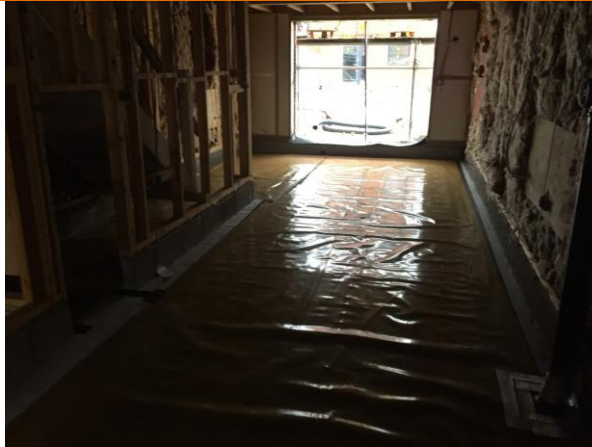
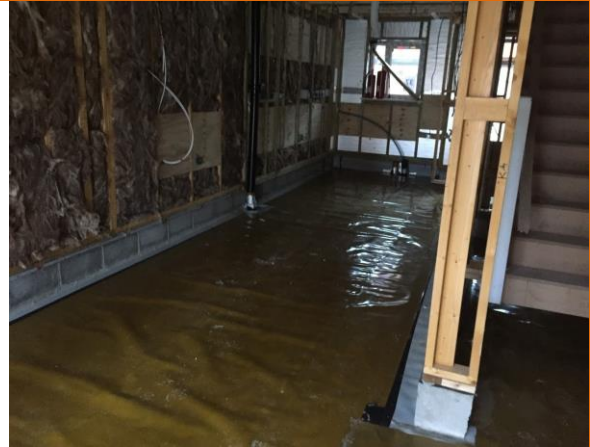
**Plot – 37**

**General Condition of Membrane-Good Condition**

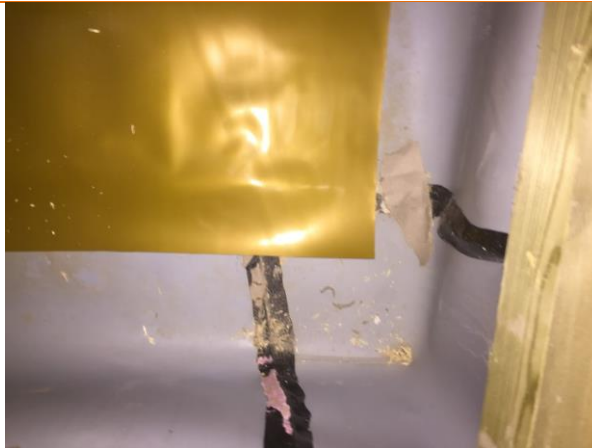
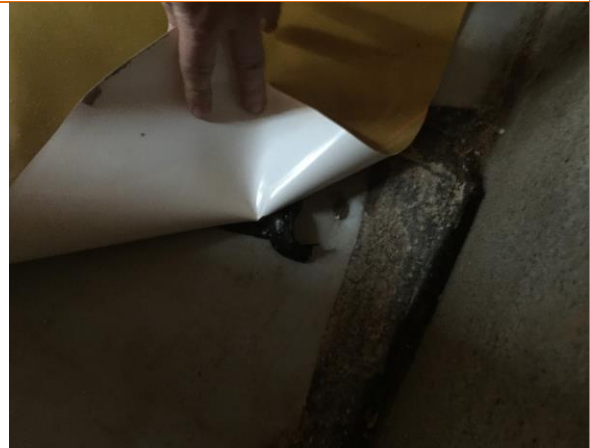
**Verification of Joints and Seals-Good Condition**

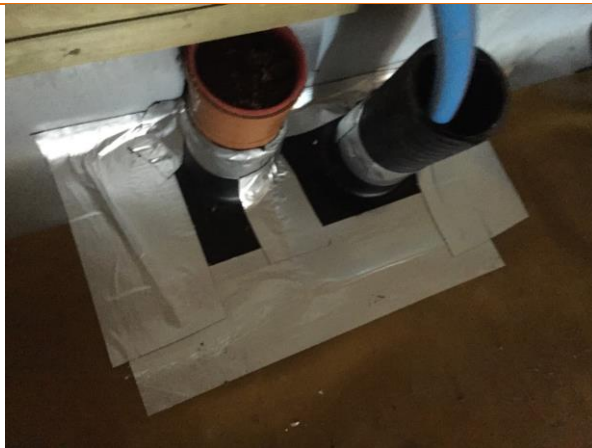
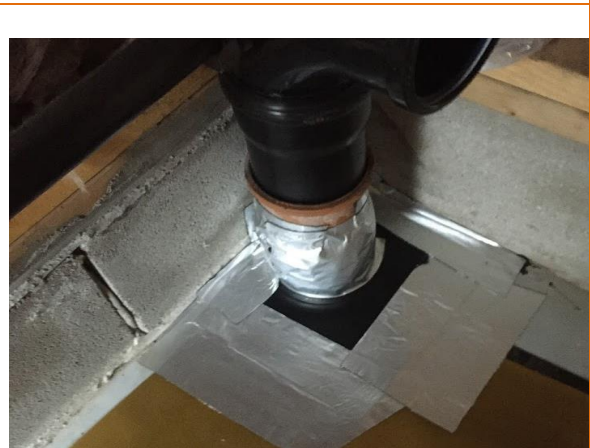
**Verification of Service Penetrations-Good Condition**

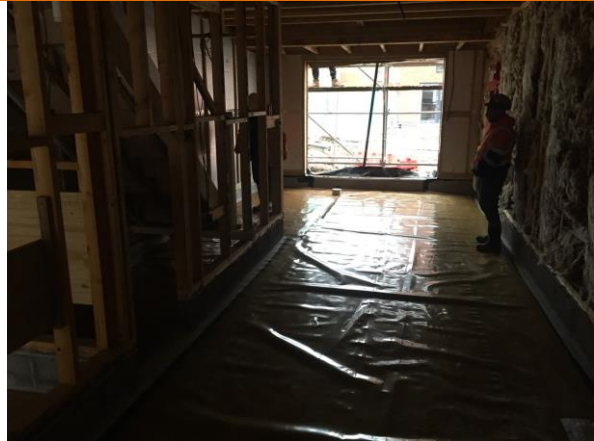
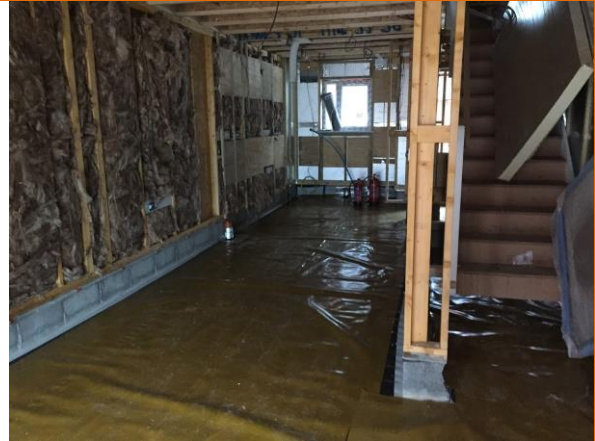
**Plot – 38**

**General Condition of Membrane-Good Condition**

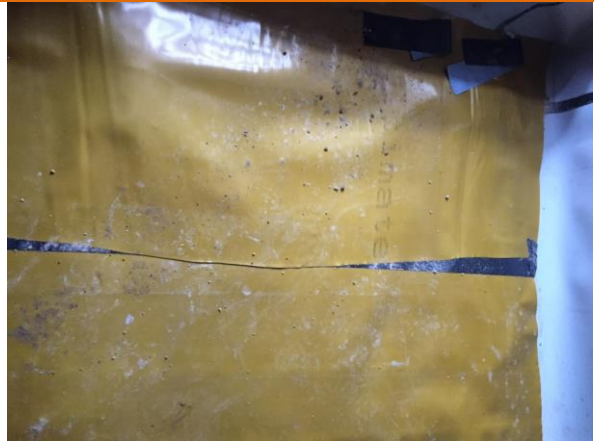
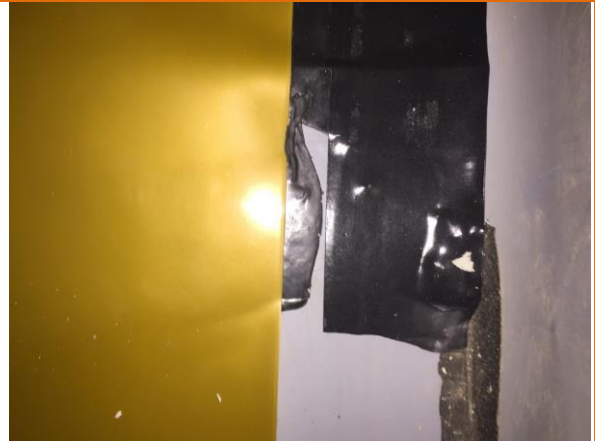
**Verification of Joints and Seals-Good Condition**

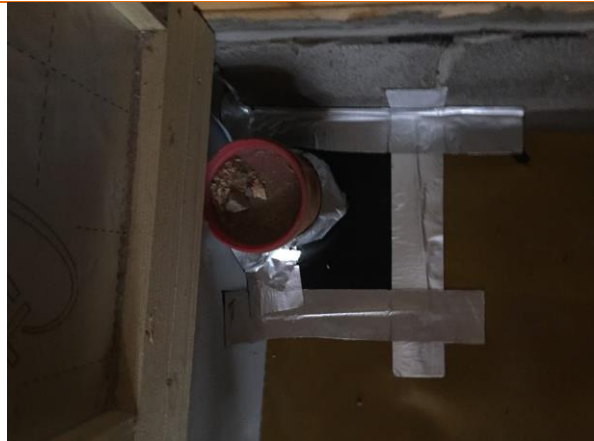
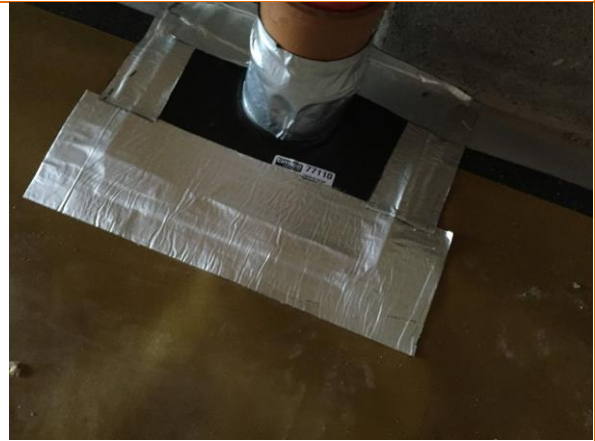
**Verification of Service Penetrations-Good Condition**

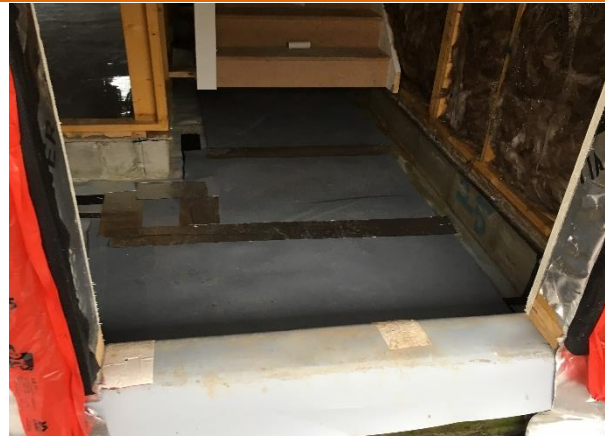
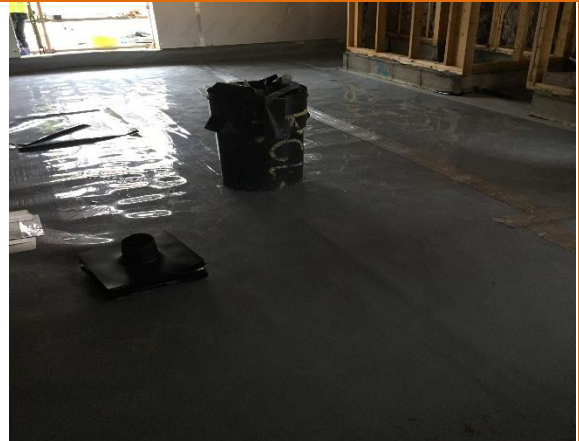
**Plot – 40**

**General Condition of Membrane-Good Condition**

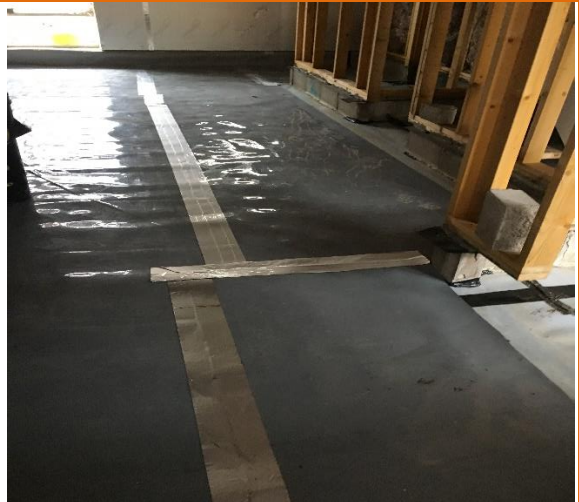
**Verification of Joints and Seals-Good Condition**

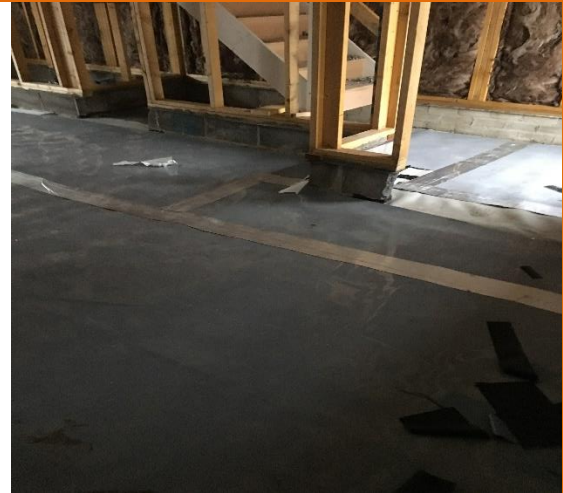
**Plot – 41**

**General Condition of Membrane-Good Condition**

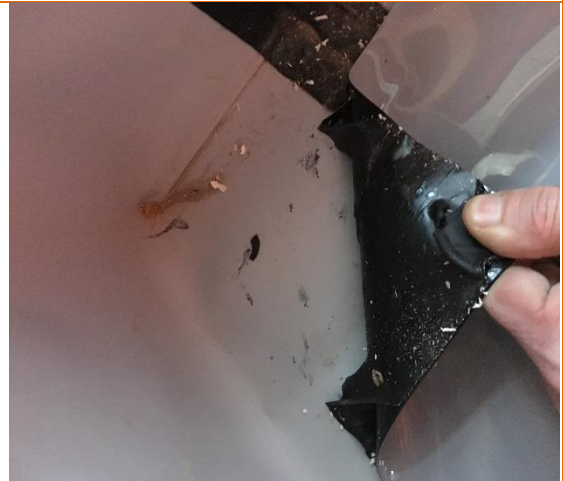
**Verification of Joints and Seals-Good Condition**

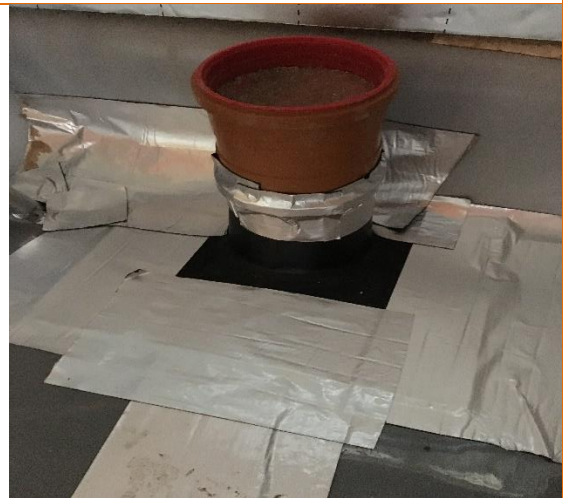
**Verification of Service Penetrations-Good Condition**

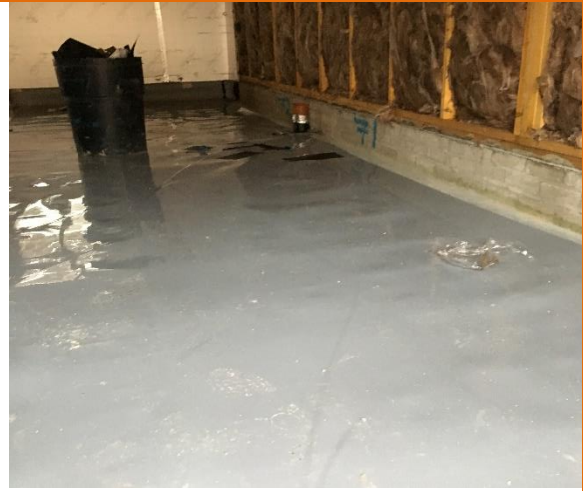
**Plot – 42**

**General Condition of Membrane-Good Condition**

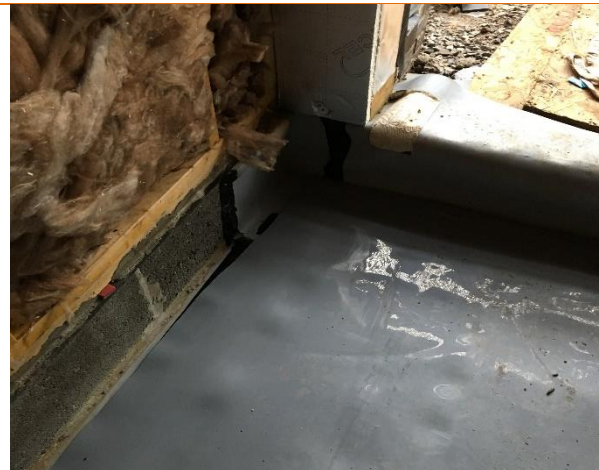
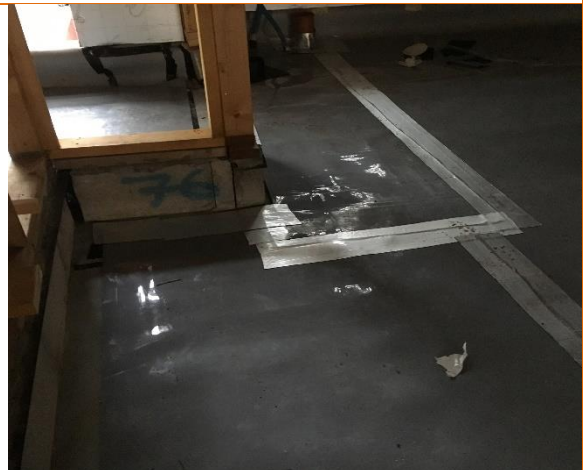
**Verification of Joints and Seals-Good Condition**

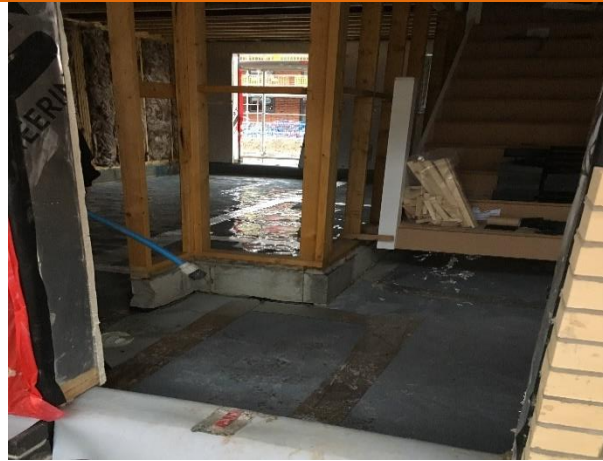
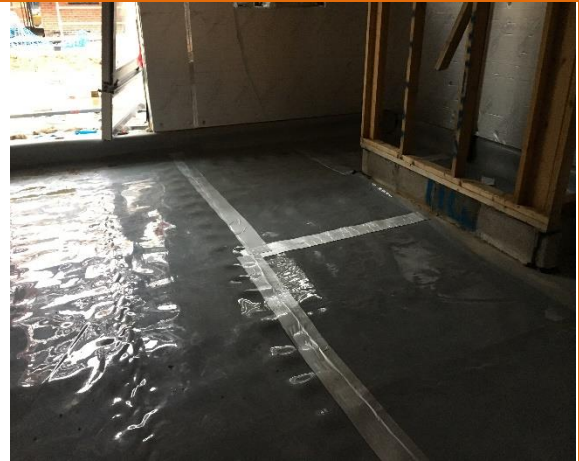
**Plot – 44**

**General Condition of Membrane-Good Condition**

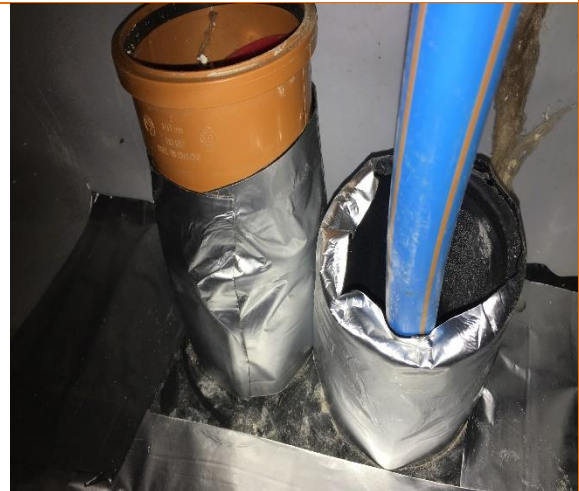
**Verification of Service Penetrations-Good Condition**

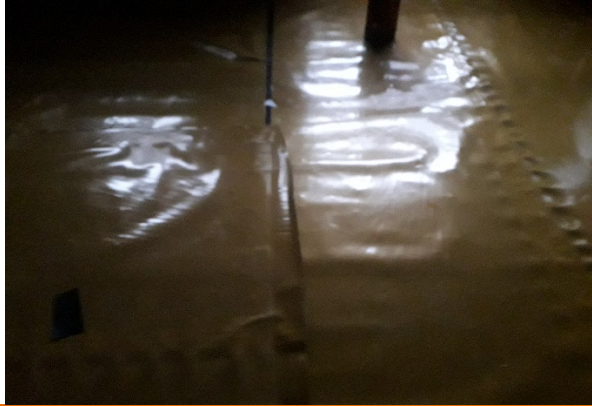
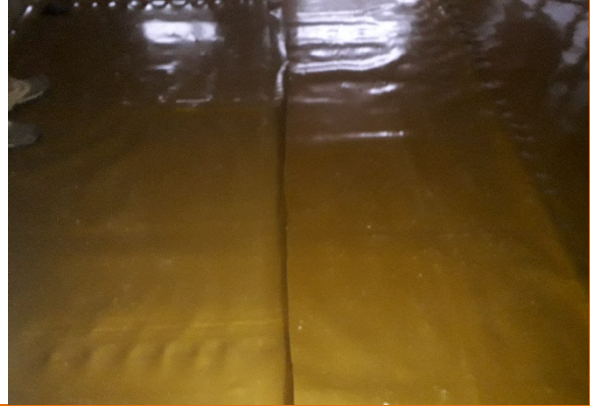
**Plot - 45**

**General Condition of Membrane-Good Condition**

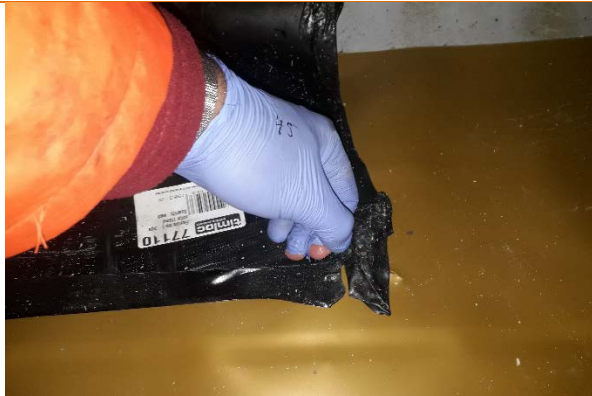
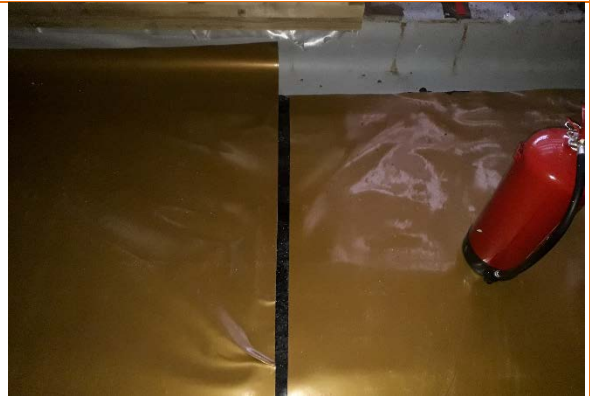
**Verification of Joints and Seals-Good Condition**

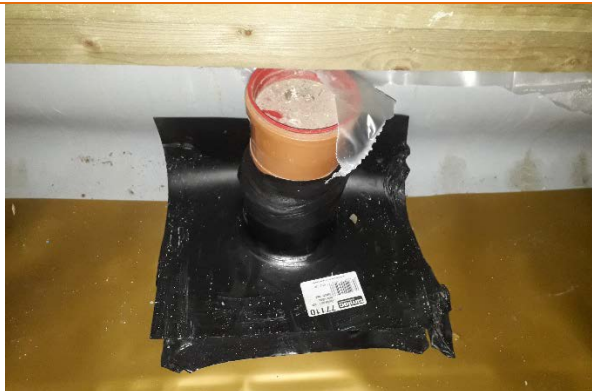
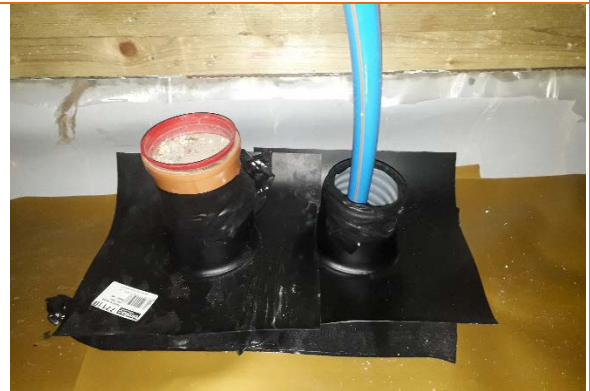
**Verification of Service Penetrations-Good Condition**

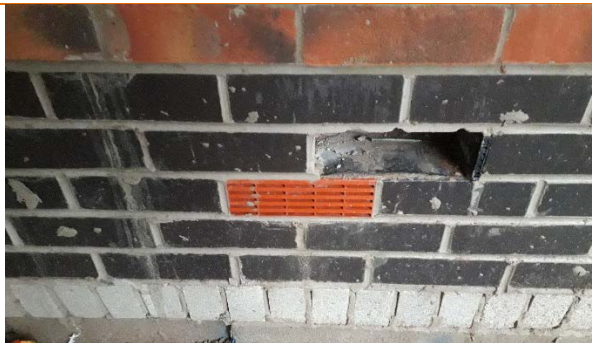
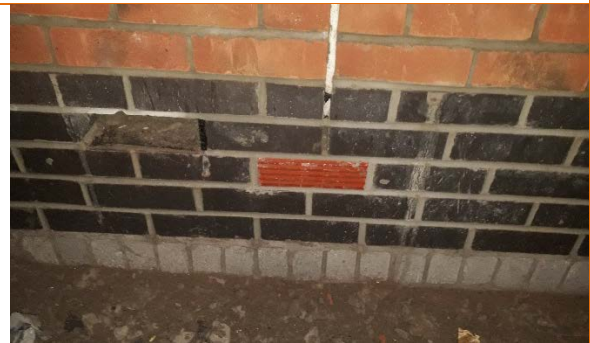
**Verification of Ventilation-Good Condition**

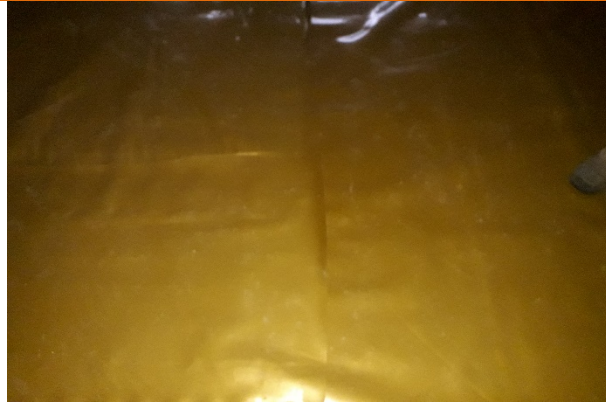
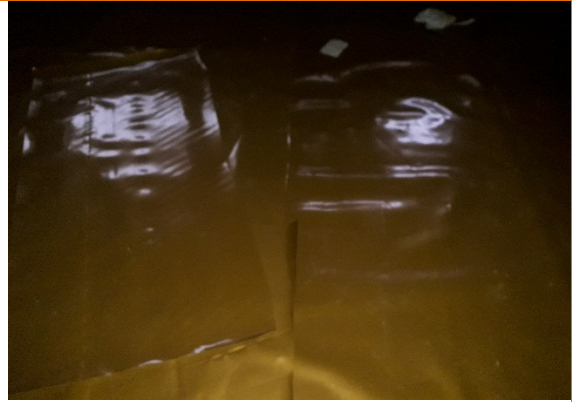
**Plot - 46**

**General Condition of Membrane-Good Condition**

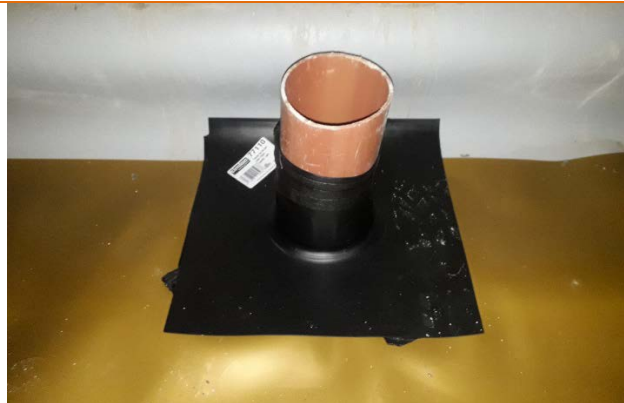
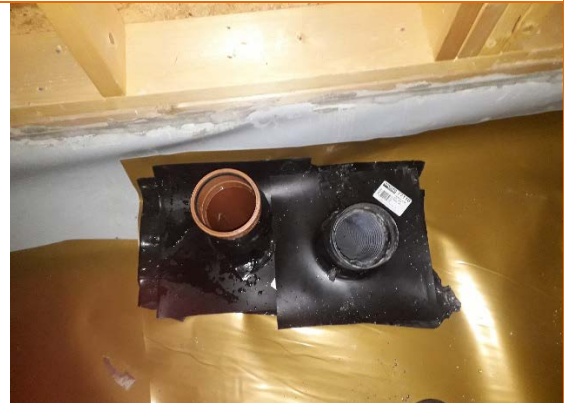
**Verification of Joints and Seals-Good Condition**

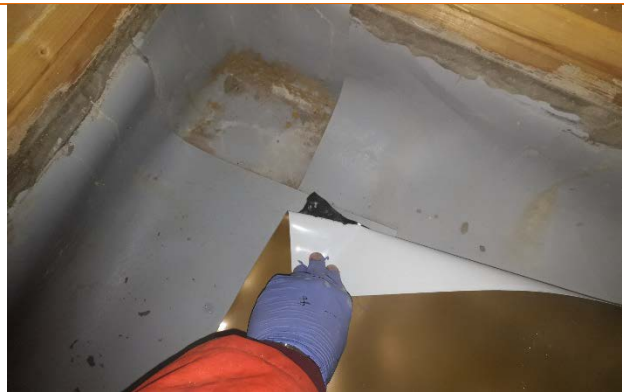
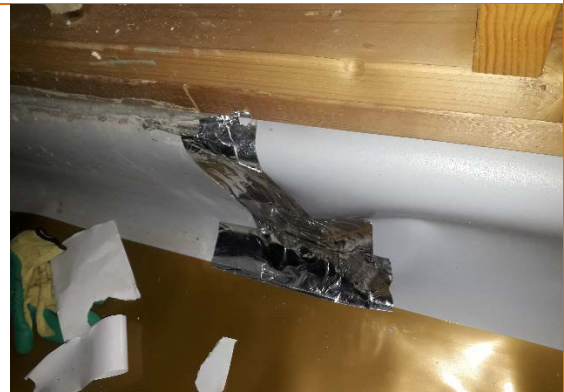
**Verification of Service Penetrations-Good Condition**

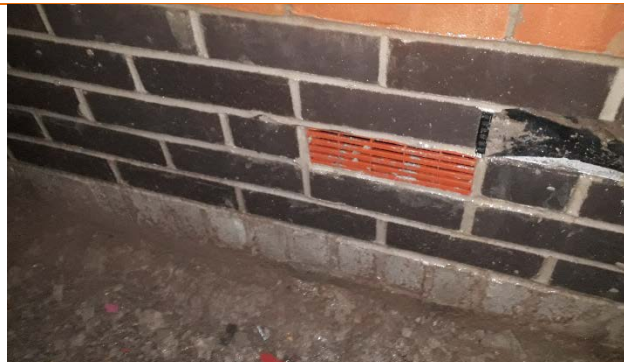
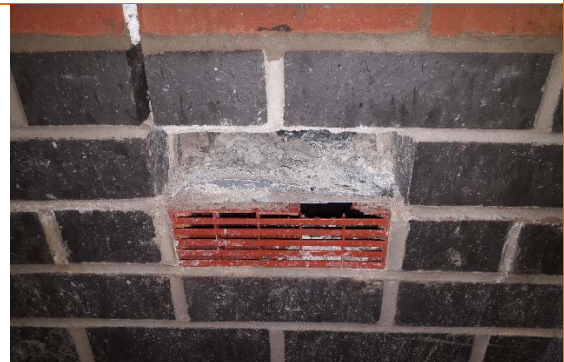
**Verification of Ventilation-Good Condition**

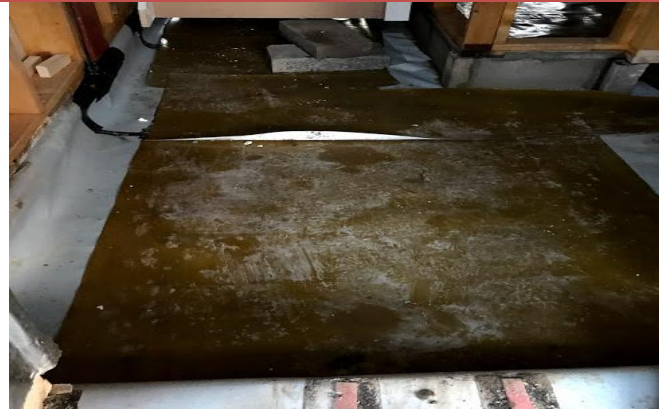
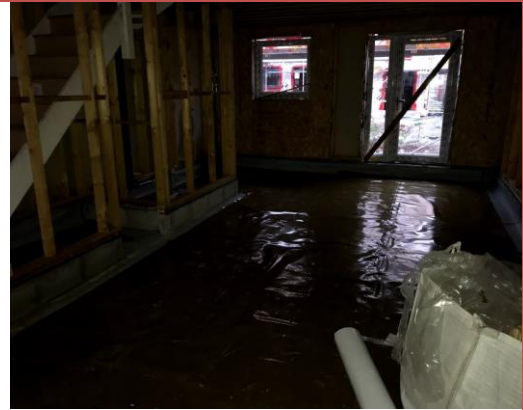
**Plot – 47**

**General Condition of Membrane-Good Condition**

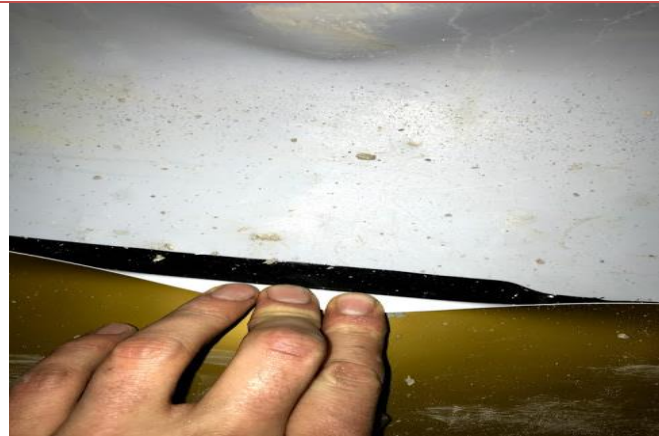
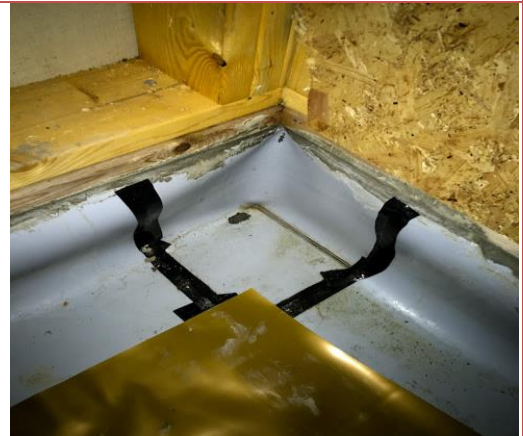
**Verification of Joints and Seals-Good Condition**

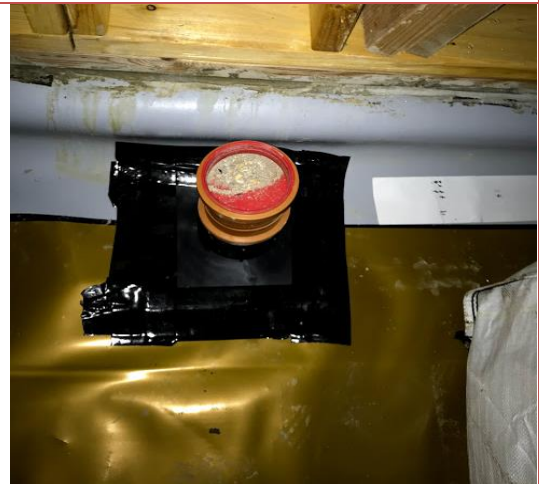
**Verification of Service Penetrations-Good Condition**

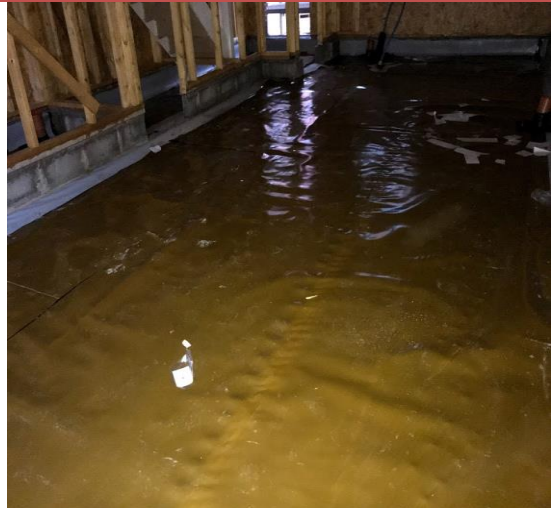
**Plot - 50**

**General Condition of Membrane-Good Condition**

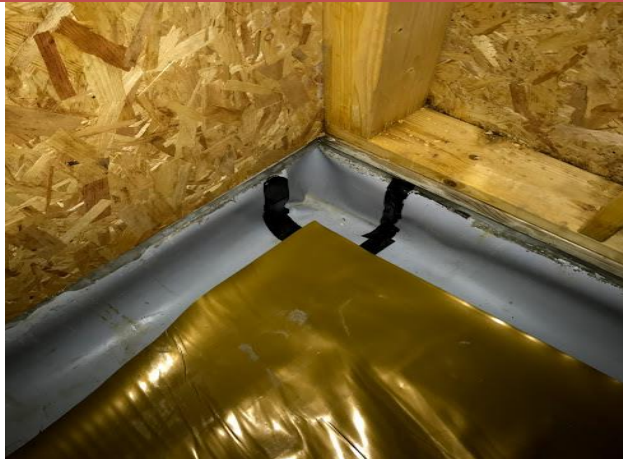
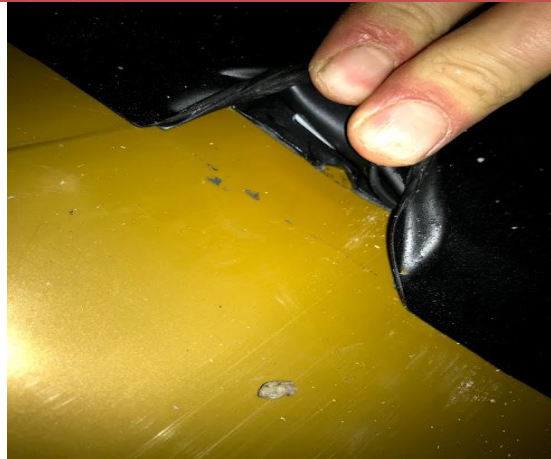
**Verification of Joints and Seals-Good Condition**

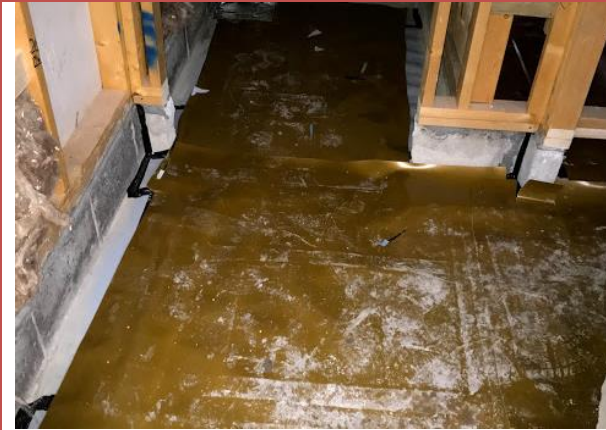
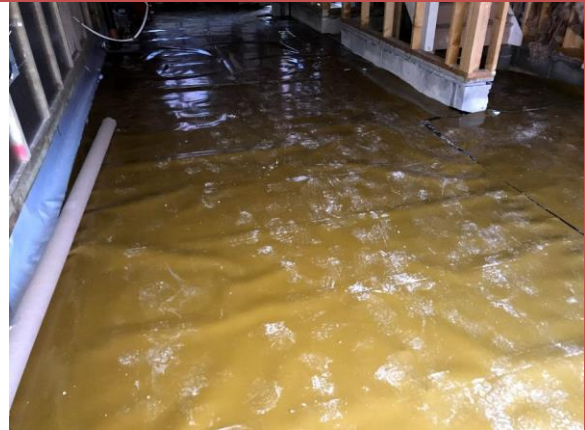
**Plot - 51**

**General Condition of Membrane-Good Condition**

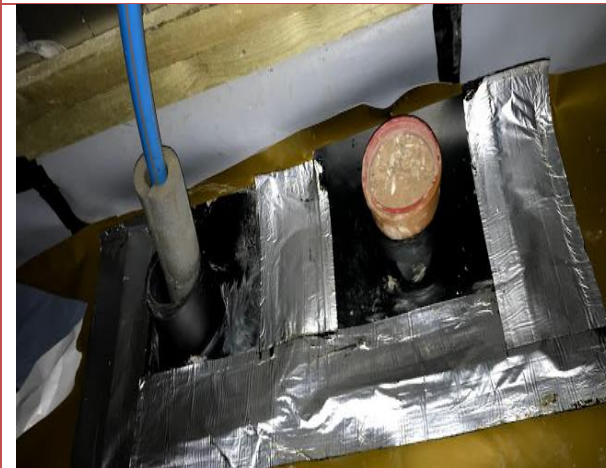
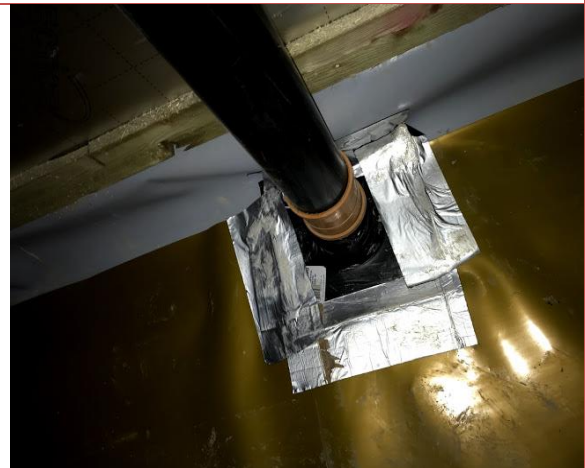
**Verification of Service Penetrations-Good Condition**

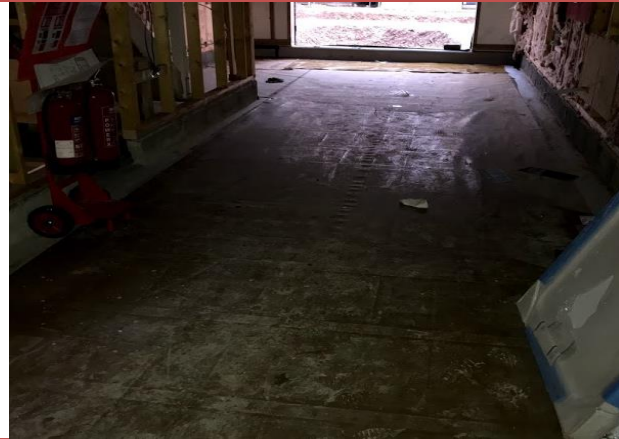
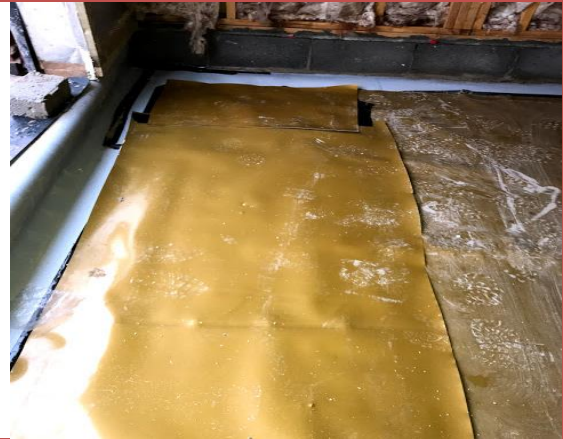
**Plot - 52**

**General Condition of Membrane-Good Condition**

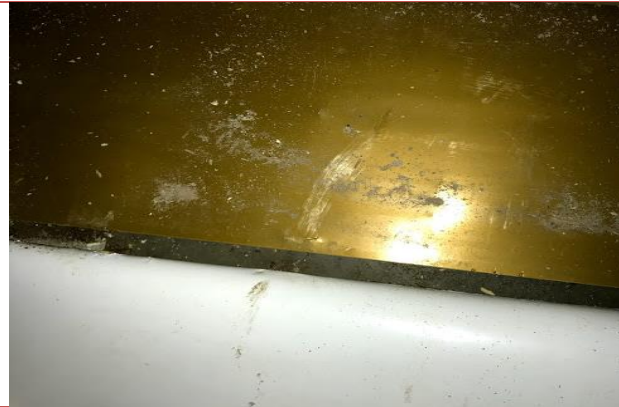
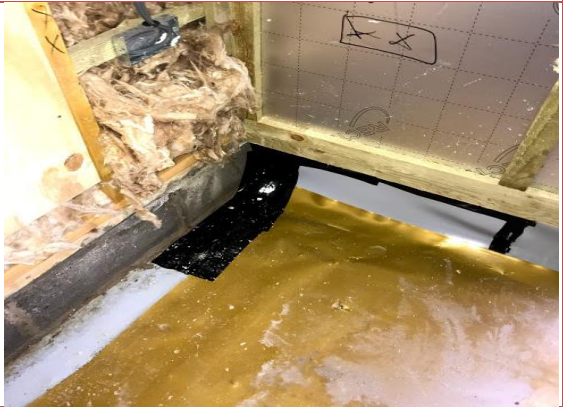
**Verification of Joints and Seals-Good Condition**

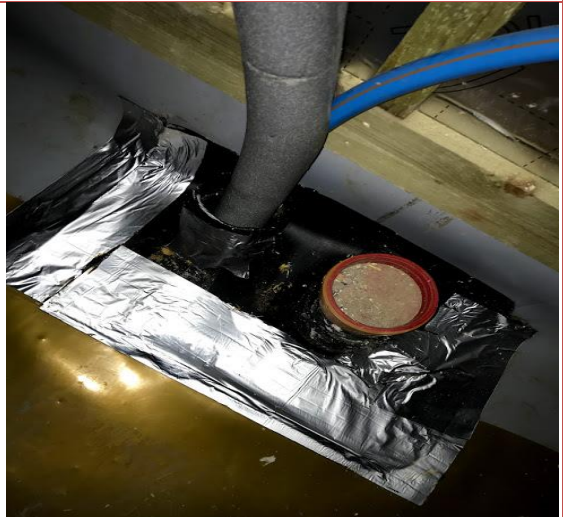
**Verification of Service Penetrations-Good Condition**
