Validation Completion Report  
Plots 1-54  
Bowes Street, Manchester

Reference:11-813-R5-2  
Date: May 2022

Plots 1-54  
Former Stagecoach Bus Depot  
Land off Bowes Street  
Manchester

Prepared for:  
**Rowlinson Construction**

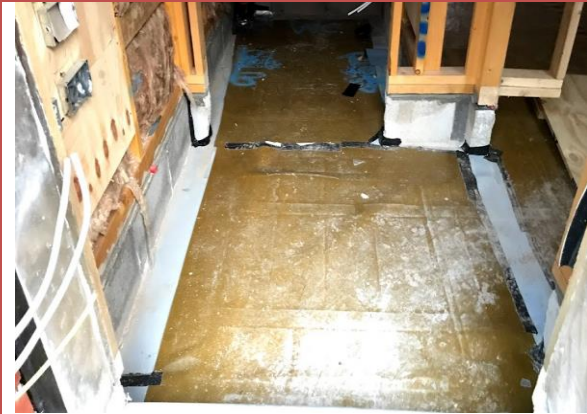
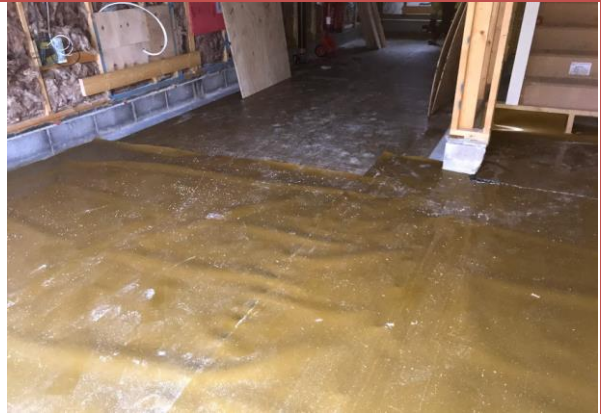
**Plot - 53**

**General Condition of Membrane-Good Condition**

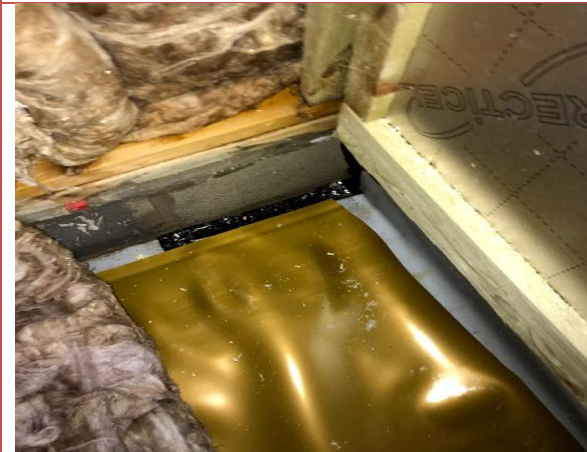
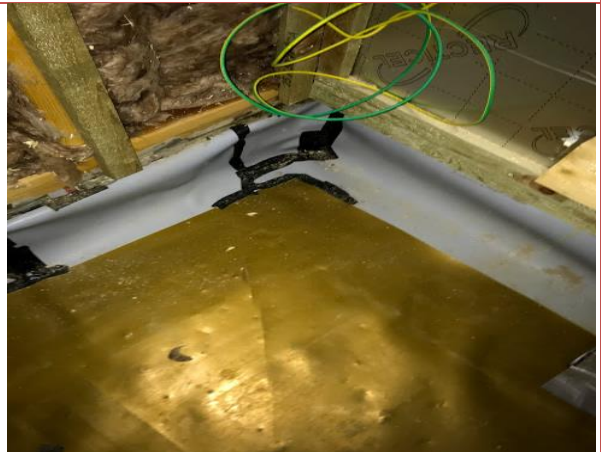
**Verification of Joints and Seals-Good Condition**

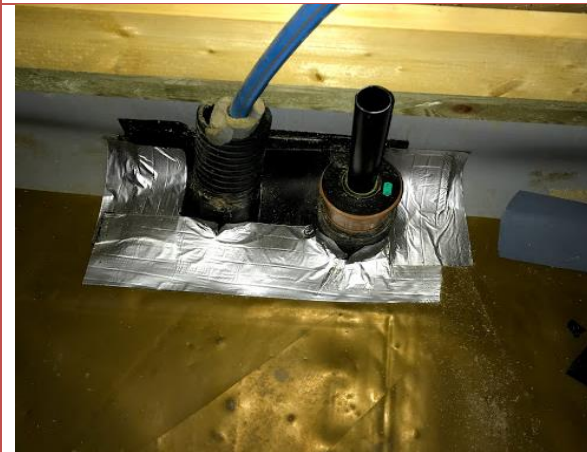
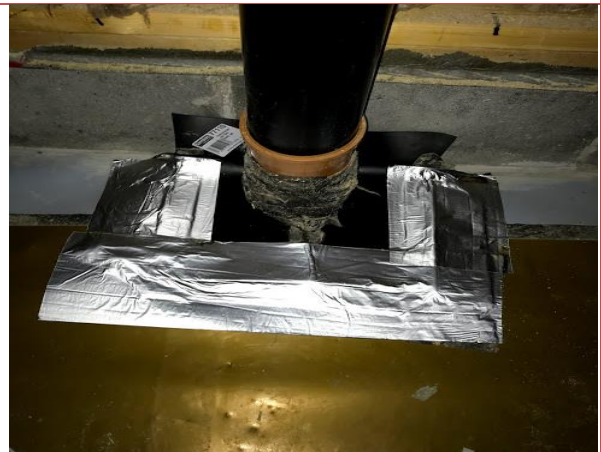
**Verification of Service Penetrations-Good Condition**

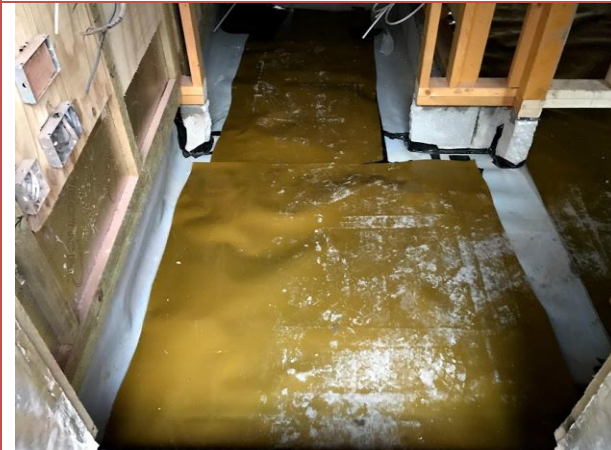
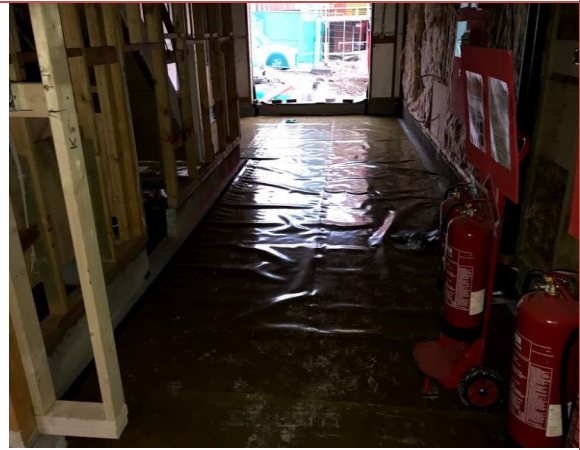
**Plot - 54**

**General Condition of Membrane-Good Condition**

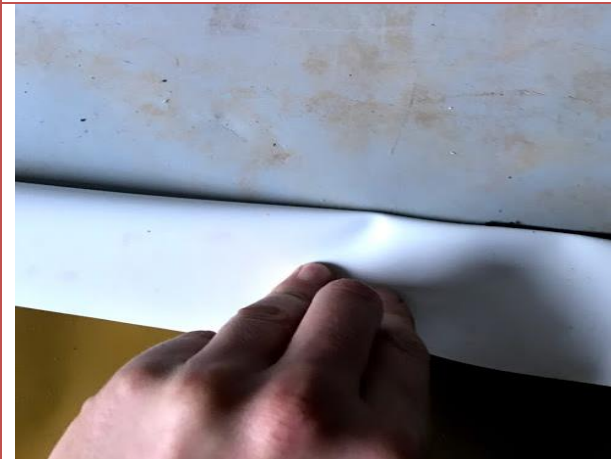
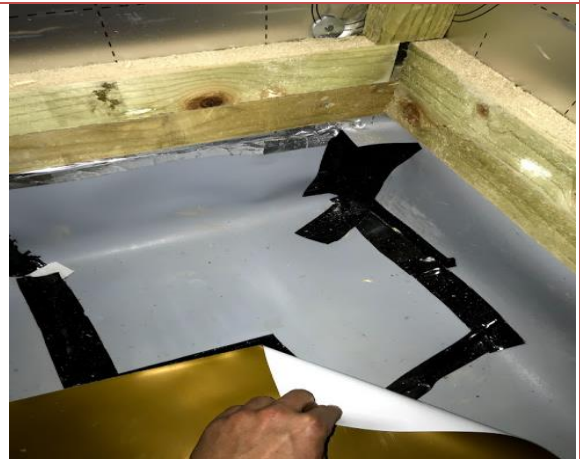
**Verification of Joints and Seals-Good Condition**

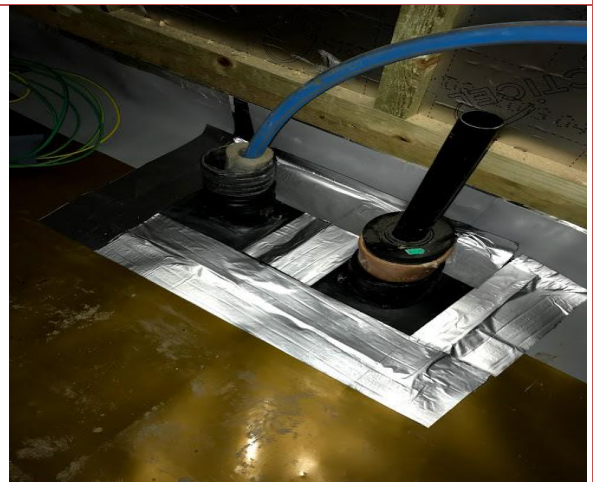
**Verification of Service Penetrations-Good Condition**
