Heritage defect repair specification and methodology

1-3 Back Turner Street,  
Manchester M4 1FR

Date: 02 February 2021

Reference: 91420/38/JPC/LAP

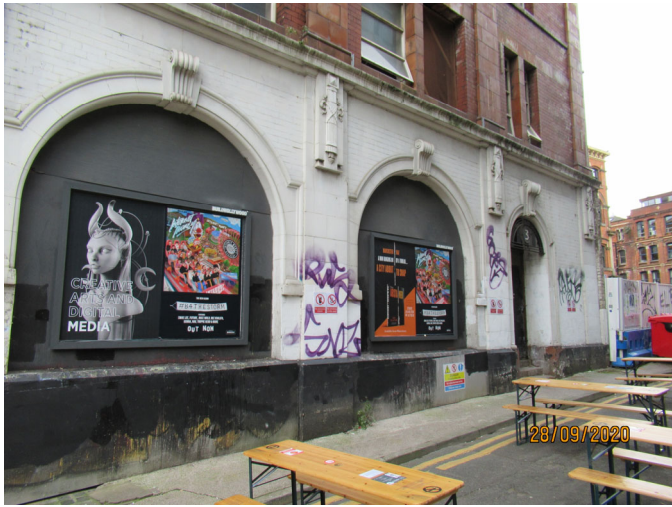
| 1. | Typical view of the Back Turner Street elevation. | <p>28/09/2020</p> |

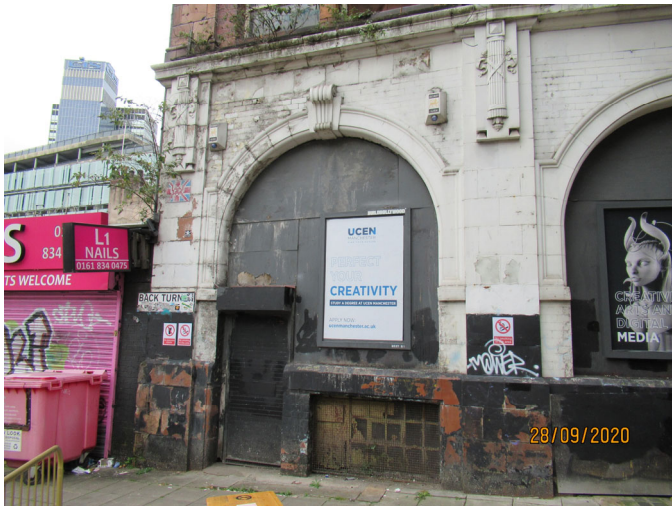
| 2. | Typical view of the Back Turner Street elevation. | <p>28/09/2020</p> |

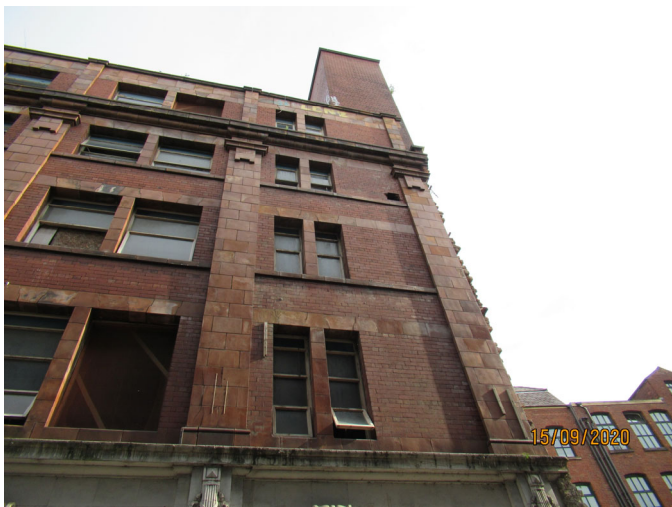
| 3. | Typical view of the front elevation, stone pilasters and missing windows. | <p>15/09/2020</p> |

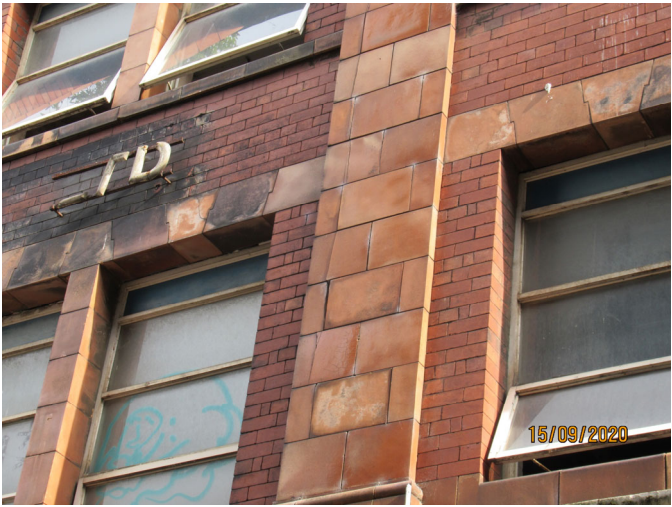
| 7. | View of historic signage fixings to front elevation. | |

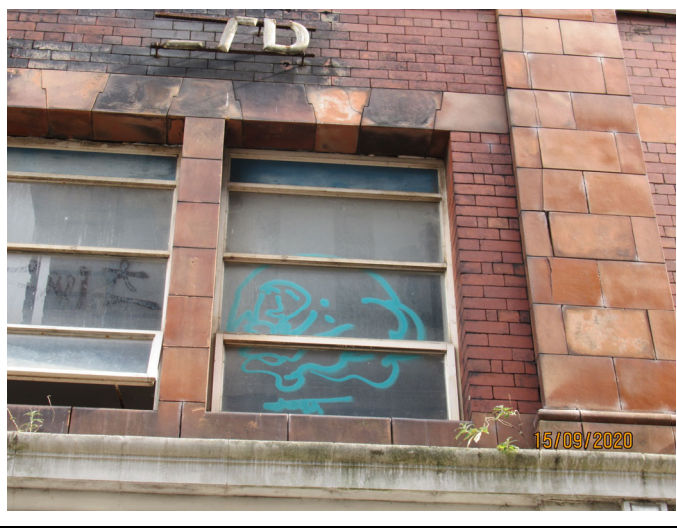
| 20. | Typical view of modern retrofitted timber window to front elevation. | <p>A photograph showing a close-up of a modern retrofitted timber window set into a brick wall. The window frame is made of dark wood and shows signs of wear and cracking. The glass is multi-paned and has some blue graffiti on it. The surrounding brickwork is red and shows some weathering. A date stamp '15/09/2020' is visible in the bottom right corner of the image.</p> |

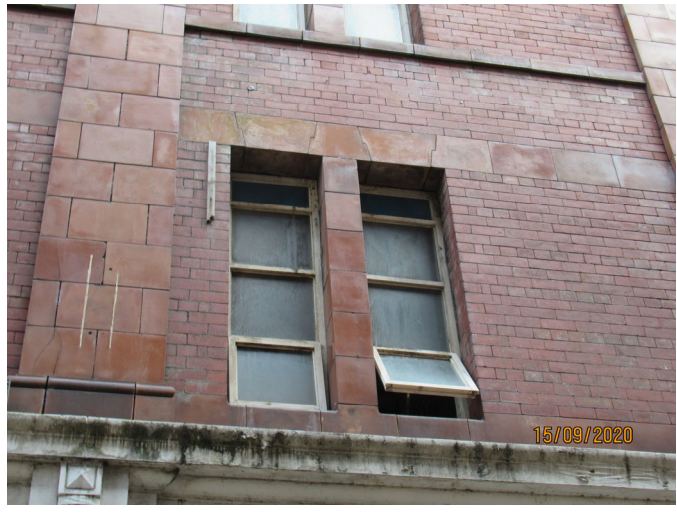
| 21. | Typical view of modern retrofitted timber window to front elevation. | <p>A photograph showing a close-up of a modern retrofitted timber window set into a brick wall. The window frame is made of dark wood and shows signs of wear and cracking. The glass is multi-paned and has some blue graffiti on it. The surrounding brickwork is red and shows some weathering. A date stamp '15/09/2020' is visible in the bottom right corner of the image.</p> |

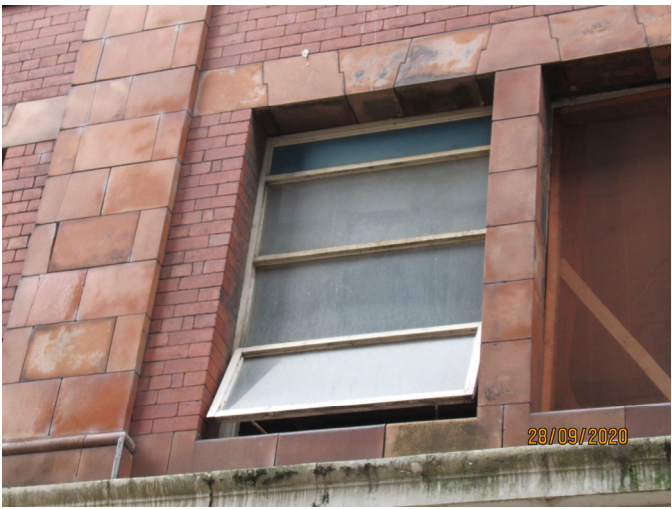
| 22. | Typical view of modern retrofitted timber window to front elevation. | |

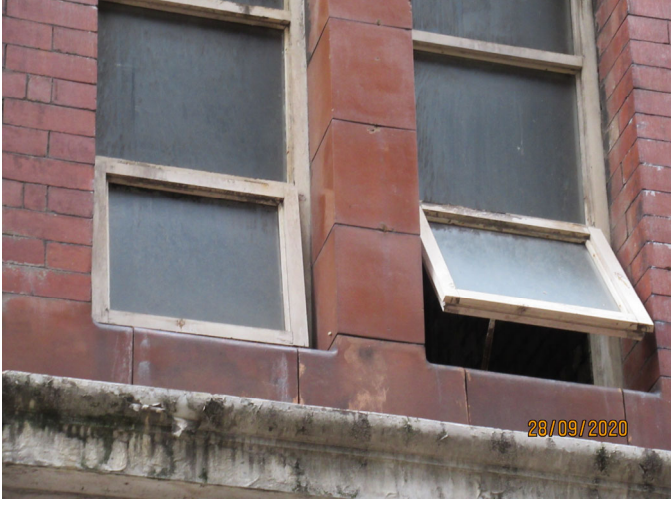
| 23. | Typical view of modern retrofitted timber window to front elevation. | |

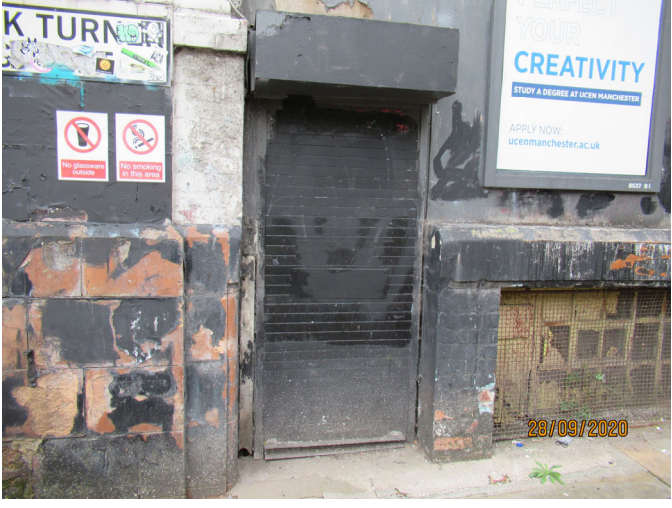
| 26. | Typical view of roller shutter door to entrance door. | |

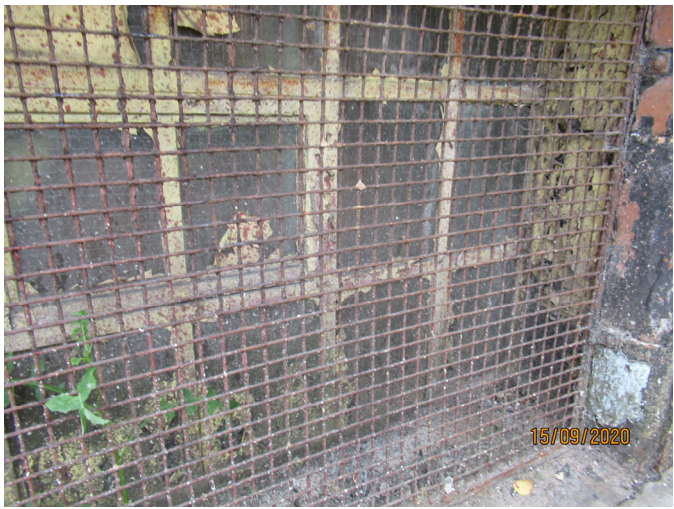
| 28. | Typical view of painted basement windows. | |

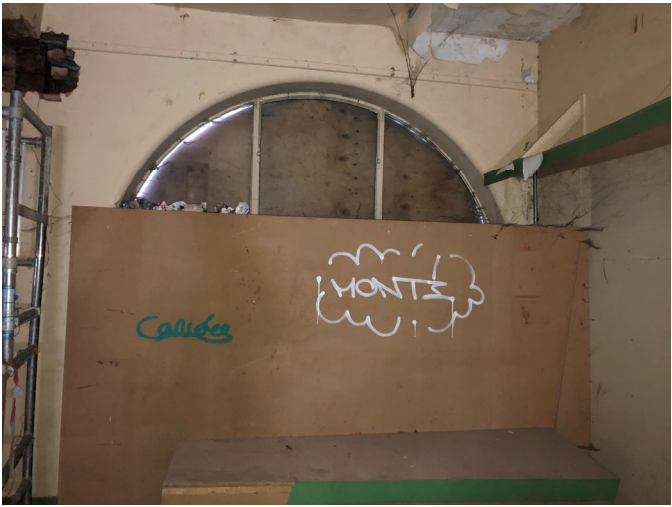
| 34. | Typical view of assumed original metal fan light window. | |

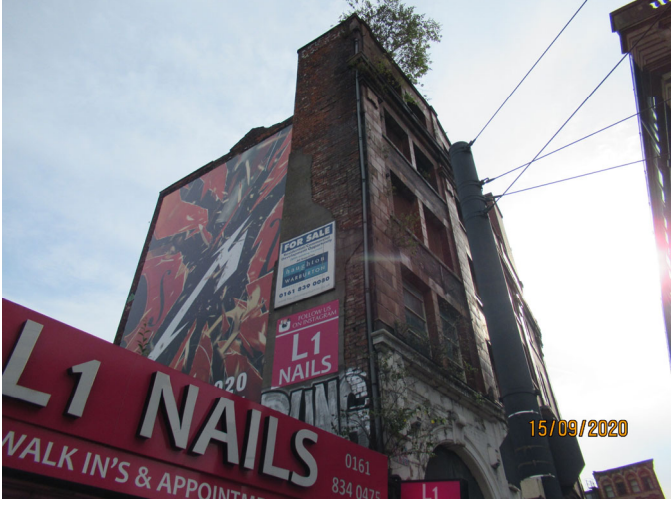
| 35. | General view of Shudehill elevation. | |

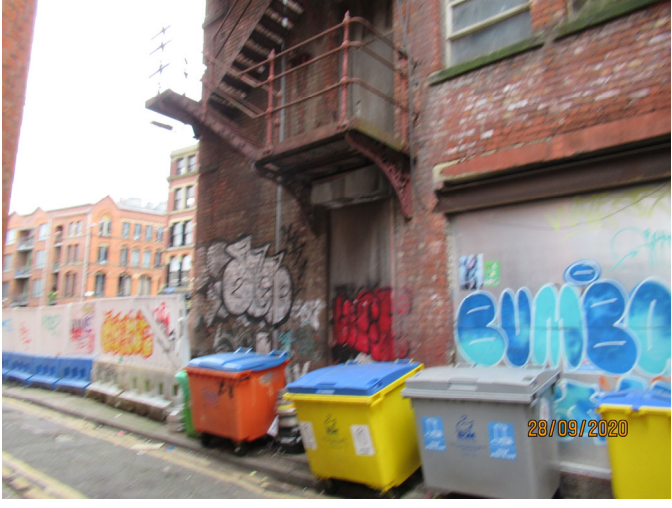
| 38. | General view of Soap Street elevation. | |

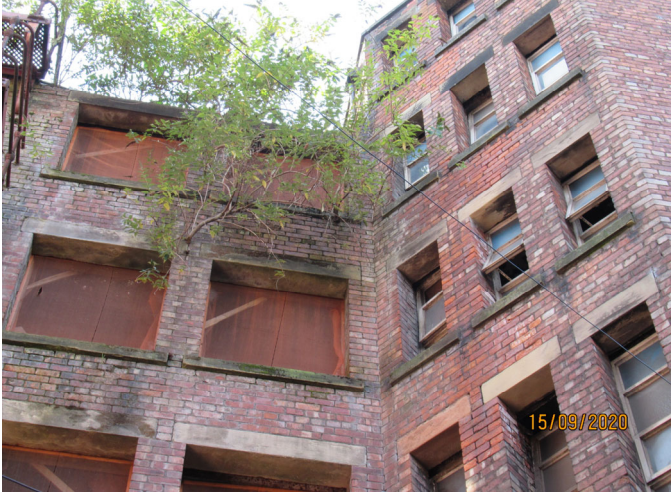
| 39. | General view of Soap Street elevation. | |

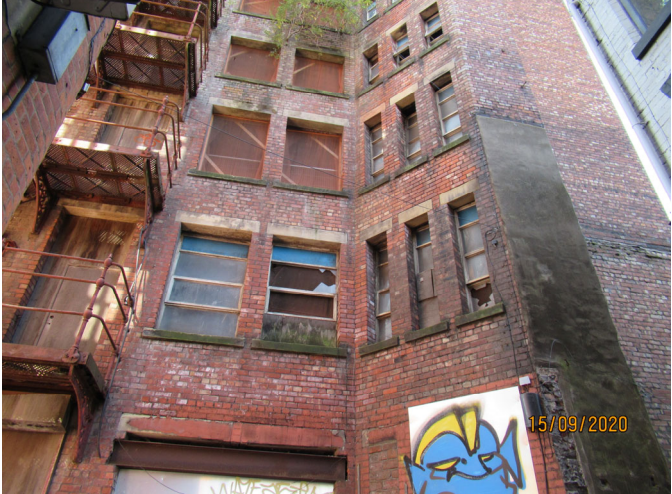
| 45. | General view of modern retrofitted windows to rear elevation. | |

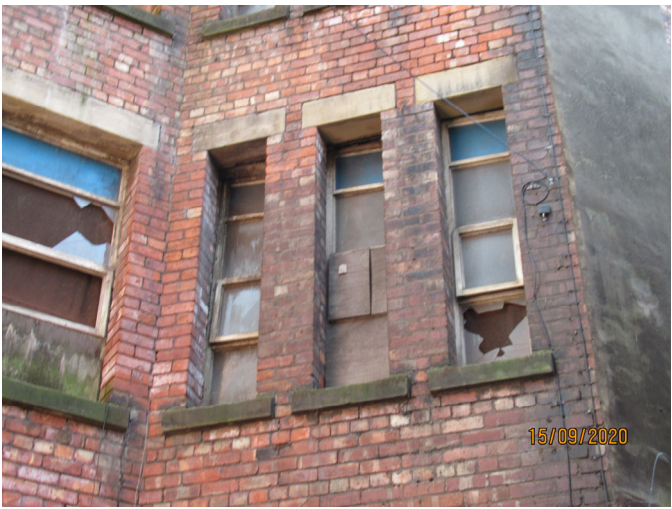
| 46. | Typical view of modern retrofitted windows to rear elevation. | <p>A close-up photograph of a brick wall featuring three modern, narrow, vertical windows. The windows are set within concrete frames. The brickwork is a mix of red and brown tones. A date stamp '15/09/2020' is visible in the bottom right corner of the image.</p> |

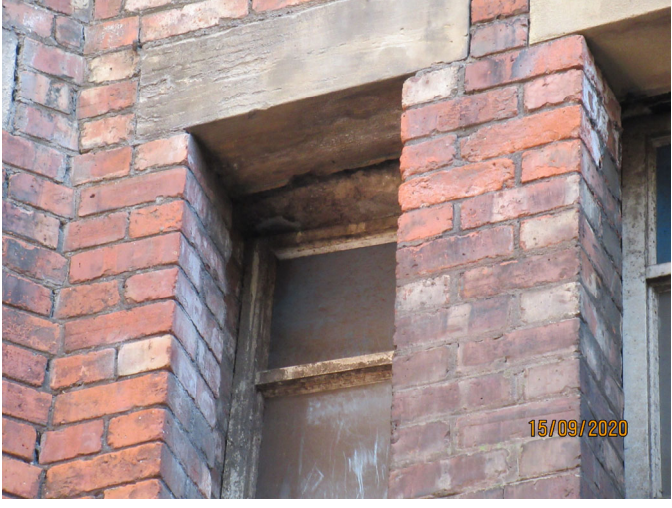
| 47. | Typical view of modern retrofitted windows to rear elevation. | <p>A close-up photograph of a brick wall featuring a modern, narrow, vertical window. The window is set within a concrete frame. The brickwork is a mix of red and brown tones. A date stamp '15/09/2020' is visible in the bottom right corner of the image.</p> |

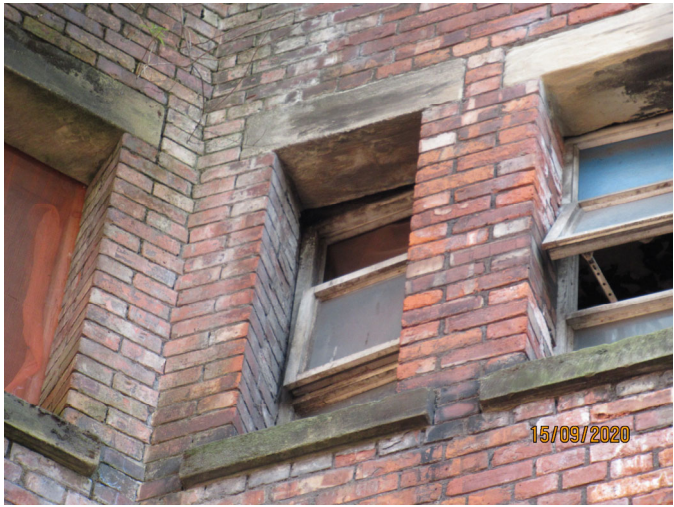
| 49. | Typical view of modern retrofitted windows to rear elevation. | |

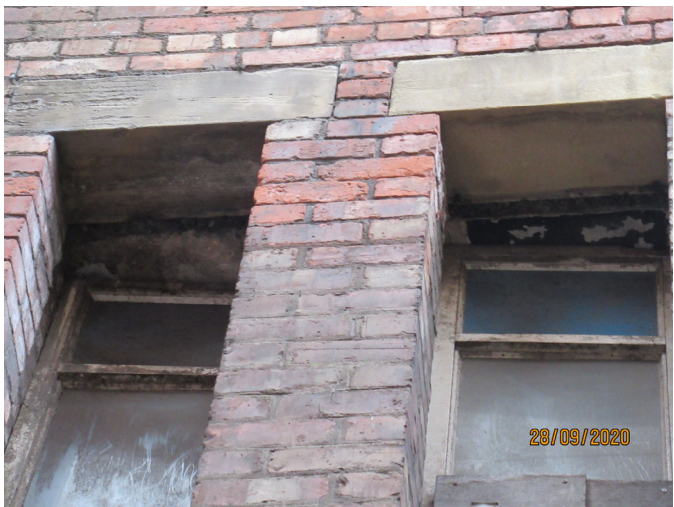
| 51. | Typical view of modern retrofitted windows to rear elevation. | |
