# **Hexagon Tower**

Deterioration of Cladding  
Pre-planning Report

March 2021

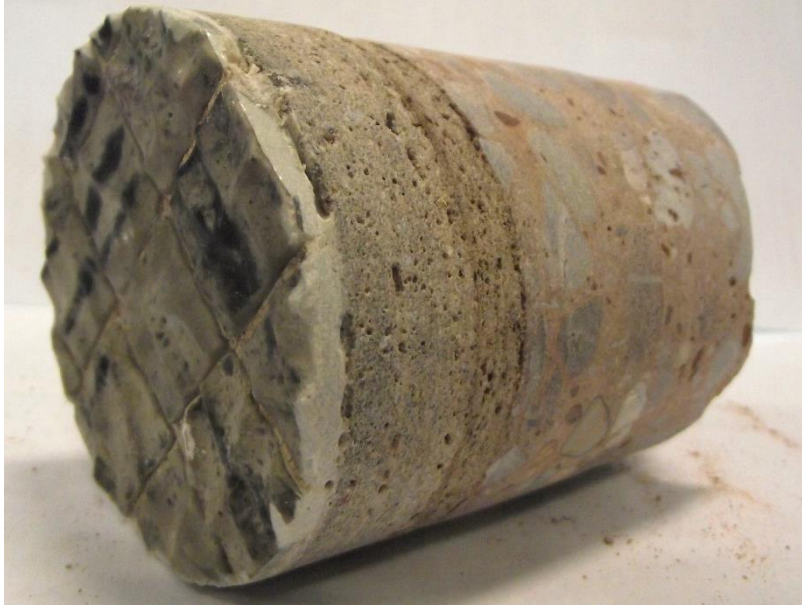
An additional photograph is included in Figure 2.2 which shows that the mosaic tile surface of the cladding is not formed from individual 'mini-mosaics' but rather comprises a sheet of material. It can also be seen that porosity often exists at the grout-bedding render interface.

**Figure 2.2: Additional core photograph showing the form of the cladding**
