Invek Surveys Ltd

Green End Development

03 December 2019

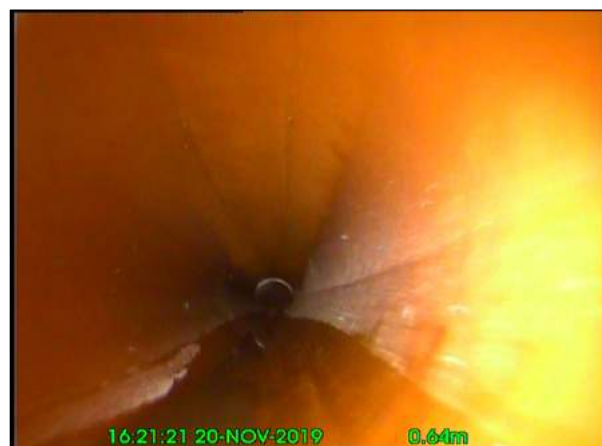
Photo: 3\_3A  
 0.65m, Clear water level, 5% of the vertical dimension

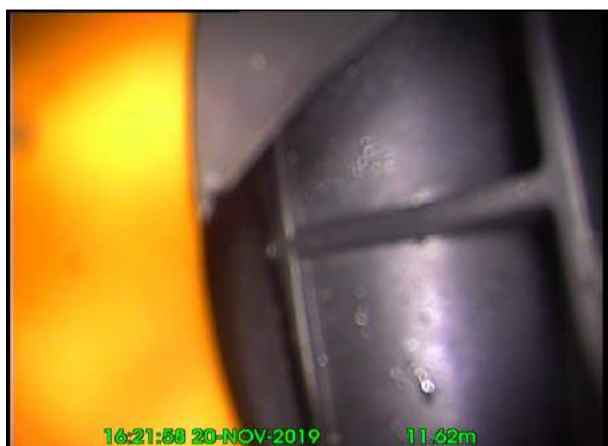
Photo: 3\_6A

11.8m, Finish node type, other special chamber reference  
number: Tank Remarks: Tank

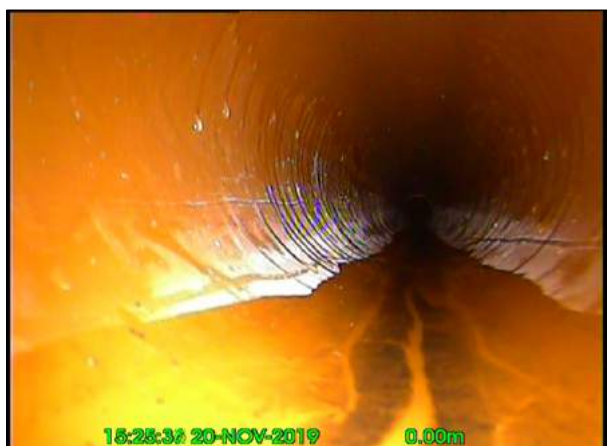
Photo: 4\_2A  
 0m, Clear water level, 5% of the vertical dimension

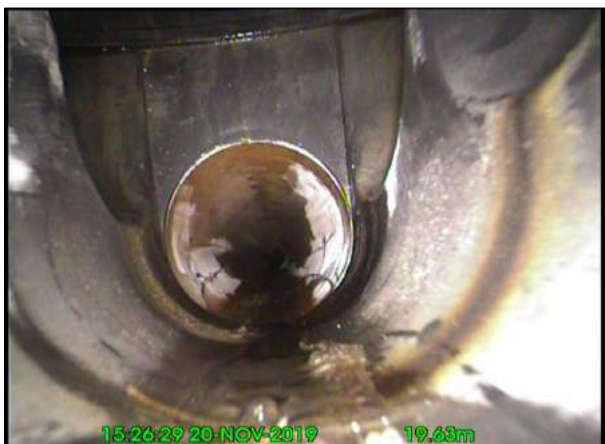
Photo: 4\_6A

19.6m, Finish node type, manhole reference number: S10

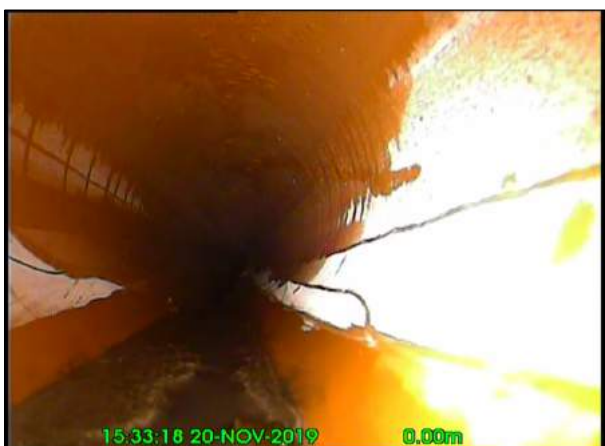
Photo: 6\_2A  
 0m, Turbid water level, 10% of the vertical dimension

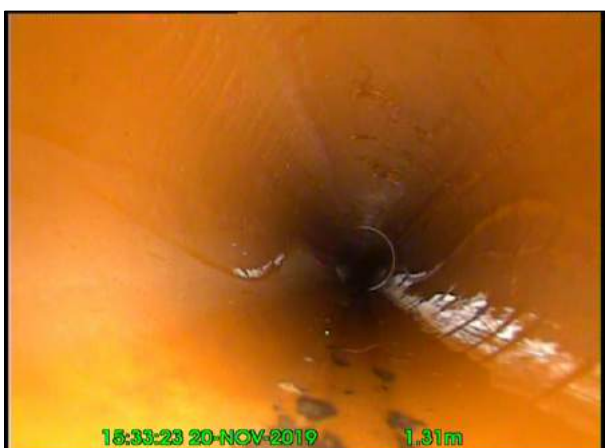
Photo: 6\_4A  
 1.3m, Clear water level, 5% of the vertical dimension

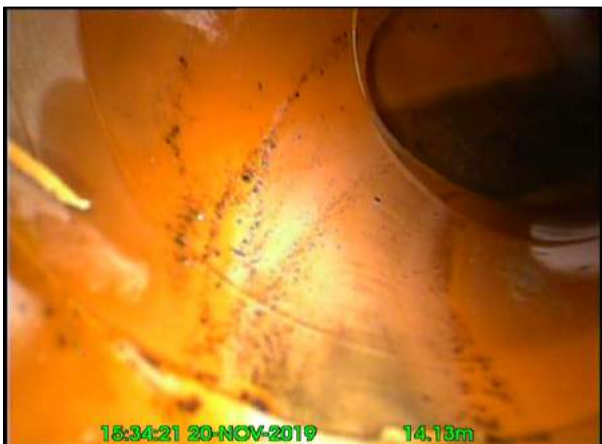
Photo: 6\_10A  
 14.2m, Line deviates right

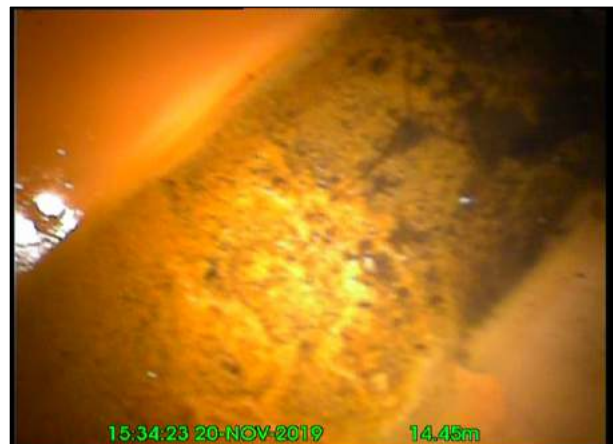
Photo: 6\_11A  
 14.5m, Finish node type, major connection without manhole  
 reference number: Junction

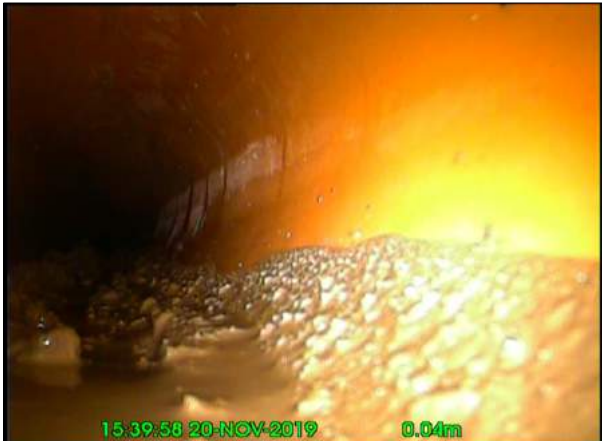
Photo: 7\_2A  
 0m, Turbid water level, 5% of the vertical dimension

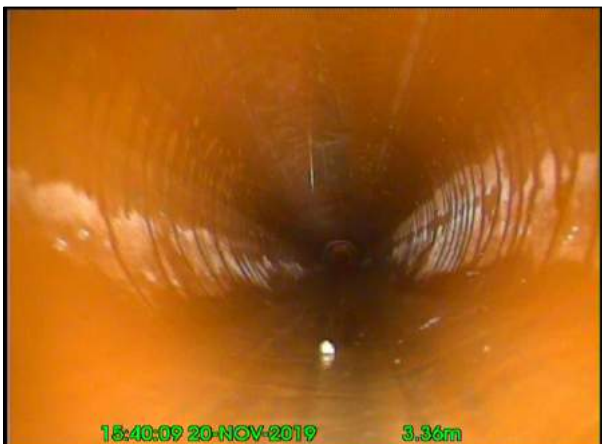
Photo: 7\_5A  
 3.36m, Water level, 0% of the vertical dimension

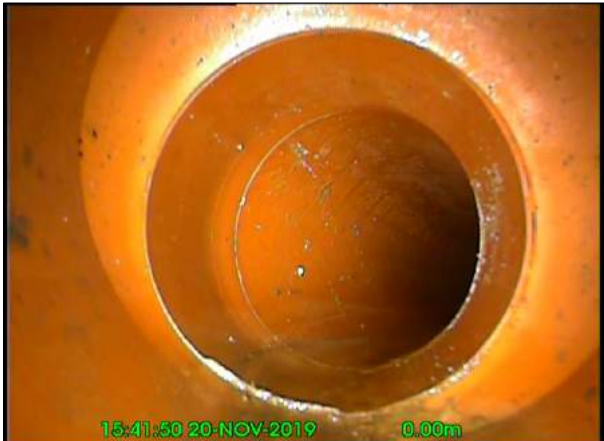
Photo: 8\_2A  
0m, Clear water level, 5% of the vertical dimension

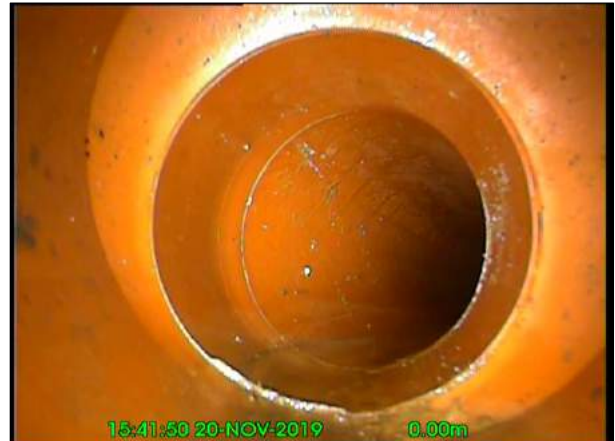
Photo: 8\_3A  
0.3m, Shape changes to circular, 100mm high

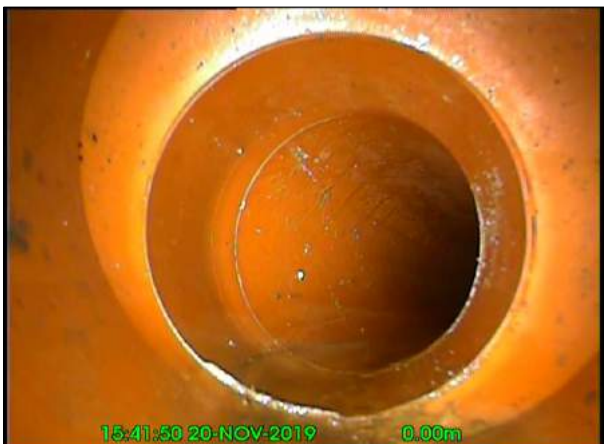
Photo: 8\_4A  
0.3m, Line deviates right

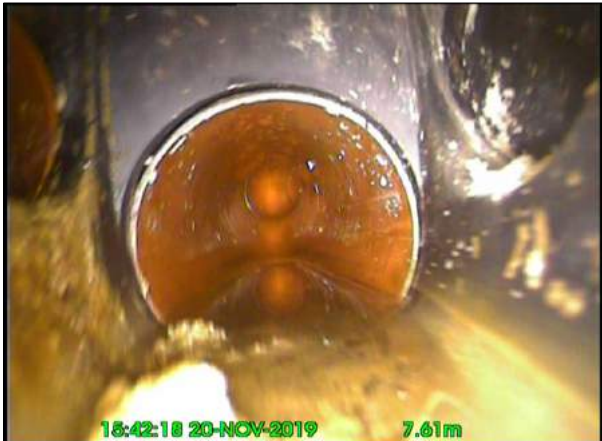
Photo: 8\_6A

7.6m, Finish node type, manhole reference number: S12

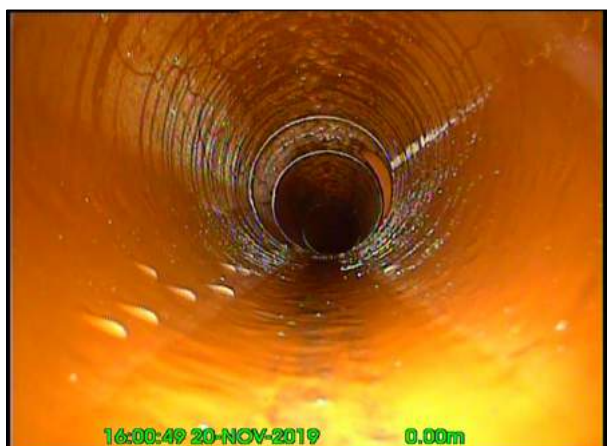
Photo: 9\_2A  
 0m, Clear water level, 5% of the vertical dimension

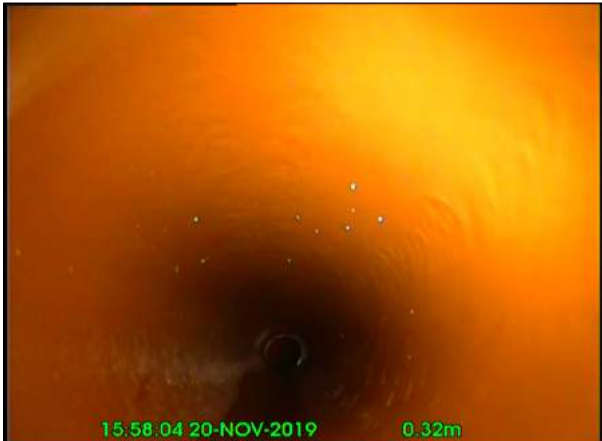
Photo: 10\_2A  
 0m, Clear water level, 5% of the vertical dimension

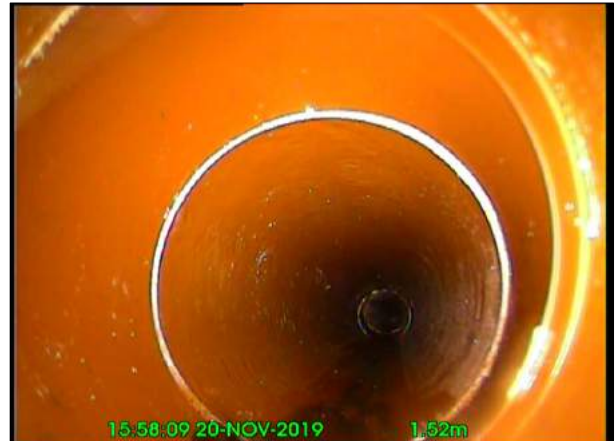
Photo: 10\_3A  
 1.6m, Line deviates right

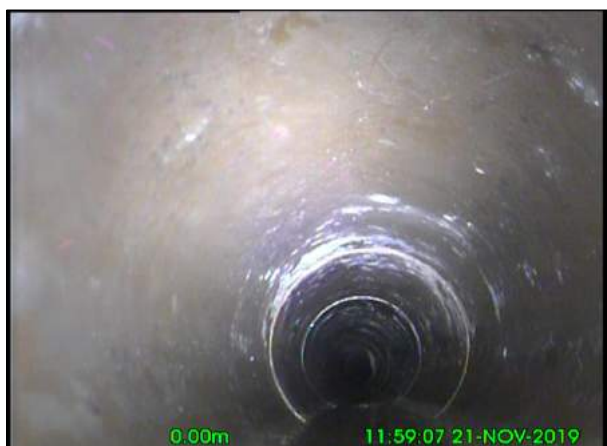
Photo: 11\_2A  
 0m, Turbid water level, 15% of the vertical dimension

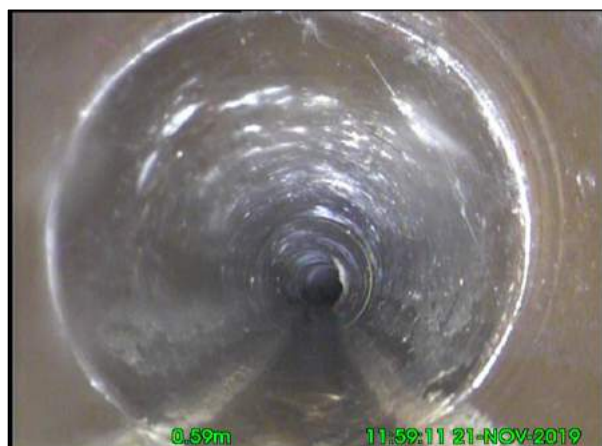
Photo: 11\_3A  
 0.6m, Clear water level, 10% of the vertical dimension

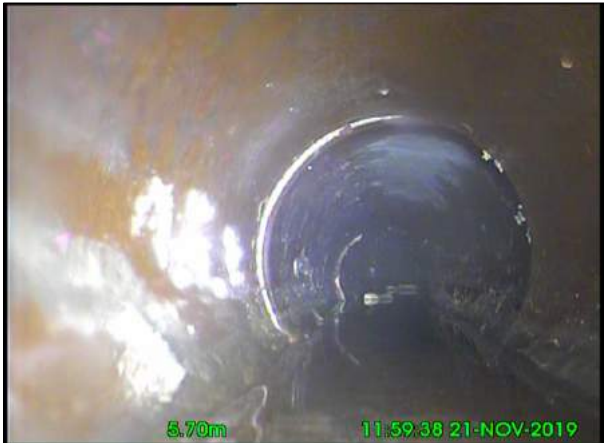
Photo: 11\_6A  
 5.7m, Clear water level, 15% of the vertical dimension

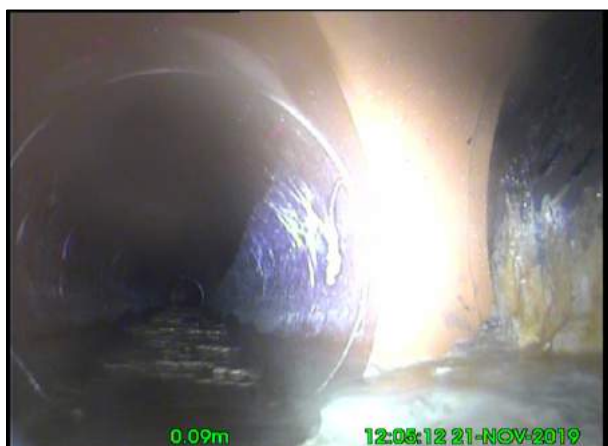
Photo: 12\_2A  
 0m, Clear water level, 15% of the vertical dimension

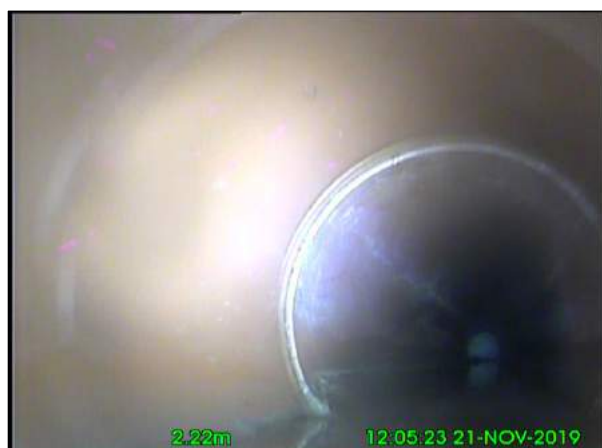
Photo: 12\_5A  
 2.3m, Line deviates right

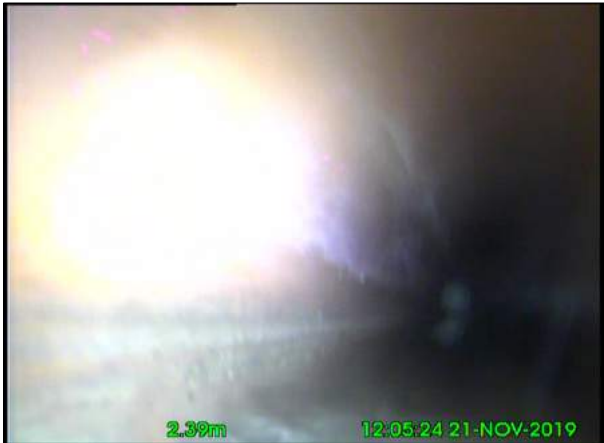
Photo: 12\_7A  
2.4m, Turbid water level, 20% of the vertical dimension

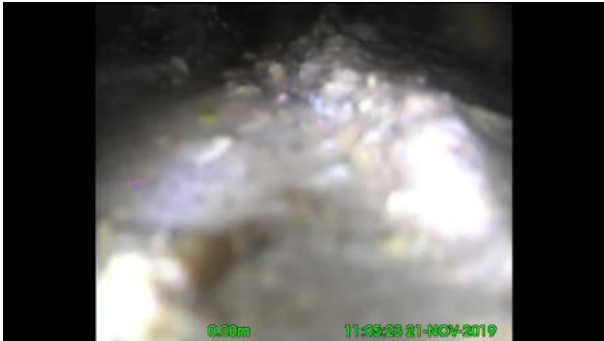
Photo: 13\_2A  
 0m, Turbid water level, 5% of the vertical dimension

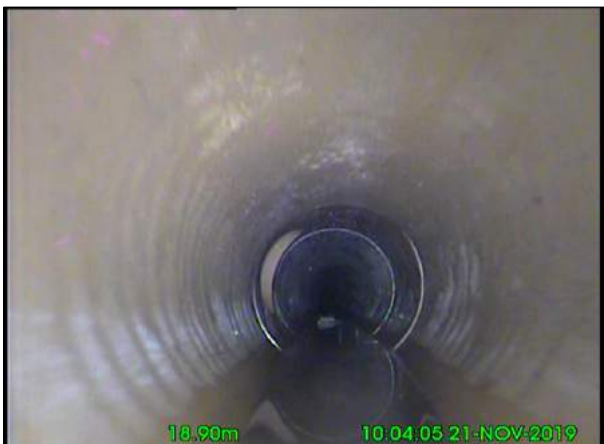
Photo: 15\_9A  
 18.9m, Turbid water level, 10% of the vertical dimension

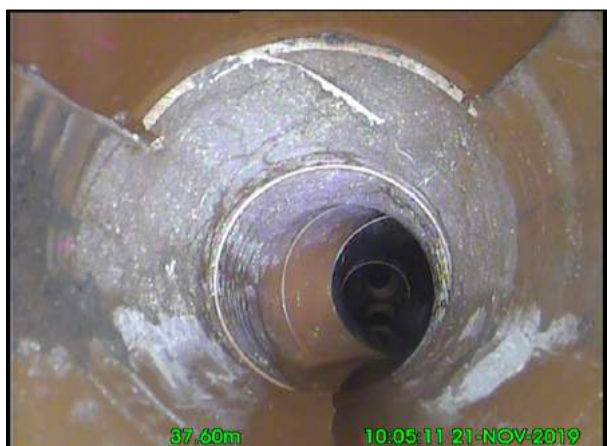
Photo: 15\_21A

38m, Survey abandoned Remarks: Survey stopped here

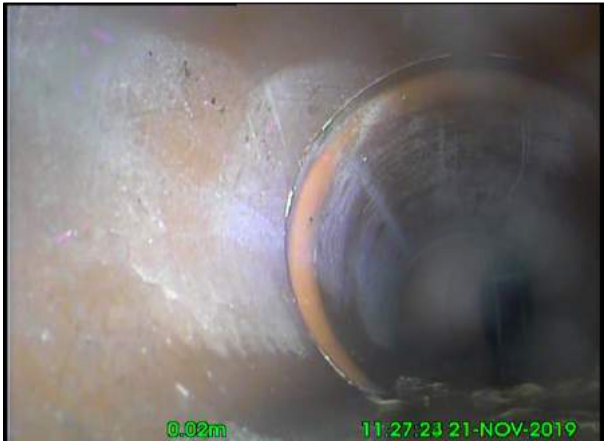
Photo: 18\_2A  
0m, Clear water level, 10% of the vertical dimension

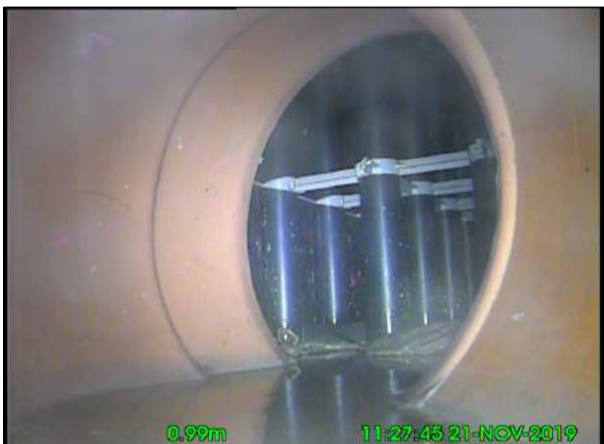
Photo: 18\_4A  
1.3m, Line deviates right

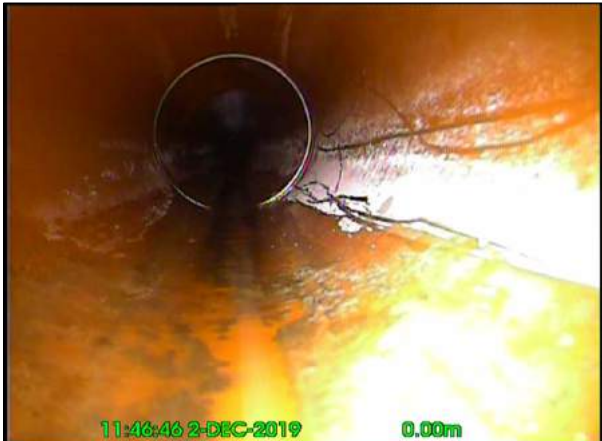
Photo: 19\_2A  
 0m, Clear water level, 5% of the vertical dimension

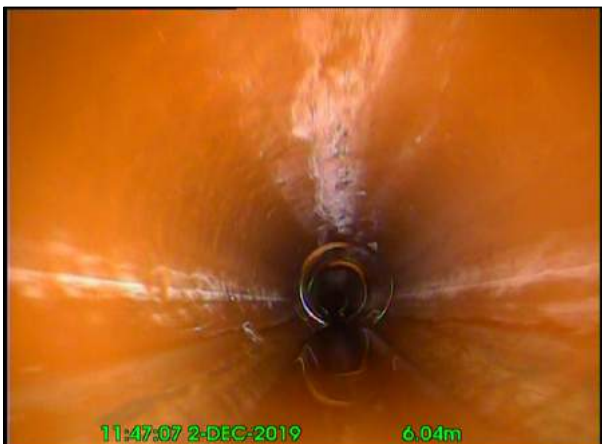
Photo: 19\_4A  
 6.05m, Clear water level, 10% of the vertical dimension

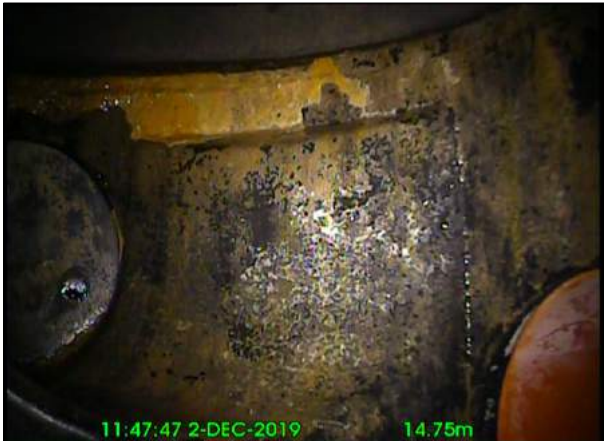
Photo: 19\_10A

14.7m, Finish node type, manhole reference number: S05

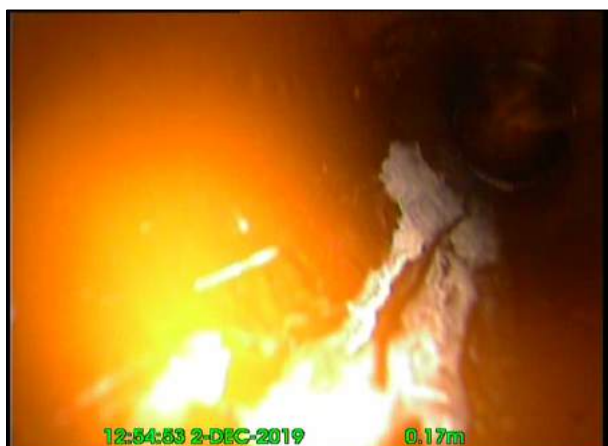
Photo: 21\_2A  
 0m, Clear water level, 5% of the vertical dimension

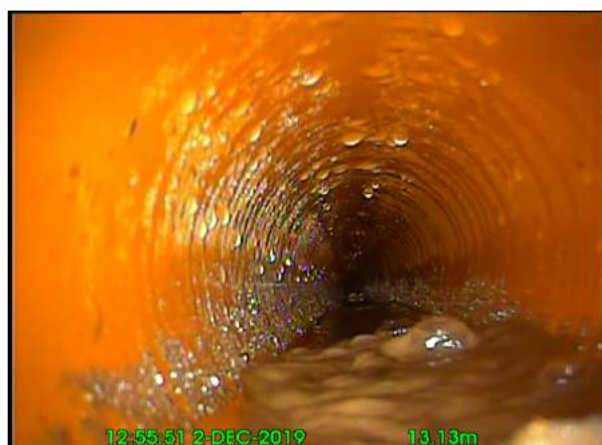
Photo: 21\_8A  
 13.2m, Settled deposits, fine, 10% cross-sectional area loss

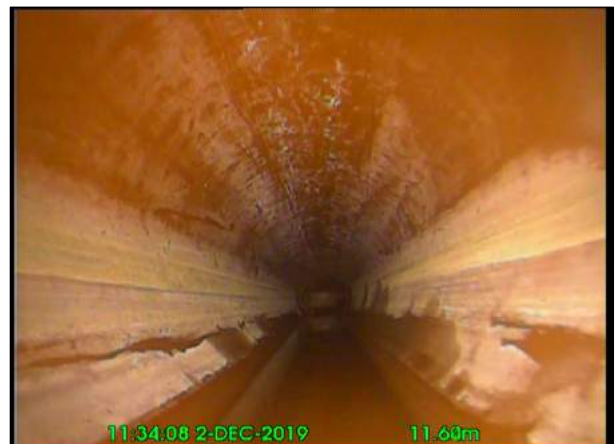
Photo: 22\_5A  
 11.6m, Clear water level, 10% of the vertical dimension

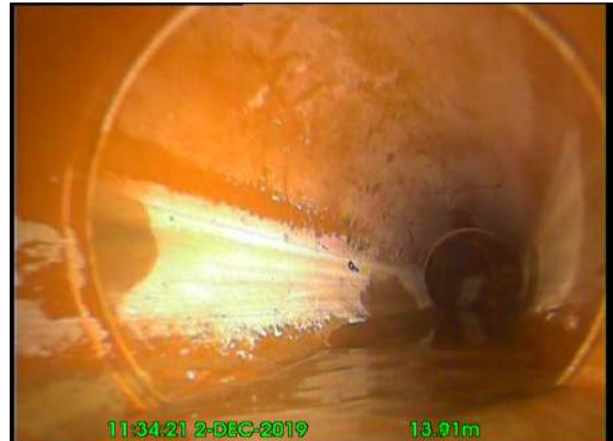
Photo: 22\_7A  
 13.9m, Line deviates right

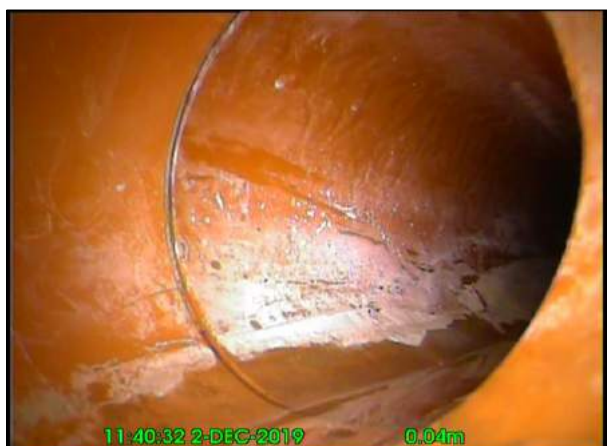
Photo: 23\_2A  
 0m, Clear water level, 5% of the vertical dimension

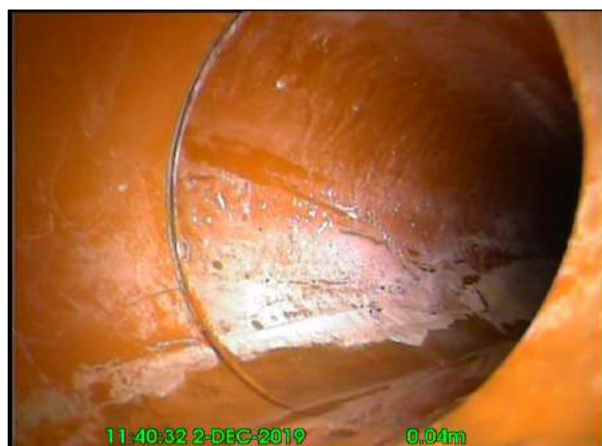
Photo: 23\_3A  
 0.2m, Line deviates right

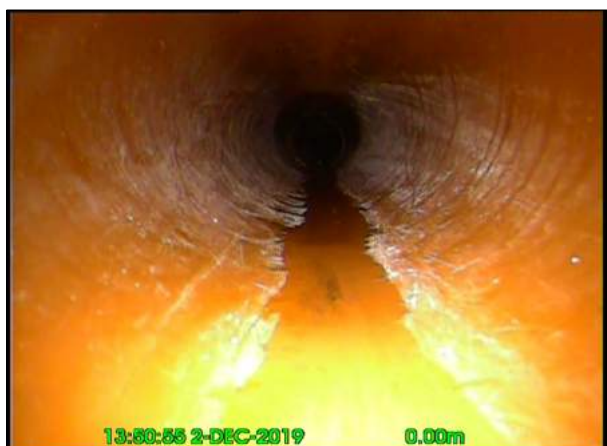
Photo: 24\_2A  
 0m, Clear water level, 5% of the vertical dimension

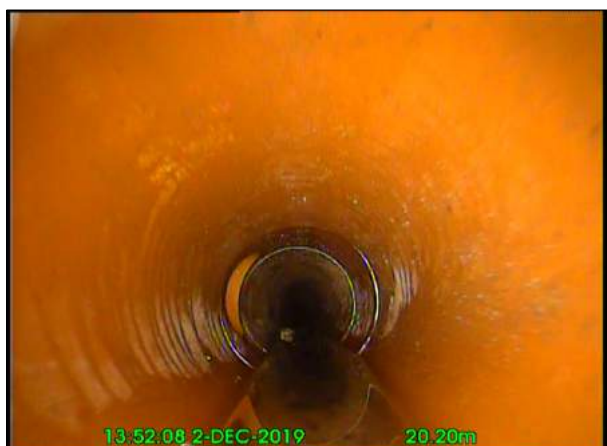
Photo: 24\_10A  
 20.2m, Clear water level, 10% of the vertical dimension

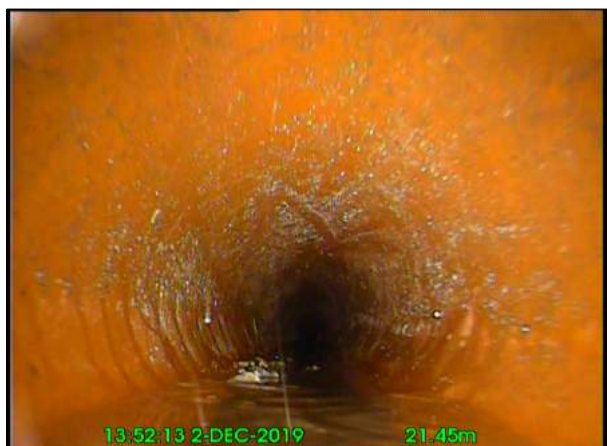
Photo: 24\_12A  
 21.45m, Clear water level, 20% of the vertical dimension

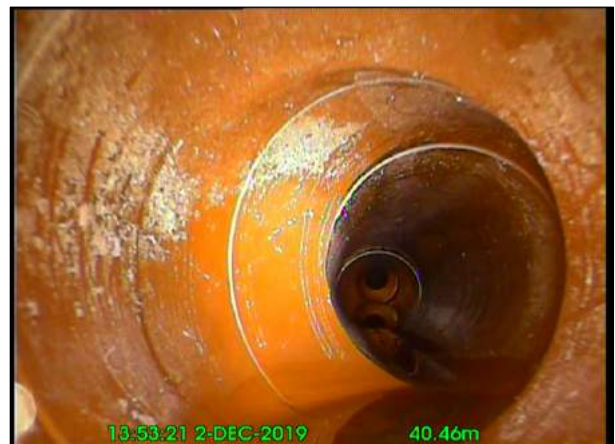
Photo: 24\_21A  
 40.6m, Line deviates right

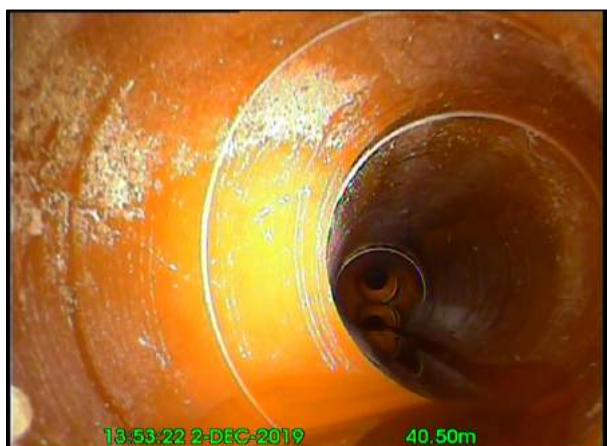
Photo: 24\_22A  
40.7m, Shape changes to circular, 100mm high

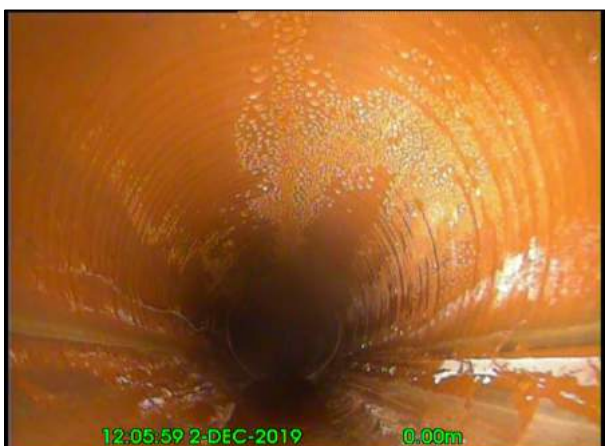
Photo: 25\_2A  
0m, Clear water level, 5% of the vertical dimension
