# Elizabeth Street, Cheetham Hill

## Phase 4 Validation Report

**Curtins Ref: 080139-CUR-XX-XX-T-GE-00006**

Site Address: Land off Elizabeth Street, Cheetham Hill, Manchester, M8 8BB

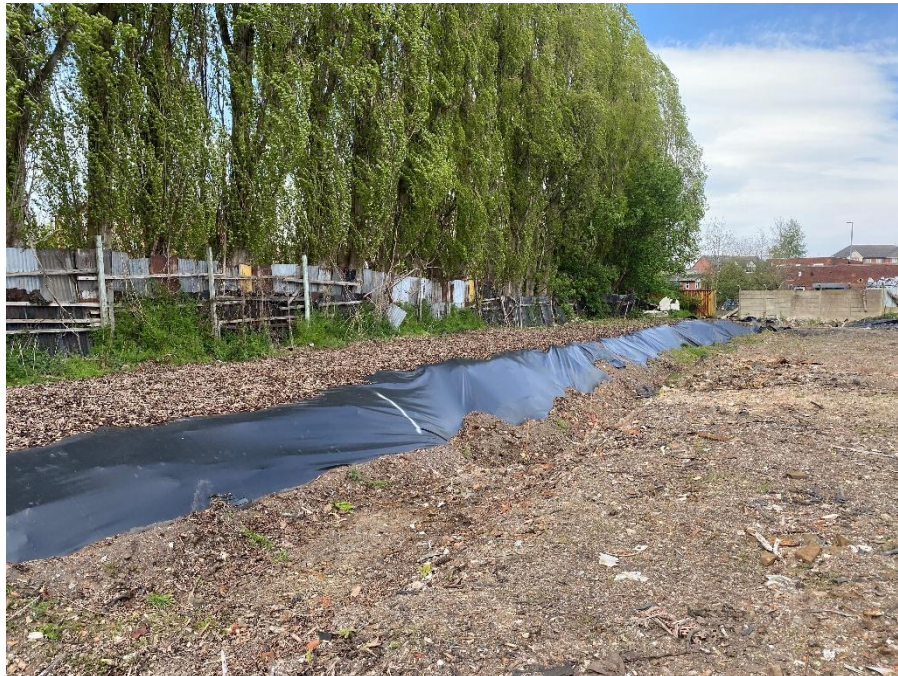
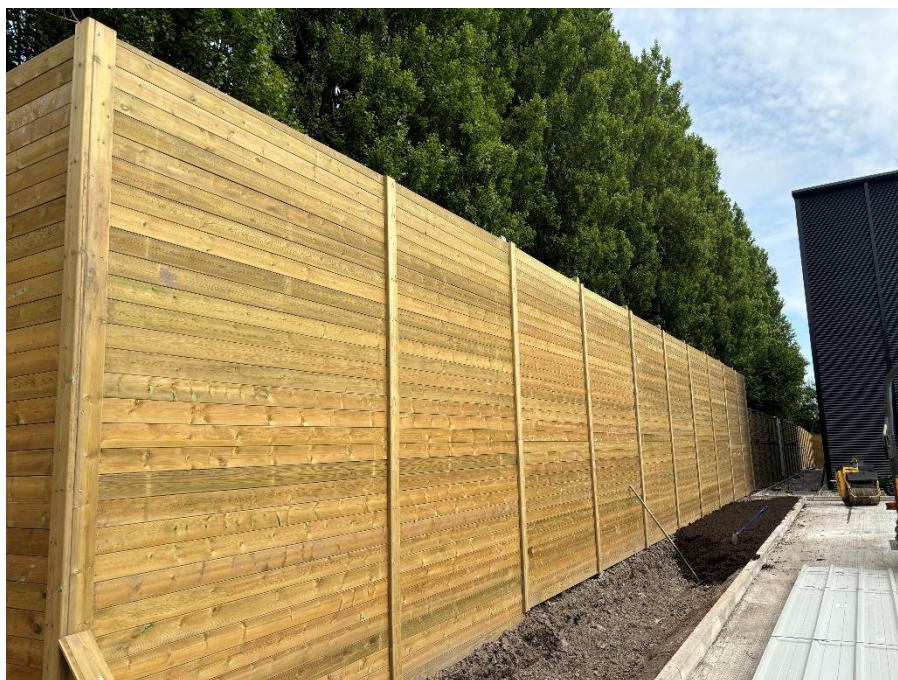
| Notes: | Non-developable Area (Exclusion Zone)<br>Installation of membrane and Installation of barrier fence. |

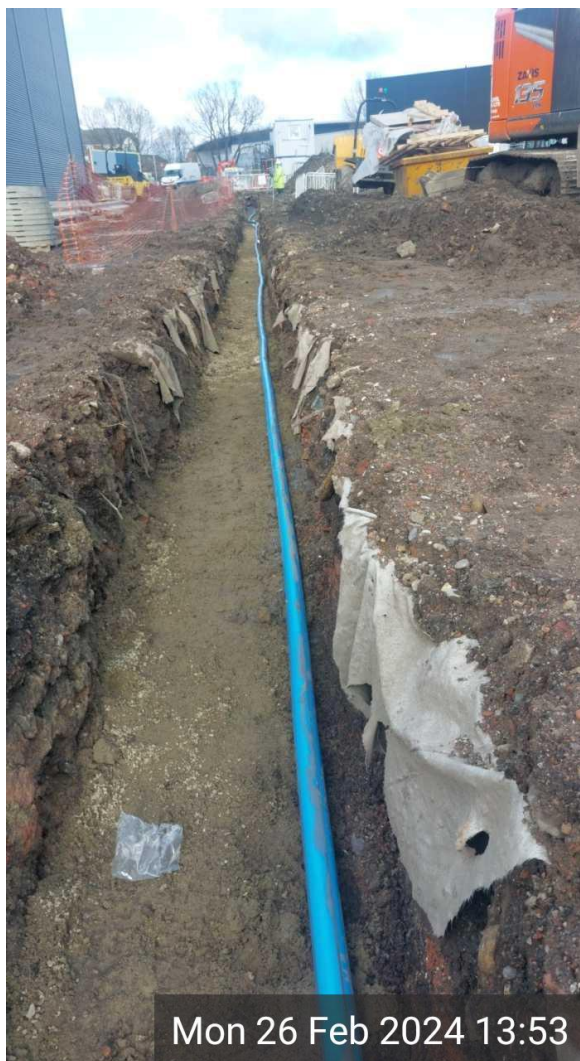
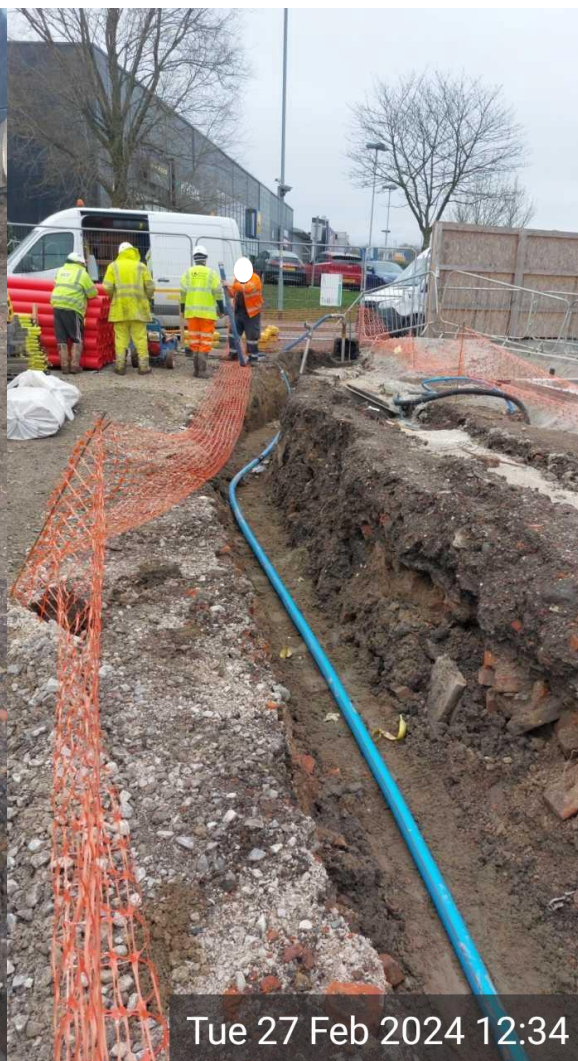
| Notes: | Installation of Protectaline Barrier Pipe (United Utilities) |

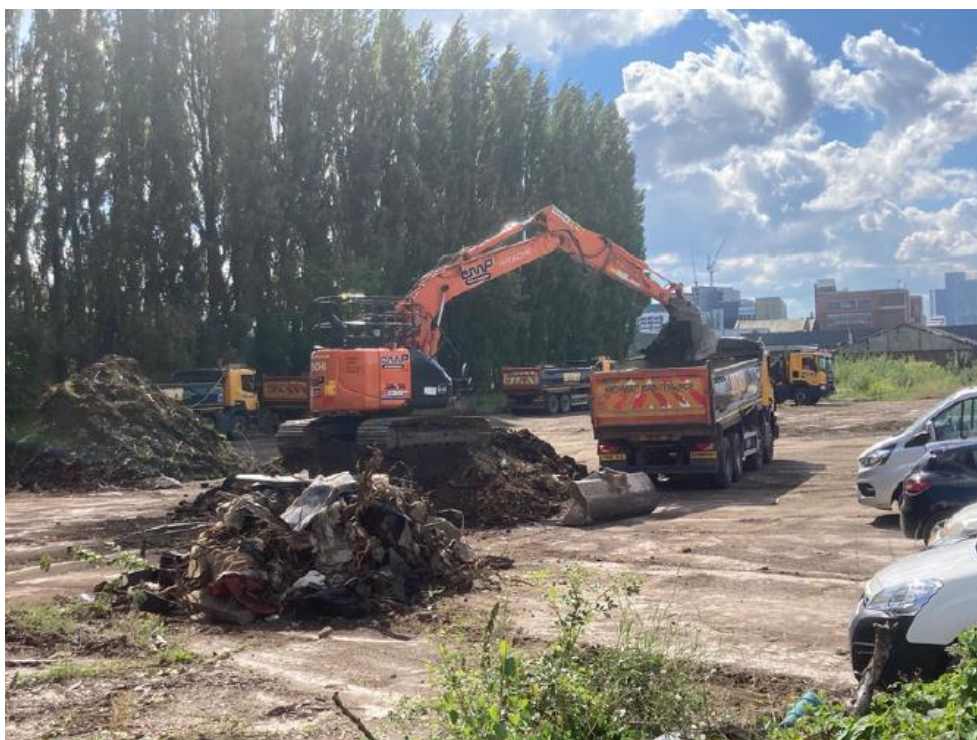
**Figure 0-1 Japanese Knotweed material being loaded in to wagons for offsite disposal**

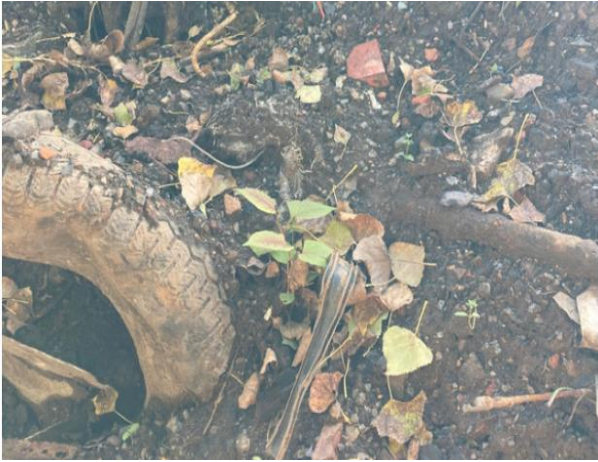
Figure 1: Japanese knotweed regrowth (17/10/22)

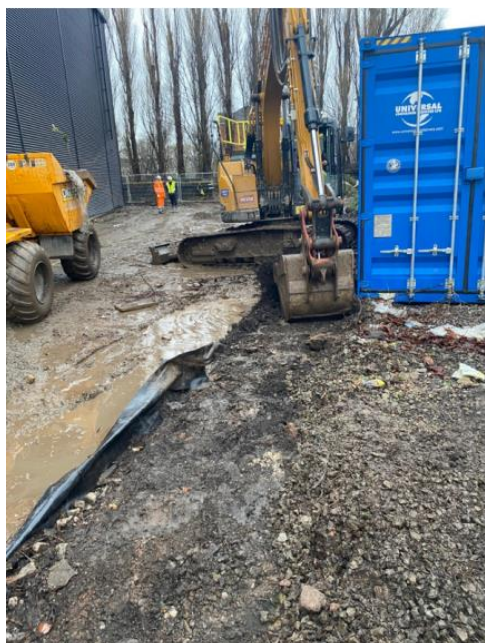
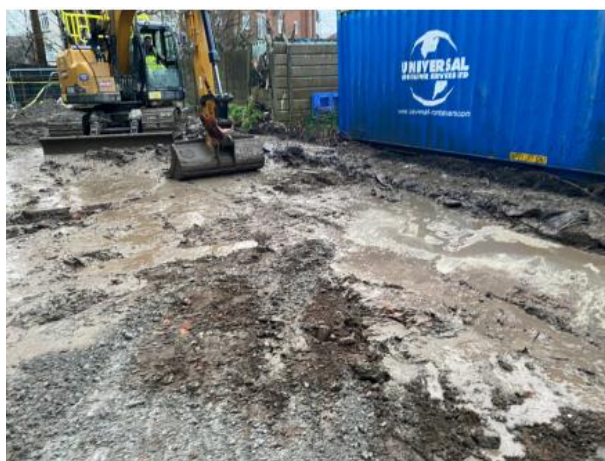
Figures 8 and 9: Excavation of Japanese knotweed along root barrier (January 2024)

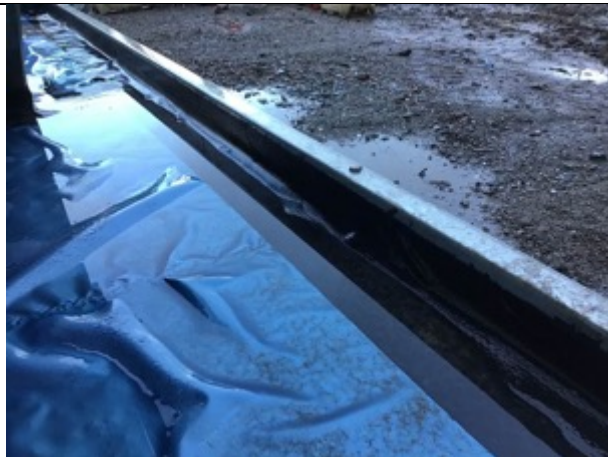
Unit 2 sealed retro fit detailing

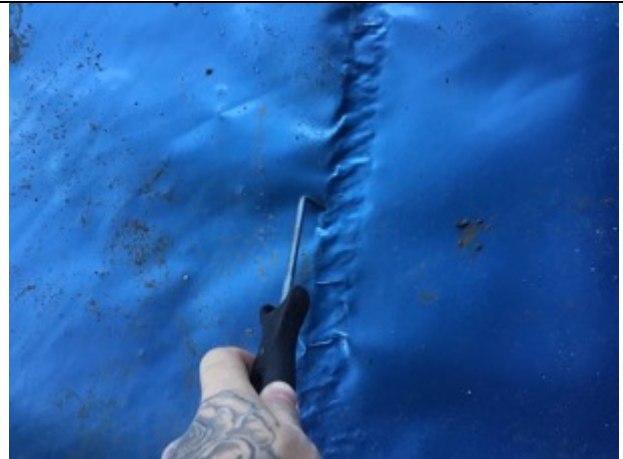
Probe test to sealed hand weld membrane joint

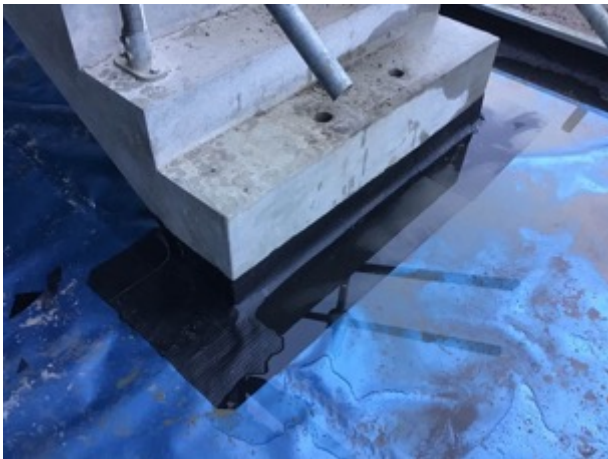
Sealed retro fit detailing to stairs

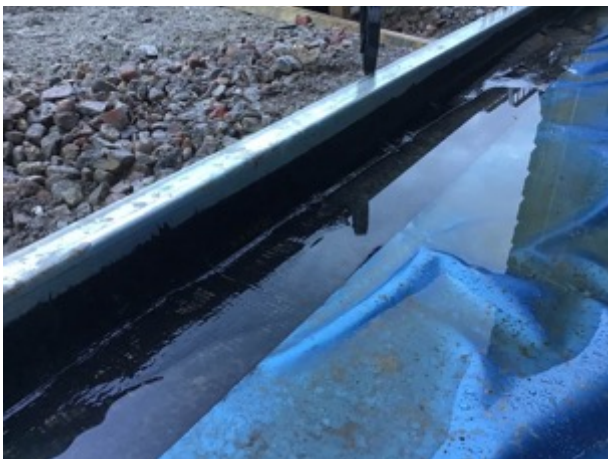
Sealed perimeter retro fit detailing

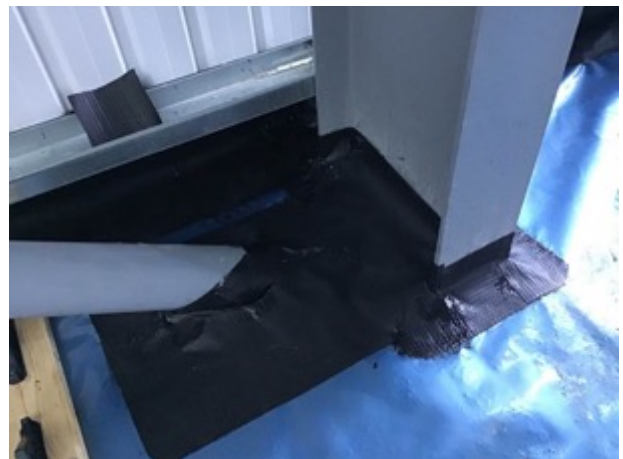
Sealed stanchion detailing

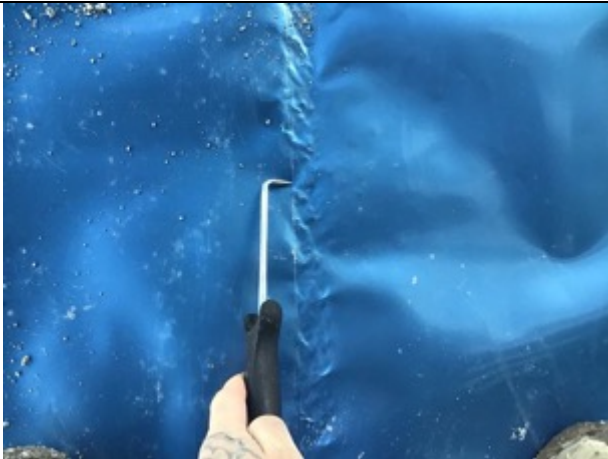
Probe test to sealed hand weld membrane joint

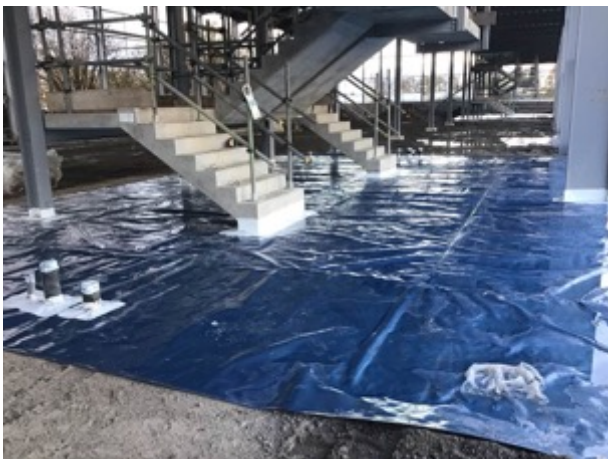
Core area 5 & 6 overview

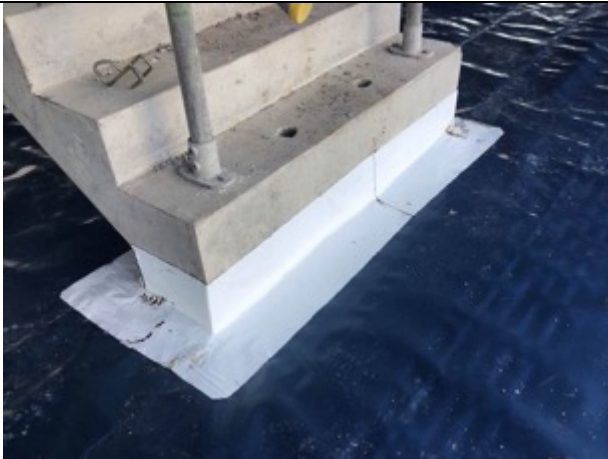
Core 5 sealed stair detailing

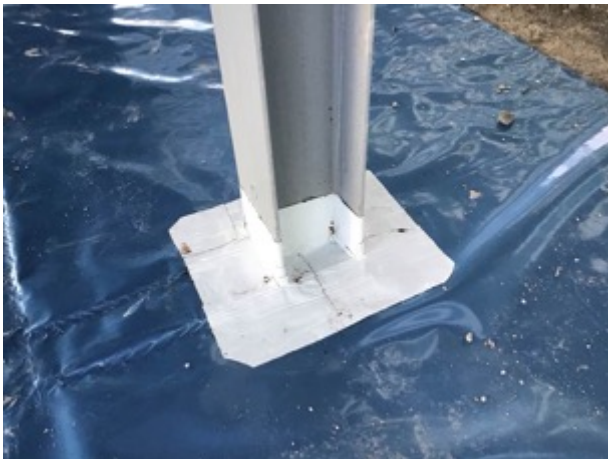
Core 6 sealed stanchion detailing

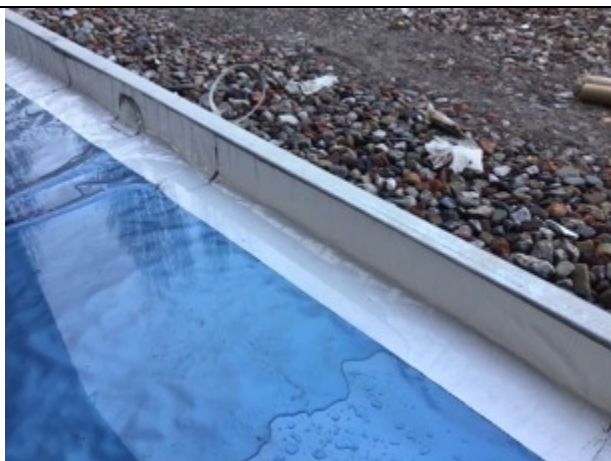
Core 8 sealed perimeter retro fit detailing

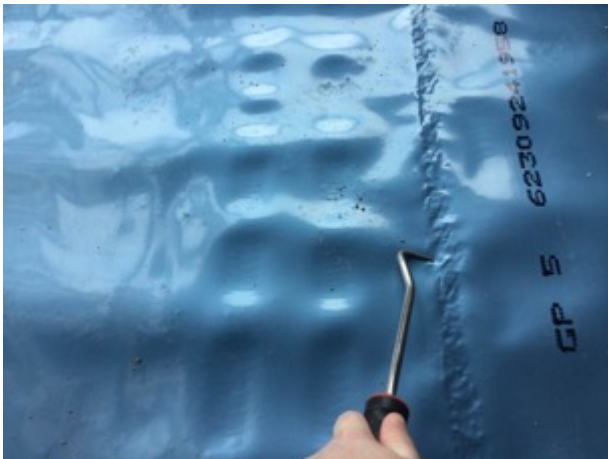
Pick testing along the hand welded lap joint.

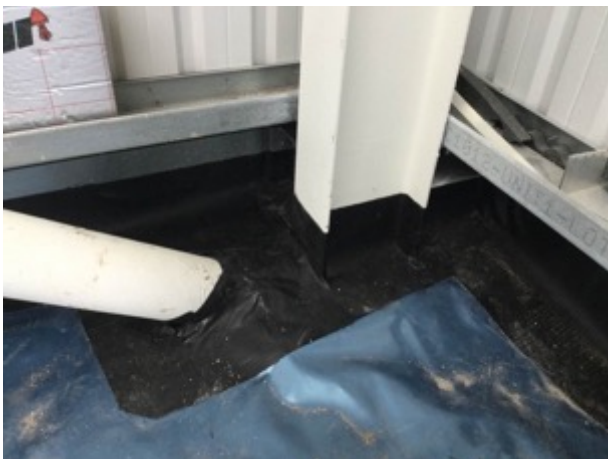
Steel stanchion and column details.

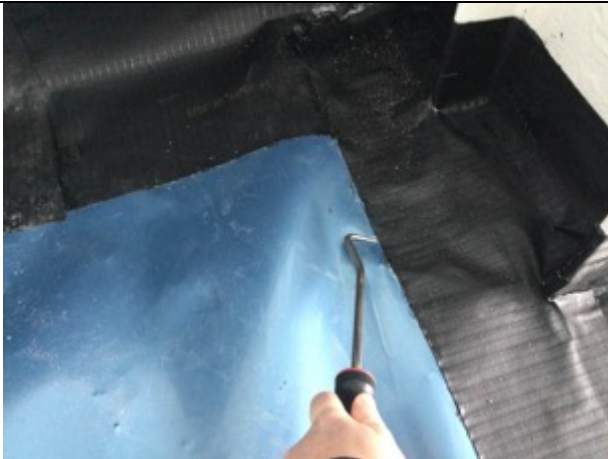
Pick testing to the SAGM detail.

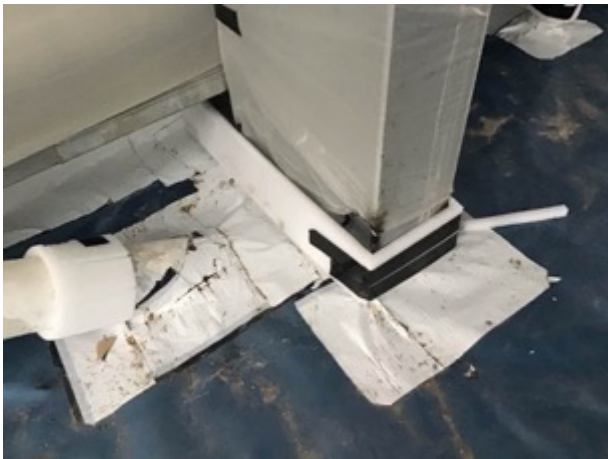
Unit 2 stanchion detailing

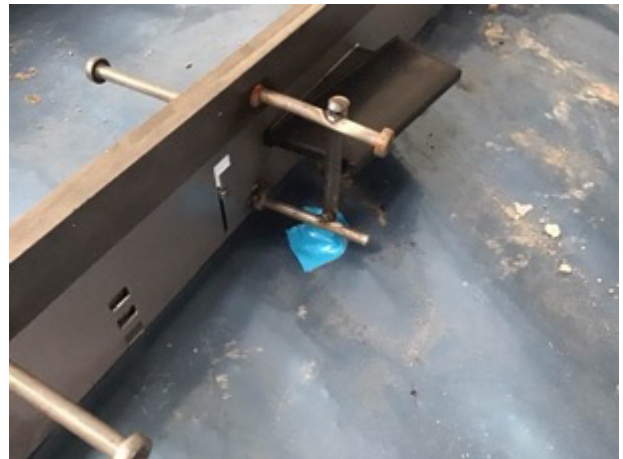
Unit 2 pin seals

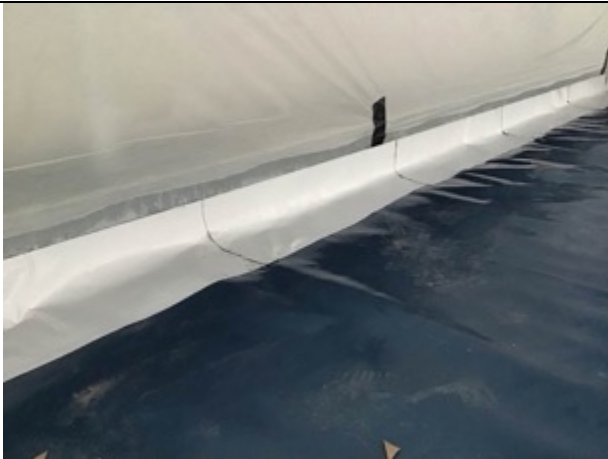
Unit 3 retro fit detailing

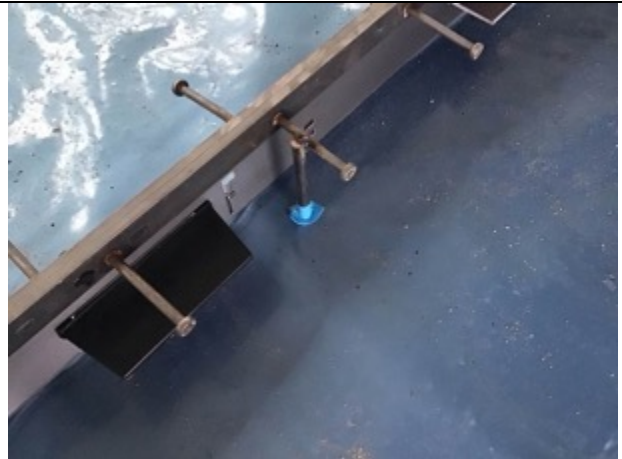
Unit 3 pin seals

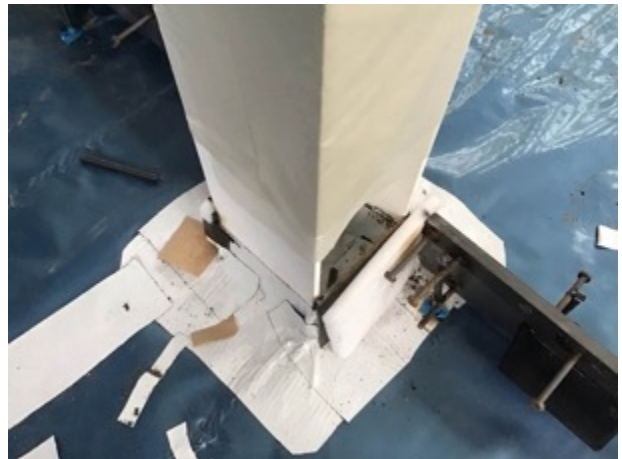
Unit 3 stanchion detailing

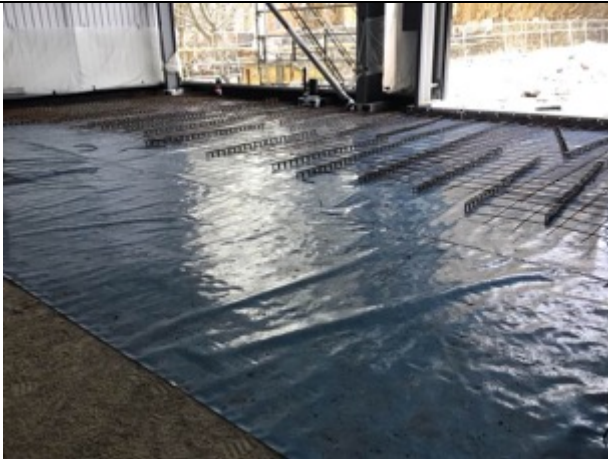
Under Croft area overview

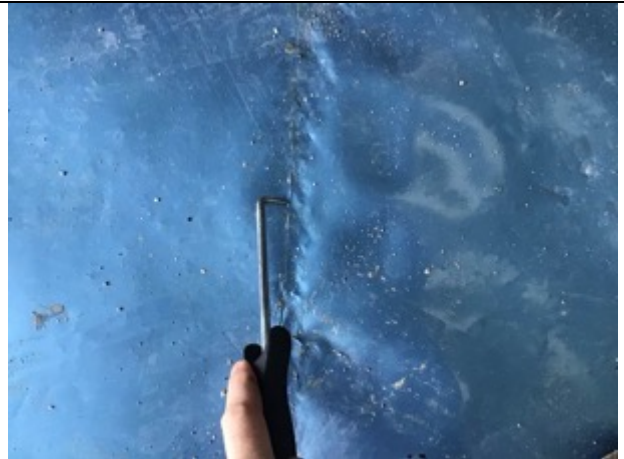
Membrane sealed to existing core area membrane

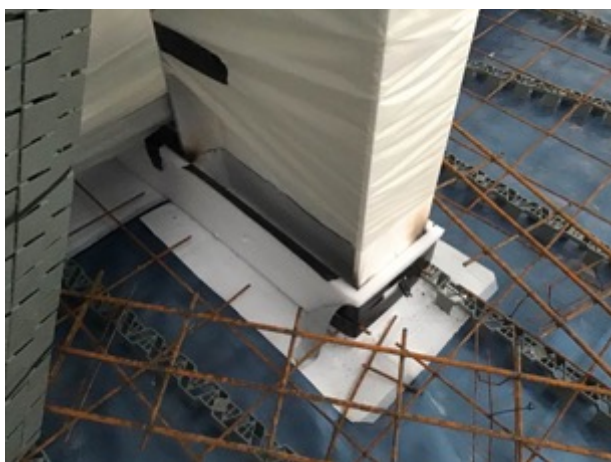
Sealed stanchion detailing

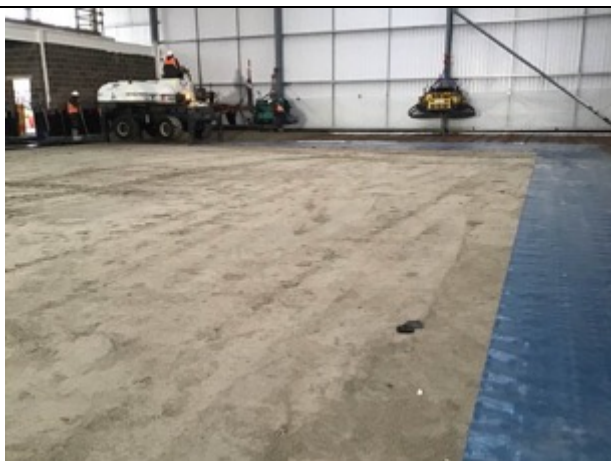
Pour area overview

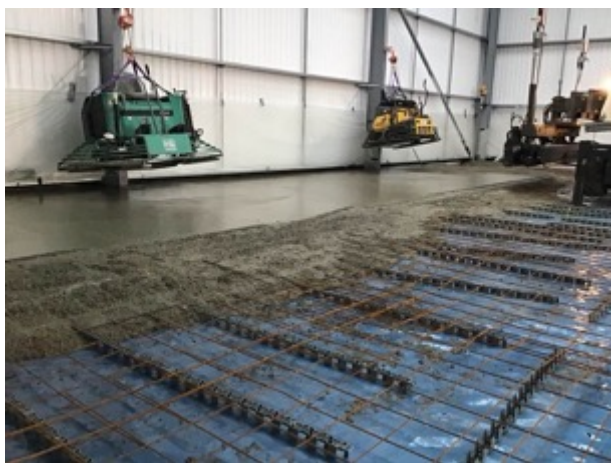
Concrete pour

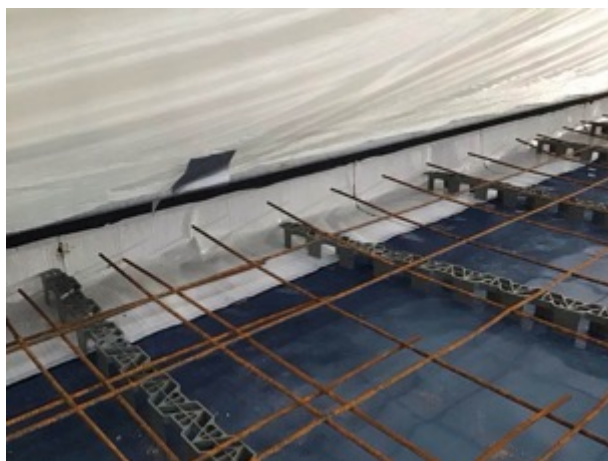
Perimeter retro fit detailing

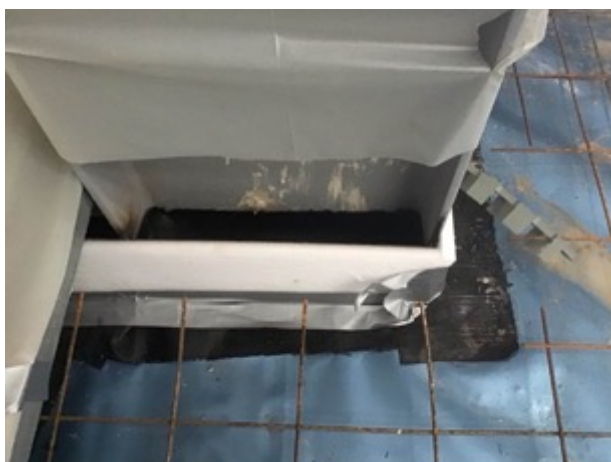
Sealed stanchion detailing

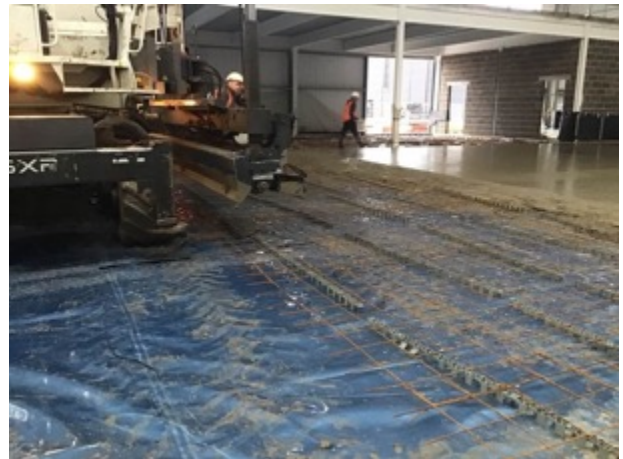
Plant keeping off the mesh over the membrane

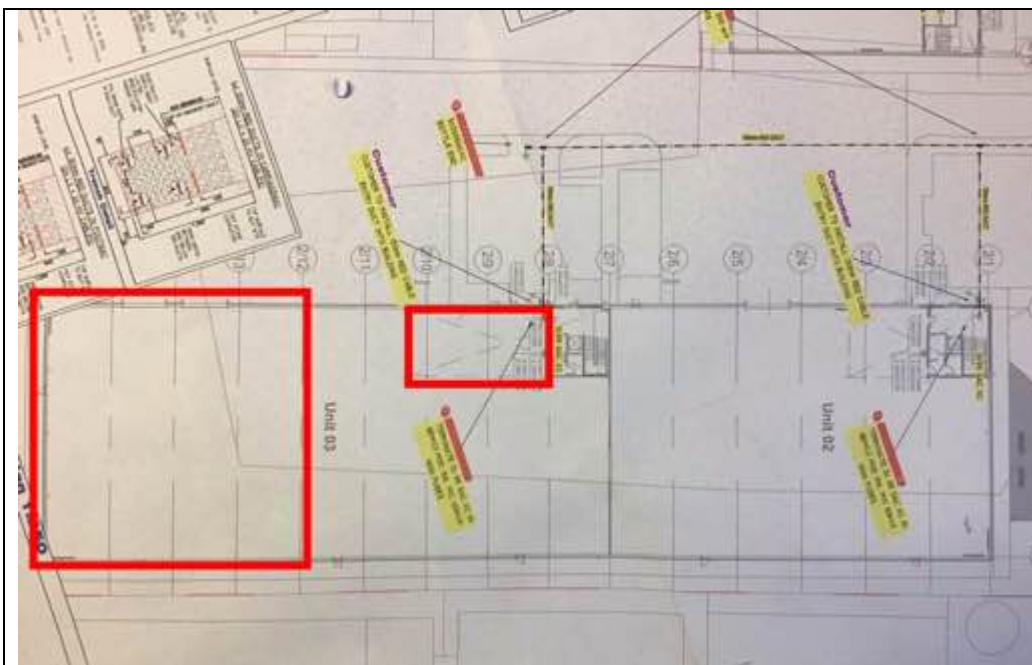
Area Inspected

| <p><b><u>(List any defects to detailing work and joints):</u></b></p> <p>During our inspection the following defects and repairs were carried out: 4no patch repairs made by the installers using SAGM and heat applied.</p> <p>Have any defects identified above been satisfactorily rectified <input checked="" type="checkbox"/> Yes <input type="checkbox"/> No <input type="checkbox"/> N/A</p> <p>The Area has passed inspection <input checked="" type="checkbox"/></p> <p>The Area has failed inspection and a corrective action sheet has been left with the contractor <input type="checkbox"/></p> <p>The Area is incomplete as detailed above <input type="checkbox"/></p> <p>Signed: <b>Dan Squire</b> Date: <b>24/01/2024</b></p> | | | |

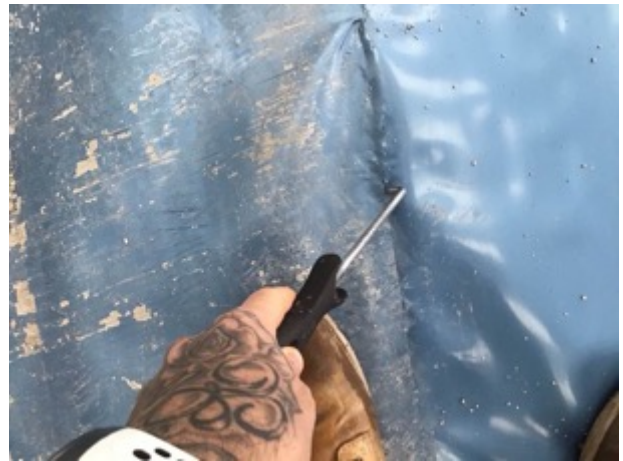
Probe test to hand welds

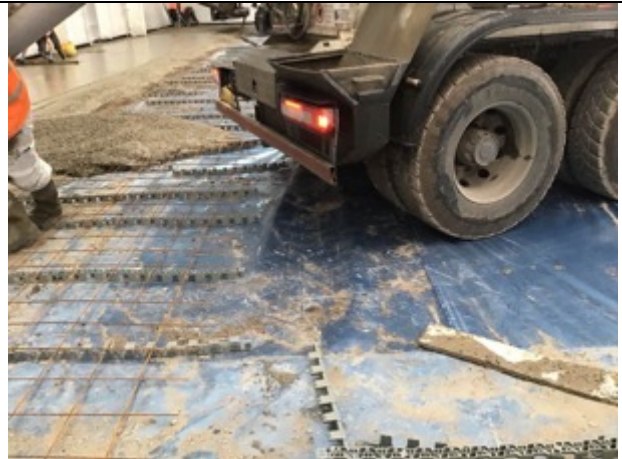
Plant keeping off the mesh over the membrane

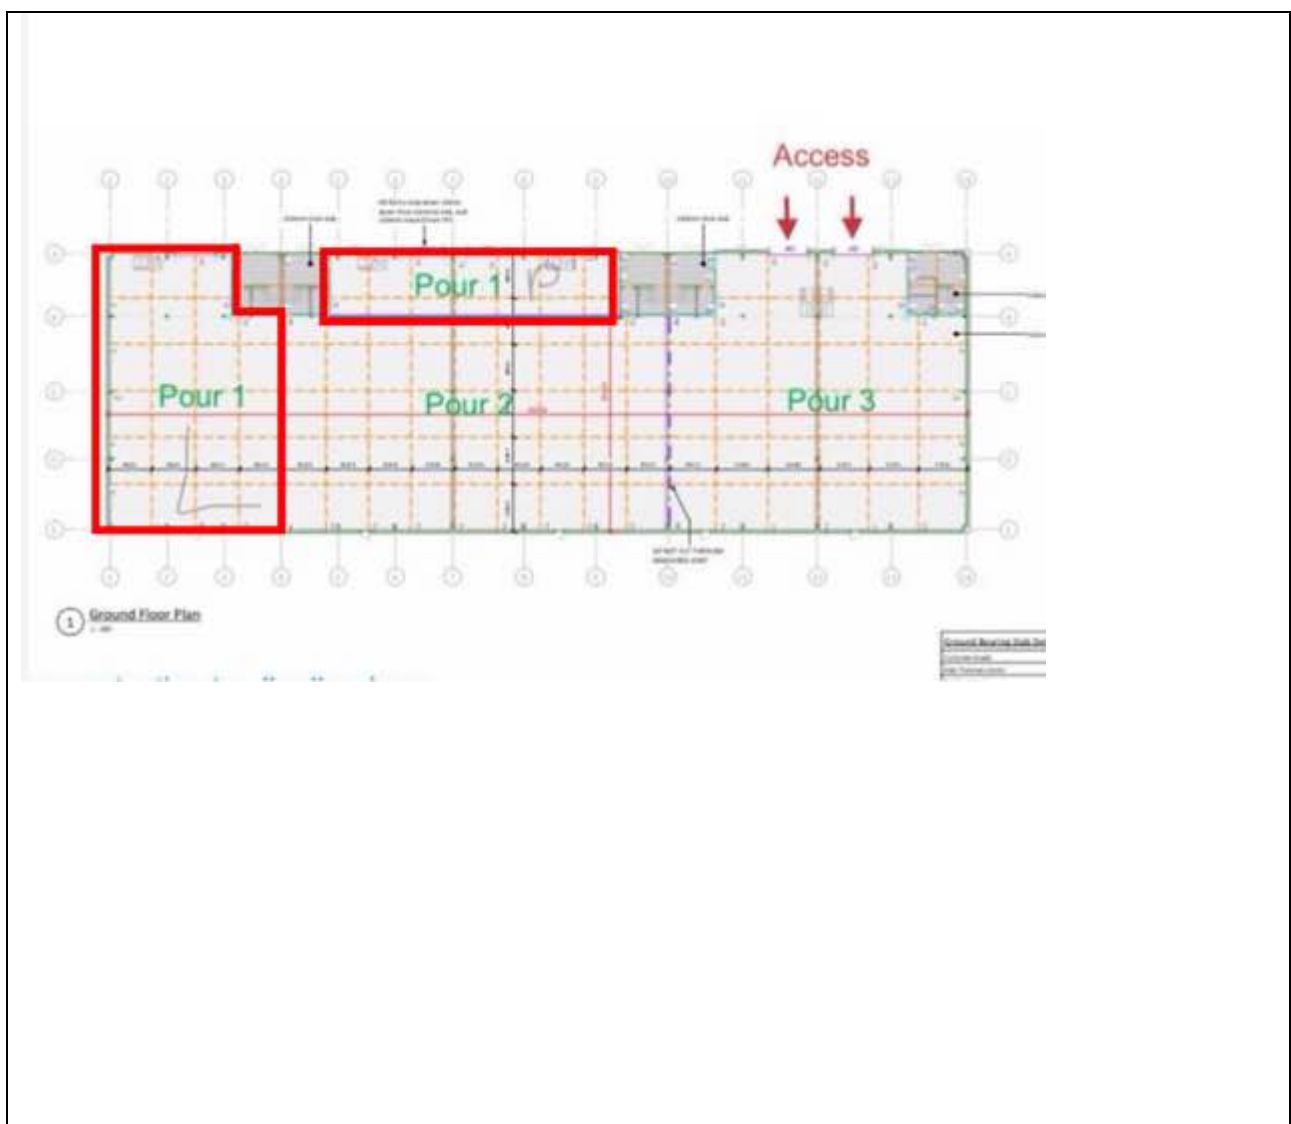
Area Inspected

| | <p><b><u>(List any defects to detailing work and joints):</u></b></p> <p>During our inspection the following defects and repairs were carried out: 11no patch repairs made by the installers using SAGM and heat applied.</p> <p>Have any defects identified above been satisfactorily rectified <input checked="" type="checkbox"/> Yes <input type="checkbox"/> No <input type="checkbox"/> N/A</p> <p>The Area has passed inspection <input checked="" type="checkbox"/></p> <p>The Area has failed inspection and a corrective action sheet has been left with the contractor <input type="checkbox"/></p> <p>The Area is incomplete as detailed above <input type="checkbox"/></p> <p>Signed: <b>Dan Squire</b> Date: <b>25/01/2024</b></p> |

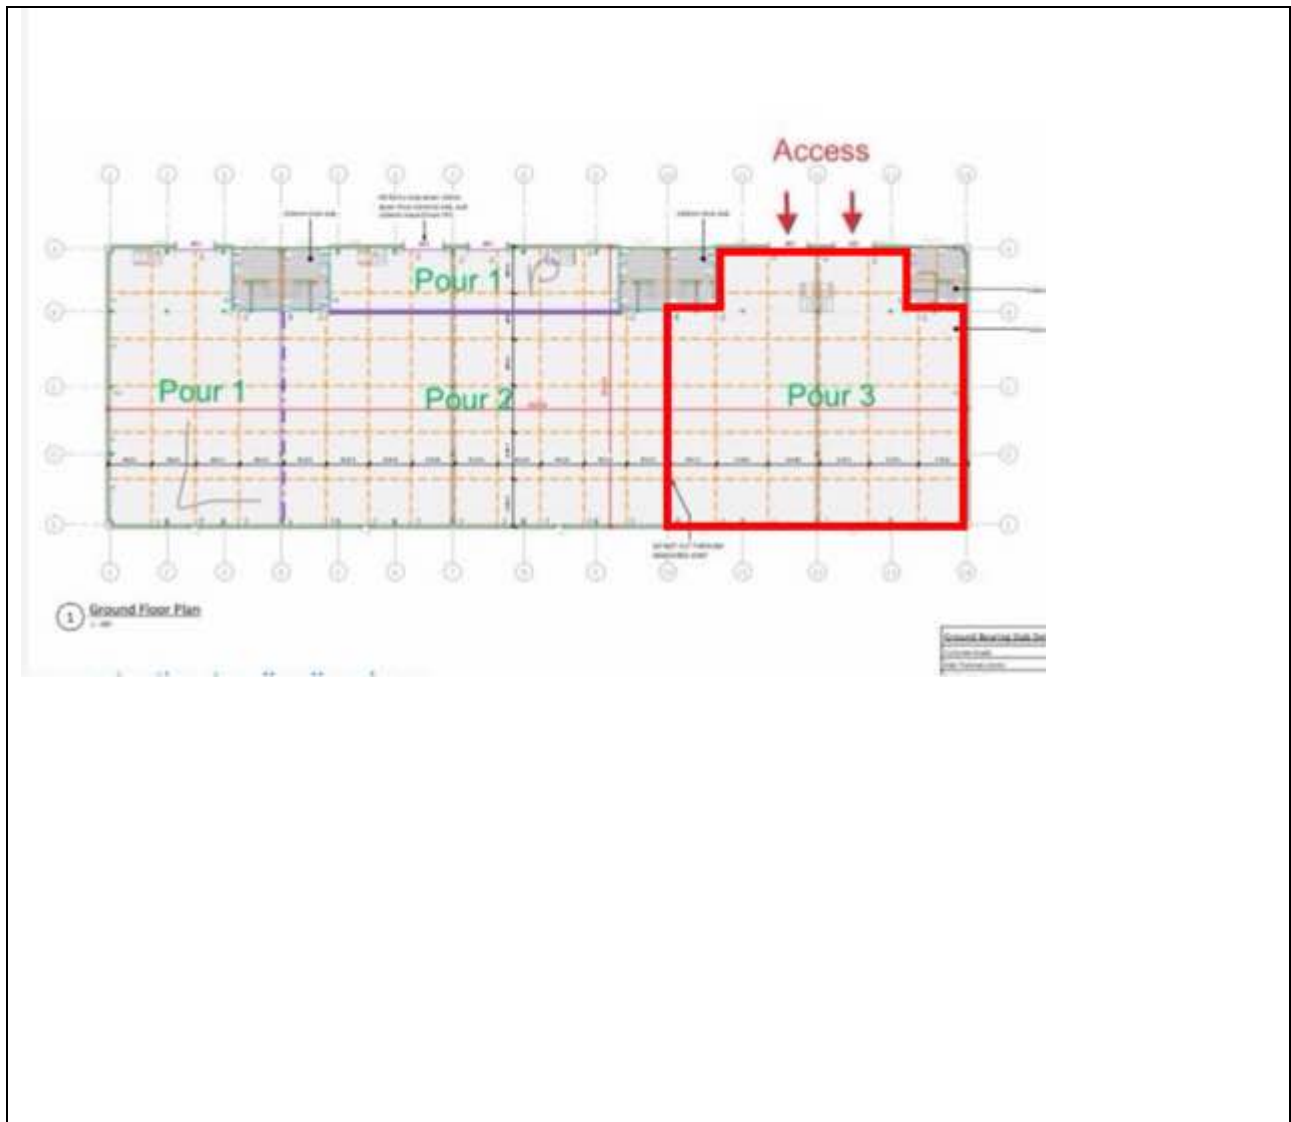
Area Inspected

| <p><b><u>(List any defects to detailing work and joints):</u></b></p> <p>During our inspection the following defects and repairs were carried out: 6no patch repairs made by the installers using SAGM and heat applied.</p> <p>Have any defects identified above been satisfactorily rectified <input checked="" type="checkbox"/> Yes <input type="checkbox"/> No <input type="checkbox"/> N/A</p> <p>The Area has passed inspection <input checked="" type="checkbox"/></p> <p>The Area has failed inspection and a corrective action sheet has been left with the contractor <input type="checkbox"/></p> <p>The Area is incomplete as detailed above <input type="checkbox"/></p> <p>Signed: <b>Dan Squire</b> Date: <b>29/01/2024</b></p> | | | |

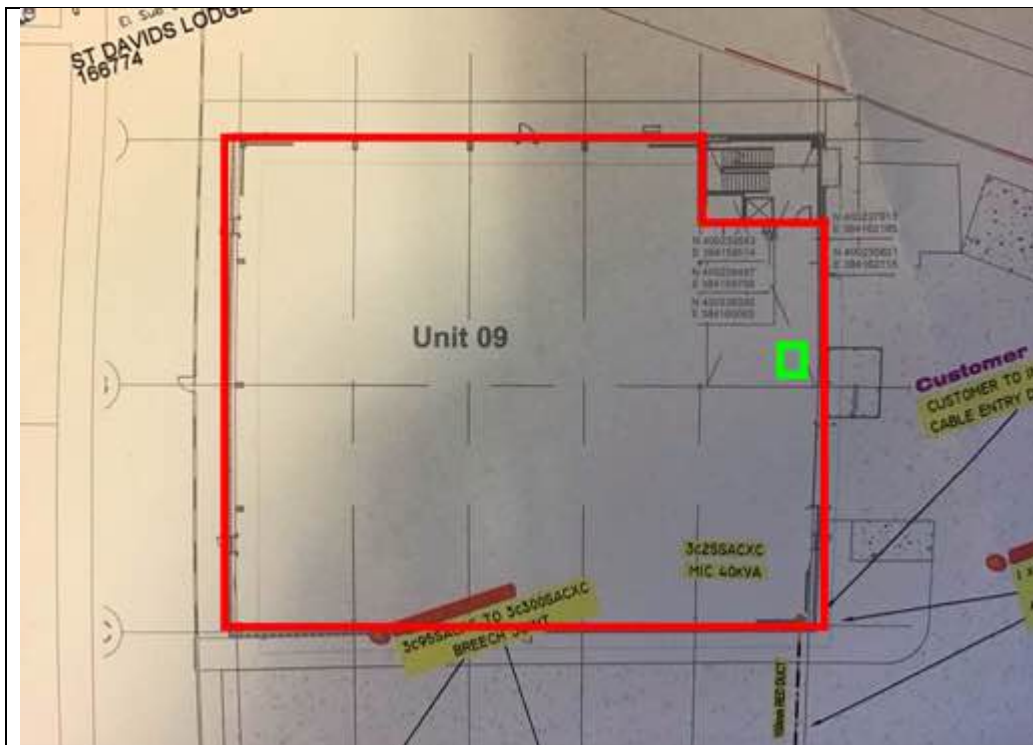
Area Inspected

| | Installation Notes | <p><b><u>(brief description of area/plots and list of defects/repairs identified to the main membrane sheet, excluding detailing and joints)</u></b></p> <p>MEC Environmental carried out a thorough visual inspection of the membrane that was laid on a just in time basis in front of a laser pour, during our inspection we witnessed the installer carrying out their own CQA repairs as the pour progressed. The membrane is lined across the full footprint of the building upon a sand blinded and rolled substrate. The membrane is auto welded into panels and hand welded into position as the pour progresses. The membrane is sealed to the perimeter edge using SAGM as a retro fit detail. All stanchions and pipe penetrations are sealed using SAGM. There is 1no boxed out section from the pour where the membrane has been taken up and over the temporary shuttering to allow it to be joined and sealed at a later date when the shuttering is removed. The approximate location of this is marked in green on the marked up plan.</p> | | | |

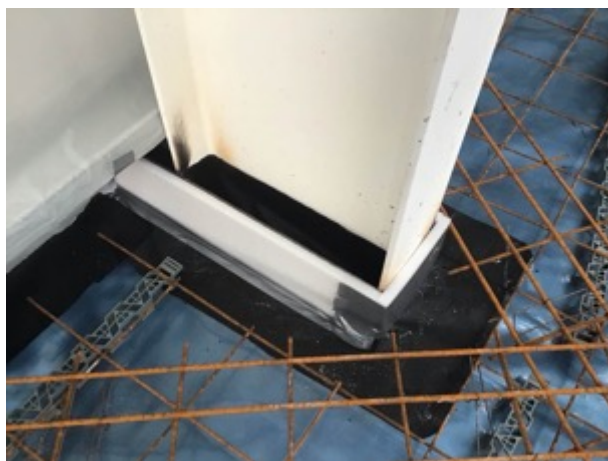
Sealed stanchion detailing

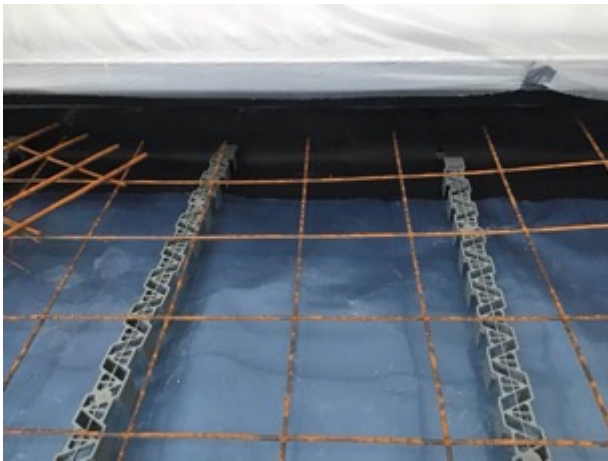
Perimeter retro fit detailing
