Bat Survey Report - 2025 Surveys

**Fallowfield Campus Redevelopment  
Project**

**John Graham Construction Ltd**

Report Reference: GRA001-013-004/001/002

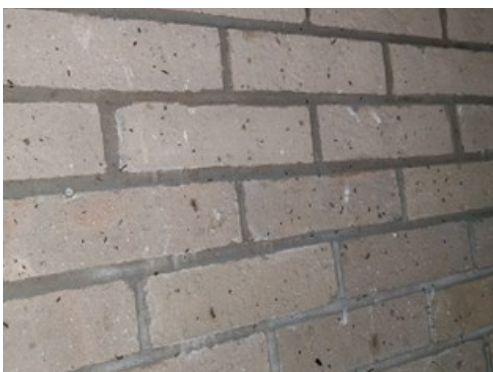
Photograph 15:  
Bat droppings on the wall of B18
