**STRUCTURAL SURVEY REPORT:  
621 BURNAGE LANE, MANCHESTER, M19 1WB**

RP-H1137-01-R0

**STRUCTURAL SURVEY OF:  
621 BURNAGE LANE, MANCHESTER, M19 1WB**

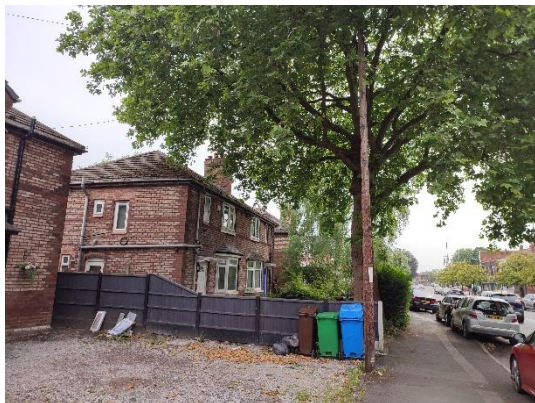
*Photo 2 – Alternative view of tree, identifying its location within the Client's property boundary*

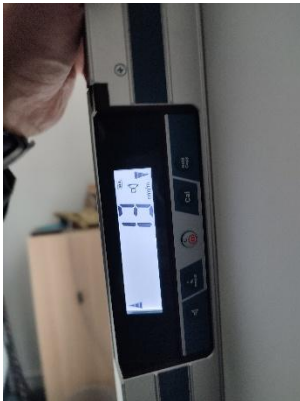
- (i.)      Inclinometer level readings taken on all loadbearing and interior dividing walls, inclinations of up to 13 mm per meter were recorded.
- (ii.)     Horizontal level checks were undertaken on the floors of the various first floor rooms, readings between 2mm to 11mm per metre were recorded.
- (iii.)    Widespread internal cracks ranging between 1mm to 2mm wide. The condition of the cracks indicate recent movement and were noted on all load bearing walls including the party wall.
- (iv.)     Deep horizontal and diagonal cracks of up to 2mm per metre were observed in proximity to the first floor windows (i.e. beneath the windows and at corners).
- (v.)      Numerous cracks in the brittle finishes on the ceiling were observed.

*Photo 30 – Verticality checks on the walls indicate inclinations of up to 13mm per metre in areas*

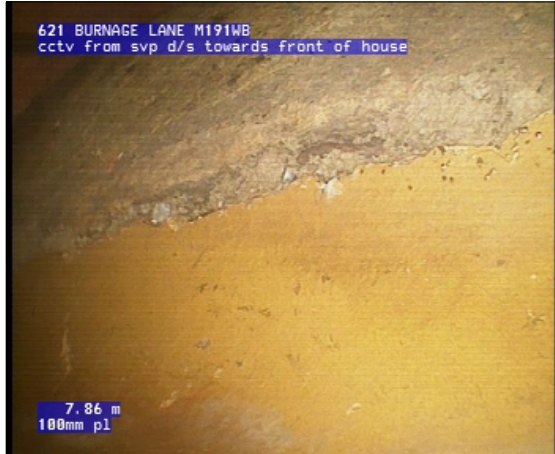
Photo: 1\_1\_17\_A.jpg, 00:01:40

7.86m, Finish node type, manhole reference number: FOH

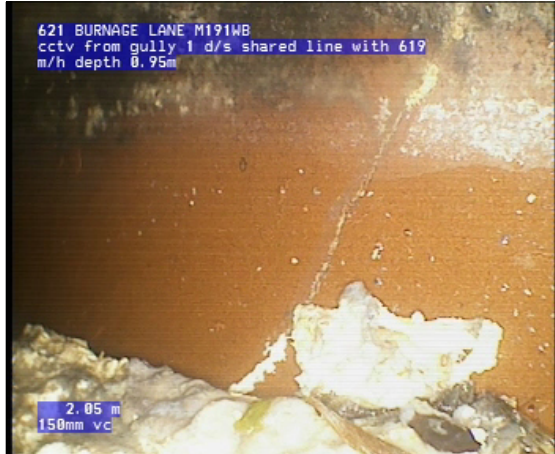
Photo: 3\_3\_26\_A.jpg, 00:00:41

2.05m, Finish node type, other special chamber reference  
 number: Shared Line Remarks: Complete Junction with shared  
 line

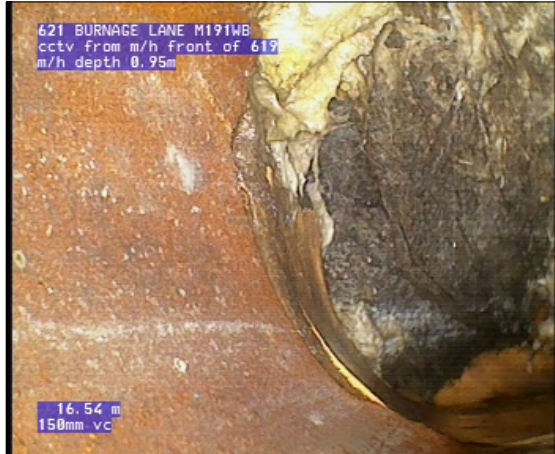
Photo: 5\_5\_49\_A.jpg, 00:02:47

16.54m, Finish node type, other special chamber reference number: D/S Remarks: survey complete
