Gas Membrane Installation  
Validation Report  
Triton Construction  
Trade City  
Elizabeth Street  
Cheetham Hill  
Manchester  
M8 8JJ

## Appendix 1 – Site Survey Sheets

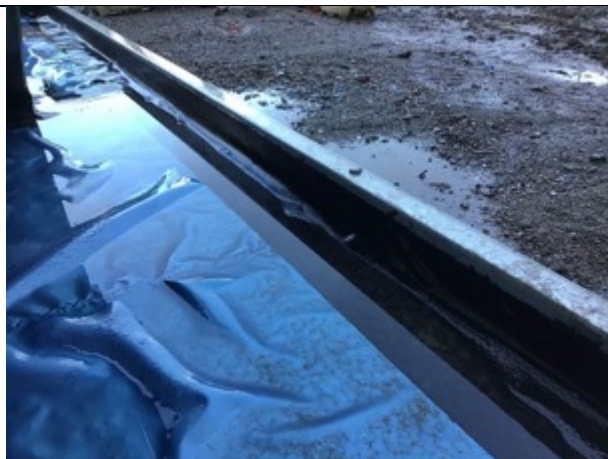
Unit 2 sealed retro fit detailing

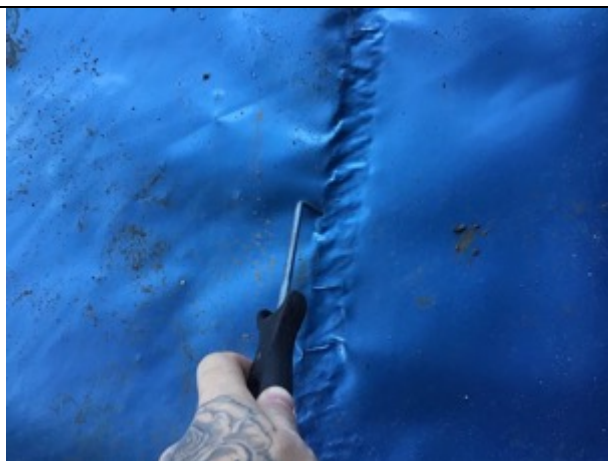
Probe test to sealed hand weld membrane joint

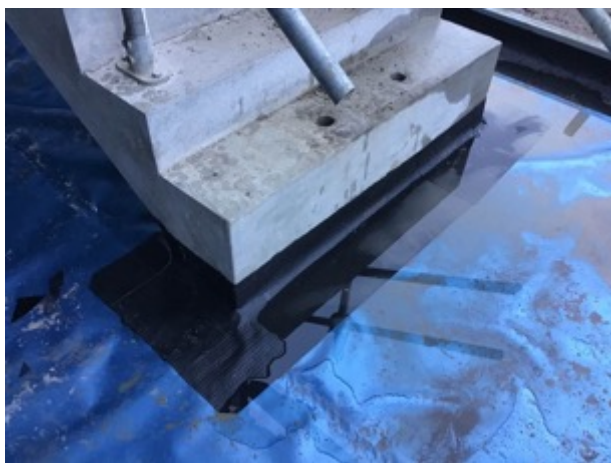
Sealed retro fit detailing to stairs

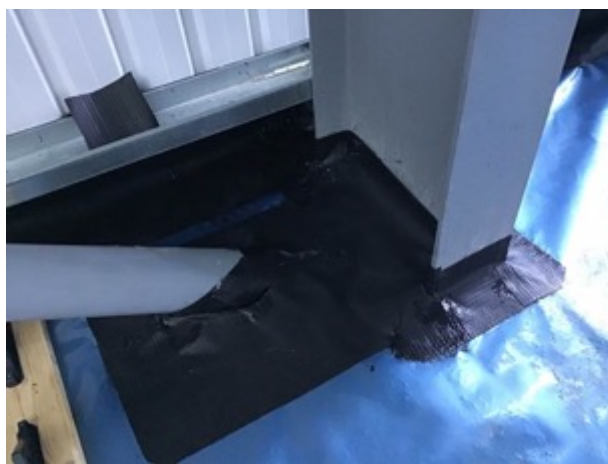
Sealed stanchion detailing

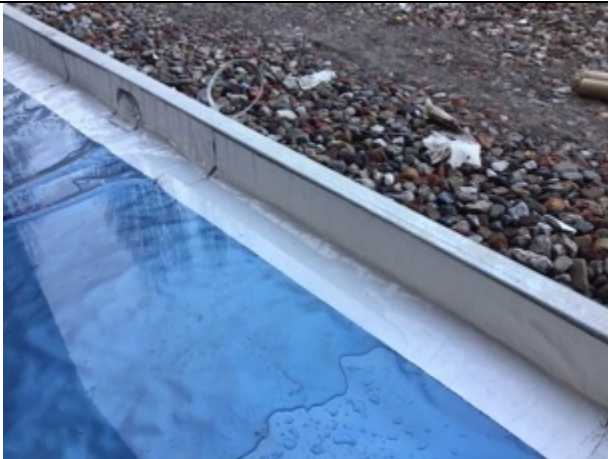
Core 8 sealed perimeter retro fit detailing

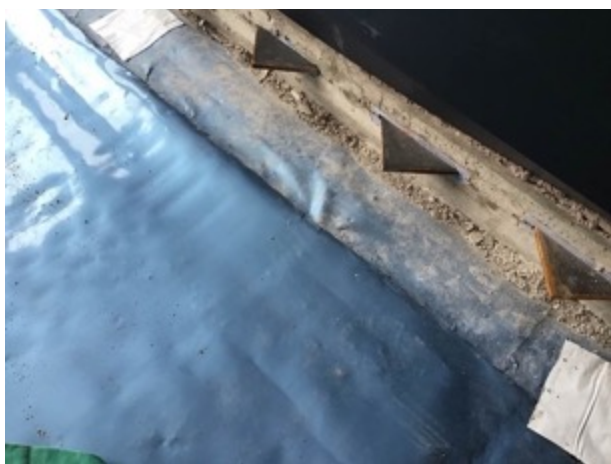
Unit 3 membrane sealed to core area existing membrane

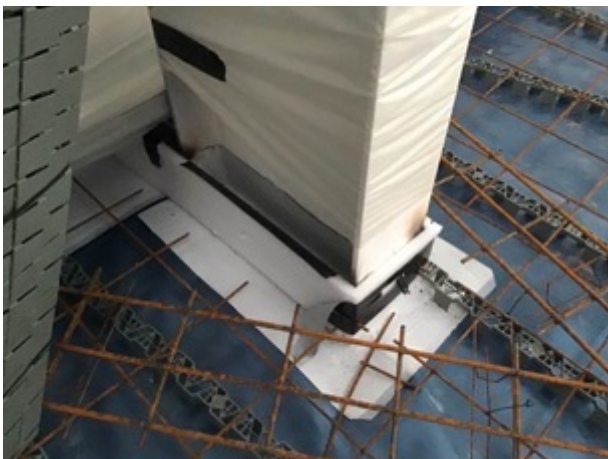
Sealed stanchion detailing

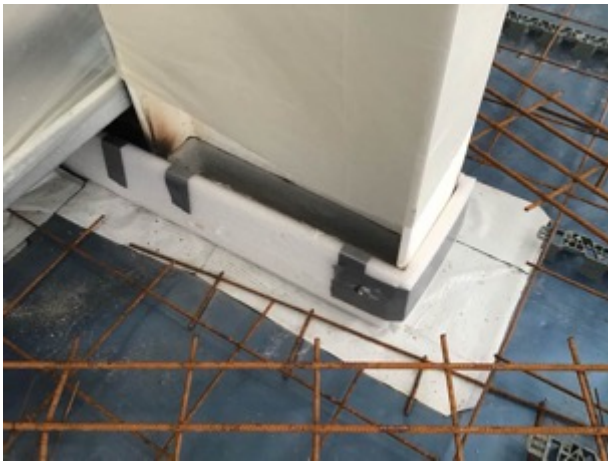
Sealed stanchion detailing

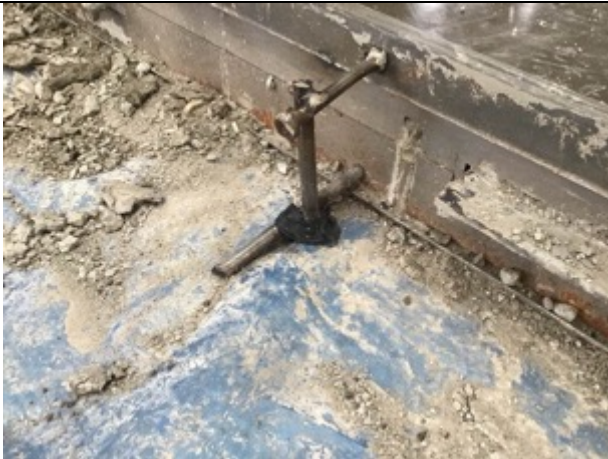
Butyl tape on armoured joint pin

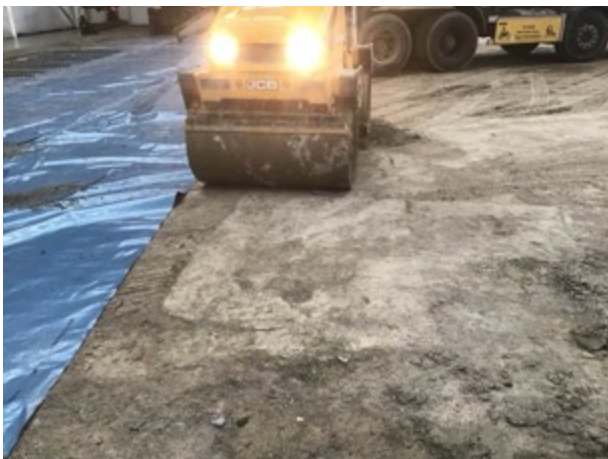
Sub grade prep

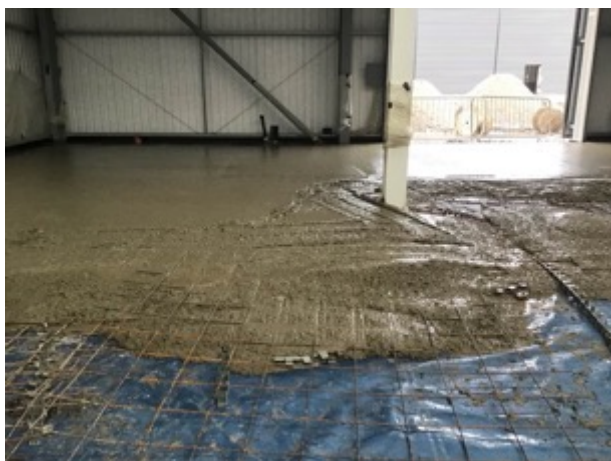
Laser screed pour

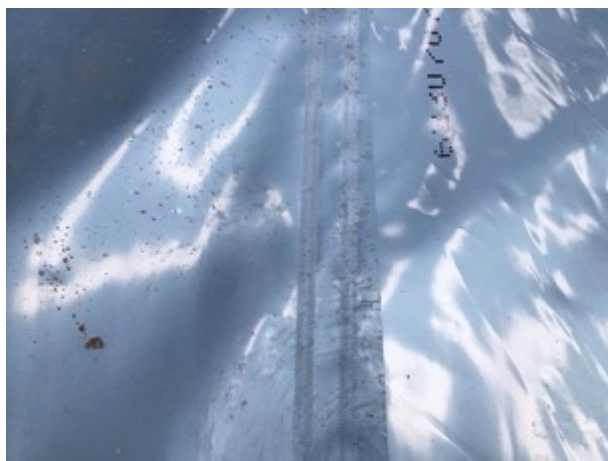
Sealed auto weld membrane joint

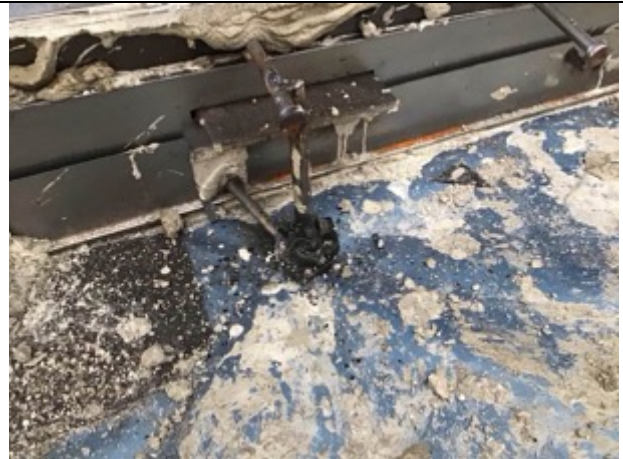
Butyl tape around armoured joint pin

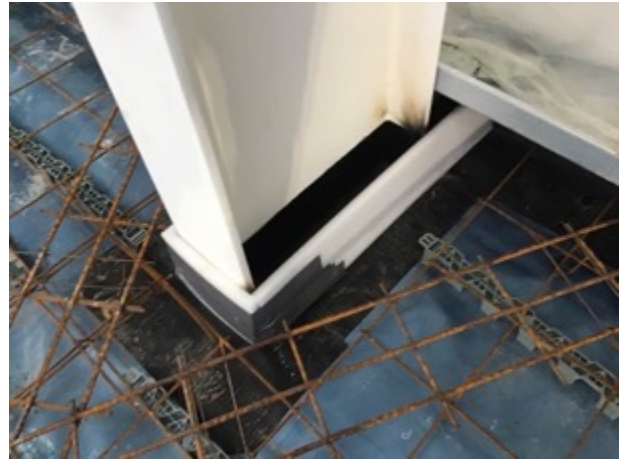
Sealed stanchion detailing

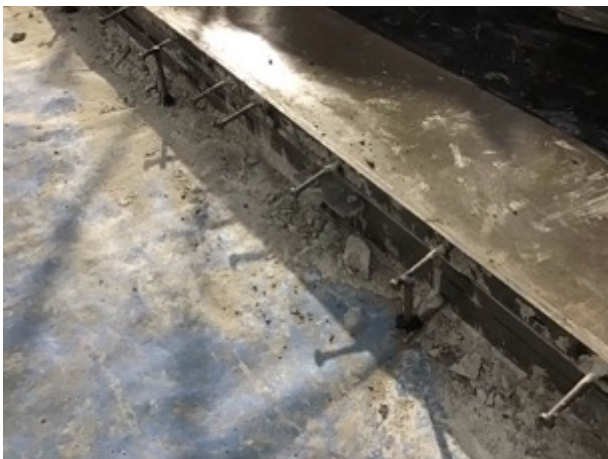
Pins sealed with butyl tape

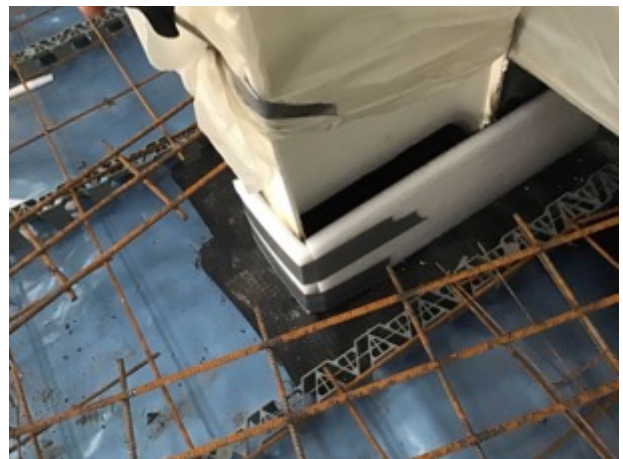
Sealed stanchion detailing

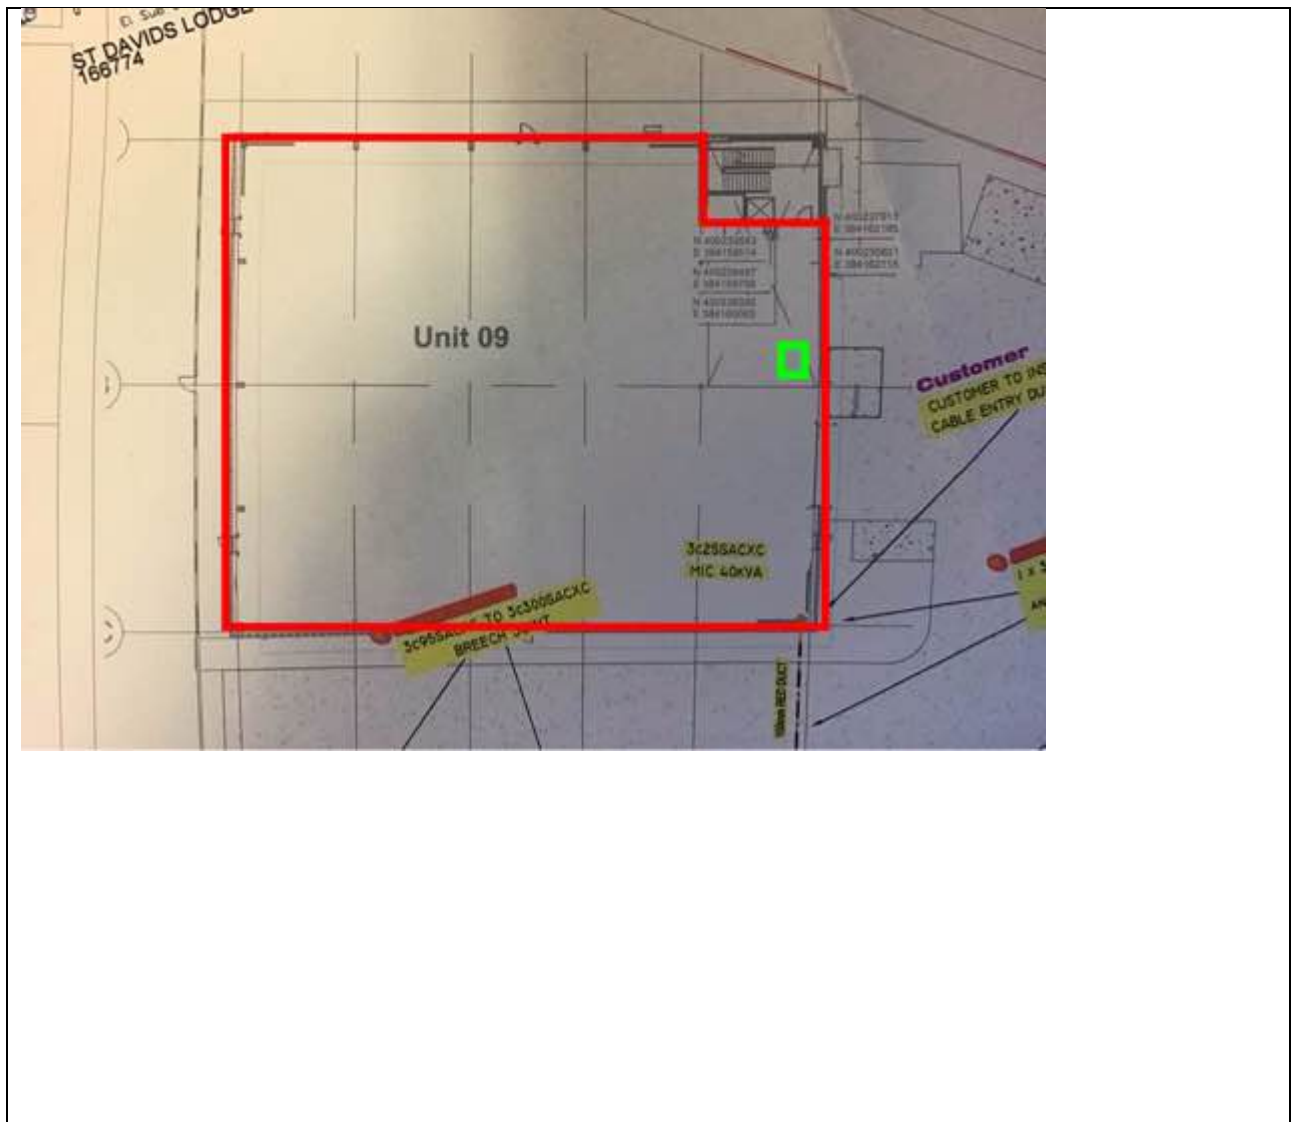
Area Inspected

| | Installation Notes | <p><b><u>(brief description of area/plots and list of defects/repairs identified to the main membrane sheet, excluding detailing and joints)</u></b></p> <p>MEC Environmental carried out a thorough visual inspection of the membrane that was laid on a just in time basis in front of a laser pour, during our inspection we witnessed the installer carrying out their own CQA repairs as the pour progressed. The membrane is lined across the full footprint of the building upon a sand blinded and rolled substrate. The membrane is auto welded into panels and hand welded into position as the pour progresses. The membrane is sealed to the perimeter edge using SAGM as a retro fit detail. All stanchions and pipe penetrations are sealed using SAGM. There is 1no boxed out section from the pour where the membrane has been taken up and over the temporary shuttering to allow it to be joined and sealed at a later date when the shuttering is removed. The approximate location of this is marked in green on the marked up plan.</p> | | |

| | <p><b><u>(List any defects to detailing work and joints):</u></b></p> <p>During our inspection the following defects and repairs were carried out: 5no patch repairs made by the installers using SAGM and heat applied.</p> <p>Have any defects identified above been satisfactorily rectified <input checked="" type="checkbox"/> Yes <input type="checkbox"/> No <input type="checkbox"/> N/A</p> <p>The Area has passed inspection <input checked="" type="checkbox"/></p> <p>The Area has failed inspection and a corrective action sheet has been left with the contractor <input type="checkbox"/></p> <p>The Area is incomplete as detailed above <input type="checkbox"/></p> <p>Signed: <b>Dan Squire</b> Date: <b>30/01/2024</b></p> | | | |

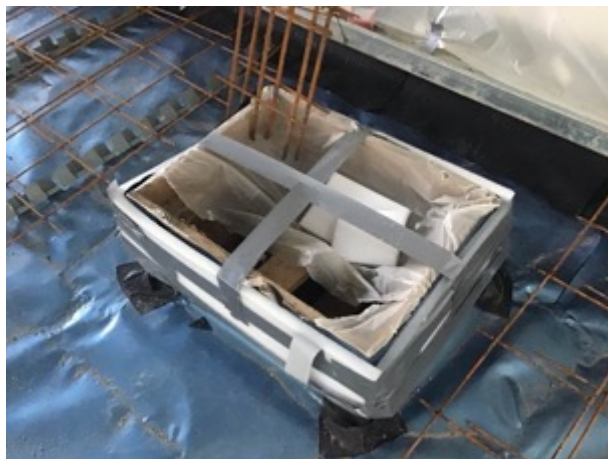
Boxed out area
