# Hutton + Rostron Environmental Investigations Limited

## 466-468 Moss Lane East: Window Condition Survey

Site note 3 for 27-28 February 2024, job no. 214-22

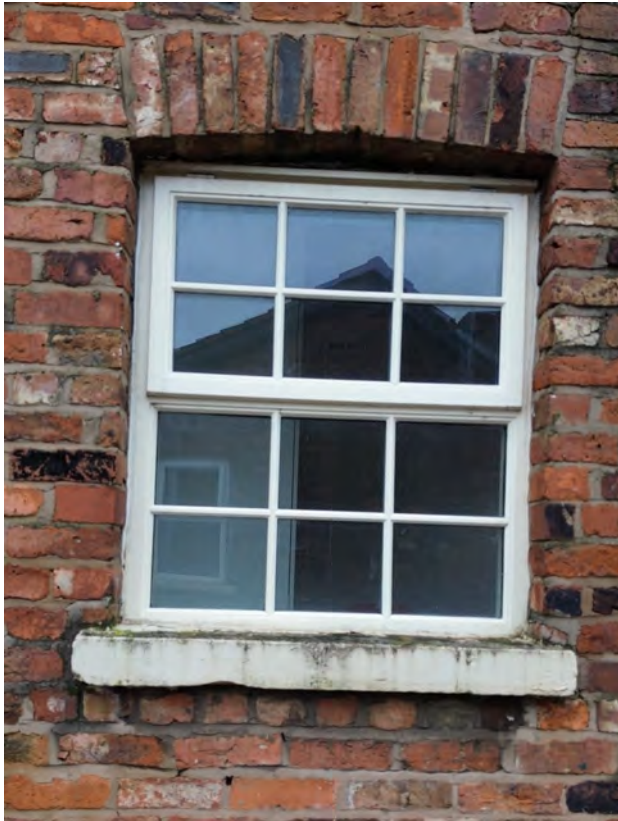
**Fig 1:**

Window E.2.1; showing general view

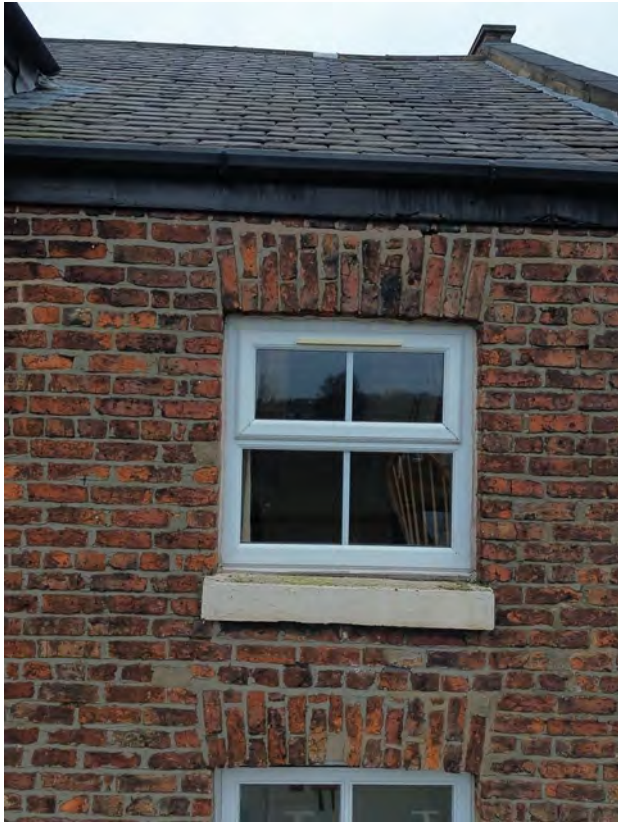
**Fig 3:**

Window S.2.3; showing general view

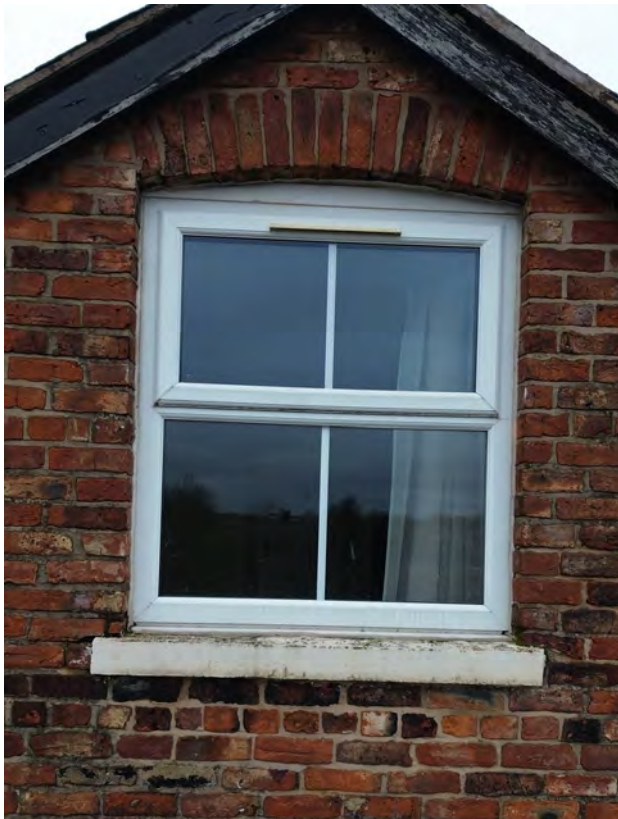
**Fig 4:**

Window S.2.4; showing general view

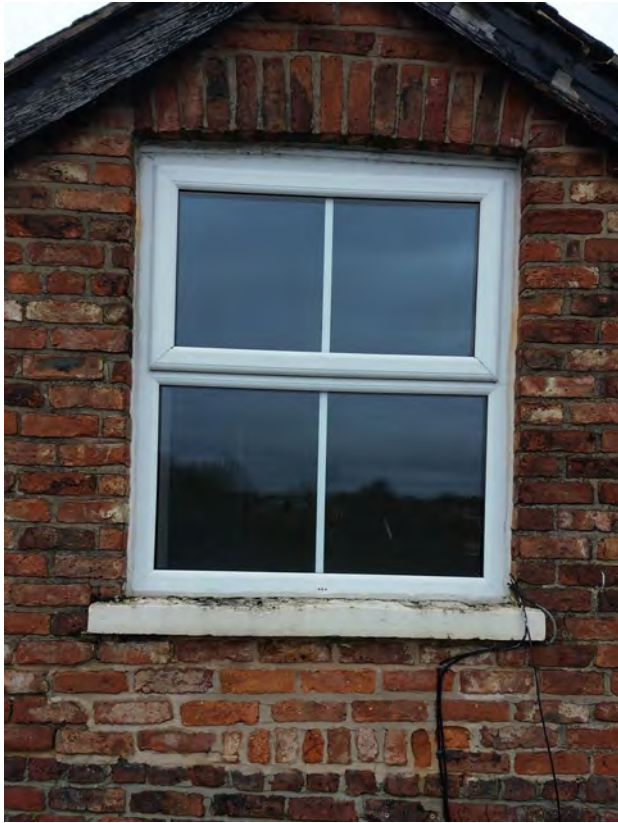
**Fig 5:**

Window S.2.5; showing general view

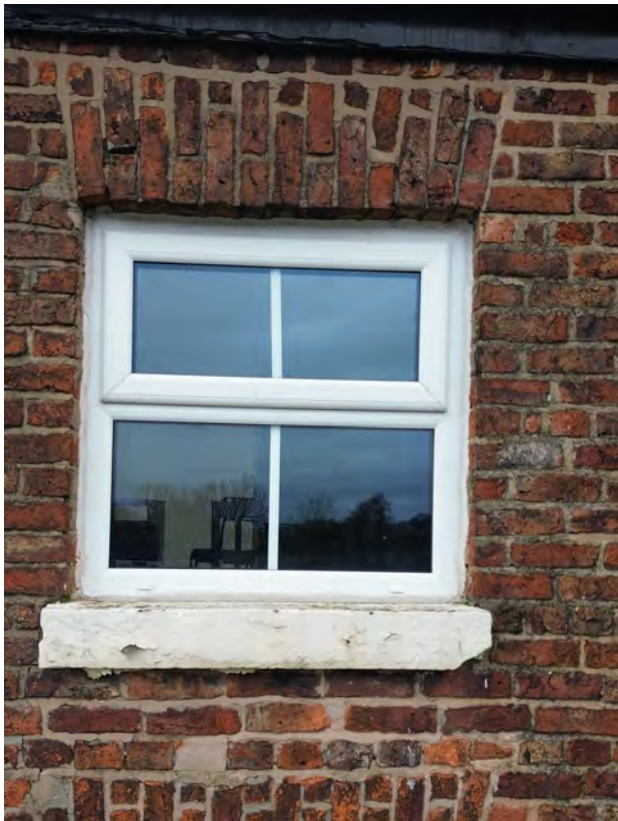
**Fig 6:**

Window S.2.6; showing general view

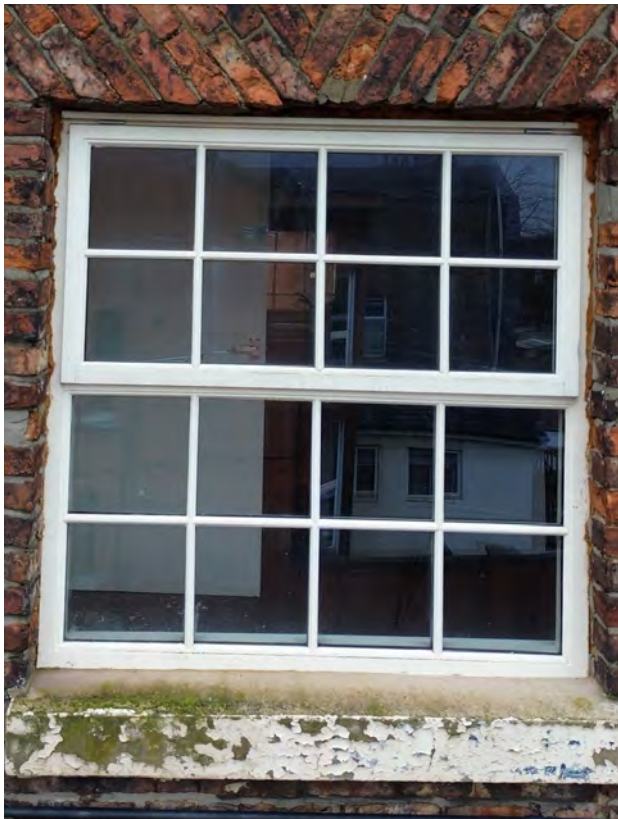
**Fig 8:**

Window W.2.7; showing general view

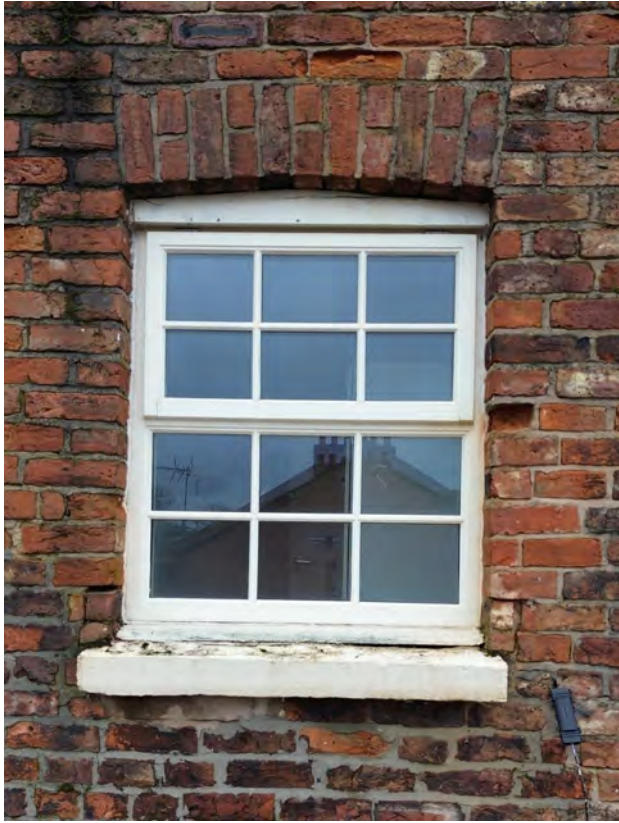
**Fig 9:**

Window W.2.8; showing general view

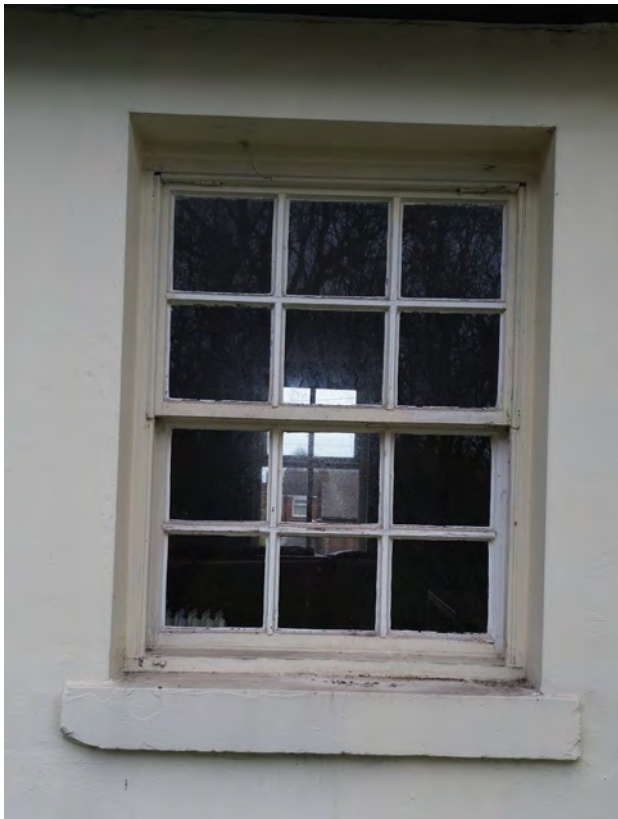
**Fig 16:**

Window N.1.5; showing general view

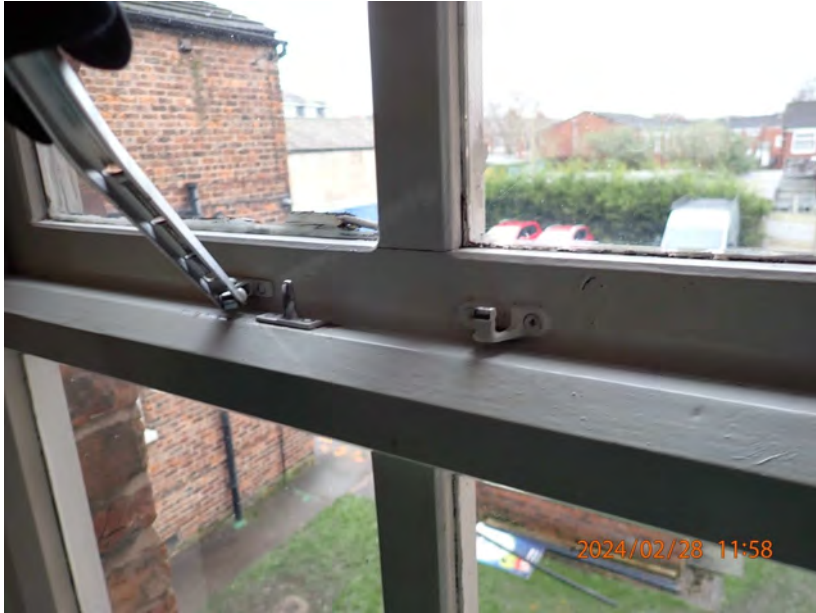
**Fig 19:**

Window S.1.6; showing non-matching pins to casement stay, preventing casement stay from being locked shut

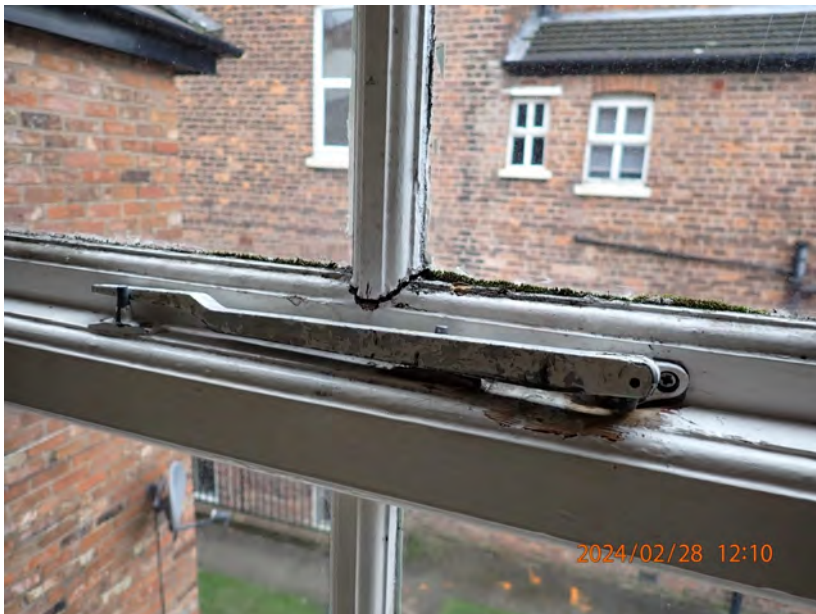
**Fig 24:**

Window E.1.8; showing casement stay misaligned with pins, preventing stay from being locked shut

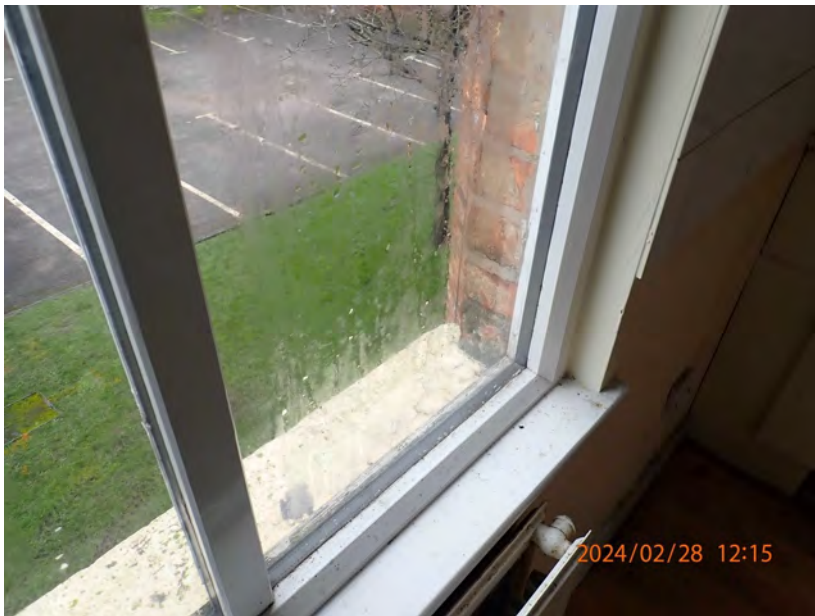
Fig 26:

Window S.1.9; showing condensate within the glazing unit

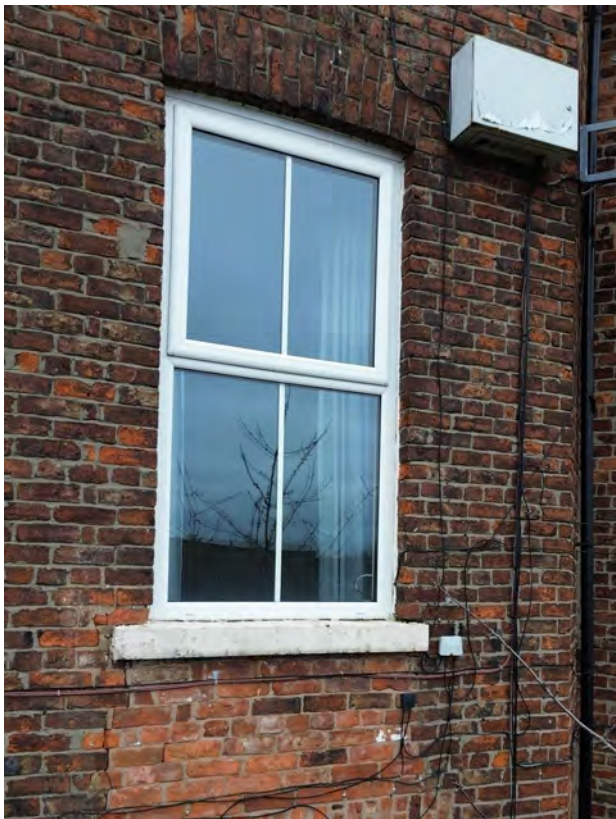
**Fig 30:**

Window S.1.11; showing general view

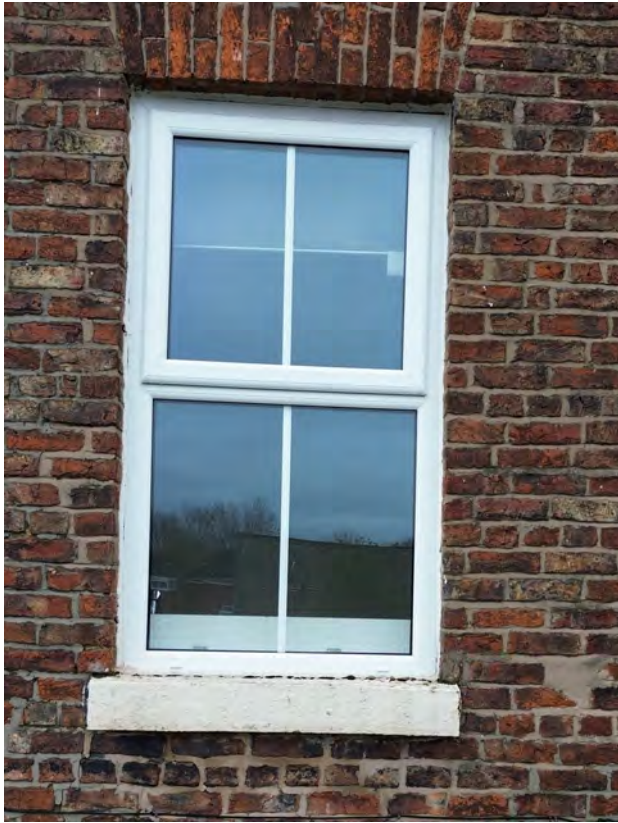
**Fig 31:**

Window S.1.12; showing general view

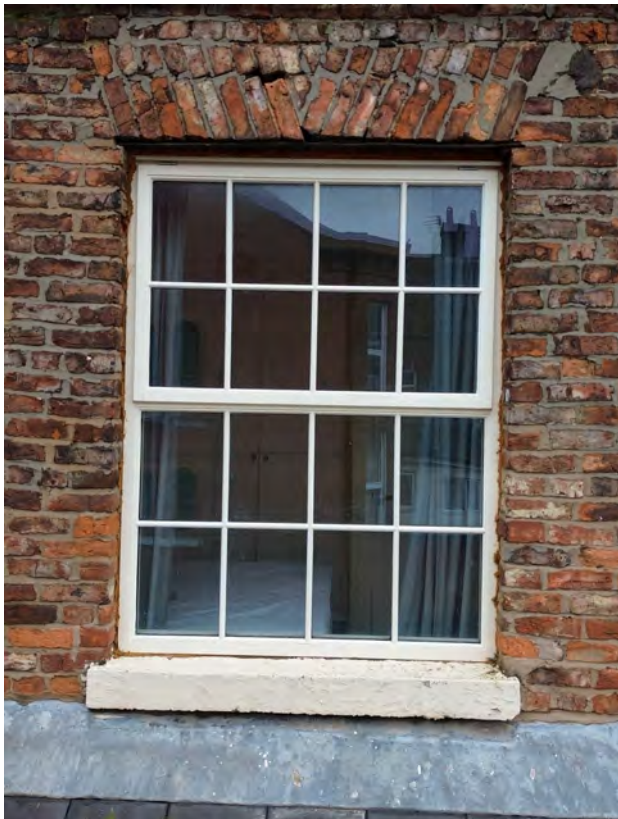
**Fig 32:**

Window W.1.13; showing general view

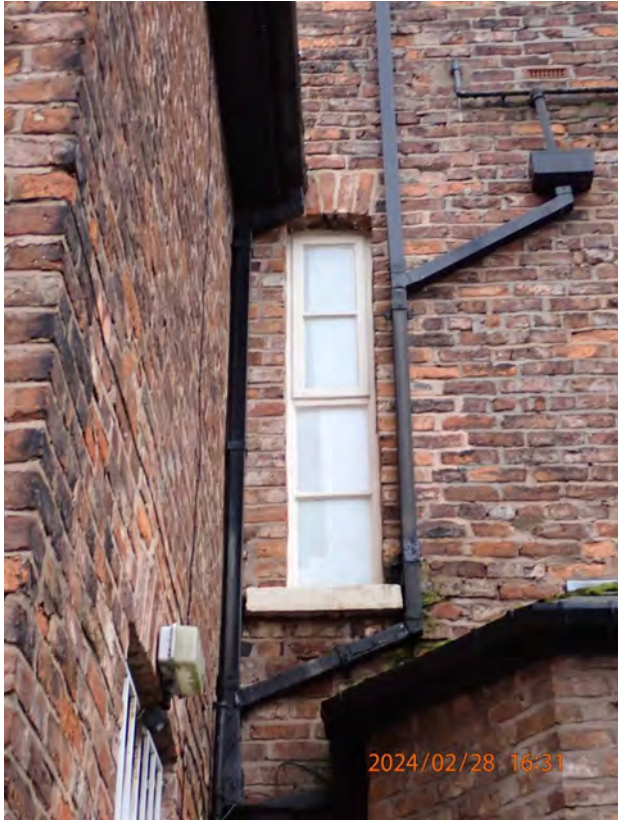
**Fig 33:**

Window W.1.14; showing general view

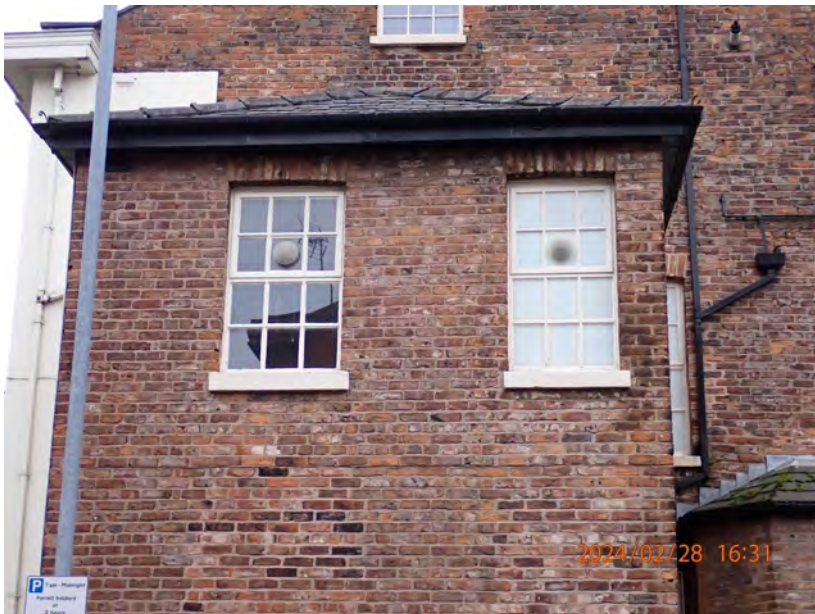
**Fig 34:**

Windows W.1.15 and W.1.16; showing general view

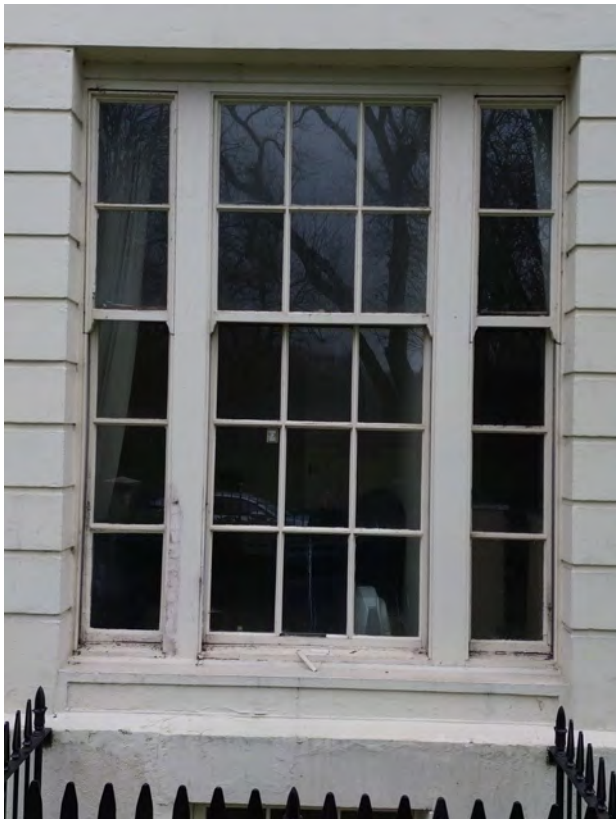
**Fig 36:**

Windows N.G.2a, N.G.2b and N.G.2c;  
showing general view

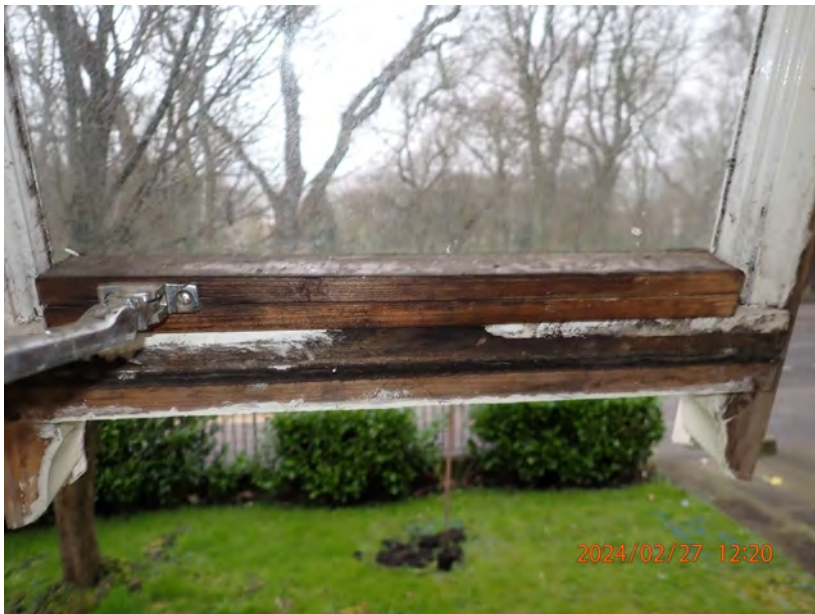
**Fig 38:**

Window N.G.2a; showing arrangement of timber batons to allow fixing of casement stay

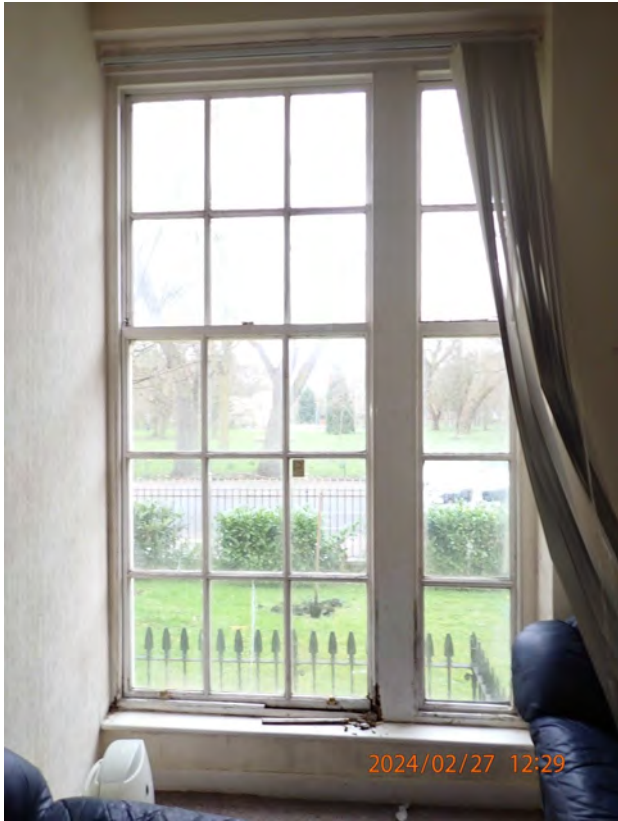
**Fig 39:**

Windows N.G.2b and N.G.2c; showing general view from interior

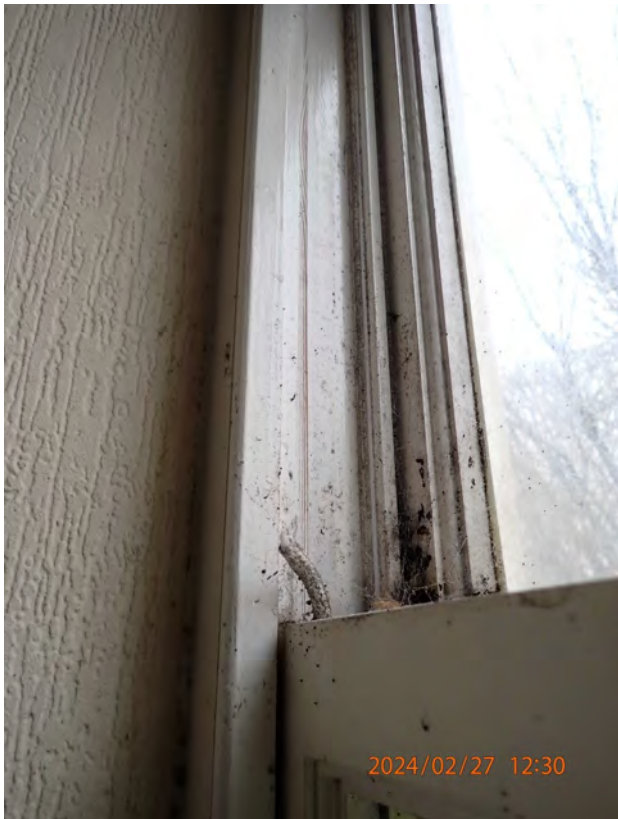
**Fig 40:**

Window N.G.2b; showing snapped sash cord

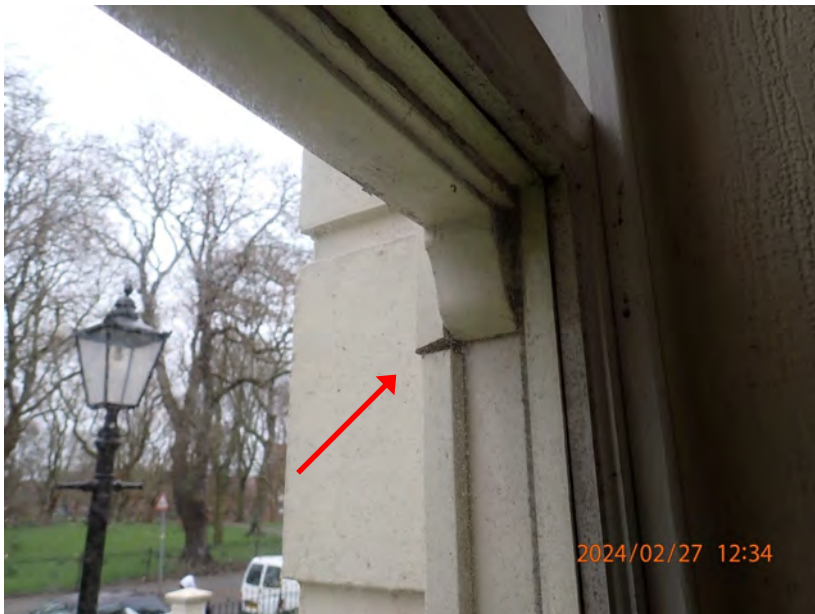
**Fig 44:**

Window N.G.2c; showing where former sliding sash has been cut to form timber casement

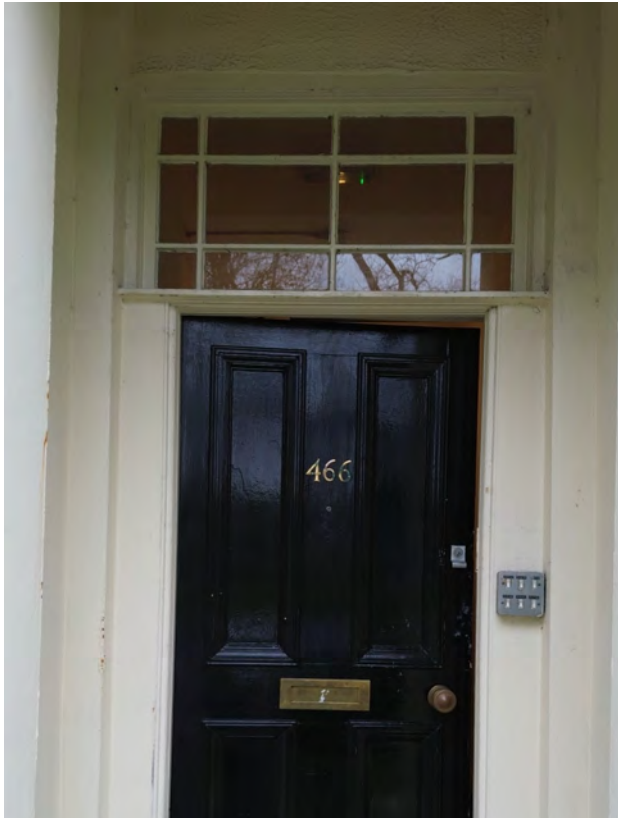
**Fig 45:**

Window N.G.3; showing general view

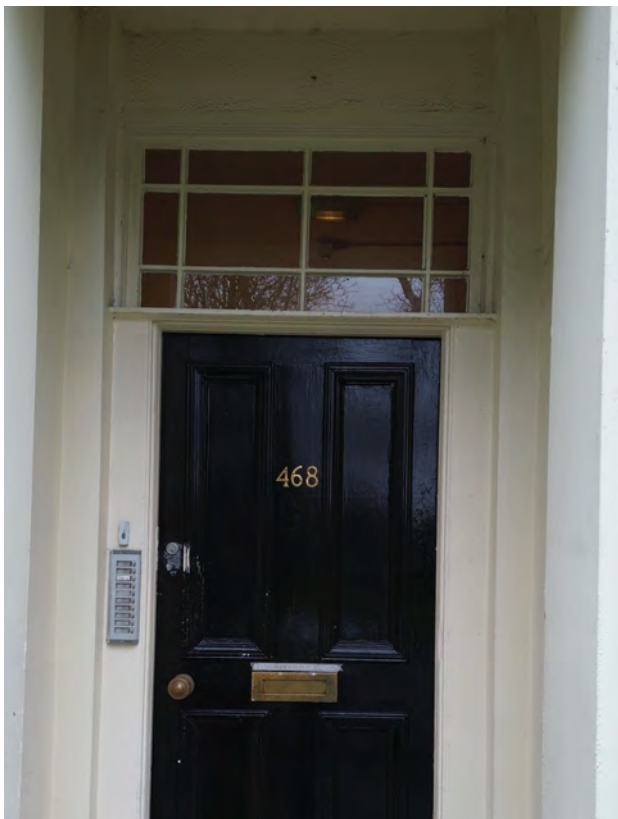
**Fig 46:**

Window N.G.4; showing general view

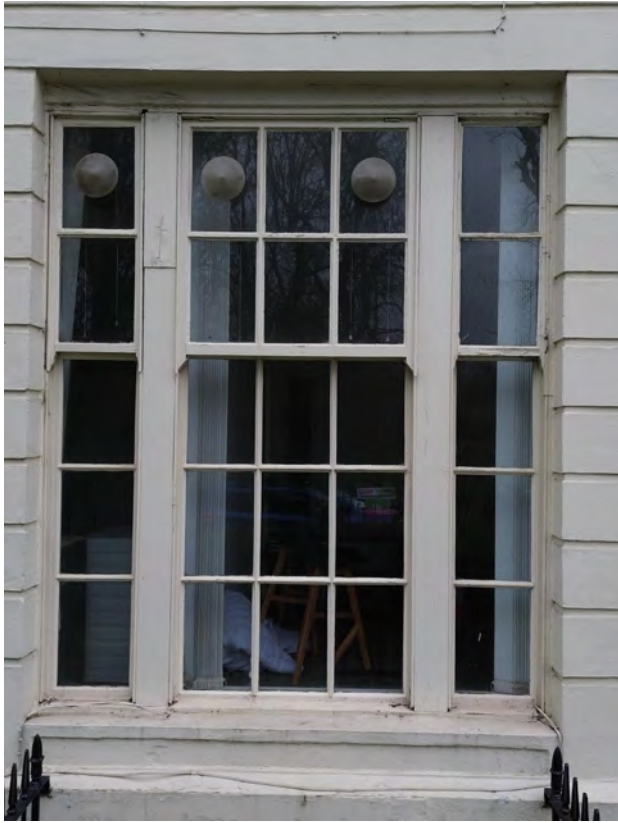
**Fig 47:**

Window N.G.5a, N.G.5b and N.G.5c;  
showing general view

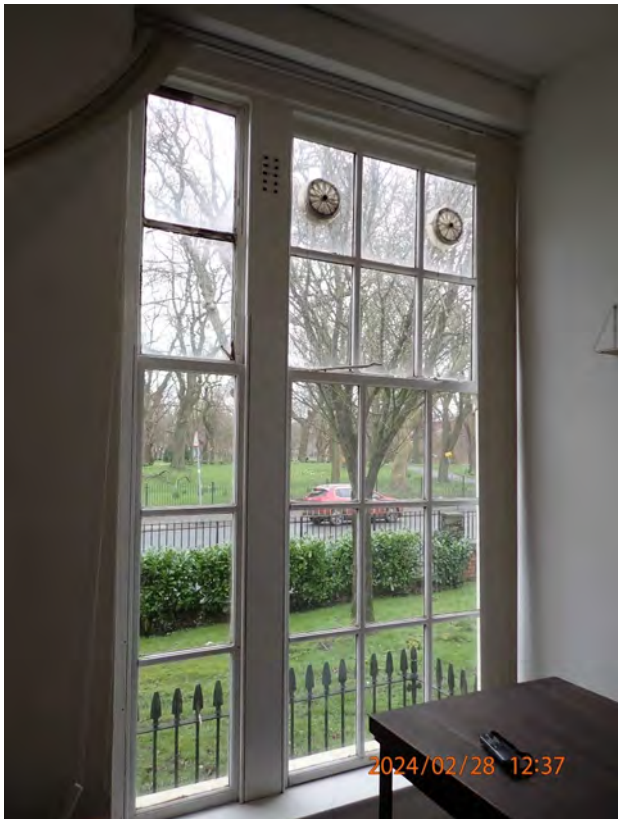
**Fig 48:**

Window N.G.5a and N.G.5b; showing  
general view from interior

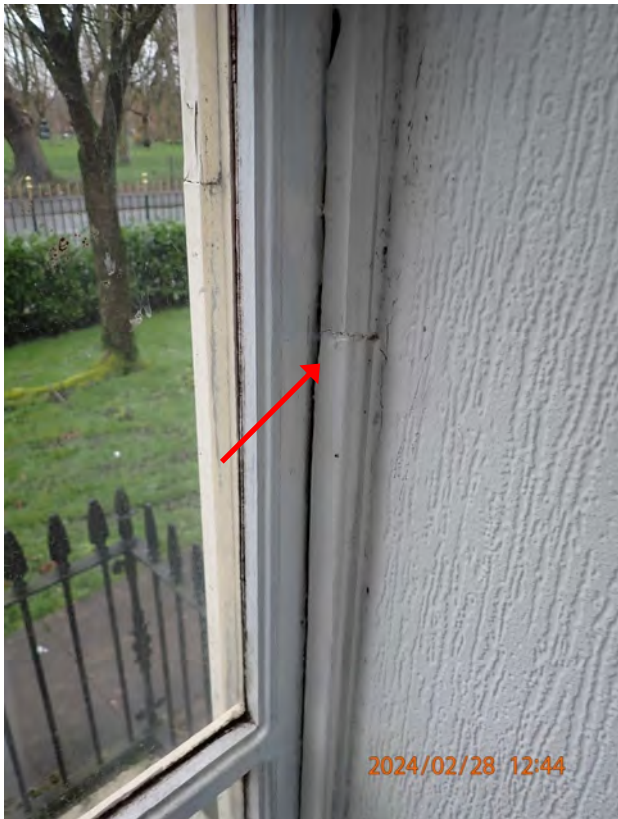
**Fig 50:**

Window N.G.5b; showing previous timber splice repair

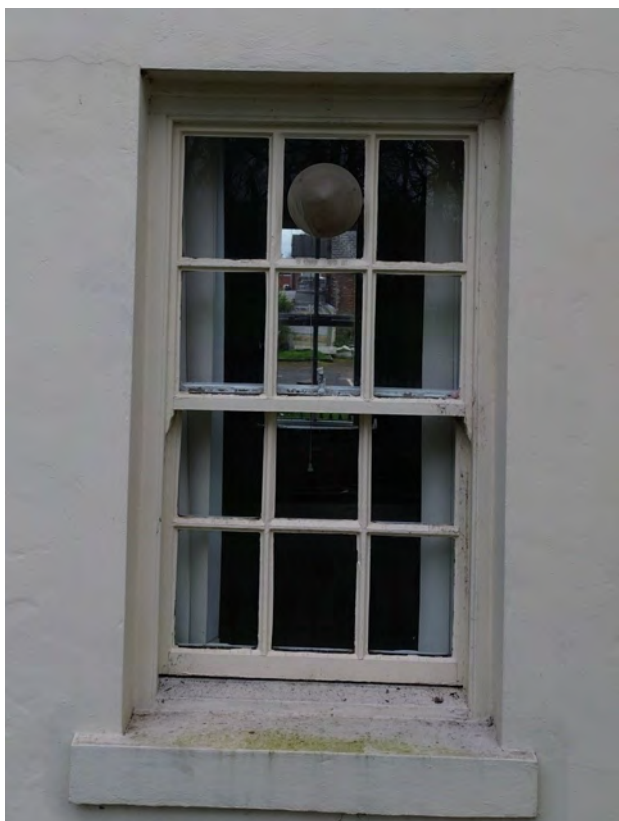
**Fig 52:**

Window N.G.6; showing general view

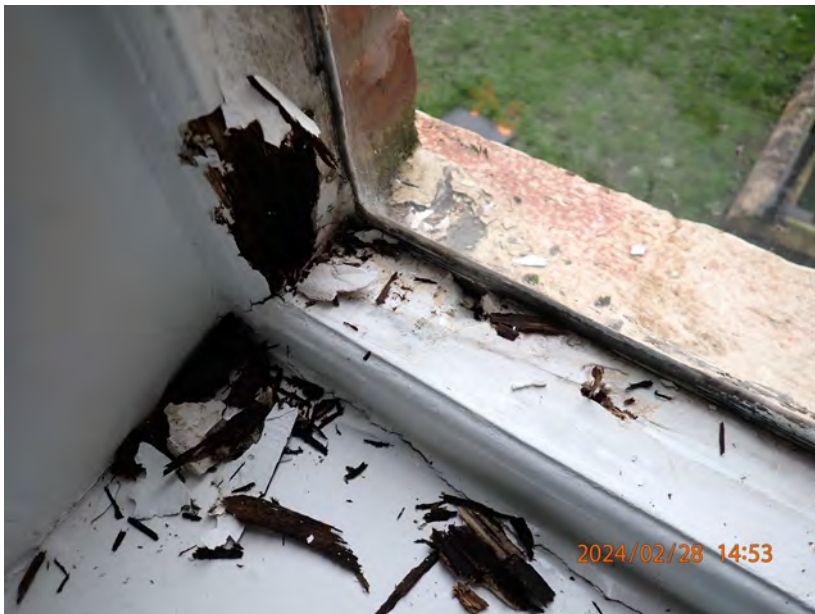
**Fig 54:**

Window S.G.7; showing timber decay to jamb and sill

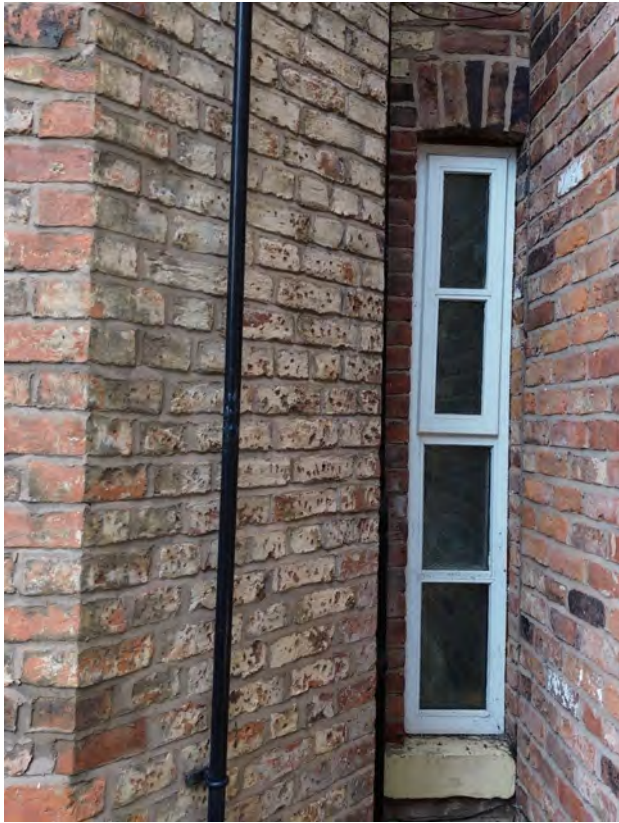
**Fig 55:**

Window E.G.8; showing general view

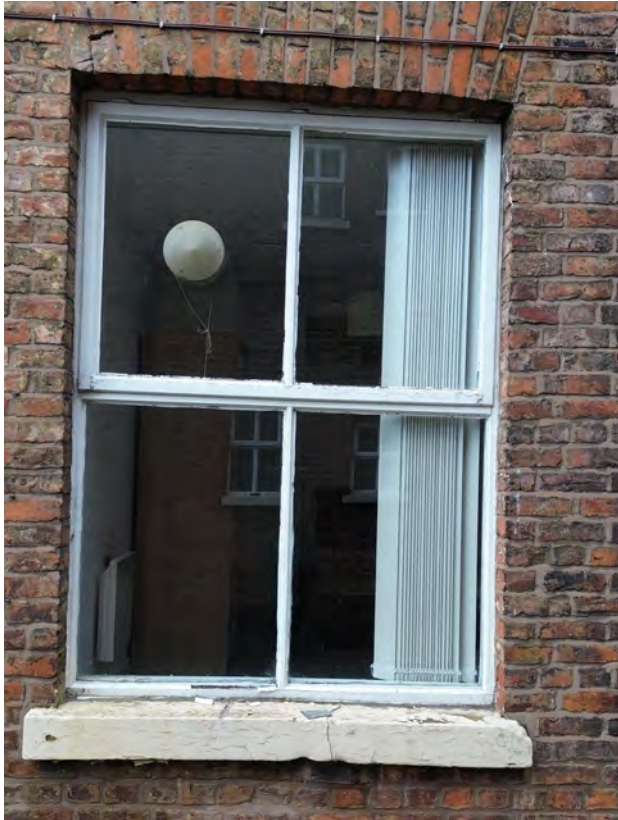
**Fig 57:**

Window E.G.9; showing general view

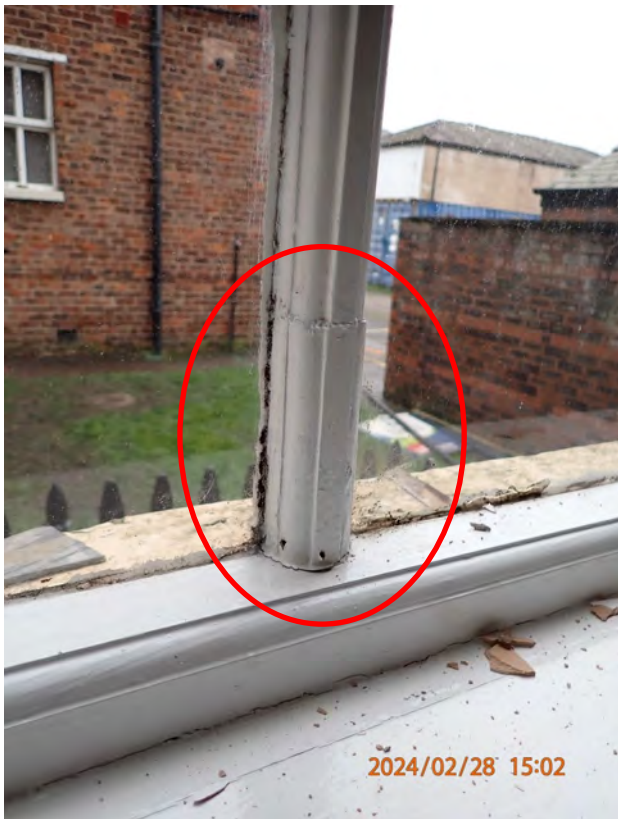
**Fig 58:**

Window E.G.9; showing timber splice repair to mullion

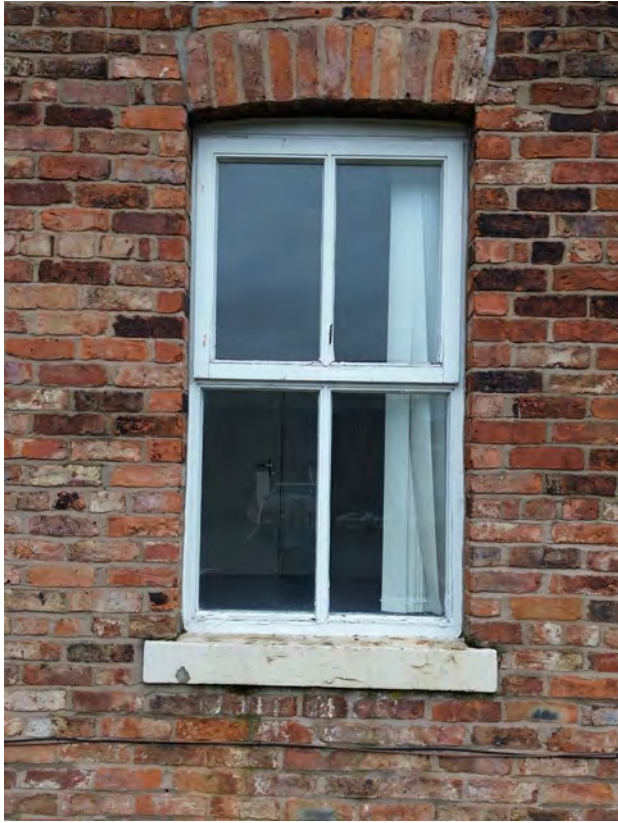
**Fig 59:**

Window S.G.10; showing general view

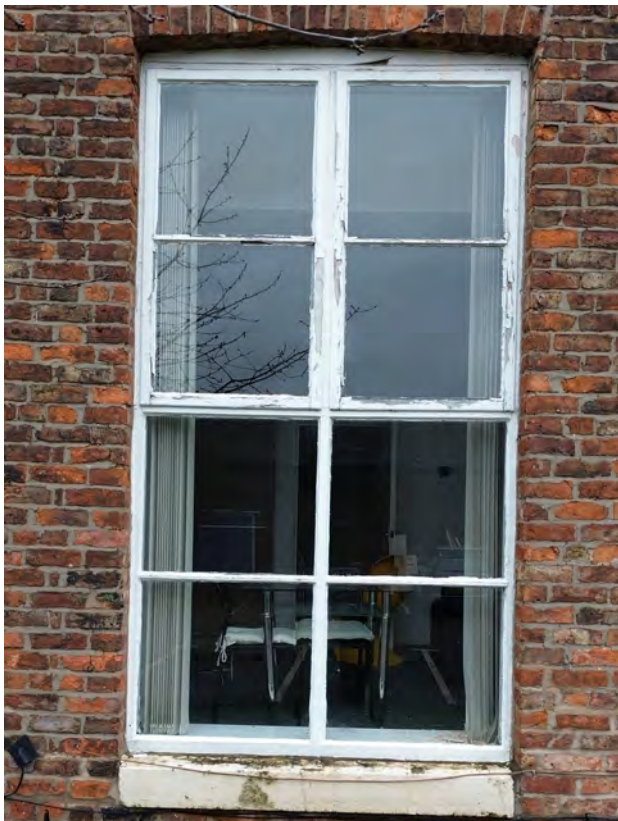
**Fig 60:**

Window S.G.11; showing general view

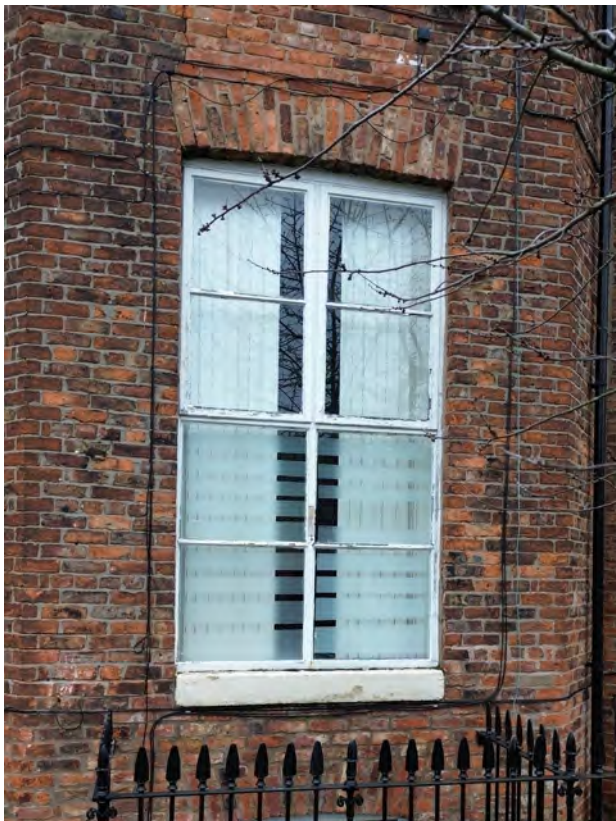
**Fig 62:**

Window S.G.12; showing general view

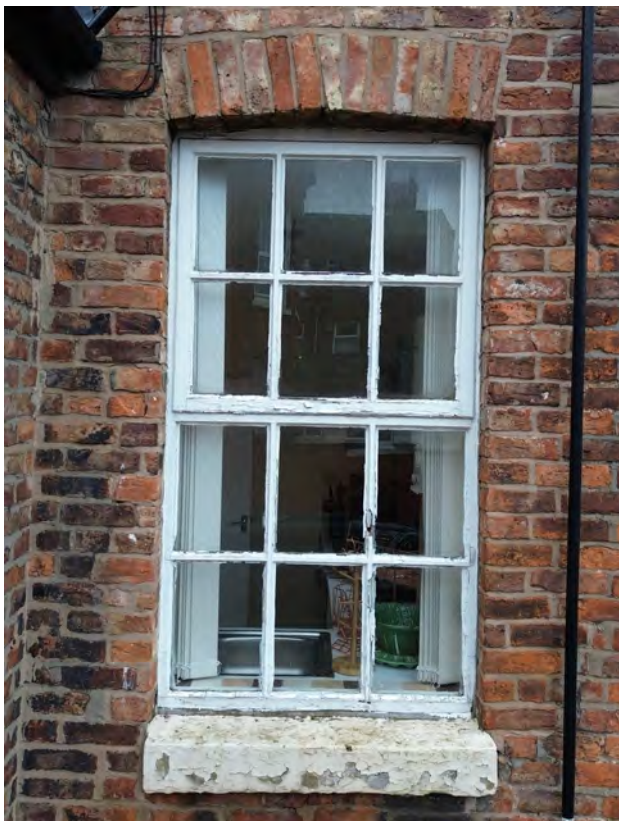
**Fig 64:**

Window W.G.14; showing general view

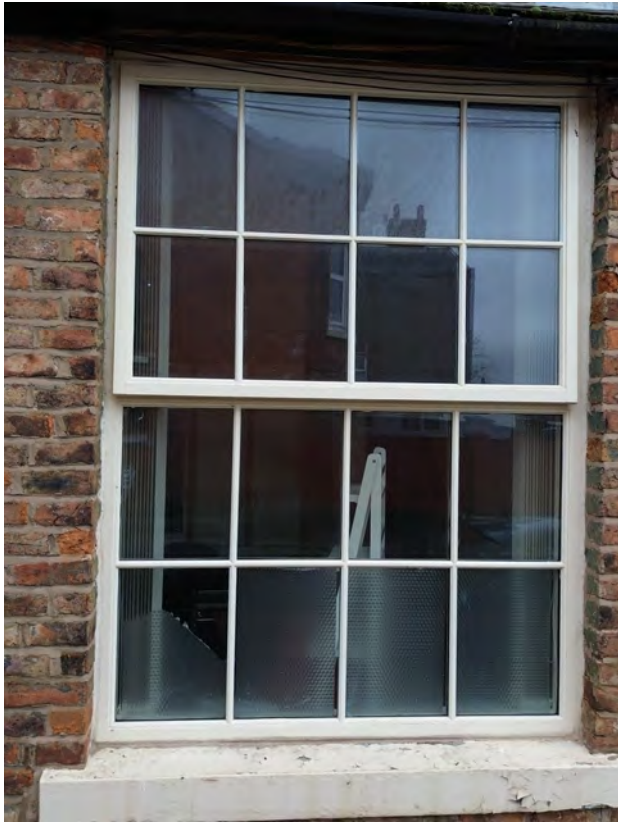
**Fig 65:**

Window W.G.15; showing general view

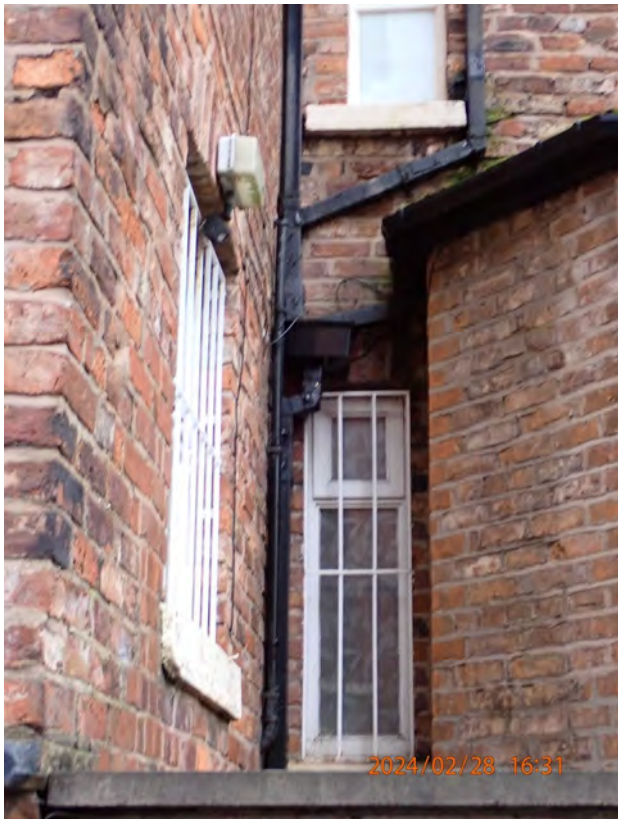
**Fig 66:**

Window W.G.16; showing general view

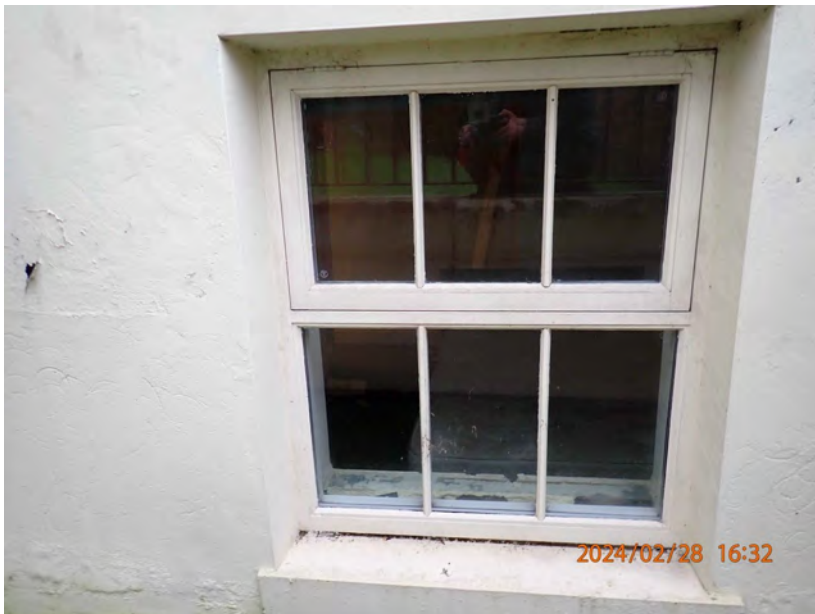
**Fig 68:**

Window N.B.1; showing general view

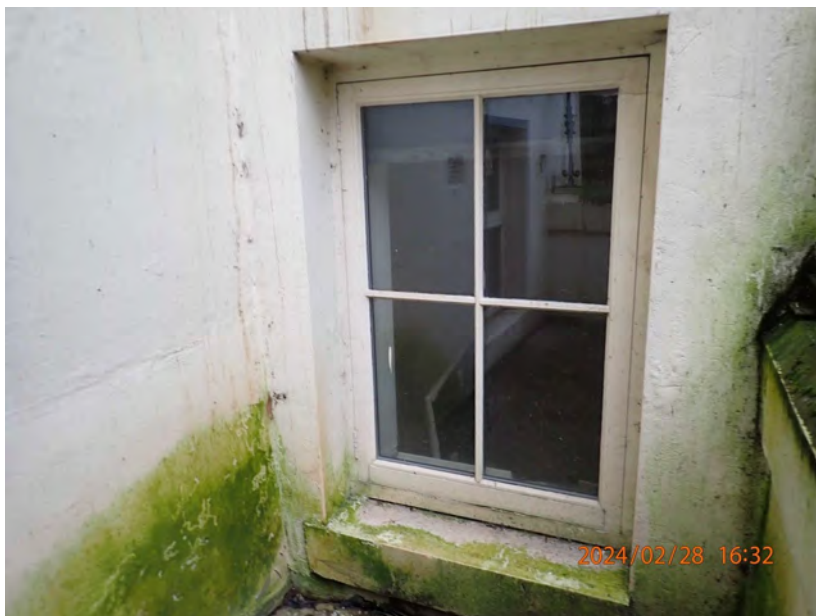
**Fig 72:**

| REF | ELEV | FLOOR | UNIT | WINDOW TYPE | MAT | DIMENSIONS (MM) | OPERABILITY | RELEASE | EASE | REHANG | BALANCE | RENEW | RE-ALIGN | ELEMENTS TO REPAIR | ELEMENTS TO REPLACE | PREVIOUS REPAIRS | GLAZING & PUTTY | FURNITURE | DECORATION | ADDITIONAL COMMENTS | PHOTO REFERENCE |
|---|---|---|---|---|---|---|---|---|---|---|---|---|---|---|---|---|---|---|---|---|---|
| E.B.5 | E | B | 5 | 2x2 pane timber casement with 1no. side hung opening casement | Timber | ~1140x760mm | Inoperable - handle to locking mechanism is missing meaning window cannot be unlocked | - | - | - | - | - | - | - | - | - | Double-glazed | 1no. modern chrome casement stay and 1no. modern chrome locking mechanism. Handle to locking mechanism is missing, meaning window cannot be unlocked. <b>Locking mechanism should be replaced</b> | Window has been painted with a modern, film-forming paint which is inappropriate for a timber window and is flaking.<br><b>Decoration should be stripped back and window redecorated with an appropriate moisture vapour permeable paint</b> | | Fig. 72 |

Window E.B.5; showing general view

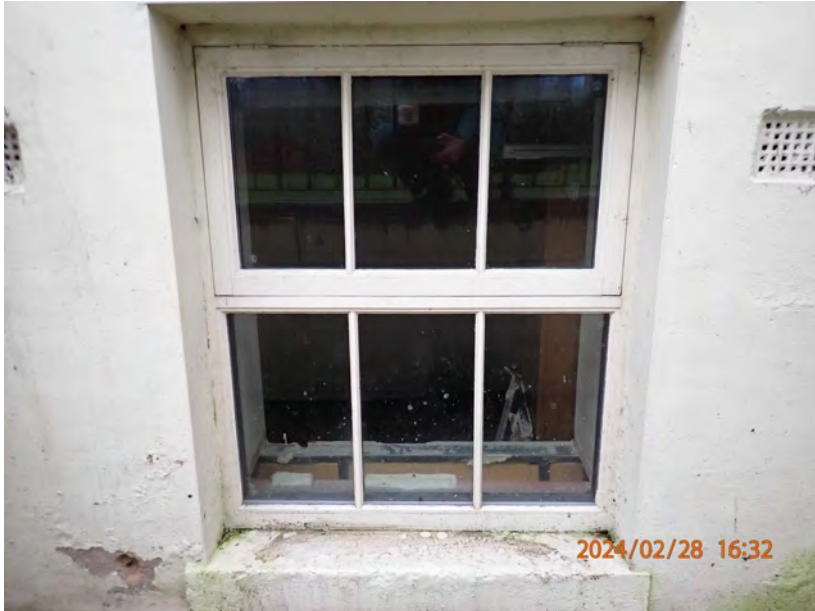
**Fig 73:**

| REF | ELEV | FLOOR | UNIT | WINDOW TYPE | MAT | DIMENSIONS (MM) | OPERABILITY | RELEASE | EASE | REHANG | BALANCE | RENEW | RE-ALIGN | ELEMENTS TO REPAIR | ELEMENTS TO REPLACE | PREVIOUS REPAIRS | GLAZING & PUTTY | FURNITURE | DECORATION | ADDITIONAL COMMENTS | PHOTO REFERENCE |
|---|---|---|---|---|---|---|---|---|---|---|---|---|---|---|---|---|---|---|---|---|---|
| N.B.6 | N | B | 6 | 2x3 pane timber casement with 1no. opening awning | Timber | ~1120x970mm | Operable | - | - | - | - | - | - | - | - | - | Double-glazed. | 2no. modern chrome casement stays to awning | Window has been painted with a modern, film-forming paint which is inappropriate for a timber window and is flaking.<br><b>Decoration should be stripped back and window redecorated with an appropriate moisture vapour permeable paint</b> | | Fig. 73 |

Window N.B.6; showing general view

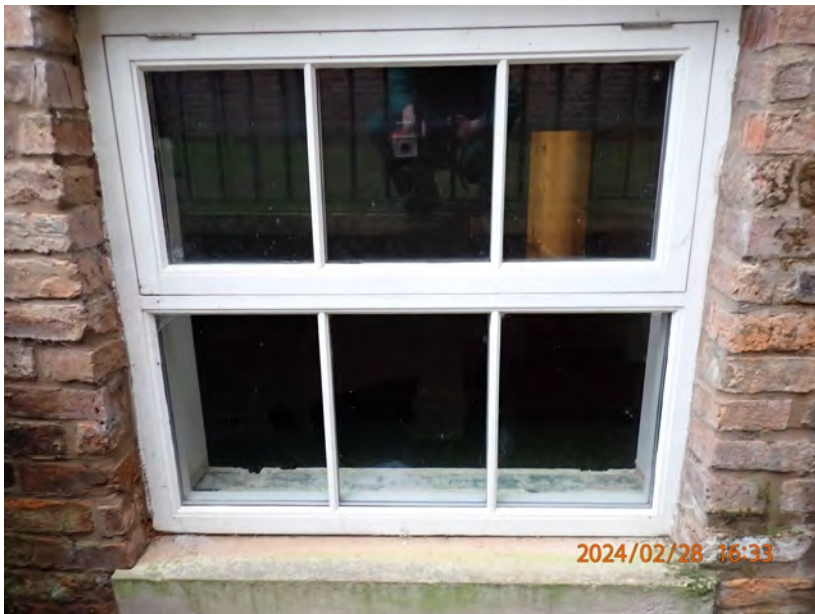
**Fig 74:**

| REF | ELEV | FLOOR | UNIT | WINDOW TYPE | MAT | DIMENSIONS (MM) | OPERABILITY | RELEASE | EASE | REHANG | BALANCE | RENEW | RE-ALIGN | ELEMENTS TO REPAIR | ELEMENTS TO REPLACE | PREVIOUS REPAIRS | GLAZING & PUTTY | FURNITURE | DECORATION | ADDITIONAL COMMENTS | PHOTO REFERENCE |
|---|---|---|---|---|---|---|---|---|---|---|---|---|---|---|---|---|---|---|---|---|---|
| E.B.7 | E | B | 7 | 2x3 pane timber casement with 1no. opening awning | Timber | ~1010x1095mm | Operable | - | - | - | - | - | - | - | - | - | Double-glazed. Window putty is in serviceable condition | 2no. modern casement stays to awning | Window has been painted with a modern, film-forming paint which is inappropriate for a timber window and is flaking.<br><b>Decoration should be stripped back and window redecorated with an appropriate moisture vapour permeable paint</b> | | Fig. 74 |

Window E.B.7; showing general view

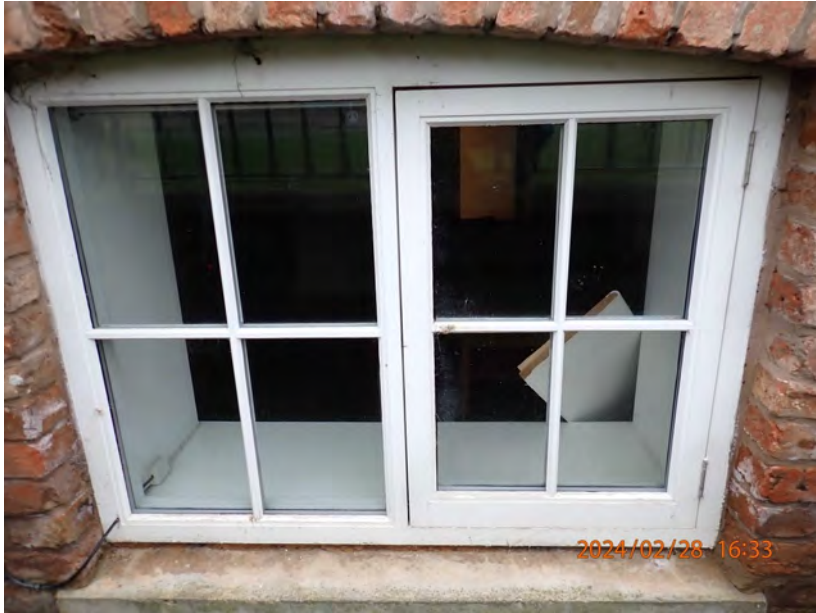
**Fig 75:**

| REF | ELEV | FLOOR | UNIT | WINDOW TYPE | MAT | DIMENSIONS (MM) | OPERABILITY | RELEASE | EASE | REHANG | BALANCE | RENEW | RE-ALIGN | ELEMENTS TO REPAIR | ELEMENTS TO REPLACE | PREVIOUS REPAIRS | GLAZING & PUTTY | FURNITURE | DECORATION | ADDITIONAL COMMENTS | PHOTO REFERENCE |
|---|---|---|---|---|---|---|---|---|---|---|---|---|---|---|---|---|---|---|---|---|---|
| S.B.8 | S | B | 8 | 2x4 pane timber casement with 1no. side-hung opening casement to east | Timber | ~855x1155mm | Partially operable - casement is binding in frame | | Casement | | | | | - | - | - | Double-glazed | 1no. modern chrome casement stay with 1no. modern chrome locking mechanism | Window has been painted with a modern, film-forming paint which is inappropriate for a timber window and is flaking.<br><b>Decoration should be stripped back and window redecorated with an appropriate moisture vapour permeable paint</b> | | Fig. 75 |

Window S.B.8; showing general view
