# Hutton + Rostron Environmental Investigations Limited

## 466-468 Moss Lane East: Window Condition Survey

Site note 3 for 27-28 February 2024, job no. 214-22

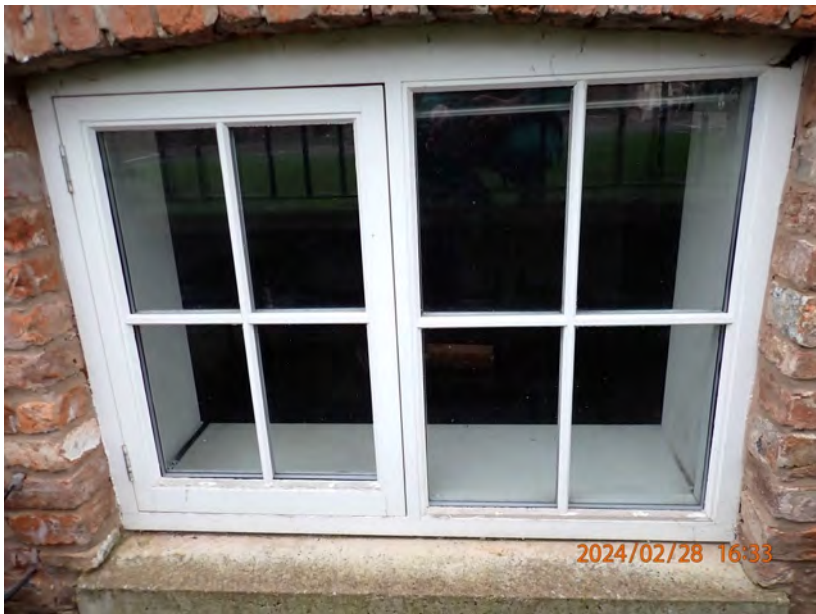
**Fig 76:**

| REF | ELEV | FLOOR | UNIT | WINDOW TYPE | MAT | DIMENSIONS (MM) | OPERABILITY | RELEASE | EASE | REHANG | BALANCE | RENEW | RE-ALIGN | ELEMENTS TO REPAIR | ELEMENTS TO REPLACE | PREVIOUS REPAIRS | GLAZING & PUTTY | FURNITURE | DECORATION | ADDITIONAL COMMENTS | PHOTO REFERENCE |
|---|---|---|---|---|---|---|---|---|---|---|---|---|---|---|---|---|---|---|---|---|---|
| S.B.9 | S | B | 9 | 2x4 pane timber casement with 1no. side-hung opening casement to west | Timber | ~855x1200mm | Operable | - | - | - | - | - | - | - | - | - | Double-glazed. Window putty is in serviceable condition | 1no. modern chrome casement stay with 1no. modern chrome locking mechanism | Window has been painted with a modern, film-forming paint which is inappropriate for a timber window and is flaking.<br><b>Decoration should be stripped back and window redecorated with an appropriate moisture vapour permeable paint</b> | | Fig. 76 |

Window S.B.9; showing general view

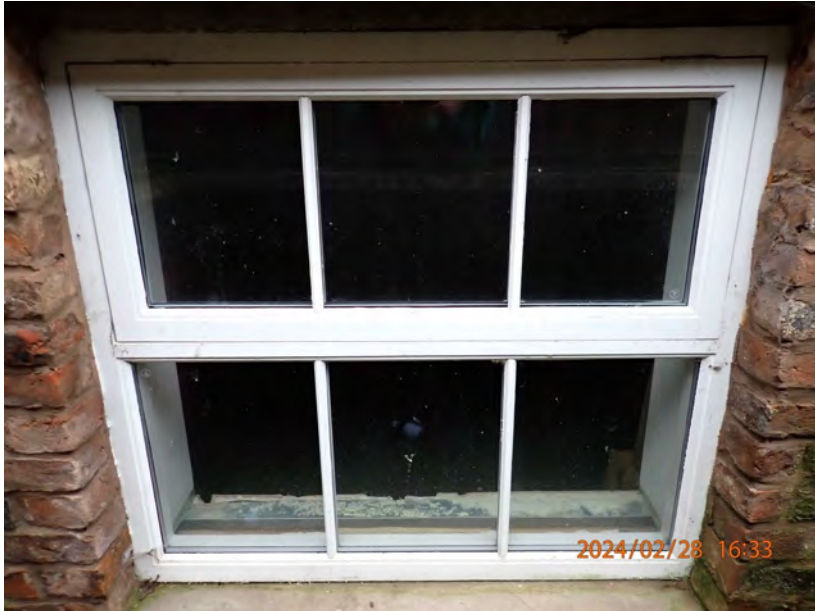
**Fig 77:**

| REF | ELEV | FLOOR | UNIT | WINDOW TYPE | MAT | DIMENSIONS (MM) | OPERABILITY | RELEASE | EASE | REHANG | BALANCE | RENEW | RE-ALIGN | ELEMENTS TO REPAIR | ELEMENTS TO REPLACE | PREVIOUS REPAIRS | GLAZING & PUTTY | FURNITURE | DECORATION | ADDITIONAL COMMENTS | PHOTO REFERENCE |
|---|---|---|---|---|---|---|---|---|---|---|---|---|---|---|---|---|---|---|---|---|---|
| W.B.10 | W | B | 10 | | Timber | ~1005x1095mm | Partially operable - casement stays are binding on casement causing mechanical wear to frame | - | - | - | - | - | - | - | - | - | Double-glazed. Window putty is in serviceable condition | 2no. modern chrome casement stays to awning. <b>Casement stays should be relocated to stop binding and mechanical wear</b> | Window has been painted with a modern, film-forming paint which is inappropriate for a timber window and is flaking.<br><b>Decoration should be stripped back and window redecorated with an appropriate moisture vapour permeable paint</b> | | Fig. 77 |

Window W.B.10; showing general view
