# Inspection Report

Project Name: Upper Campfield  
Start Date:  
Client: T J M Projects Limited  
Jackson Street  
St Helens

| Project Name | Project Number | Project Date |
|---|---|---|
| Upper Campfield | | 20/08/2024 |

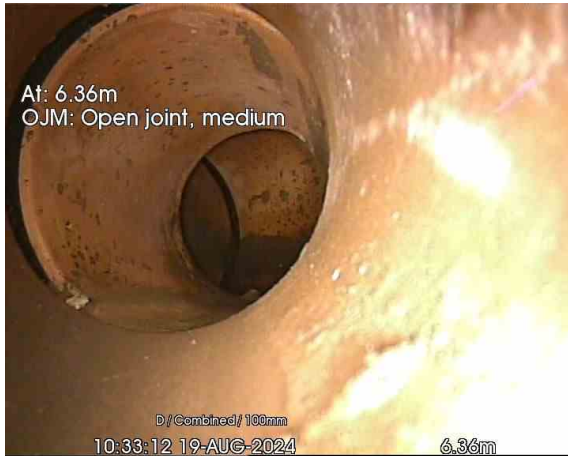
5\_6-36m\_103312.jpg, 00:01:11, 6.36 m  
Open joint, medium

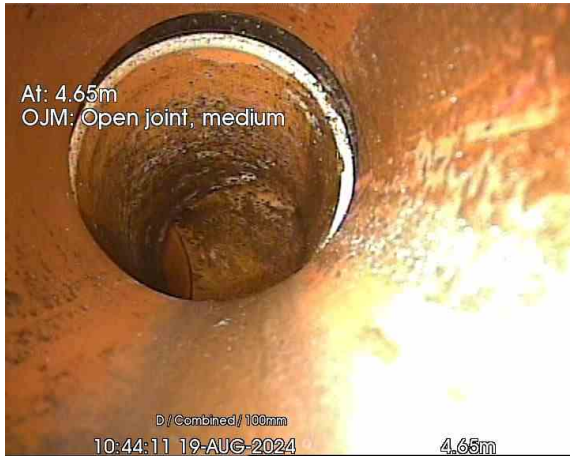
7\_4-65m\_104411.jpg, 00:01:03, 4.65 m  
Open joint, medium

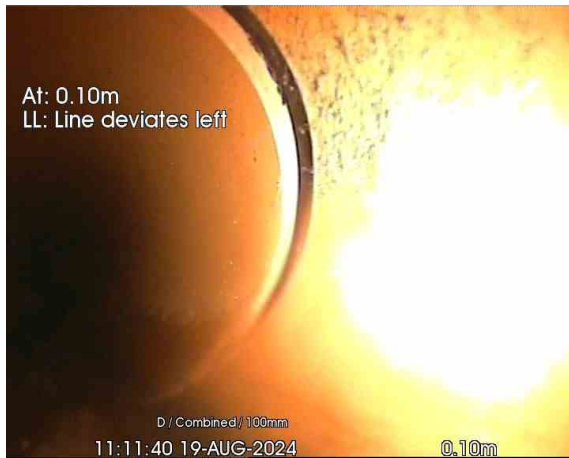
12\_0-10m\_111140.jpg, 00:00:06, 0.10 m  
Line deviates left

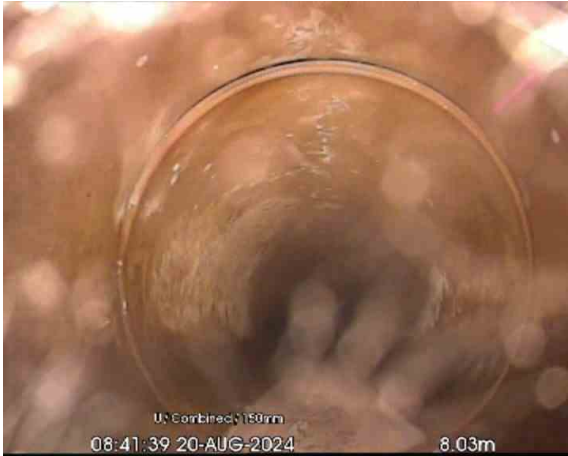
AX\_b979f001-f043-4f2d-a4d9-4687af72dbe4\_20240820\_1106  
37\_582.jpg, 00:00:42, 8.03 m  
Joint displaced, medium
