## GAS MEMBRANE VALIDATION – BENNETT STREET

| Project Name: Bennett Street |
| Project Number: 15-974 |
| Plots: 16 & 17 |

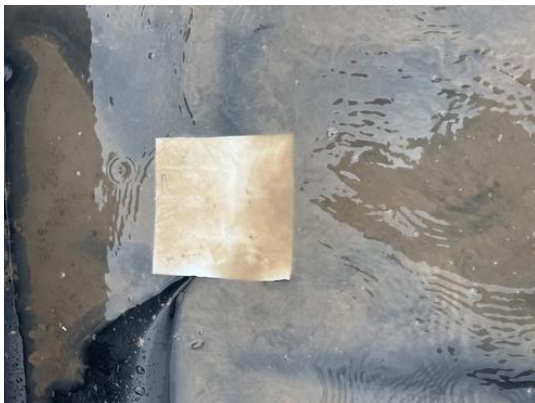
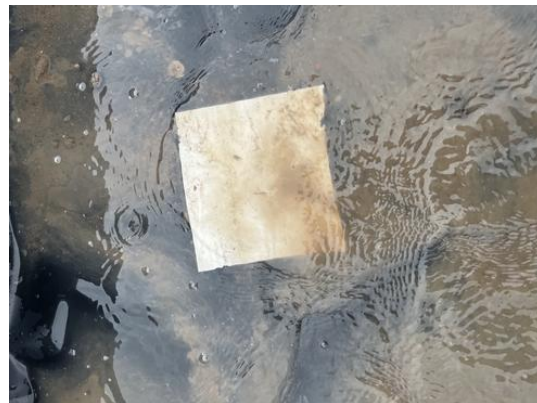
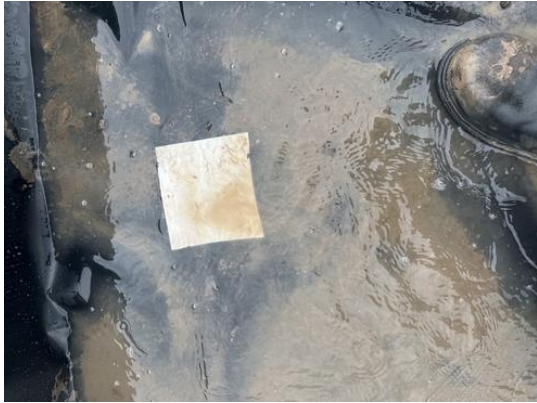
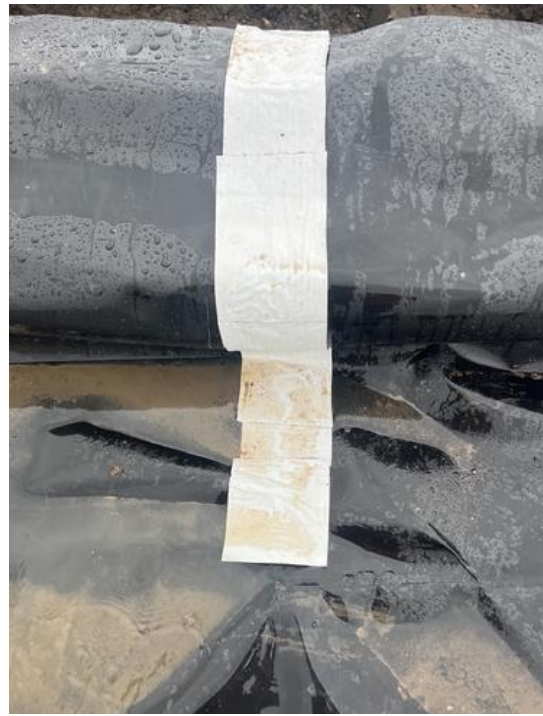
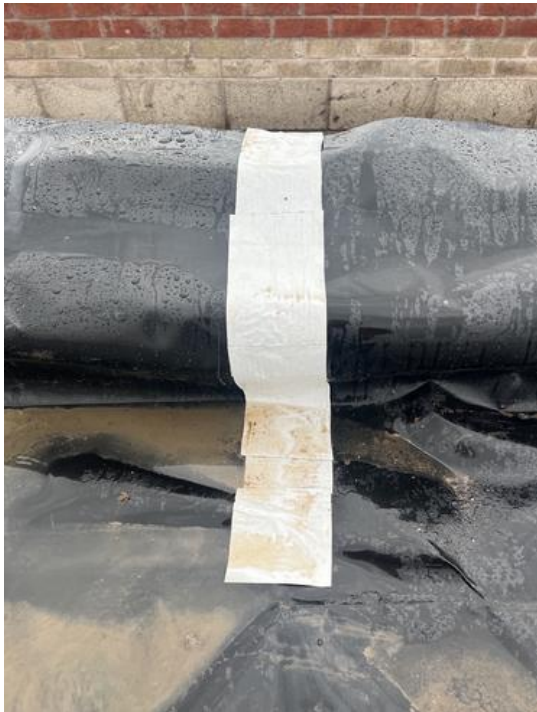
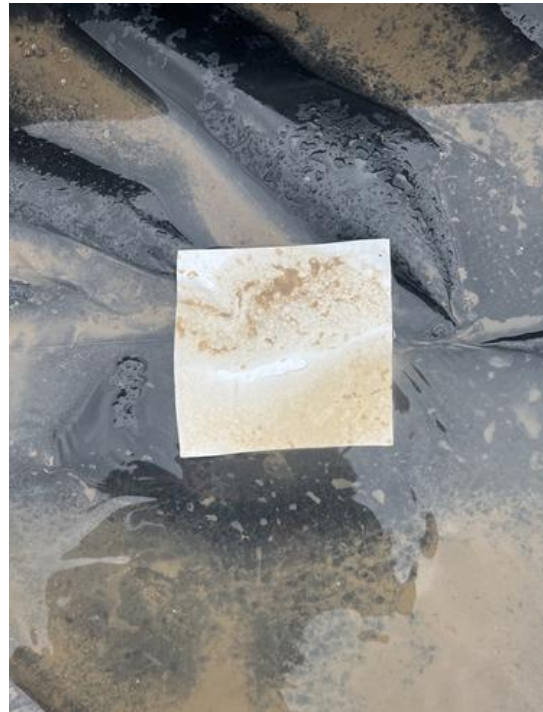
Gas Membrane Condition: Open punctures, tears, rips, stretching, Presence of debris, Repairs, Signs of weakness such as raised or sunken indentations, Protection plan in place to restrict access to lain gas membrane? IF FAIL DESCRIPTION IN ACTIONS AND PHOTOS REQUIRED

Pass

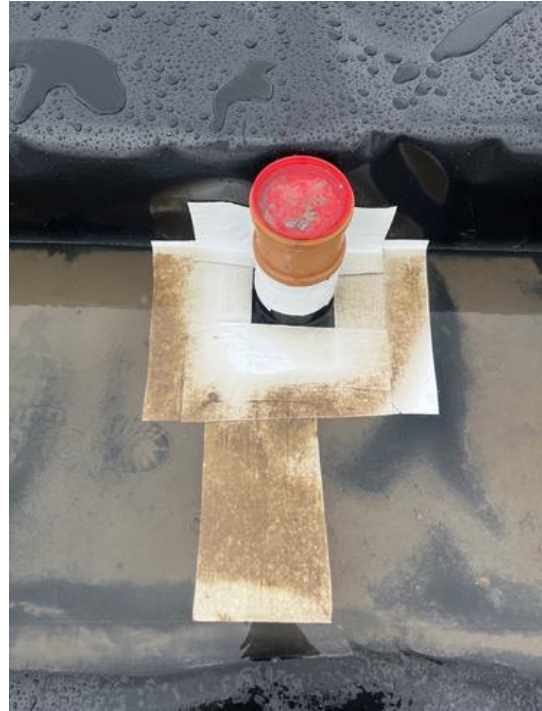
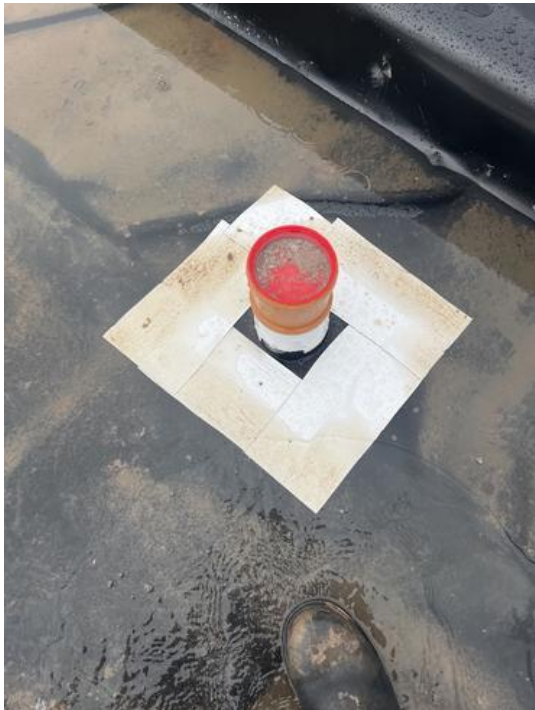
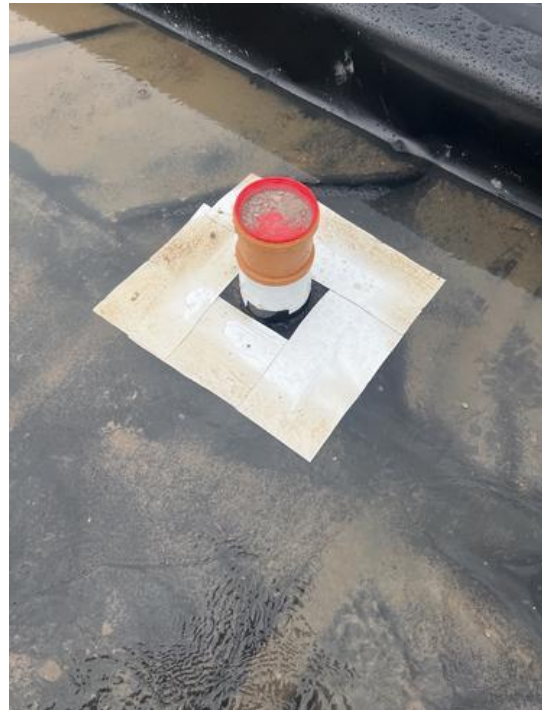
Service entries seals: Top hats seal arrangements fixed around service entries? Use of Jubilee clips?

Yes
