# Asbestos Analyst's Certificate Report

Job Ref No: **538234**, Cert Ref No: **89608**, Account Ref No: **25660**, Contract Ref No: **85664**

## First Street, Manchester City Centre, M15 4AA

**Title:** Asbestos Fibre Air Monitoring at First Street, Central Manchester

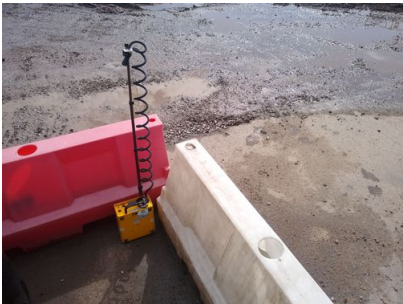
Additional Photo 4

Adjacent potentially contaminated spoil during removal

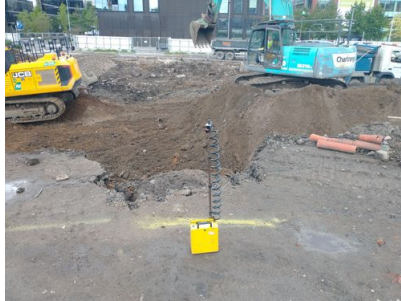
| Additional Photo 1 | <br>Image Added: 2022-09-08 13:28:16<br>position of pump |

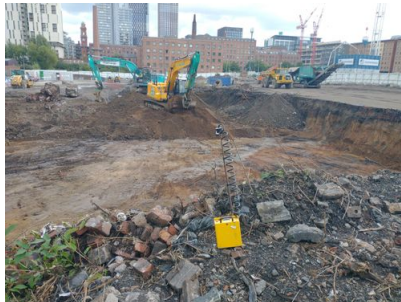
| Additional Photo 2 | <br>Image Added: 2022-09-08 13:28:43<br>Position of pump |

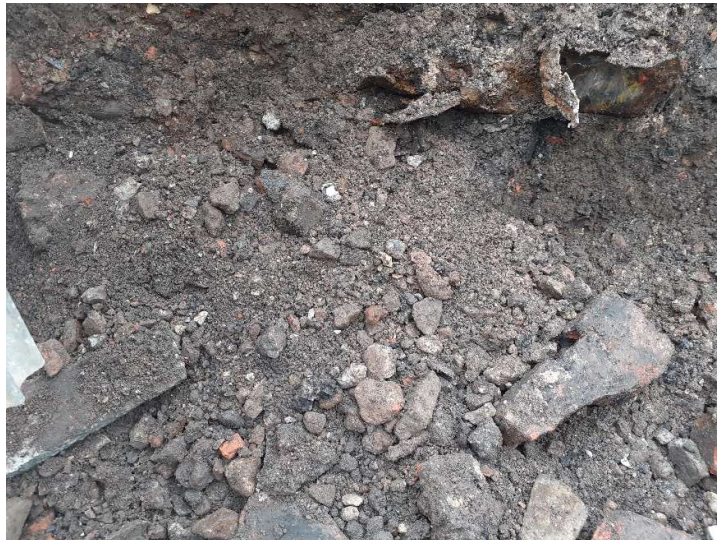
Plate 2: Friday 25<sup>th</sup> August 2022. Asbestos hotspot 1 – image of the eastern side.

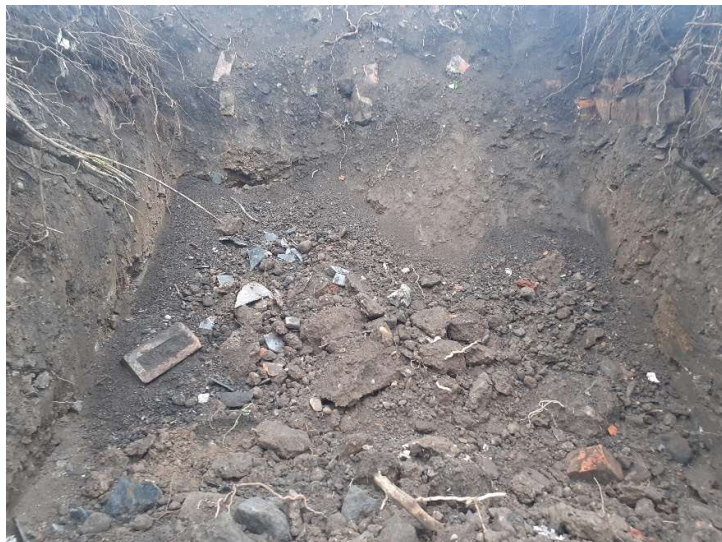
Plate 23: Friday 25<sup>th</sup> August 2022. Asbestos fragments found in made ground excavations.

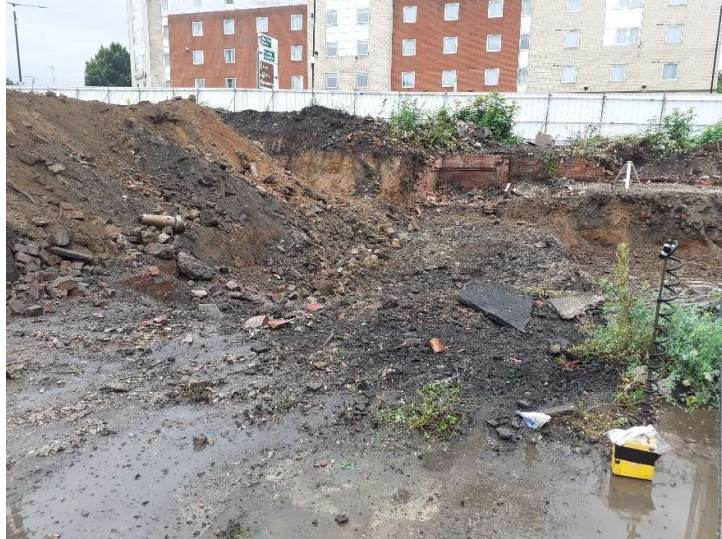
Plate 36: Tuesday 6<sup>th</sup> September 2022. Air monitoring location near excavations.

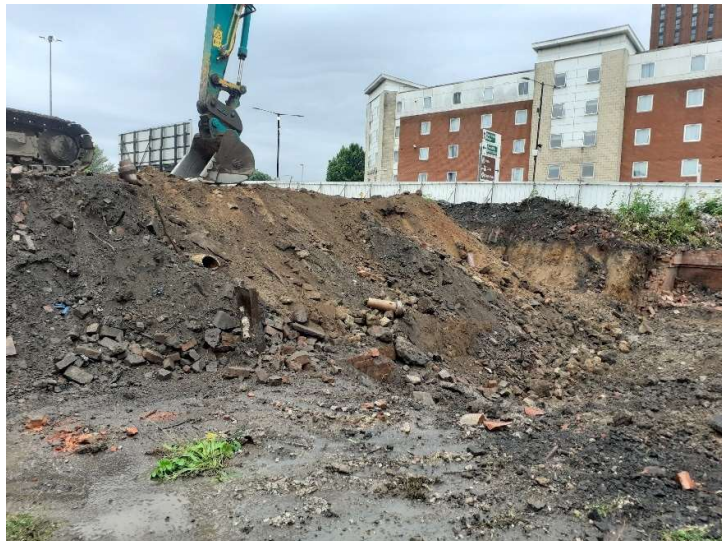
Plate 37: Tuesday 6<sup>th</sup> September 2022. Made ground stockpiles.

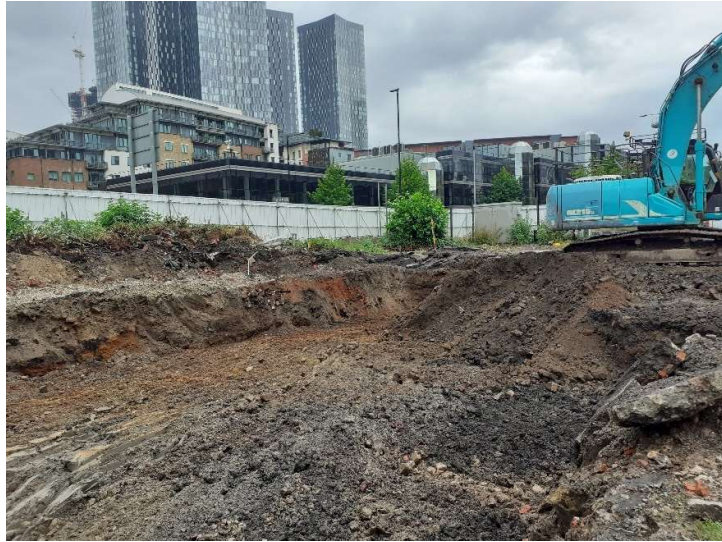
Plate 38: Tuesday 6<sup>th</sup> September 2022. Made ground excavations.

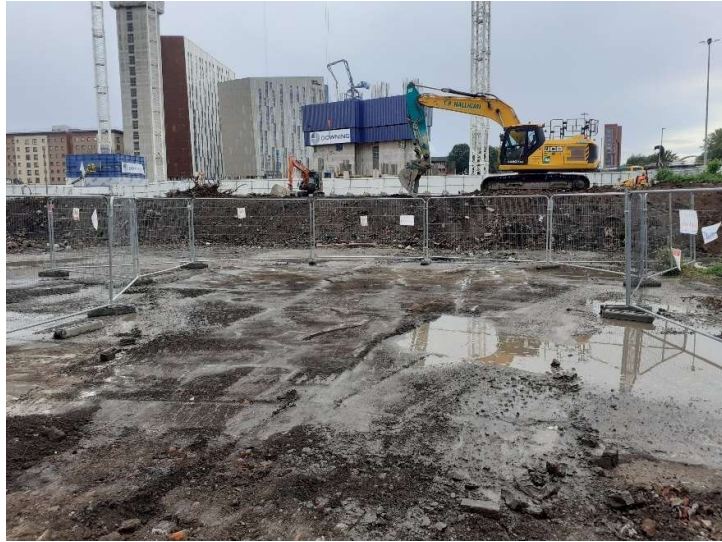
Plate 40: Tuesday 6<sup>th</sup> September 2022. Stockpiled made ground.

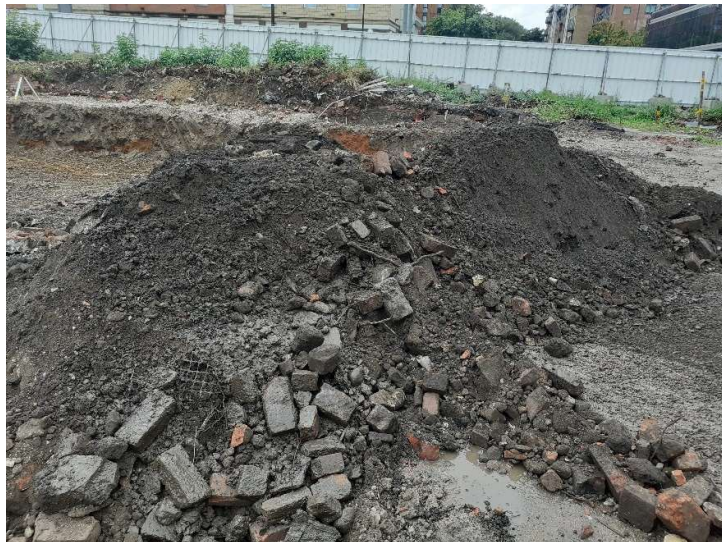
Plate 41: Tuesday 6<sup>th</sup> September 2022. Excavated made ground.
