## REFURBISHMENT / DEMOLITION ASBESTOS SURVEY

Units 1, 2, 3, 4, 5, 6, 7 & 8 Ambrose Street,  
Gorton, Manchester, M12 5DD

| <b>Project Reference:</b> | PEC1483 |
| <b>Project date:</b> | Tuesday 7 <sup>th</sup> May 2024 |

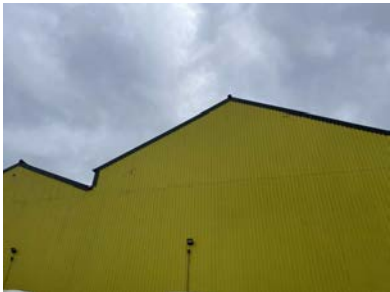
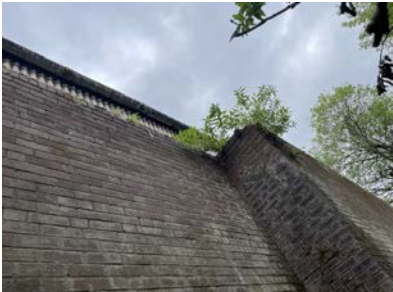
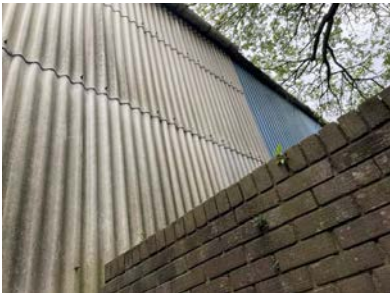
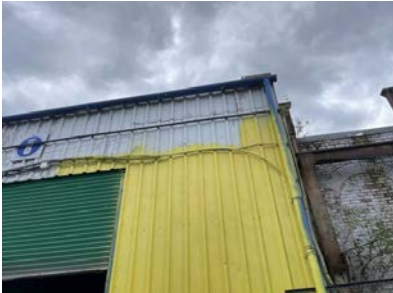
| External wall construction | | |

| | Tin / asbestos cement sheet / brick | |

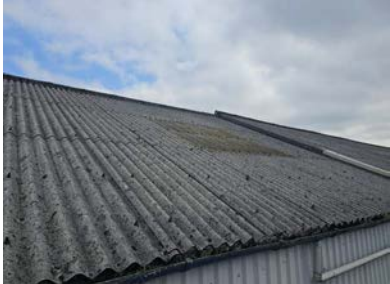
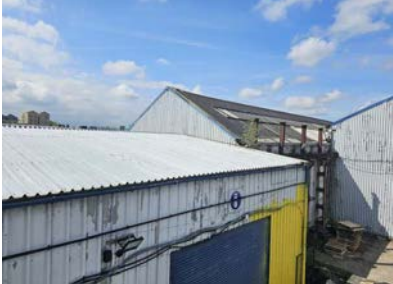
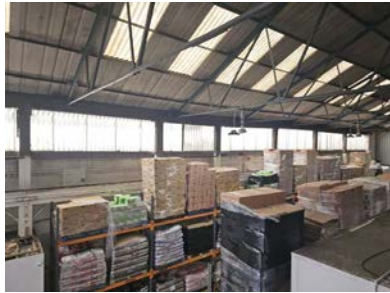
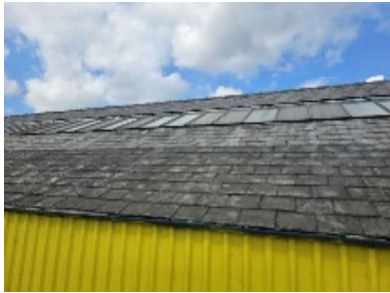
| Roof construction | | |

| | Asbestos cement sheets / slate / tin sheets | |

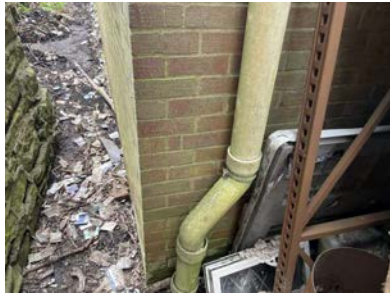
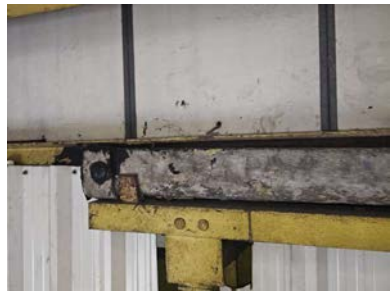
| Rainwater Goods | | |

| | Asbestos cement / plastic | |

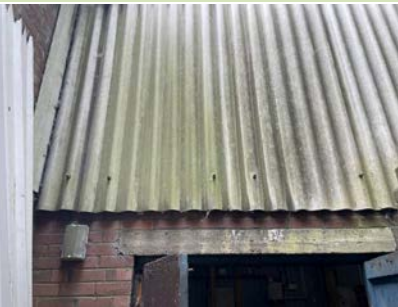
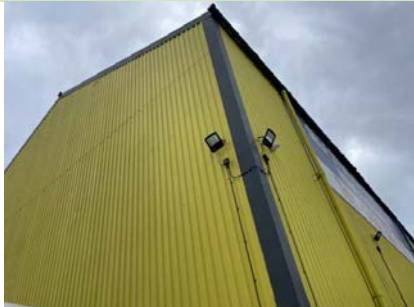
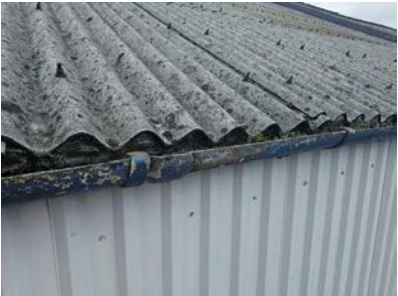
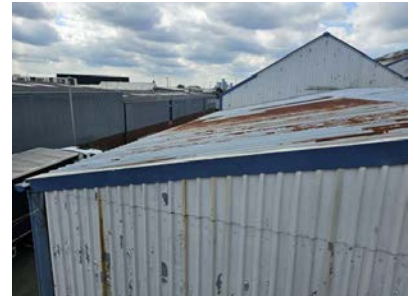
| Type of Profiled Sheets found | | |

| | Asbestos cement / tin / fibre glass | |

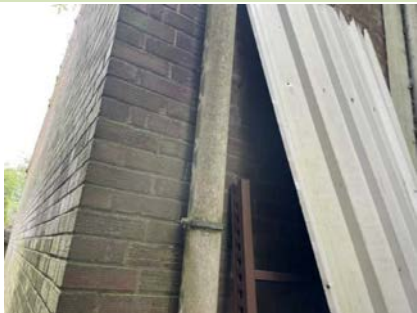
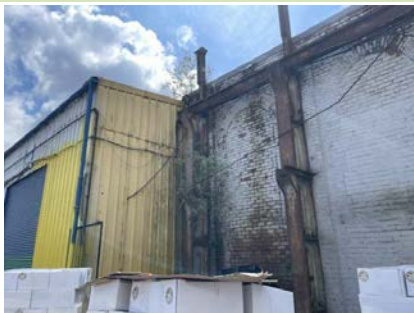
| External pipework | | |

| | Plastic / asbestos cement / steel | |

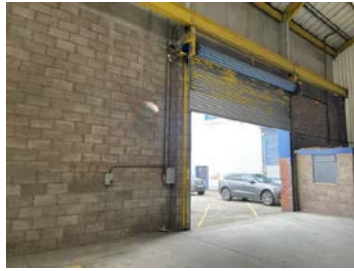
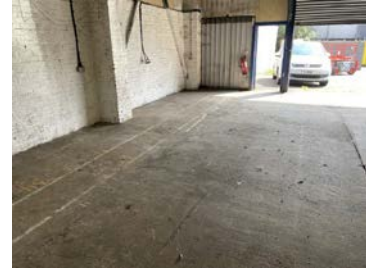
Wall Construction – solid walls

Block / brick / tin

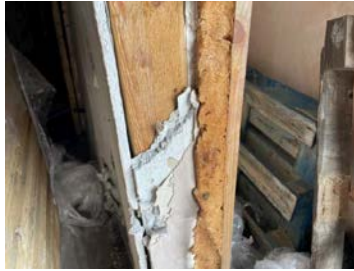
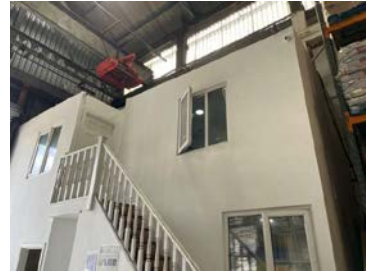
Wall construction – Partition

Plasterboard / timber

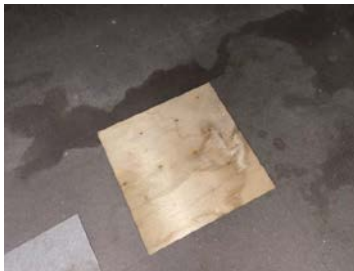
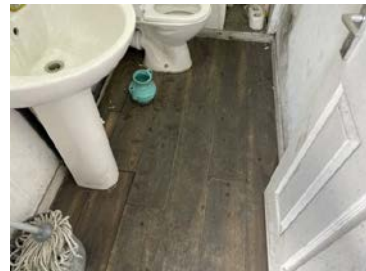
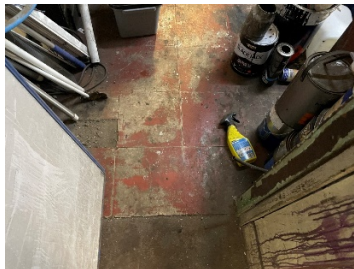
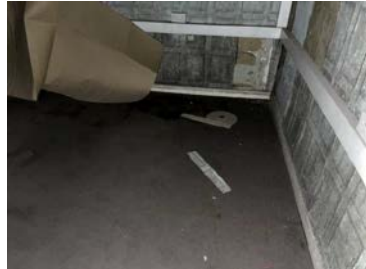
Floor coverings

Carpet / laminate / vinyl / asbestos thermoplastic floor tile

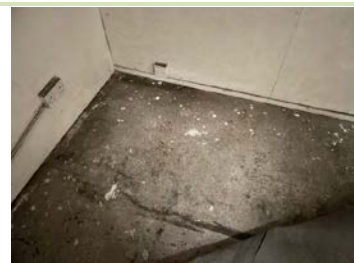
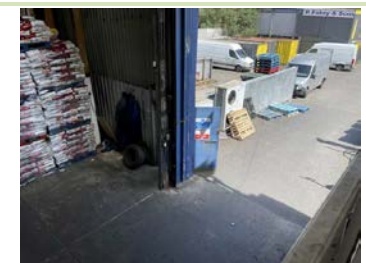
Floors beneath coverings

Concrete

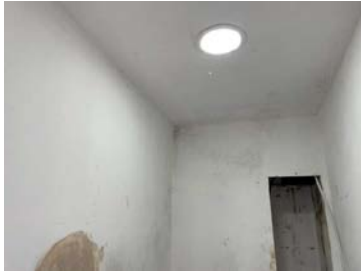
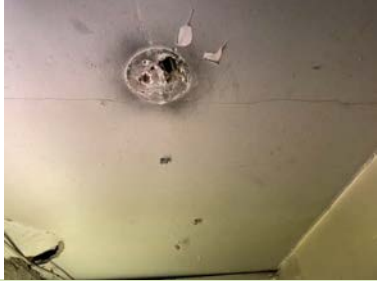
| Ceilings – fixed / Solid | | |

| | Plasterboard / hardboard | |

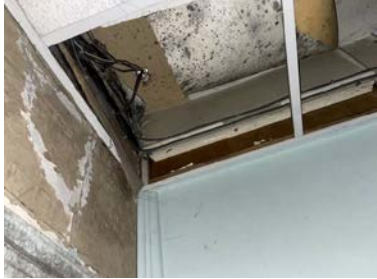
| Ceilings – Suspended | | |

| | None asbestos organic material | |

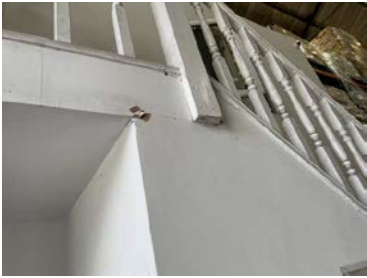
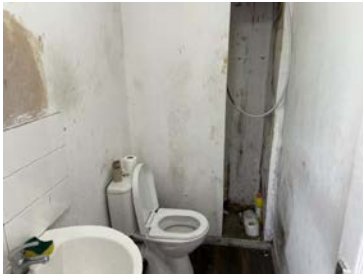
| Boxwork construction | | |

| | Plasterboard / timber | |

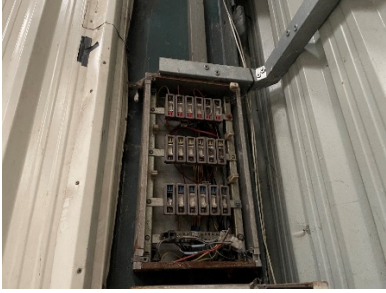
| Electrics | |

| | Asbestos containing |

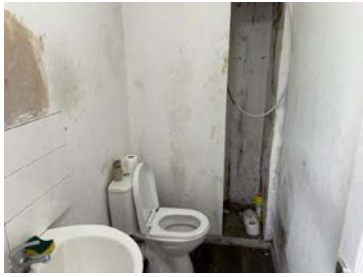
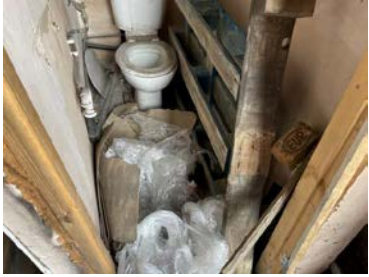
| Toilet Cisterns | | |

| Porcelain | | |

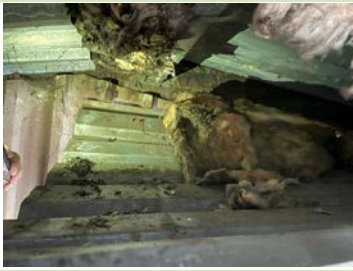
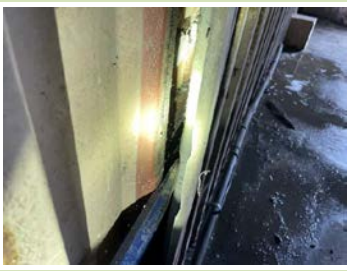
| Others | | |

| None asbestos MMMF insulation found within tin sheets to unit 6 | | |
