| 29 Red Lion Street<br>Chesham Bucks<br>HP5 1EJ | Phase 1 Only<br>Grimshaw Lane<br>Manchester | |

PIPELINE SCHEDULES for 9762 - SW

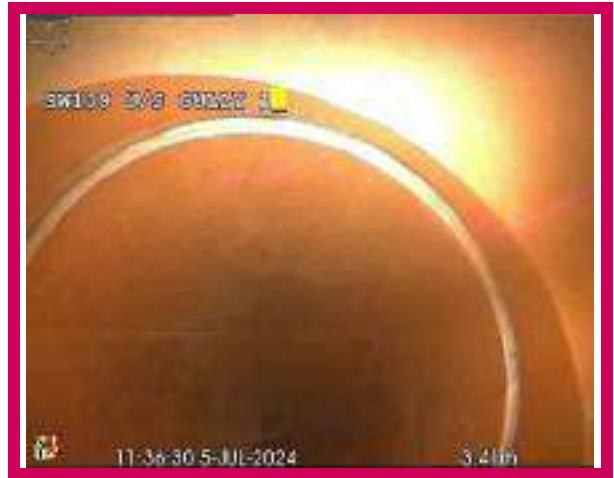
2, 00:00:25, 3.41 m  
Finish node, other special chamber, reference: Gully 1, Line  
reduces to 100mm before gully.

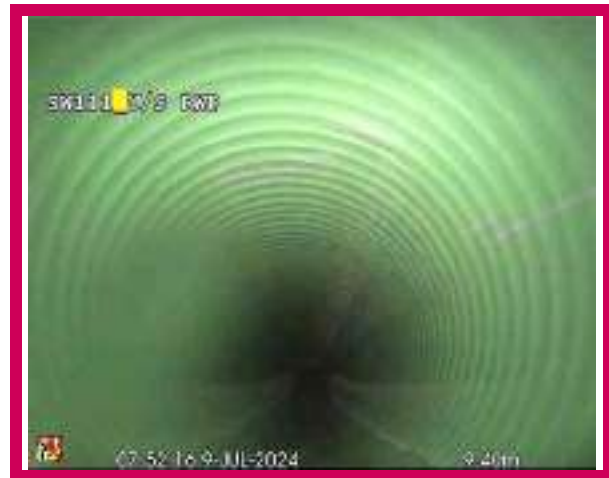
2, 00:00:30, 9.40 m  
Water level, 5% of the vertical dimension

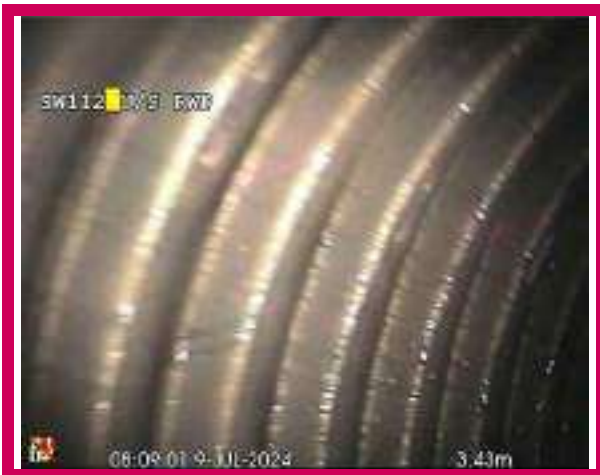
3, 00:00:17, 3.43 m  
Finish node, other special chamber, reference: RWP, In  
bottom of RWP

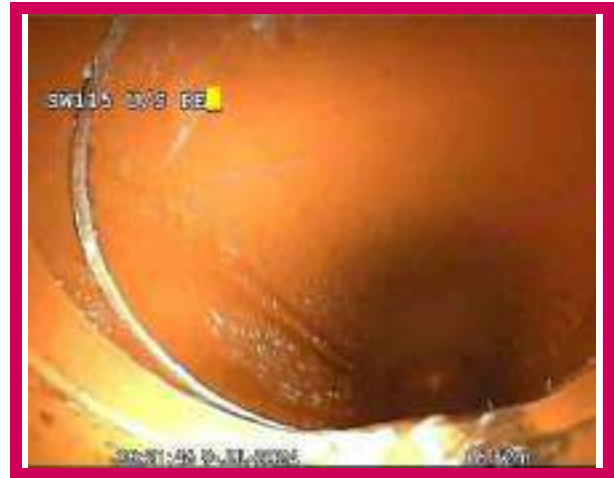
2, 00:00:43, 16.82 m  
 Finish node, other special chamber, reference: RE, In rodding eye.

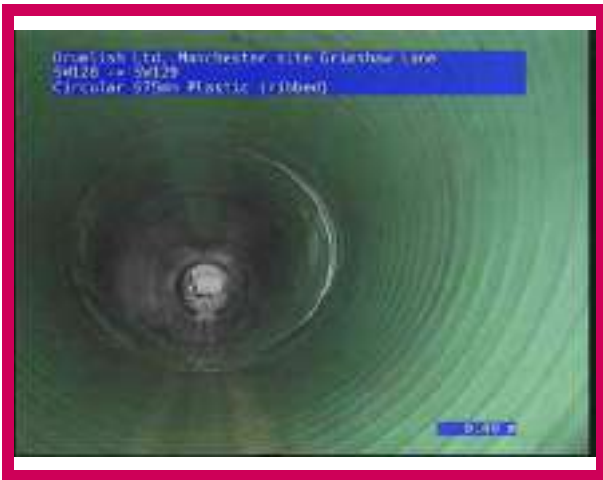
1, 00:00:00, 0.00 m  
Water level, 5% of the vertical dimension

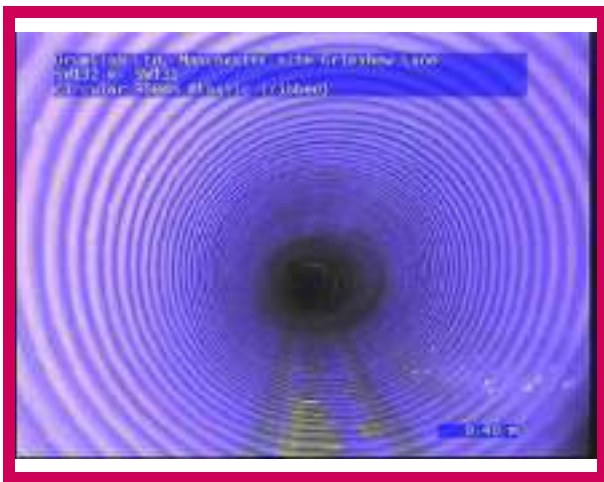
1, 00:00:00, 0.00 m  
Water level, 5% of the vertical dimension

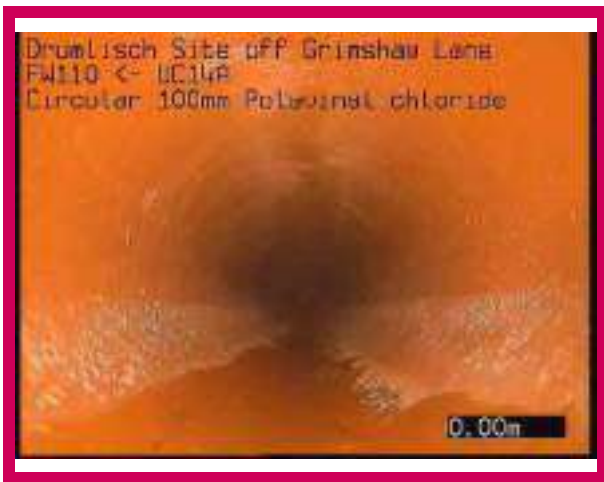
1, 00:00:00, 0.00 m  
Water level, 5% of the vertical dimension

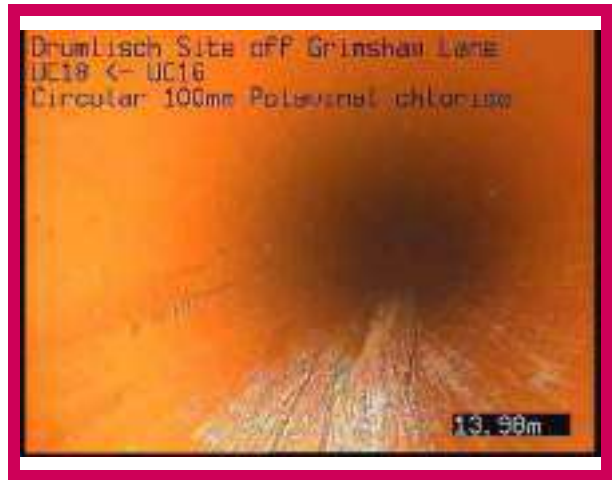
2, 00:01:01, 13.98 m  
Line deviates right

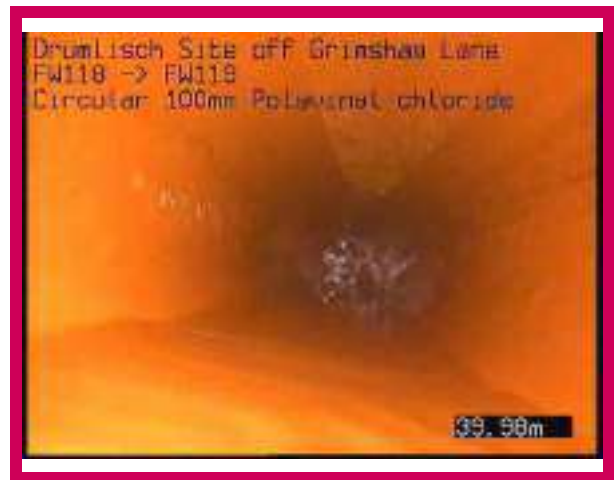
2, 00:02:51, 39.98 m  
Water level, 15% of the vertical dimension

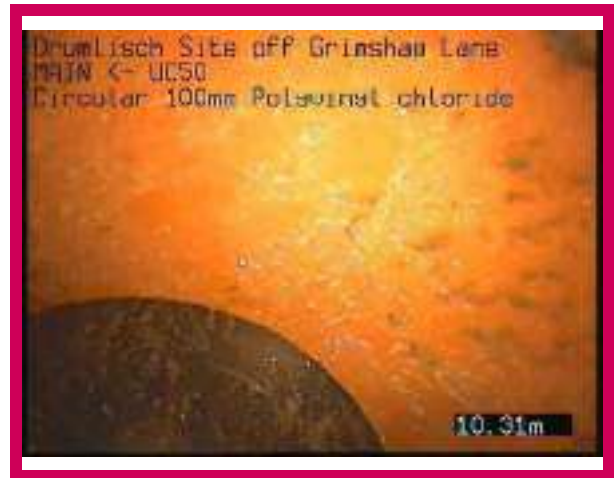
2, 00:00:46, 10.31 m  
Finish node, gully, reference: UC50

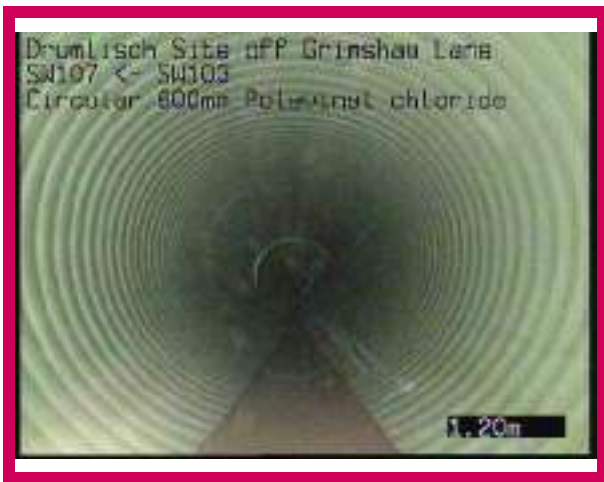
1, 00:00:00, 0.00 m  
Start node, catchpit, reference: SW107

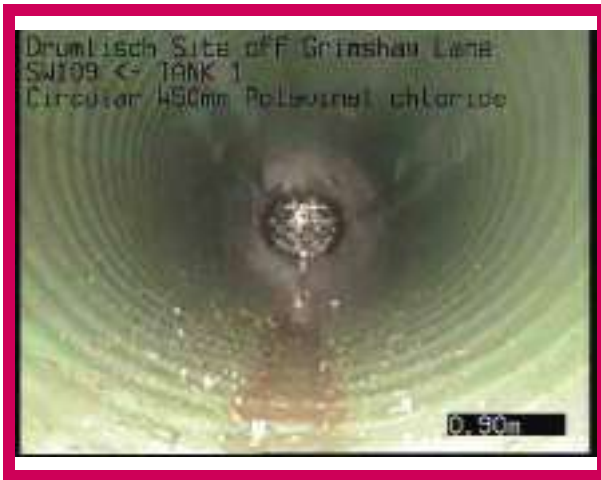
1, 00:00:00, 0.00 m  
Start node, catchpit, reference: SW109

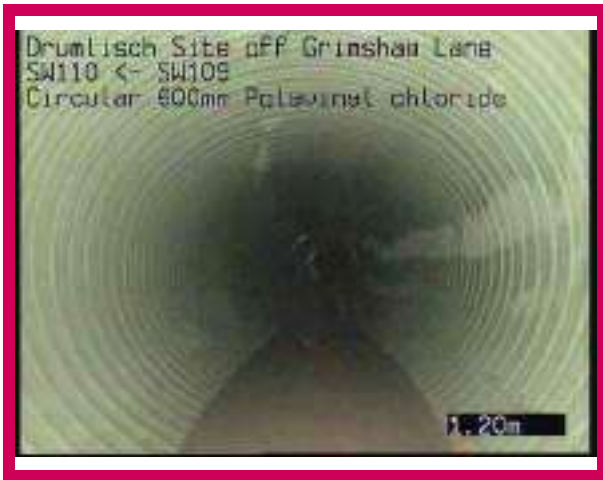
1, 00:00:00, 0.00 m  
Start node, catchpit, reference: SW110
