**Report Reference No: EL-01287**

**Riverpark Trading Estate / Former Abattoir Site,  
Riverpark Road,  
Manchester M40 2XT.**

## **Asbestos Demolition Survey Report**

**Date 25/02/2024**

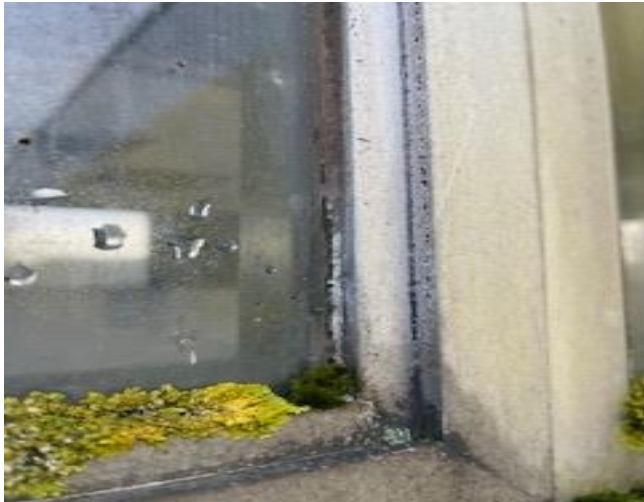
| Location: | Security office top of ramp | | |

| Item: | Putty to windows | | |

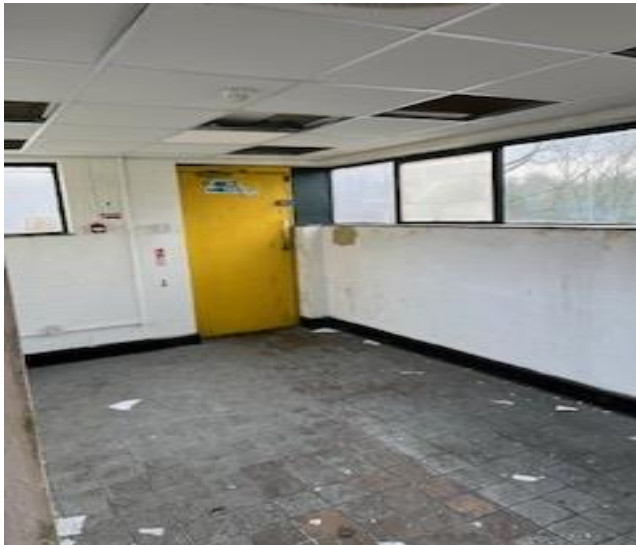
| Location: | Security office top of ramp | | |

| Item: | Walls / Ceiling / Floor | | |

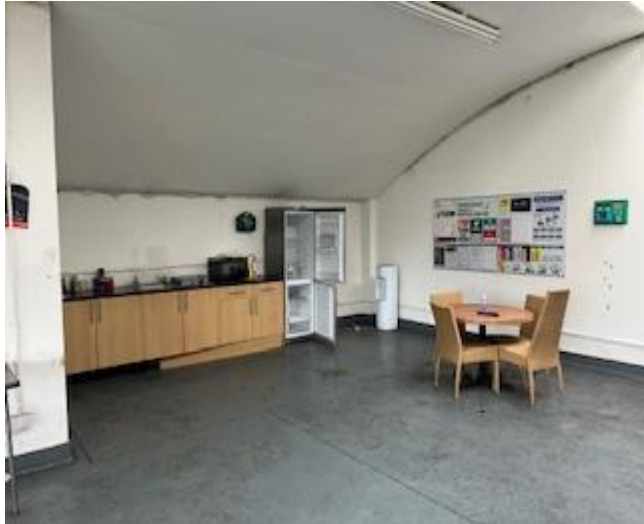
| Location: | Canteen | | |

| Item: | Bitumen sink pad | | |

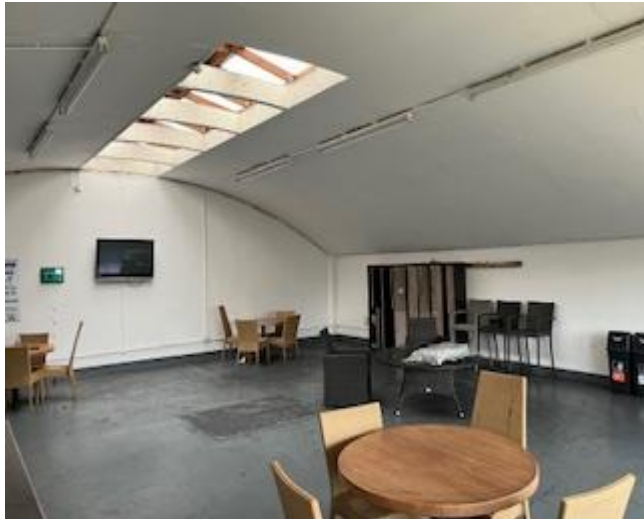
| Location: | Canteen | | |

| Item: | Ceiling / Walls / Floor | | |

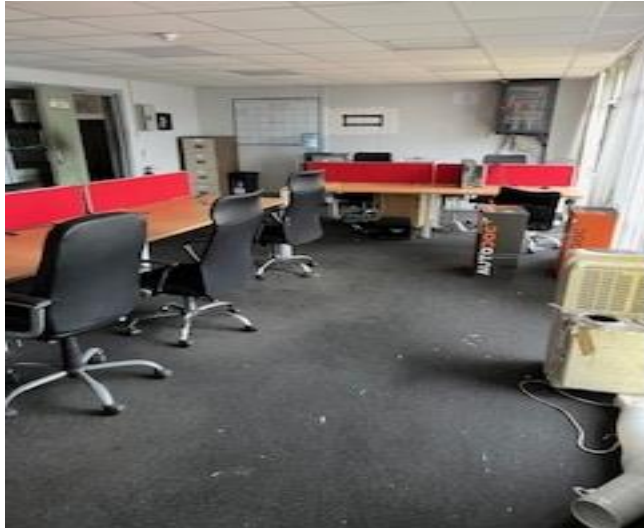
| Location: | Office | | |

| Item: | Ceiling / Walls / Floor | | |

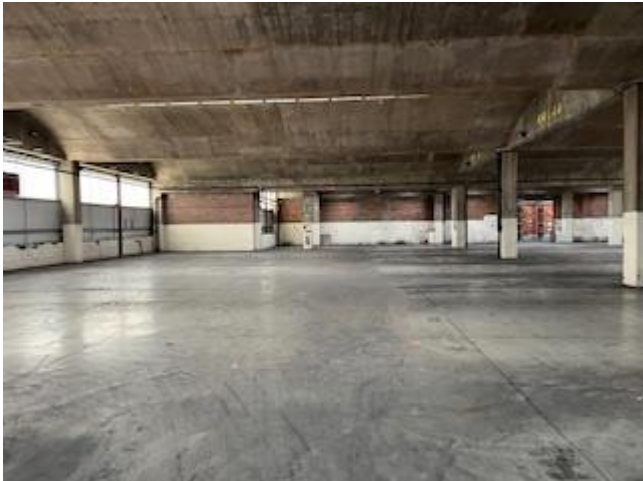
| Location: | Main warehouse | | |

| Item: | Ceiling / Walls / Floor | | |

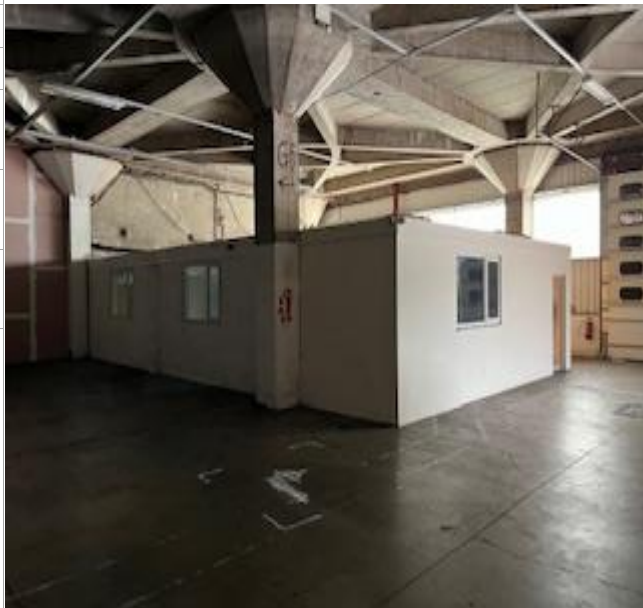
| Location: | Offices | | |

| Item: | Ceiling / Walls / Floor | | |

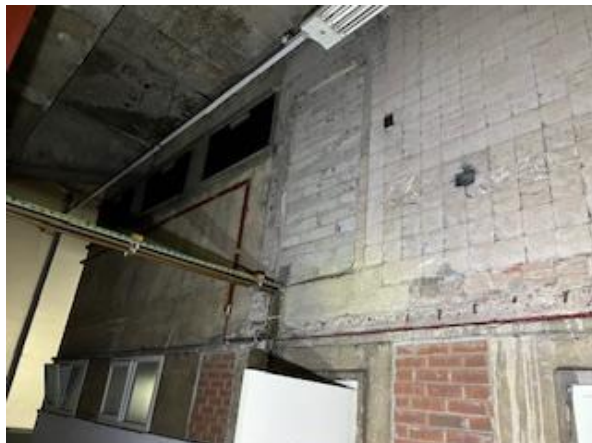
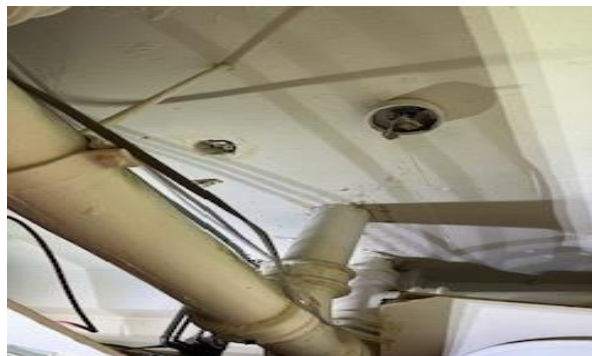
| Asbestos Type(s): | Amosite | 2 | |
| Identification Method: | S003 / S006 | | |
| | Internal building with 2 x floors<br>Bothe floors have spray coating debris. | | |

| Action: | Remove by a licenced asbestos removal contractor in accordance with the 2012 asbestos regulations. | | |

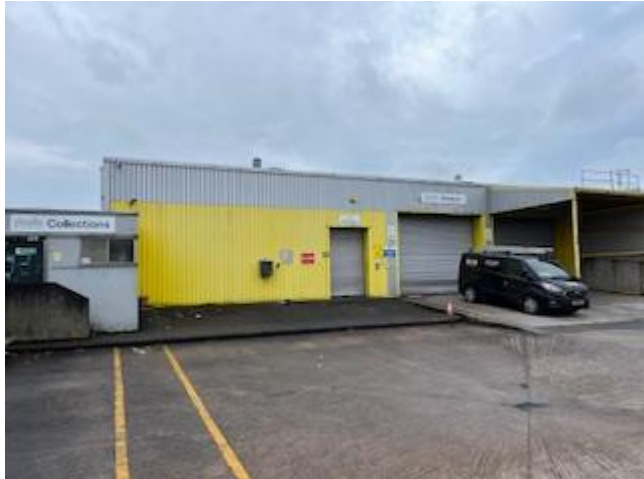
| Location: | Externals | | |

| Item: | Roof / Walls / Rainwater Goods | | |

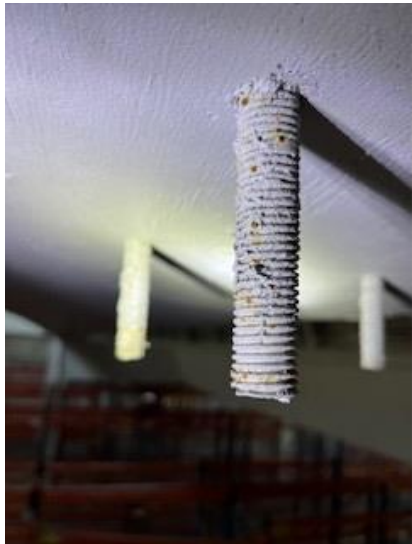
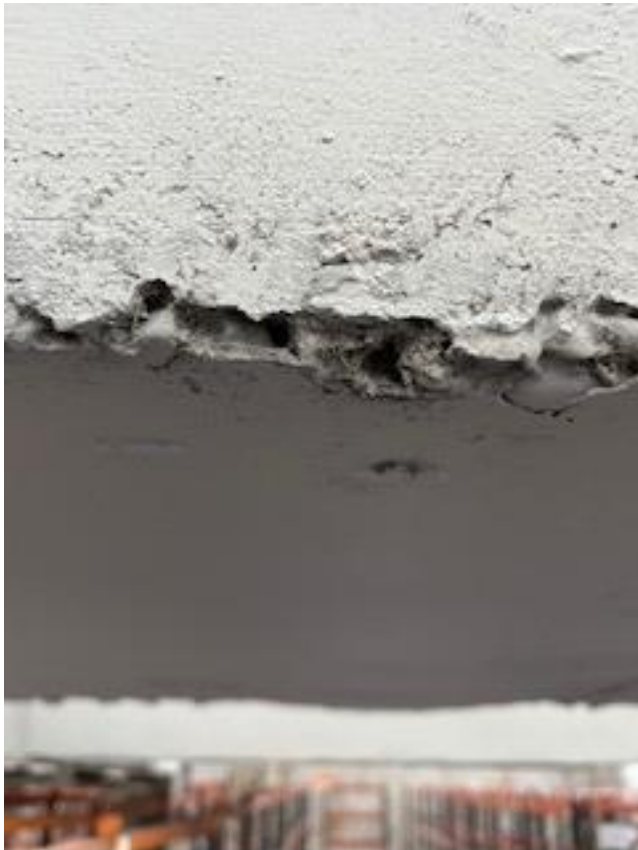
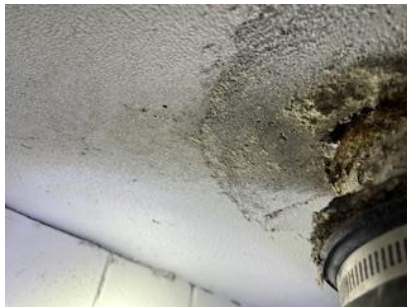
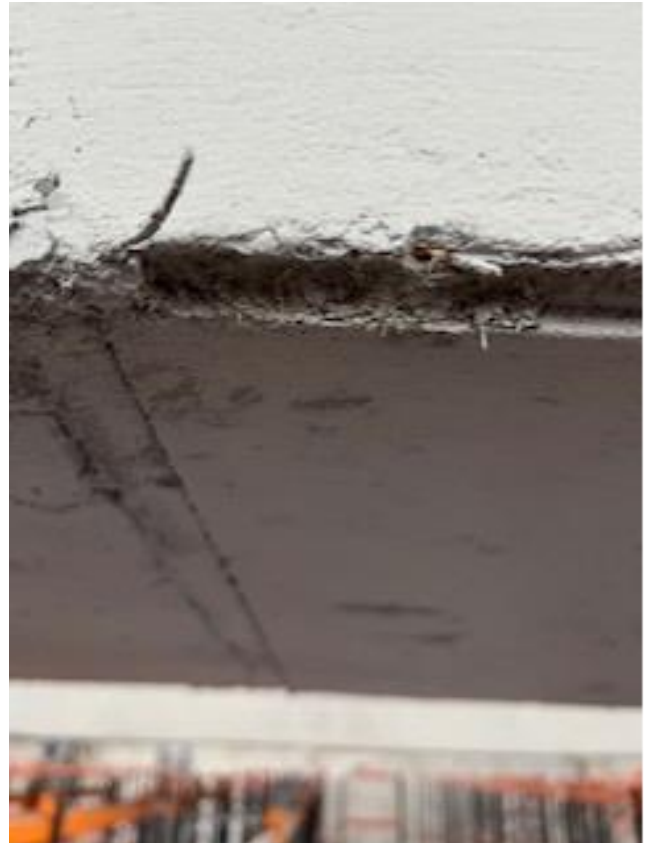
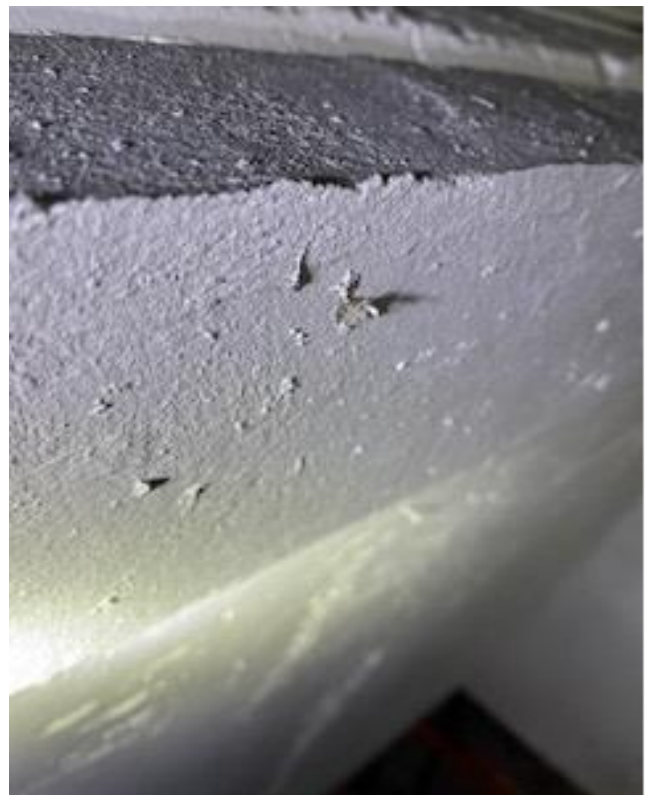
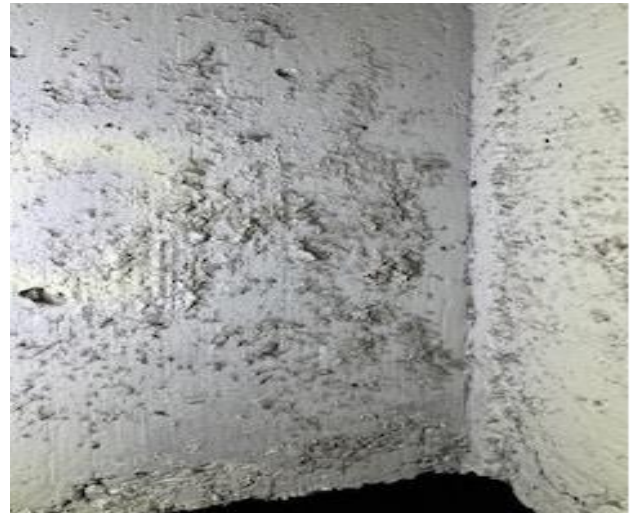
| Identification Method: | Sampled & Visual | | |
| Sample Reference: | S001 / 003 / 004 / 005 / 006 / 007 / 008 / 009 / 010 / 011 / 012 | | |

Remove by a licenced asbestos removal contractor in accordance with the 2012 asbestos regulations.

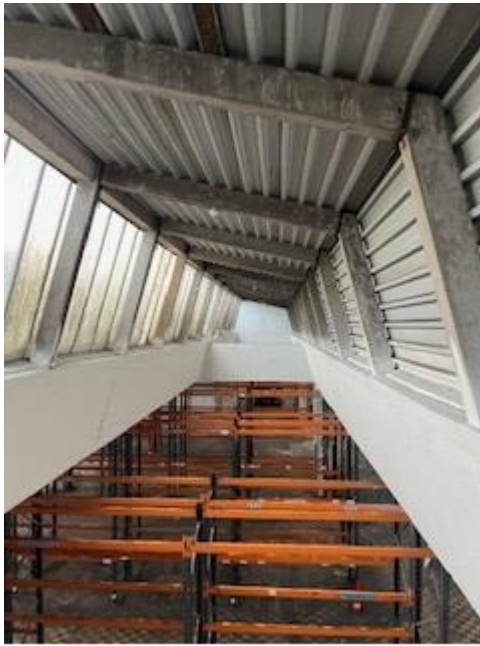
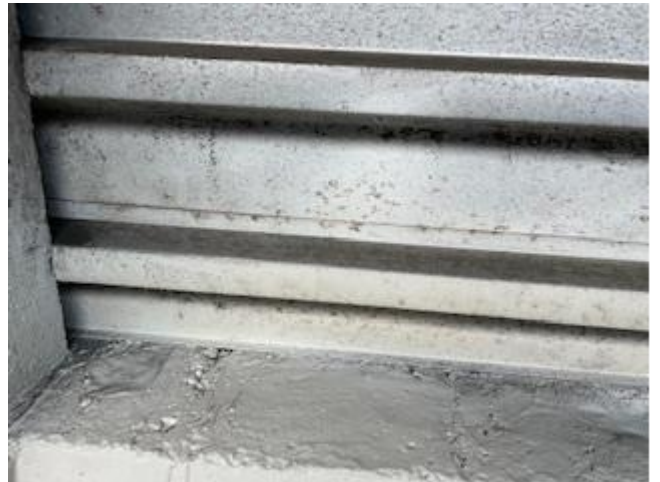
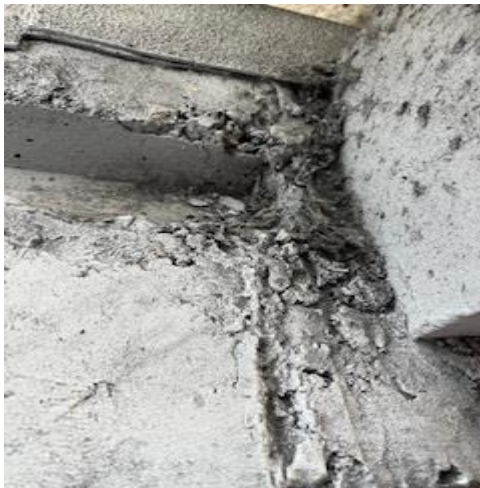
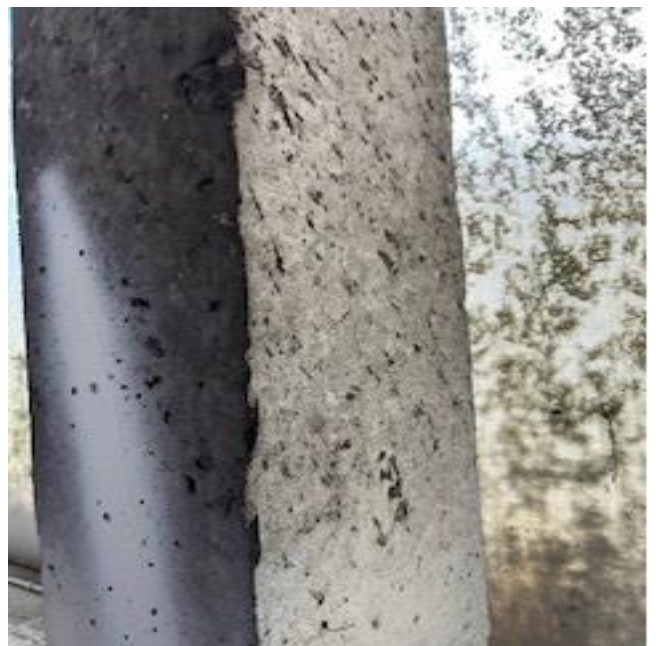
| Identification Method: | Sampled & Visual | | |
| Sample Reference: | <b>S014 / 015</b> | | |

Remove by a licenced asbestos removal contractor in accordance with the 2012 asbestos regulations.

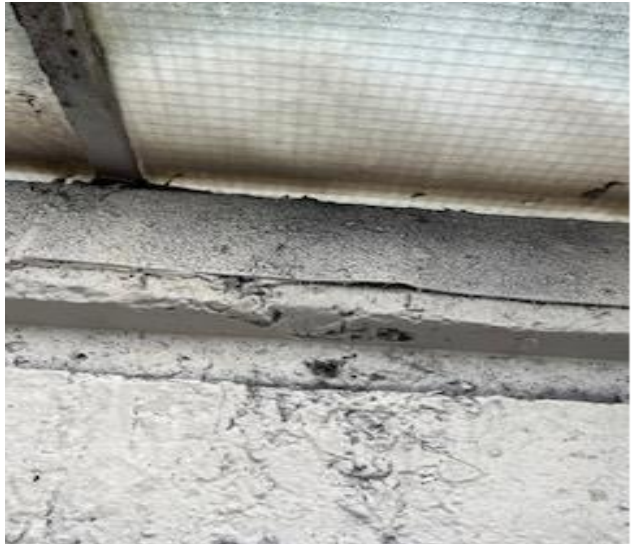
| Location: | Internal | | |

| Item: | Bitumen beneath windows | | |

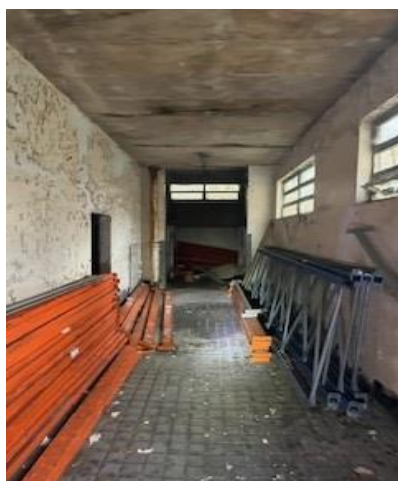
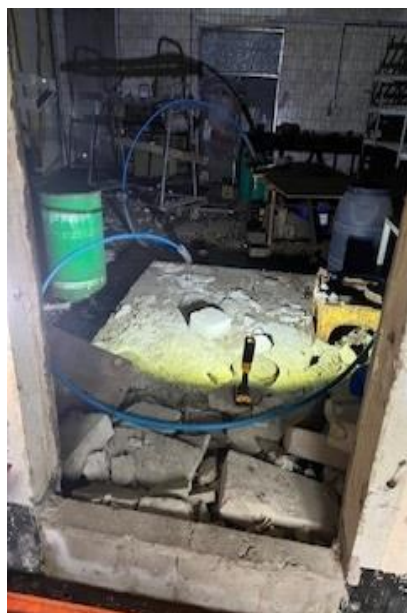
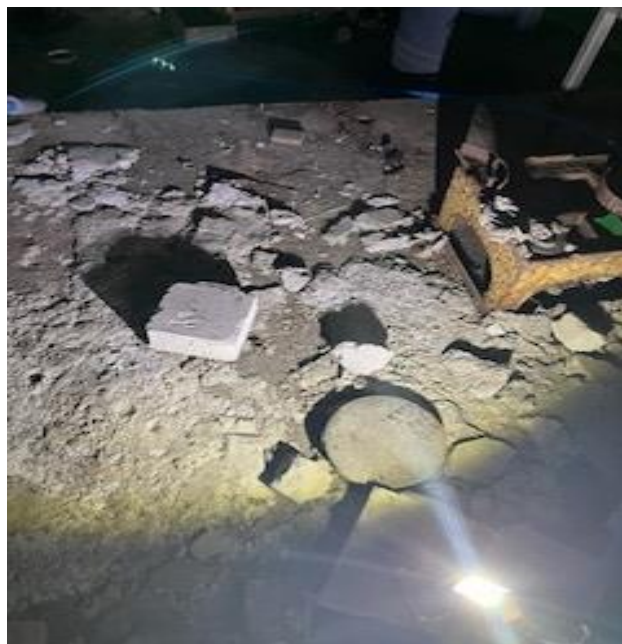
| Identification Method: | Sampled & Visual | | |
| Sample Reference: | S022 / 023 / 024 / 025 | | |

Remove by a licenced asbestos removal contractor in accordance with the 2012 asbestos regulations.

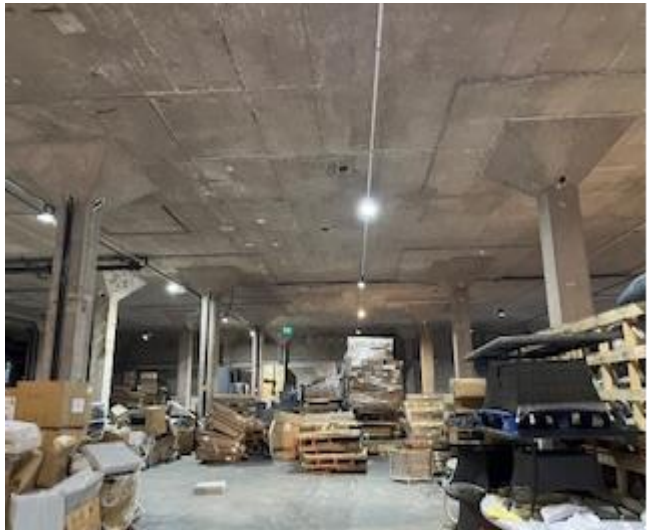
| Location: | Warehouse | | |

| Item: | Ceiling / Walls / Floor | | |

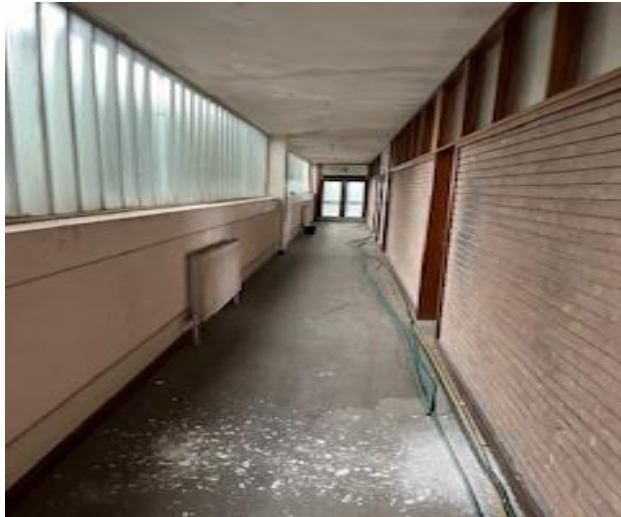
| Location: | Office | | |
| Item: | Rope Seals to Windows | | |
| Condition: | N/A | 0 | |

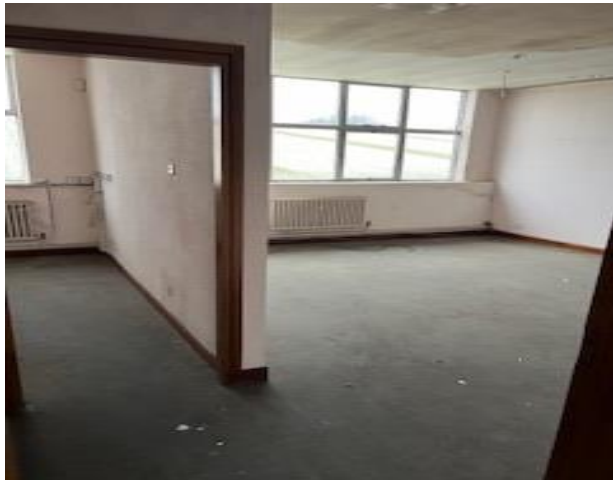
| Location: | Office | | |
| Item: | Offices – general view | | |

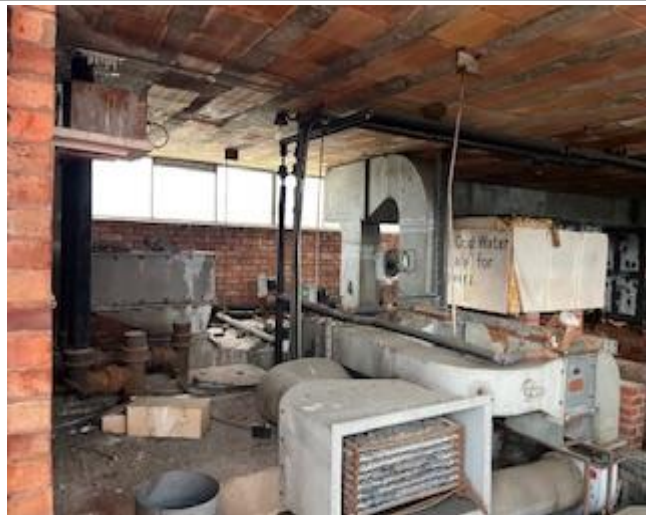
| Location: | Tank Room | | |
| Item: | Bitumen pads | | |
| Condition: | N/A | 0 | |

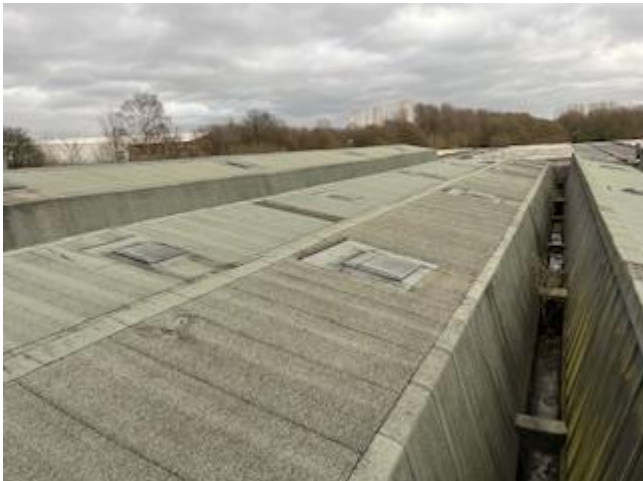
| Location: | External Block 2 | | |
| Item: | Roof / Walls / Rainwater Goods | | |

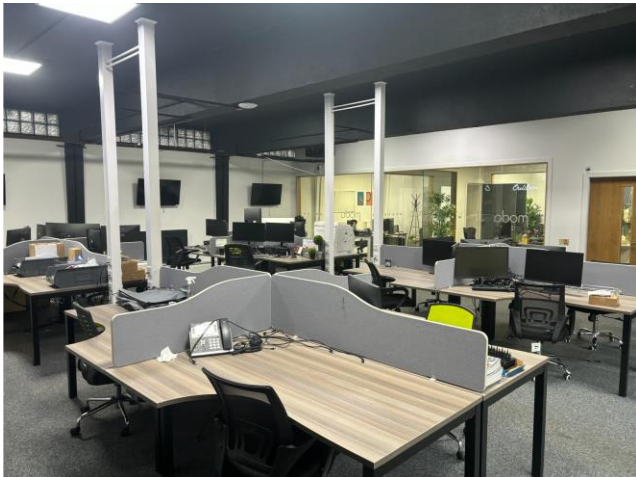
| Location: | Block 3 – Offices | | |
| Item: | Ceiling / Walls / Floor – Throughout | | |

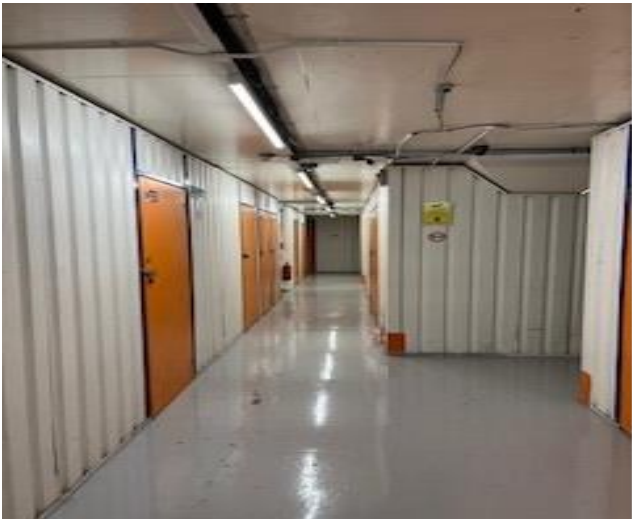
| Location: | Basement | | |
| Item: | Ceiling / Walls / Floor | | |

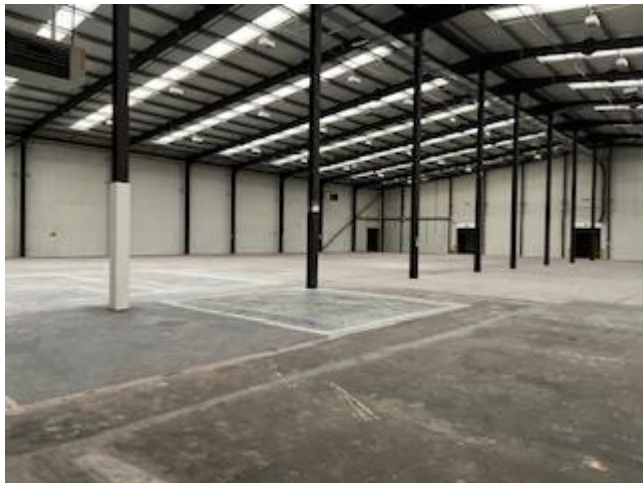
| Location: | Ground Floor / Offices / W/C | | |
| Item: | Ceiling / Walls / Floor – Throughout | | |

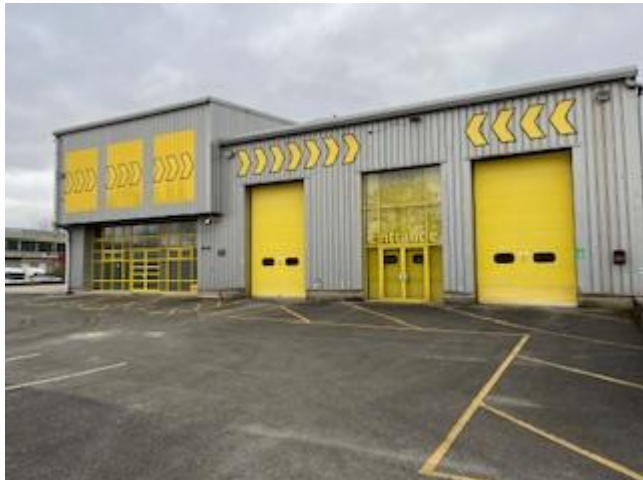
| Location: | External | | |
| Item: | Roof / Walls / Rainwater Goods | | |

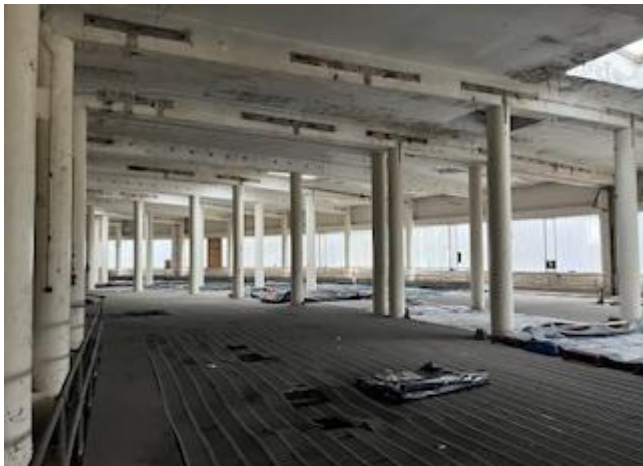
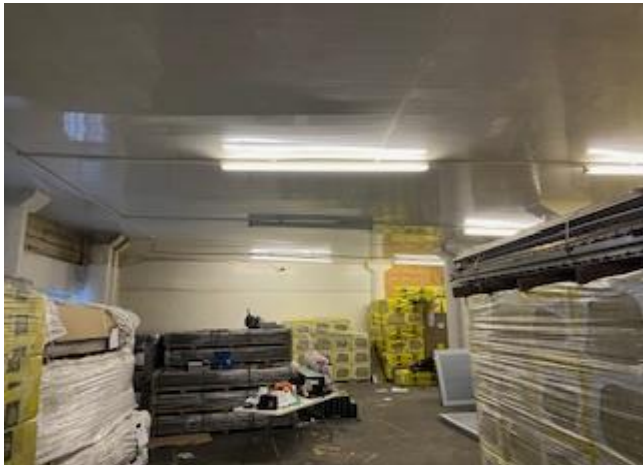
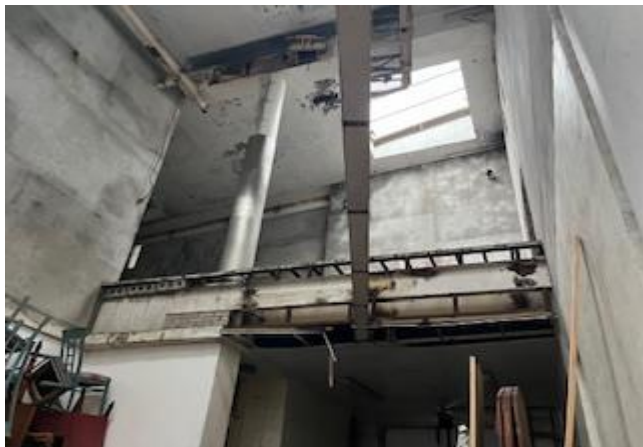
| Location: | Ground & First | | |
| Item: | Ceiling / Walls / Floor | | |

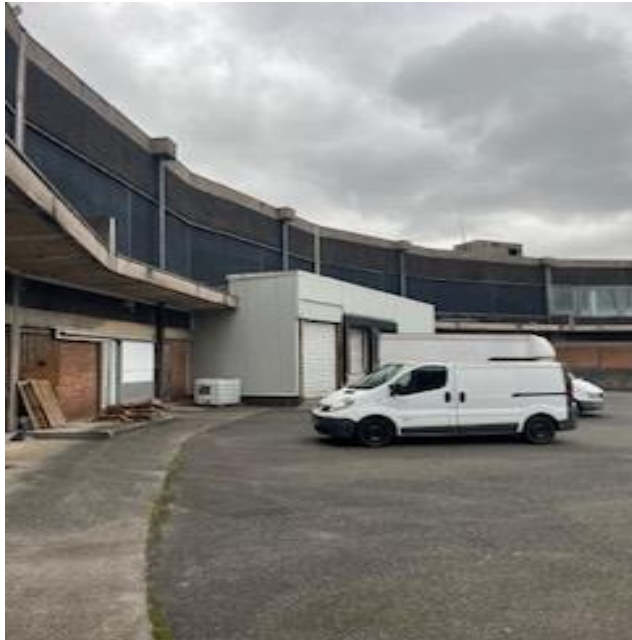
| Location: | Ground & First Floor | | |
| Item: | Roof / Walls / Rainwater Goods | | |

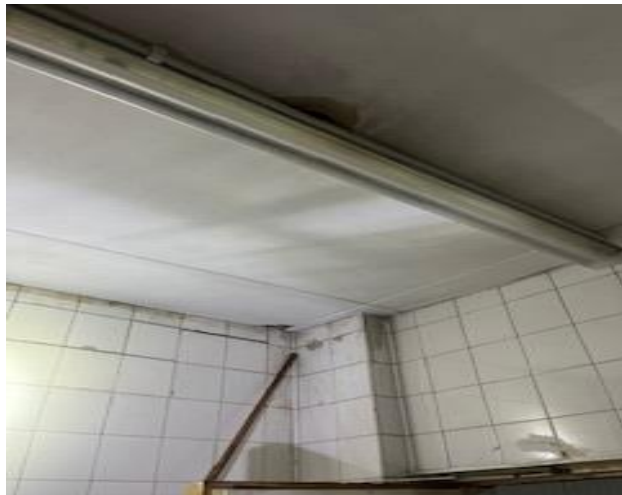
| Location: | Ground – Main Entrance | | |
| Item: | Board to Ceiling | | |
| Condition: | N/A | 0 | |

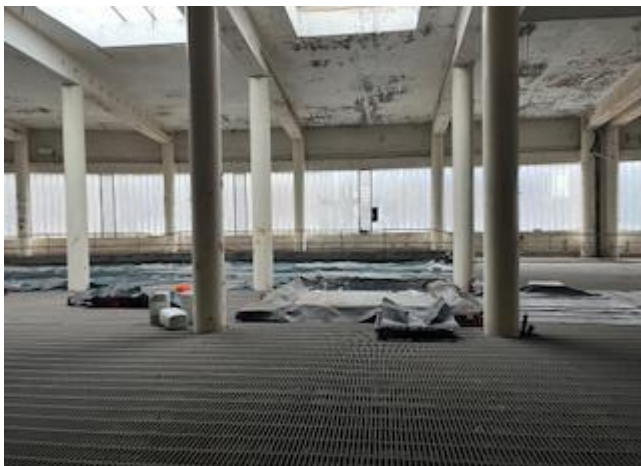
| Location: | Steels | | |
| Item: | Dust and Debris | | |
| Condition: | N/A | 0 | |

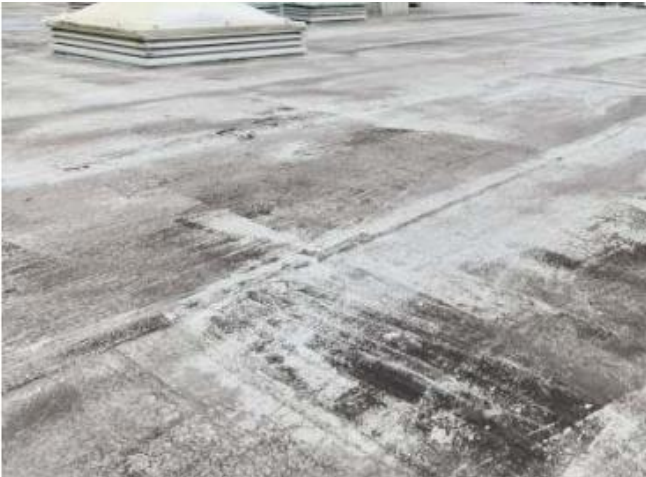
| Location: | External | | |
| Item: | Roof / Walls / Rainwater Goods | | |

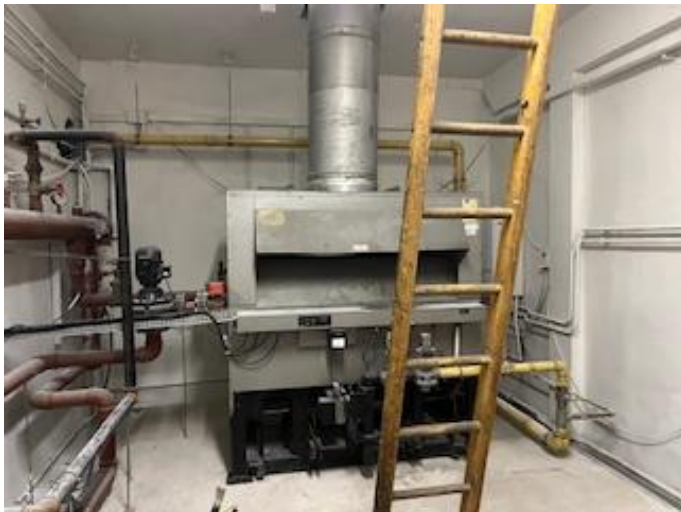
| Location: | Boiler Room | | |
| Item: | Walls / Floor / Ceiling | | |

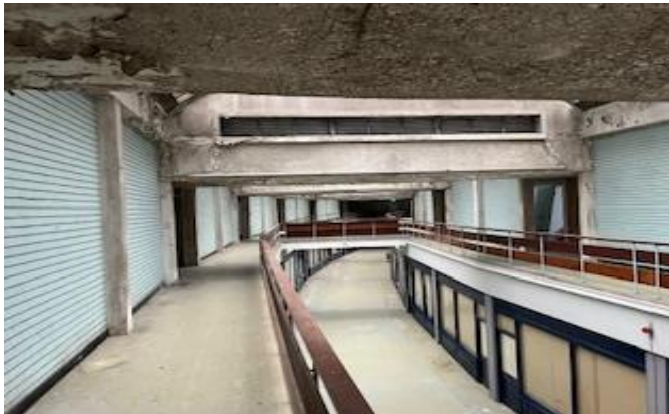
| Condition: | Fair | I | |
| Asbestos Type(s): | Chrysotile | I | |
| Sample Reference: | S001 / 002 / 005 / 006 | | |

| Action: | Remove by a licenced asbestos removal contractor in accordance with the 2012 asbestos regulations. | | |

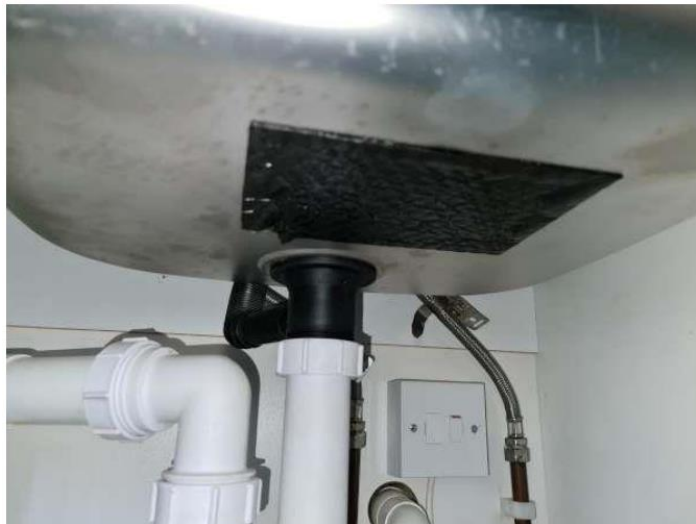
| Location: | Offices | | |
| Item: | Sink Pads | | |
| Condition: | N/A | 0 | |

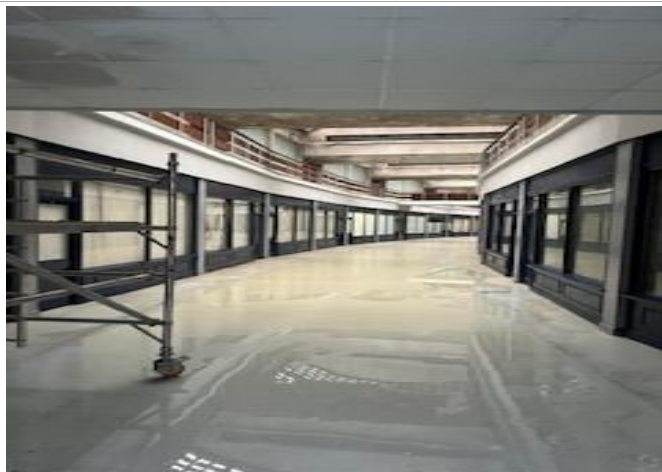
| Location: | 3 Small Units | | |
| Item: | Sink Pads | | |
| Condition: | N/A | 0 | |

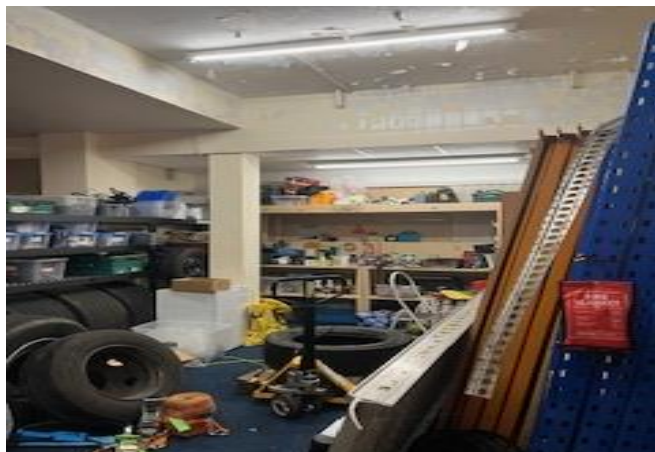
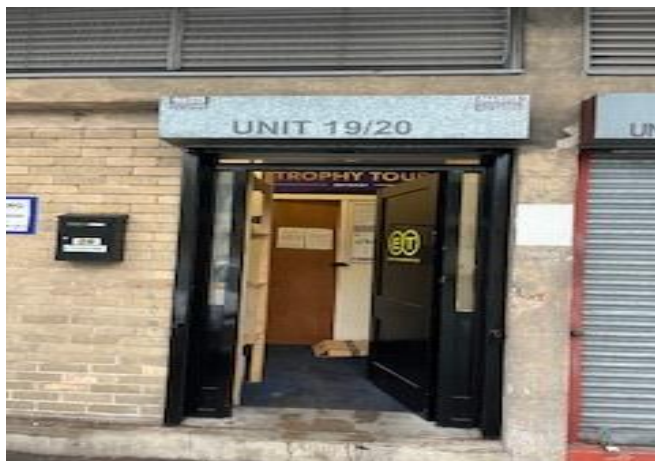
| | Tenanted Units | | |

| | Access was granted to 3 X small unit in various locations on the ground floor, no asbestos was identified – Structure of the building all looks the same | | |

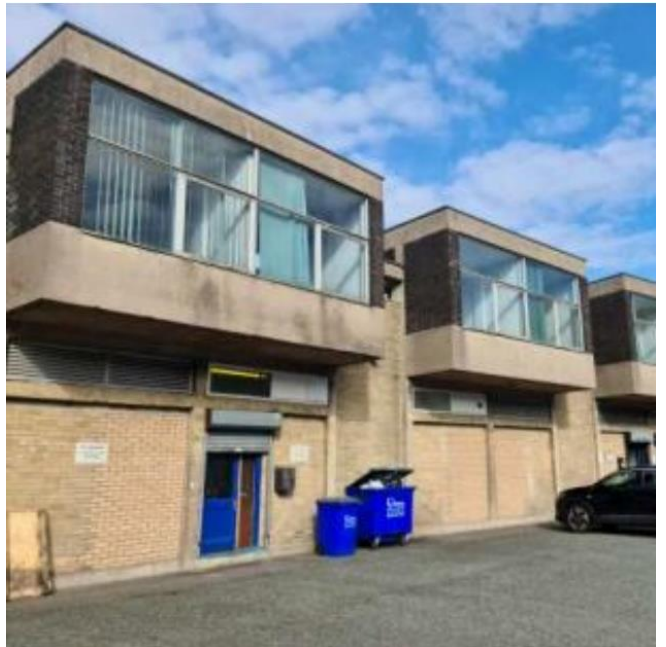
| <b>Location:</b> | External | | |
| <b>Item:</b> | Roof / Walls / Rainwater Goods | | |

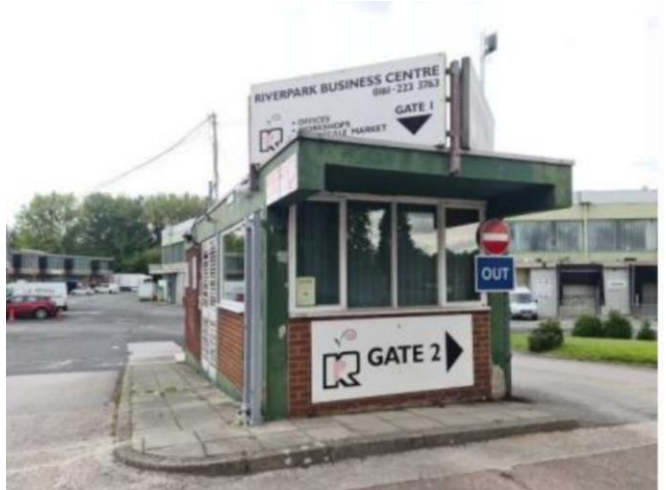
| Location: | External | | |
| Item: | Roof / Walls / Rainwater Goods | | |

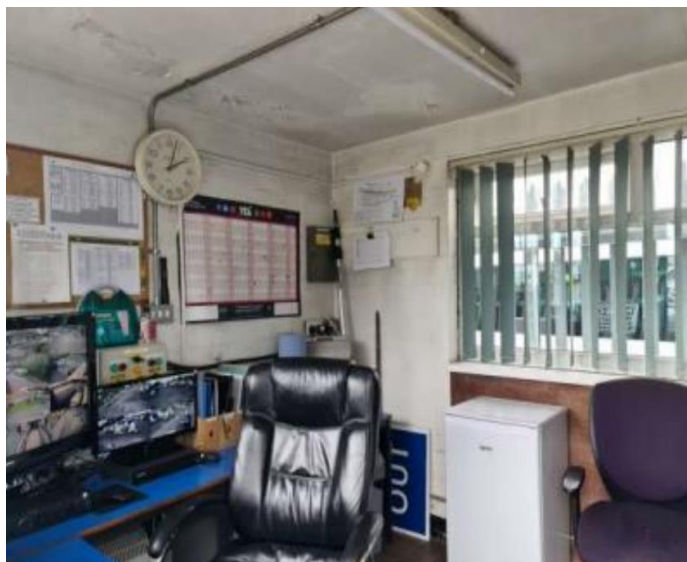
| Location: | Internal | | |
| Item: | Ceiling / Walls / Floor | | |

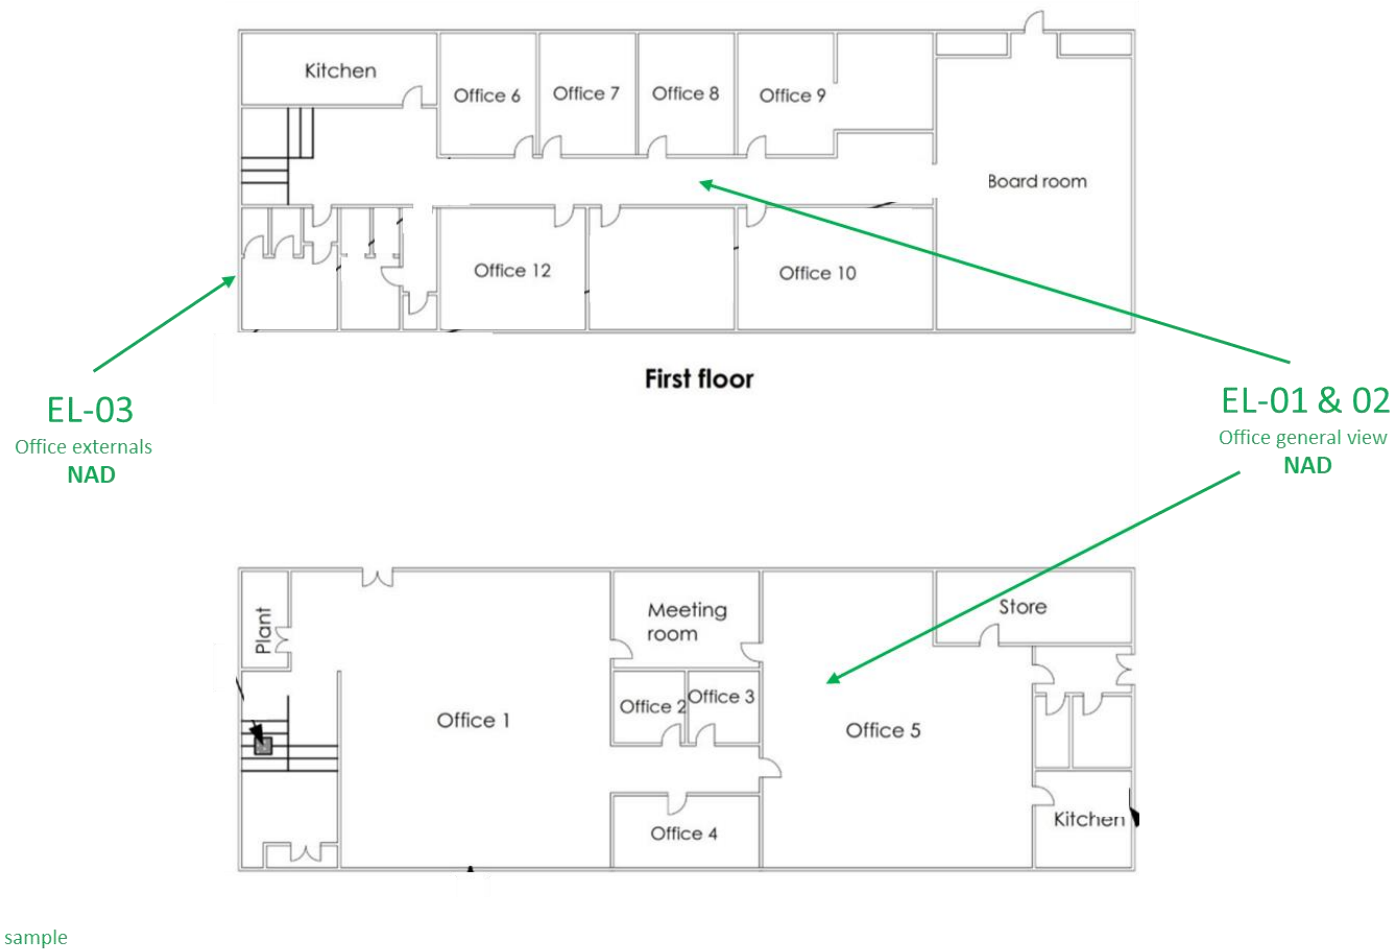
## Block 3 - Offices - No Asbestos detected
