**Project Name:** Amspec Limited - Lower Campfield - LSO0373827 - merged  
**Project Status:** Complete  
**Project Date:** 27/06/2024  
**Lanes Division:** Manchester

As requested, we have recently carried out a drainage CCTV survey at the site location and our full and detailed findings are contained in the attached CCTV report which you can review at your leisure.

Section 2: Cracks, deposits coarse 10%, deposits fine 10%  
Section 3: Deposits fine 10-20%, hole in drain, joint displaced medium  
Section 4: Deposits fine 10%, deposits coarse 10%  
Section 5: Deposits fine 10-20%, deposits coarse 10%  
Section 6: Deposits coarse 10-20%  
Section 7: Deposits fine 10-20%, cracks, deposits hard 30%  
Section 8: Deposits fine 10%  
Section 10: Deposits fine 10%  
Section 11: Deposits fine 10-40%  
Section 12: Deposits hard 10%, deposits fine 10-20%  
Section 13: Deposits fine 10%, deposits hard 30%  
Section 14: Deposits fine 10-50%, deposits hard 10%  
Section 15: Crack longitudinal  
Section 16: Fracture longitudinal  
Section 17: Settled deposits 10%  
Section 18: Settled deposits 10%  
Section 19: Settled deposits up to 30%  
Section 20: Settled deposits 10% and crack circumferen

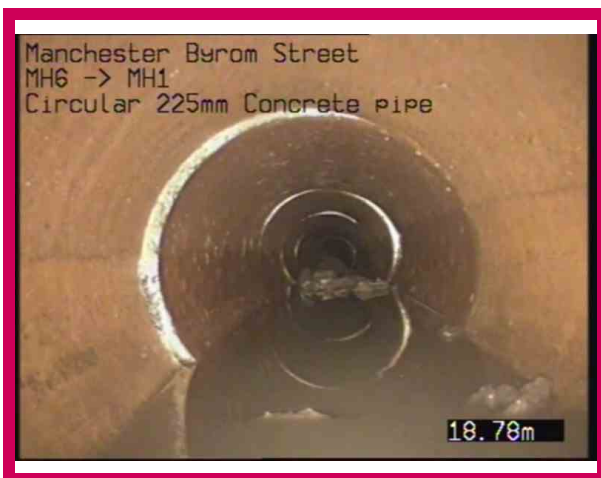
11, 00:01:19, 18.79 m  
Survey abandoned, Due to debris

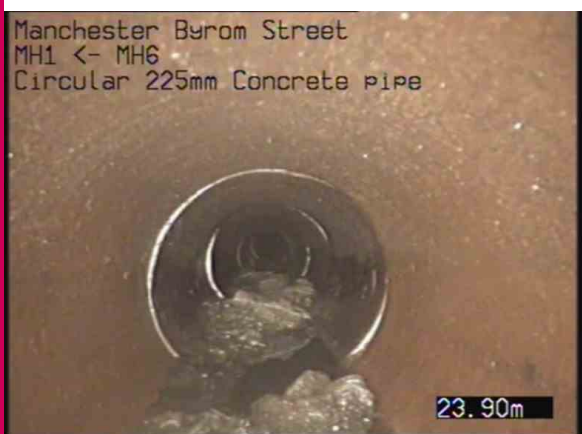
15, 00:02:16, 23.90 m  
Survey abandoned, Due to debris
