| Site name: A&H Construction - Lowry Park,<br>Grimshaw Lane, Manchester. | | Units/ plots checked: : Unit 6 core area line outs | | | |
| Inspection by: Dan Squire | | Weather: 7°C Wet | | | |

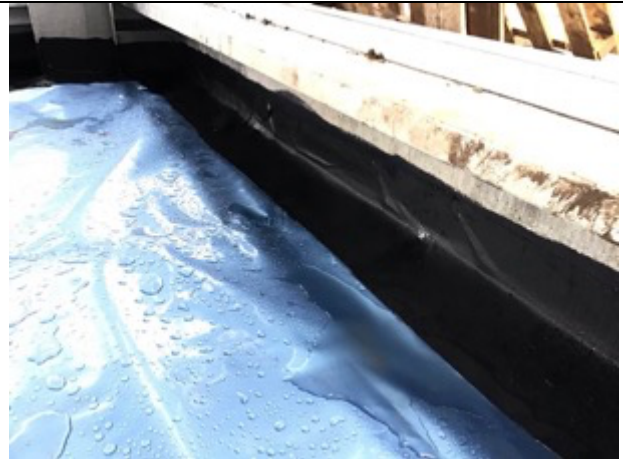
Stair core 2 retro fit detailing

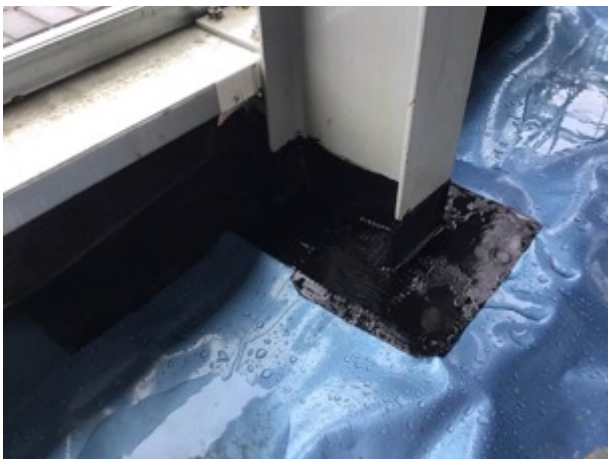
Stair core 2 stanchion detailing

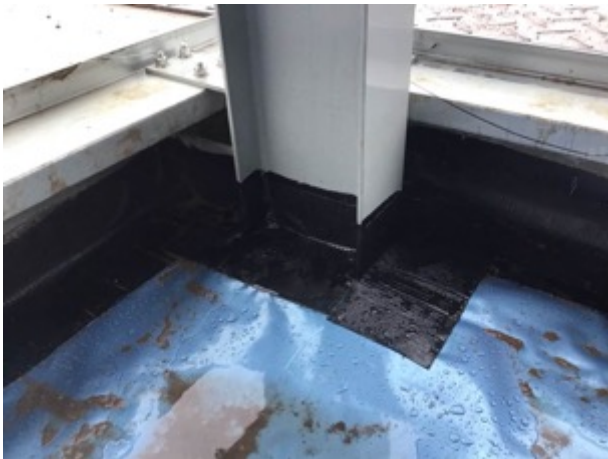
Stair core3 stanchion detailing

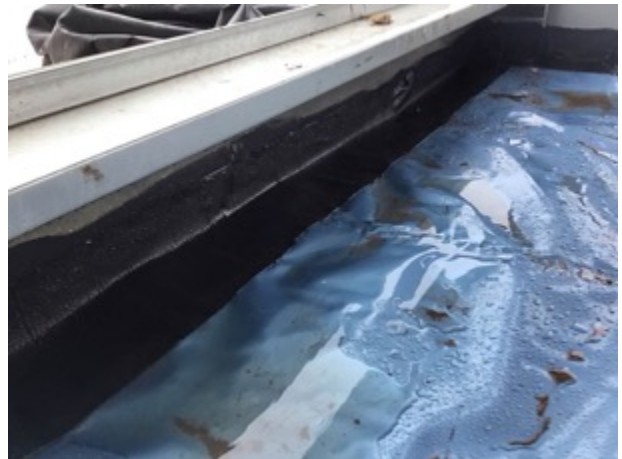
Stair core 3 retro fit detailing

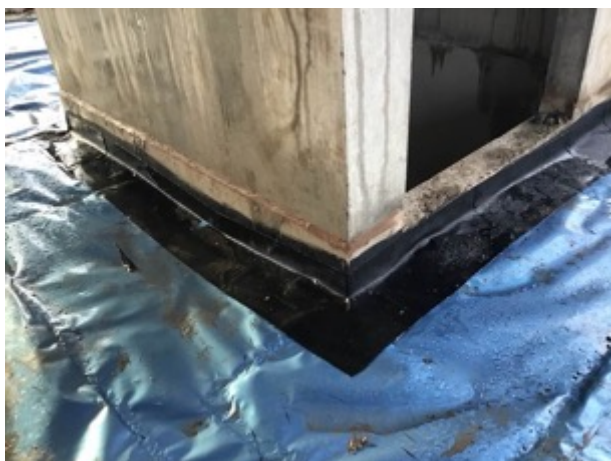
Lift pit retro fit detailing

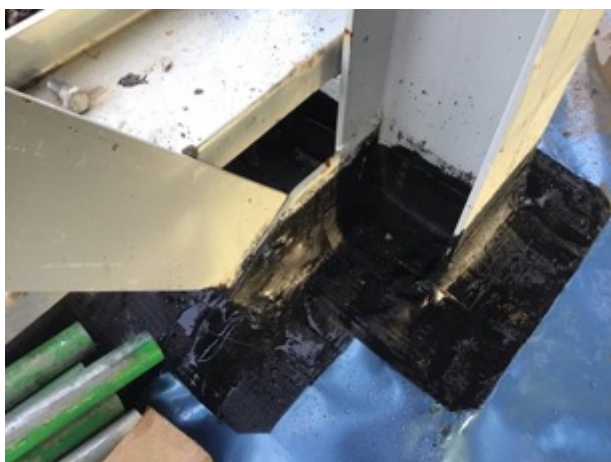
Sealed stanchion detailing

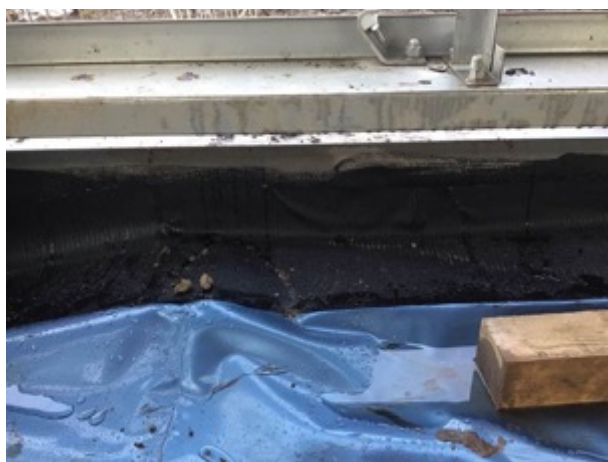
Perimeter retro fit detailing

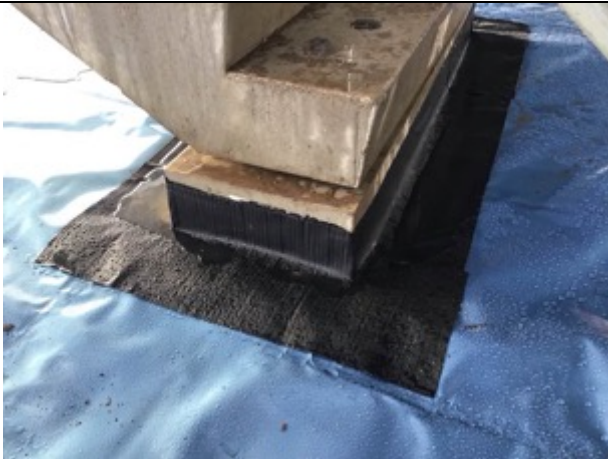
Stair base retro fit detailing

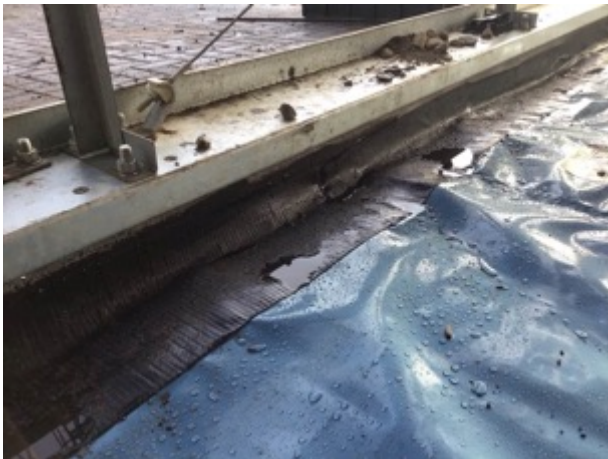
Perimeter retro fit detailing

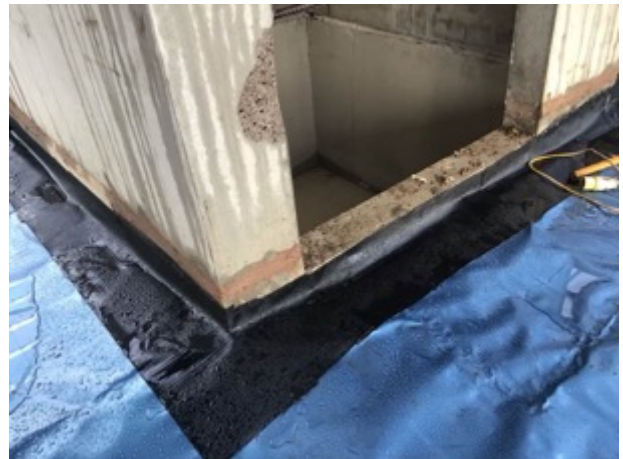
Lift pit retro fit detailing

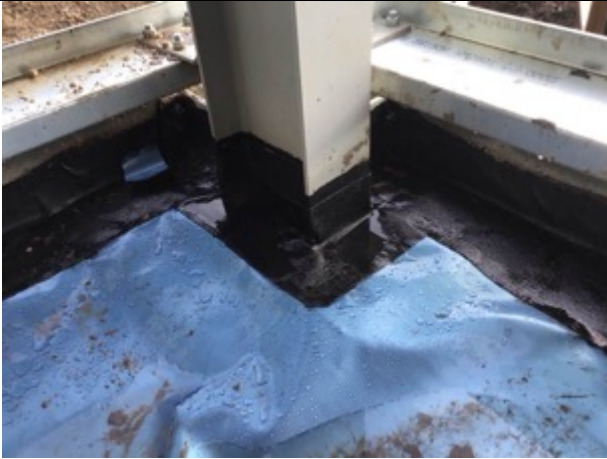
Sealed stanchion detailing

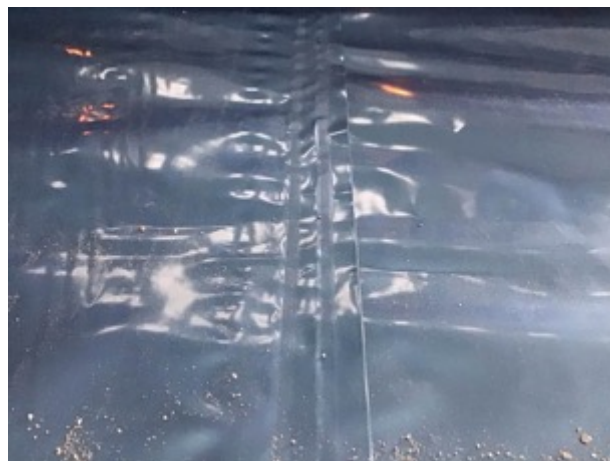
Sealed auto weld membrane joint

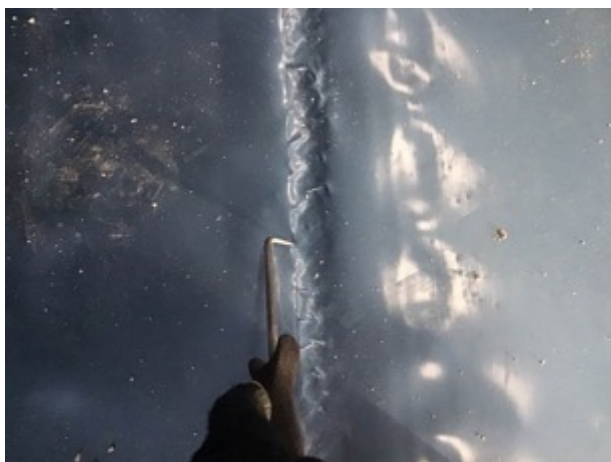
Probe test to sealed hand weld membrane joint

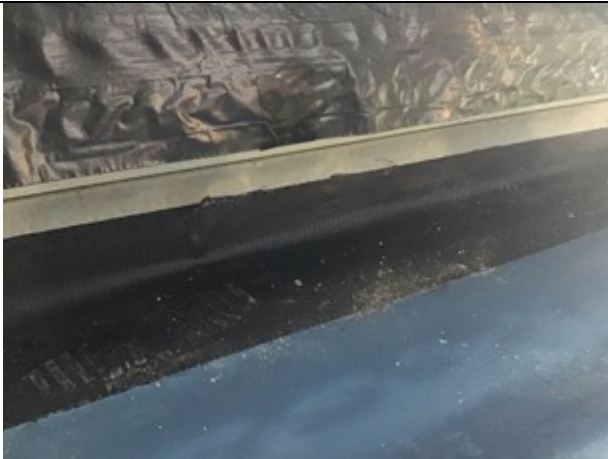
Perimeter retro fit detailing

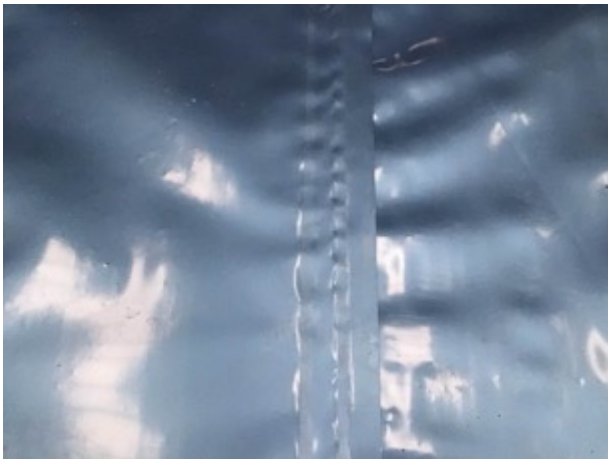
Sealed auto weld membrane joint

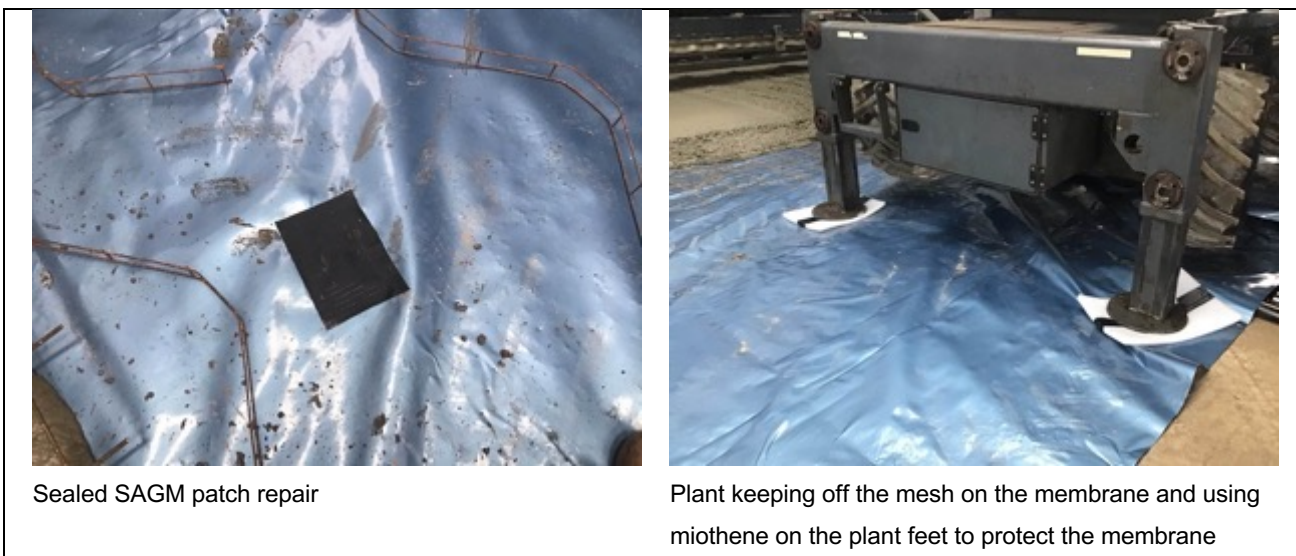
| | <p><b><u>(List any defects to detailing work and joints):</u></b></p> <p>During our inspection the following defects and repairs were carried out: 3no patch repairs carried out by the installers using SAGM and heat applied.</p> <p>Have any defects identified above been satisfactorily rectified <input checked="" type="checkbox"/> Yes <input type="checkbox"/> No <input type="checkbox"/> N/A</p> <p>The Area has passed inspection <input checked="" type="checkbox"/></p> <p>The Area has failed inspection and a corrective action sheet has been left with the contractor <input type="checkbox"/></p> <p>The Area is incomplete as detailed above <input type="checkbox"/></p> <p>Signed: <b>Dan Squire</b> Date: <b>27/02/2024</b></p> | | | |

Sealed SAGM patch repair

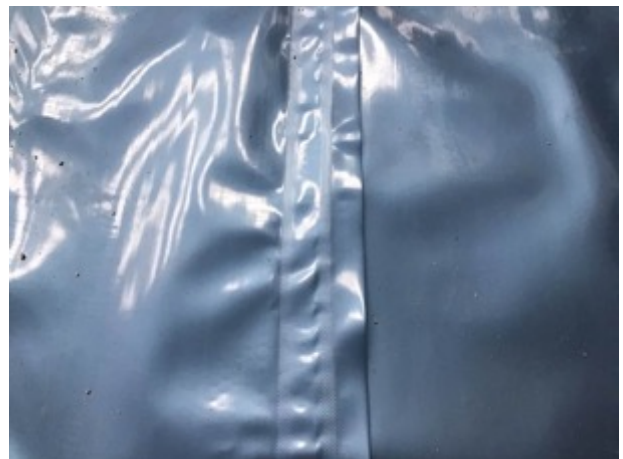
Sealed auto weld membrane joint

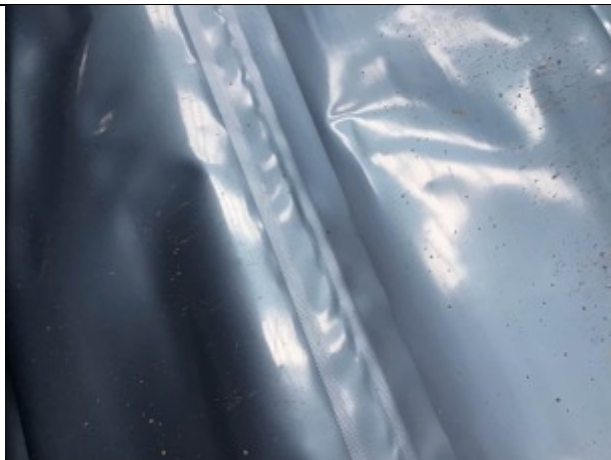
Sealed auto weld membrane joint

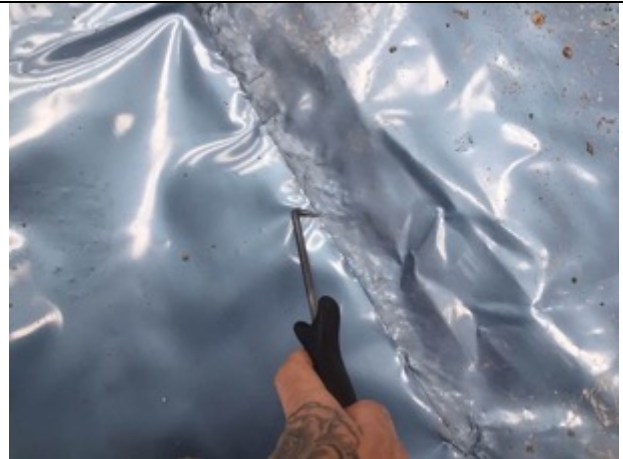
Probe test to sealed hand weld membrane joint

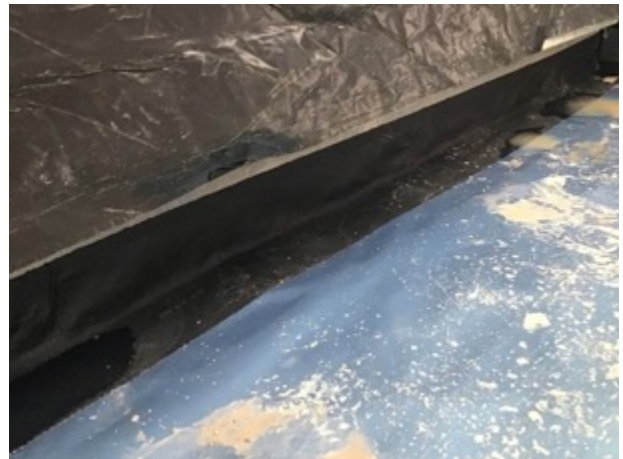
SAGM perimeter retro fit detailing

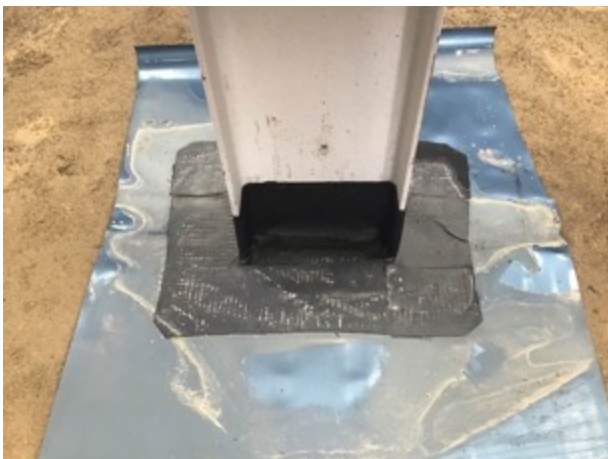
Sealed stanchion detailing using SAGM

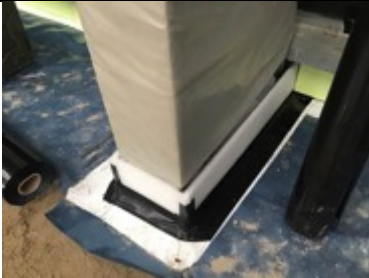
Miothene restricting stanchion  
inspection

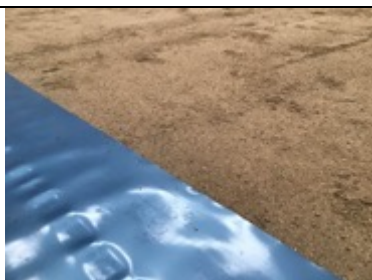
Rolled sand blinding substrate

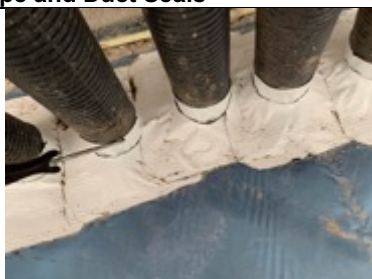
Testing pipe seals

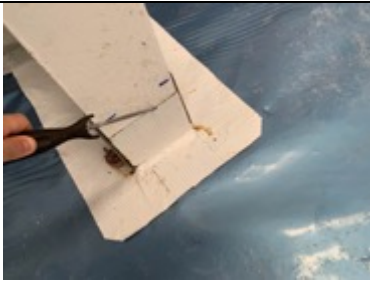
Testing stanchion detailing

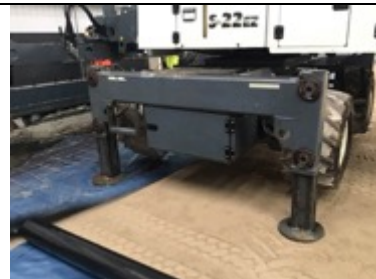
Plant keeping off the steel above the  
membrane

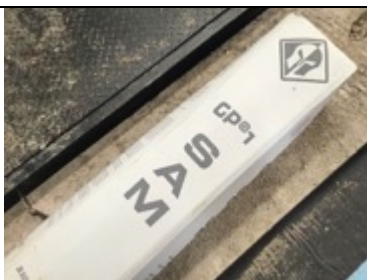
Evidence of Juta GP1 SAM

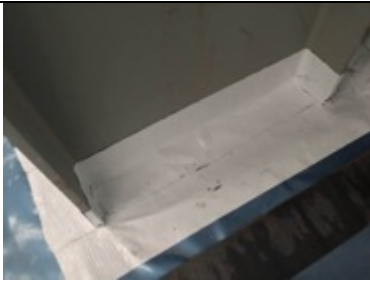
Sealed stanchion detailing using  
SAGM and heat applied

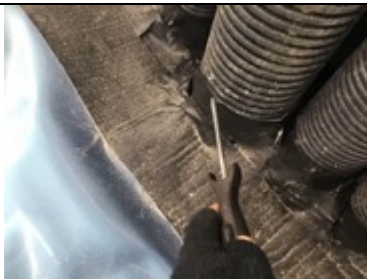
Testing pipe detailing

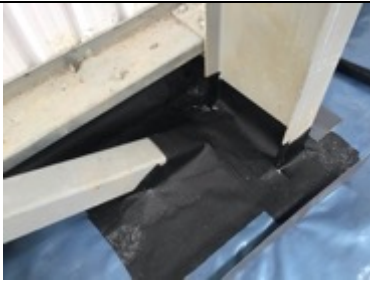
Sealed stanchion detailing using SAGM and heat applied

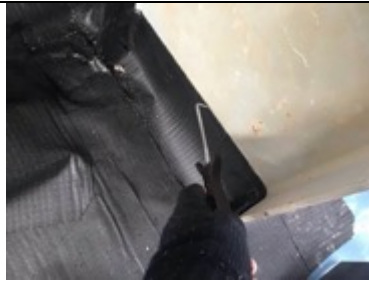
Testing stanchion detailing

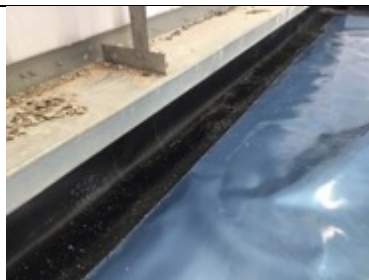
Sealed perimeter retro fit detailing  
using SAGM and heat applied

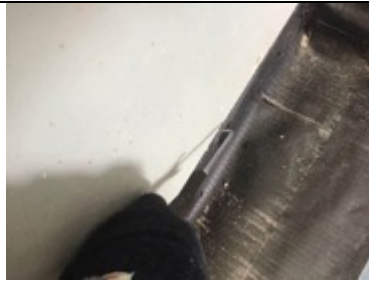
Testing stanchion detailing

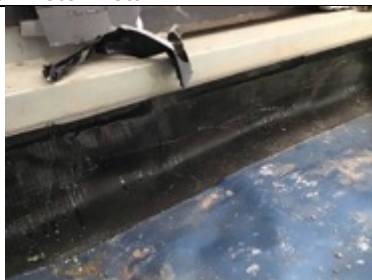
Sealed perimeter retro fit detailing  
using SAGM and heat applied

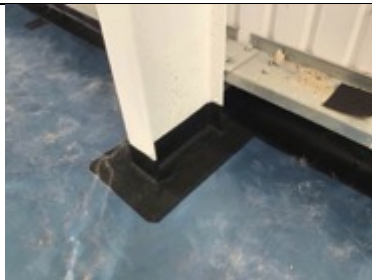
Sealed stanchion detailing using  
SAGM and heat applied

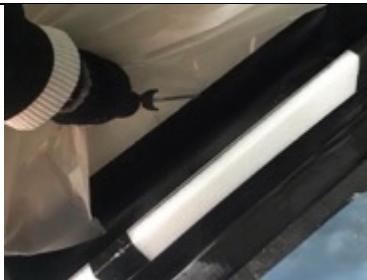
Testing stanchion detailing

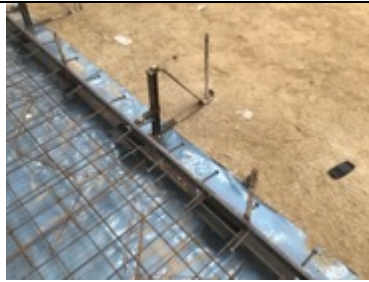
Membrane extended under the  
armoured joint

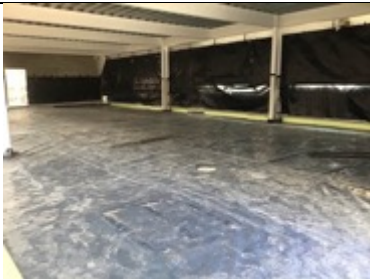
| <p>Pour area overview</p> | <p>Membrane installed under the mezzanine floor above the full layer of vent mat</p> |

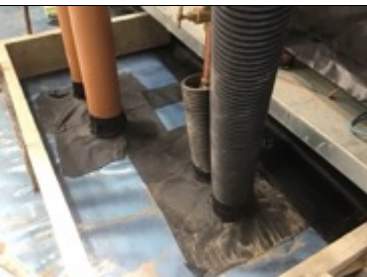
Pipe penetrations sealed using  
SAGM and heat applied

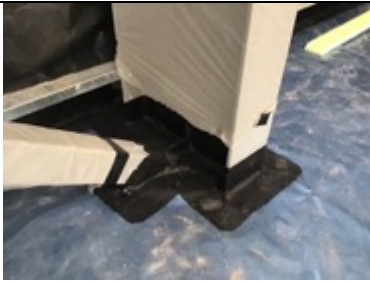
Stanchion detailing sealed using  
SAGM and heat applied

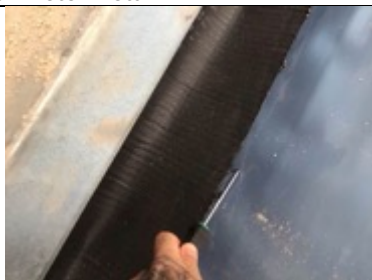
Perimeter retro fit detail testing

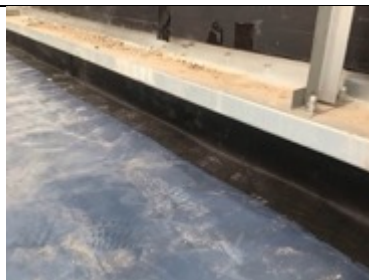
Retro fit detail to the perimeter  
cladding using SAGM and heat  
applied

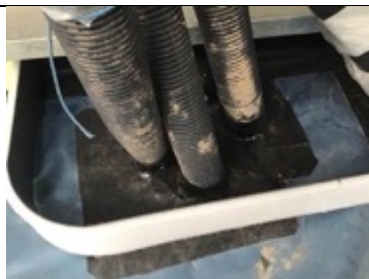
Pipe penetrations sealed using  
SAGM and heat applied

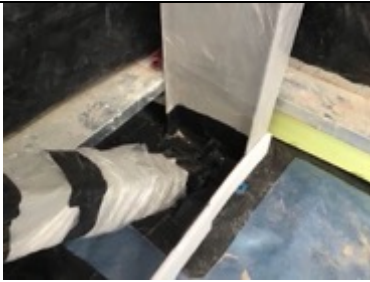
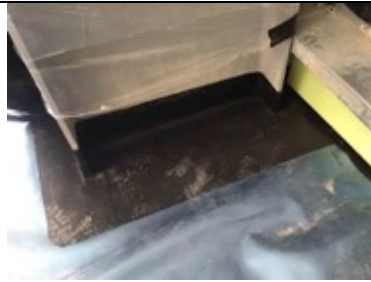
Stanchion detailing sealed using SAGM and heat applied

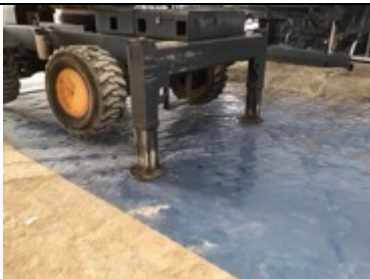
Plant keeping off the mesh above the membrane

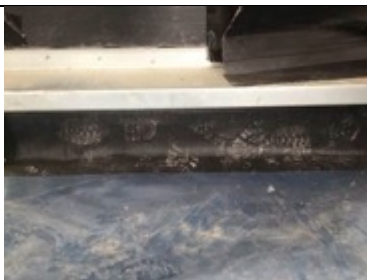
Retro fit detail to the perimeter  
cladding using SAGM and heat  
applied

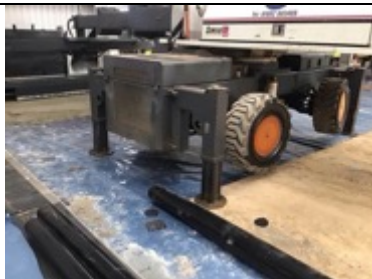
Plant keeping off the mesh above  
the membrane

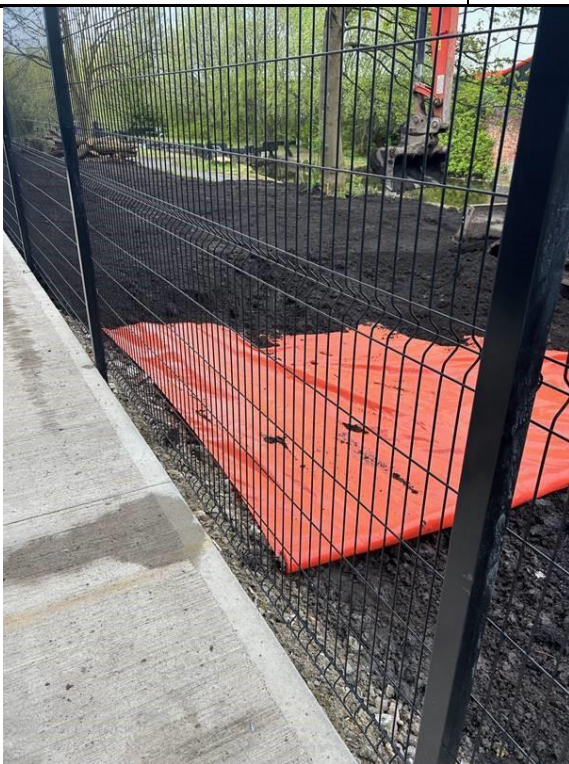
| <b>Description:</b><br><br>Geotextile membrane and topsoil installation | | | |

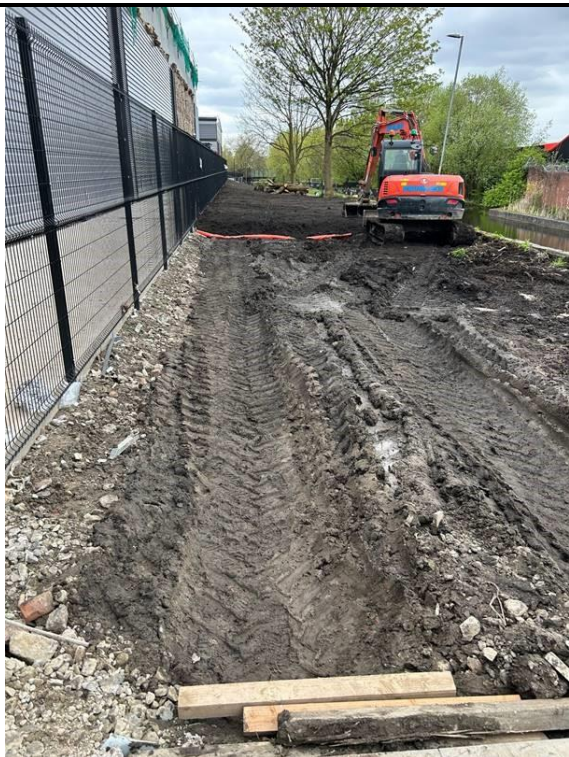
| <b>Description:</b><br><br>Geotextile membrane and topsoil installation | | | |
