# One Medlock Street Development

## Highway Pre-condition Survey

Sweco UK Limited 2888385  
 Project Name One Medlock Street Development  
 Planning Application Reference 135419/FO/2022N/A  
 Client RG Group  
 Author Jordan Bamber Sweco  
 Date 11/10/2023  
 Document reference One Medlock Pre-condition Survey

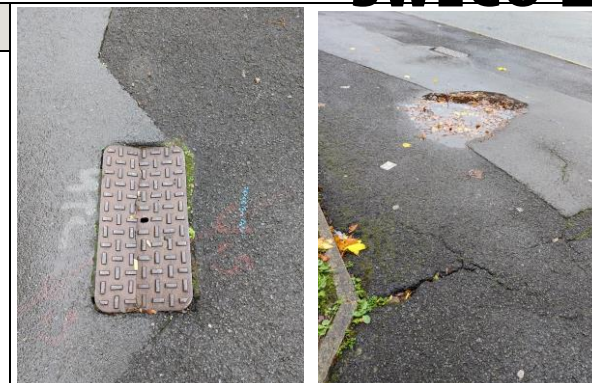
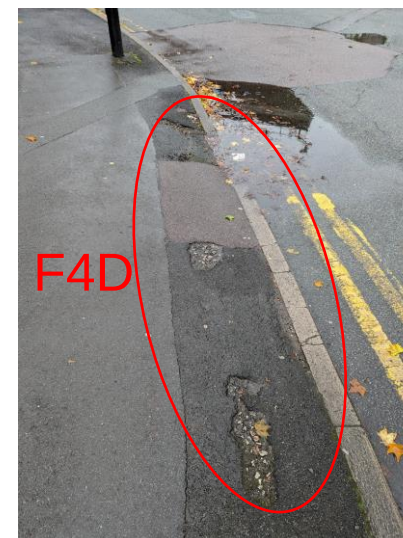
Location F4: Grid Reference X= 383655 Y= 397245

F4A. Shattered utility chamber.

F4B. Footway low spot resulting in ponding of water.

F4C. Asphalt cracking.

F4D. Potholes and cracking of kerb unit.

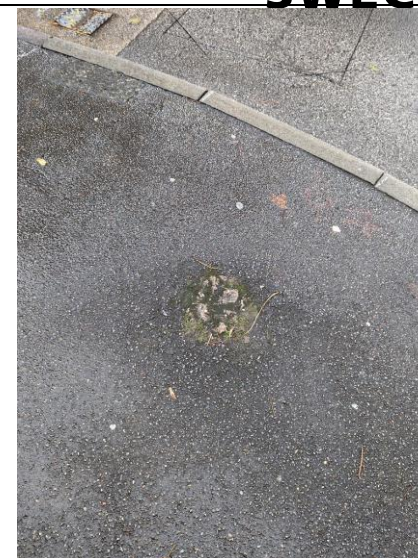
Location F8: Grid Reference X= 383598 Y= 397217

F8A. Scarring in footway from removed bollard.

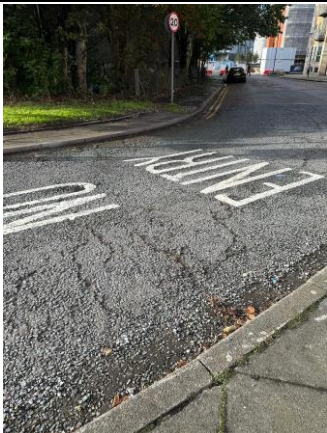
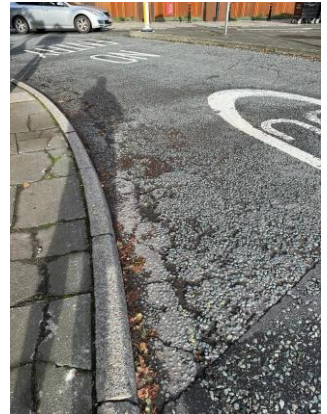
| | <p>Location C1: Grid Reference X= 383536 Y= 397159</p> | |
| | <p>Notes:</p> <p>C1A. General surface wear.</p> <p>C1B. Visible carriageway trenches.</p> <p>C1C. Cracking and general surface wear on Mancunian Way off slip.</p> | <p>Additional photo taken 13/10/2023 indicating clearer evidence of longitudinal and transverse cracking in this location in dry conditions.</p> |

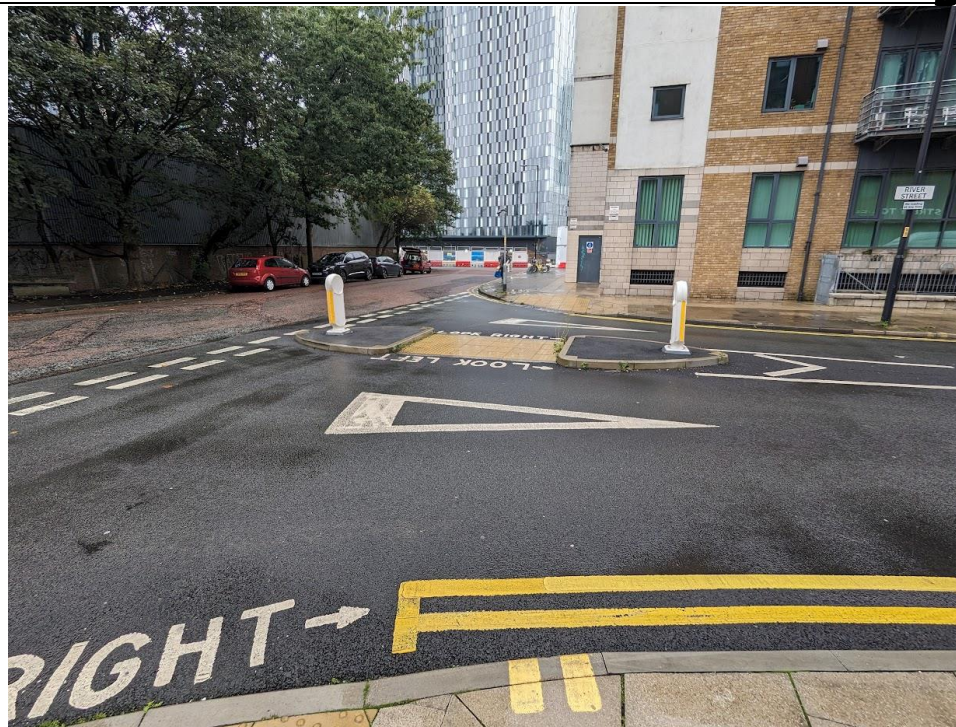
Location C4: Grid Reference X= 383533 Y= 397189

No visible damage

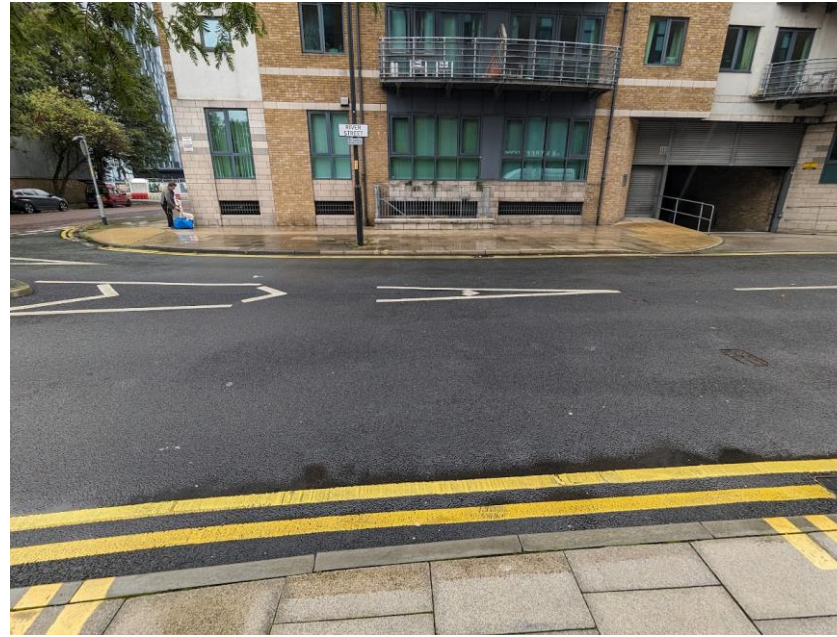
Location C5: Grid Reference X= 383545 Y= 397196

No visible damage

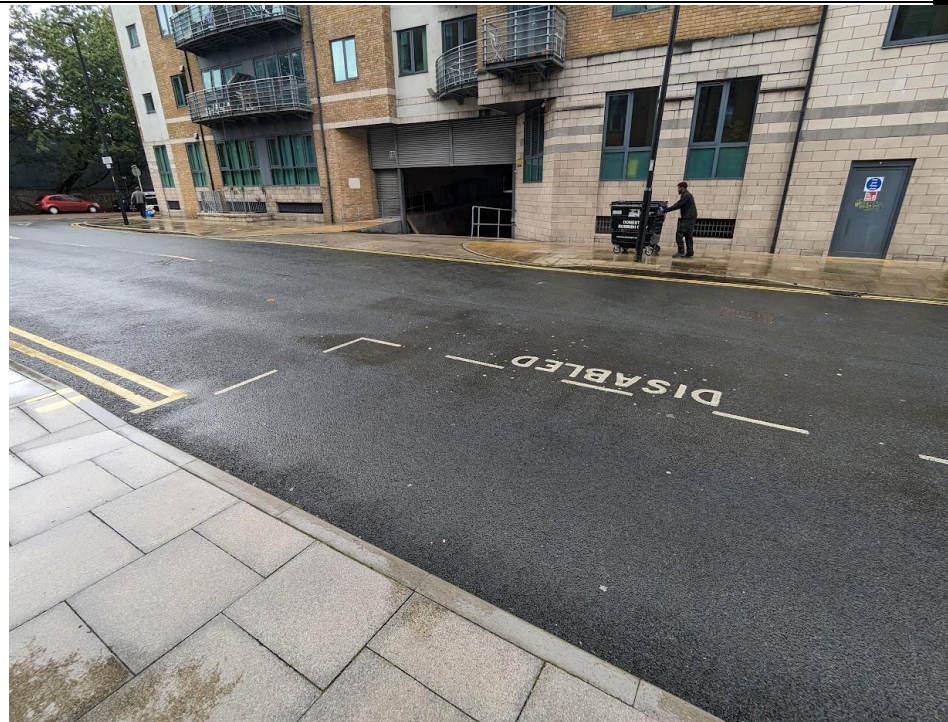
Location C6: Grid Reference X= 383557 Y= 397201

No visible damage

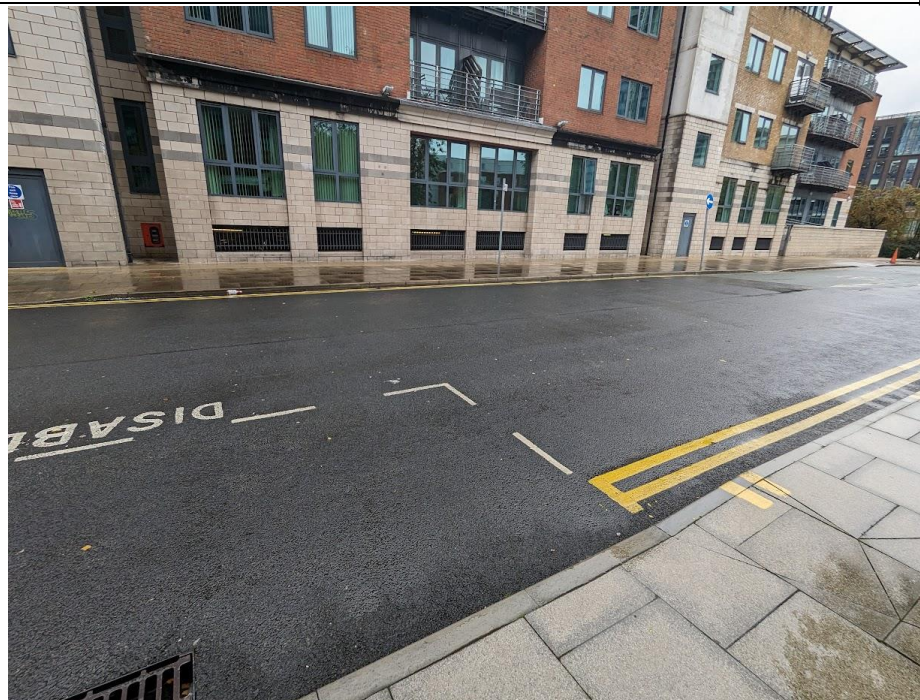
Location C7: Grid Reference X= 383570 Y= 397209

No visible damage

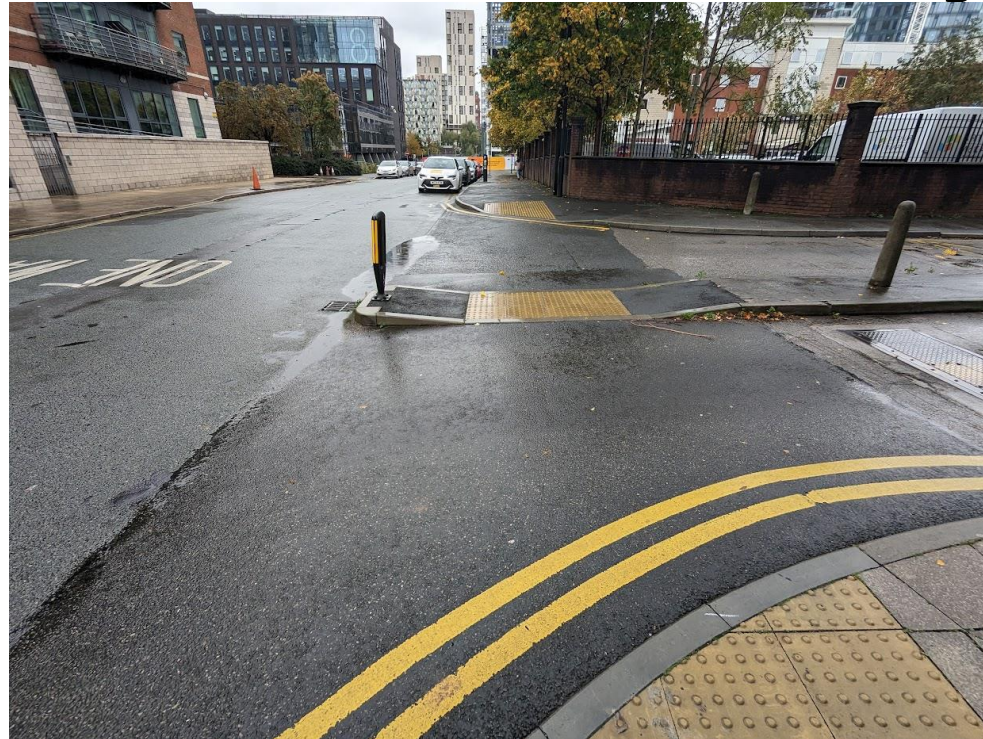
Location C9: Grid Reference X= 383588 Y= 397210

No visible damage

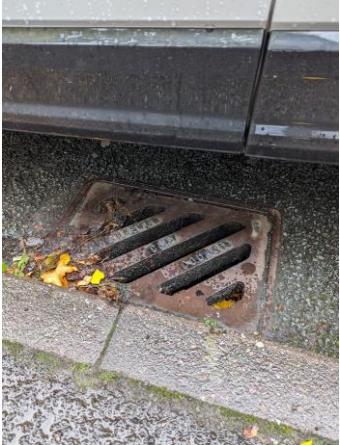
| | <div data-bbox="952 159 1563 199"> <p>Location C12: Grid Reference X= 383623 Y= 397237</p> </div> <div data-bbox="952 204 1563 783"> </div> <div data-bbox="952 804 1563 922"> <p>Notes:</p> <p>C12A. Longitudinal Cracking with significant surface failure</p> <p>C12B. Transverse Cracking</p> </div> <div data-bbox="1570 156 1908 603"> </div> |

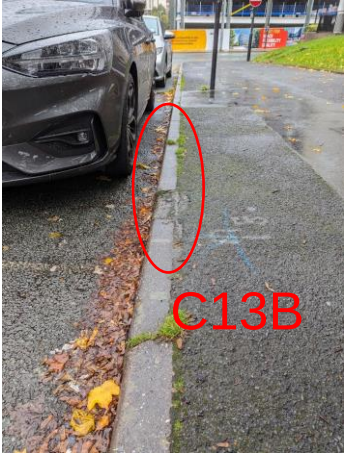
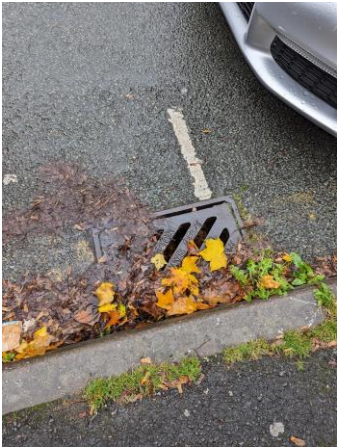
| | <p>Location C13: Grid Reference X= 383638 Y= 397245</p> <p>Notes:</p> <p>C13A. Longitudinal cracking with significant surface failure</p> <p>C13B. Kerb units deteriorated</p> <p>C13C. Debris build up at gully pot</p> | |

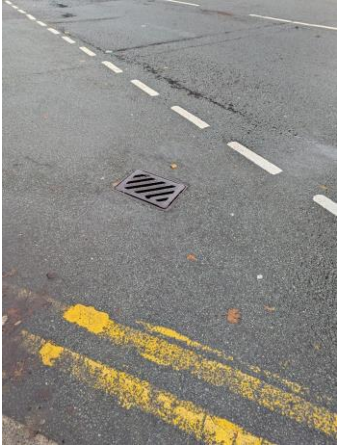
| | <p>Location C14: Grid Reference X= 383651 Y= 397252</p> <p>Notes:</p> <p>C14A. Longitudinal and transverse cracking</p> <p>C14B. Longitudinal cracking with minor surface failure</p> | |

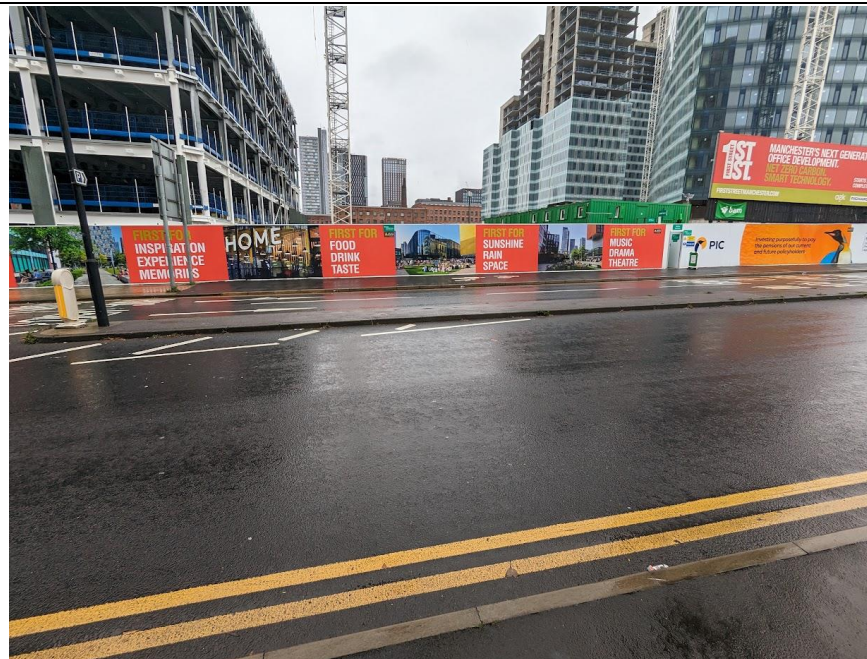
Location C18: Grid Reference X= 383689 Y= 397211

No visible damage
