FEDERATION  
COOPERATIVE WHOLESALE  
NEW CENTRAL PREMISES - MANCHESTER

Hanover House  
And E-Block,  
Manchester

**HERITAGE STATEMENT:**

Significance Appraisal and Impact Assessment

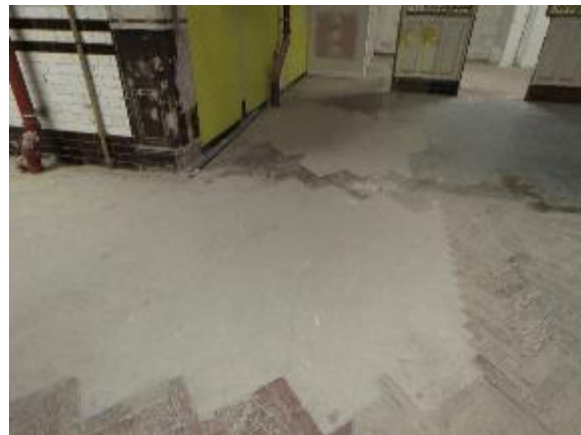
**Figure 43:** An area of the timber parquet floor which has been lifted

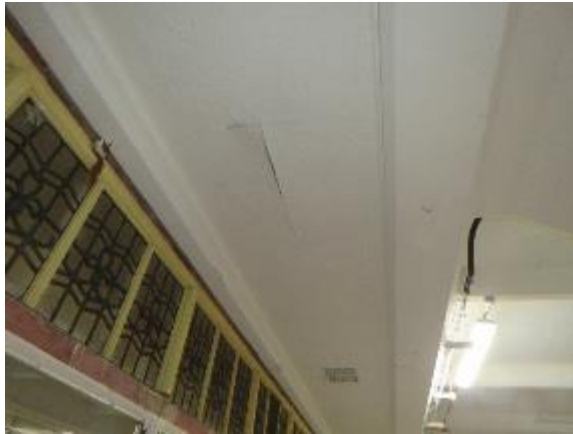
**Figure 44:** View of surviving glazed brickwork and plastered walls with abundance of M&E at ceiling level,

| <b>Walls</b> | Removal of paint to glazed bricks, repair and re-grouting of joints where required. Replacement of failed plaster with new plaster and re-decoration of external walls. | The proposed works will have a <b>minor beneficial impact</b> on the historic fabric through replacing decayed fabric, repairing fabric that is in poor condition and putting the wall finishes back into good condition. |

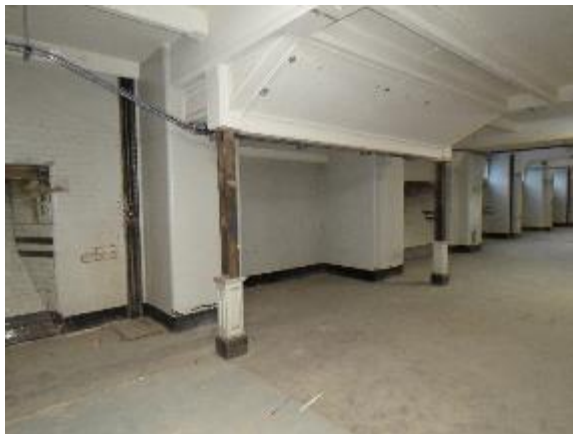
**Figure 48:** General view of basement windows on Corporation street (southern end of elevation) showing surviving glazed bricks (partially painted) and concrete floor structure.

| Building element | Proposal | Impact/Explanation |
|---|---|---|
| <b>Basement Windows</b> | Removal of 6no. basement windows and replacement with ventilation louvres. | The works will result in a <b>minor adverse impact</b> by eroding historic fabric of high significance from the Corporation Street Elevation. |

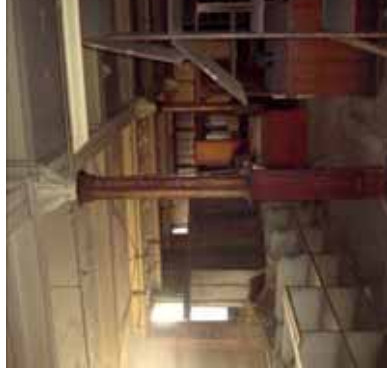
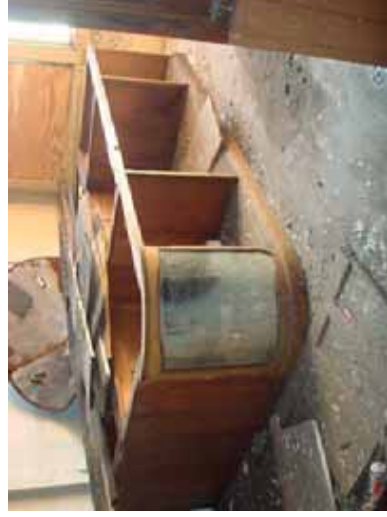
**Fig. 6.1.6 and 6.1.7.** 2011. Early coloured timber panelling encase the cast-iron columns on the 4th floor. This early display case was found on the sixth floor.

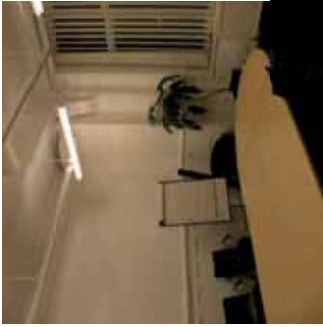
**Photo 57. HB.2F.14-** Early, possible original dado panelling.

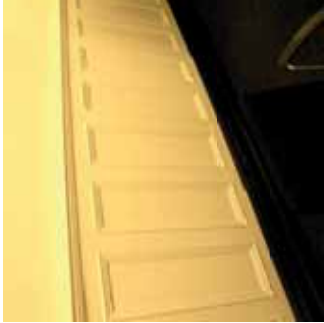
**Photo 61. HB.2F.14-** Early, possible original dado panelling.

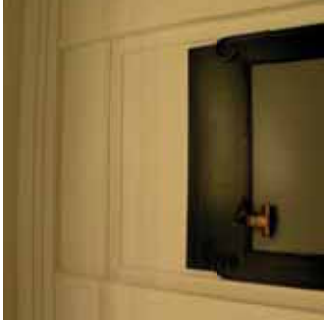
**Photo 64. HB.3F.03** - ca. 1930's architrave

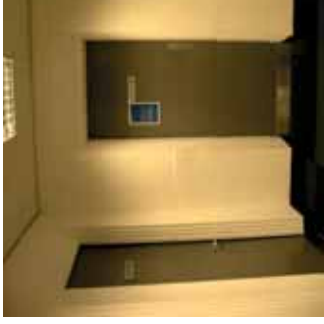
**Photo 65. HB.3F.15-** ca. 1930's architrave
