## Jonathan Davidson Architects

Neptune Mill  
Chapelton St, Manchester

Historic & Industrial Features Audit  
353 PD 2001 (P2)

*October 2023*

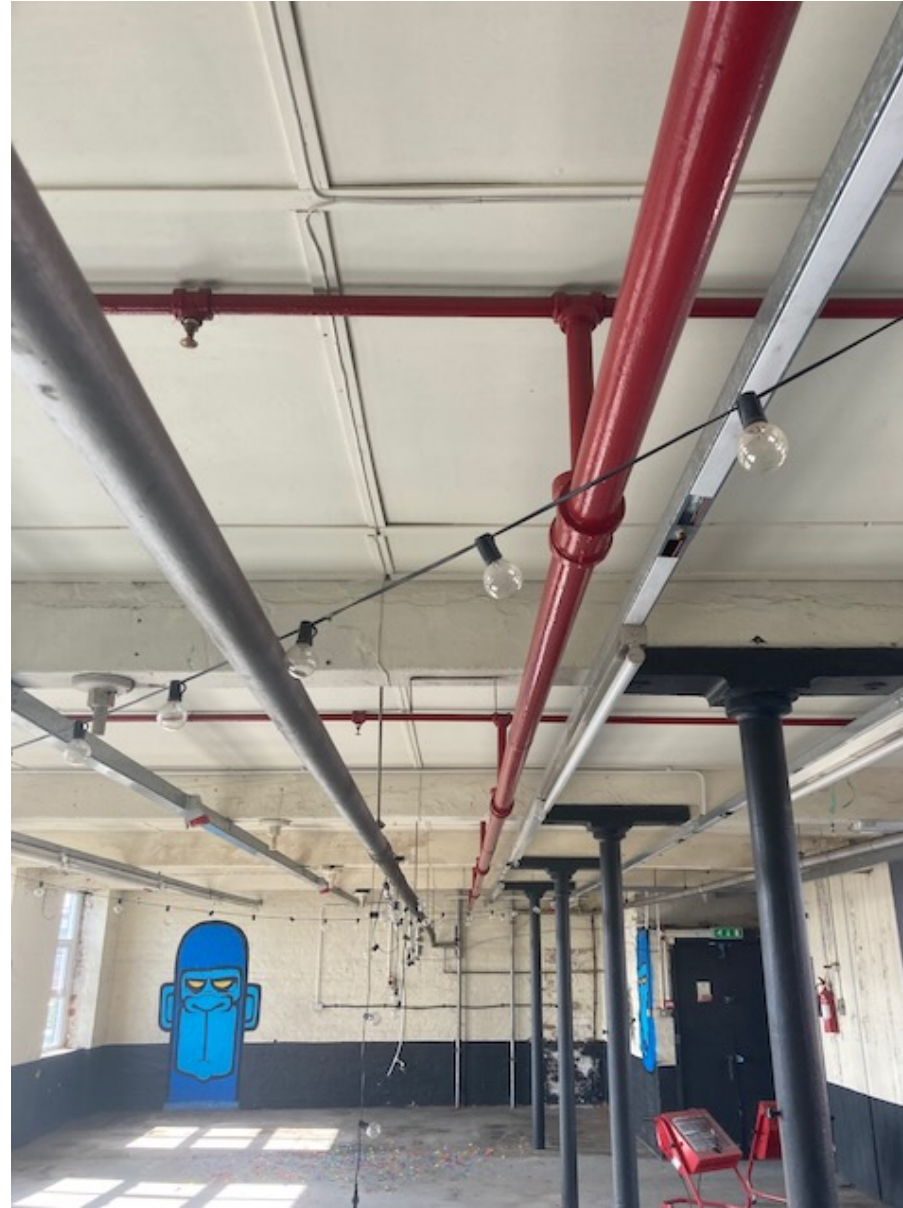
**ITEM G8**  
Typical sprinkler pipework layout

| Ref | Historic / Industrial Feature | Description | Removed / Retained | Works to be undertaken |
|---|---|---|---|---|
| G8 | Sprinkler pipework and equipment | Cast iron / steel sprinkler pipework to all floors with inlets / valves at ground floor level | Removed | All sprinkler pipework and equipment to be removed |

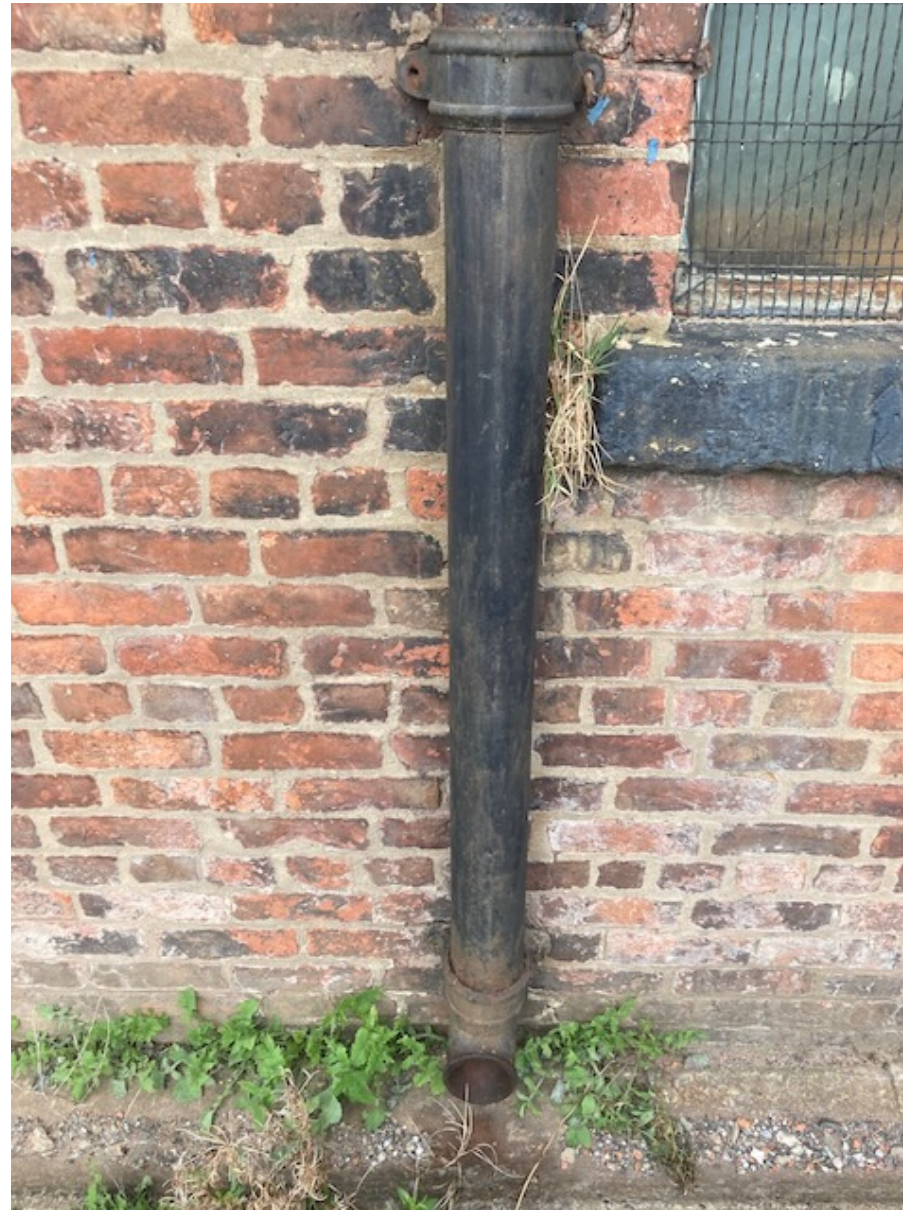
**ITEM G14**  
Cast iron rainwater pipe to Baird Street

| Ref | Historic / Industrial Feature | Description | Removed / Retained | Works to be undertaken |
|---|---|---|---|---|
| G14 | External rainwater goods | Mixture of cast iron and uPVC hopper heads and downpipes | Removed & replaced | All rainwater goods to be renewed in cast iron |

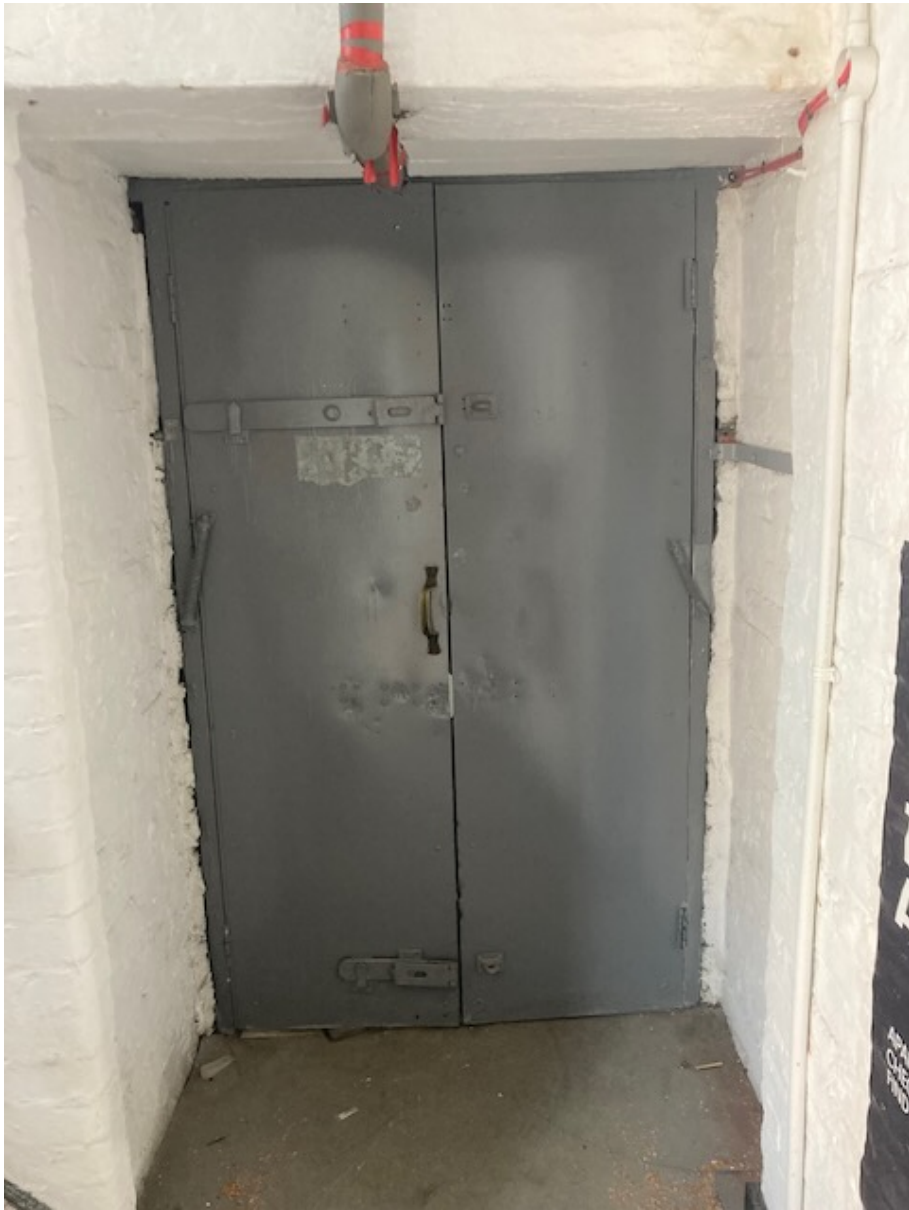
**ITEM 11**  
Brickwork lobby and timber doors to north east stair (stair side)

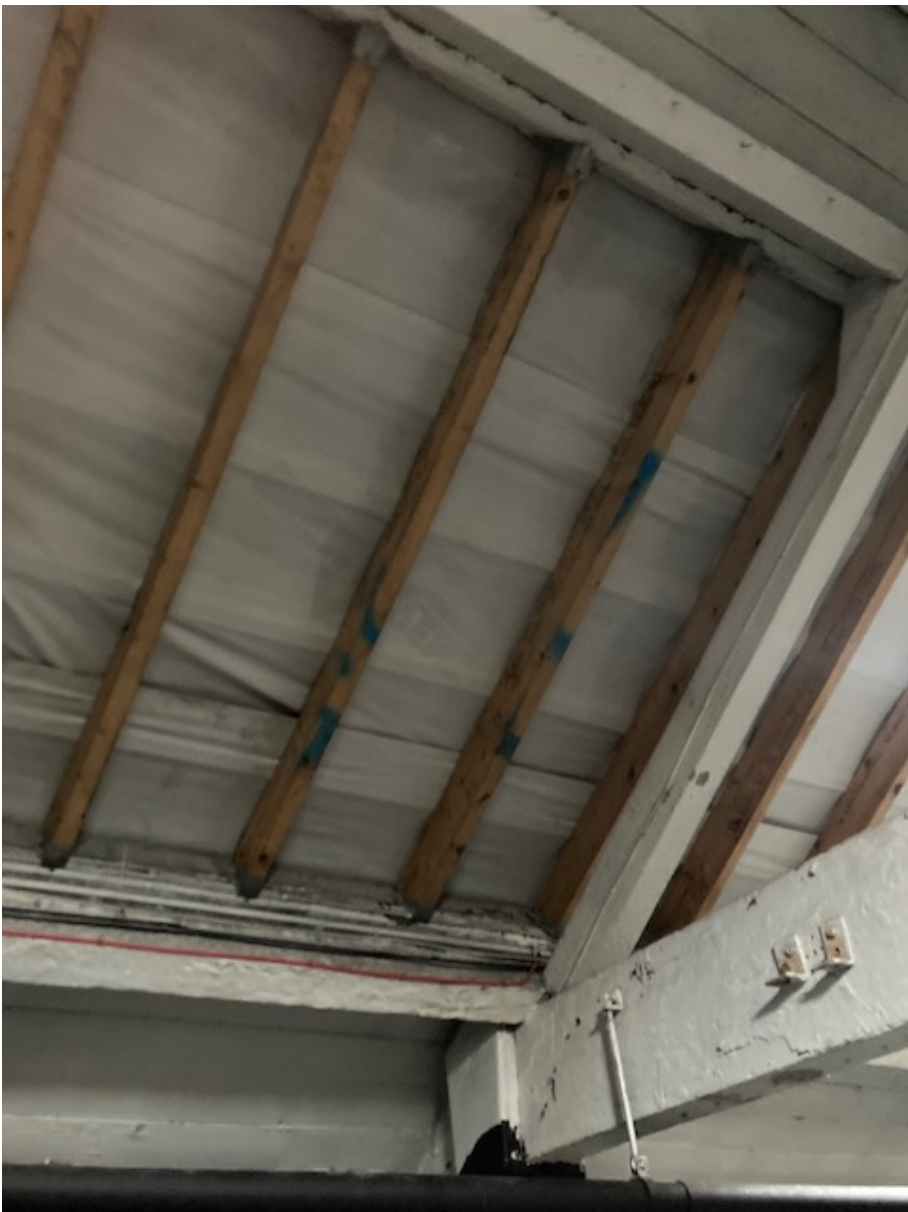
**ITEM 43**  
Infill rafters to former rooflight opening between purlins
