# DRAINAGE SURVEY

Job Number  
**LAYERSERV0001859**

Brunswick Mill,  
Bradford Road,  
Manchester,  
M40 7EZ

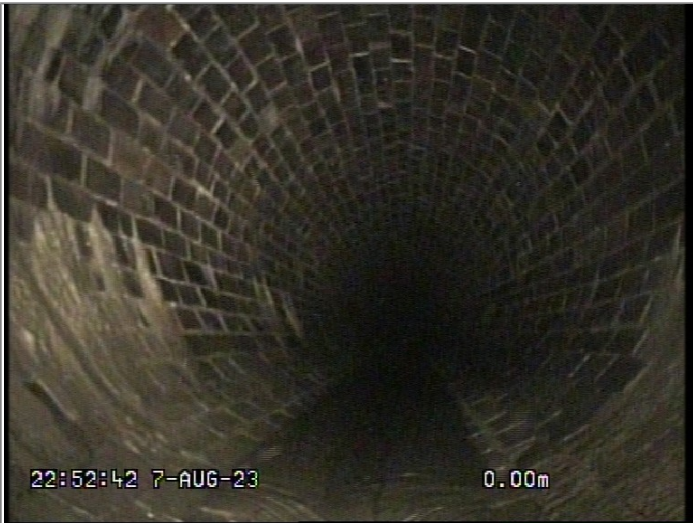
| Job Number<br>LAYERSERV0001859 | Surveyed by (Operator)<br>Joe COLLINS | Base Unit<br>DJVV56JNNH | Date<br>07/08/2023 |
|---|---|---|---|
| Start node type, manhole, reference 7600 | | Water level 5% height/diameter | |

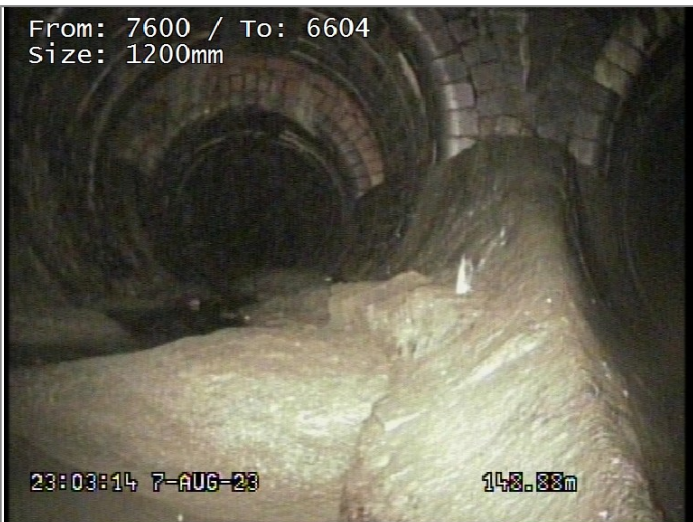
| Job Number<br>LAYERSERV0001859 | Surveyed by (Operator)<br>Joe COLLINS | Base Unit<br>DJVV56JNNH | Date<br>07/08/2023 |
|---|---|---|---|
| Junction at 3 o'clock, diameter 1200mm | | Finish node type, manhole, reference 6707 | |

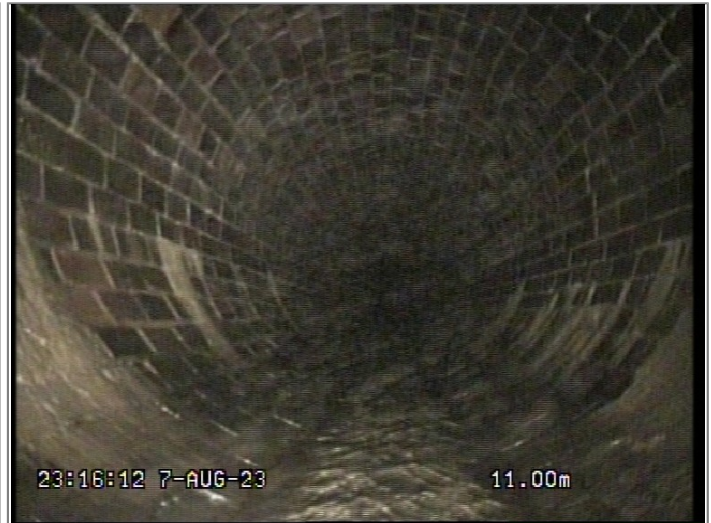
Water level 5% height/diameter

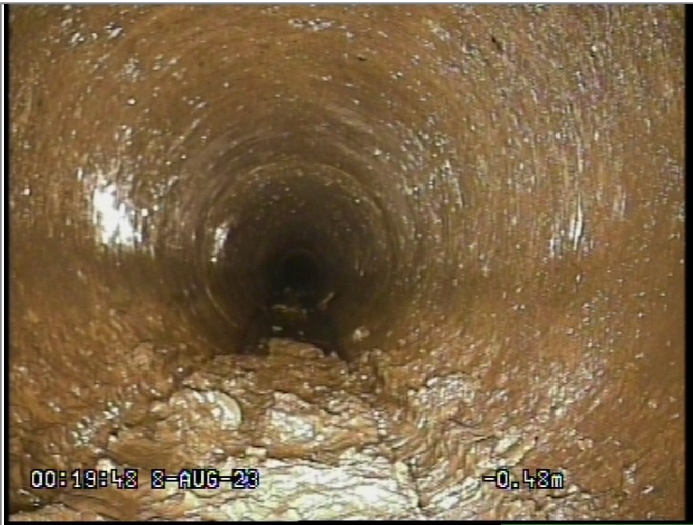
| Job Number<br>LAYERSERV0001859 | Surveyed by (Operator)<br>Joe COLLINS | Base Unit<br>DJVV56JNNH | Date<br>08/08/2023 |
|---|---|---|---|
| Start node type, manhole, reference 6602 | | | |

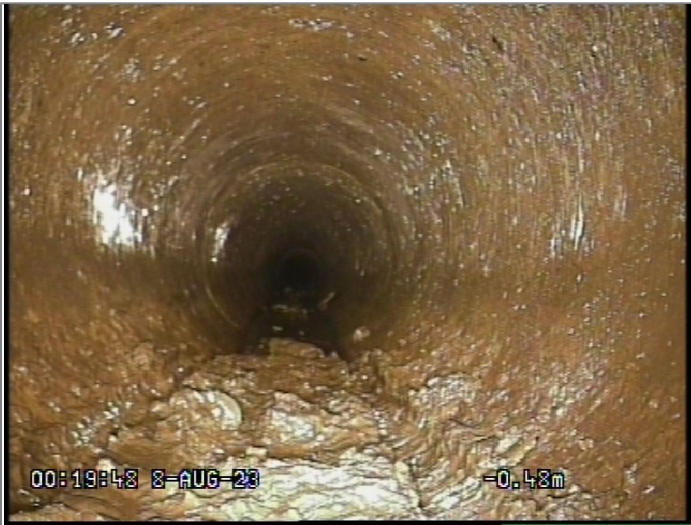
| Job Number<br>LAYERSERV0001859 | Surveyed by (Operator)<br>Joe COLLINS | Base Unit<br>DJVV56JNNH | Date<br>08/08/2023 |
|---|---|---|---|
| Water level 5% height/diameter | | | |

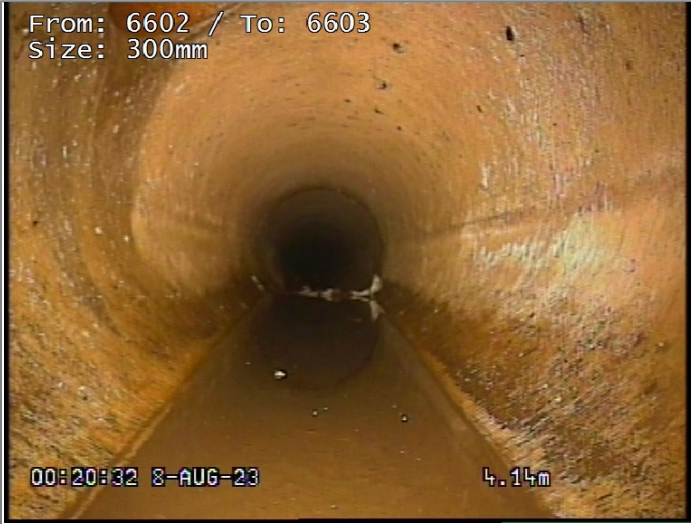
| Job Number<br>LAYERSERV0001859 | Surveyed by (Operator)<br>Joe COLLINS | Base Unit<br>DJVV56JNNH | Date<br>08/08/2023 |
|---|---|---|---|
| Connection other than junction at 11 o'clock, diameter 150mm | | | |

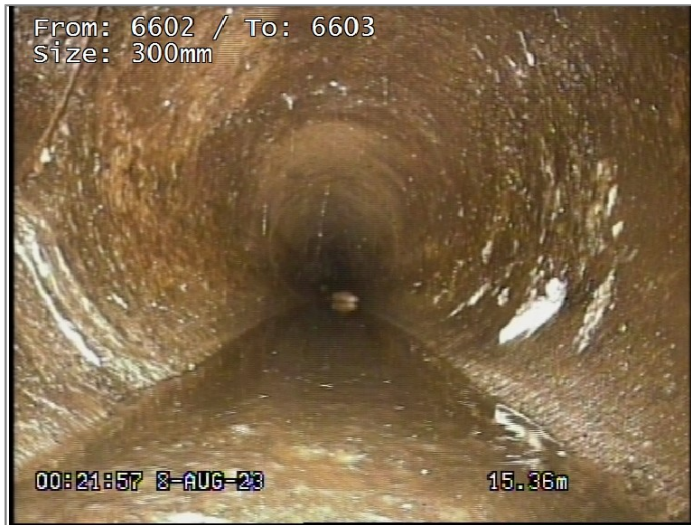
Connection other than junction at 10 o'clock, diameter 150mm

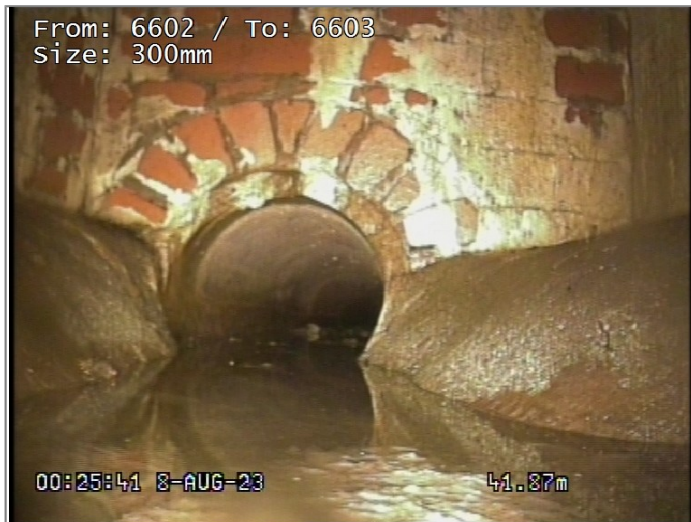
Finish node type, manhole, reference 6603

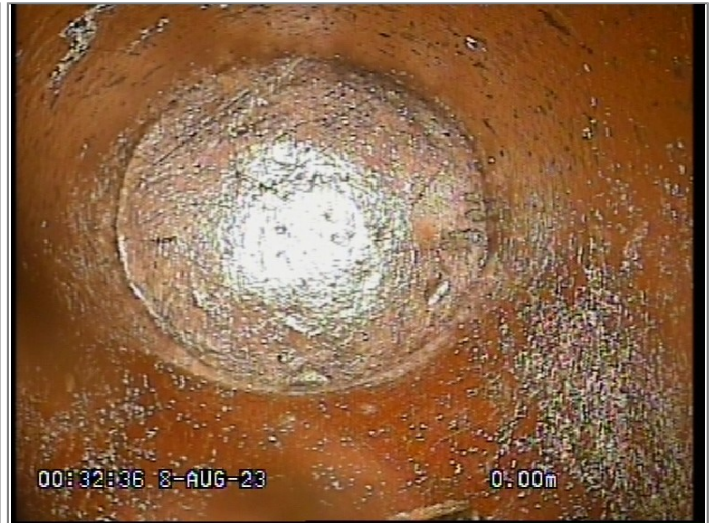
Water level 5% height/diameter

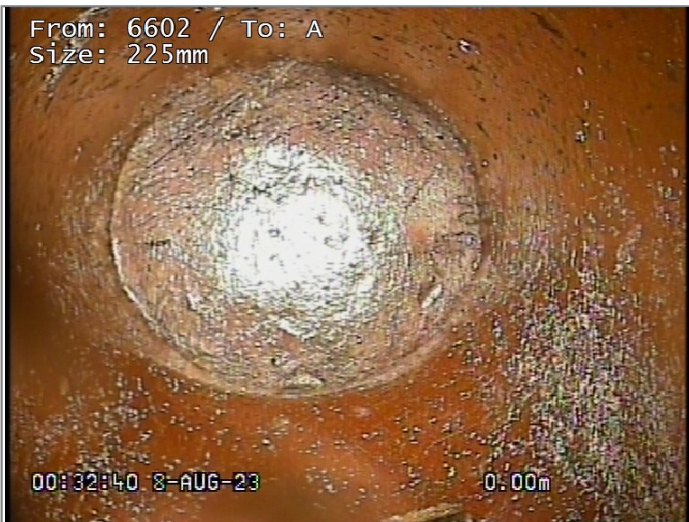
Finish node type, other special chamber, reference A

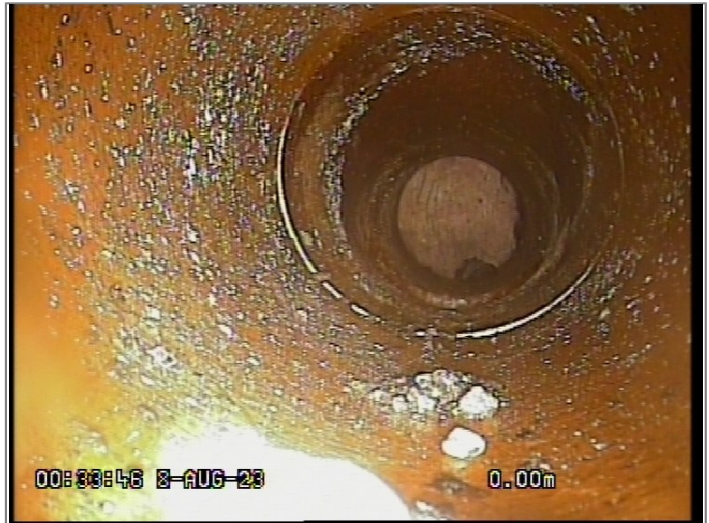
Water level 5% height/diameter

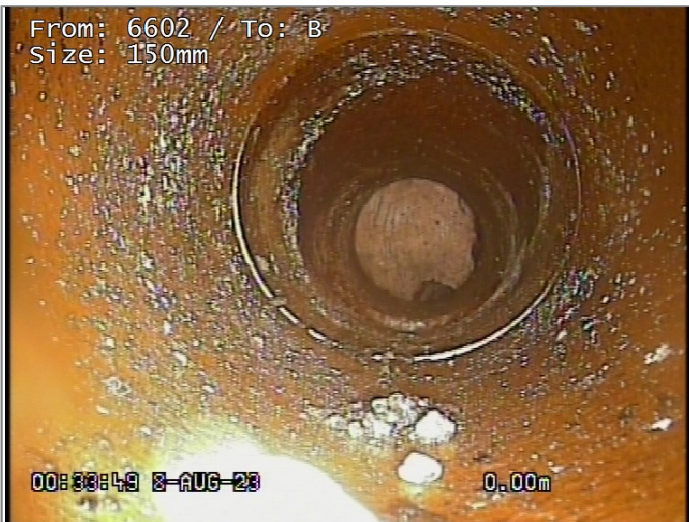
Finish node type, other special chamber, reference B

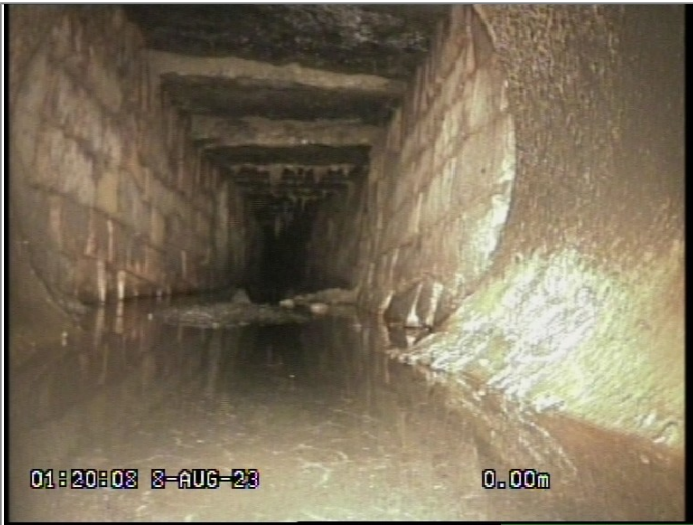
| Job Number<br>LAYERSERV0001859 | Surveyed by (Operator)<br>Joe COLLINS | Base Unit<br>DJVV56JNNH | Date<br>08/08/2023 |
|---|---|---|---|
| Start node type, manhole, reference 5502 | | | |

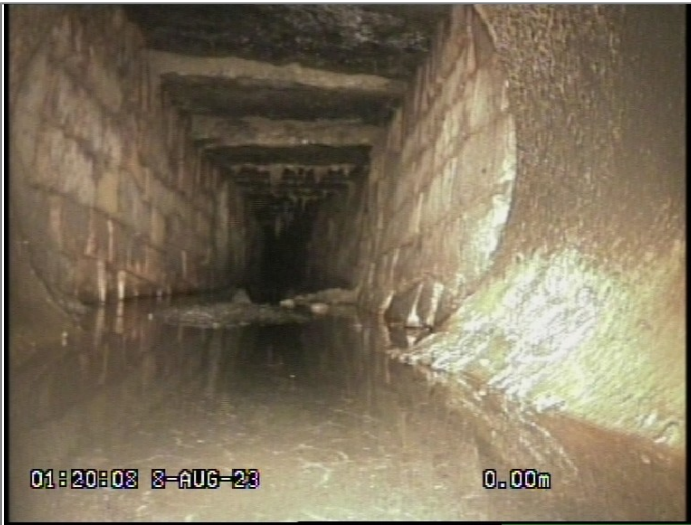
| Job Number<br>LAYERSERV0001859 | Surveyed by (Operator)<br>Joe COLLINS | Base Unit<br>DJVV56JNNH | Date<br>08/08/2023 |
|---|---|---|---|
| Water level 5% height/diameter | | | |

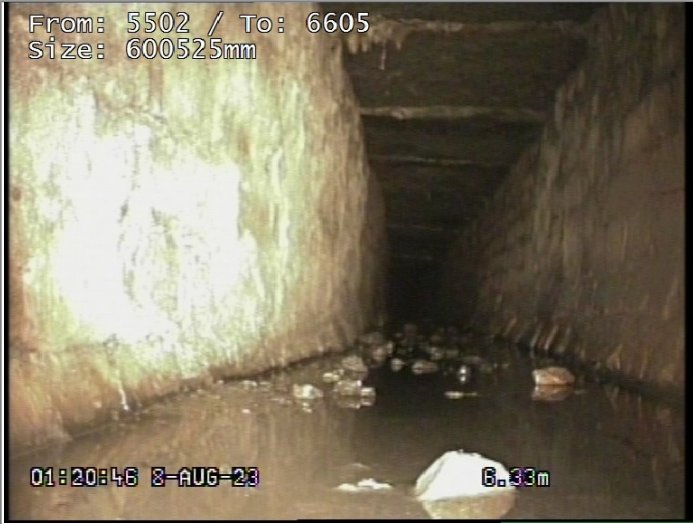
| Job Number<br>LAYERSERV0001859 | Surveyed by (Operator)<br>Joe COLLINS | Base Unit<br>DJVV56JNNH | Date<br>08/08/2023 |
|---|---|---|---|
| From: 5502 / To: 6605<br>Size: 600525mm<br>Connection other than junction at 3 o'clock, diameter 225mm | | | |

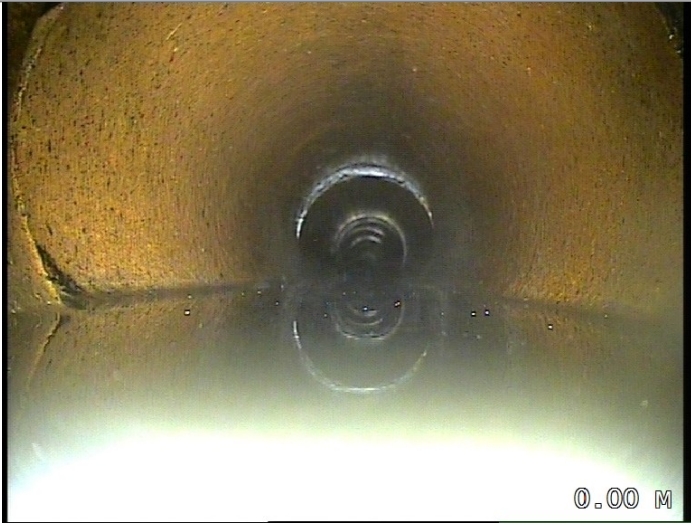
| Job Number<br>LAYERSERV0001859 | Surveyed by (Operator)<br>Joe COLLINS | Base Unit<br>DJVV56JNNH | Date<br>11/08/2023 |
|---|---|---|---|
| <p>0.00 M</p> <p>Start node type, manhole, reference MH1</p> | | | |

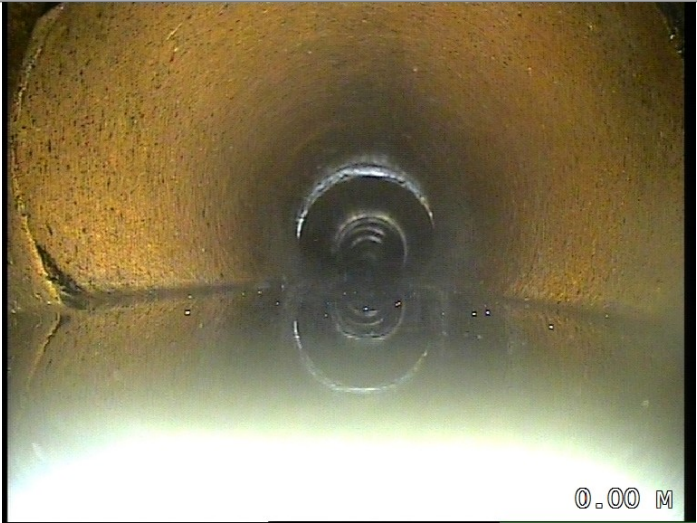
| Job Number<br>LAYERSERV0001859 | Surveyed by (Operator)<br>Joe COLLINS | Base Unit<br>DJVV56JNNH | Date<br>11/08/2023 |
|---|---|---|---|
| <p>0.00 M</p> <p>Water level 5% height/diameter</p> | | | |

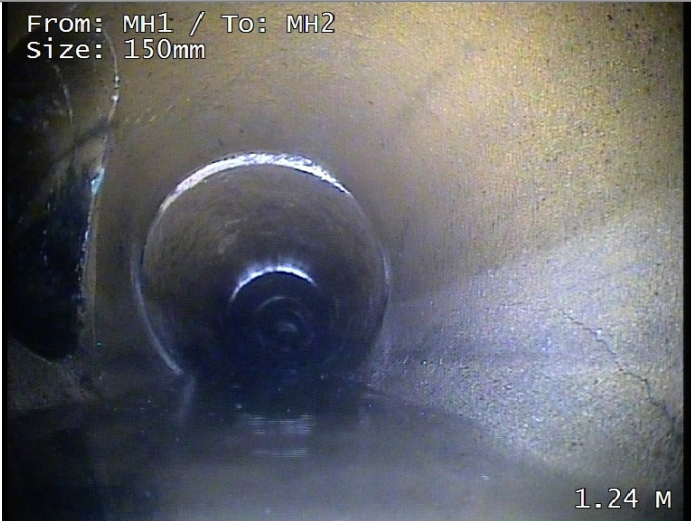
| Job Number<br>LAYERSERV0001859 | Surveyed by (Operator)<br>Joe COLLINS | Base Unit<br>DJVV56JNNH | Date<br>11/08/2023 |
|---|---|---|---|
| <p>From: MH1 / To: MH2<br/>Size: 150mm</p> <p>1.24 M</p> <p>Junction at 9 o'clock, diameter 100mm</p> | | | |

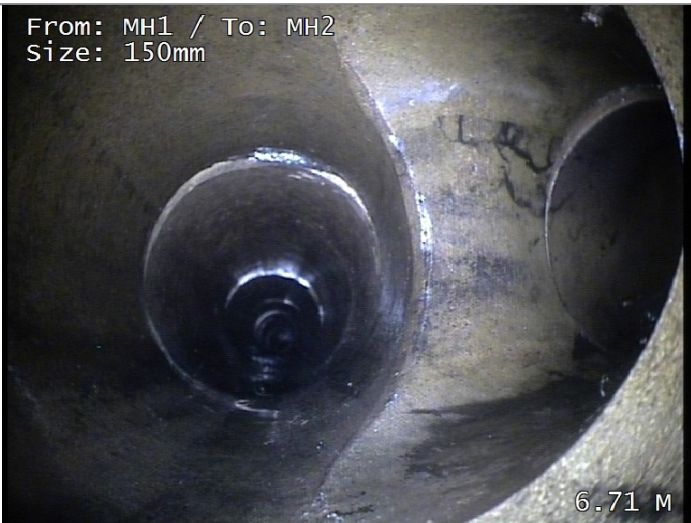
| Job Number<br>LAYERSERV0001859 | Surveyed by (Operator)<br>Joe COLLINS | Base Unit<br>DJVV56JNNH | Date<br>11/08/2023 |
|---|---|---|---|
| <p>From: MH1 / To: MH2<br/>Size: 150mm</p> <p>6.71 M</p> <p>Junction at 3 o'clock, diameter 150mm</p> | | | |

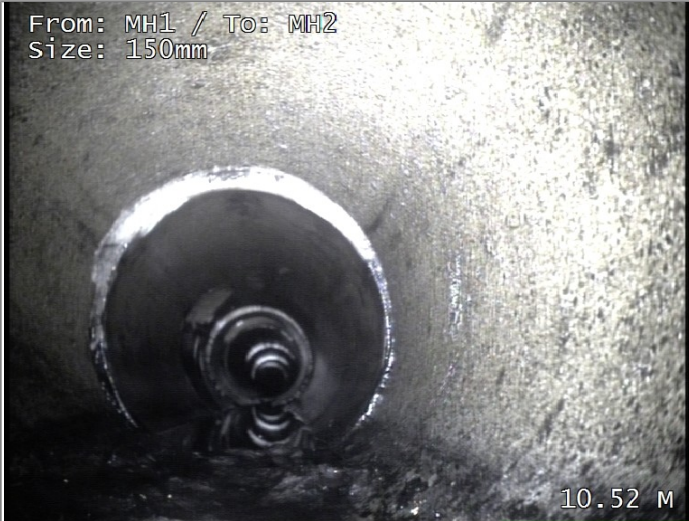
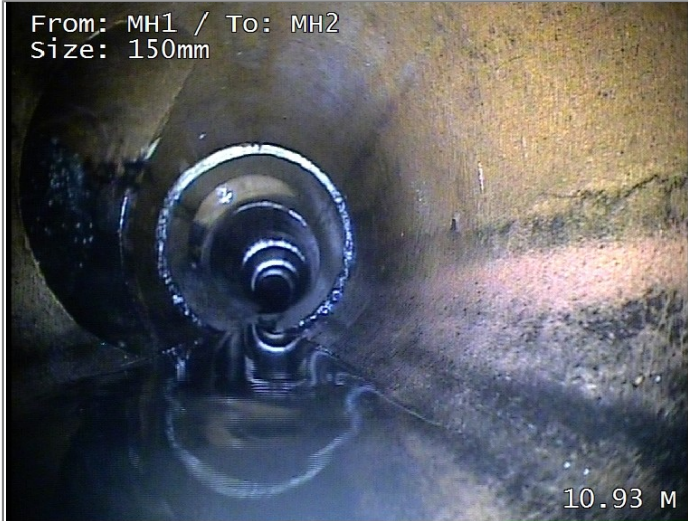
| Job Number<br>LAYERSERV0001859 | Surveyed by (Operator)<br>Joe COLLINS | Base Unit<br>DJVV56JNNH | Date<br>11/08/2023 |
|---|---|---|---|
| <div><div>From: MH1 / To: MH2<br/>Size: 150mm</div><div><div>10.52 M</div></div><div>Settled deposits hard or compacted 5% cross-sectional area loss, Start</div></div> | <div><div>From: MH1 / To: MH2<br/>Size: 150mm</div><div><div>10.93 M</div></div><div>Settled deposits hard or compacted 5% cross-sectional area loss, Finished</div></div> | | |

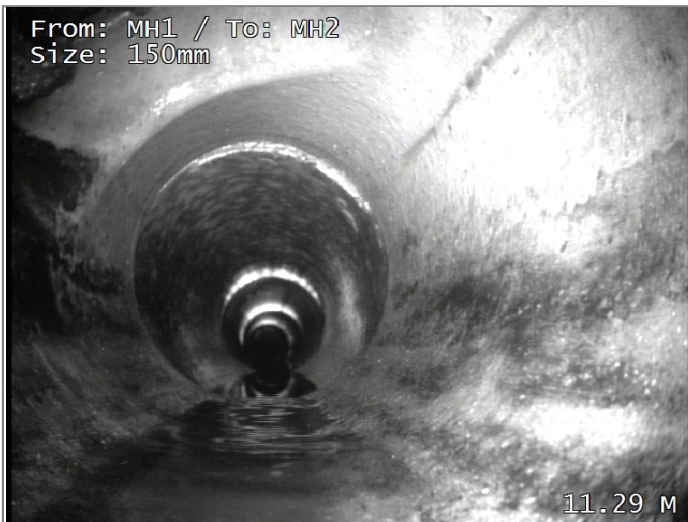
| Job Number<br>LAYERSERV0001859 | Surveyed by (Operator)<br>Joe COLLINS | Base Unit<br>DJVV56JNNH | Date<br>11/08/2023 |
|---|---|---|---|
| <div><div>From: MH1 / To: MH2<br/>Size: 150mm</div><div><div>10.93 M</div></div><div>Junction at 9 o'clock, diameter 150mm</div></div> | <div><div>From: MH1 / To: MH2<br/>Size: 150mm</div><div><div>11.29 M</div></div><div>Junction at 10 o'clock, diameter 100mm</div></div> | | |

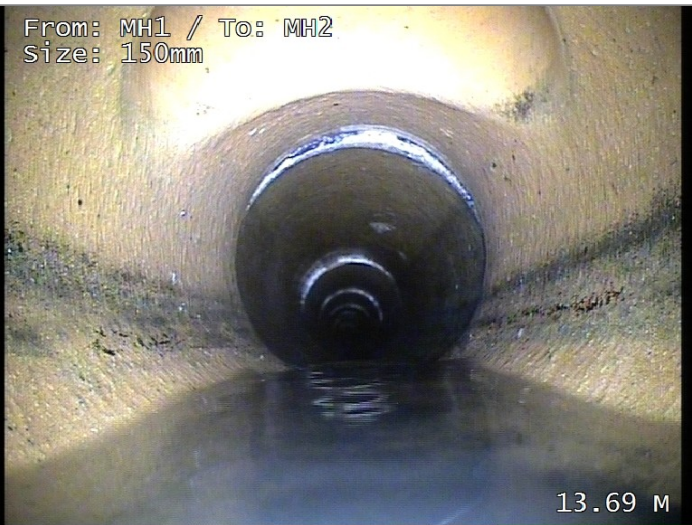
| Job Number<br>LAYERSERV0001859 | Surveyed by (Operator)<br>Joe COLLINS | Base Unit<br>DJVV56JNNH | Date<br>11/08/2023 |
|---|---|---|---|
| <div><div>From: MH1 / To: MH2<br/>Size: 150mm</div><div><div>13.17 M</div></div><div>Fracture circumferential from 12 to 12 o'clock</div></div> | <div><div>From: MH1 / To: MH2<br/>Size: 150mm</div><div><div>13.69 M</div></div><div>Junction at 12 o'clock, diameter 150mm</div></div> | | |

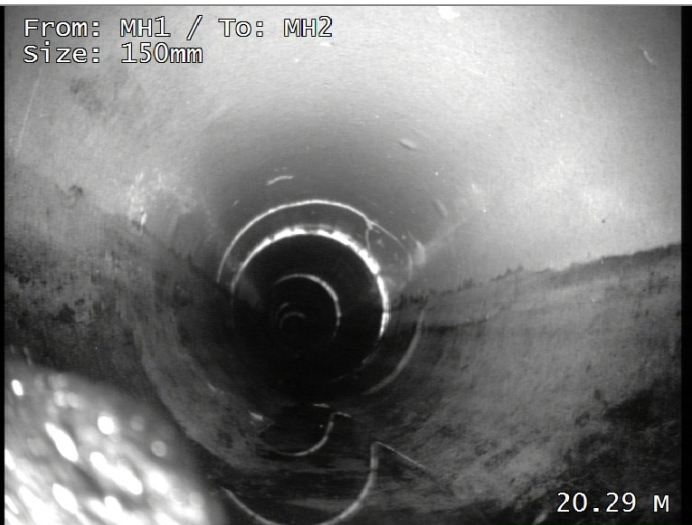
| Job Number<br>LAYERSERV0001859 | Surveyed by (Operator)<br>Joe COLLINS | Base Unit<br>DJVV56JNNH | Date<br>11/08/2023 |
|---|---|---|---|
| <div>From: MH1 / To: MH2<br/>Size: 150mm</div> <div></div> <div>19.83 M</div> <div>Settled deposits hard or compacted 10% cross-sectional area loss</div> | <div>From: MH1 / To: MH2<br/>Size: 150mm</div> <div></div> <div>20.29 M</div> <div>Attached deposits, encrustation from 6 to 9 o'clock 5% cross-sectional area loss</div> | | |

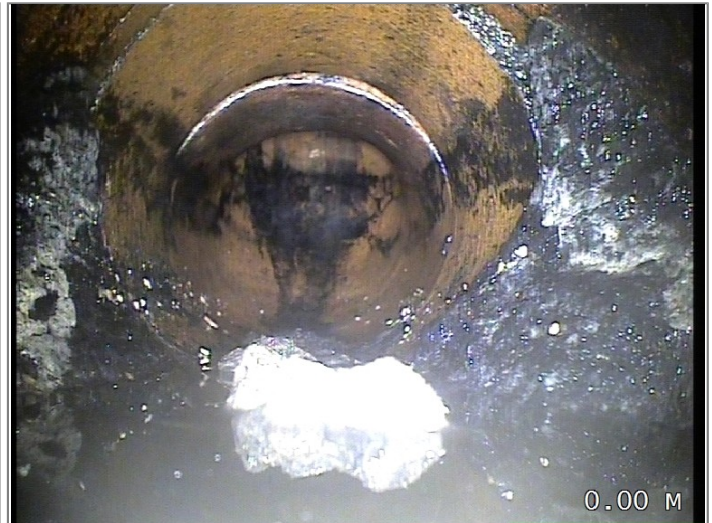
Water level 5% height/diameter

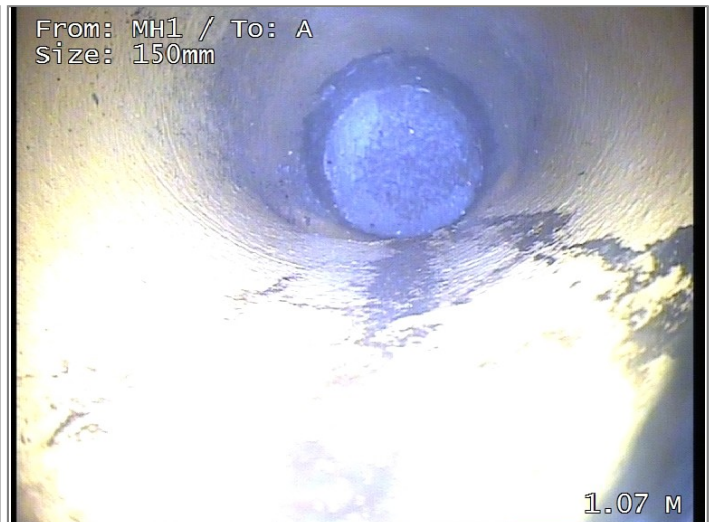
Finish node type, other special chamber, reference A

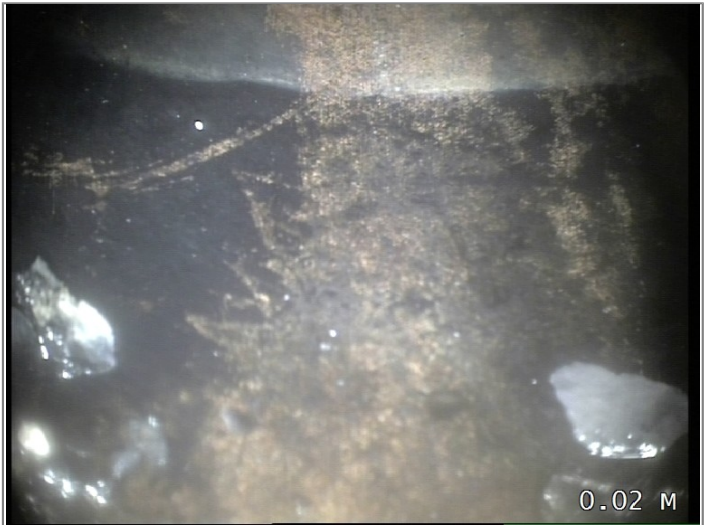
Water level 5% height/diameter

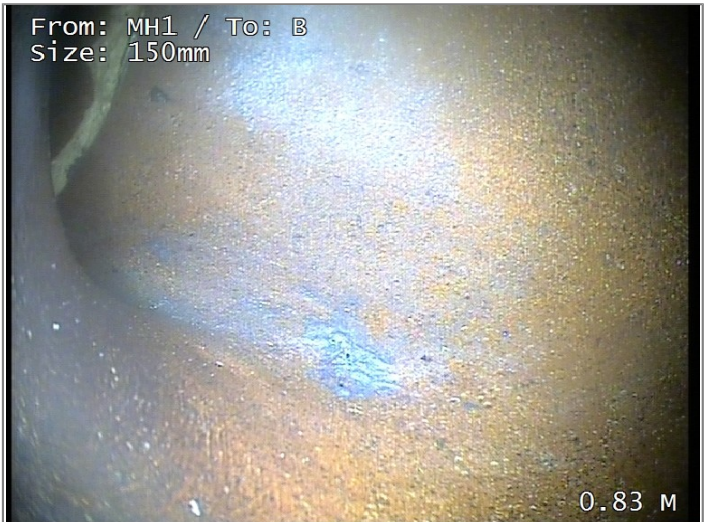
Finish node type, other special chamber, reference B

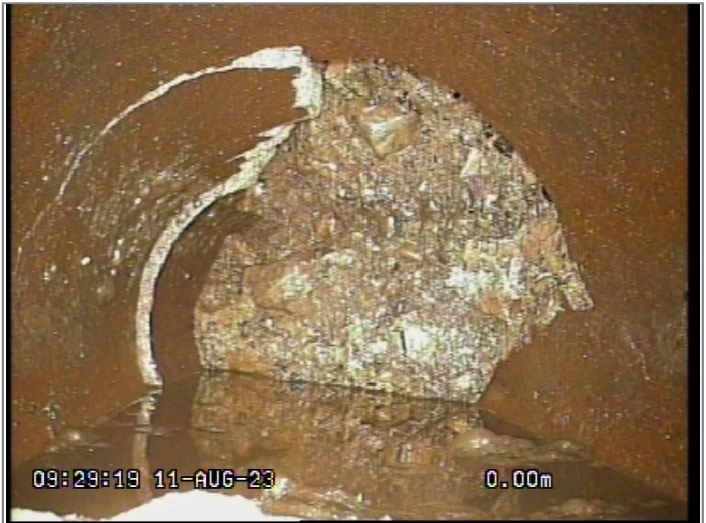
Water level 5% height/diameter

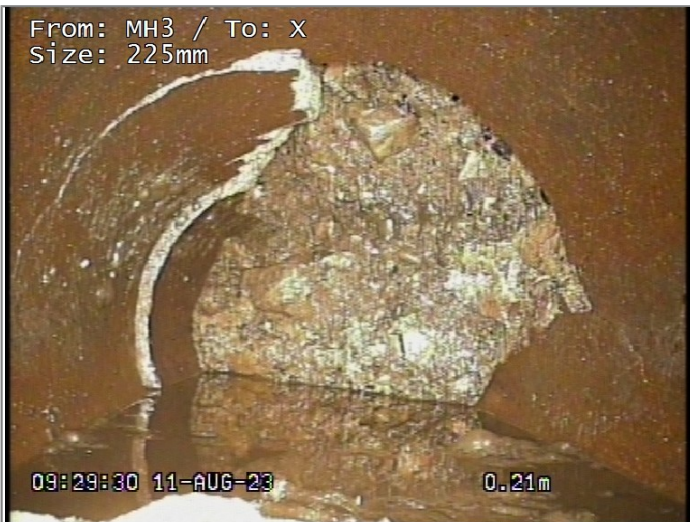
Finish node type, other special chamber, reference X

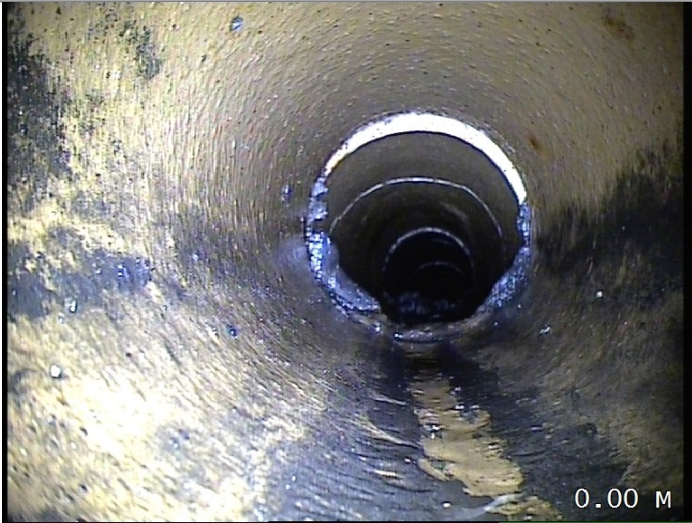
| Job Number<br>LAYERSERV0001859 | Surveyed by (Operator)<br>Joe COLLINS | Base Unit<br>DJVV56JNNH | Date<br>11/08/2023 |
|---|---|---|---|
| <p>0.00 M</p> <p>Start node type, manhole, reference MH3</p> | | | |

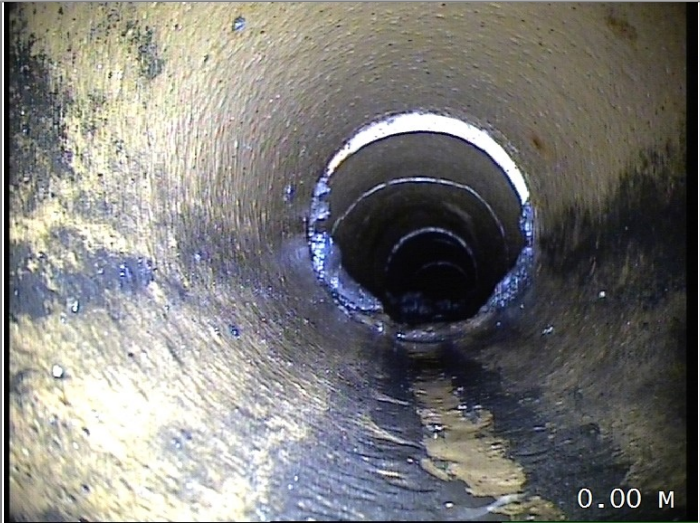
| Job Number<br>LAYERSERV0001859 | Surveyed by (Operator)<br>Joe COLLINS | Base Unit<br>DJVV56JNNH | Date<br>11/08/2023 |
|---|---|---|---|
| <p>0.00 M</p> <p>Water level 5% height/diameter</p> | | | |

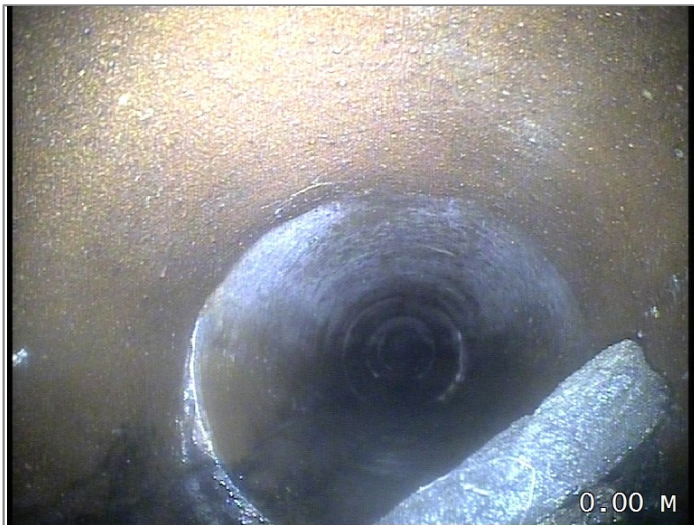
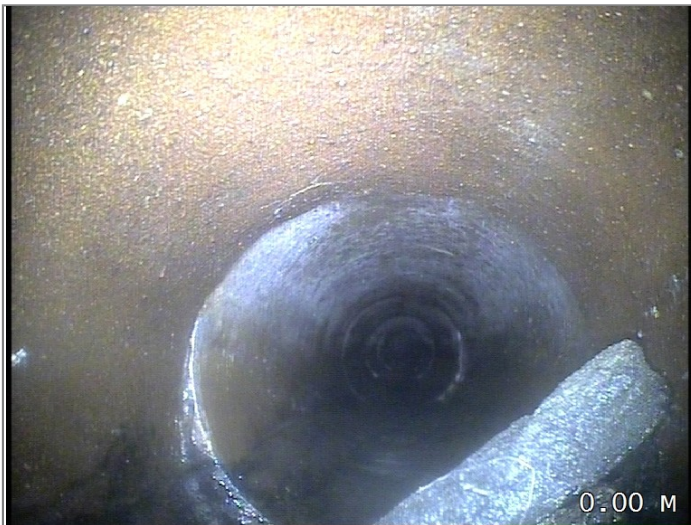
| Job Number<br>LAYERSERV0001859 | Surveyed by (Operator)<br>Joe COLLINS | Base Unit<br>DJVV56JNNH | Date<br>11/08/2023 |
|---|---|---|---|
| <p>0.00 M</p> <p>Start node type, manhole, reference MH4</p> | <p>0.00 M</p> <p>Water level 5% height/diameter</p> | | |

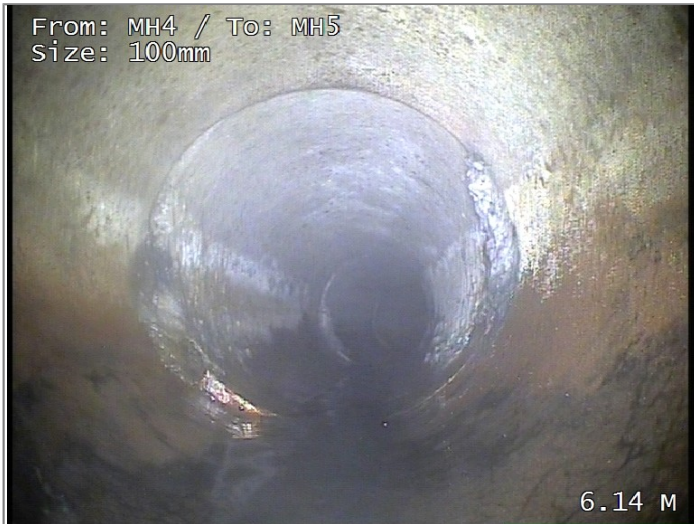
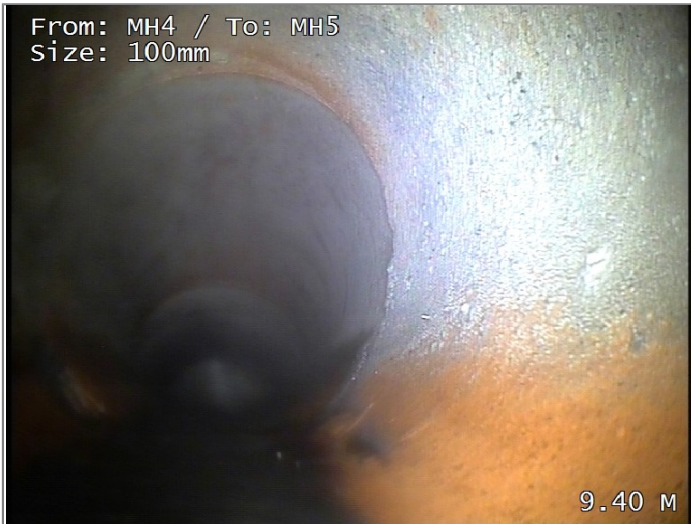
| Job Number<br>LAYERSERV0001859 | Surveyed by (Operator)<br>Joe COLLINS | Base Unit<br>DJVV56JNNH | Date<br>11/08/2023 |
|---|---|---|---|
| <p>From: MH4 / To: MH5<br/>Size: 100mm</p> <p>6.14 M</p> <p>Line of drain/sewer deviates right, Start</p> | <p>From: MH4 / To: MH5<br/>Size: 100mm</p> <p>9.40 M</p> <p>Line of drain/sewer deviates right, Finished</p> | | |

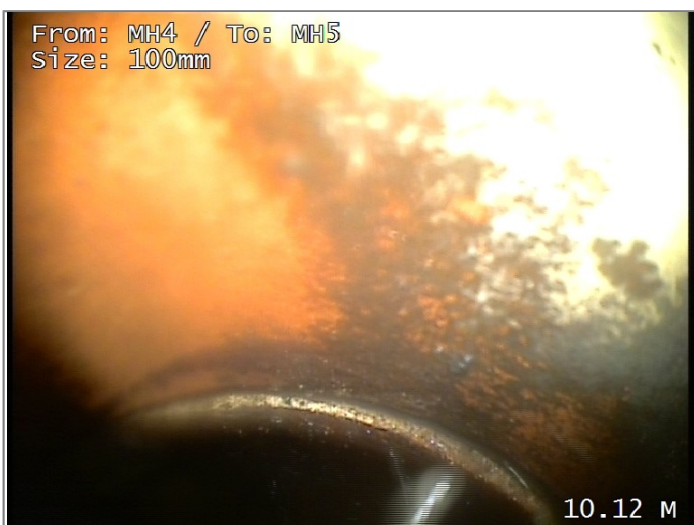
| Job Number<br>LAYERSERV0001859 | Surveyed by (Operator)<br>Joe COLLINS | Base Unit<br>DJVV56JNNH | Date<br>11/08/2023 |
|---|---|---|---|
| <p>From: MH4 / To: MH5<br/>Size: 100mm</p> <p>10.12 M</p> <p>Line of drain/sewer deviates down</p> | <p>From: MH4 / To: MH5<br/>Size: 100mm</p> <p>11.00 M</p> <p>Finish node type, other special chamber, reference MH5J</p> | | |

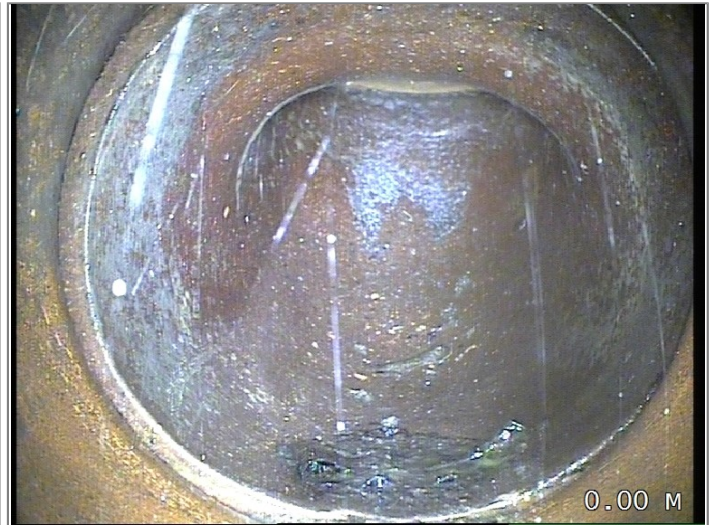
Water level 5% height/diameter

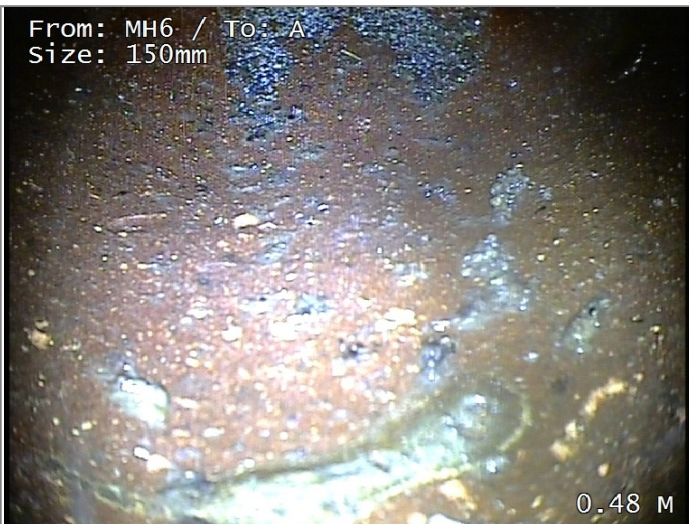
Finish node type, other special chamber, reference A

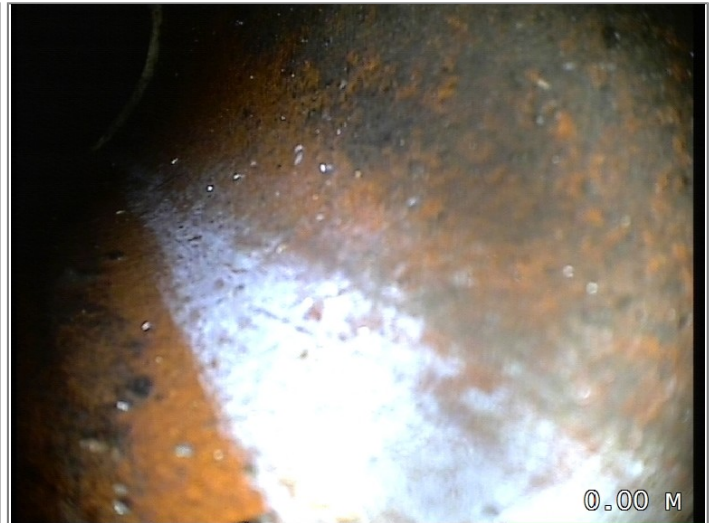
Water level 5% height/diameter

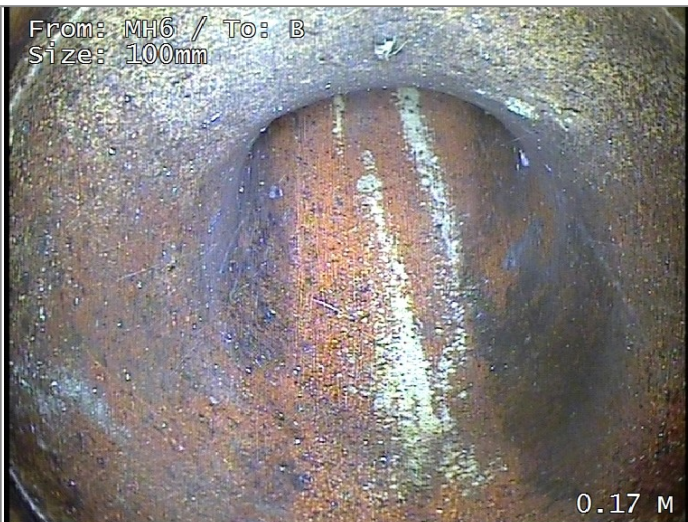
Finish node type, other special chamber, reference B

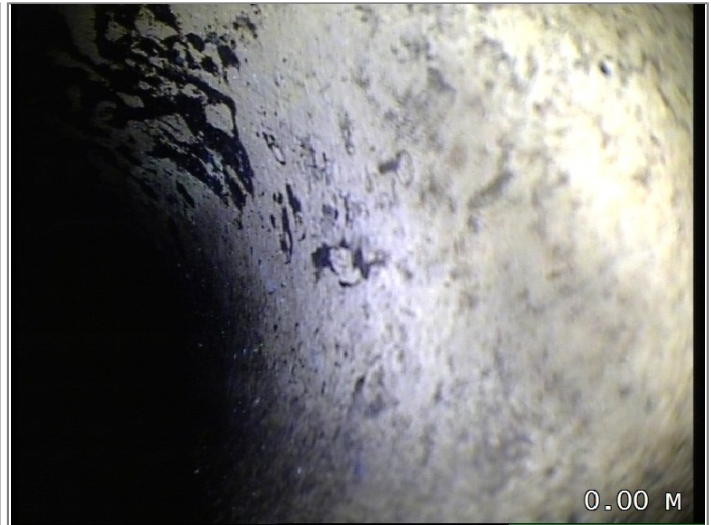
Water level 5% height/diameter

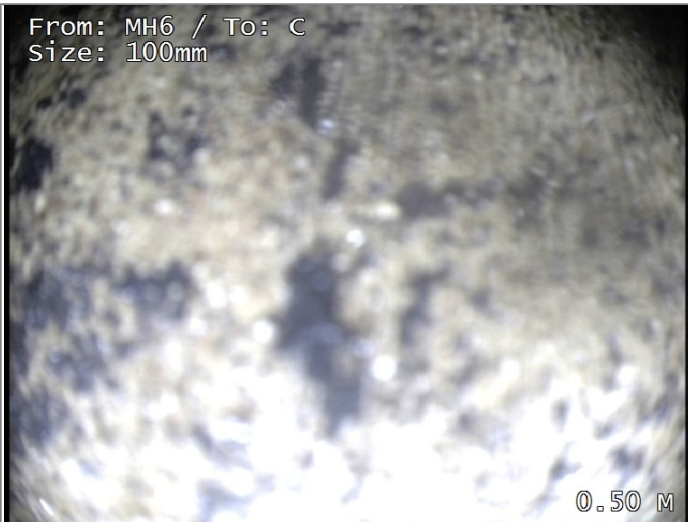
Finish node type, other special chamber, reference C
