## Schedule of Condition For

Wellington House,  
39 — 41 Piccadilly,  
Manchester  
M1 4AJ

JPM Real Estate Management Limited  
Northspring,  
70 Spring Gardens,  
Manchester,  
M2 2BQ

Dated: 22<sup>nd</sup> March 2022

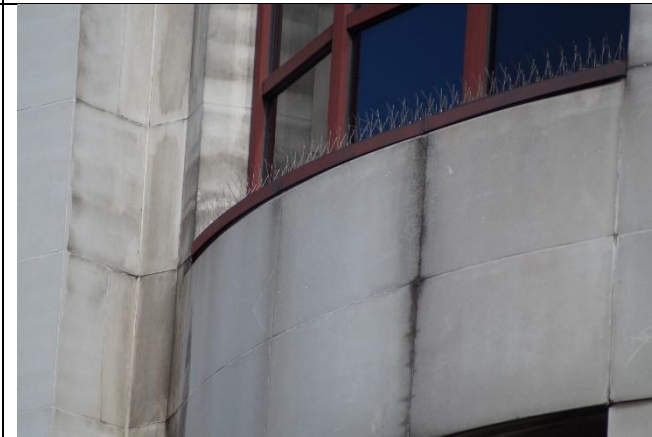
Concrete stone block infills soiled with washed out and eroded jointing.

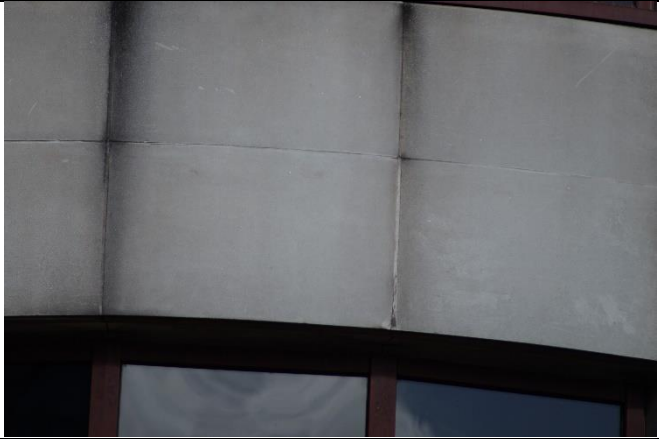
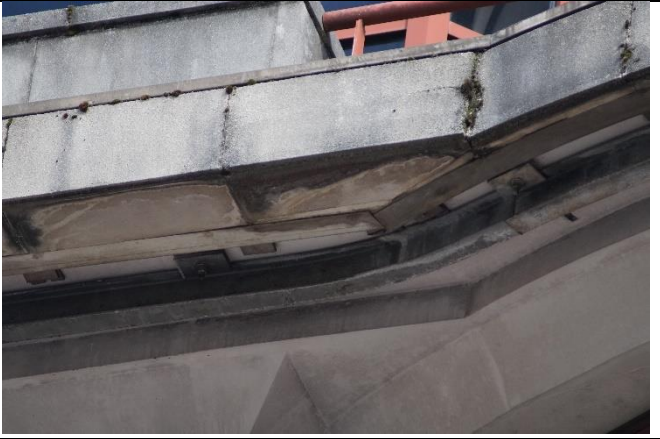
| <p>Generally.</p> | | <p>Generally.</p> | |

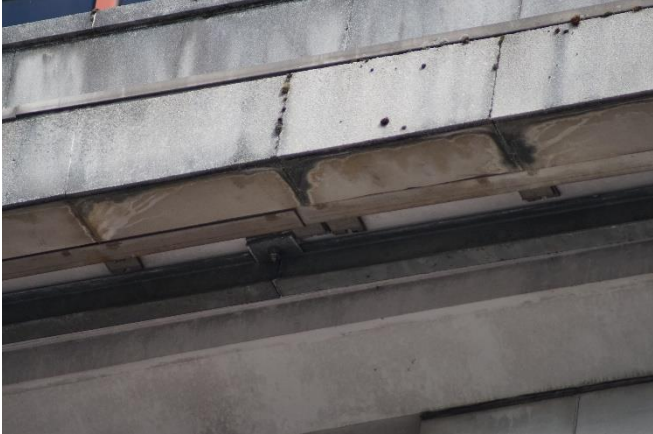
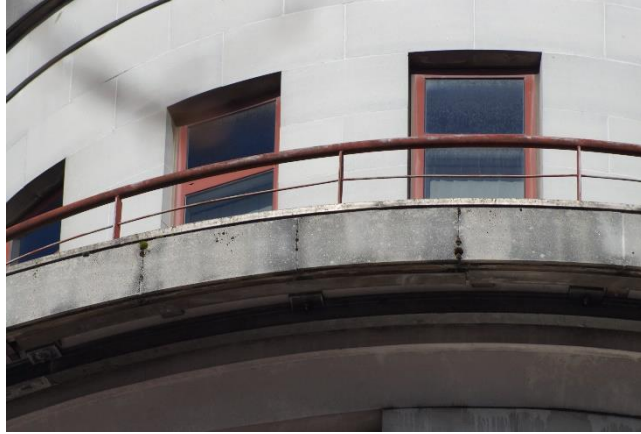
| <p>Generally.</p> | | <p>Generally.</p> | |

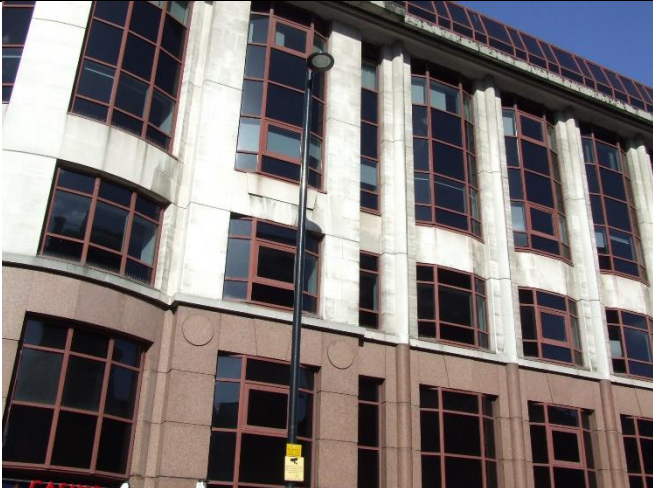
| <p>Side elevation.</p> <p>Steel frame building with stone or concrete block façade infills to curtain wall and rainscreen aluminium cladding systems.</p> | | <p>Aluminium double glazed rainscreen claddings and curtain walling windows systems.</p> <p>Soiled frame and leaking rubber sealed to the windows generally.</p> <p>Concrete stone block infills soiled with washed out and eroded jointing.</p> | |

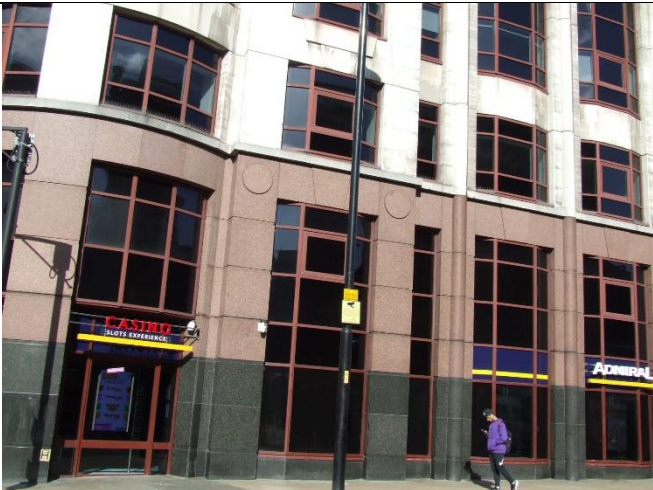
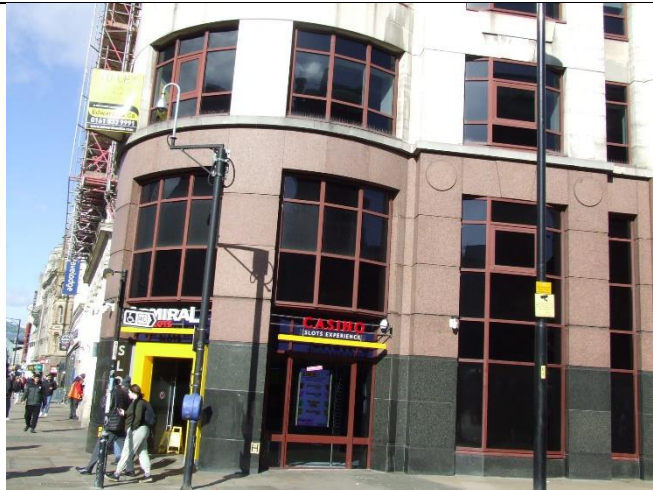
| <p>Generally.</p> | | <p>Generally.</p> | |

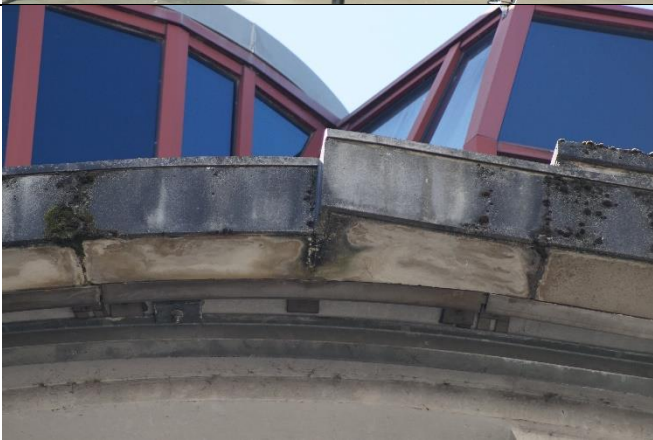
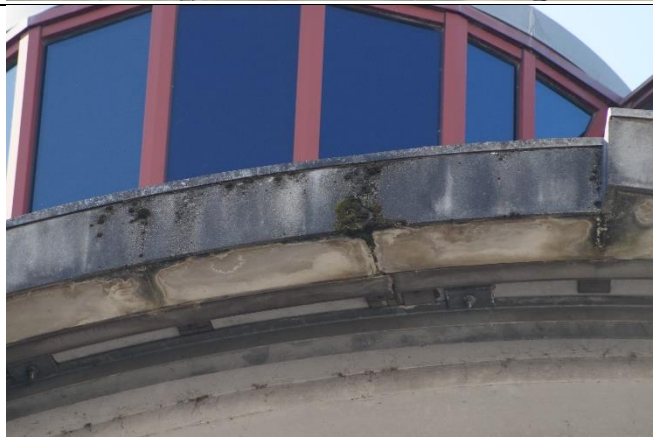
| <p>Concrete stone block infills soiled with washed out and eroded jointing.</p> | | <p>Concrete stone block infills soiled with washed out and eroded jointing.</p> | |

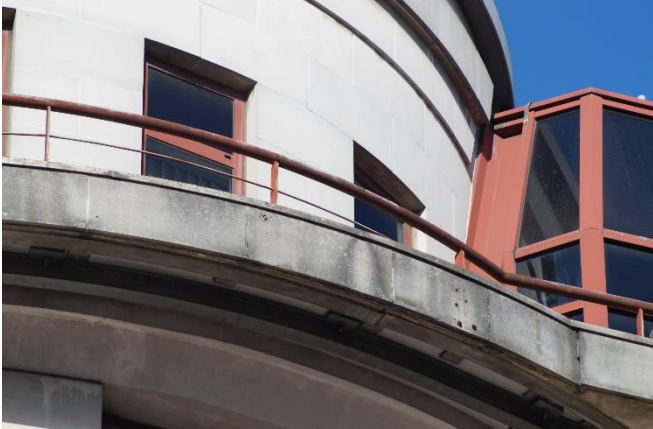
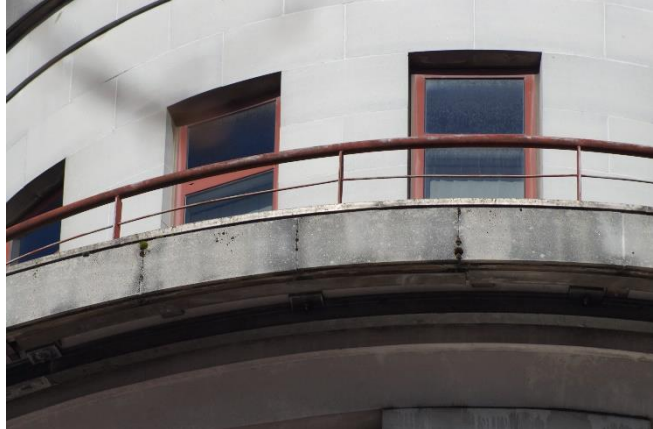
| Generally. | | Generally. | |

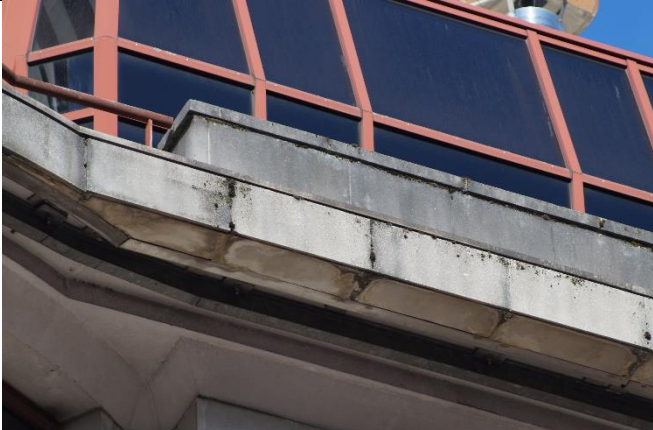
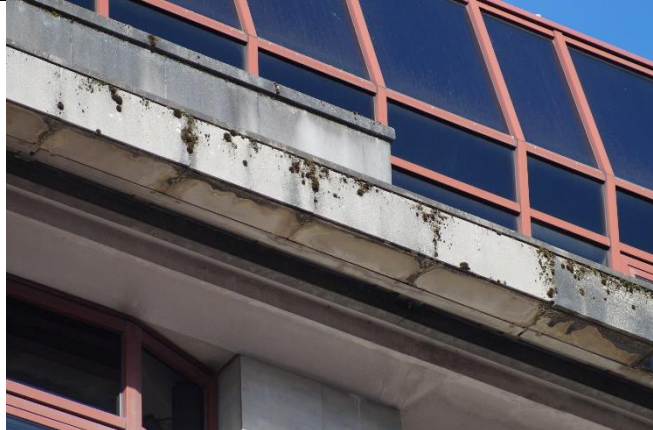
| Generally. | | Concrete stone block infills soiled with washed out and eroded jointing. | |

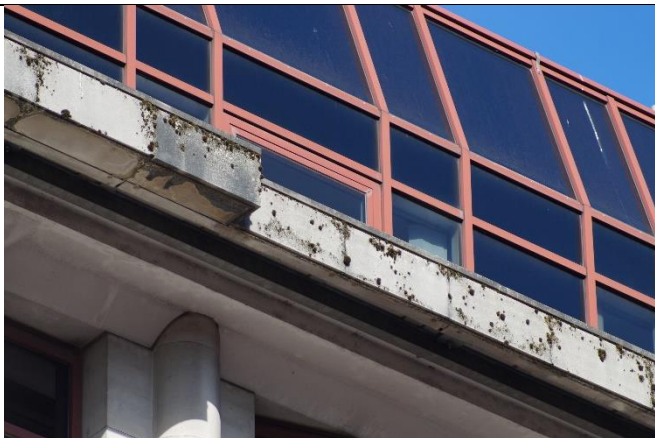
Concrete stone block infills soiled with washed out and eroded jointing.

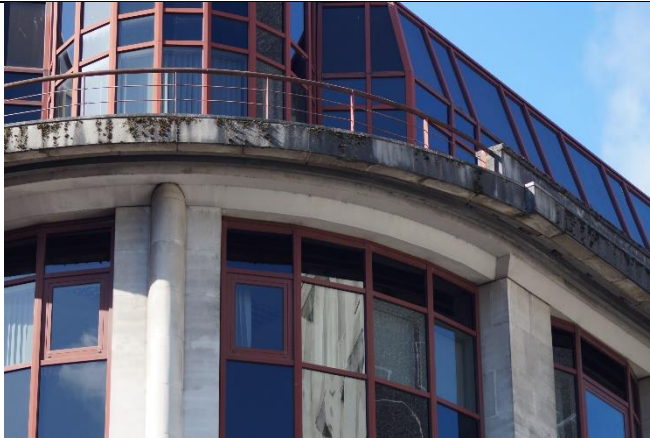
Concrete stone block  
infills soiled with  
washed out and  
eroded jointing.

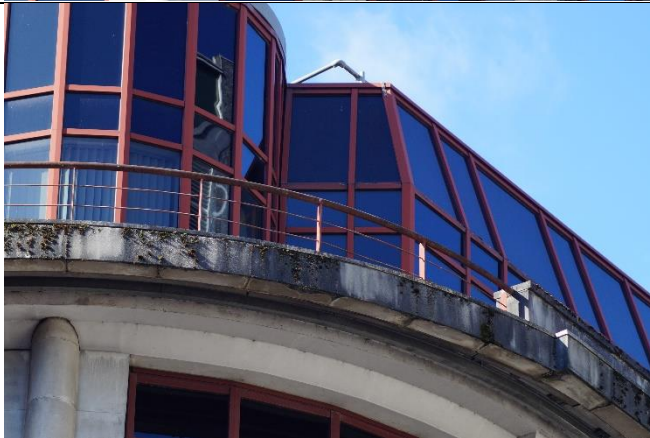
Concrete stone block  
infills soiled with  
washed out and  
eroded jointing.

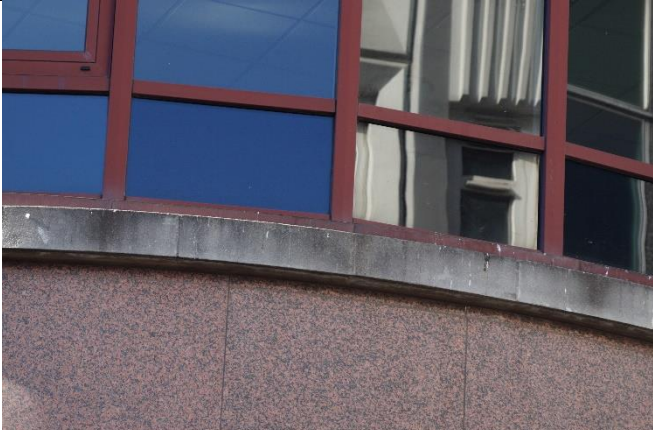
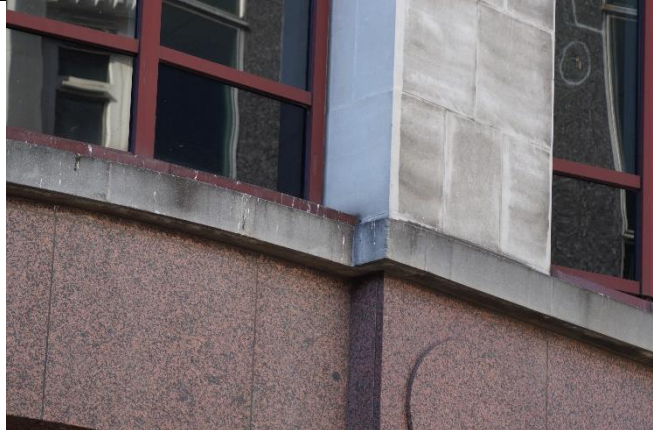
| <p>Generally.</p> | | <p>Concrete stone block infills soiled with washed out and eroded jointing.</p> | |

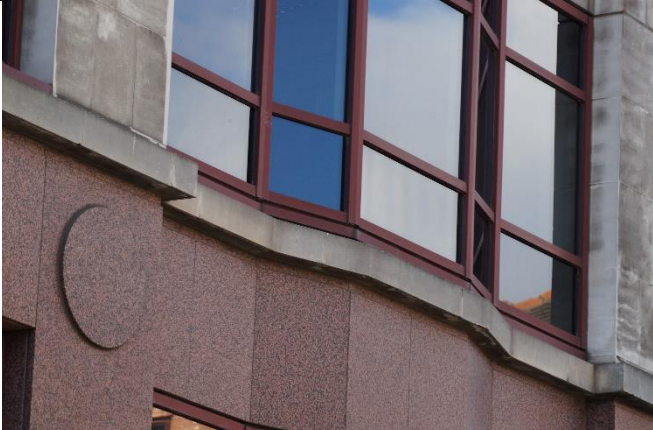
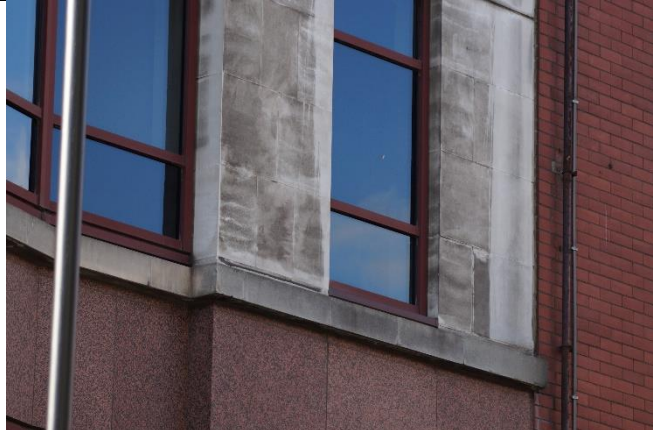
| <p>Generally.</p> | | <p>Concrete stone block infills soiled with washed out and eroded jointing.</p> | |

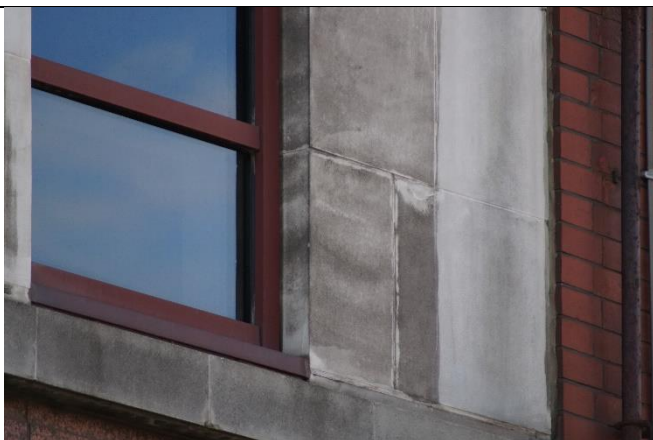
Concrete stone block  
infills soiled with  
washed out and  
eroded jointing.

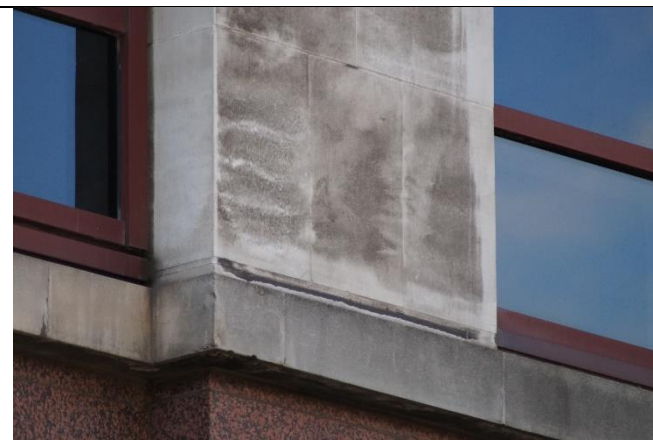
Concrete stone block  
infills soiled with washed  
out and eroded jointing.

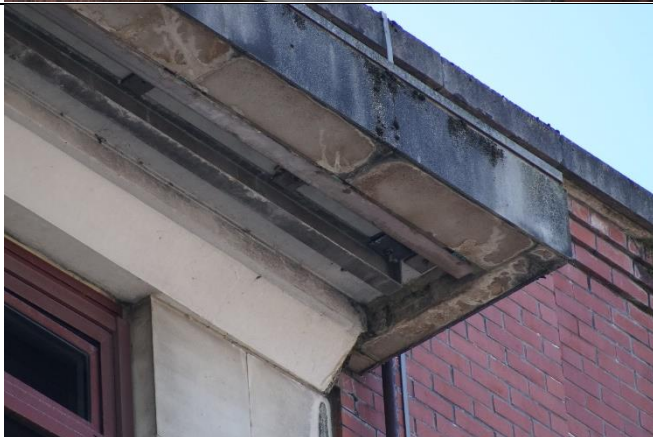
Concrete stone block  
infills soiled with  
washed out and  
eroded jointing.

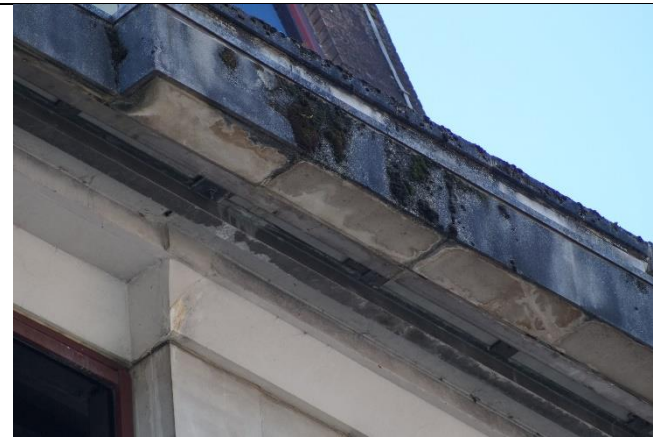
Concrete stone block  
infills soiled with washed  
out and eroded jointing.

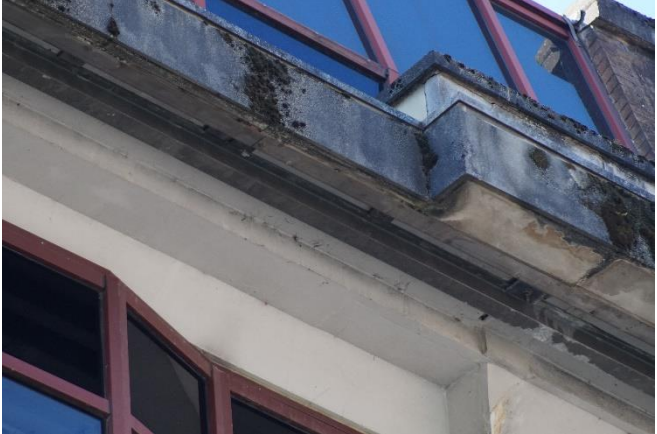
| <p>Generally.</p> | | <p>Concrete stone block infills soiled with washed out and eroded jointing.</p> | |

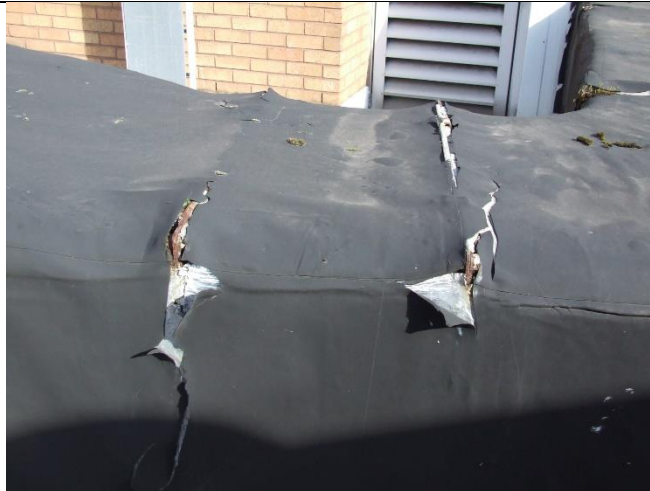
Single ply rubber weathering to the air handling ducts is perished.

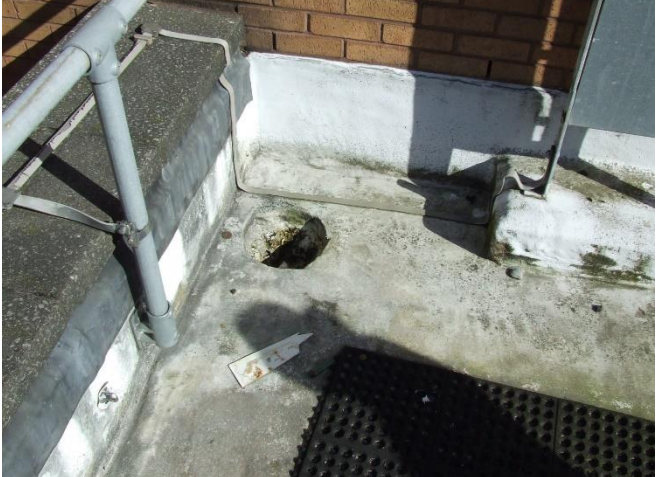
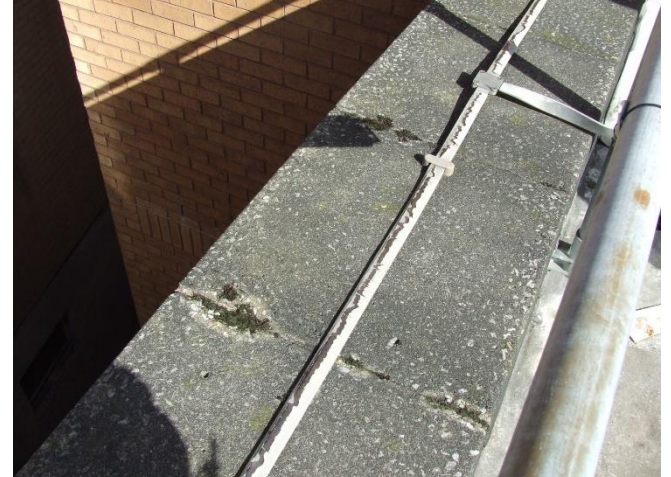
| <p>Asphalt roof deck coated with solar reflective treatments.</p> <p>Some distress in the finish with crazed surfaces and peeling back of solar reflective treatments.</p> | | <p>Eroded and washed out pointing to the concrete coping joints.</p> <p>Lightening protection plastic coating is split and conductor exposed to the weather.</p> | |

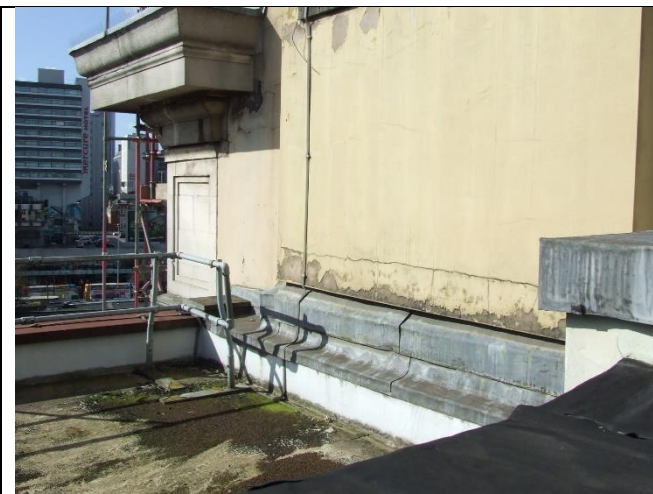
Generally.

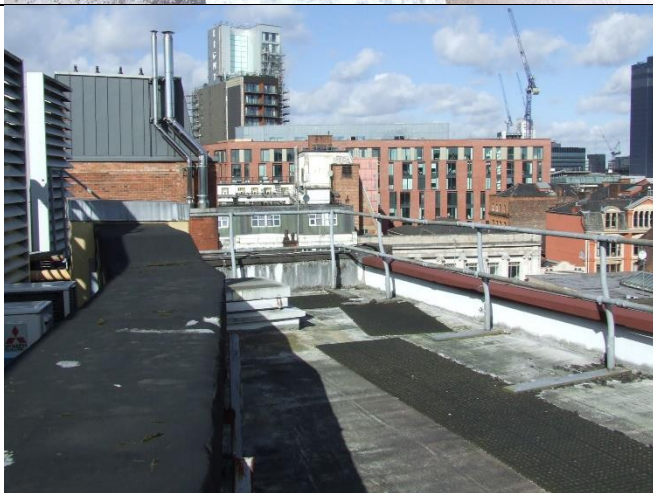
Generally.

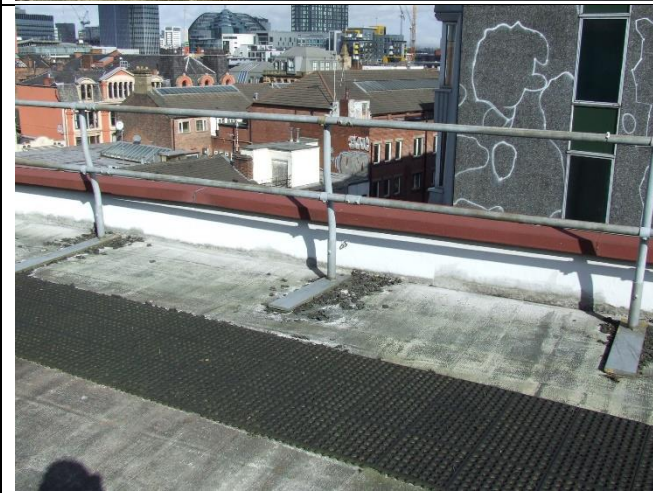
Asphalt roof deck coated with solar reflective treatments.

Some distress in the finish with crazed surfaces and peeling back of solar reflective treatments.

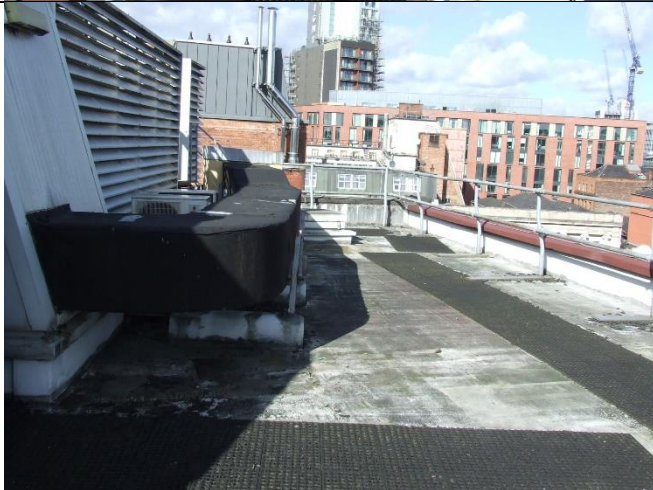
Asphalt roof deck coated with solar reflective treatments.

Some distress in the finish with crazed surfaces and peeling back of solar reflective treatments.

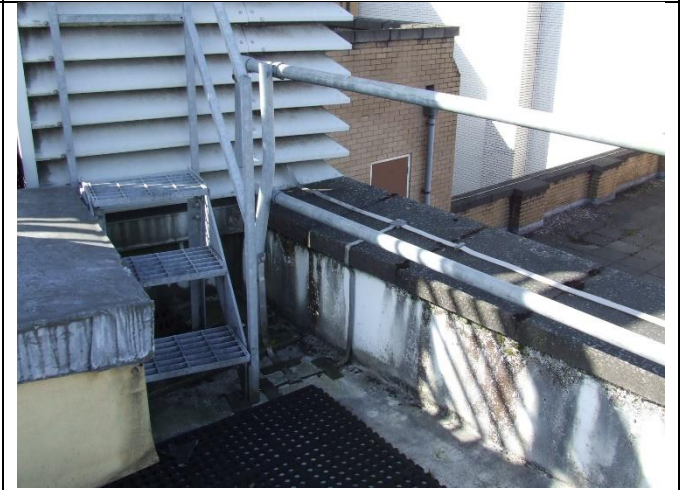
Generally.

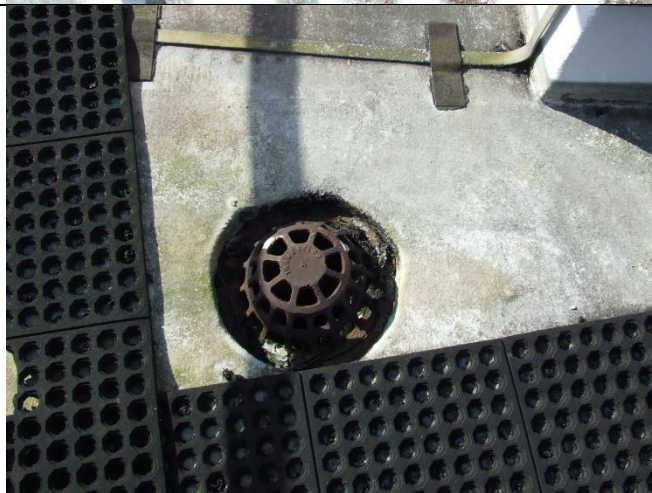
Generally.

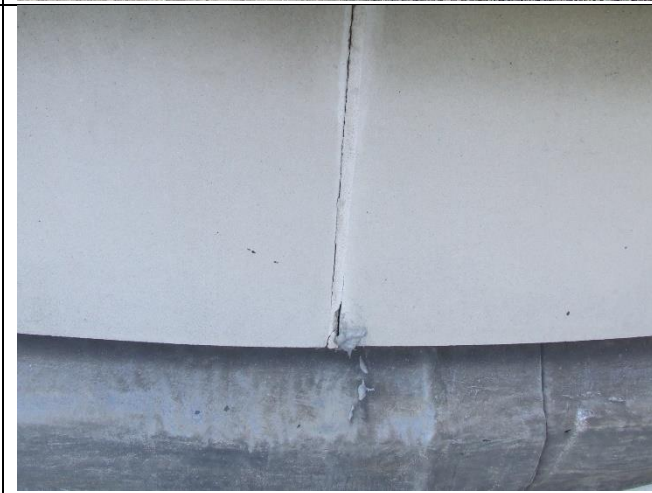
Eroded and washed out pointing to the masonry joints.
