## Schedule of Condition

27-29 Church Street  
Manchester  
M4 1PE

Dated: 23<sup>rd</sup> October 2023

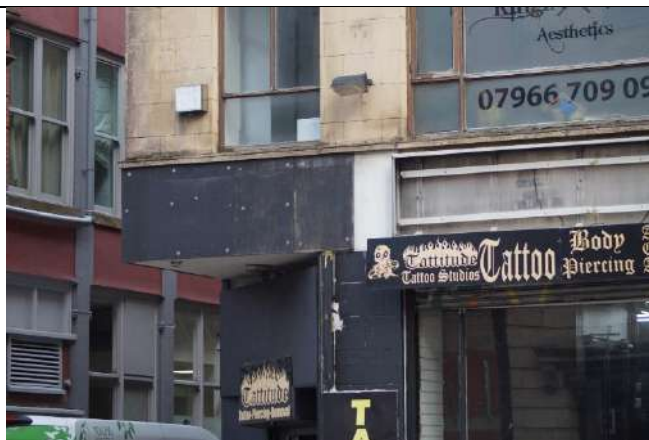
Shop front facades and stall risers are also untidy and poorly decorated.

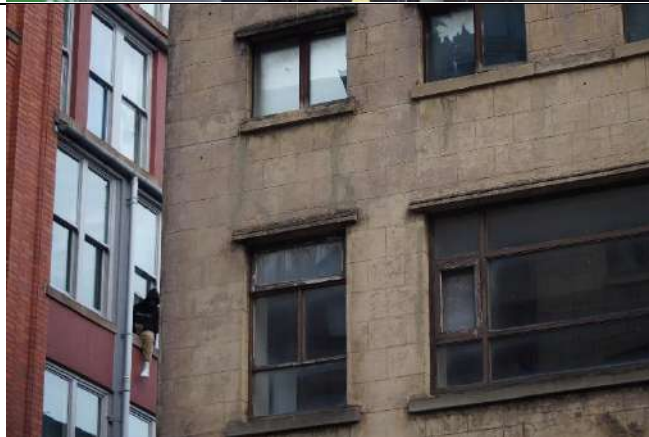
Rendered art décor façade is distressed with delaminated renders and broken and cracked masonry below. Possibly some bond loss in the brickwork below.

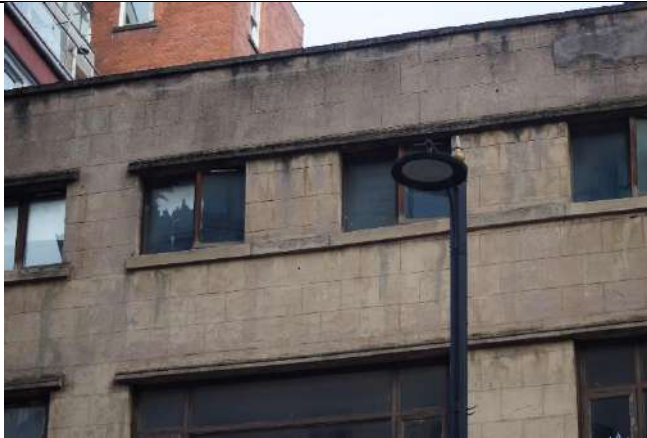
Rendered art décor façade is distressed with delaminated renders and broken and cracked masonry below. Possibly some bond loss in the brickwork below.

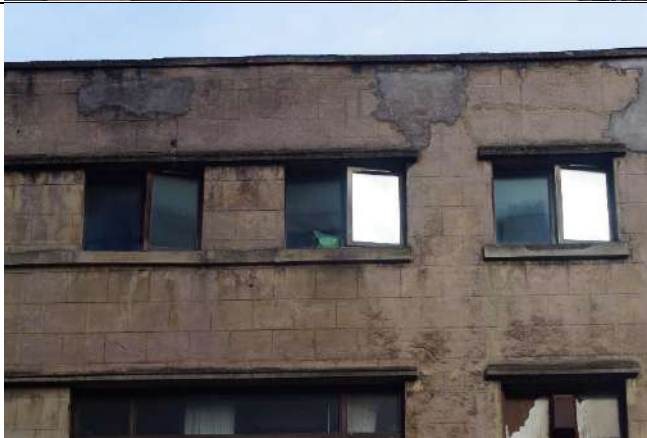
Rendered art décor façade is distressed with delaminated renders and broken and cracked masonry below. Possibly some bond loss in the brickwork below.

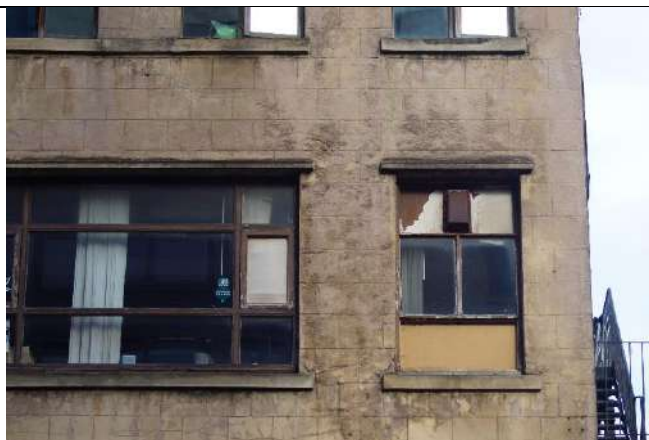
Rendered art décor façade is distressed with delaminated renders and broken and cracked masonry below. Possibly some bond loss in the brickwork below.

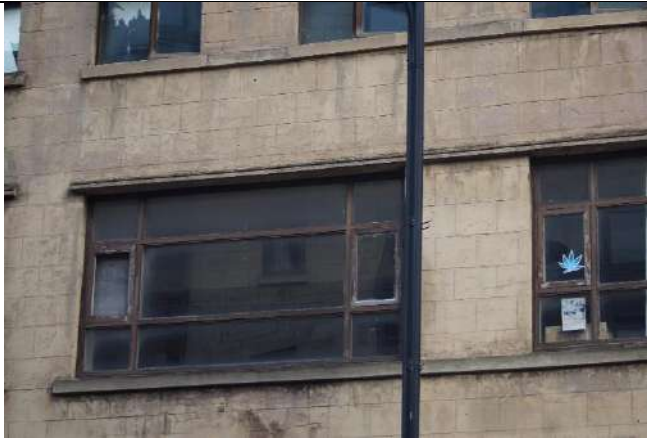
Rendered art décor façade is distressed with delaminated renders and broken and cracked masonry below. Possibly some bond loss in the brickwork below.

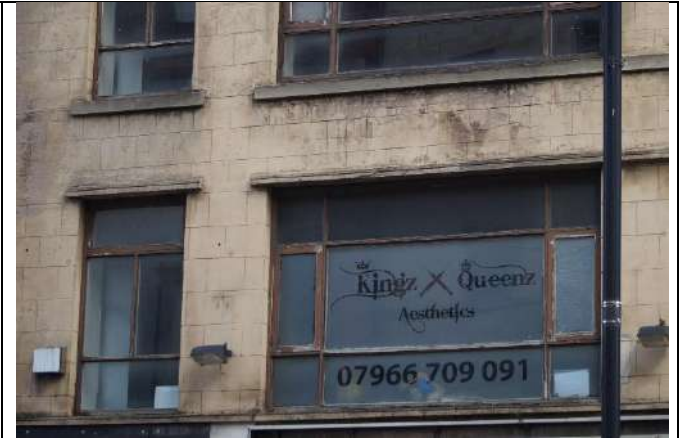
Timber style windows are distressed with ill fitting casement, draughty generally and rotting to the frames.

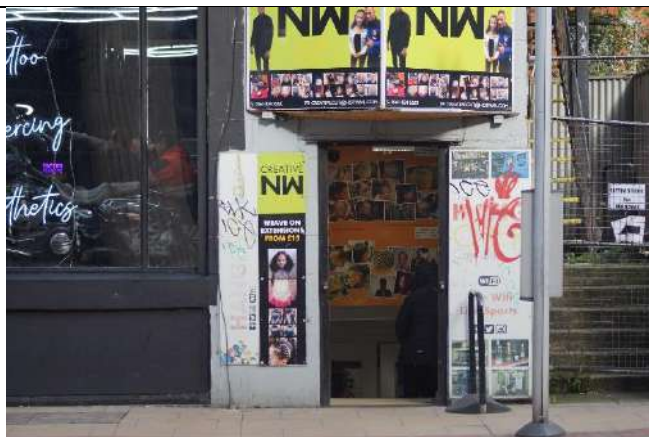
Shop fronts are untidy.  
With graffiti.

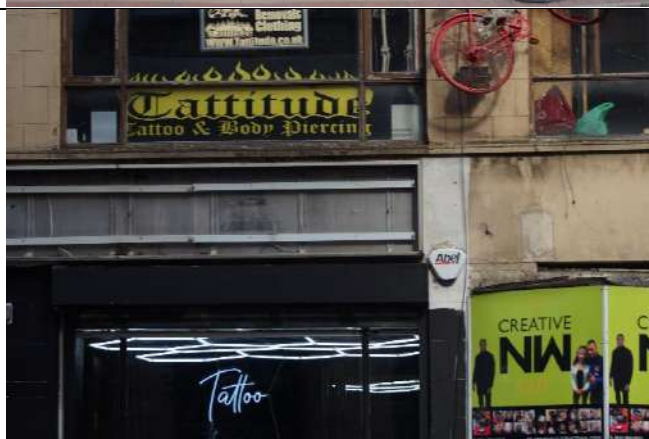
Canopy and shop stall  
risers are distressed.

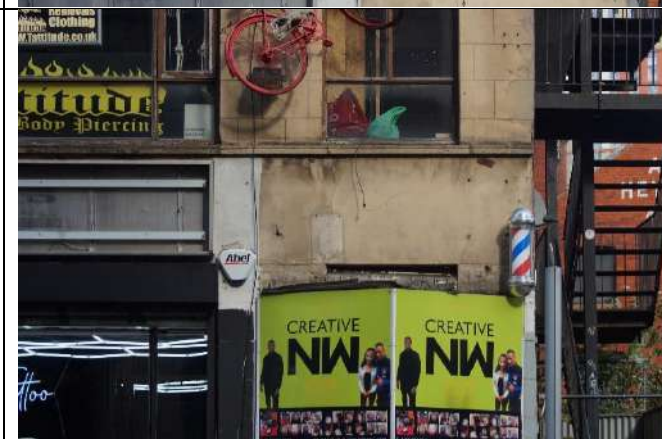
Shop fronts are untidy.  
With graffiti.

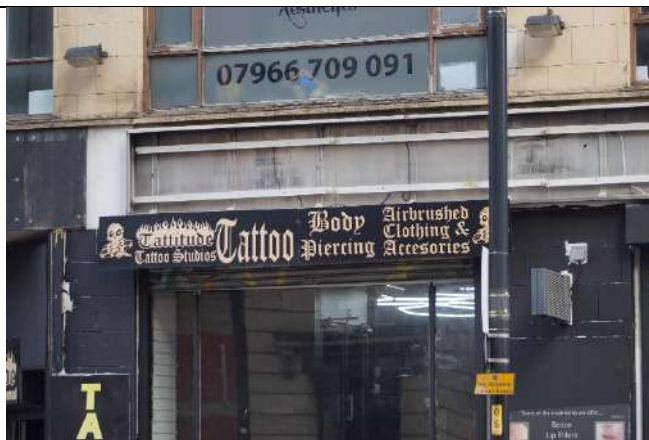
Canopy and shop stall  
risers are distressed.

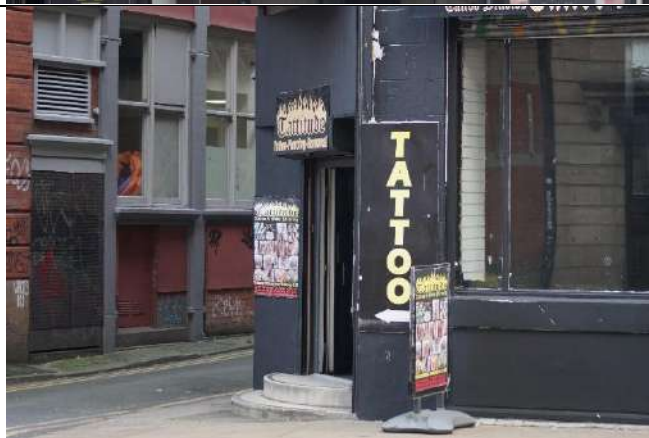
Canopy and shop stall  
risers are distressed.

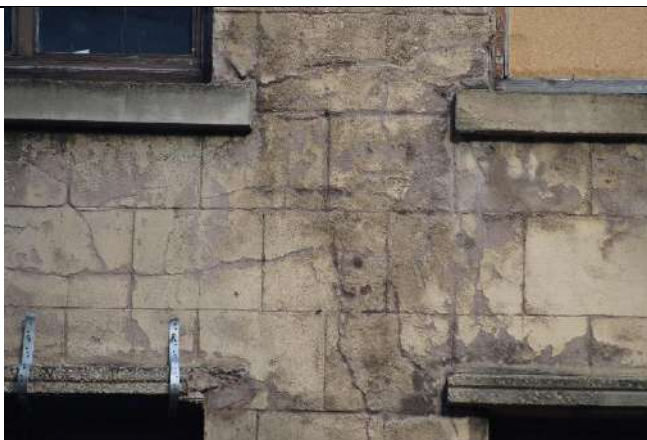
Render is added, delaminated and there is evidence of cracked brickwork below the render which is an indication of bond loss.

Concrete lintels are spilt and RE bars may be corroding.

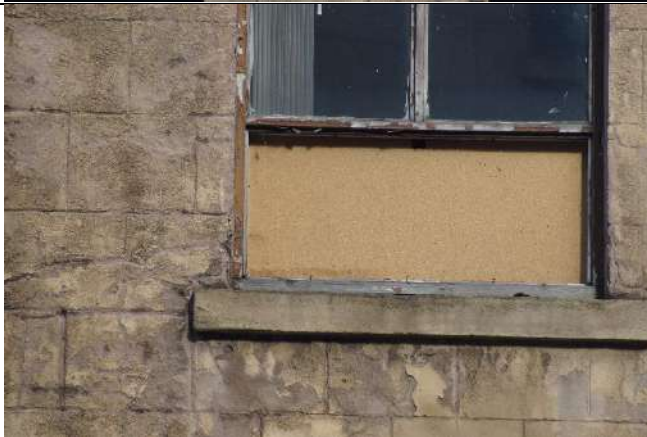
Render is added, delaminated and there is evidence of cracked brickwork below the render which is an indication of bond loss.

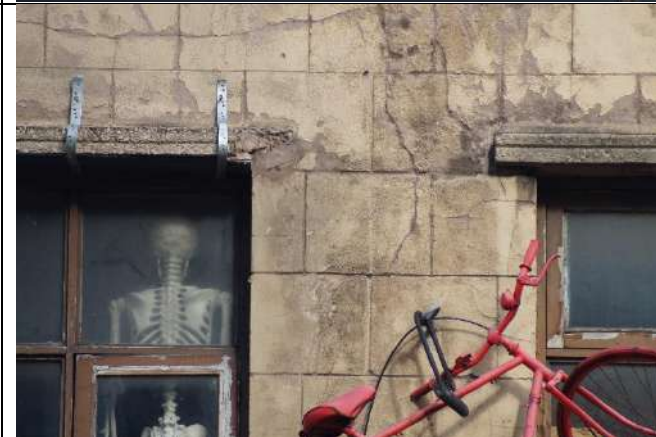
Concrete lintels are spilt and RE bars may be corroding.

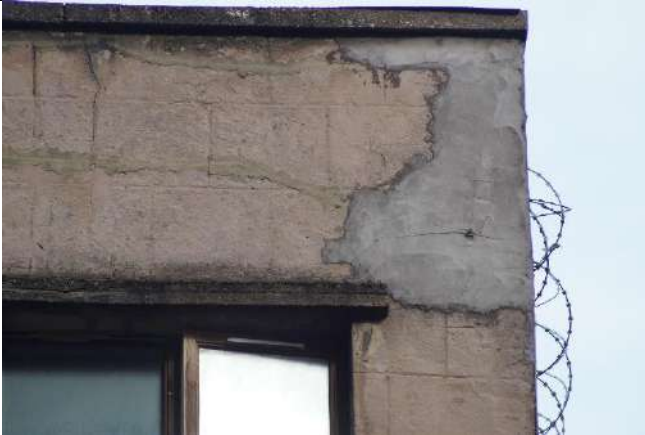
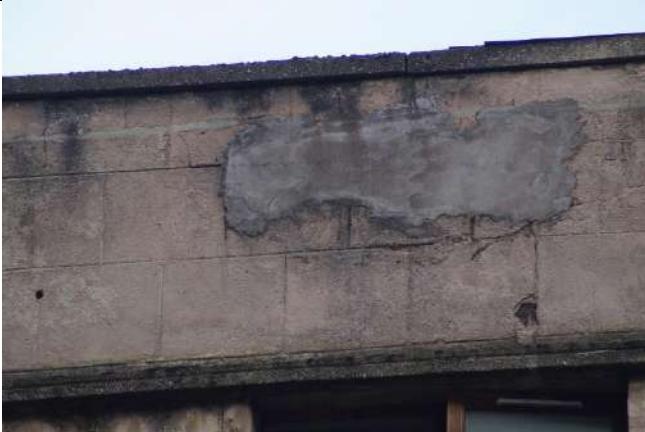
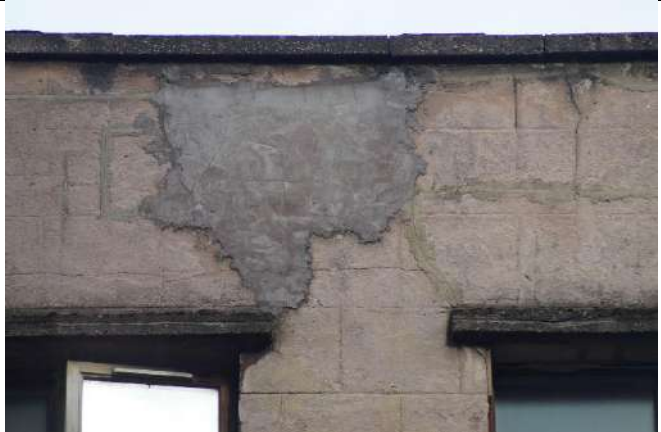
| <p>Render is addled, delaminated and there is evidence of cracked brickwork below the render which is an indication of bond loss.</p> | | <p>Render is addled, delaminated and there is evidence of cracked brickwork below the render which is an indication of bond loss.</p> | |
| <p>Render is addled, delaminated and there is evidence of cracked brickwork below the render which is an indication of bond loss.</p> | | <p>Render is addled, delaminated and there is evidence of cracked brickwork below the render which is an indication of bond loss.</p> | |

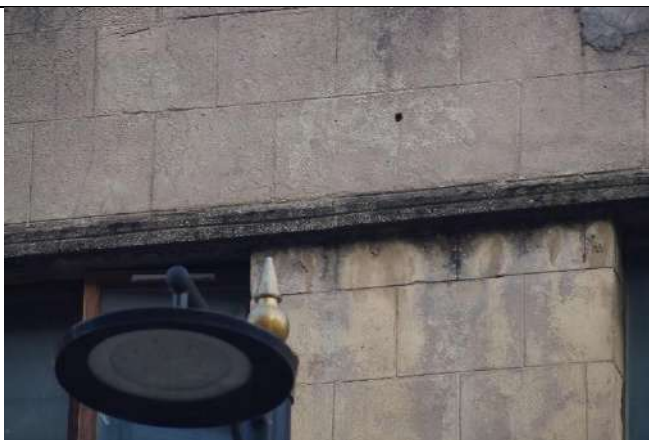
Render is addled, delaminated and there is evidence of cracked brickwork below the render which is an indication of bond loss.

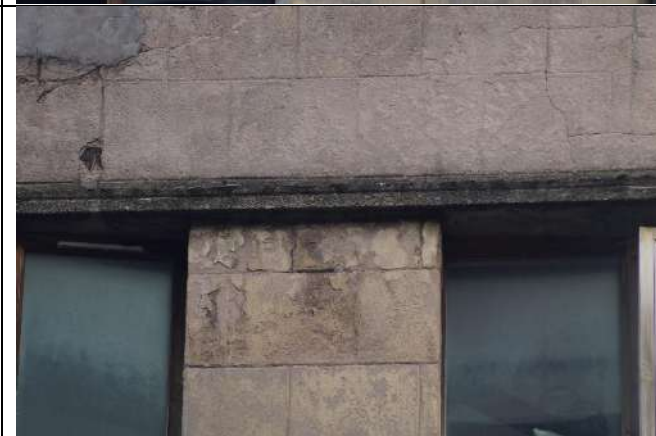
Render is addled, delaminated and there is evidence of cracked brickwork below the render which is an indication of bond loss.

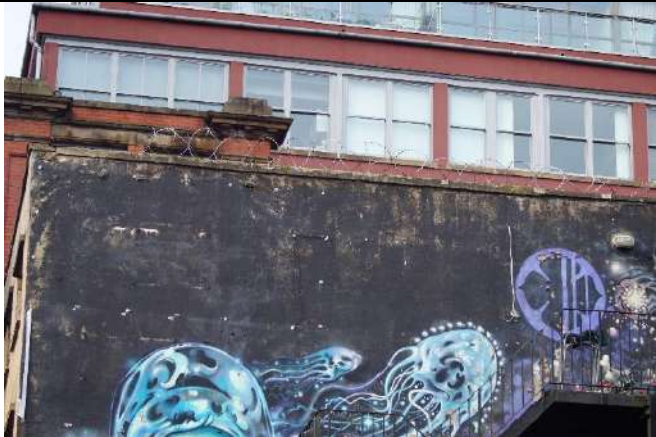
| <p><b><i>RIGHT HAND SIDE ELEVATION</i></b></p> <p>Render is added, delaminated and there is evidence of cracked brickwork below the render which is an indication of bond loss.</p> | | Generally. | |

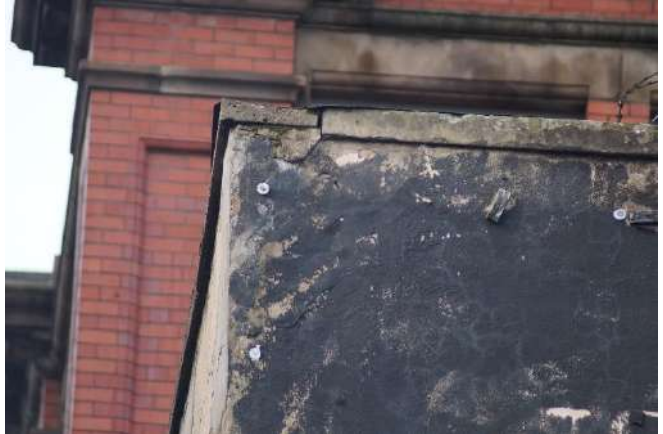
| <p>Generally.</p> | | <p>Render is added, delaminated and there is evidence of cracked brickwork below the render which is an indication of bond loss.</p> | |

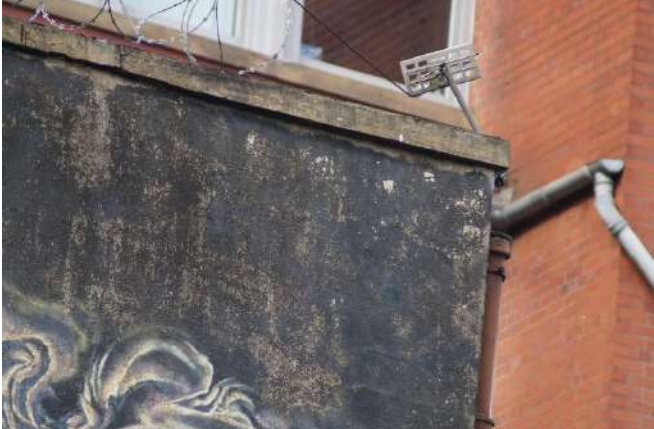
| <p>Render is added, delaminated and there is evidence of cracked brickwork below the render which is an indication of bond loss.</p> | | <p>Generally.</p> | |

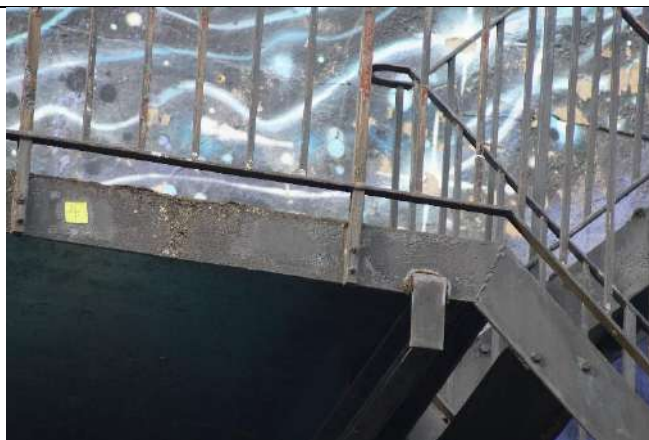
Steel fire escape stair is rusting and is decoratively distressed.

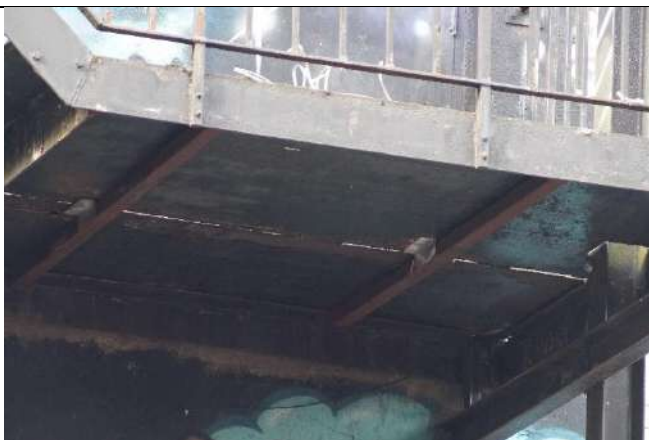
Steel fire escape stair is rusting and is decoratively distressed.

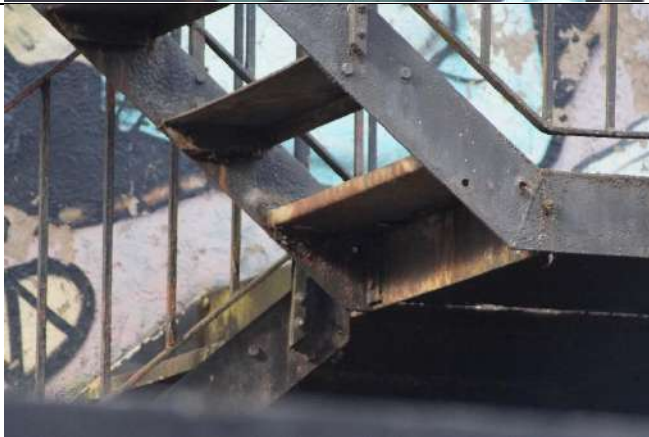
Steel fire escape stair is rusting and is decoratively distressed.

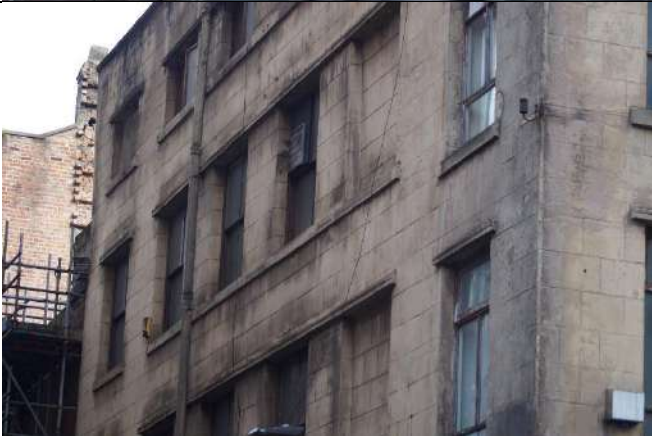
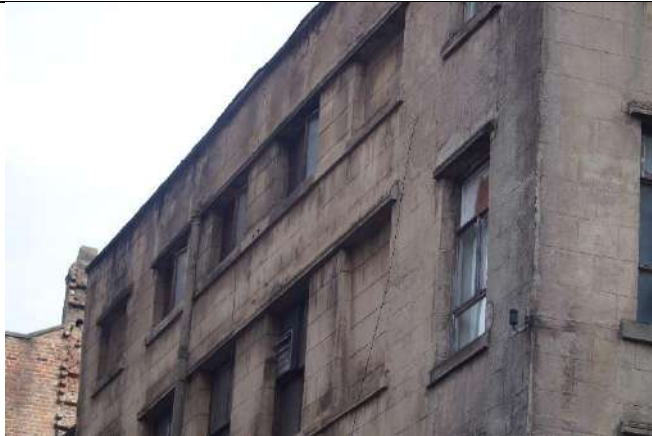
| <p>Render is added, delaminated and there is evidence of cracked brickwork below the render which is an indication of bond loss.</p> | | <p>Render is added, delaminated and there is evidence of cracked brickwork below the render which is an indication of bond loss.</p> | |

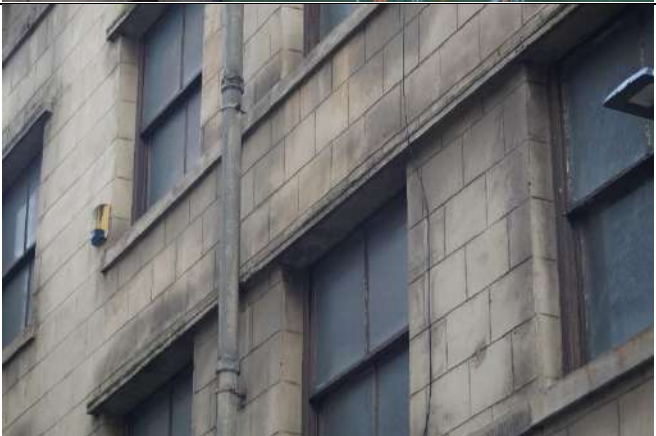
| <p>Timber style windows are distressed with ill fitting casement, draughty generally and rotting to the frames.</p> | | <p>Render is added, delaminated and there is evidence of cracked brickwork below the render which is an indication of bond loss.</p> | |

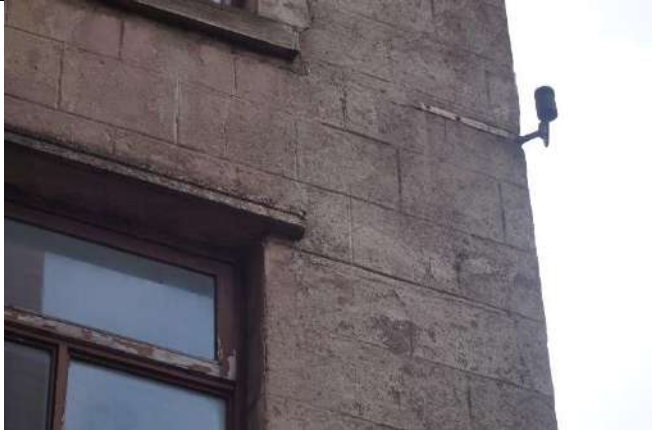
| <p>Timber style windows are distressed with ill fitting casement, draughty generally and rotting to the frames.</p> | | <p>Render is added, delaminated and there is evidence of cracked brickwork below the render which is an indication of bond loss.</p> | |

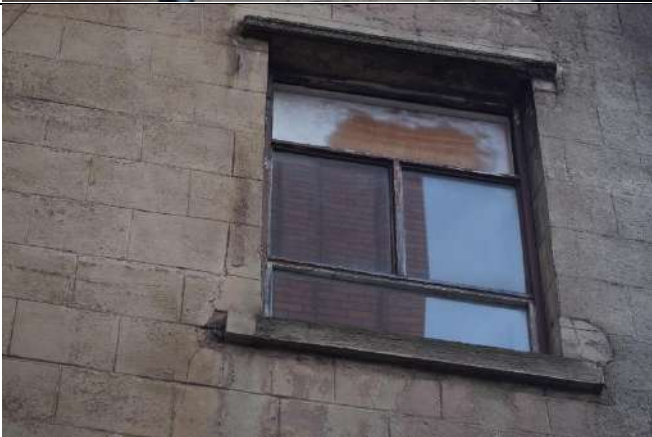
| <p>Timber style windows are distressed with ill fitting casement, draughty generally and rotting to the frames.</p> | | <p>Render is added, delaminated and there is evidence of cracked brickwork below the render which is an indication of bond loss.</p> | |

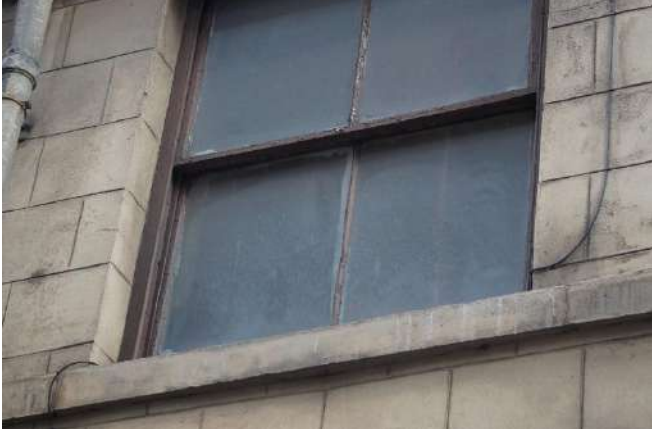
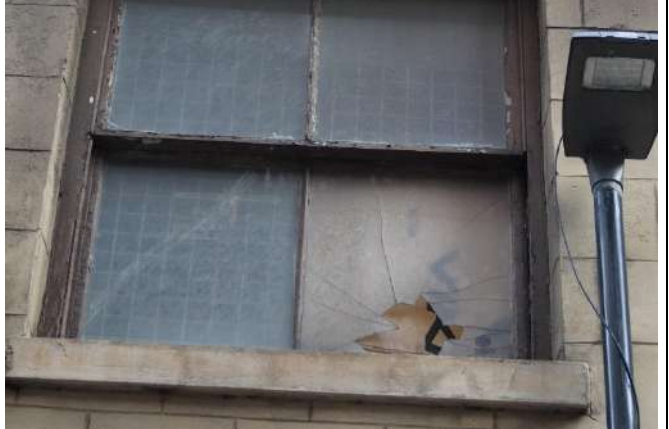
| <p>Timber style windows are distressed with ill fitting casement, draughty generally and rotting to the frames.</p> | | <p>Timber style windows are distressed with ill fitting casement, draughty generally and rotting to the frames.</p> | |

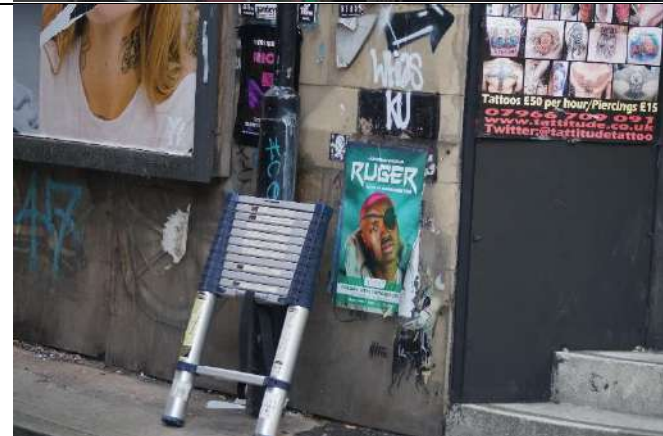
| <p>Canopy and shop stall risers are distressed.</p> | | <p>Generally.</p> | |

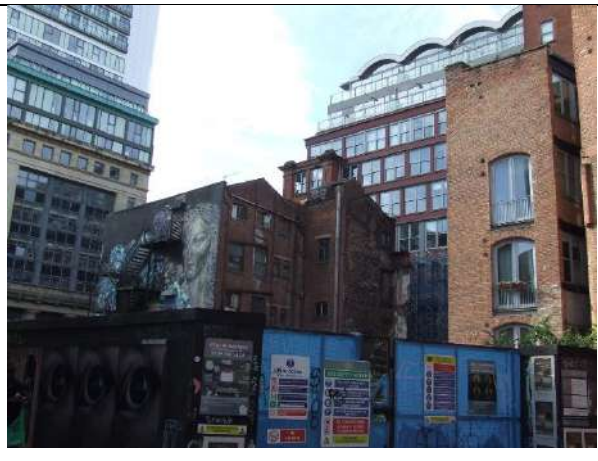
| <p>Rear elevation brickwork is generally distressed and in need of overhauling and repointing generally.</p> <p>Where the adjacent building has not been rebuilt after demolition the face of brick is at risk of weather penetration and needs to be repointed and made good to keep the property wind and water tight.</p> | | <p>Timber windows distressed as above with rot and a lack of good and regular decoration.</p> | |

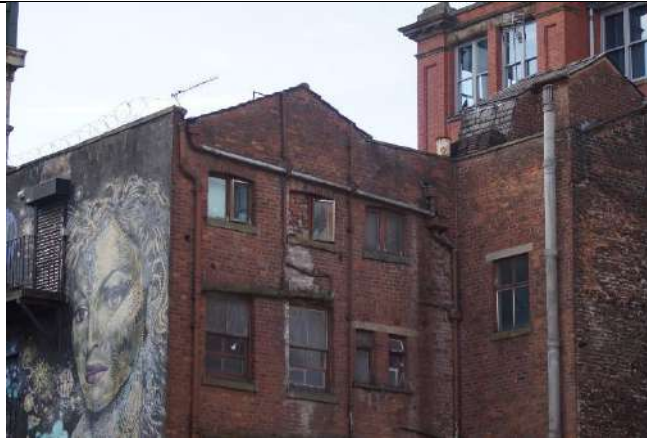
Rear elevation brickwork is generally distressed and in need of overhauling and repointing generally.

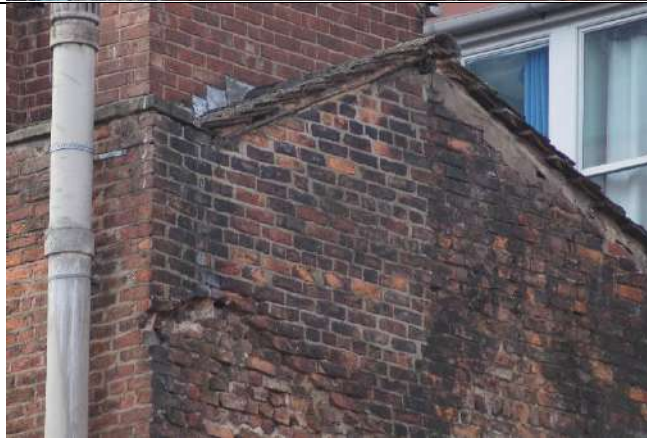
Rear elevation brickwork is generally distressed and in need of overhauling and repointing generally.

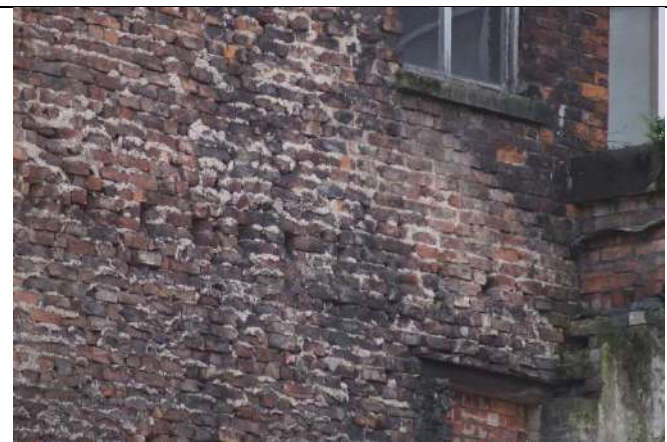
| <p>Where the adjacent building has not been rebuilt after demolition the face of brick is at risk of weather penetration and needs to be repointed and made good to keep the property wind and water tight.</p> | | <p>Generally.</p> | |

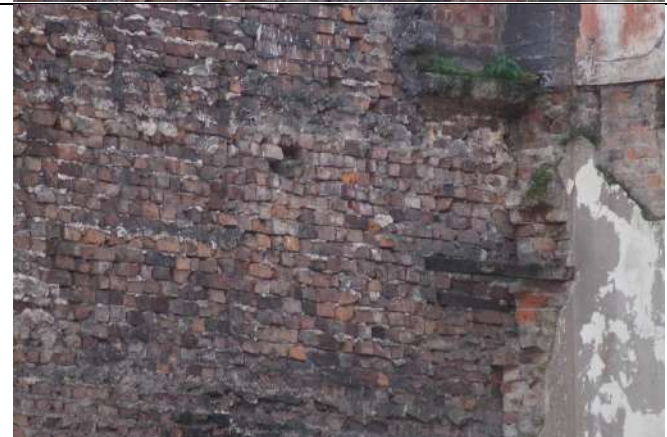
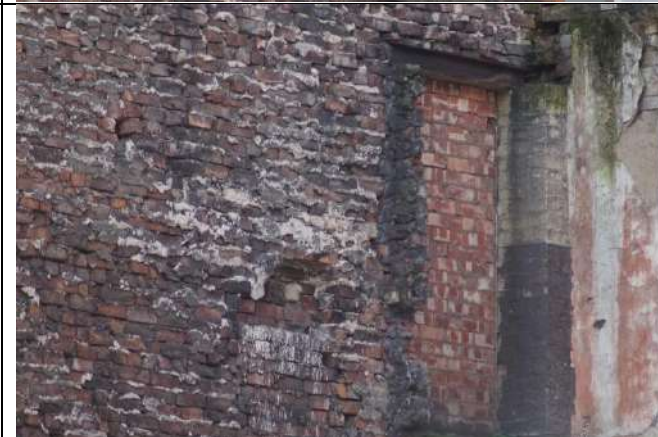
| <p>Where the adjacent building has not been rebuilt after demolition the face of brick is at risk of weather penetration and needs to be repointed and made good to keep the property wind and water tight.</p> | | <p>Where the adjacent building has not been rebuilt after demolition the face of brick is at risk of weather penetration and needs to be repointed and made good to keep the property wind and water tight.</p> | |

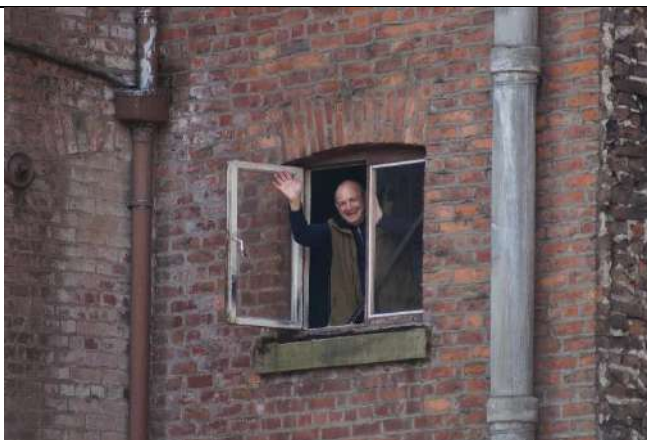
Timber windows distressed as above with rot and a lack of good and regular decoration.

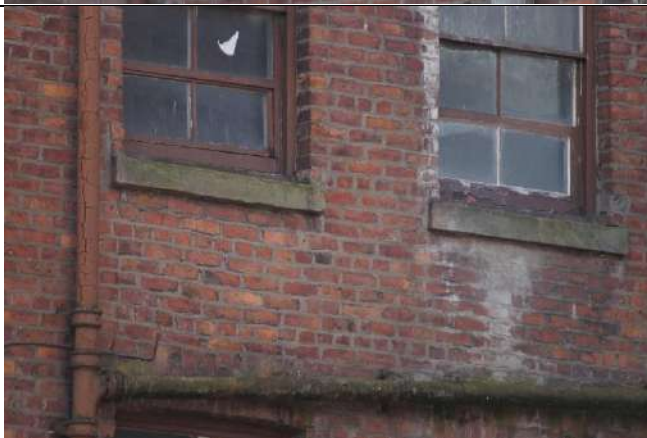
Rear elevation brickwork is generally distressed and in need of overhauling and repointing generally.

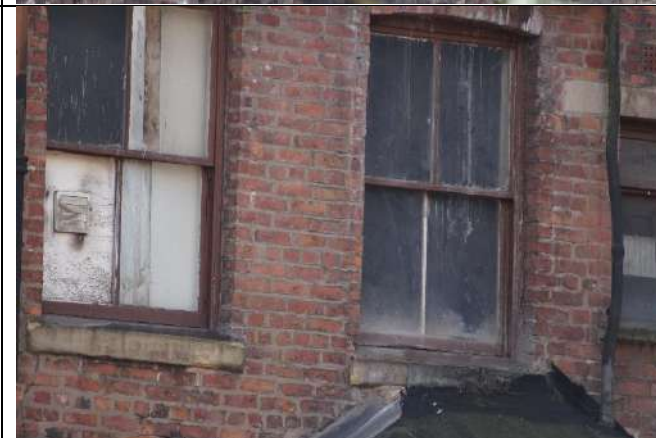
Timber windows distressed as above with rot and a lack of good and regular decoration.

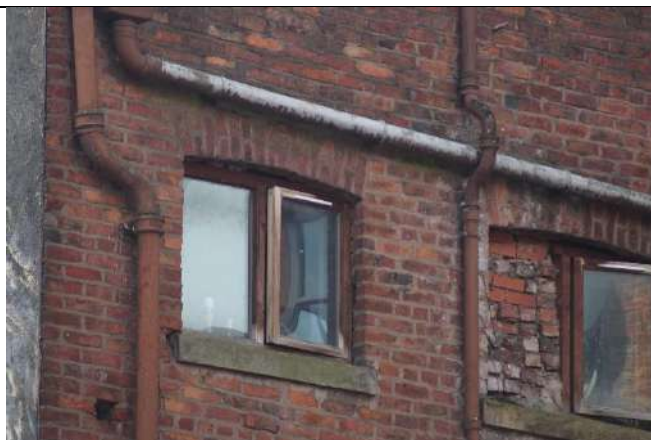
Rear elevation brickwork is generally distressed and in need of overhauling and repointing generally.

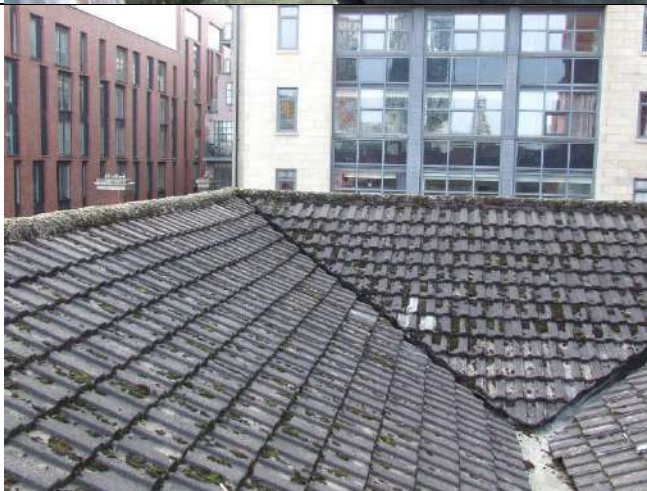
Main roof of aged concrete interlocking tiles.

The tiles are heavily moss pitted and are becoming porous.

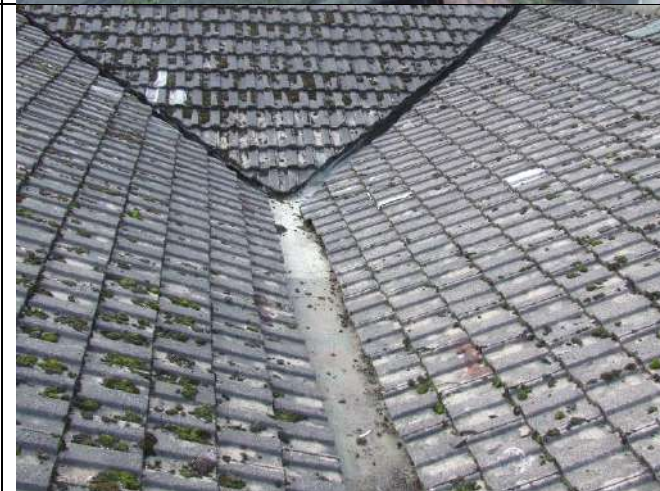
Main roof of aged concrete interlocking tiles.

The tiles are heavily moss pitted and are becoming porous.

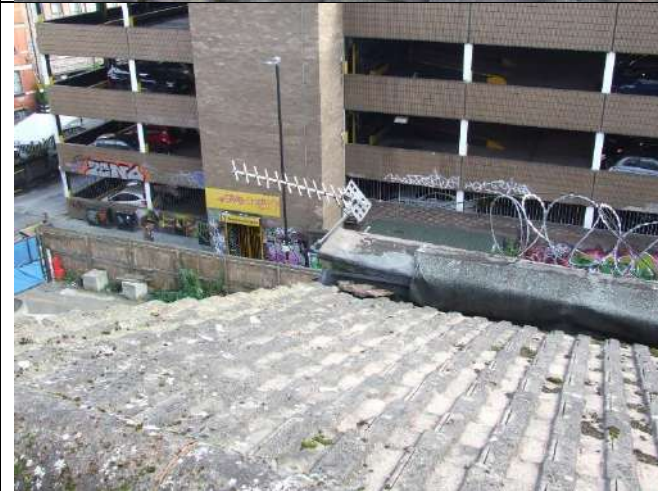
Main roof of aged concrete interlocking tiles.

The tiles are heavily moss pitted and are becoming porous.

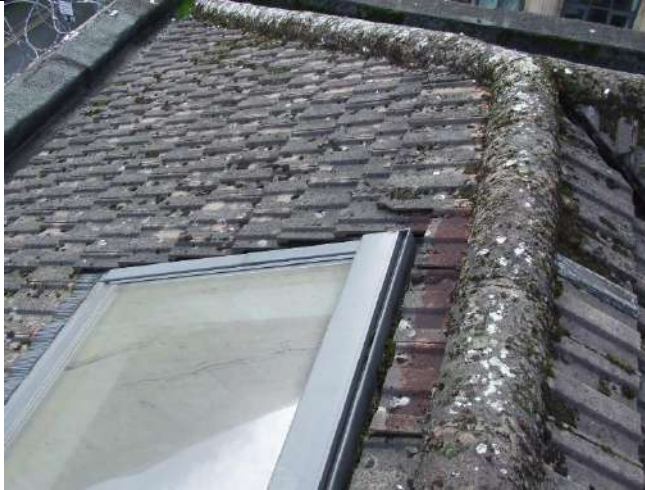
Heavy moss and pitting to the tiles.

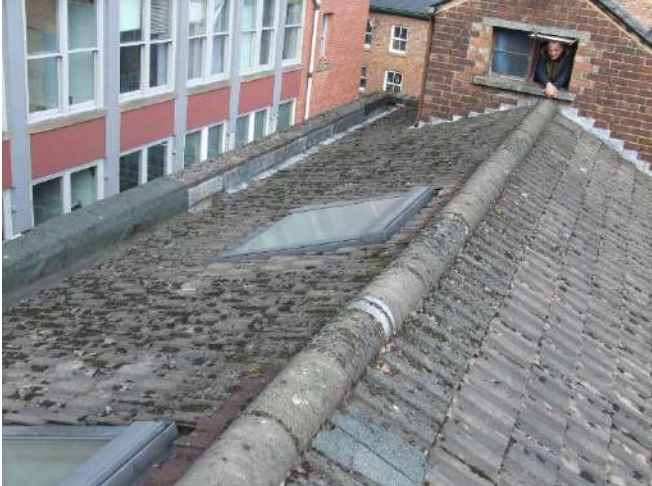
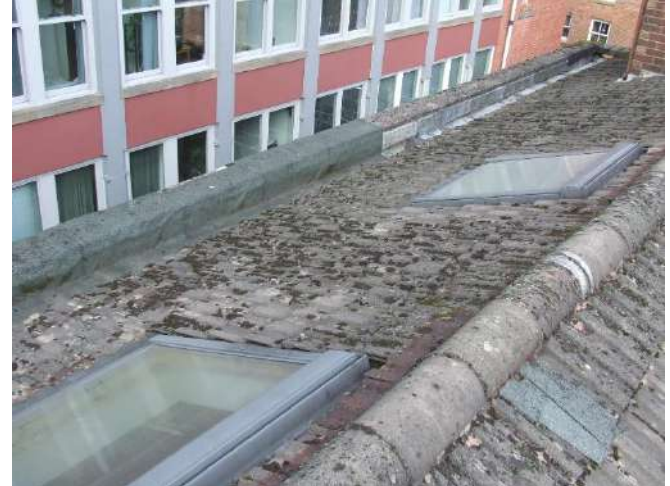
| <p>Generally.</p> | | <p>Generally.</p> | |

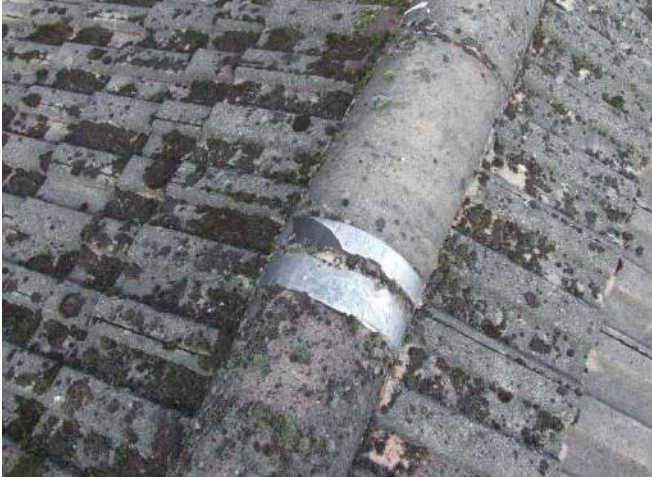
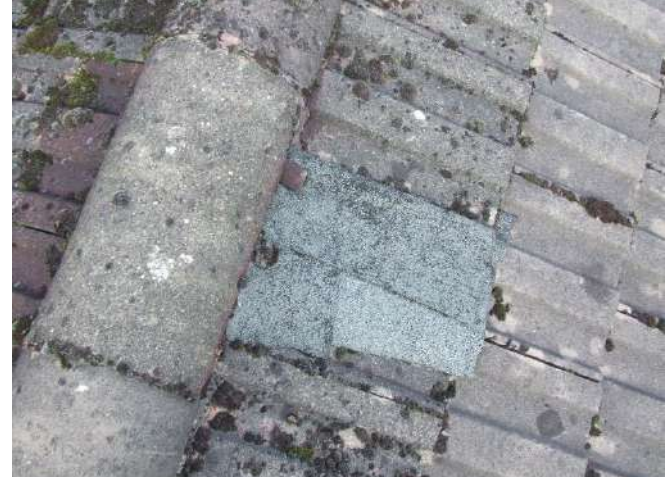
| <p>Example of patched and sealed tiles with flashband.</p> | | <p>Example of patched and sealed tiles with flashband.</p> | |

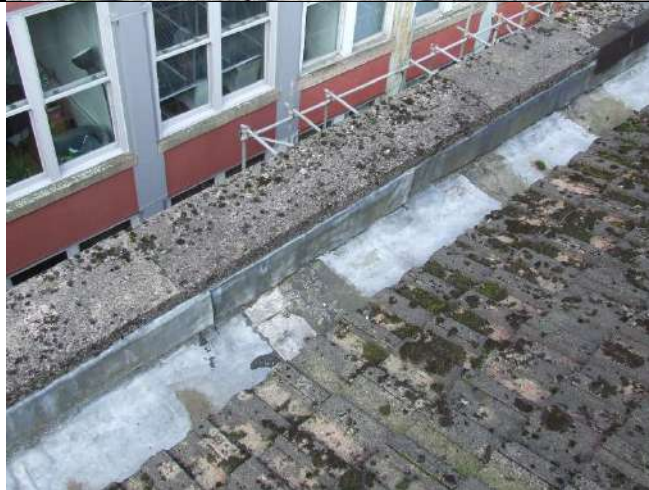
Patched lead parapet gutters.

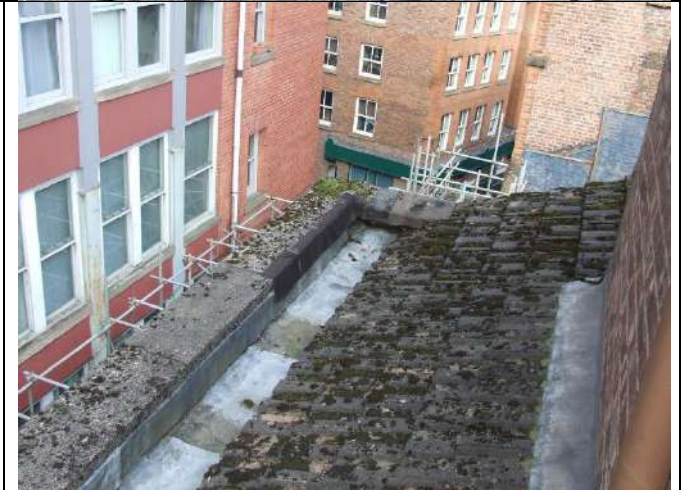
Patched lead parapet gutters.

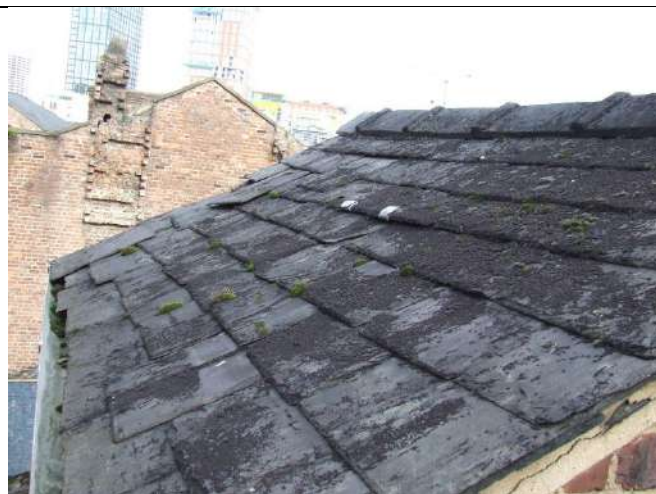
Old slate roof to the plant room has been sealed with bitumen.
