# One Medlock Street Development

## Highway Pre-condition Survey

Sweco UK Limited 2888385  
**Project Name** One Medlock Street Development  
**Planning Application Reference** 135419/FO/2022N/A  
**Client** RG Group  
**Author** Jordan Bamber Sweco  
**Date** 11/10/2023  
**Document reference** One Medlock Pre-condition Survey

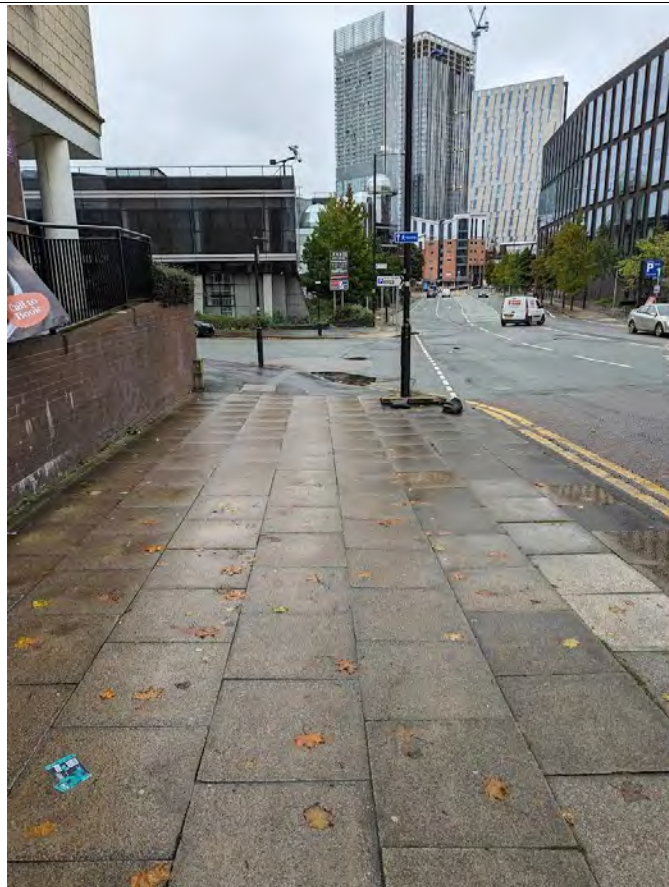
Location F3: Grid Reference X= 383665 Y= 397238

No visible damage

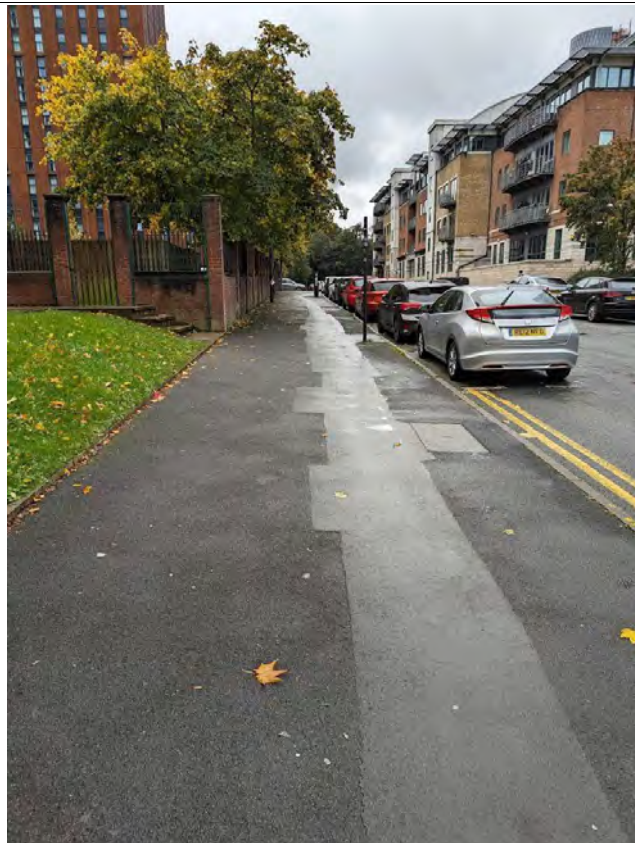
Location F5: Grid Reference X= 383642 Y= 397241

No visible damage

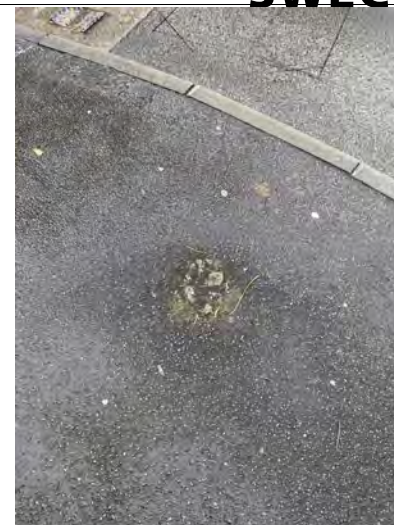
Location F8: Grid Reference X= 383598 Y= 397217

F8A. Scarring in footway from removed bollard.

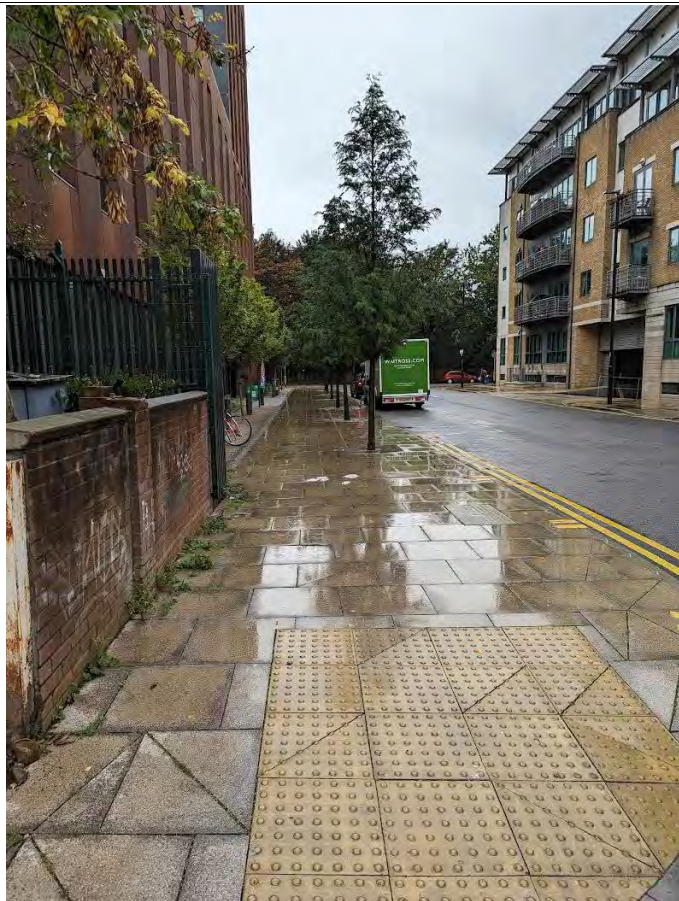
Location F9: Grid Reference X= 383568 Y= 397202

No visible damage

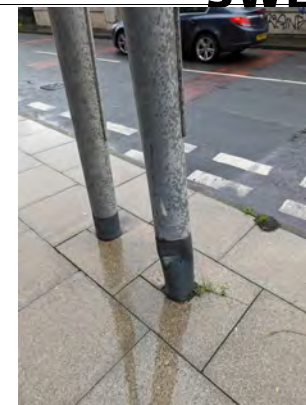
F12A. Damaged sign-post base

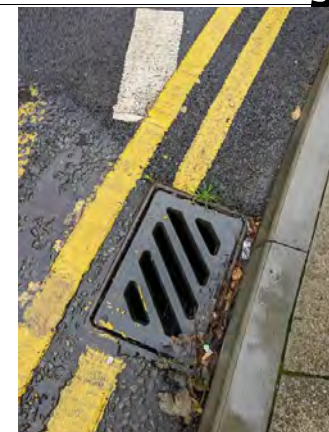
Location C3: Grid Reference X= 383523 Y= 397184

C3A. General surface wear.

C3B. Visible carriageway trenches of contrasting colour surface course.

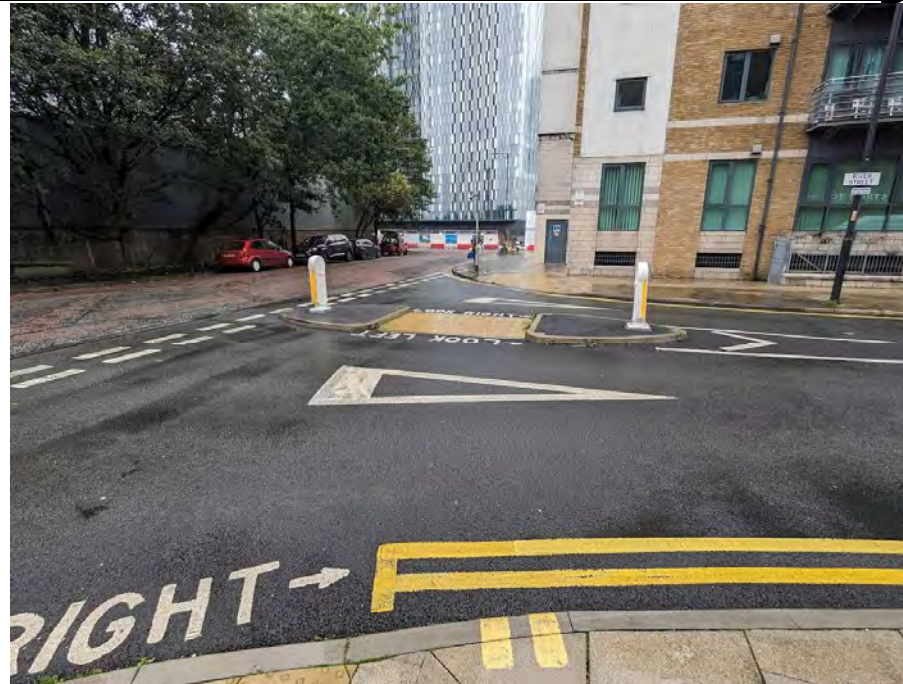
Location C4: Grid Reference X= 383533 Y= 397189

No visible damage

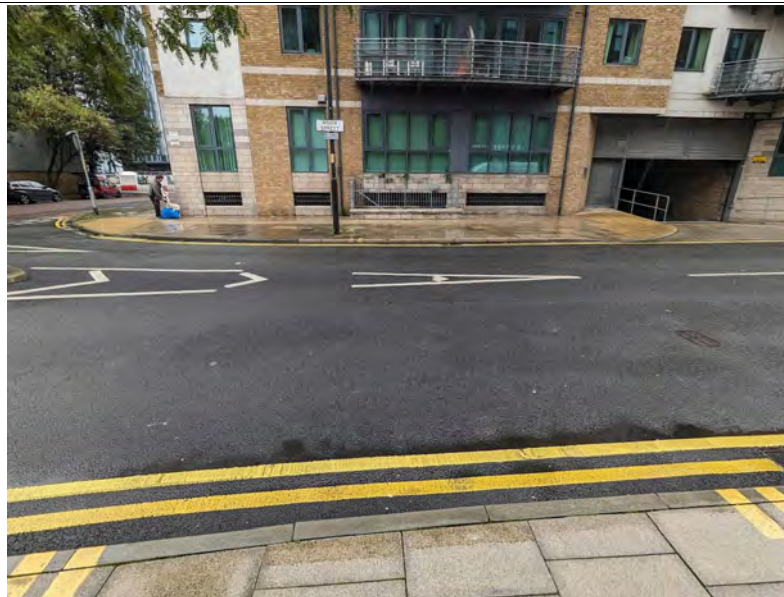
Location C5: Grid Reference X= 383545 Y= 397196

No visible damage

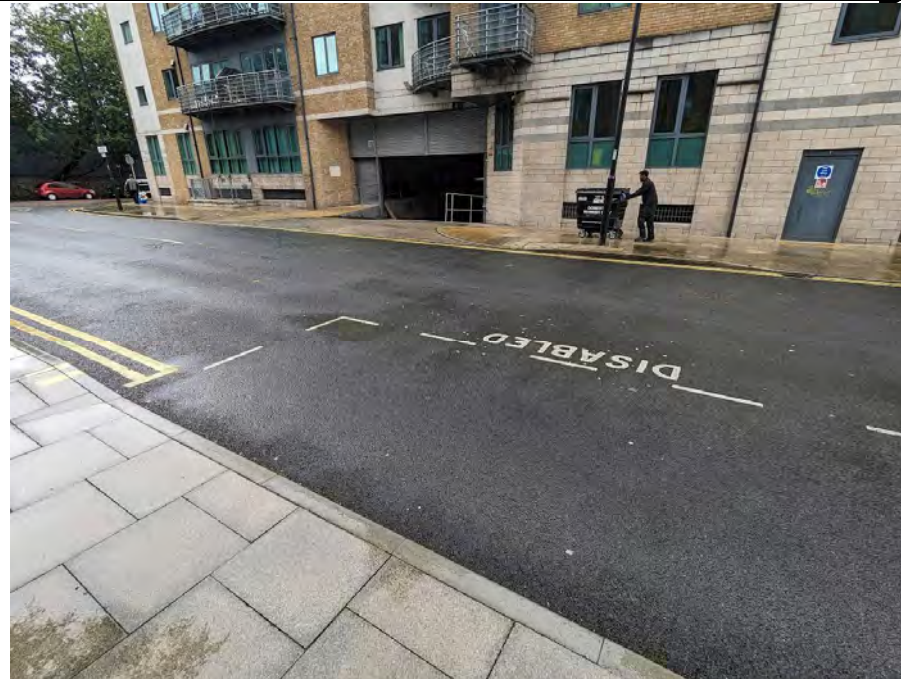
Location C6: Grid Reference X= 383557 Y= 397201

No visible damage

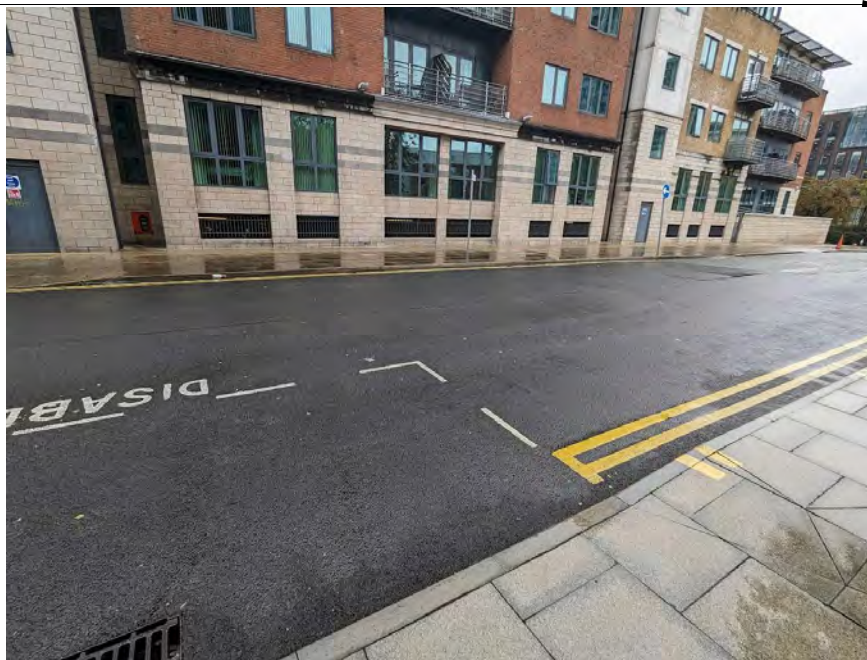
Location C7: Grid Reference X= 383570 Y= 397209

No visible damage

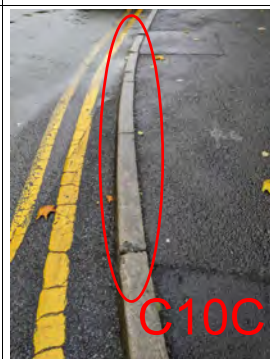
C10A. Longitudinal Cracking

C10B. General surface wear

C10C. Worn down kerb units

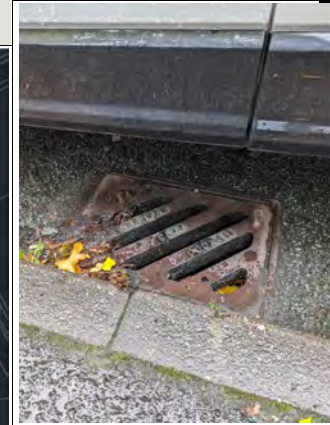
Location C12: Grid Reference X= 383623 Y= 397237

C12A. Longitudinal Cracking with significant surface failure

C12B. Transverse Cracking

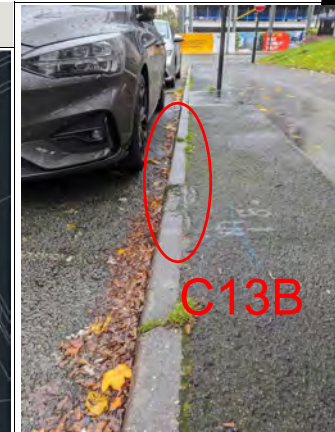
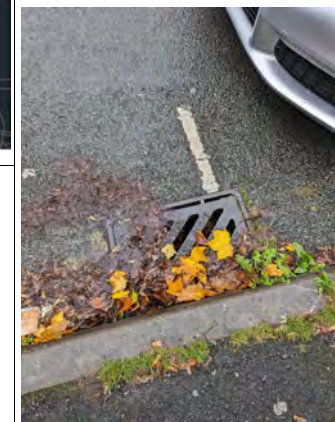
Location C13: Grid Reference X= 383638 Y= 397245

C13A. Longitudinal cracking with significant surface failure

C13B. Kerb units deteriorated

C13C. Debris build up at gully pot

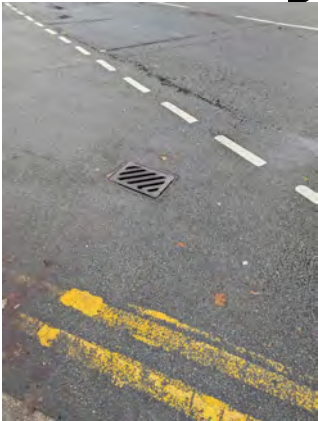
| | <p>Location C14: Grid Reference X= 383651 Y= 397252</p> <p>Notes:</p> <p>C14A. Longitudinal and transverse cracking</p> <p>C14B. Longitudinal cracking with minor surface failure</p> | |

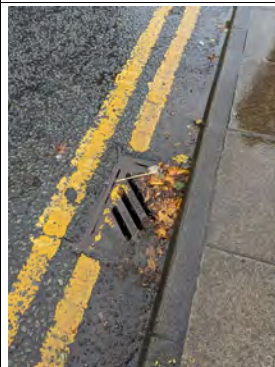
C15A. Longitudinal cracking in right wheel track of lane 1 northbound

C15B. General surface wear

C15C. Debris build up at gully pot
