Roof Asset Management Programme

Manchester Royal Exchange Condition Survey

Prepared By  
Tom Boon

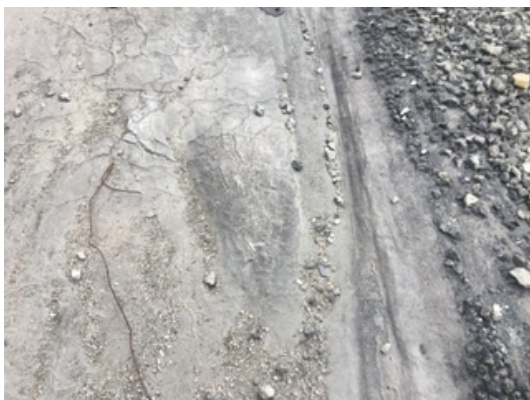
**Photo 8**

Example of a blister in the asphalt

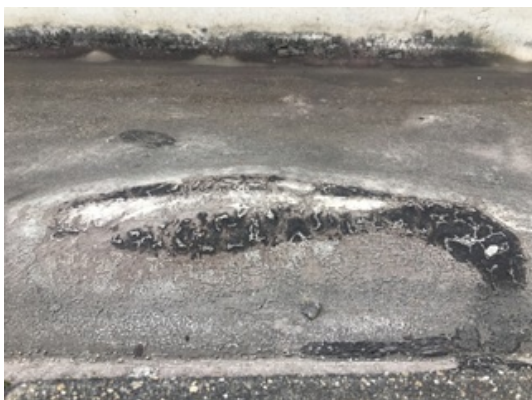
**Photo 12**

Example of a blister in the asphalt

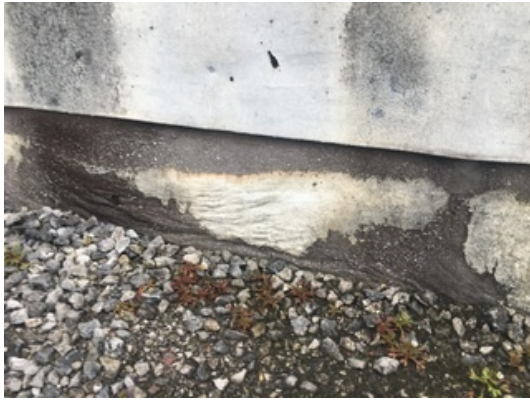
**Photo 13**

Another example of slumping around the perimeter of the building

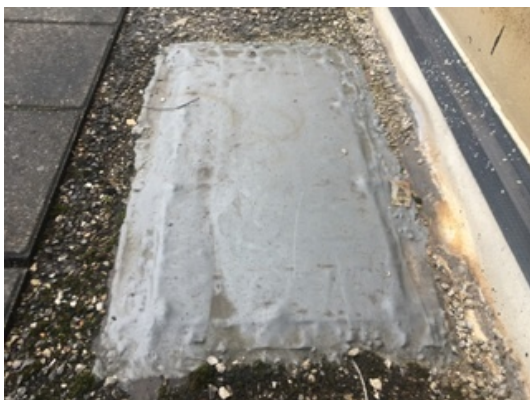
**Photo 16**

Remedial works have been carried out in this section using a liquid coating, this is only a short term fix and will start to peel at the leading edge over time.

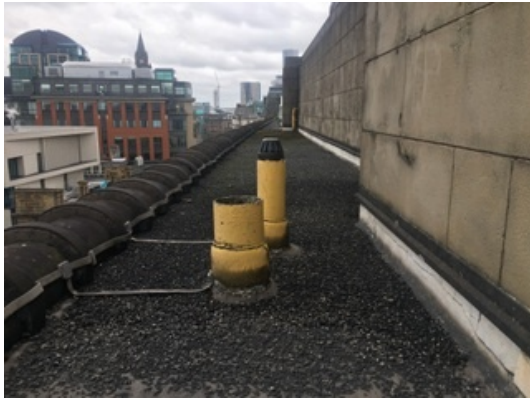
**Photo 17**

I was unable to access this section without edge protection

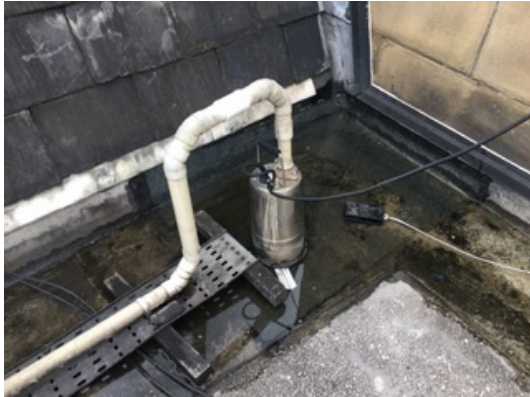
**Photo 14**

Water pump has been installed in this area due to incorrect falls on the roof

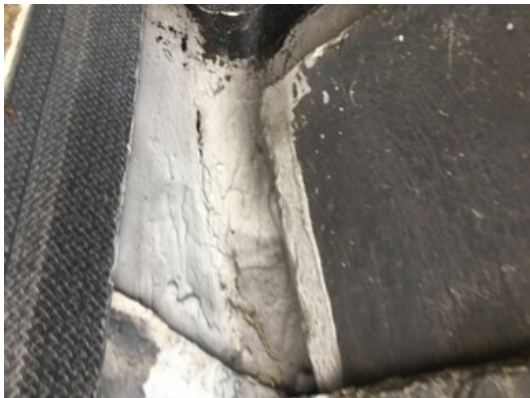
**Photo 15**

Example of remedial works carried out

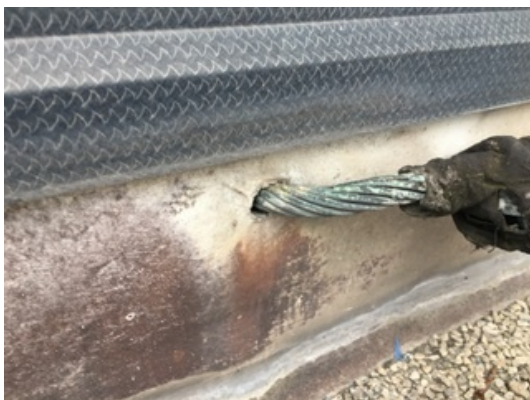
**Photo 16**

As discussed in the summary this lightening conductor is incorrectly detailed

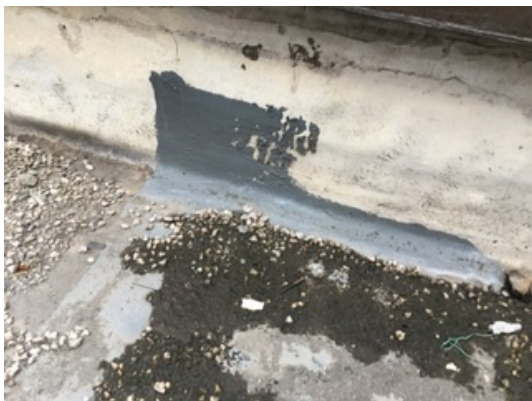
**Photo 3**

Unreinforced liquids used in this area, this perimeter also displays slumping

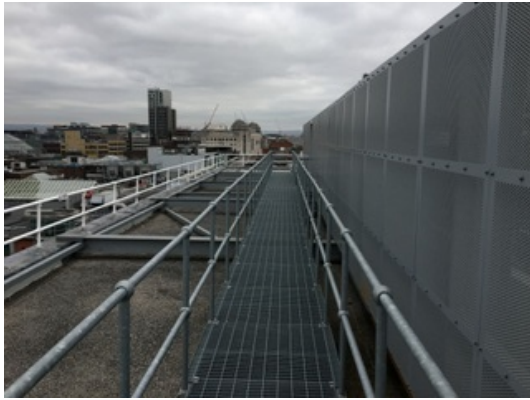
**Photo 13**

Roof Overview

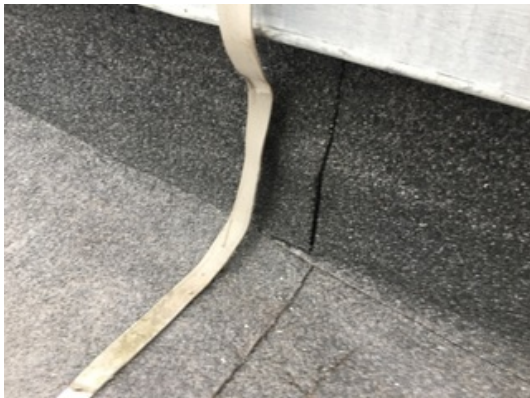
**Photo 12**

Laps starting to debond in some areas

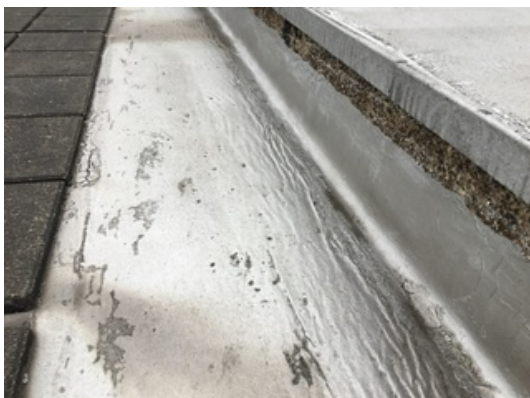
**Photo 13**

Another example of the above

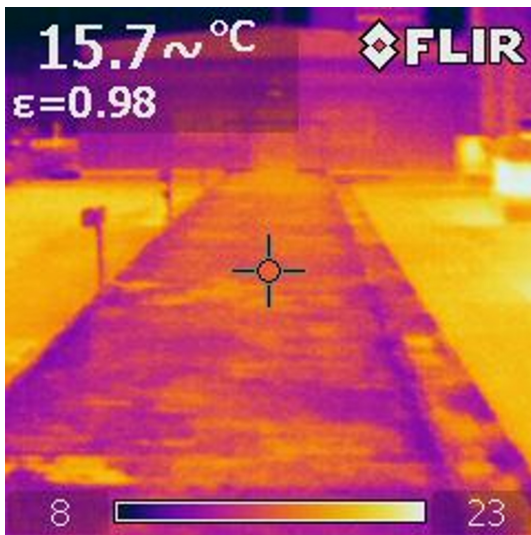
**Photo 15**

In order to fully understand the extent of water ingress across the site, thermal imaging photos were taken on the roof section. As is very clear to see, the yellow areas are where the roof is emitting a large amount of heat from the facility due to poor thermal capabilities and the purple and black areas are water ingress issues.

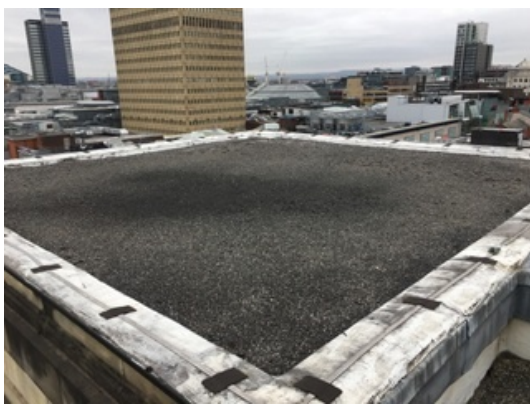
**Photo 1**

Roof Section G overview

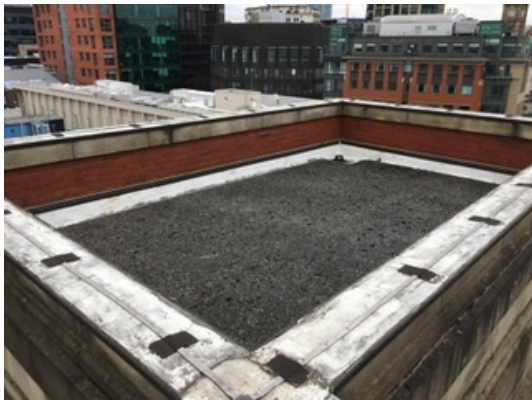
**Photo 4**

Overview of roof section H no issues to report
