# **Land at Victoria Avenue East, New Moston**

## **Proposed Retail Development**

### **Flood Risk Assessment & Outline Drainage Strategy**

For: Aldi Stores Ltd.

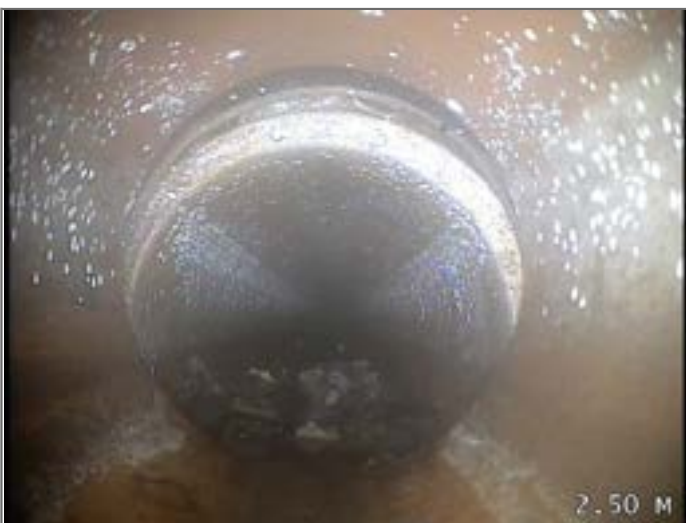
Joint displaced large

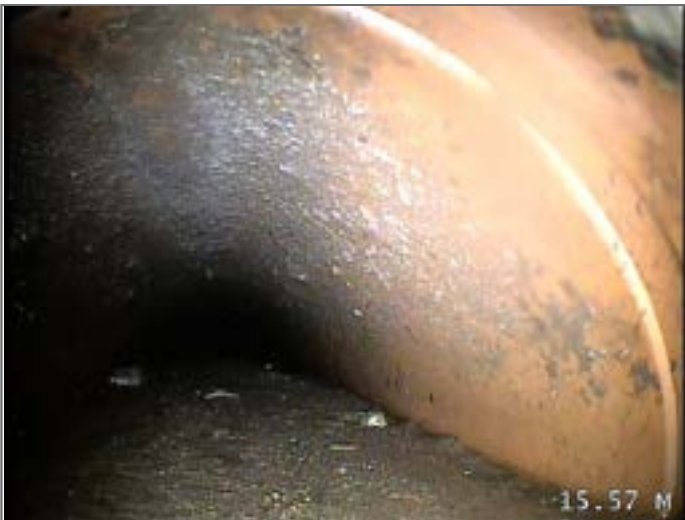
Survey abandoned - Remark: UNABLE TO PASS DUE TO HIGH SILT DEPOSITS

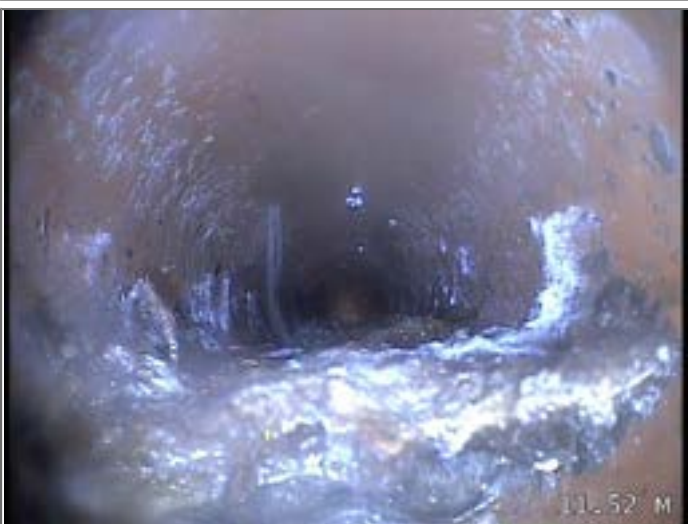
Attached deposits, encrustation from 4 to 8 o'clock 20% cross-sectional area loss

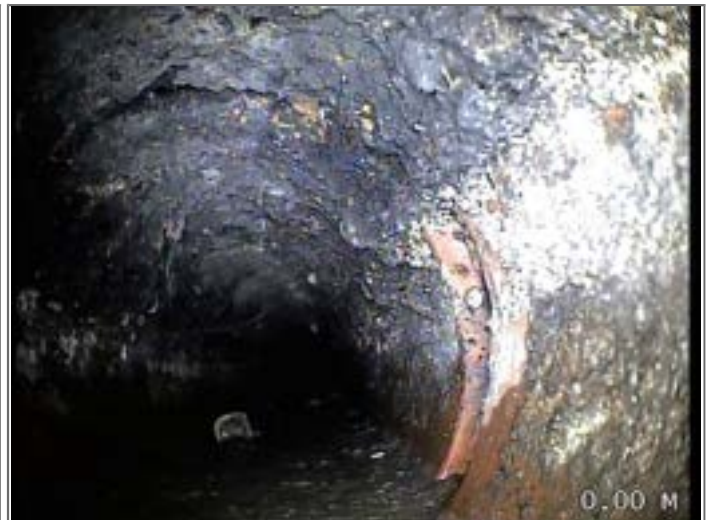
Other attached deposits from 8 to 4 o'clock 5% cross-sectional area loss - Remark SILT

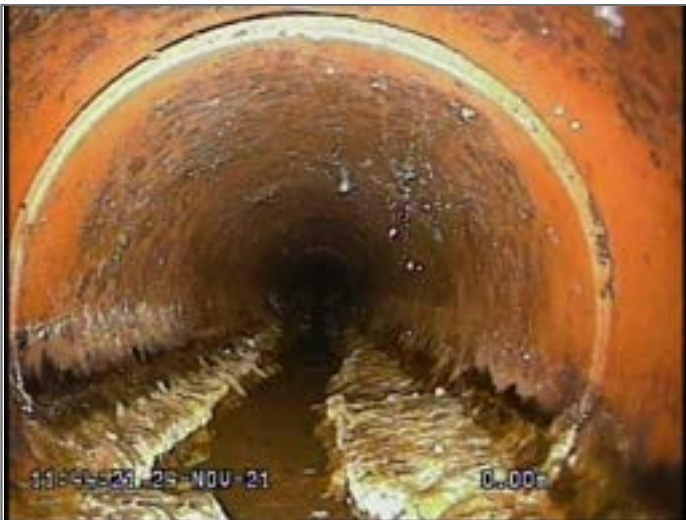
Attached deposits, fouling from 5 to 7 o'clock 10% cross-sectional area loss

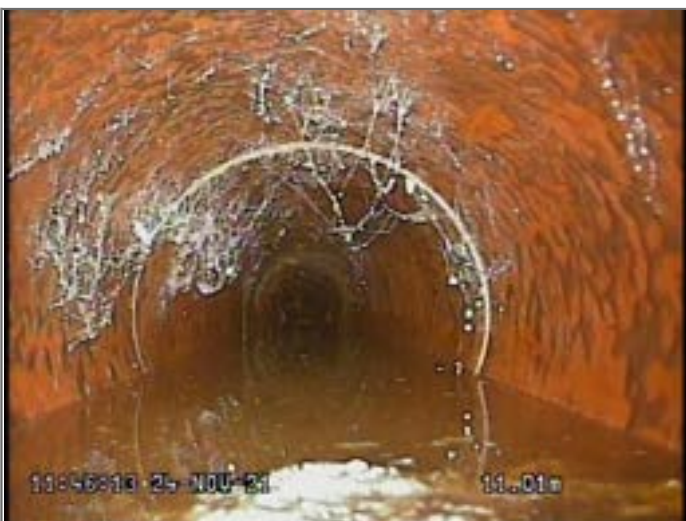
Other settled deposits 10% cross-sectional area loss - Remark: FOUL WASTE

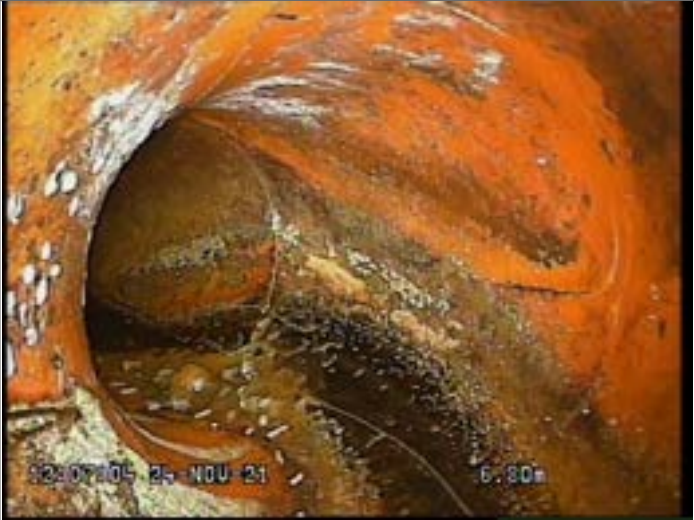
| <div></div> <p>Survey abandoned - Remark: UNABLE TO PASS THIS POINT DUE TO SHARP TURN AND DROP IN PIPE - NOT SAFE TO DO SO</p> | | | |

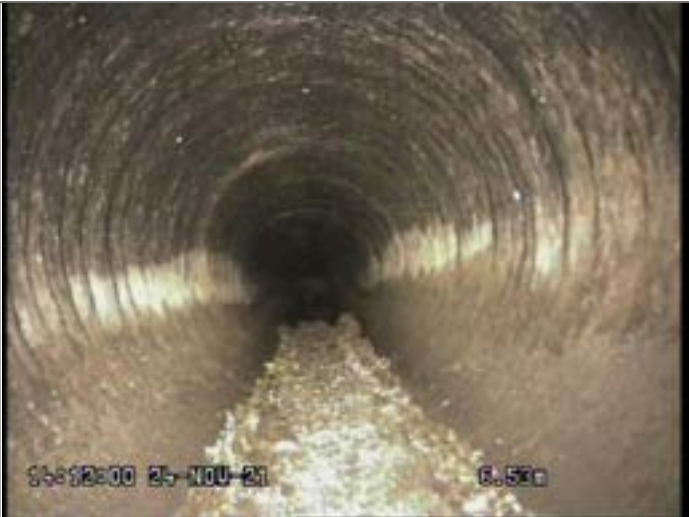
| Job Number<br>LAYERSERV0001064 | Surveyed by (Operator)<br>CHRIS LUCOCK | Base Unit<br>ELFEIYII63 | Date<br>24/11/2021 |
|---|---|---|---|
| <p>Settled deposits fine 5% cross-sectional area loss</p> | | | |

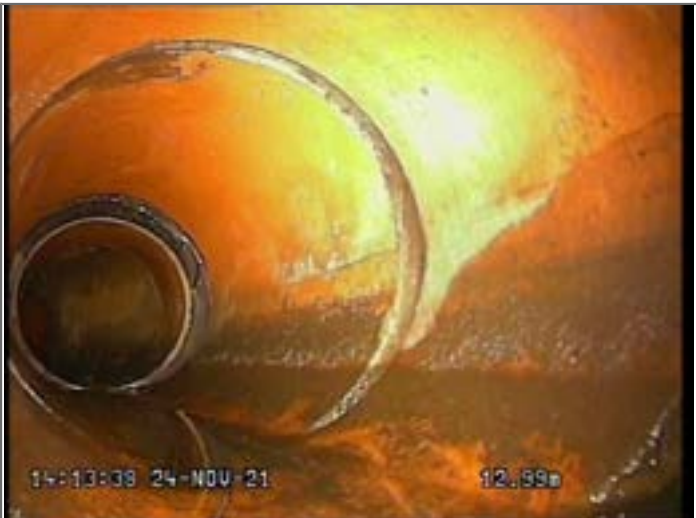
| Job Number<br>LAYERSERV0001064 | Surveyed by (Operator)<br>CHRIS LUCOCK | Base Unit<br>ELFEIYII63 | Date<br>24/11/2021 |
|---|---|---|---|
| <p>Line of drain/sewer deviates left</p> | | | |

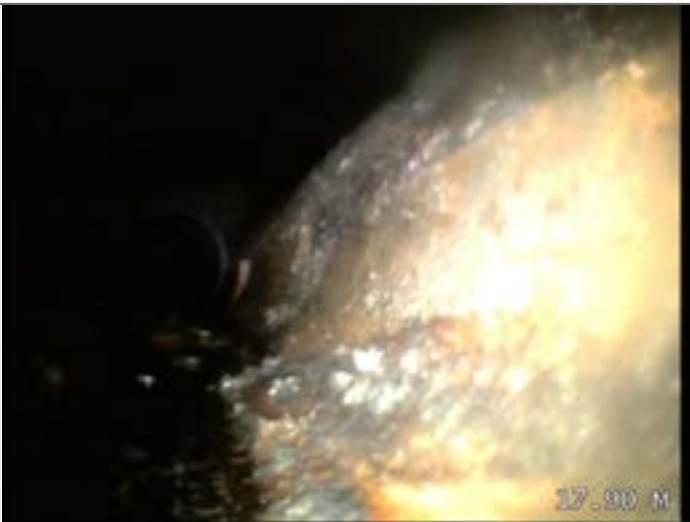
| Job Number<br>LAYERSERV0001064 | Surveyed by (Operator)<br>CHRIS LUCOCK | Base Unit<br>ELFEIYII63 | Date<br>24/11/2021 |
|---|---|---|---|
| Line of drain/sewer deviates right | | Finish node type, manhole, reference MH F8 | |

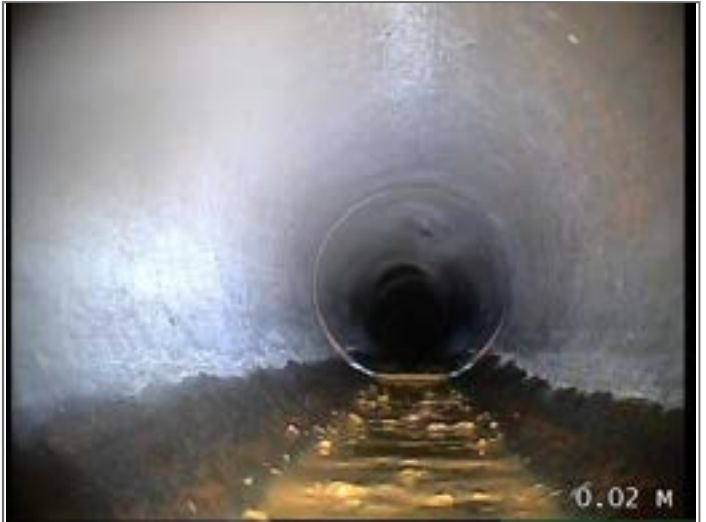
Water level 5% height/diameter

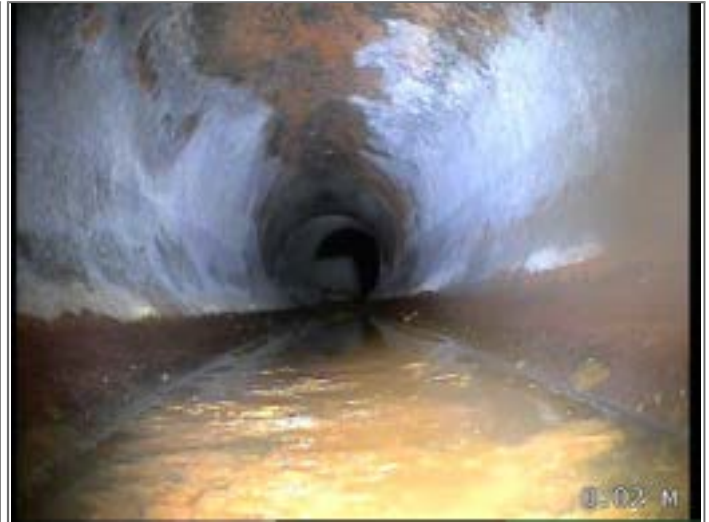
Water level 10% height/diameter

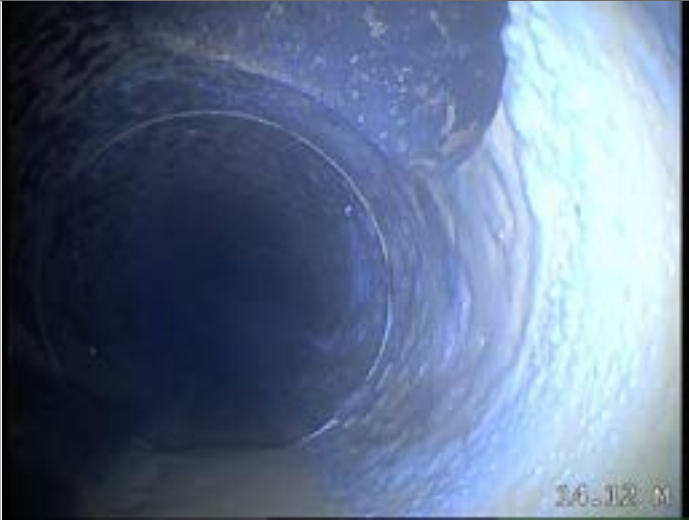
| Job Number<br>LAYERSERV0001064 | Surveyed by (Operator)<br>CHRIS LUCOCK | Base Unit<br>ELFEIYII63 | Date<br>25/11/2021 |
|---|---|---|---|
| Junction at 1 o'clock, diameter 100mm | | | |

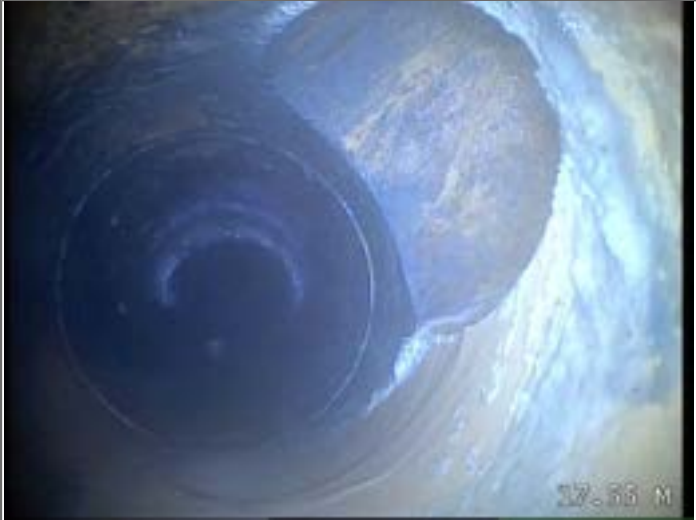
| Job Number<br>LAYERSERV0001064 | Surveyed by (Operator)<br>CHRIS LUCOCK | Base Unit<br>ELFEIYII63 | Date<br>25/11/2021 |
|---|---|---|---|
| Junction at 2 o'clock, diameter 100mm | | | |

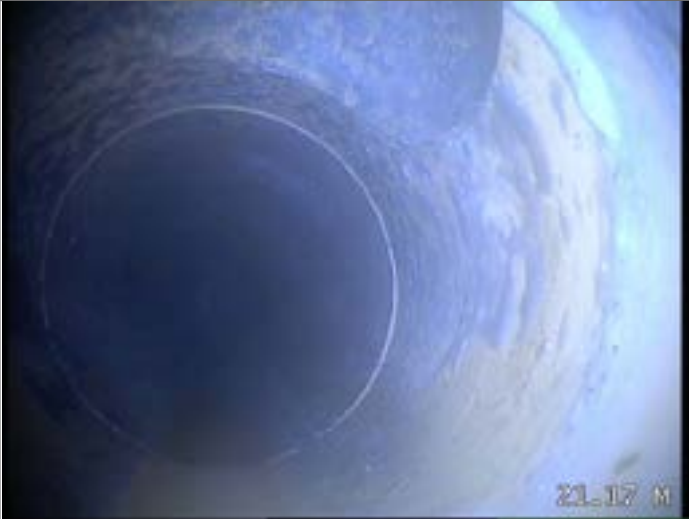
| Job Number<br>LAYERSERV0001064 | Surveyed by (Operator)<br>CHRIS LUCOCK | Base Unit<br>ELFEIYII63 | Date<br>25/11/2021 |
|---|---|---|---|
| Junction at 1 o'clock, diameter 100mm | | | |

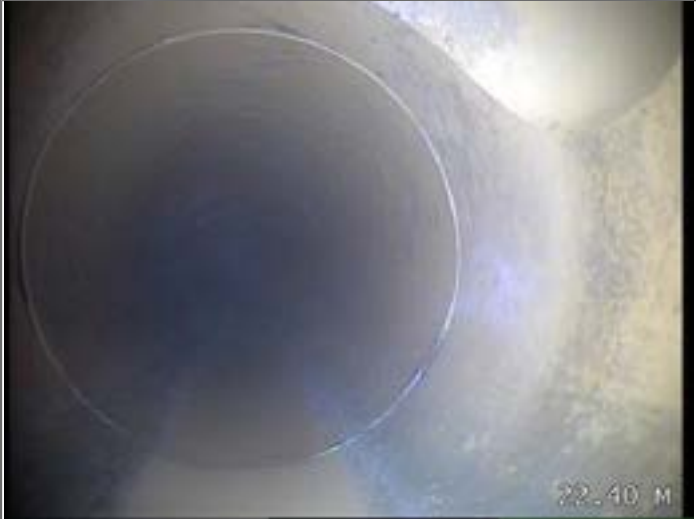
| Job Number<br>LAYERSERV0001064 | Surveyed by (Operator)<br>CHRIS LUCOCK | Base Unit<br>ELFEIYII63 | Date<br>25/11/2021 |
|---|---|---|---|
| Junction at 1 o'clock, diameter 100mm | | | |

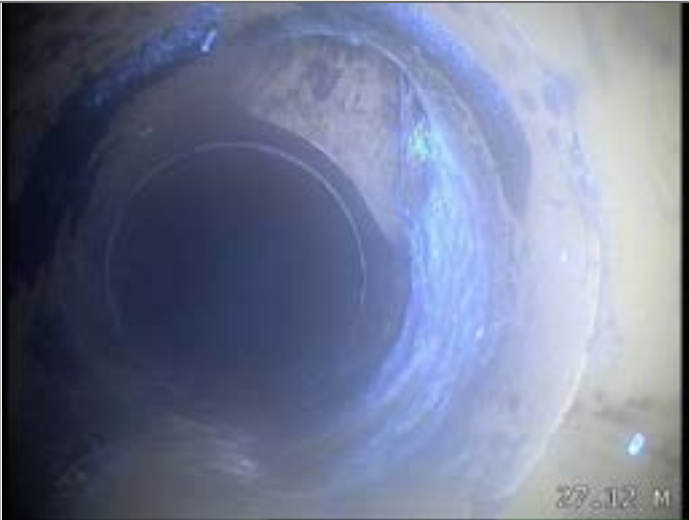
| Job Number<br>LAYERSERV0001064 | Surveyed by (Operator)<br>CHRIS LUCOCK | Base Unit<br>ELFEIYII63 | Date<br>25/11/2021 |
|---|---|---|---|
| Junction at 2 o'clock, diameter 100mm | | | |

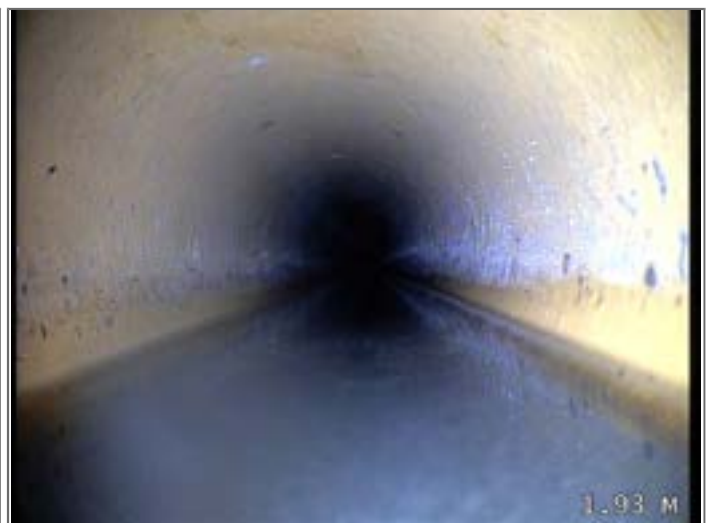
Water level 10% height/diameter

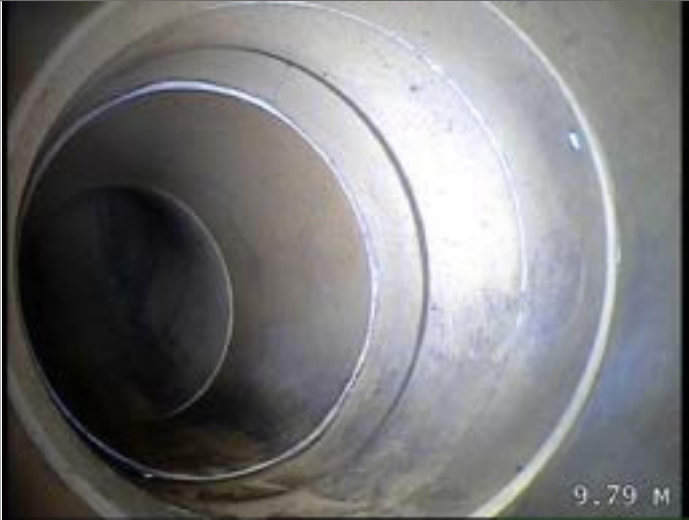
| Line of drain/sewer deviates left | | Finish node type, other special chamber, reference REST BEND | |

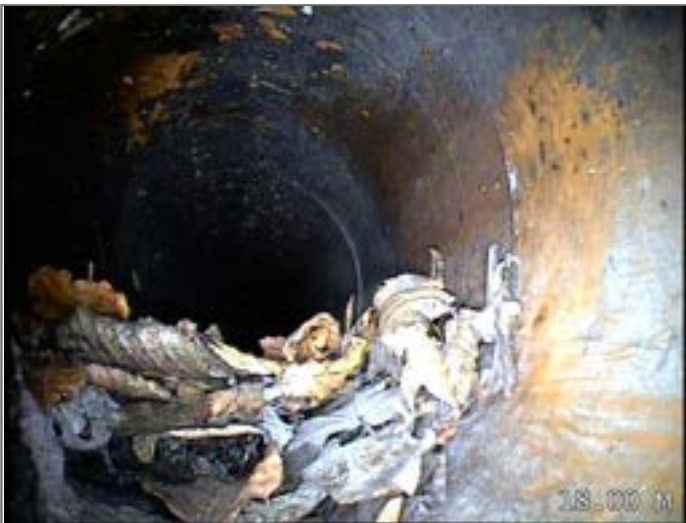
Other settled deposits 10% cross-sectional area loss - Remark: DEBRIS

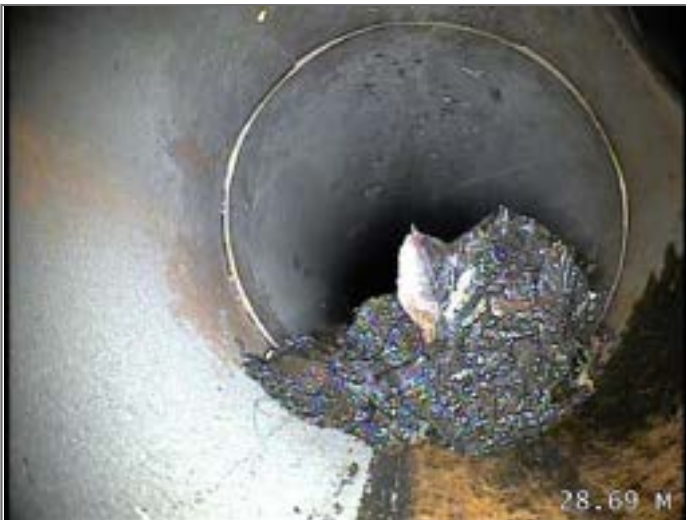
Junction at 2 o'clock, diameter 100mm

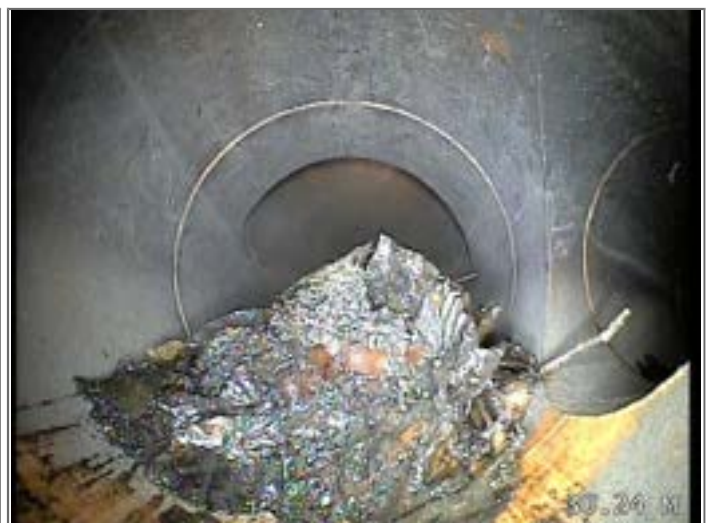
Finish node type, other special chamber, reference REST BEND

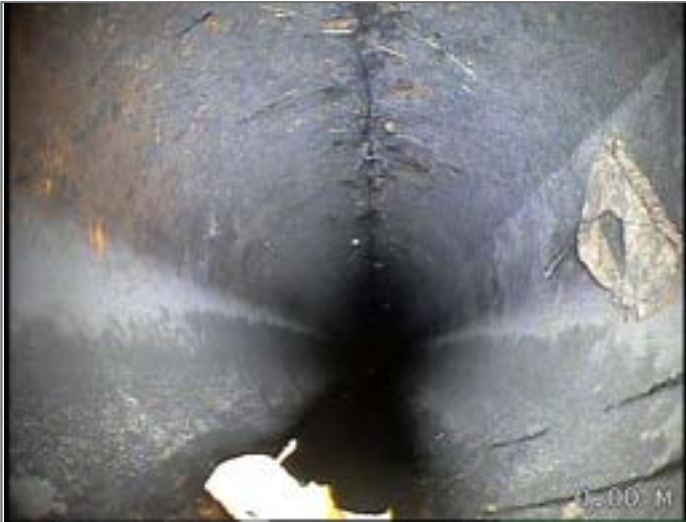
Start node type, inspection chamber, reference IC S01

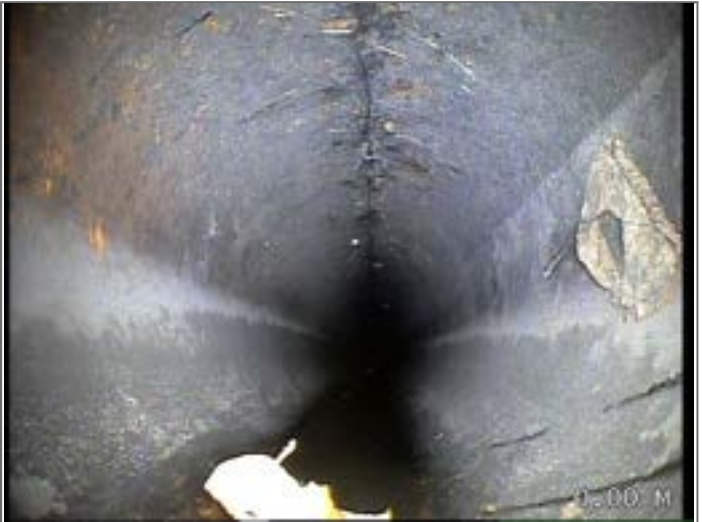
Water level 5% height/diameter

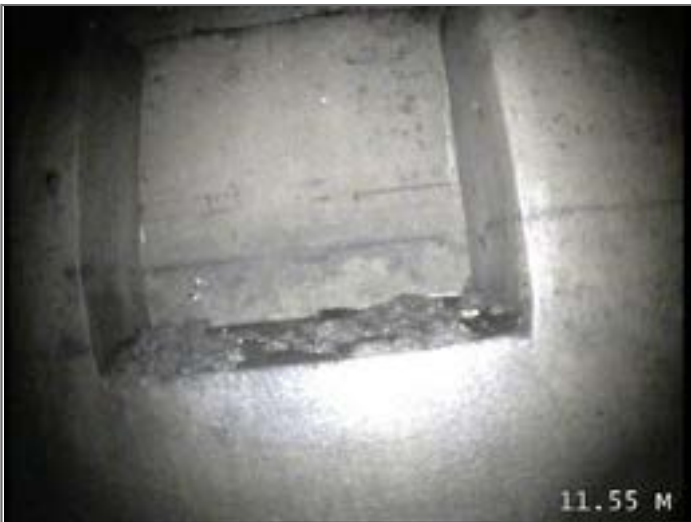
Finish node type, manhole, reference MH S12

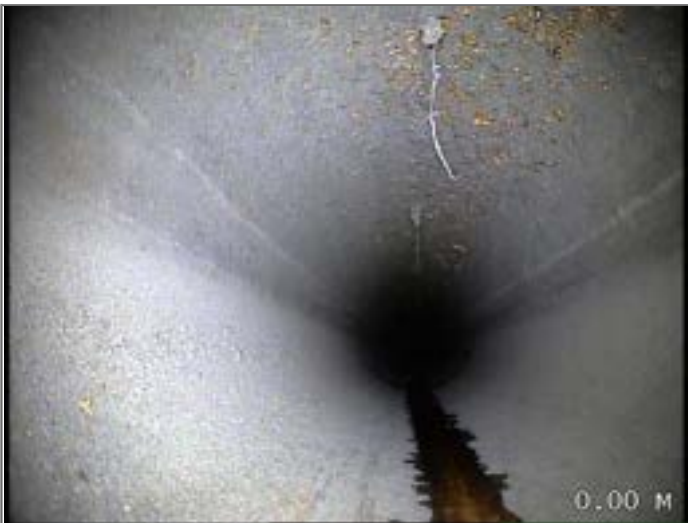
Start node type, inspection chamber, reference IC S01

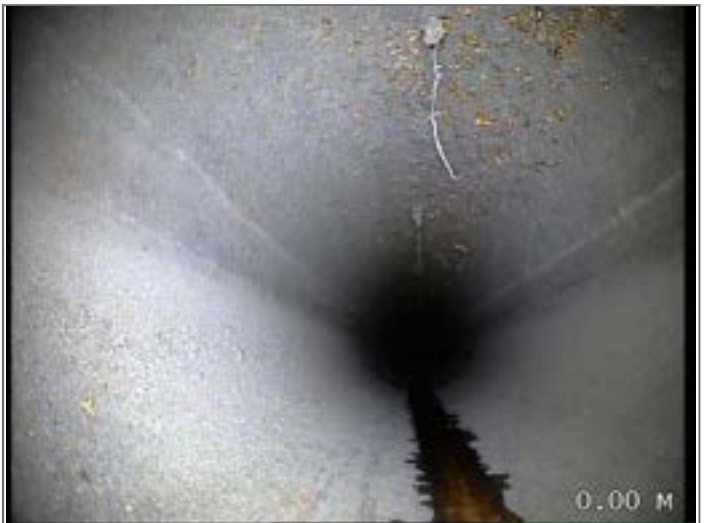
Water level 5% height/diameter

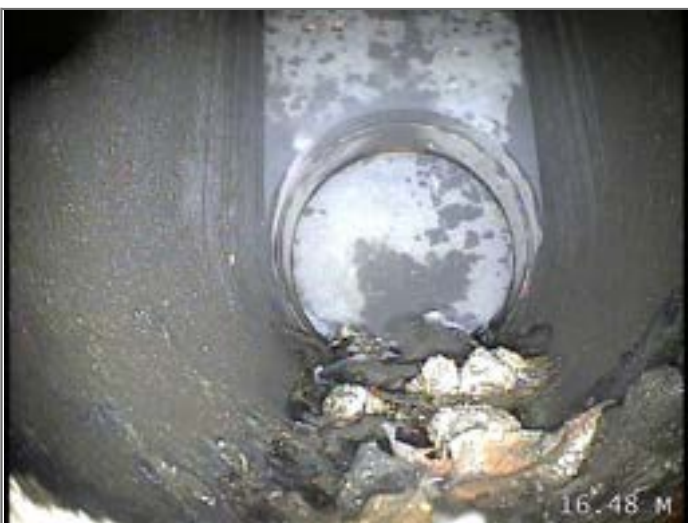
Finish node type, inspection chamber, reference IC S02

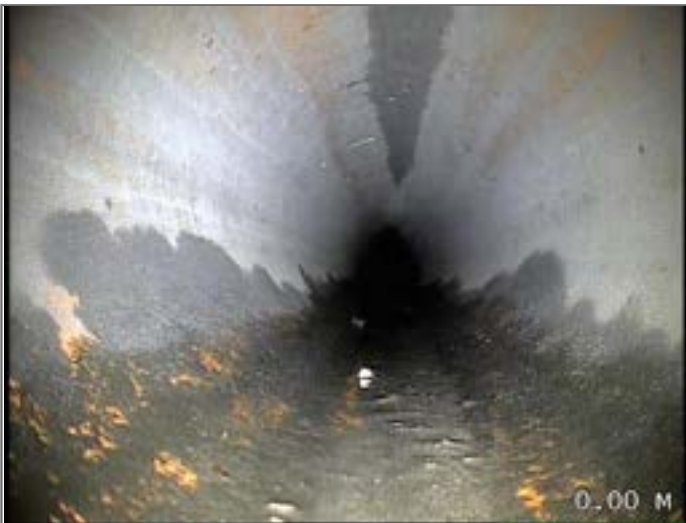
Start node type, inspection chamber, reference IC S02

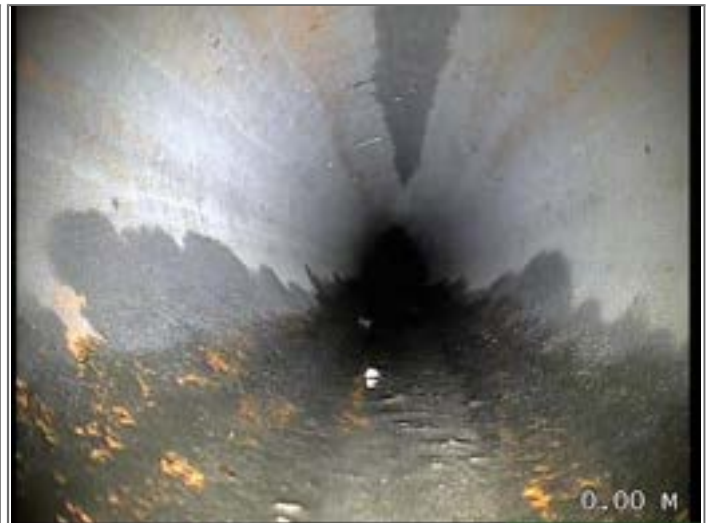
Water level 5% height/diameter

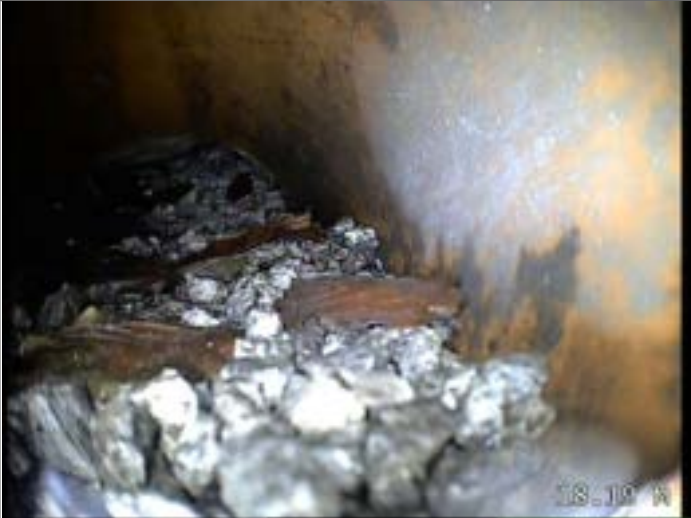
| <div><p>Finish node type, other special chamber, reference HEAD OF LINE</p></div> | | | |

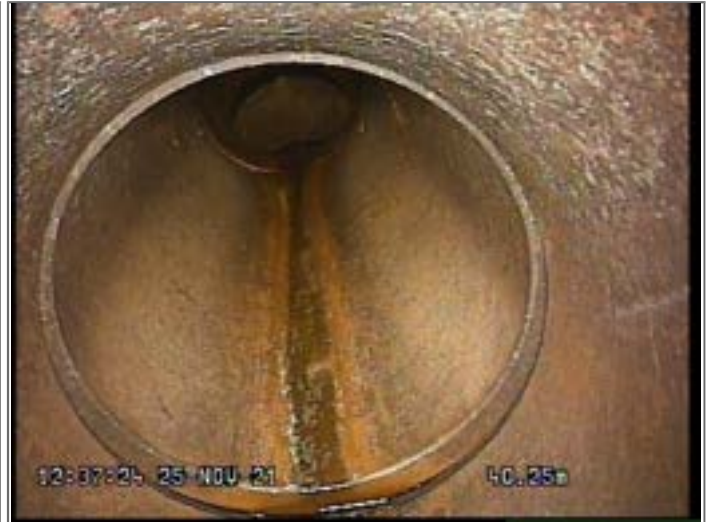
Finish node type, gully, reference GULLY

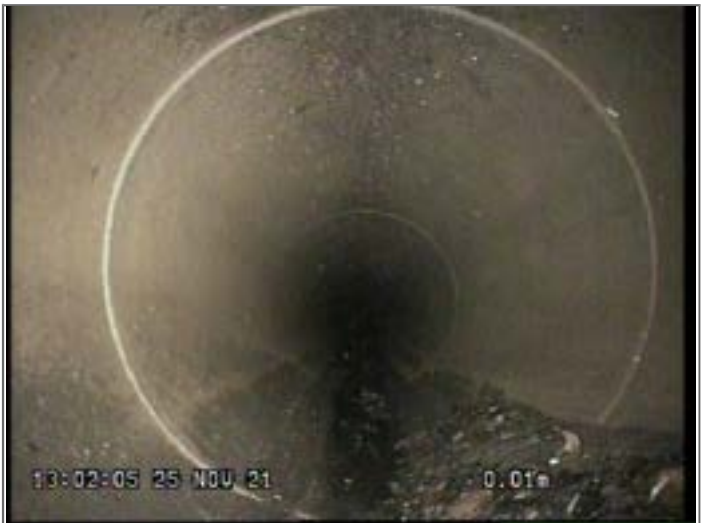
Water level 5% height/diameter

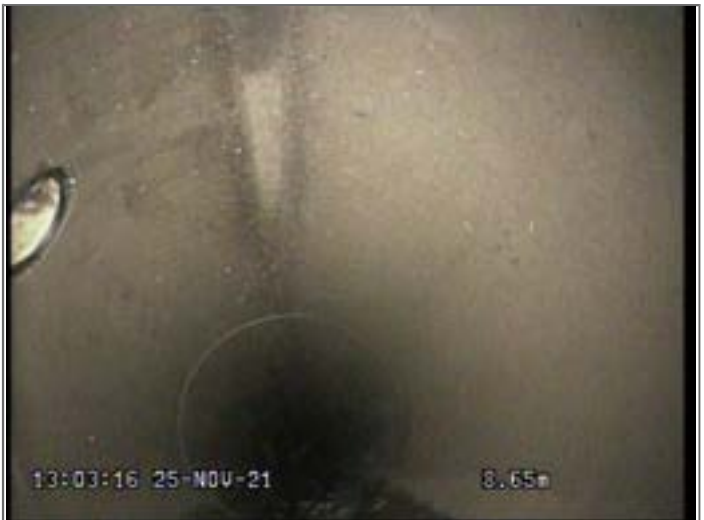
Connection other than junction at 9 o'clock, diameter 100mm

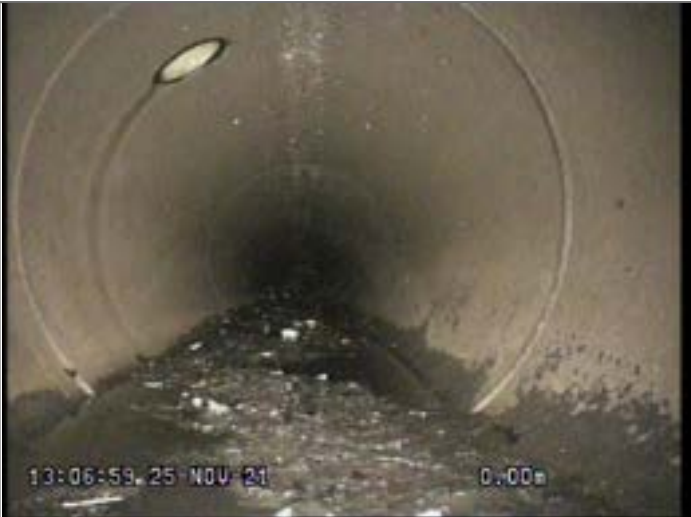
| Job Number<br>LAYERSERV0001064 | Surveyed by (Operator)<br>CHRIS LUCOCK | Base Unit<br>ELFEIYII63 | Date<br>25/11/2021 |
|---|---|---|---|
| Settled deposits fine 10% cross-sectional area loss | | | |

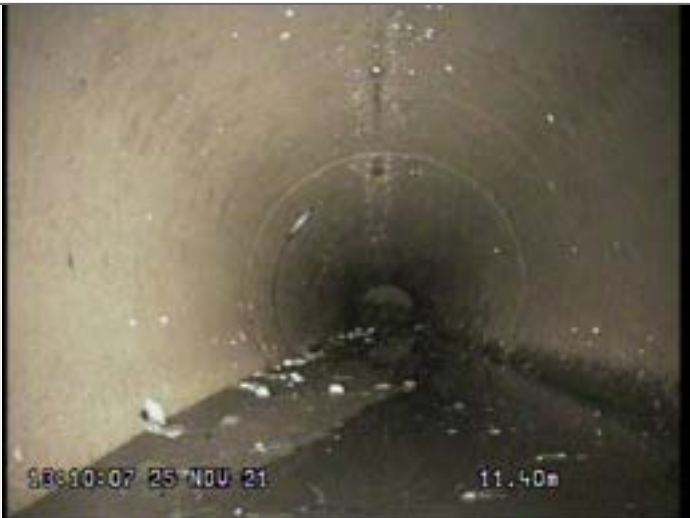
| Job Number<br>LAYERSERV0001064 | Surveyed by (Operator)<br>CHRIS LUCOCK | Base Unit<br>ELFEIYII63 | Date<br>25/11/2021 |
|---|---|---|---|
| Settled deposits fine 10% cross-sectional area loss, Start | | | |

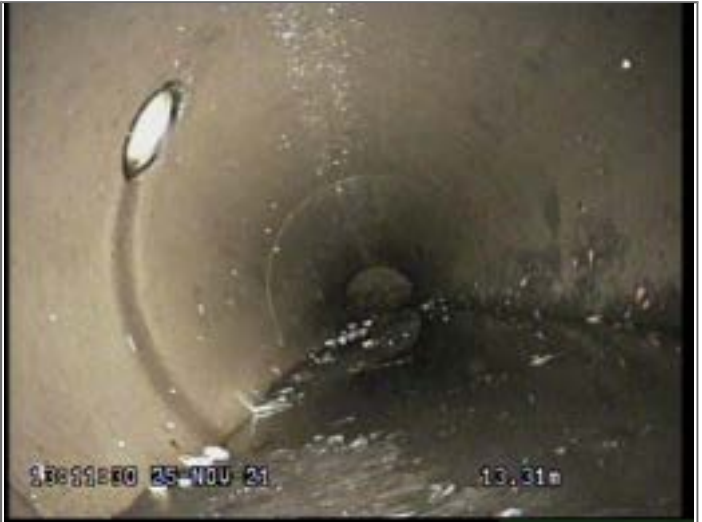
Survey abandoned - Remark: UNABLE TO PASS DUE TO HIGH SILT DEPOSITS - CLEANING REQUIRED

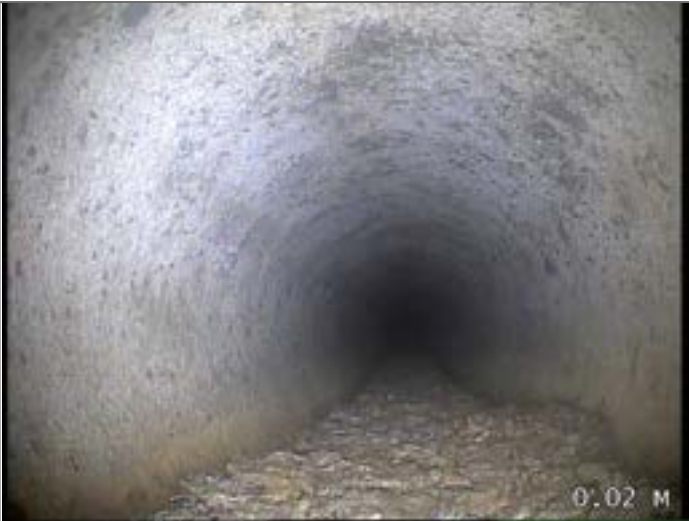
| Settled deposits fine 10% cross-sectional area loss | | | |

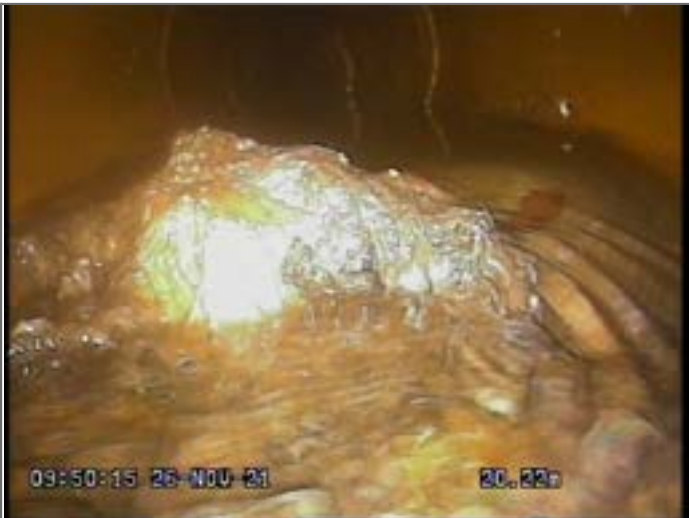
| Job Number<br>LAYERSERV0001064 | Surveyed by (Operator)<br>CHRIS LUCOCK | Base Unit<br>ELFEIYII63 | Date<br>26/11/2021 |
|---|---|---|---|
| | Junction at 9 o'clock, diameter 150mm | | Attached deposits, fouling from 4 to 8 o'clock 15% cross-sectional area loss |

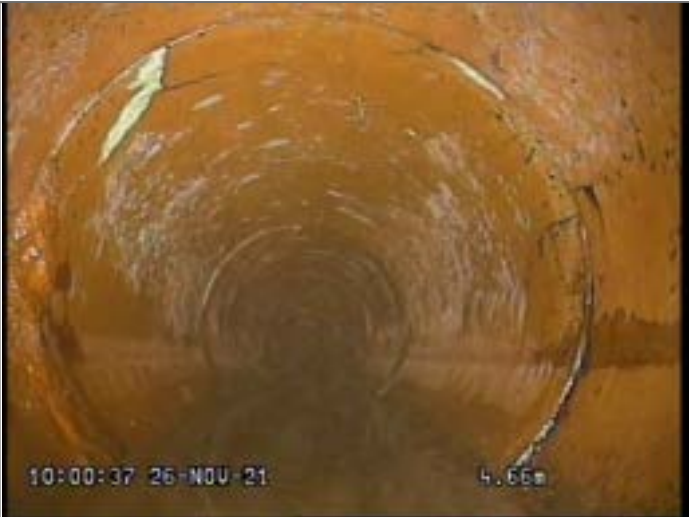
| Position | Code | Description | Photo | Type/Grade |
|---|---|---|---|---|
| 4.66 | DEE | Attached deposits, encrustation from 9 to 7 o'clock 5% cross-sectional area loss -<br>Remark: CONTINUOUS DEFECT DOWNSTREAM TO UU 1304 , Start | 5791831 | Service / 2 |

| Job Number<br>LAYERSERV0001064 | Surveyed by (Operator)<br>CHRIS LUCOCK | Base Unit<br>ELFEIYII63 | Date<br>26/11/2021 |
|---|---|---|---|
| Attached deposits, encrustation from 9 to 7 o'clock 5% cross-sectional area loss - Remark: CONTINUOUS DEFECT DOWNSTREAM TO UU 1304 , Start | | | |

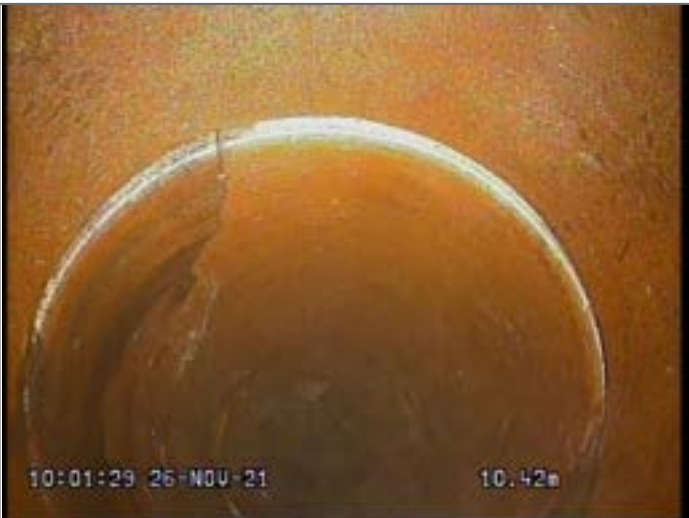
| Position | Code | Description | Photo | Type/Grade |
|---|---|---|---|---|
| 10.42 | CL | Crack longitudinal at 11 o'clock | 5791833 | Structural / 2 |

| Job Number<br>LAYERSERV0001064 | Surveyed by (Operator)<br>CHRIS LUCOCK | Base Unit<br>ELFEIYII63 | Date<br>26/11/2021 |
|---|---|---|---|
| Crack longitudinal at 11 o'clock | | | |

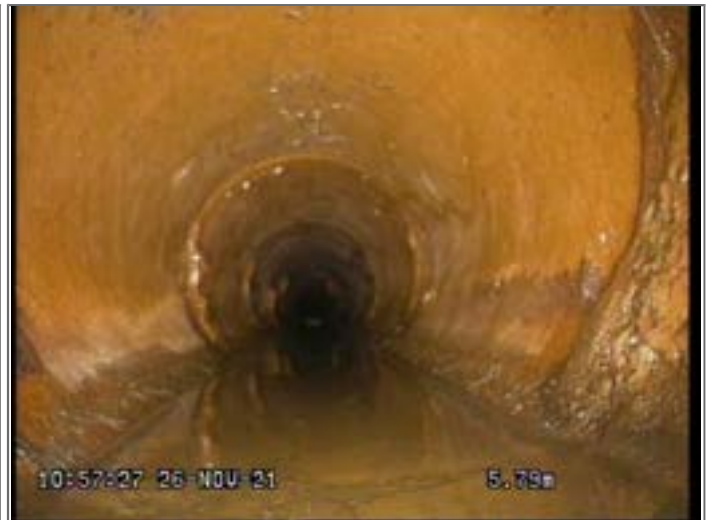
Attached deposits, encrustation from 12 to 12 o'clock 5% cross-sectional area loss, Start
