# **Asbestos Risk Management**

## **Asbestos Refurbishment and Demolition Survey Report**

**Victoria Park Probation Centre  
Laindon Road  
Manchester  
M14 5YJ**

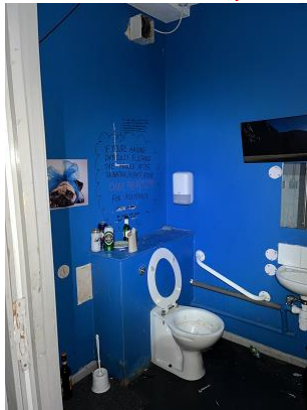
Presume over **vinyl tiles and bitumen adhesive**

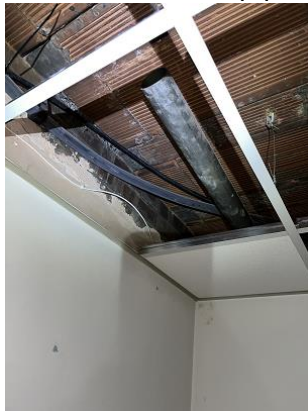
Clay block ceiling/roof deck above modern ceiling tiles

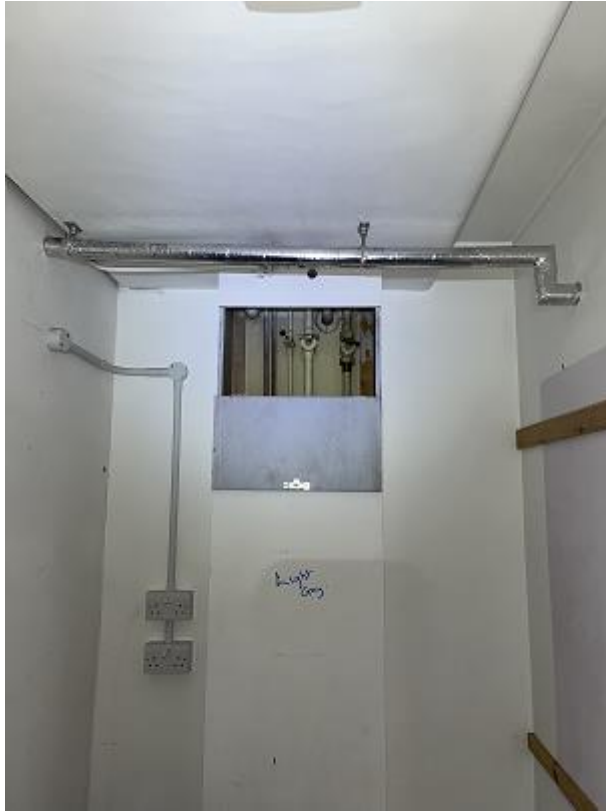
Concentric card pipe insulation within timber boxing (Sample LR01, Insulation, NADIS)

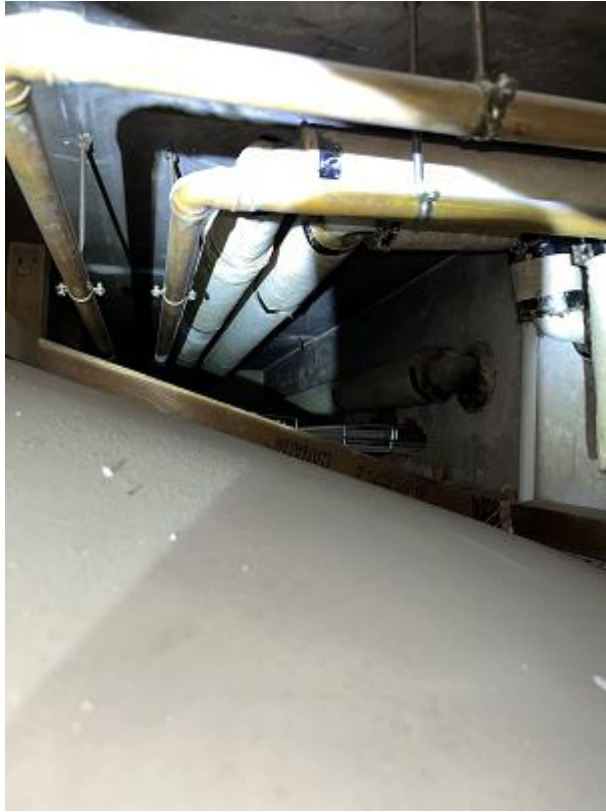
Non-asbestos pipe insulation

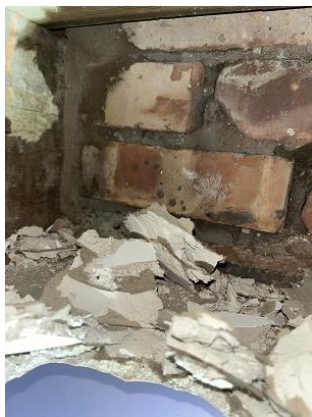
Sample LR03, plaster and plasterboard, NADIS

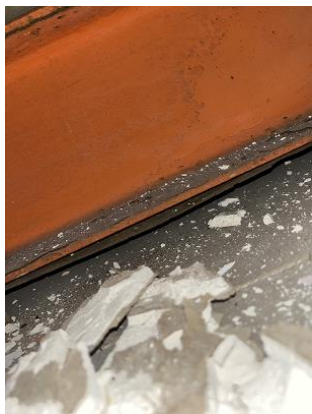
Unprotected RSJ

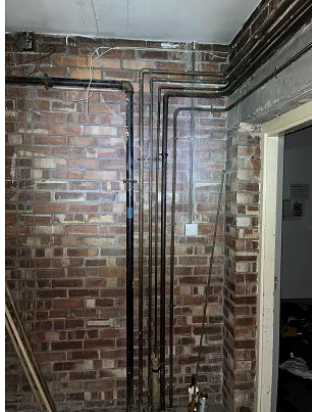
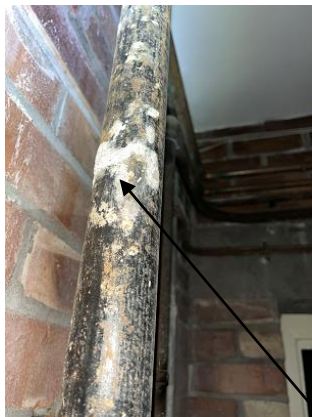
Some surface debris on pipework and wall by timber rack – Sample LR02, (multiple locations) NADIS

Sample LR02, NADIS

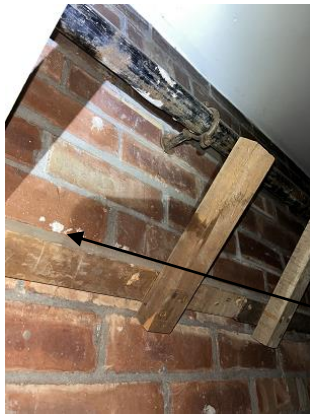
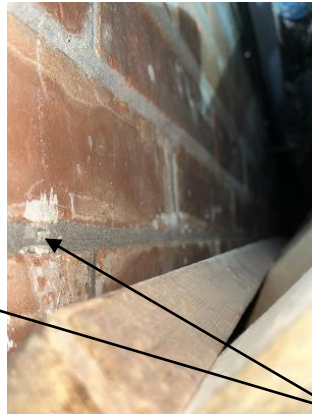
Sample LR02, NADIS

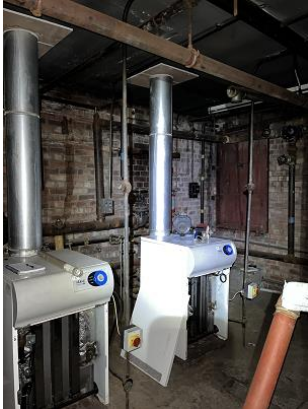
Ideal concord CXA boilers

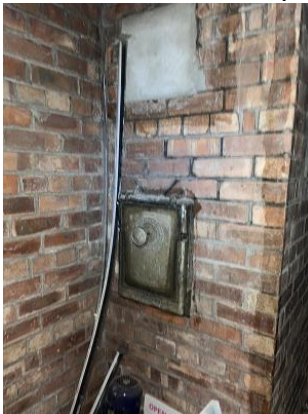
Unlined brick chimney, but presume remnant of AC flue in wall

Presume remnant of AC flue in wall

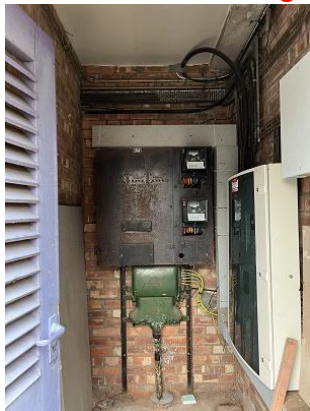
Presume ACMs to original electrical installation on rear wall

Presume ACMs to original electrical installation

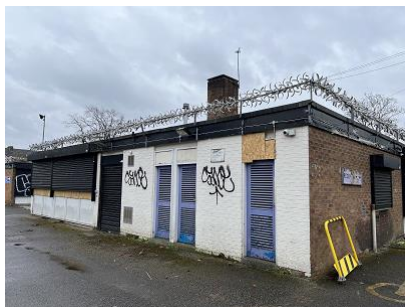
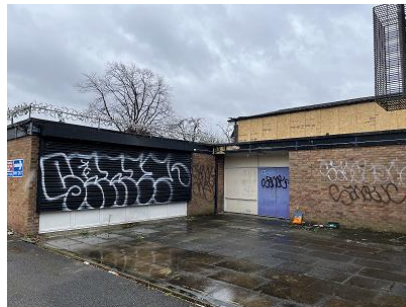
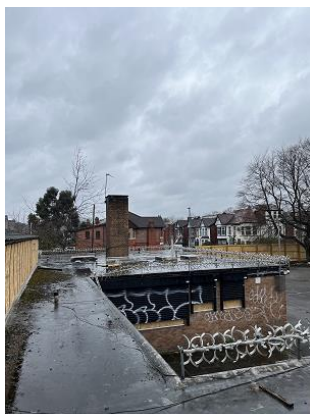
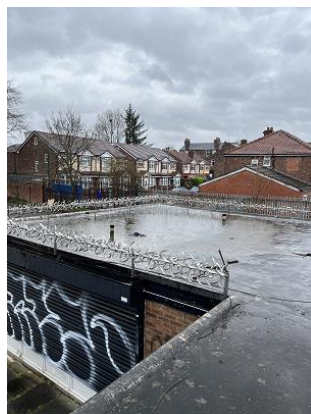
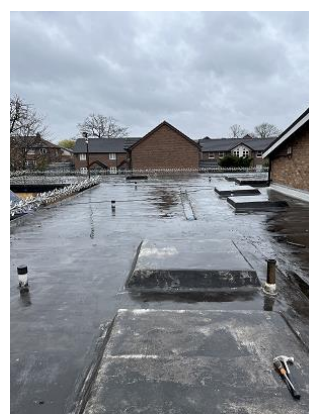
The roof appears to have been recently recoated. The skylights have been sealed and asphalted

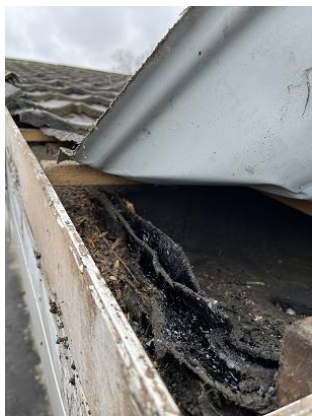
Sample LR07 and LR08, bitumen felt, NADIS)
