Thermal Imaging

**Project: Moss-side Millenium Powerhouse, Manchester**

**Build IR Ref No: 10156-1**

Build IR have been appointed to carry out a thermographic survey of the entire building, to investigate the thermal performance and identify areas of heat loss.

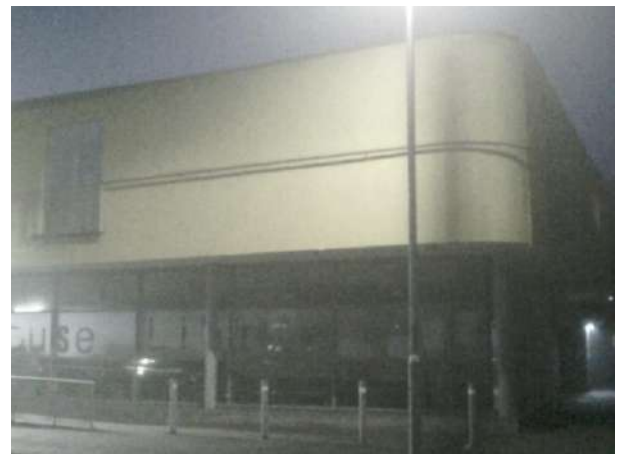
| Image number | 1 |

Insulated render to 1st floor showing good temperature consistency indicating good thermal performance.

Increased heat loss noted along edge of ground floor slab - potential thermal bridging.

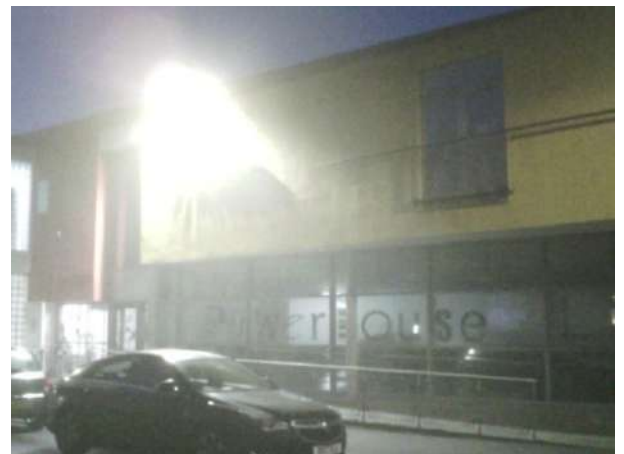
| File information | |
|---|---|
| Image number | 2 |

Thermal performance same as image 1.

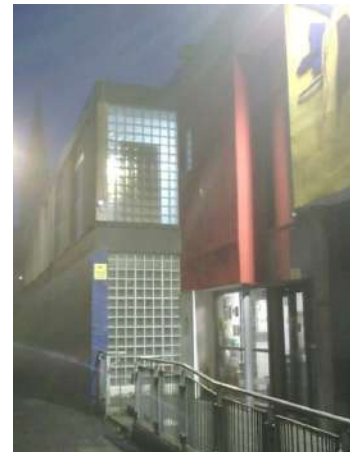
| File information | |
|---|---|
| Image number | 3 |

Glass blocks offering lower thermal performance than surrounding elements - generic throughout.

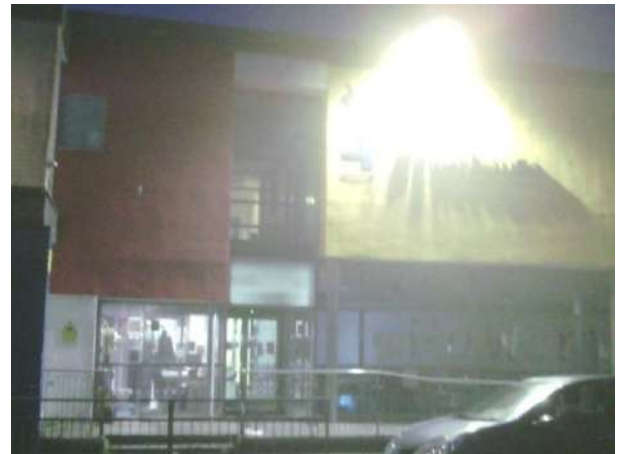
| Image number | 4 |

No further comment

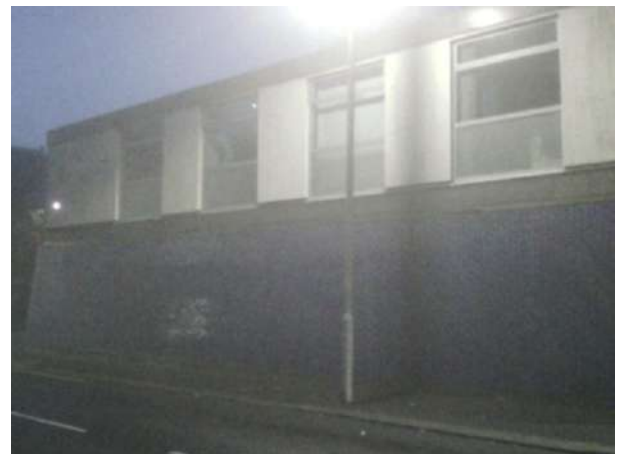
| File information | |
|---|---|
| Image number | 6 |

Continuation of image 5.

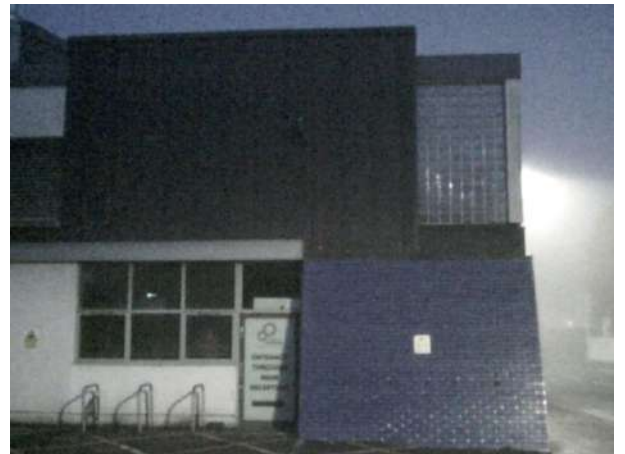
| File information | |
|---|---|
| Image number | 7 |

| Comments |
|---|
| Due to reflective nature of standing seam cladding - no useful analysis can generally be made to this element. This will be ignored in remained of report unless air leakage is noted. |

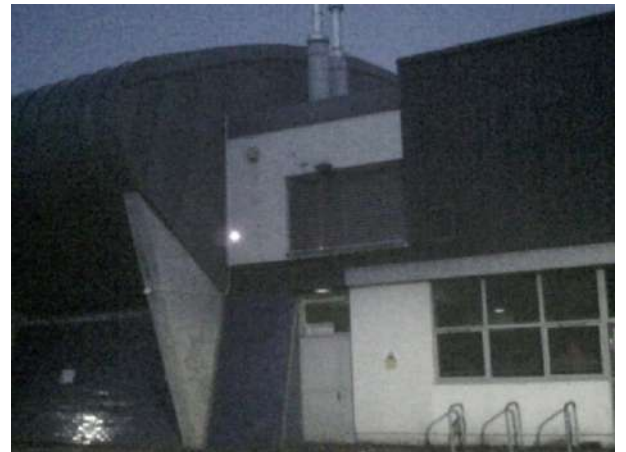
| File information | |
|---|---|
| Image number | 8 |

For arrow high level - see image 33.

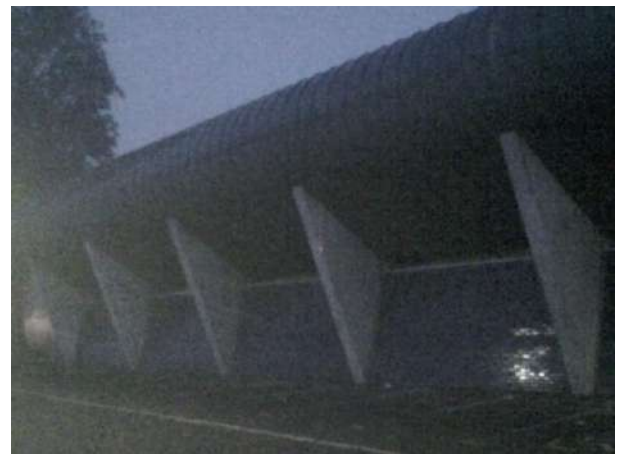
| Image number | 9 |

See image 10.

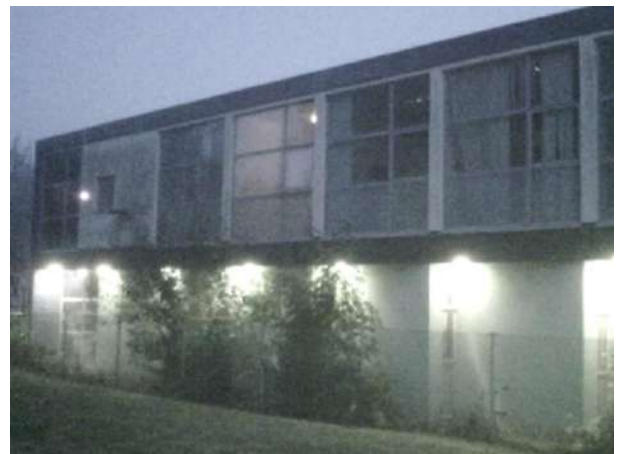
| File information | | Measurements |
|---|---|---|
| Image number | 16 | |

Continuation of increased heat loss under soffit.

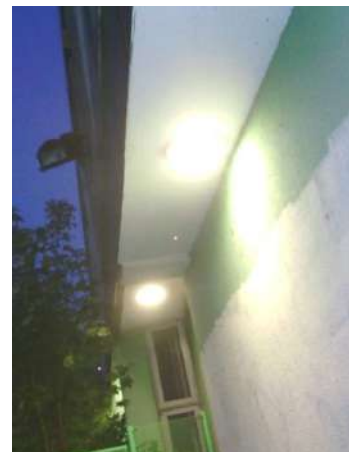
| File information | |
|---|---|
| Image number | 17 |

Close up of increased heat loss under soffit.

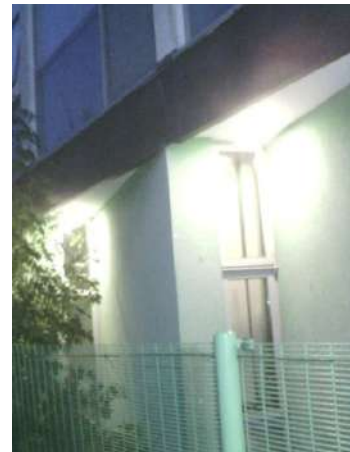
| File information | |
|---|---|
| Image number | 18 |

Close up highlights poorly performing glazing frames and increased heat loss under soffit.

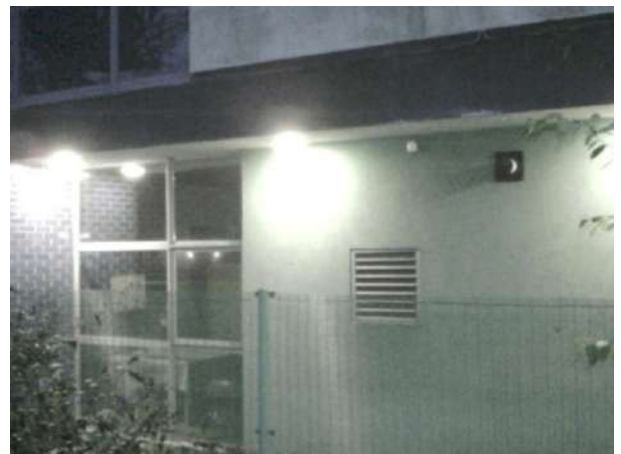
| Image number | 19 |

Area of facade is on to Plant room.  
Glazing frames performing poorly.

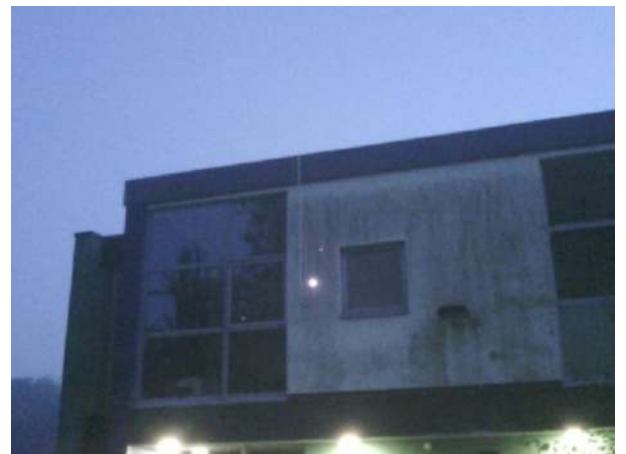
| File information | | Measurements |
|---|---|---|
| Image number | 20 | |

Glazing frames performing poorly.

Arrow indicates air leakage to corner parapet capping.

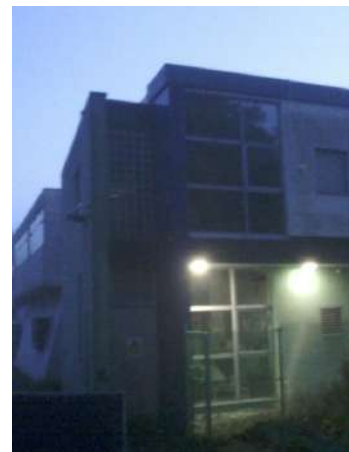
| File information | |
|---|---|
| Image number | 21 |

Glazing frames and glass blocks performing poorly.

White arrow indicates air leakage to corner parapet capping.

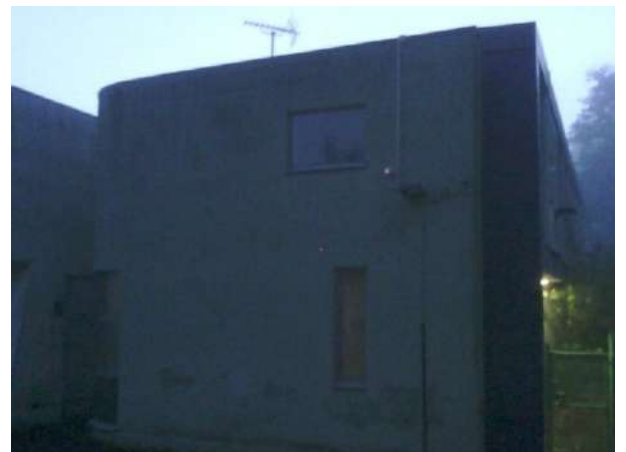
| File information | | Measurements |
|---|---|---|
| Image number | 22 | |

White arrows indicate thermal bridging down brickwork from junction with glass blocks and potential blocked up doorway.

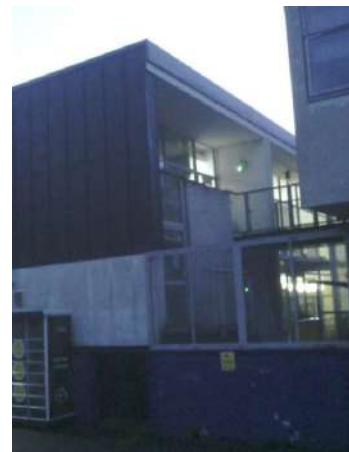
| File information | |
|---|---|
| Image number | 23 |

No comment to standing seam cladding.

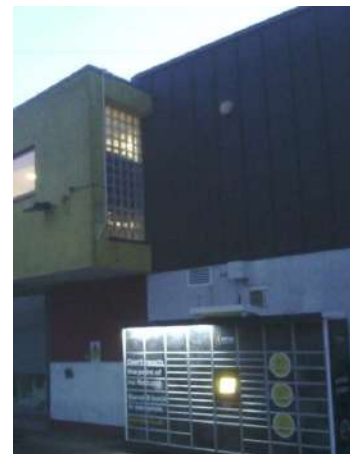
| File information | | Measurements |
|---|---|---|
| Image number | 25 | |

Glass blocks performing poorly.

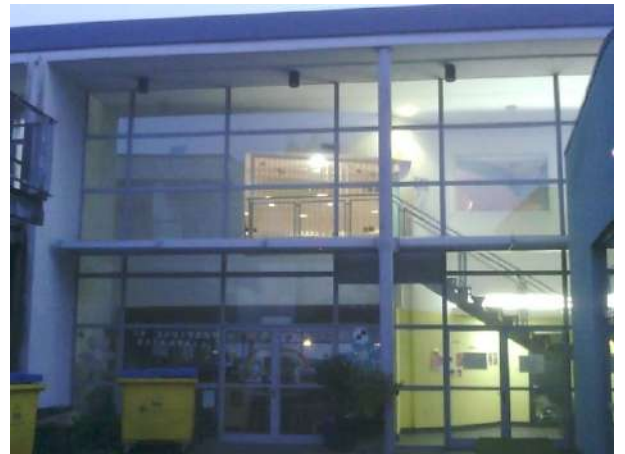
| File information | | Measurements |
|---|---|---|
| Image number | 26 | |

Glazing and frames performing poorly.

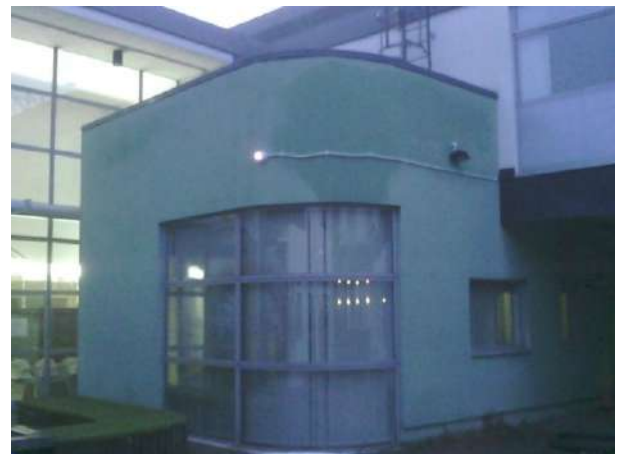
| File information | |
|---|---|
| Image number | 27 |

Insulated render performing well thermally.

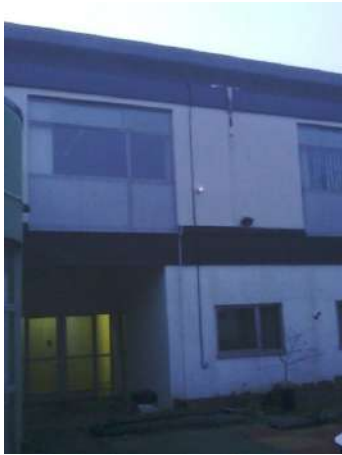
| File information | |
|---|---|
| Image number | 28 |

| Comments |
|---|
| Insulated render performing well thermally. |
| Arrow shows air leakage along parapet capping. |

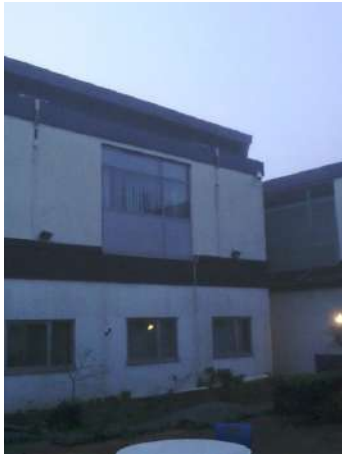
| File information | |
|---|---|
| Image number | 29 |

| Comments |
|---|
| Insulated render performing well thermally. |
| Arrow shows air leakage along parapet capping. |

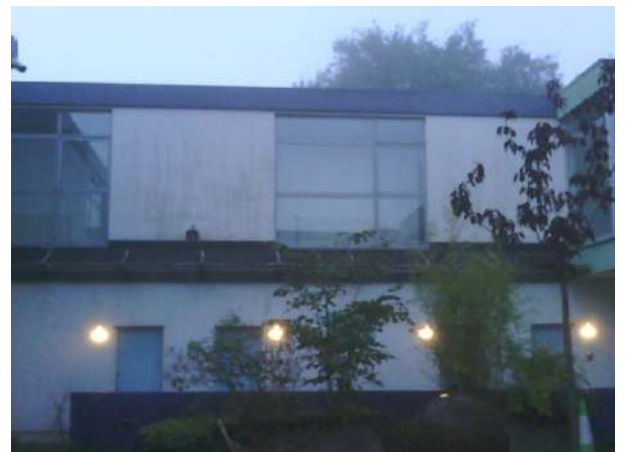
| File information | | Measurements |
|---|---|---|
| Image number | 30 | |

Insulated render performing well thermally.

Arrow shows air leakage along parapet capping.

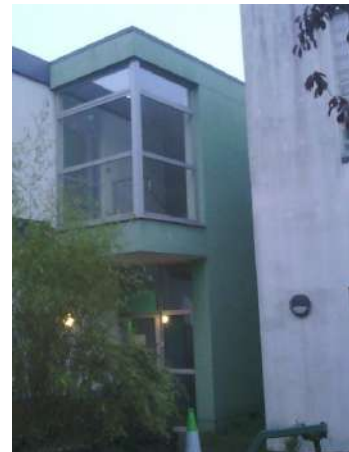
| File information | | Measurements |
|---|---|---|
| Image number | 31 | |

Glazing frames performing poorly.

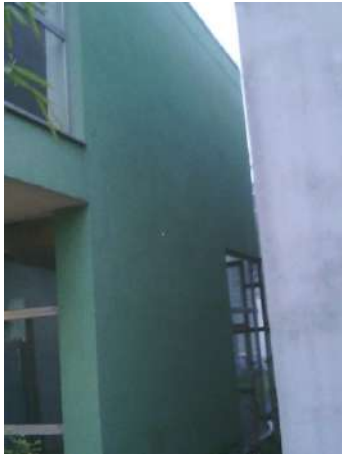
| File information | |
|---|---|
| Image number | 32 |

| Comments |
|---|
| Entire area shows warmer - likely due to shelter from Zone 4 Study building. |

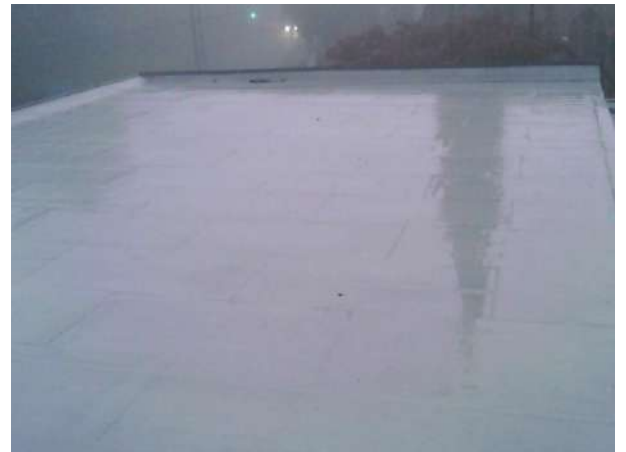
| File information | | Measurements |
|---|---|---|
| Image number | 34 | |

Good temperature consistency indicates good continuity of the insulation.

NOTE: Roof membrane damp, with standing water to some areas.

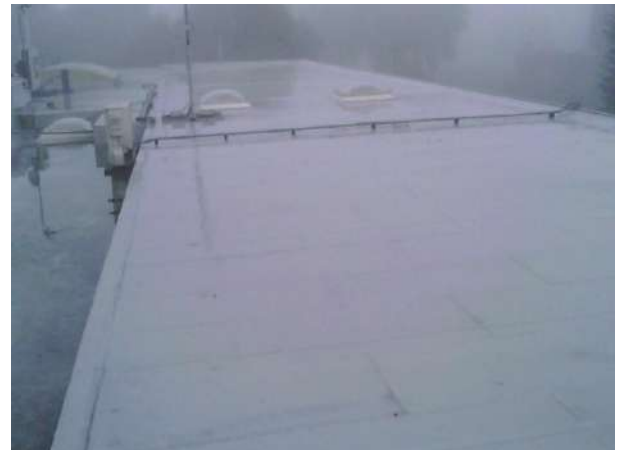
| File information | |
|---|---|
| Image number | 35 |

Good temperature consistency indicates good continuity of the insulation.

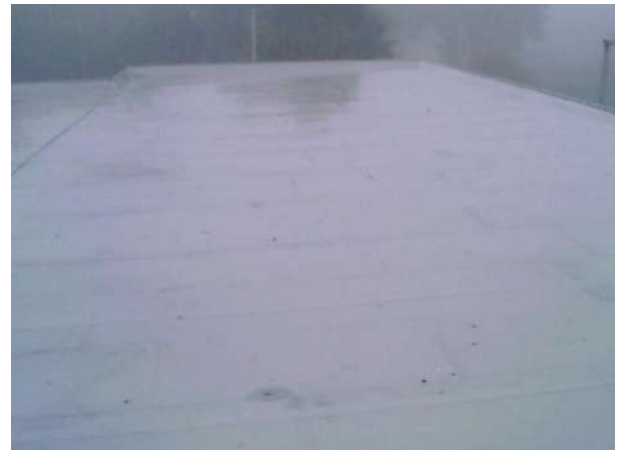
| File information | |
|---|---|
| Image number | 36 |

Good temperature consistency indicates good continuity of the insulation.

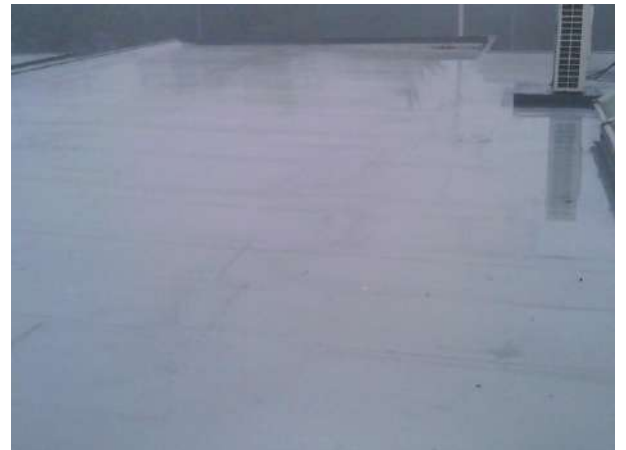
| File information | |
|---|---|
| Image number | 37 |

Good temperature consistency indicates good continuity of the insulation.

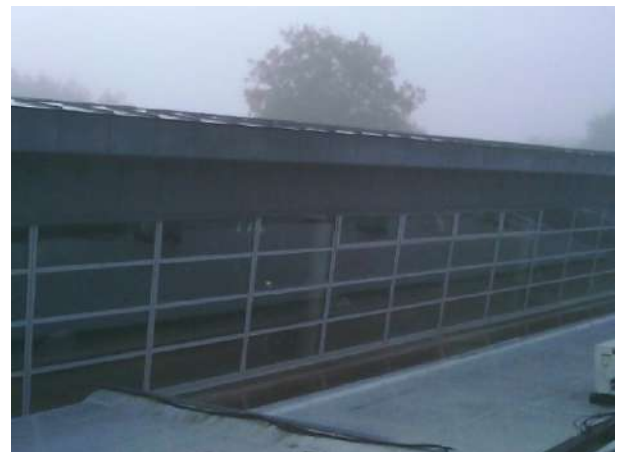
| File information | | Measurements |
|---|---|---|
| Image number | 39 | |

Glazing frames performing poorly.

Some air leakage noted to cladding at head of glazing junction.

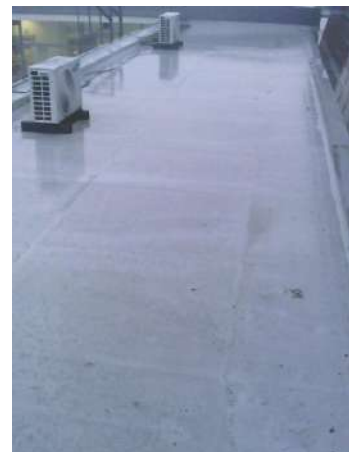
| File information | |
|---|---|
| Image number | 40 |

Good temperature consistency indicates good continuity of the insulation.

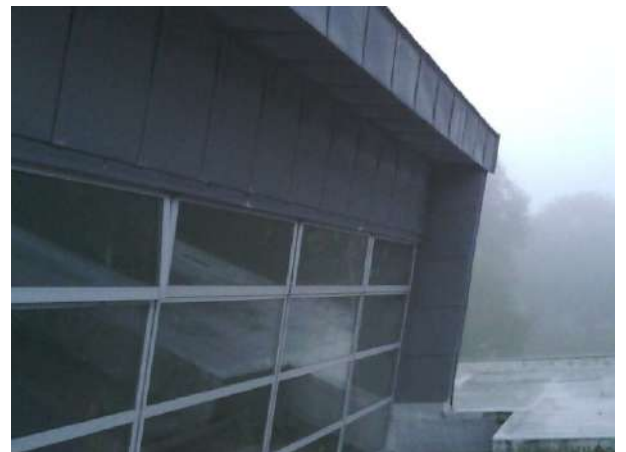
| File information | |
|---|---|
| Image number | 41 |

Glazing frames performing poorly.

Arrows indicate area of air leakage to cladding.

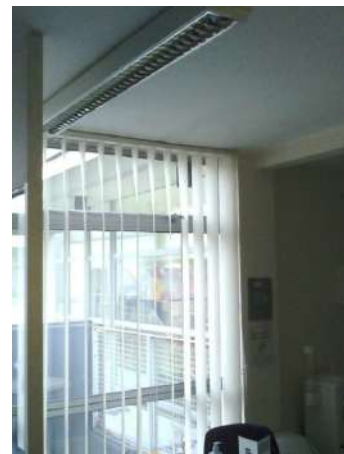
| Image number | 42 |

Glazing frames performing poorly.

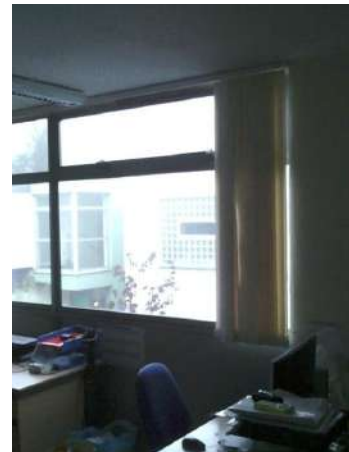
| File information | | Measurements |
|---|---|---|
| Image number | 43 | |

Glazing frames and spandrel panels performing poorly.

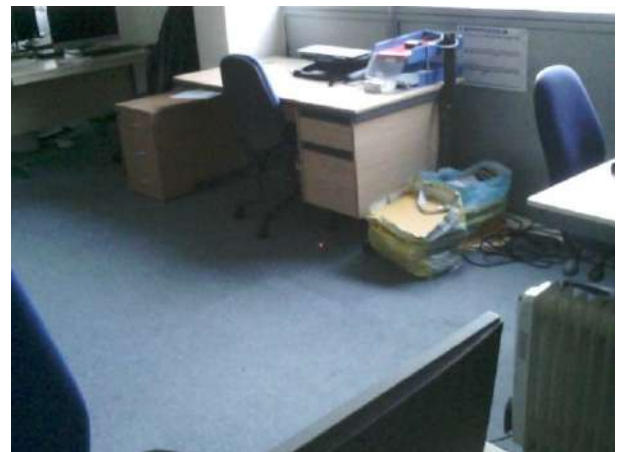
| File information | | Measurements | |
|---|---|---|---|
| Image number | 44 | | |

Cold radiating from poorly performing glazed area cooling floor.

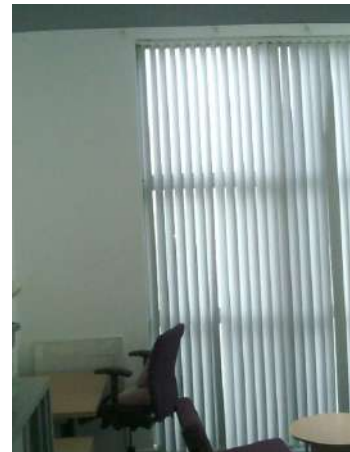
| File information | |
|---|---|
| Image number | 46 |

Wall performing well, glazing showing colder - generic along this elevation.

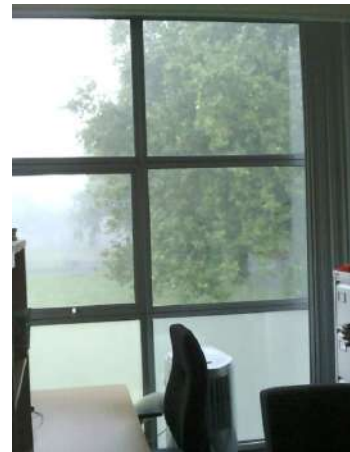
| File information | |
|---|---|
| Image number | 47 |

Glazing frames performing poorly.

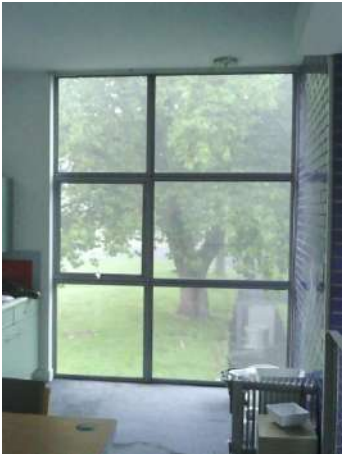
| File information | |
|---|---|
| Image number | 51 |

| Comments |
|---|
| Glazing frames performing poorly. |

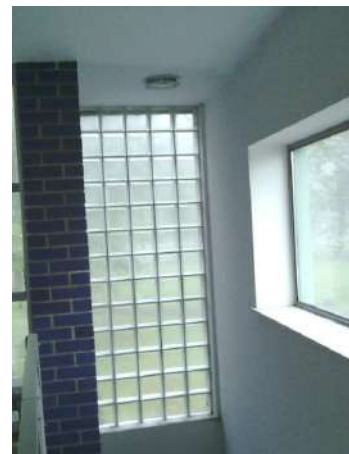
| File information | |
|---|---|
| Image number | 52 |

Glass blocks and glazing performing poorly.

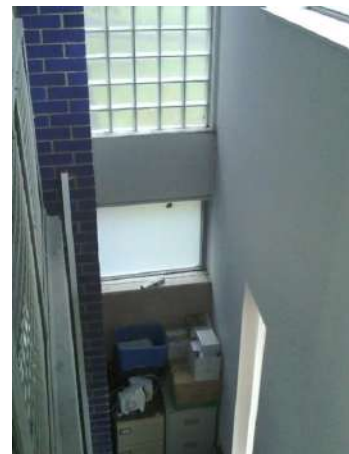
| File information | | Measurements |
|---|---|---|
| Image number | 53 | |

Zone 5 (area of previous rear door) – blocked up entrance appeared to potentially be single skin blockwork with no insulation and air infiltration behind the dry lining (thermal bypass). Window above this was single glazed so performing poorly.

Arrow indicates poorly performing inle glazed window.

Area above and below showing poor thermal performance - potentially due to cold air ingress behind plasterboard. (low level - internal of image 21 - potentially single skin blockwork with no insulation).

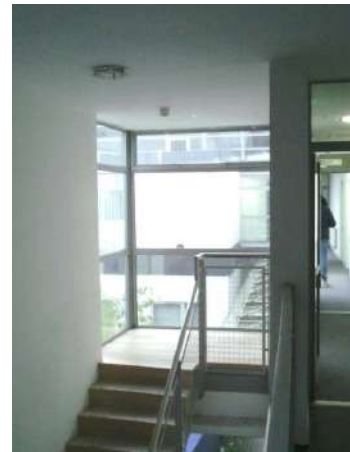
| File information | |
|---|---|
| Image number | 54 |

Glazing frames performing poorly. Cold areas highlighted high and low level are reflections from glazing.

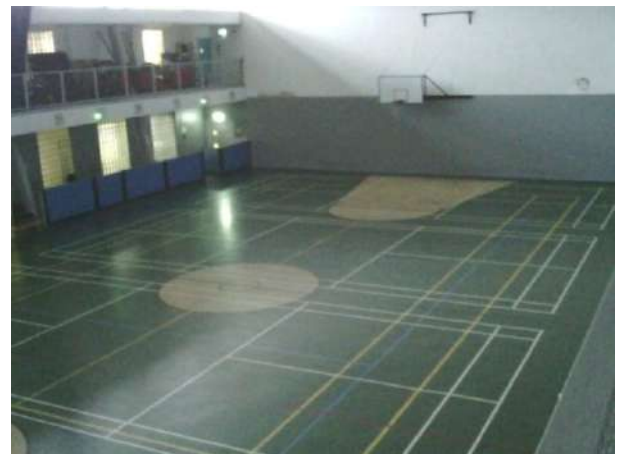
| File information | |
|---|---|
| Image number | 57 |

At time of survey - only 1 underfloor heating loop working.

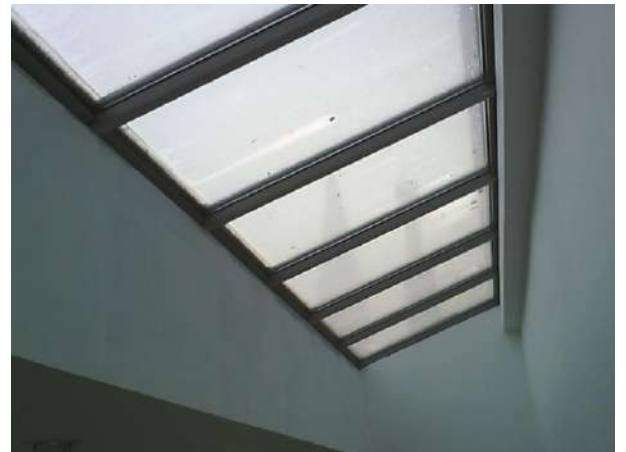
| File information | |
|---|---|
| Image number | 59 |

Cold areas to roof light upstands are due to lack of insulation OR cold air moving behind dry lining inside of insulation.

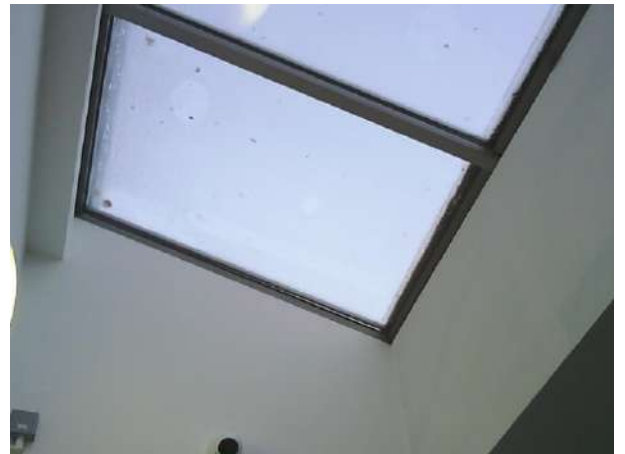
| Image number | 60 |

For comment see image 59.

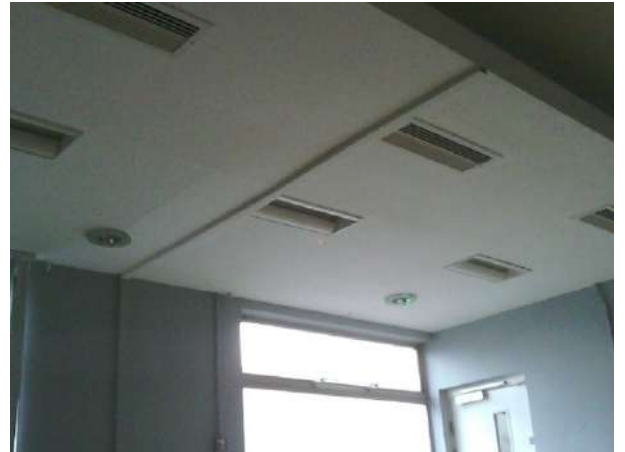
| File information | |
|---|---|
| Image number | 61 |

Glazing performing poorly and allowing cold air ingress above plasterboard ceiling.

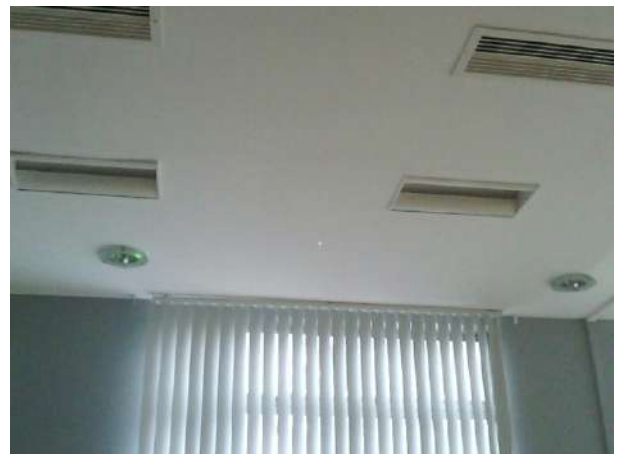
| Image number | 62 |

Continuation of image 61.

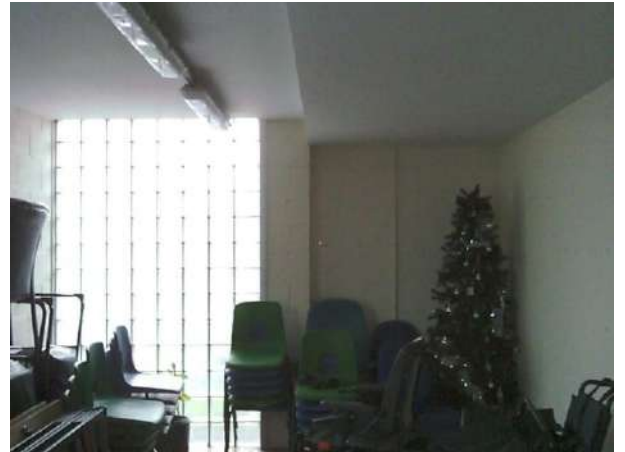
| File information | |
|---|---|
| Image number | 63 |

Glass blocks performing poorly.

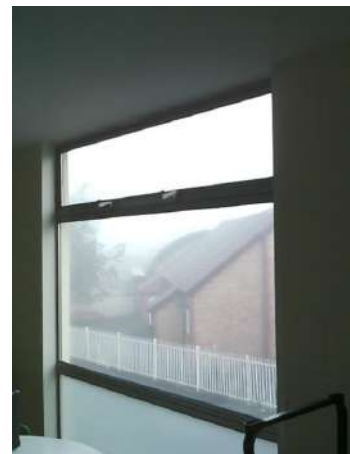
| Image number | 64 |

Glazing performing poorly and allowing above ceiling.

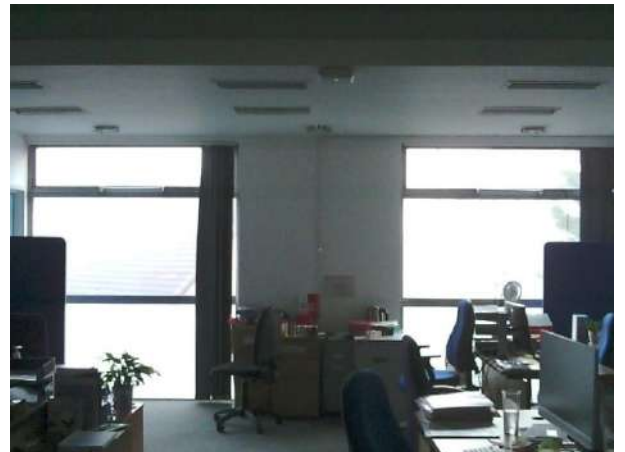
| File information | |
|---|---|
| Image number | 65 |

Glazing frames performing poorly.

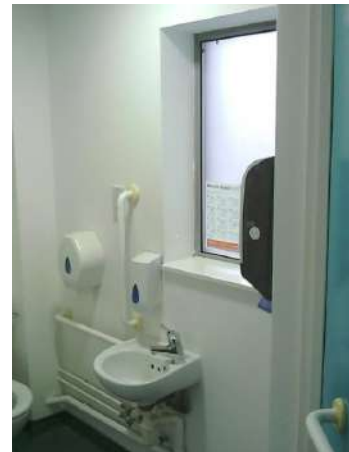
| File information | | Measurements | |
|---|---|---|---|
| Image number | 67 | | |

Glazing frames performing poorly.

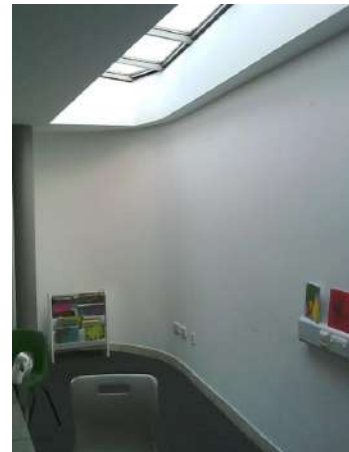
| File information | |
|---|---|
| Image number | 69 |

| Comments |
|---|
| Soffit showing colder and cold noted tracking behind plasterboard form floor area and next to glazing. |

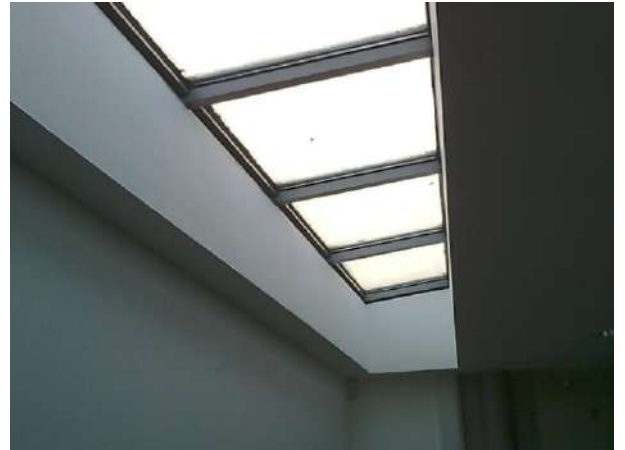
| File information | |
|---|---|
| Image number | 70 |

Cold areas to roof light upstands are due to lack of insulation OR cold air moving behind dry lining inside of insulation.

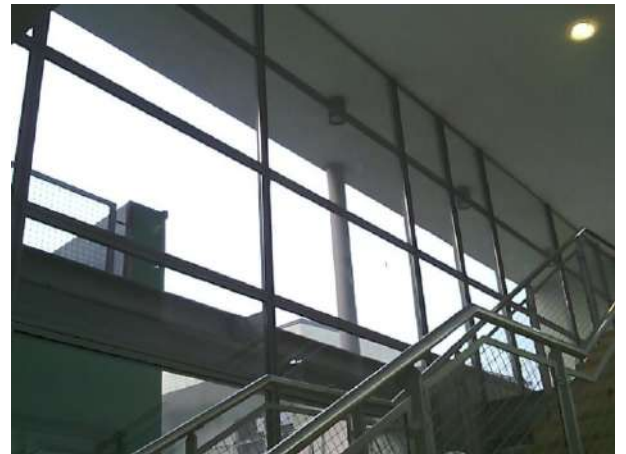
| Image number | 76 |

Poor performance of glazing frames.

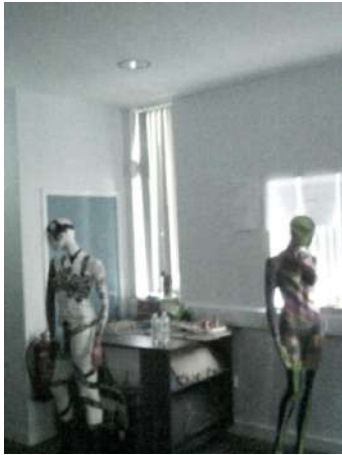
| File information | |
|---|---|
| Image number | 79 |

| Comments |
|---|
| Cold air through open window. |

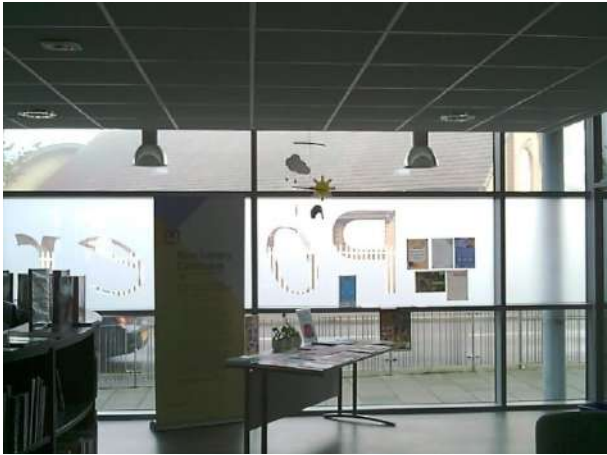
| Image number | 84 |

Increased heat loss to glazing.

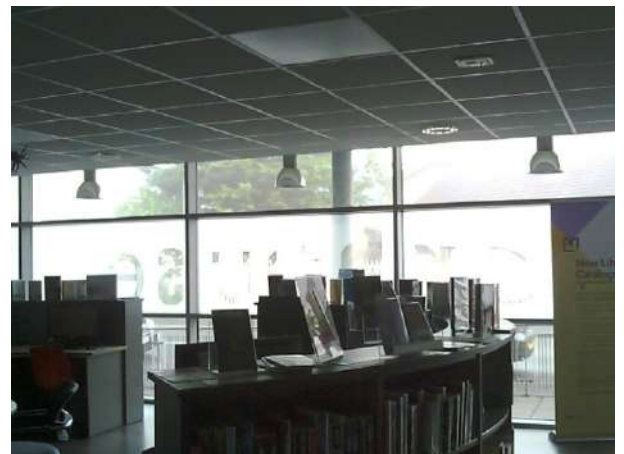
| File information | |
|---|---|
| Image number | 85 |

| Comments | |
|---|--|
| Increased heat loss to glazing. | |

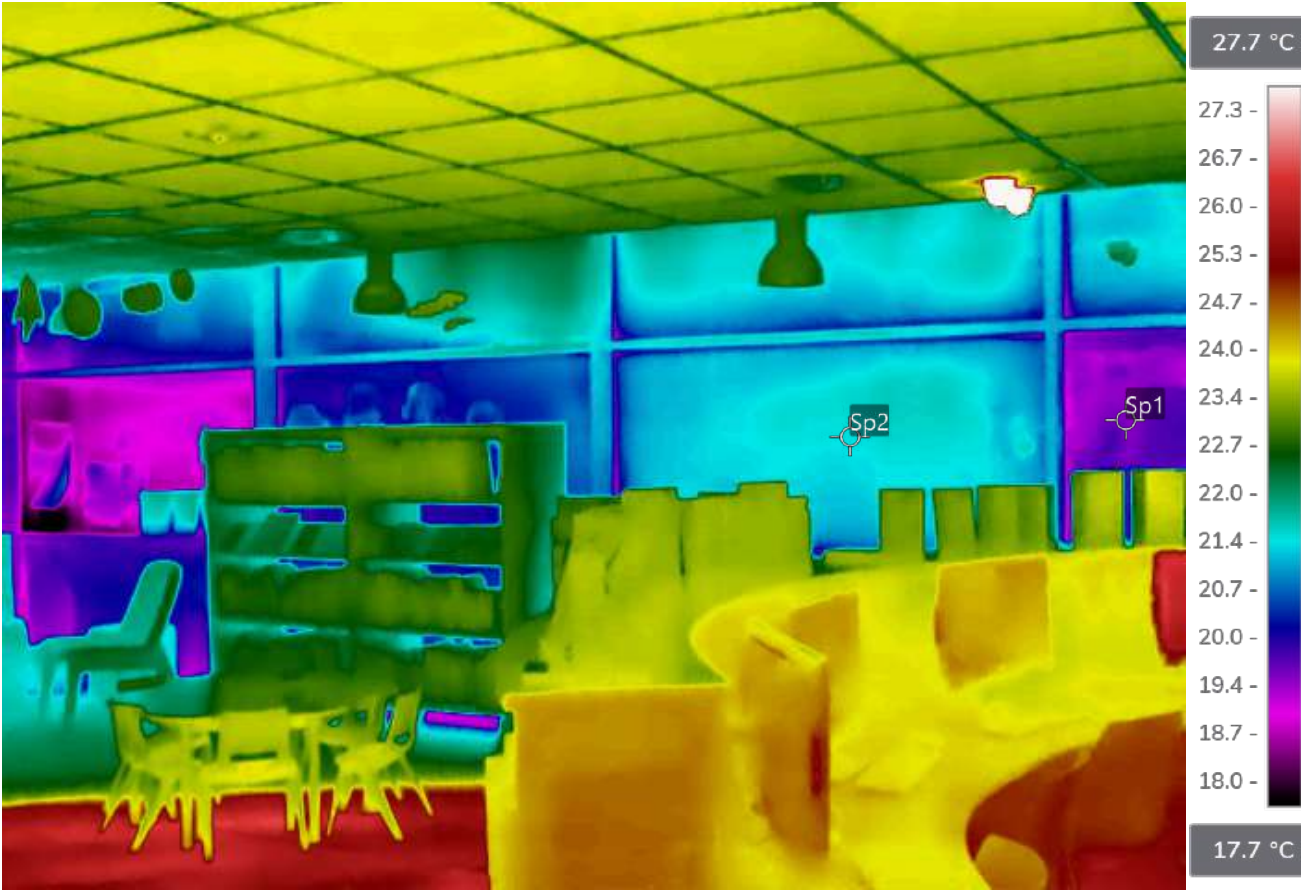
SP1 + 2 included to highlight difference in glazing performance as noted externally.

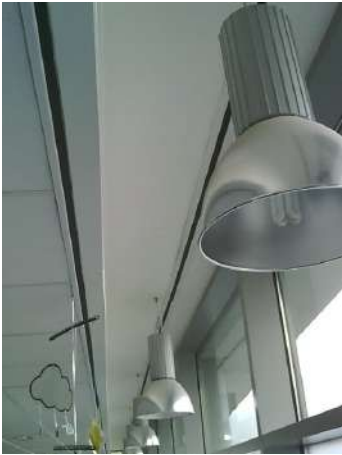
| File information | |
|---|---|
| Image number | 89 |

| Comments |
|---|
| Possible continuation of cold air above ceiling. |

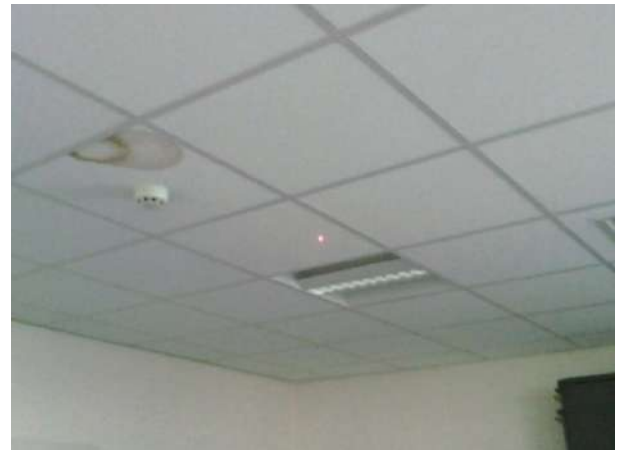
| File information | |
|---|---|
| Image number | 92 |

Colder ceiling grid indicates continuation of cold air above ceiling. Linked to image 93.

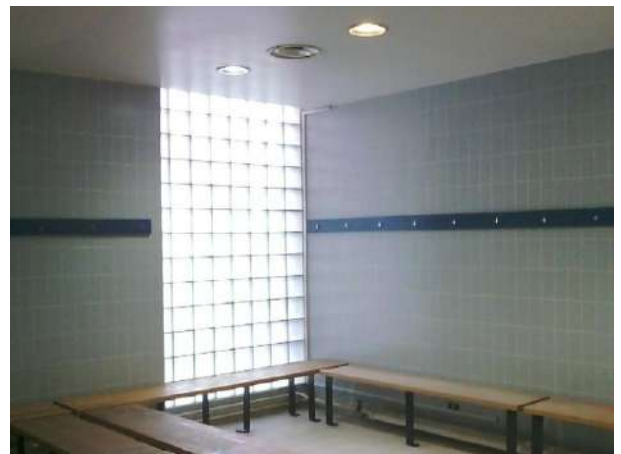
| Image number | 99 |

Poor thermal performance of glass blocks.

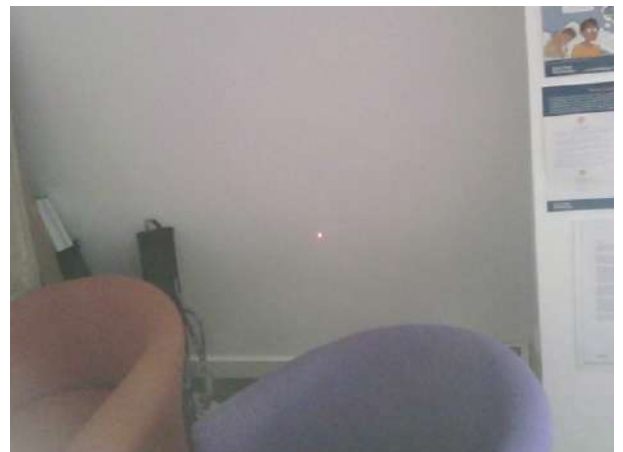
| File information | |
|---|---|
| Image number | 103 |

Cold sat low level behind dry lining - potential air flow.

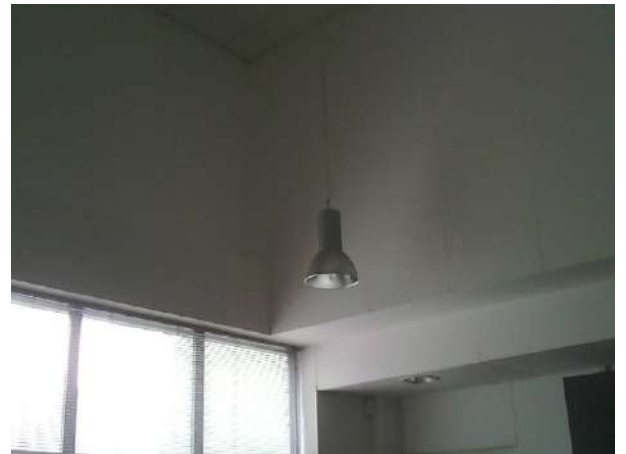
| Image number | 104 |

Possible open louvre allowing cold air behind dry lining and tracking down bulkhead.

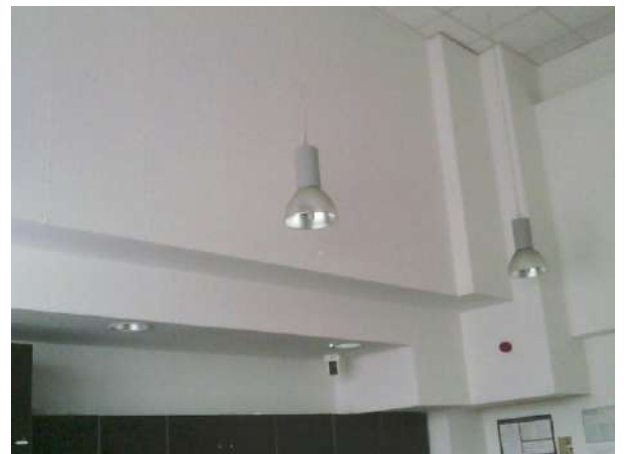
| File information | |
|---|---|
| Image number | 105 |

Continuation of cold air to bulkhead.

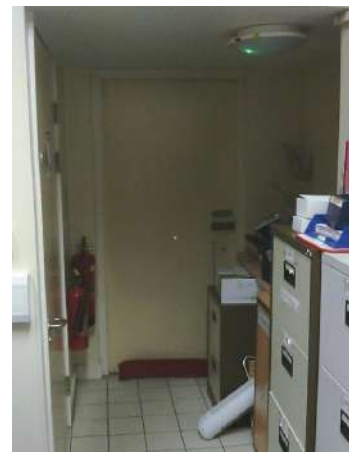
| File information | |
|---|---|
| Image number | 108 |

External door offering poor thermal performance and allowing cold air ingress.

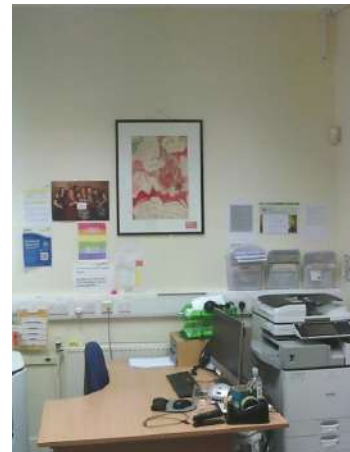
| File information | |
|---|---|
| Image number | 109 |

No further comment to elevation. Cold to left side and low level is due to open window.

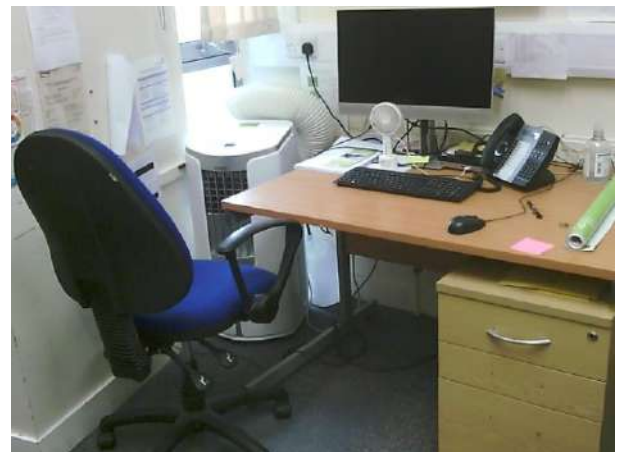
| File information | | Measurements |
|---|---|---|
| Image number | 111 | |

Area colder due to air ingress from window.

Highlighted area, potential moisture from dehumidifier.

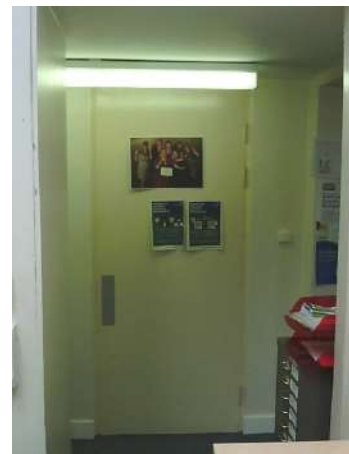
| File information | |
|---|---|
| Image number | 112 |

Generic thermal performance of blocked off external doors along this elevation.

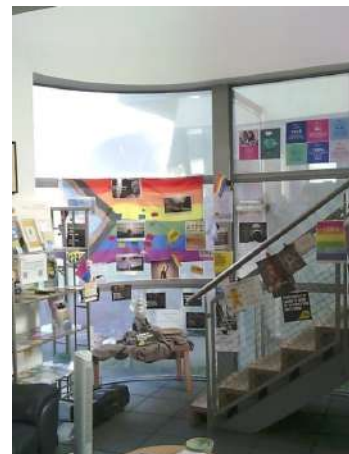
| File information | |
|---|---|
| Image number | 116 |

Poor thermal performance of glazing and frames.

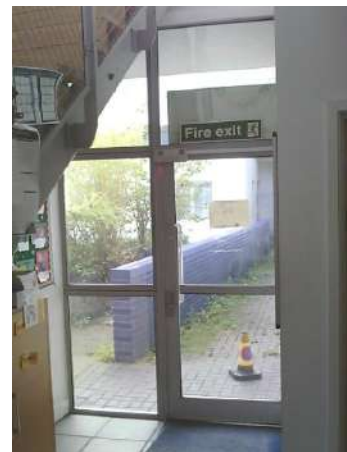
| File information | |
|---|---|
| Image number | 117 |

Poor thermal performance of glazing and frames.
