# Contaminated Land Phase One Desk Study & II Intrusive Investigation for proposed residential development at Land Off Chapel Street, Manchester, M19 3QB.

Burke Developments Ltd,  
Norwood,  
Greenacres,  
Oldham,  
OL4 3EX

May 2023

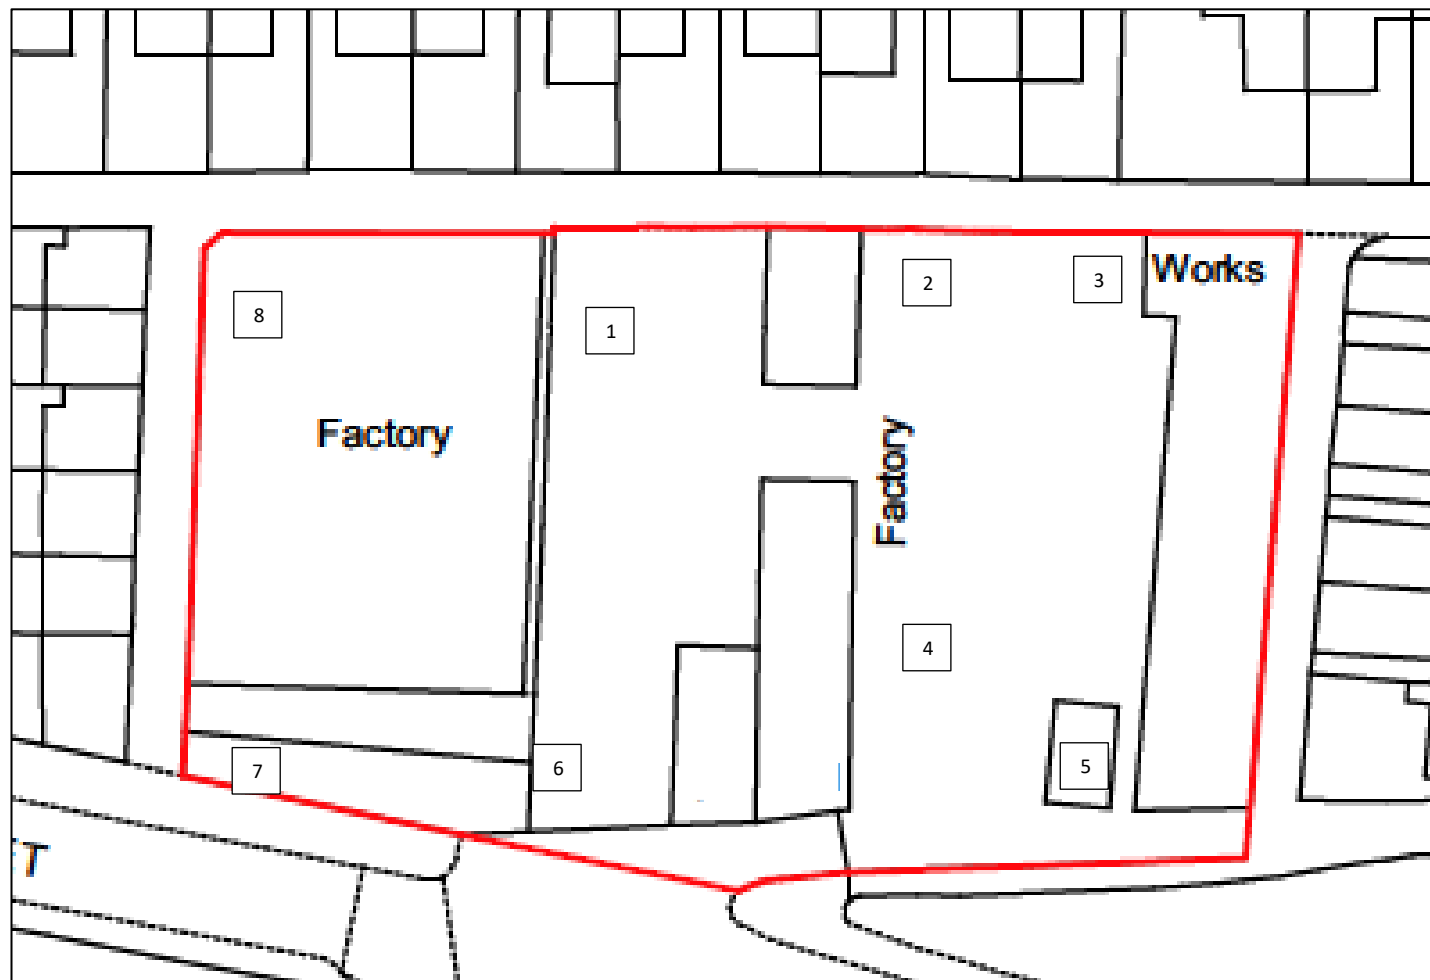
**Figure 2 – Intrusive Investigation Trail Pits Locations**

A total of eight trial pits were dug on site, the locations of these are shown on the plan in Figure 2. Two samples were taken from trail pits 1-5 & 7 and one from trail pit 6 & 8. The shallow sample from approx. 300mm bgl and the deeper one at 600mm bgl.

identified in Trail pits 1b, 3a, 5a and 6a, with further validation of the removal undertaken. This will also remove the heavy metal and asbestos contamination in these areas. Trail pit 8a also contained heavy metal contamination and this should also be removed. A clean cover system of 600mm in all garden amenity areas and 450mm in landscaped areas is then recommended.

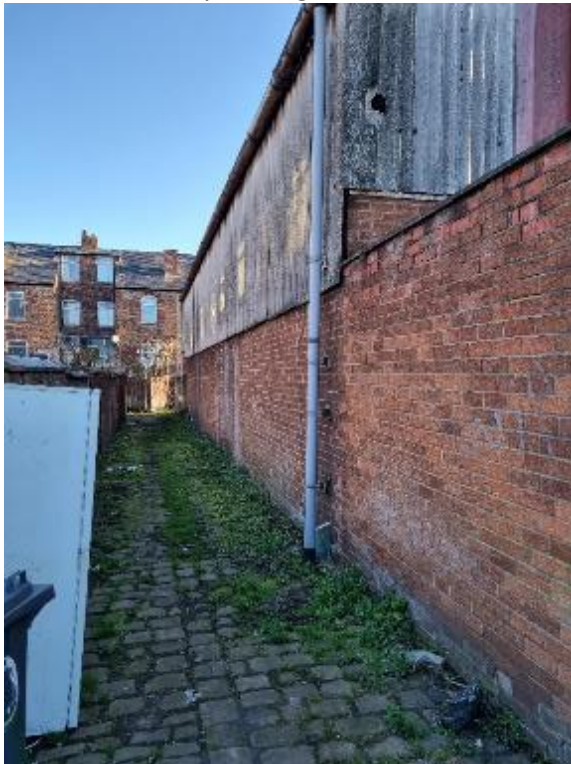
Southern boundary of the site
