# Essential Repairs including Replacement Wagon Arch Glazing

## 1830 Warehouse

Science & Industry Museum

Design and Access Statement

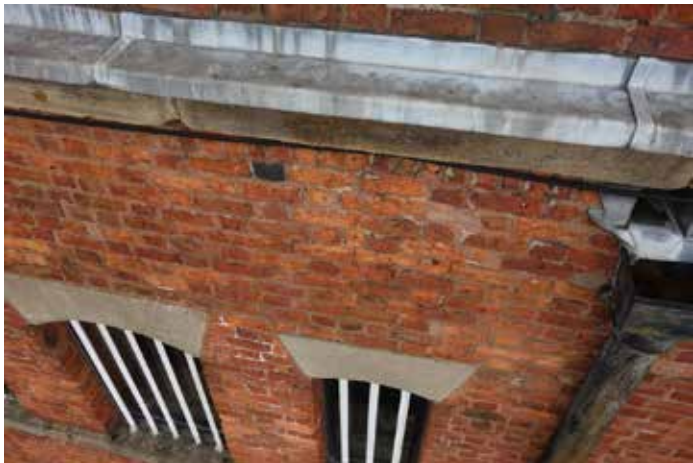
Spalled bricks. Cut out and replace bricks where erosion exceeds 15mm depth. Repoint using lime mortar.

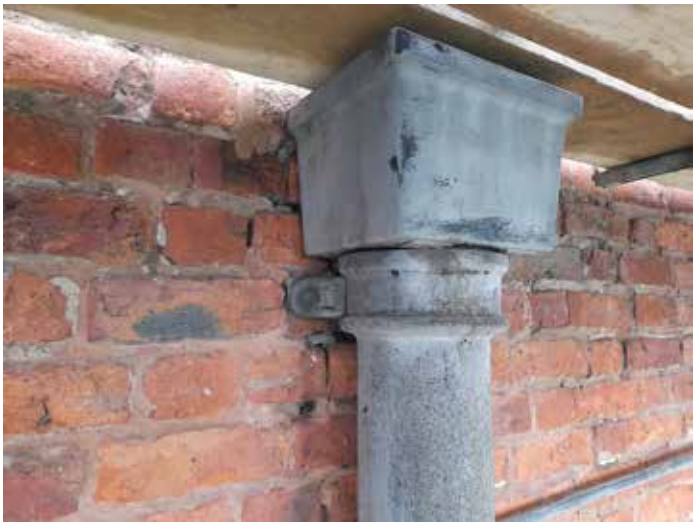
Hopperheads to be included within decoration scheme

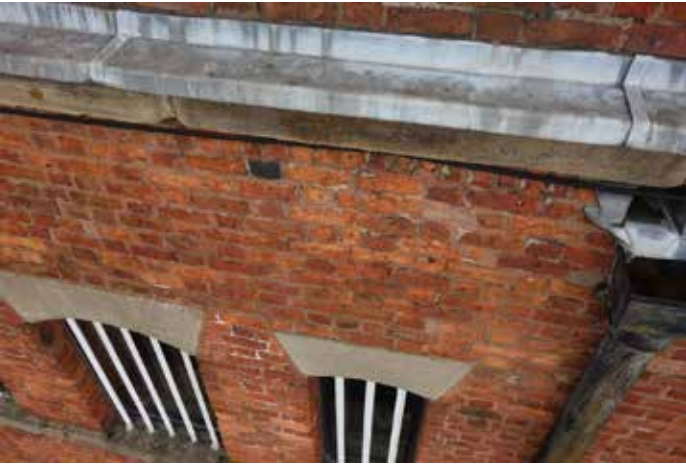
S1002: Spalled bricks. Cut out and replace bricks where erosion exceeds 15mm depth. Repoint using lime mortar.

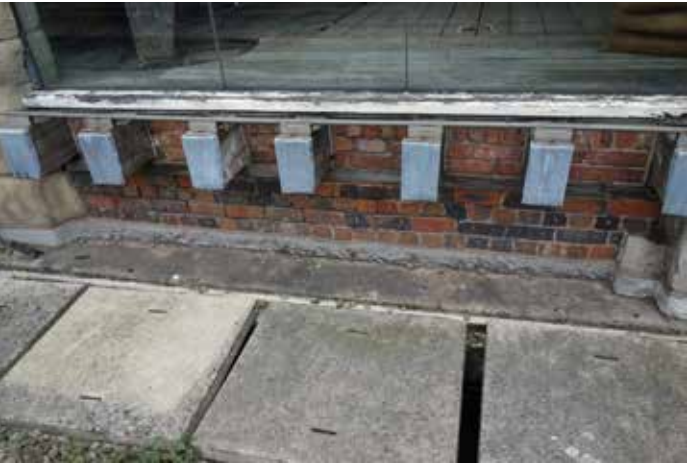
S1005: 7no. Decayed timber joists below glazed opening. Replace with new timber to match.

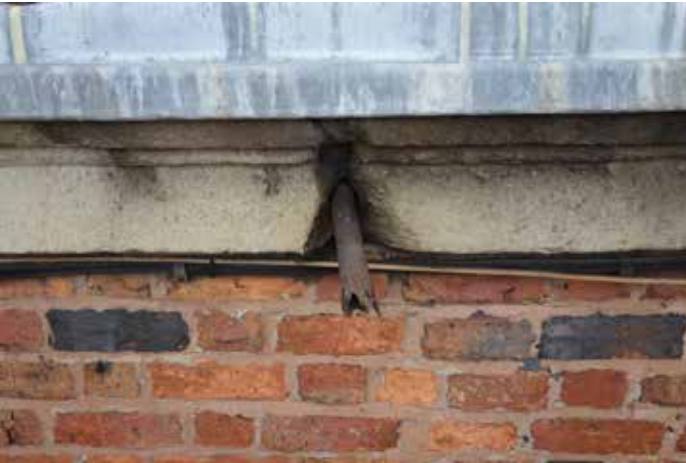
S1006: Corroding metal pipe & material loss to cornice. Remove pipe and undertake indent repair to cornice.

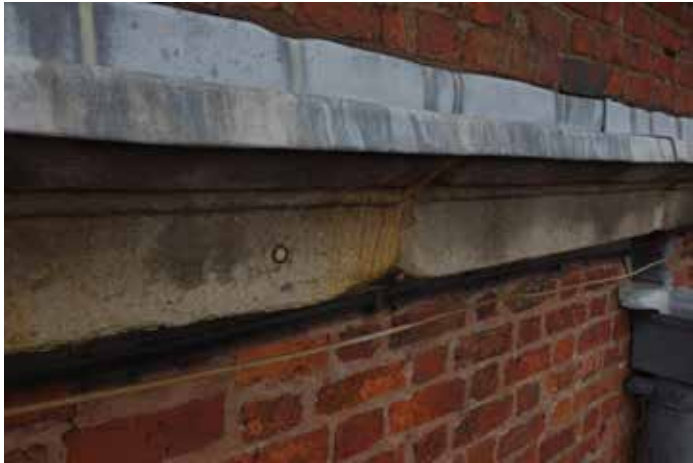
S1007: Bolt shell. Remove bolt shell.

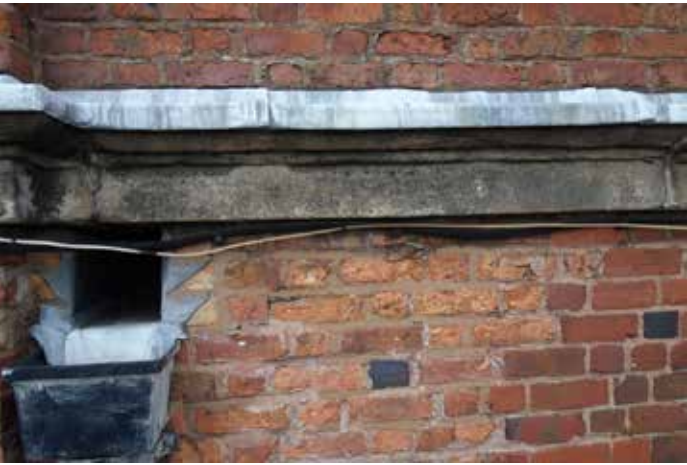
S1009: Spalled bricks. Cut out and replace bricks where erosion exceeds 15mm depth. Repoint using lime mortar.

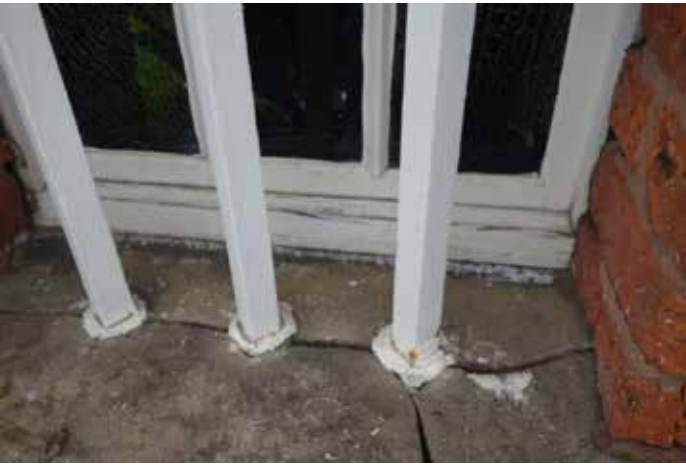
S1010: Corrosion of iron bar ends and cracks to cill. Cut out around bar embeddings and treat iron. Repoint cracks using lime mortar.

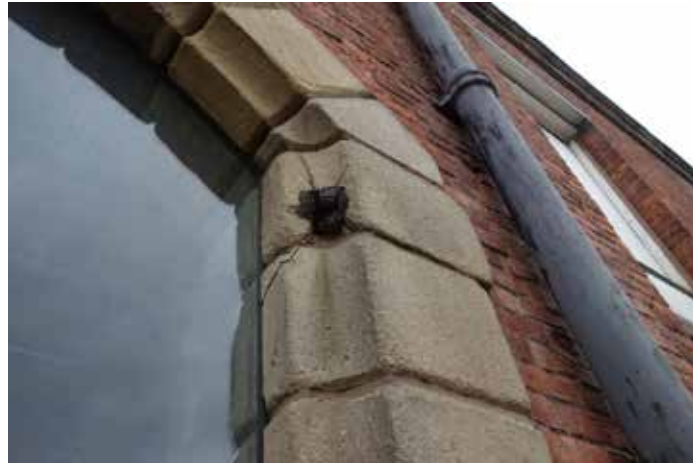
S1013: Crack/spall to block at hinge fixing. Treat ironwork, indent repair to stone block.

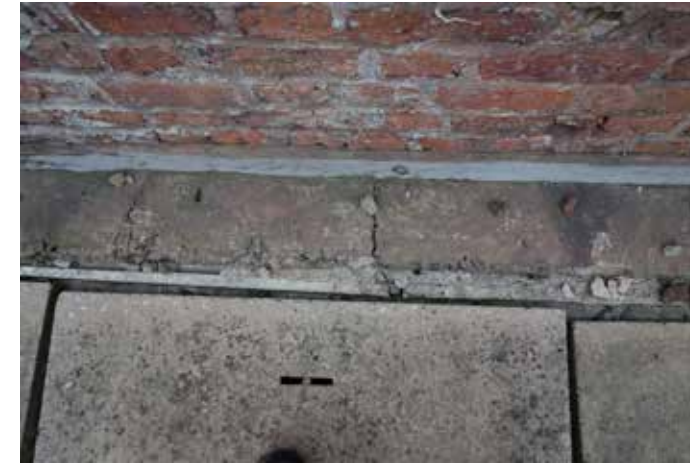
S1015: Crack through drainage channel at wall base. Further investigation required as part of viaduct drainage strategy.

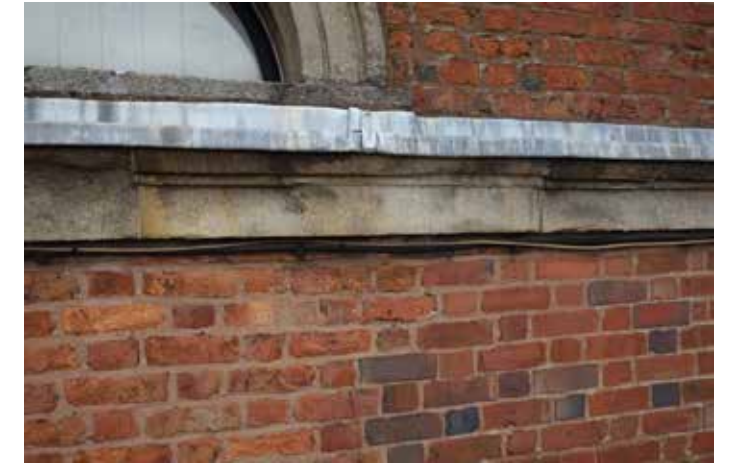
S1016: 2no. Bolt shells. Remove bolt shells.

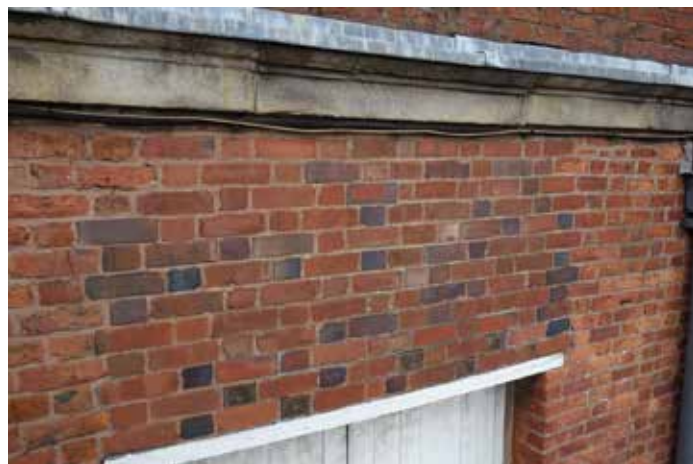
S1017: Material loss/spall. Indent repair to stone block.

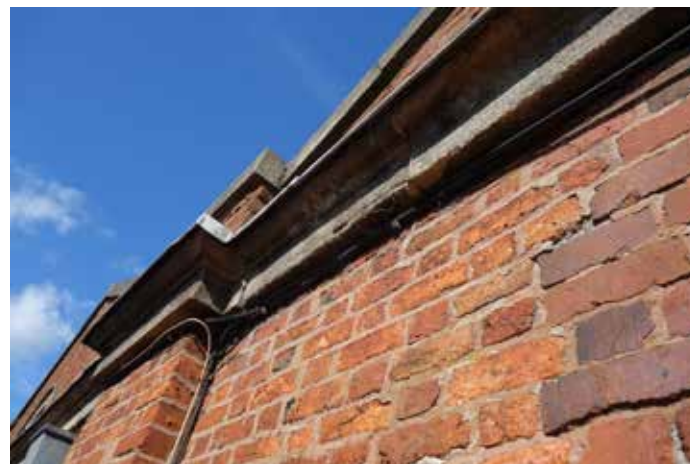
S1018: Material loss/spall. Indent repair to stone block.

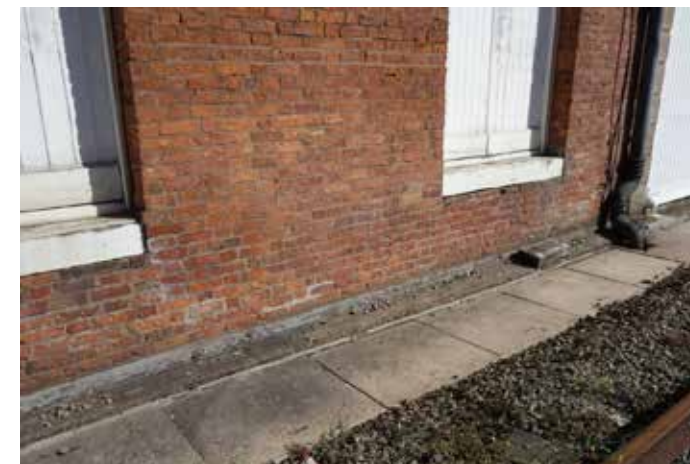
S1019: Spalled bricks. Cut out and replace bricks where erosion exceeds 15mm depth. Repoint using lime mortar.

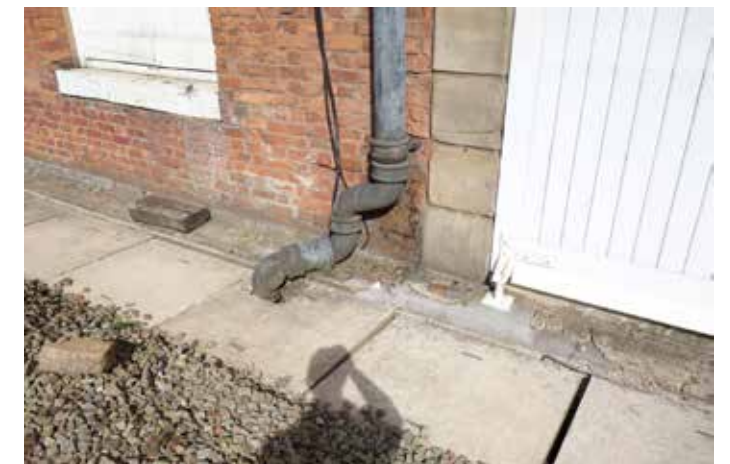
S1020: Patches of eroded pointing. Repoint using lime mortar.

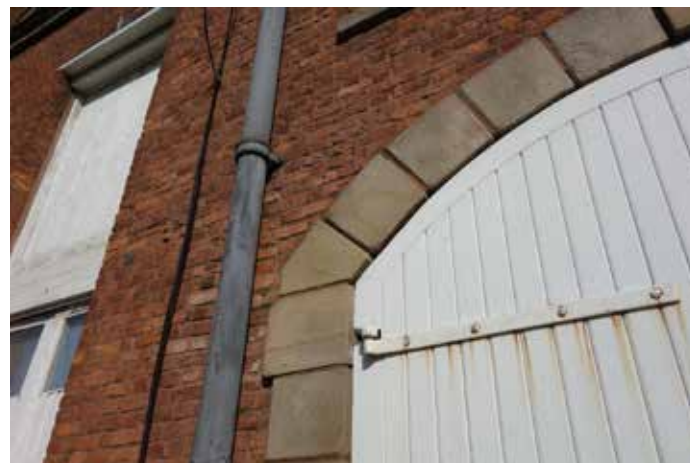
S1022: Open joint at arch block. Repoint using lime mortar.

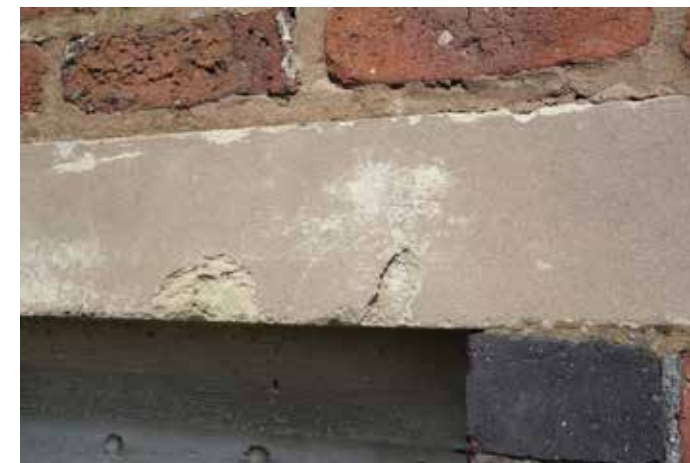
S1023: Fairing coat to RC beam is delaminating. Reapply with concrete repair mortar.

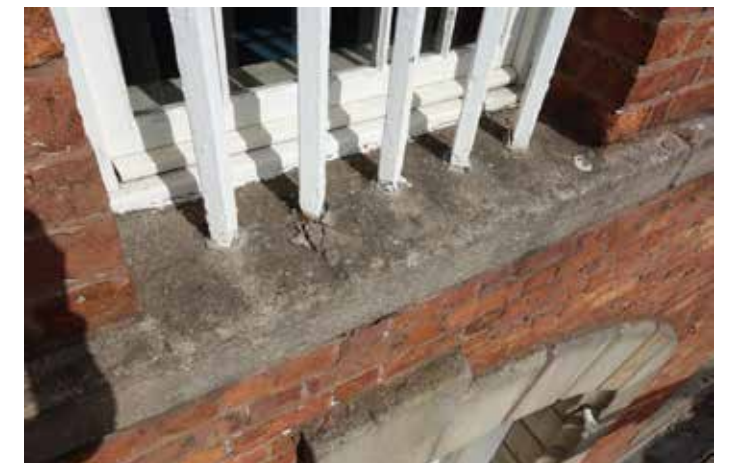
S1024: Corrosion of iron bar ends and cracks to cill. Cut out around bar embedments and treat iron. Repoint cracks using lime mortar.

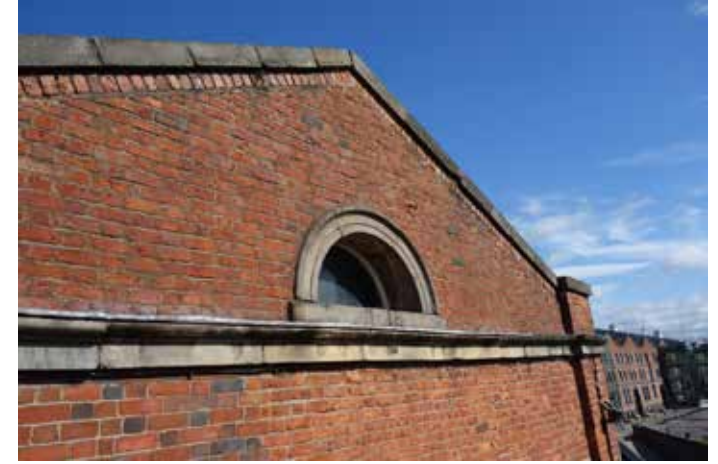
S1028: Delamination at cornice block. Indent repair to stone block.

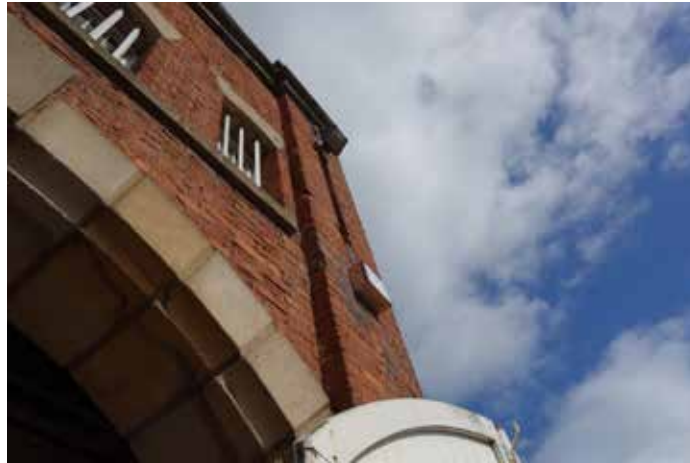
S1030: Spalled bricks. Cut out and replace bricks where erosion exceeds 15mm depth. Repoint using lime mortar.

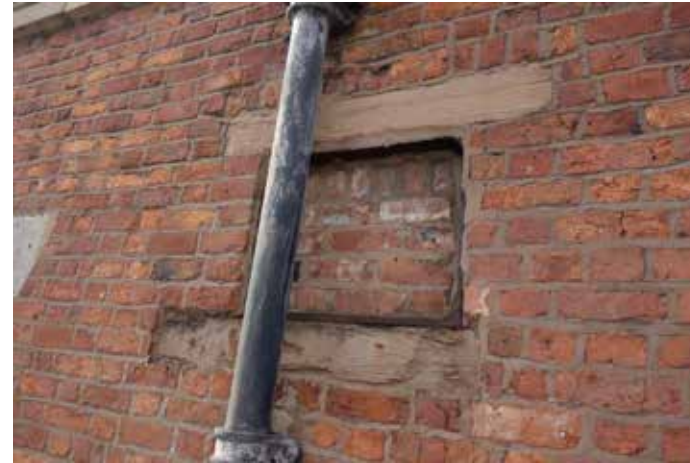
S1031: Metal duct frame is corroded. Cut out and brick in the opening.

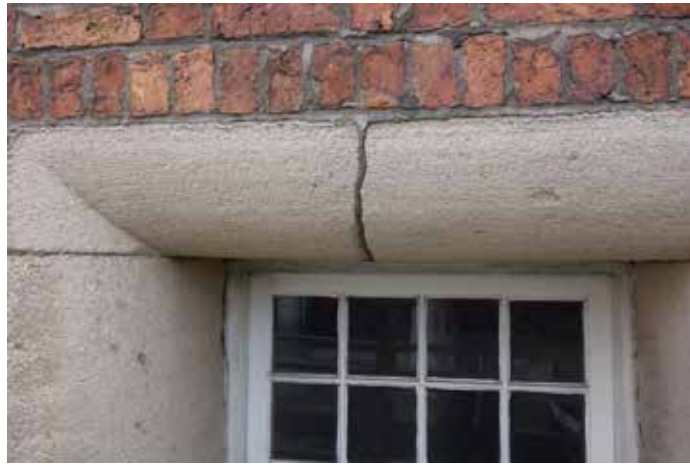
S1034: Vertical crack, c7mm width. Repoint using lime mortar.

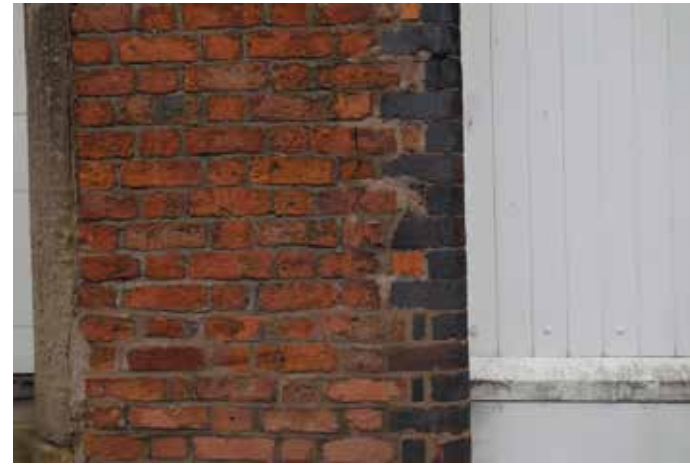
S1035: Vertical crack, c1-2mm width. Repoint using lime mortar.

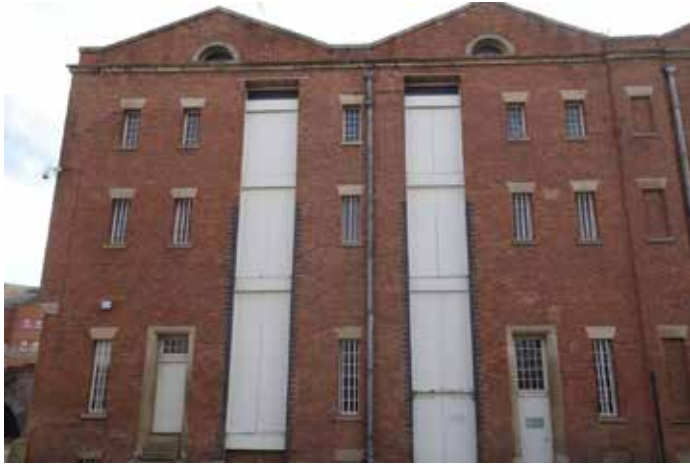
S1038: Spalled bricks. Cut out and replace bricks where erosion exceeds 15mm depth. Repoint using lime mortar.

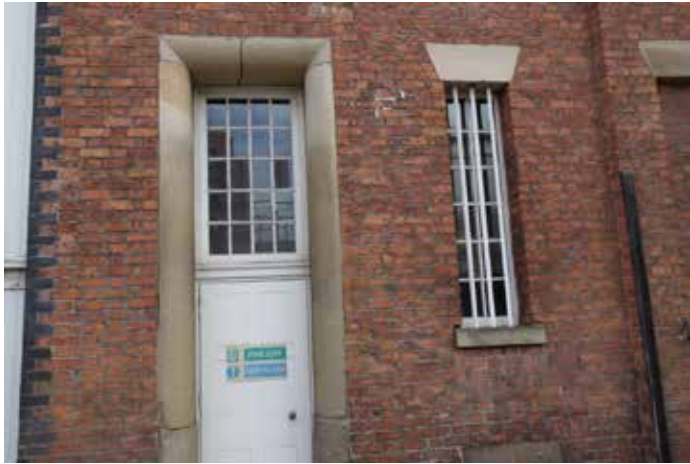
S1039: Previously repaired crack to door head, c6mm width. Rake out cementitious mortar, repoint with lime mortar.

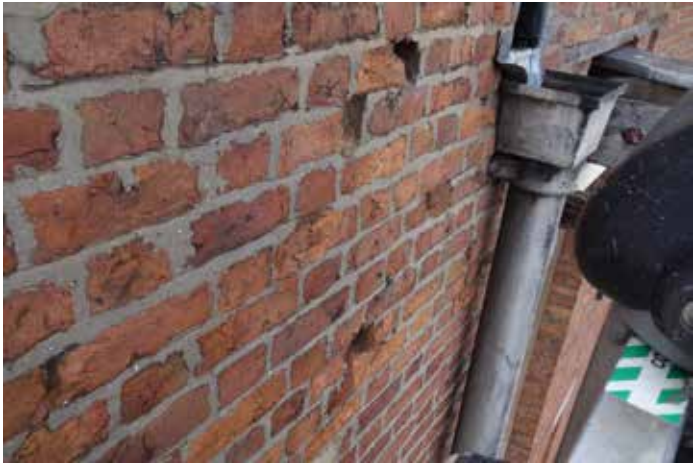
S1040: Spalled bricks. Cut out and replace bricks where erosion exceeds 15mm depth. Repoint using lime mortar.

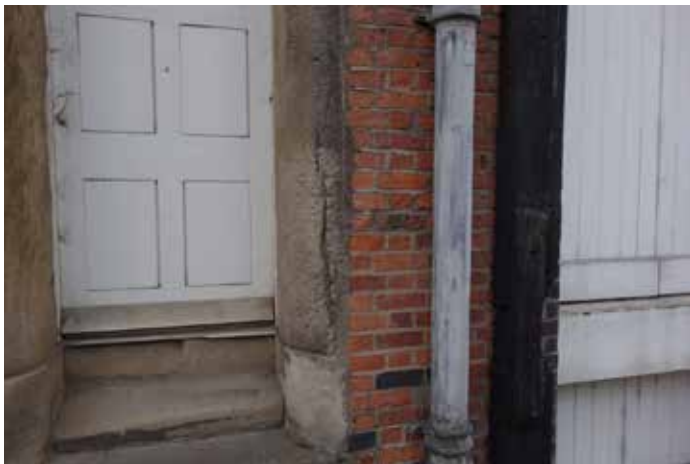
S1042: Vertical crack/fissure in stone architrave. Pin fissure using stainless steel dowels, Infill with colour matched repair mortar.

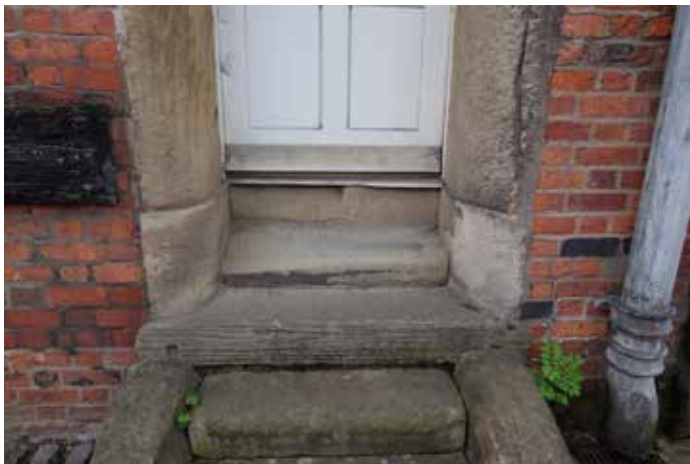
S1043: Large spall to step tread. Indent repair to stone tread.

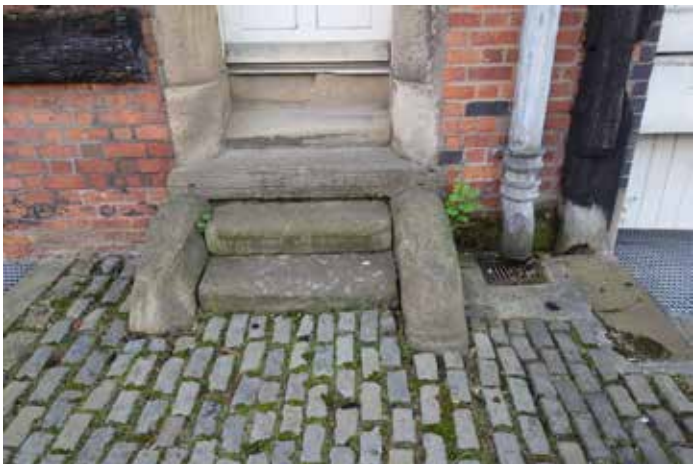
S1044: Settlement of steps. Dismantle and rebuild on new foundation.

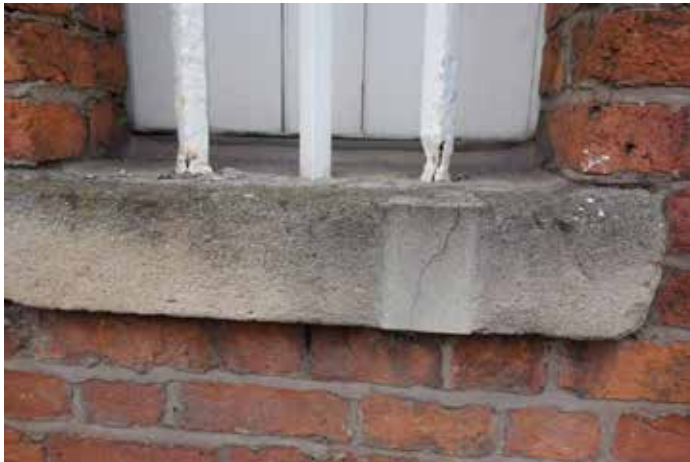
S1046: Corrosion of iron bar ends and cracks to cill. Cut out around bar embedments and treat iron. Repoint cracks using lime mortar.

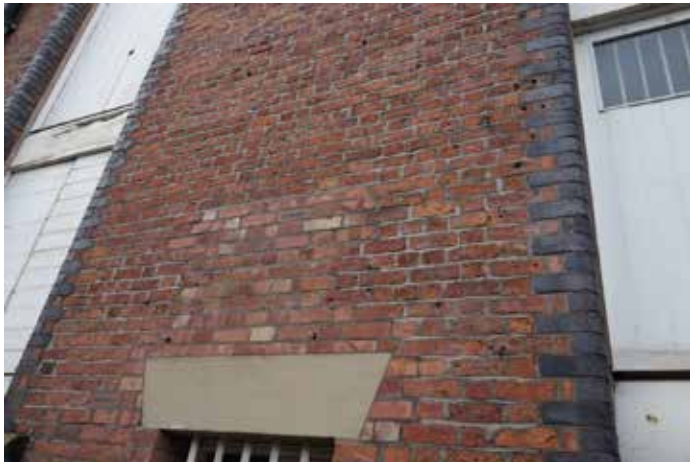
S1047: Various redundant metal bolts and fixings. Remove and infill holes using lime mortar.

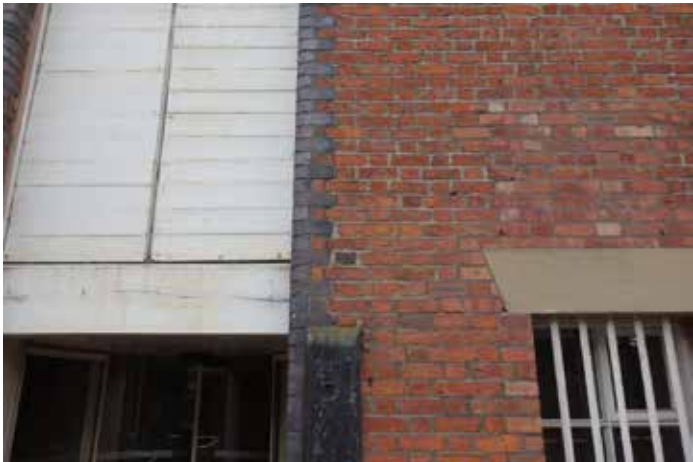
S1048: Vertical crack, 1-2mm width to RHS quoin. Pin bricks with Cemties. Repoint crack with lime mortar.

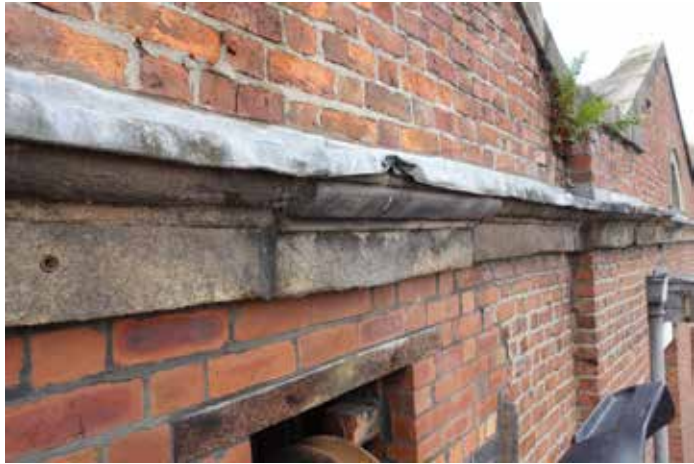
S1049: Bolt shells in cornice blocks. Remove and infill holes using lime mortar.

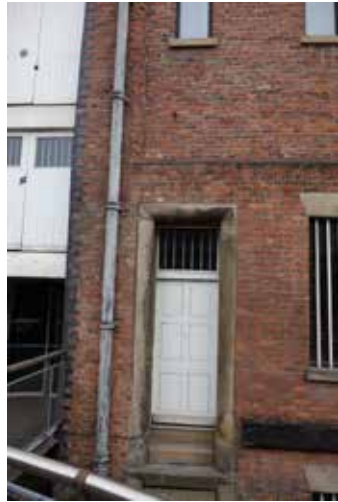
S1050: Open joints to stone architrave blocks. Repoint using lime mortar.

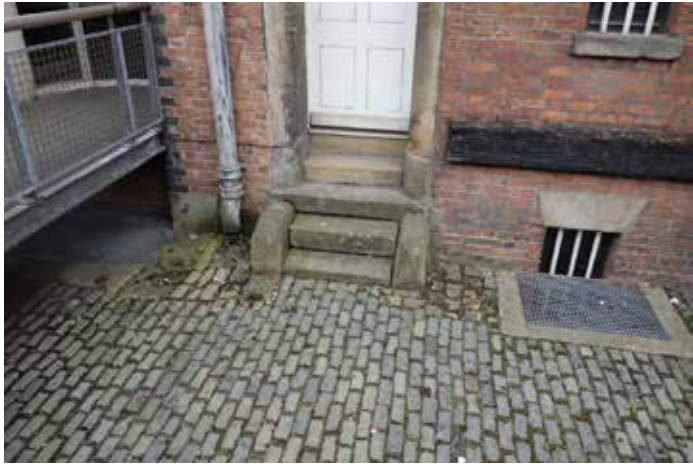
S1051: Settlement of steps. Dismantle and rebuild on new foundation.

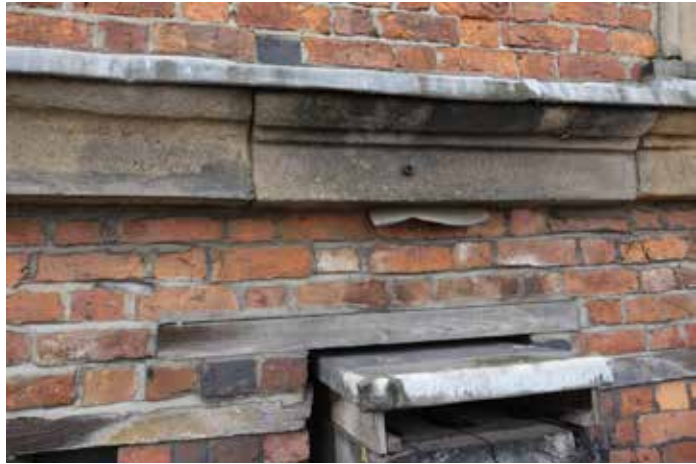
S1052: Bolt shells in cornice blocks. Remove and infill holes using lime mortar.

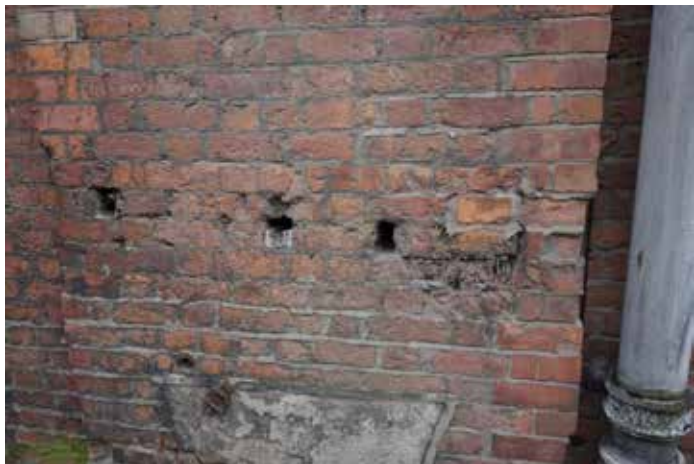
S1053: Spalled bricks. Cut out and replace bricks where erosion exceeds 15mm depth. Repoint using lime mortar.

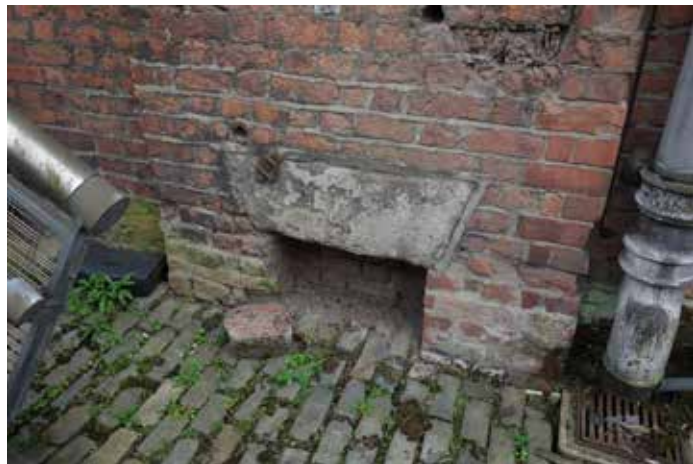
S1054: Patches of eroded pointing. Repoint using lime mortar.

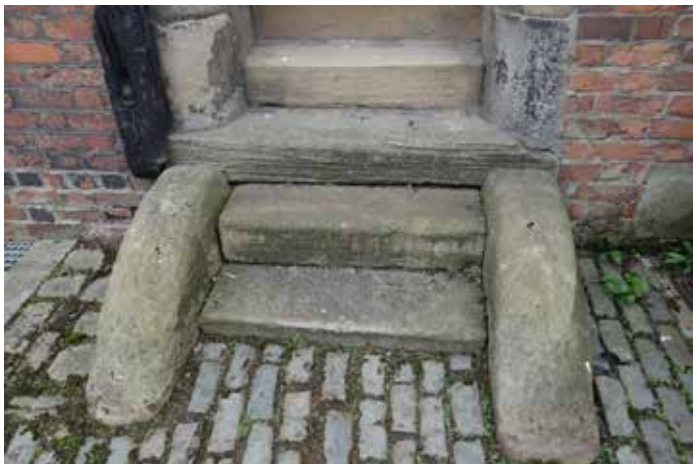
S1055: Settlement of steps. Dismantle and rebuild on new foundation.

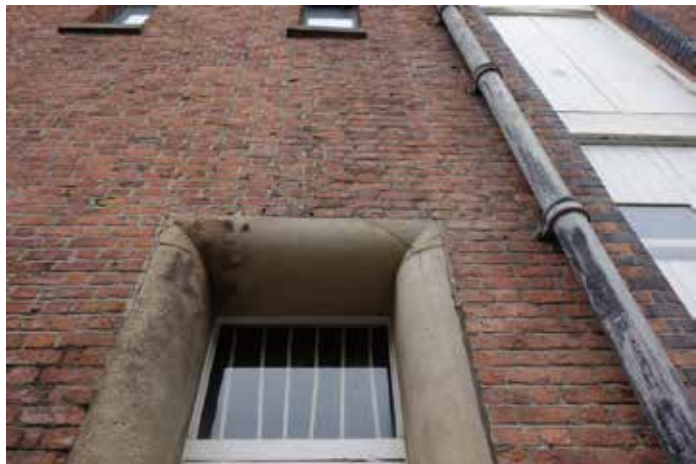
S1056: Crack in stone architrave. Pin crack with SS dowel. Repoint using lime mortar.

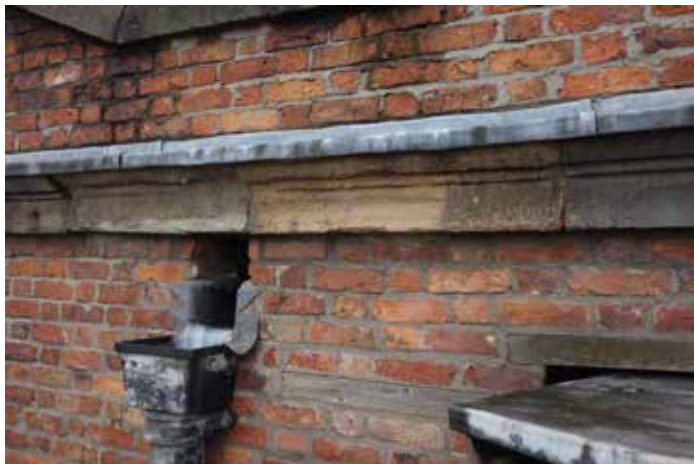
S10057: Open joints to cornice. Repoint using lime mortar.

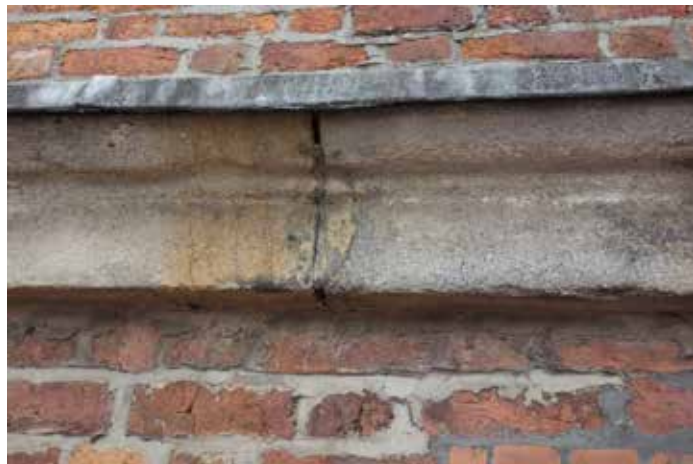
S1058: Open joints to cornice. Repoint using lime mortar.

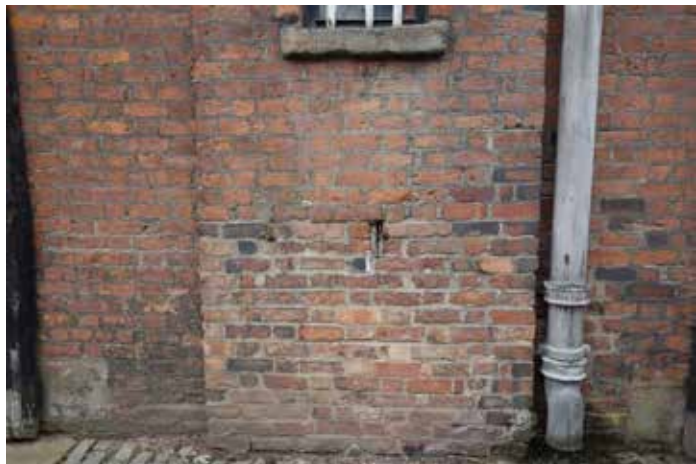
S1060: Patches of eroded pointing. Repoint using lime mortar.

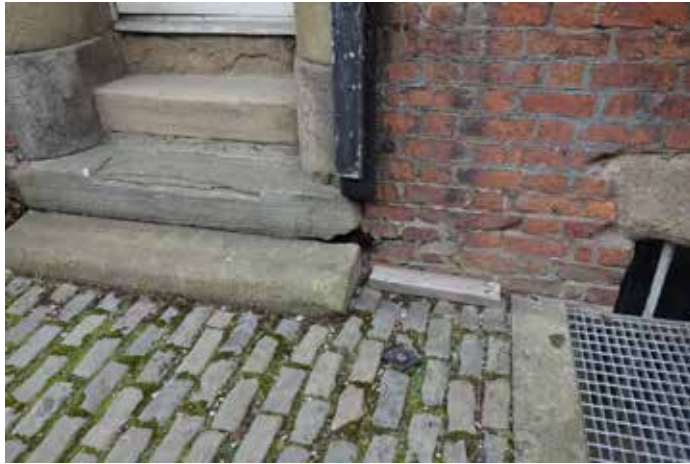
S1061: Spalled and eroded step treads. Indent repairs to 2no. treads.

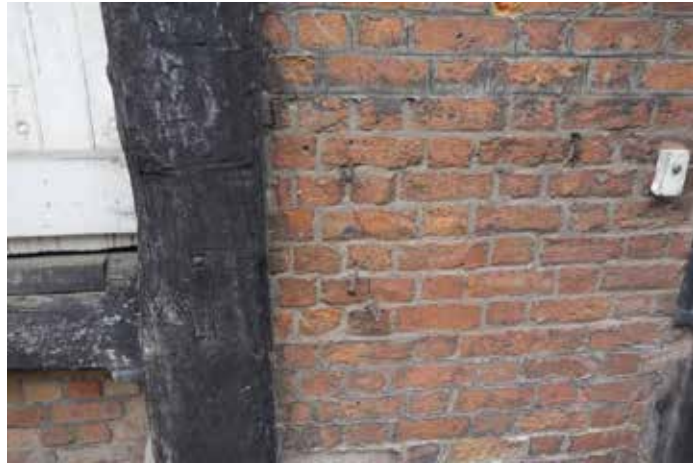
S1062: Corroding metal pin. Remove pin and repoint crack using lime mortar.

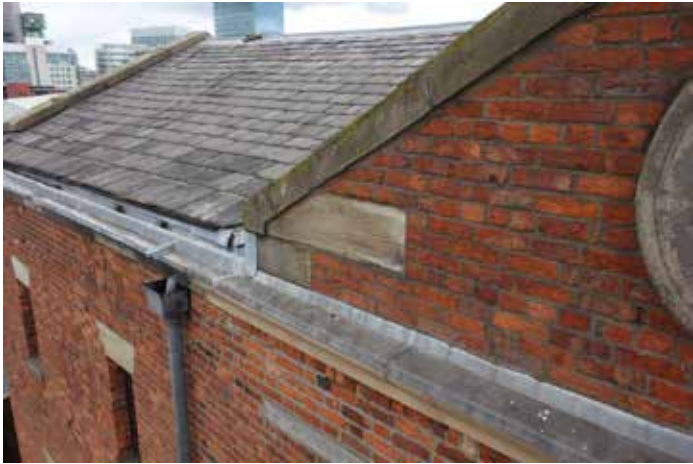
S1064: Delamination of LHS pediment block face. Indent repair to restore lost section.

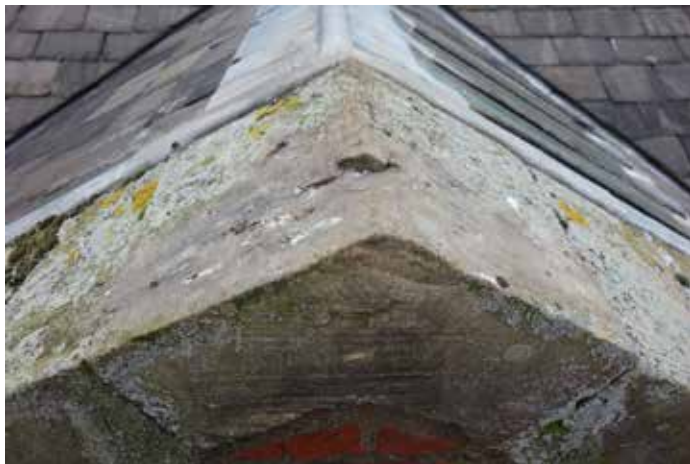
S1065: Delamination of coping blocks (2no.). Indent repair to restore lost section.

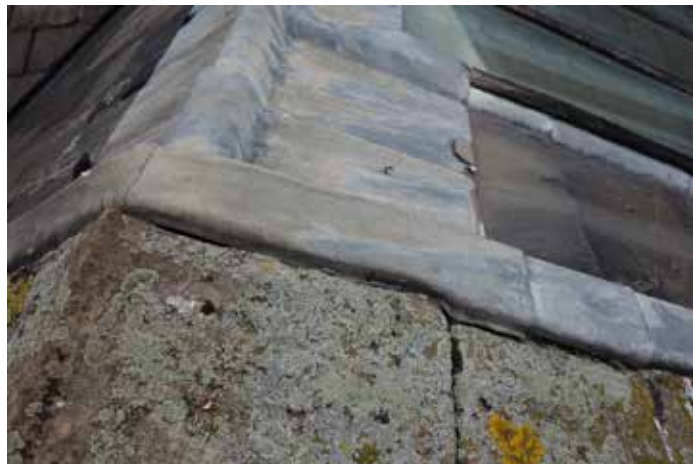
S1066: Missing pointing at lead capping. Repoint using lime mortar.

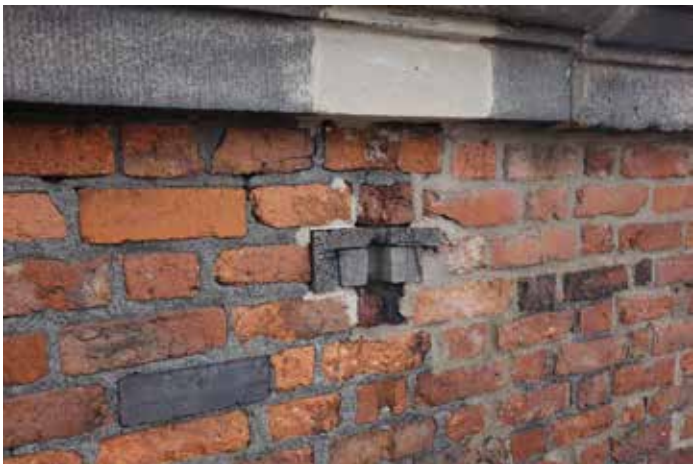
S1068: Decayed embedded timber. Remove timber and brick-in void.

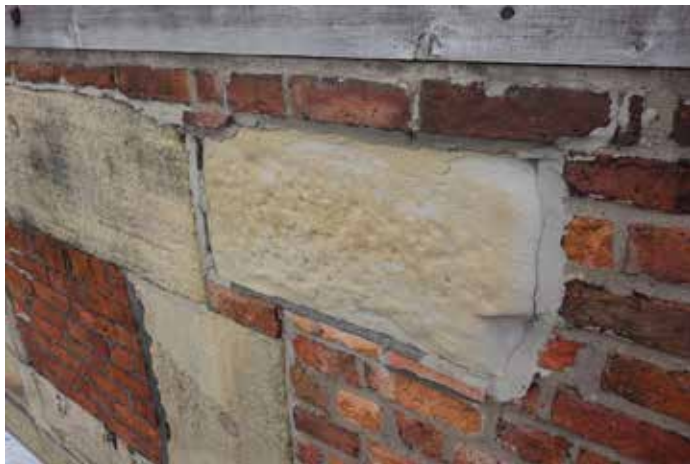
S1069: Area of delamination of stone block faces and loose pointing. Defrass stone and repoint joints using lime mortar.

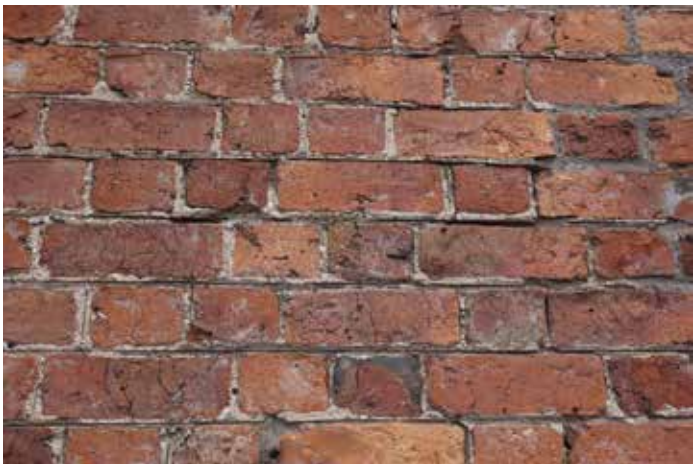
S1072: Eroded pointing over whole elevation. Repoint using lime mortar.

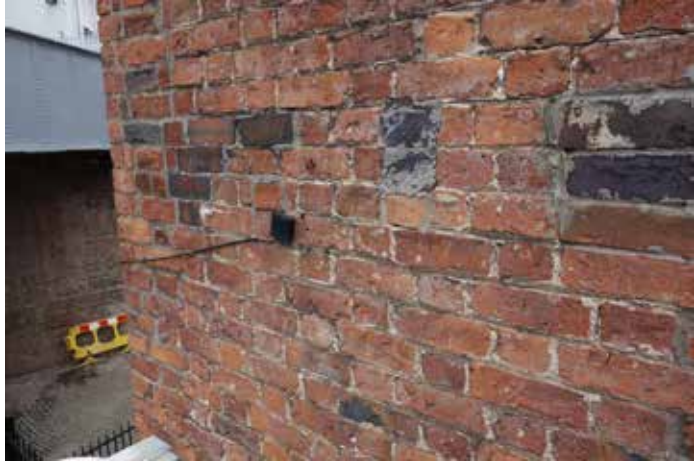
S1073: Multiple vertical cracks in brickwork. Repair using helical bar stitching. Repoint using lime mortar.

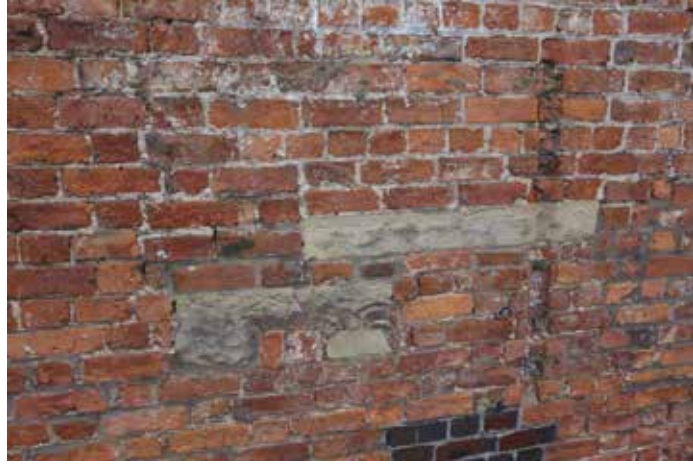
S1074: Previous surface repair failing. Indent repair to restore lost section.

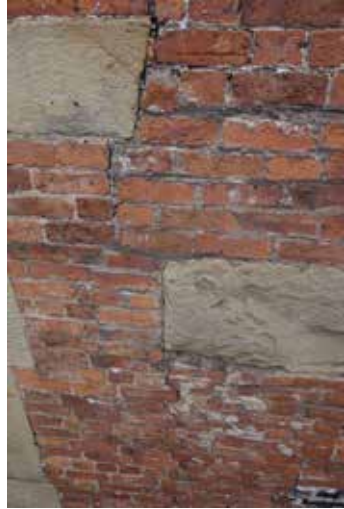
S1075: Multiple vertical cracks in brickwork. Repair using helical bar stitching. Repoint using lime mortar.

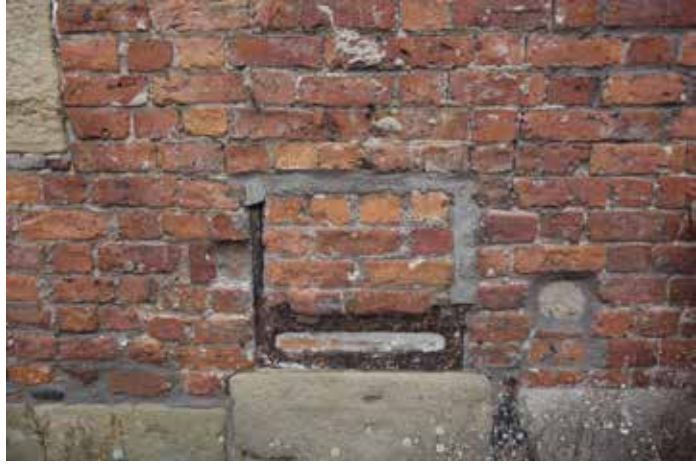
S1076: Corroding emdedded iron duct. Clean and treat where accessible. Repoint around using lime mortar.

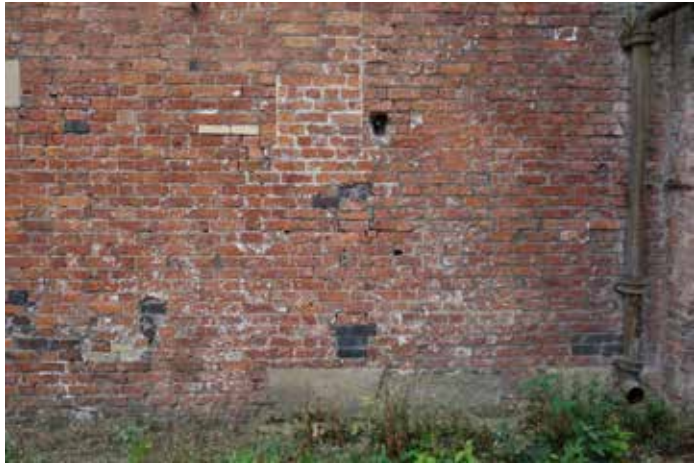
S1077: Spalled/missing bricks. Cut out and replace bricks where erosion exceeds 15mm depth. Repoint using lime mortar.

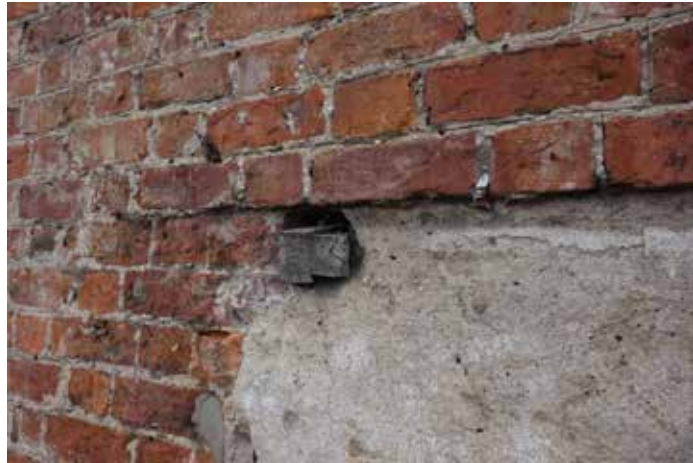
S1078: Decayed embedded timber. Remove timber and brick-in void.

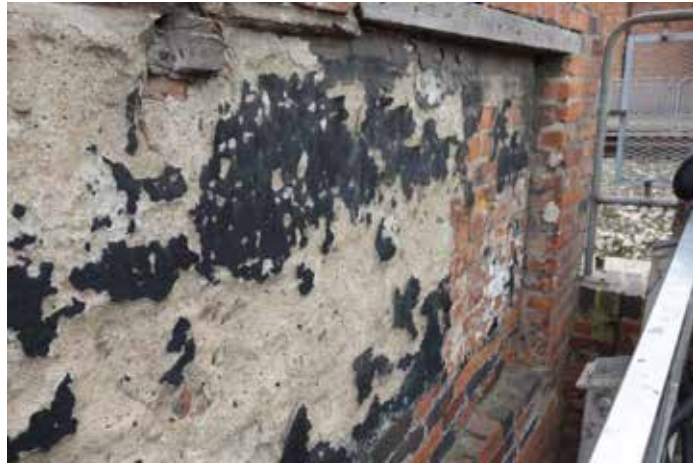
S1079: Failing area of render over brickwork. Remove and replace with new lime render.

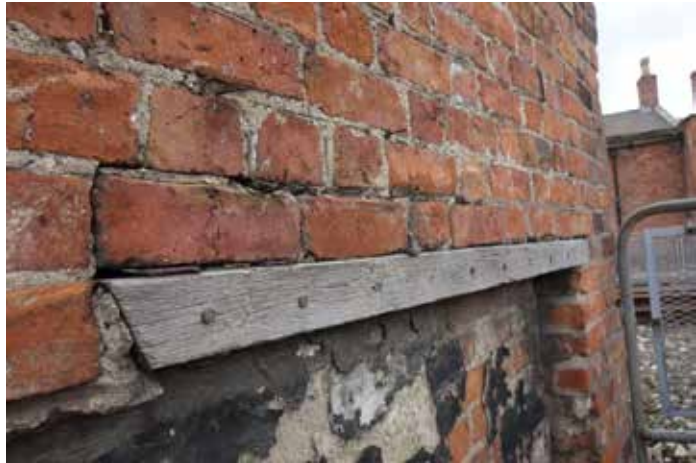
S1080: Timber lintel has poor bearing. Extend bearing.

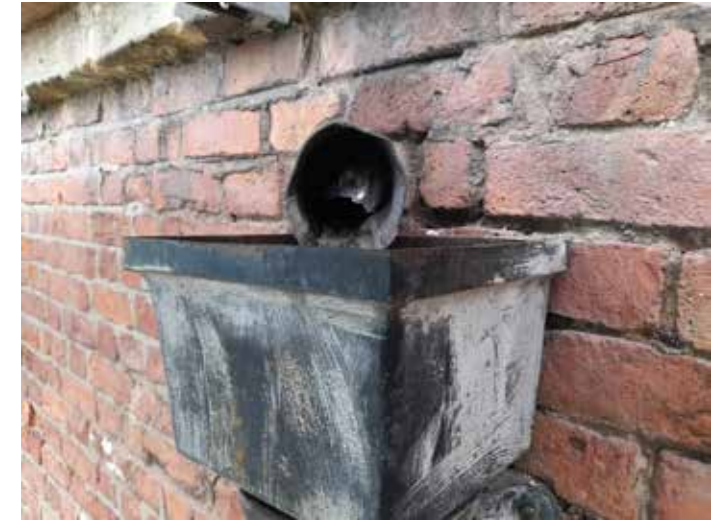
A1004: Rainwater goods. RWP outlet to replaced with Catchpit and chute.

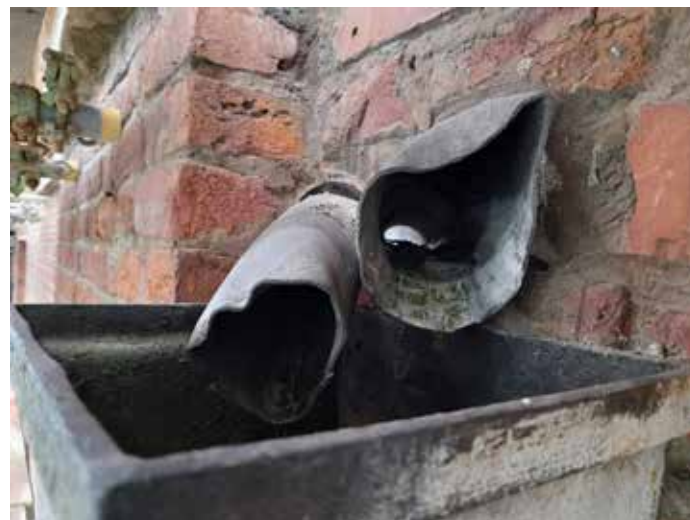
A1010: Rainwater goods. RWP outlet to replaced with Catchpit and chute.

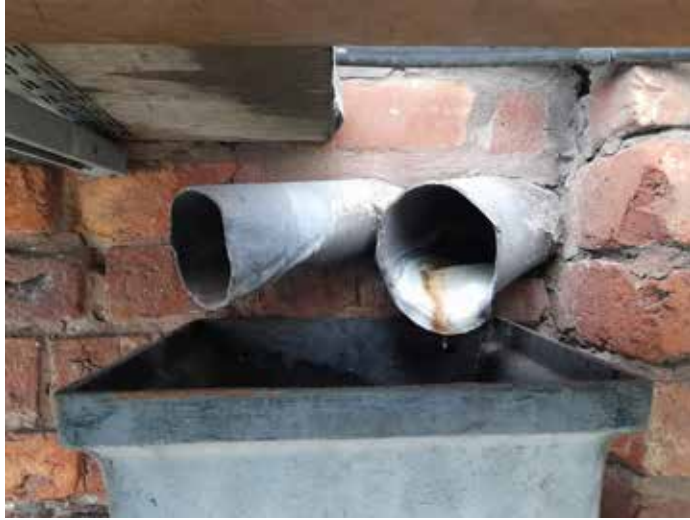
A1040: Rainwater goods. RWP outlet to replaced with Catchpit and chute.

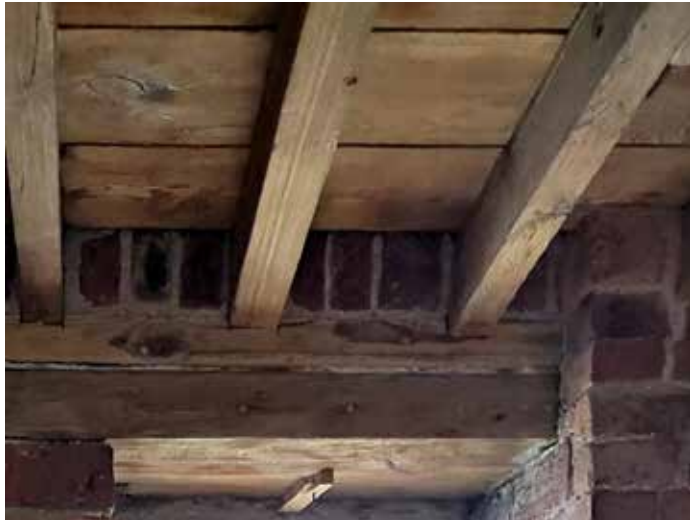
A0035: Wood piece below. Remove batten

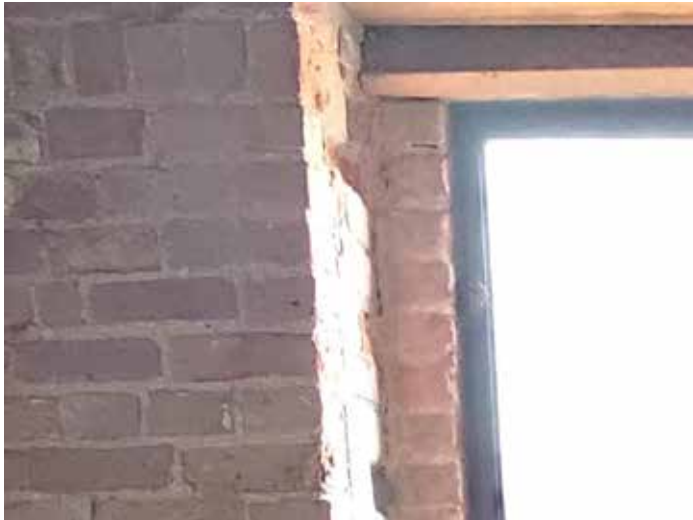
A0038: Brickwork damaged. Brick repair required

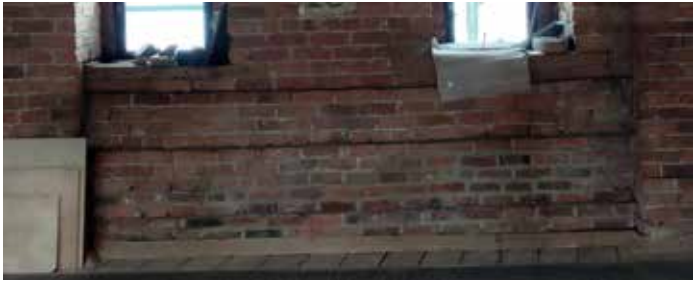
A0040: Poor pointing. Brick repair required

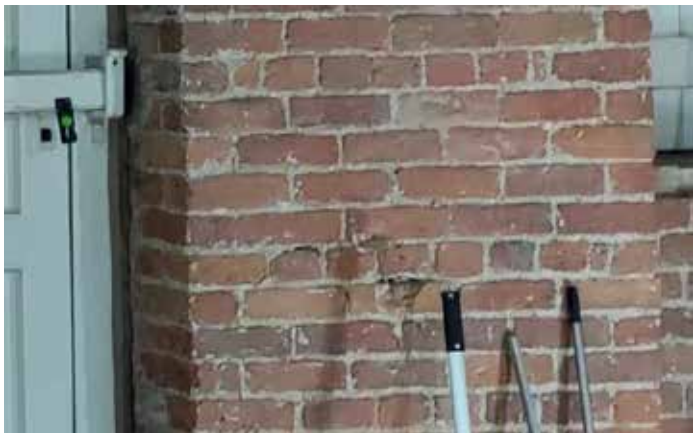
A0046 Brickwork damaged. Brick repair required

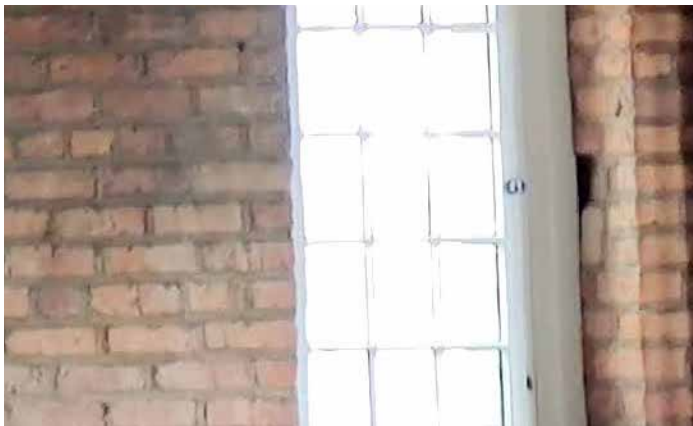
A0052: Brickwork damaged. Brick repair required
