# Essential Repairs including Replacement Wagon Arch Glazing

## 1830 Warehouse

Science & Industry Museum

Design and Access Statement

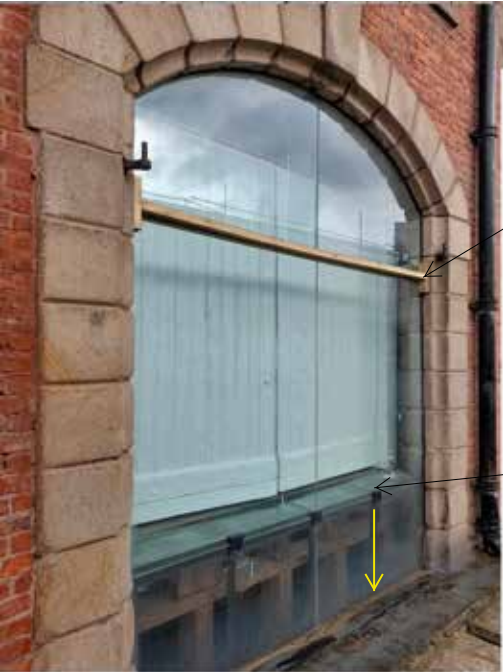
Temporary restraints.  
and shatter proof film  
internally.

Horizontal glazing not supported

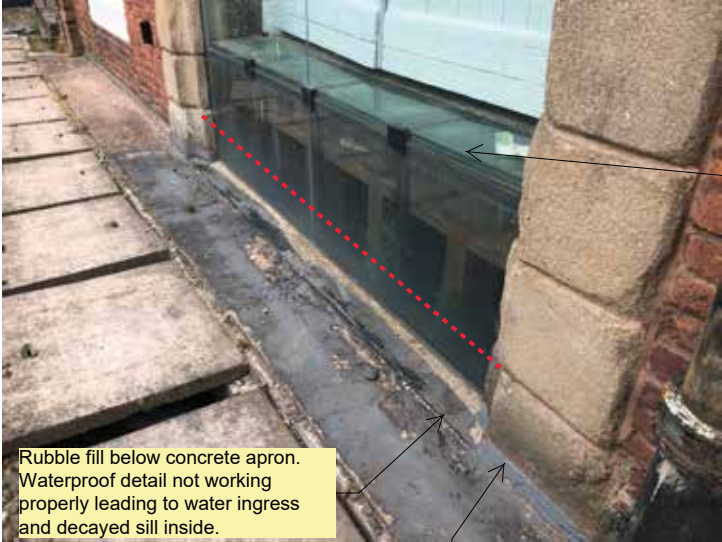
Rubble fill below concrete apron.  
Waterproof detail not working  
properly leading to water ingress  
and decayed sill inside.

80-90mm ACRYPOL

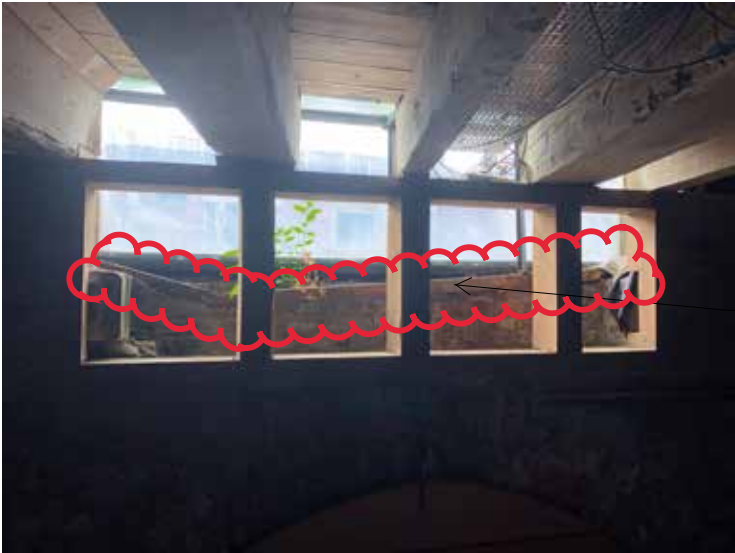
collapsed

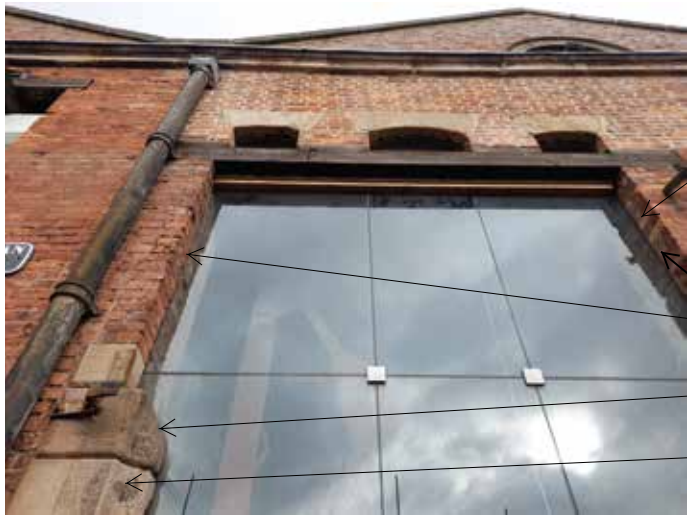
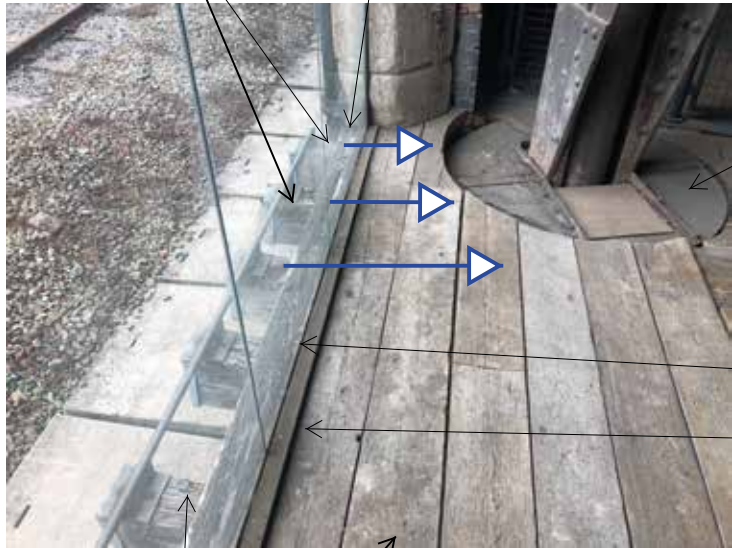
Glass cut round stone

Glass interface with stone

New flashing detail  
required to protect wood  
sill

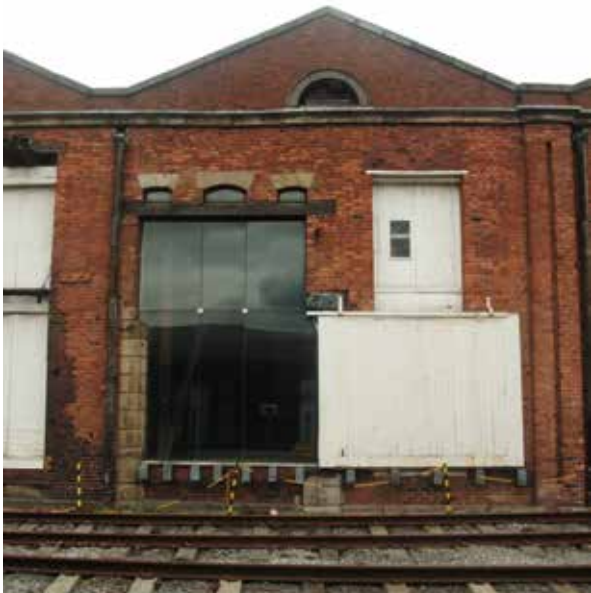
Shoe detail  
(defect to rectify)

Timber sill rotten  
↑  
Don't replicate detail

Proper shoe detail  
over joists.  
- Lead

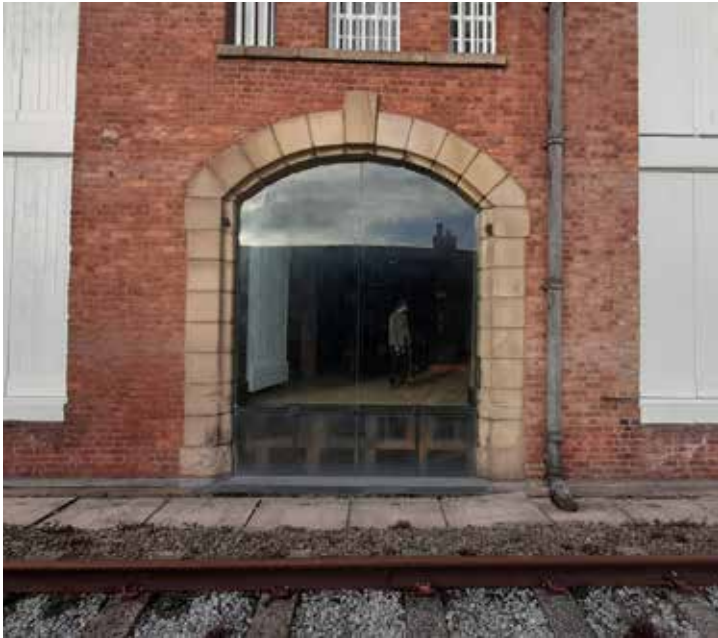
Bay 2 foreground, and Bay 3 to the right. The Bay 3 detail to the viaduct is the same as Bay 1
