**The Great Northern Warehouse**

**Survey 2022**

**Great Northern Warehouse & Deansgate Terraces, Manchester**

**Condition Survey**

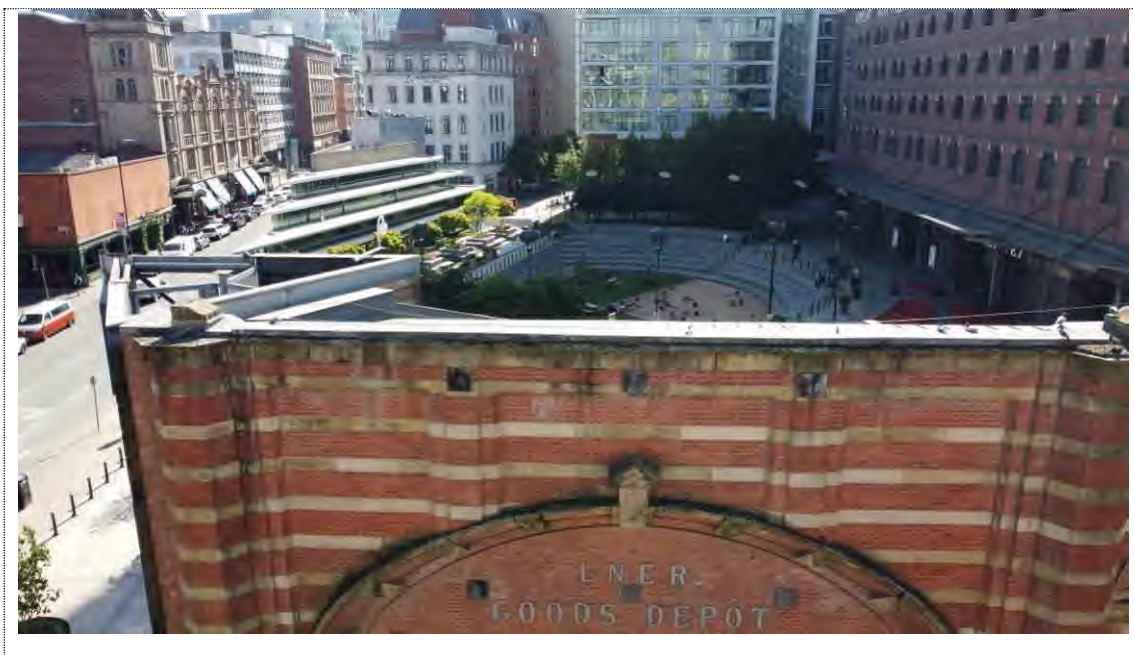
| Photograph: | 2 |

| Description: | Redress spalling stone to a sound surface. Cut out defective stone and replace new matching stone. (West facing) |

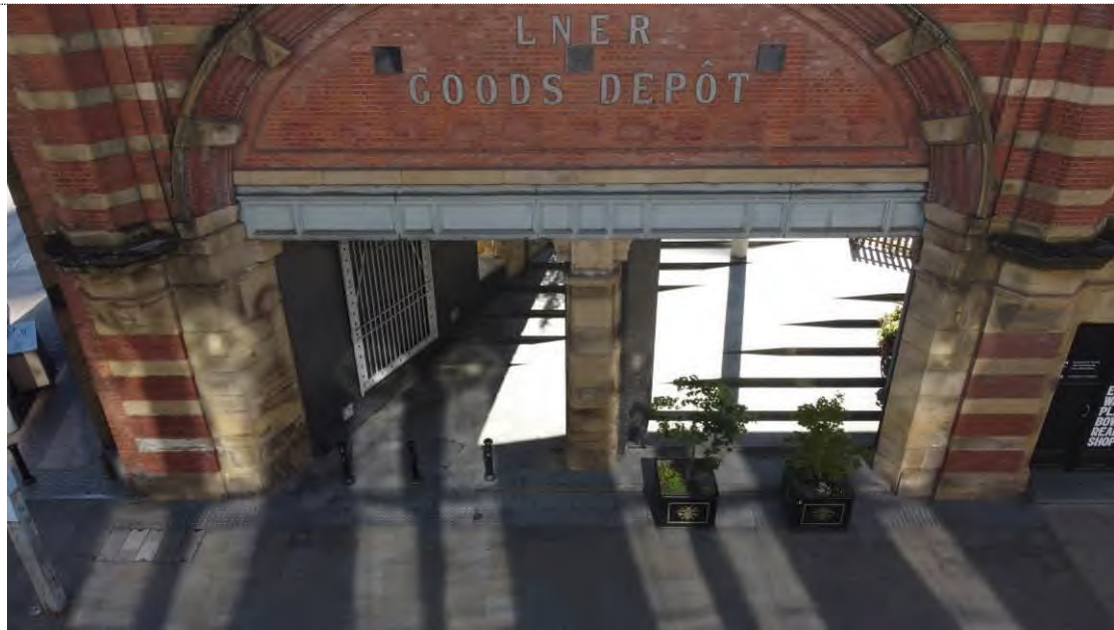
| Photograph: | 3 |

| Description: | Redress spalling stone to a sound surface. Cut out defective stone and replace new matching stone. (West facing) |

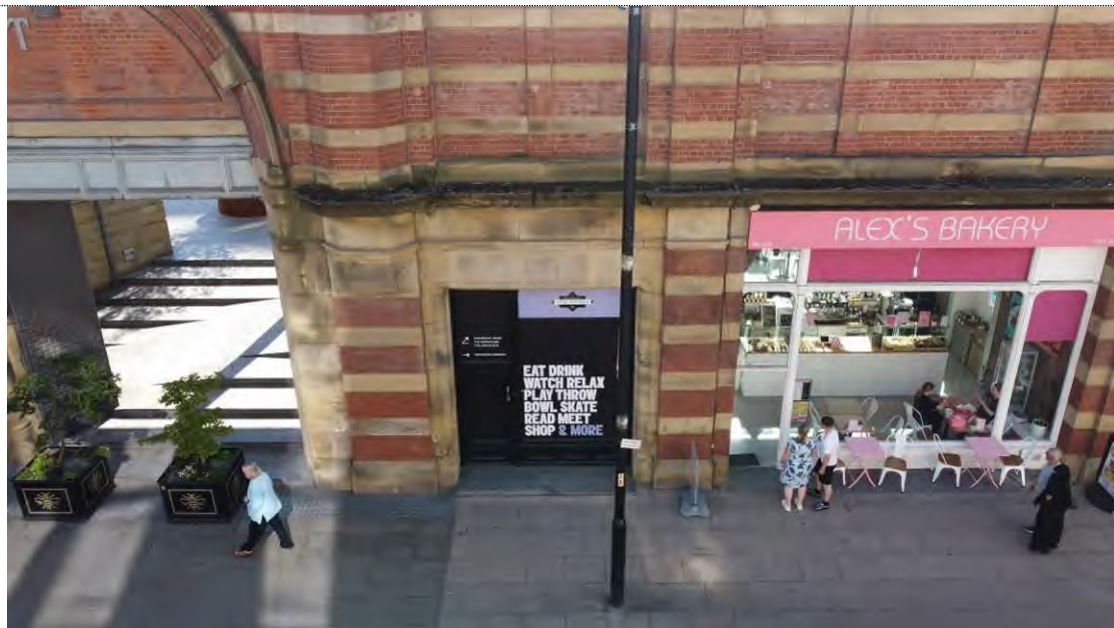
| Photograph: | 4 |

| Description: | Redress spalling stone to a sound surface. Cut out defective stone and replace new matching stone. (West facing) |

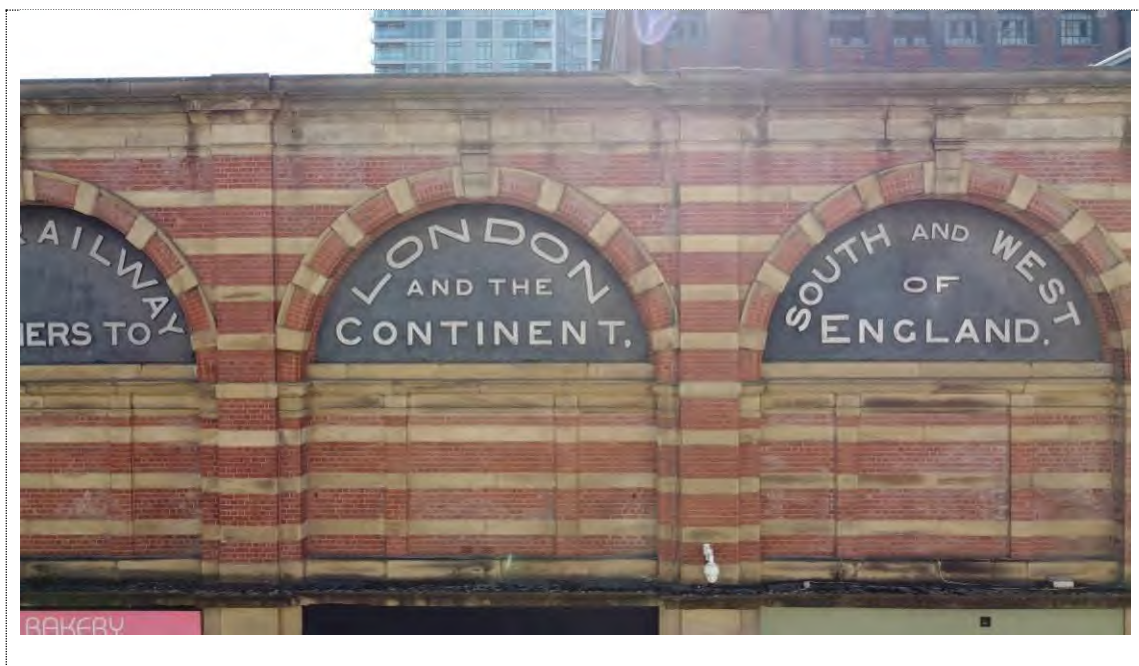
| Photograph: | 6 |

| Description: | Redress spalling stone to a sound surface. Cut out defective stone and replace new matching stone. (West facing) |

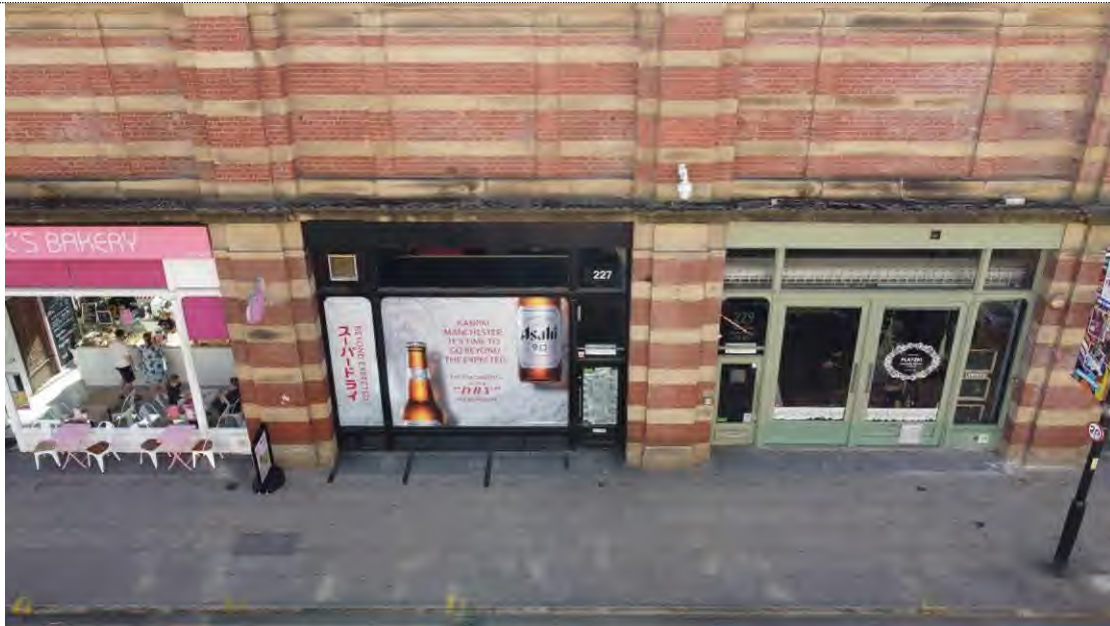
| Photograph: | 7 |

| Description: | Redress spalling stone to a sound surface. Cut out defective stone and replace new matching stone. (West facing) |

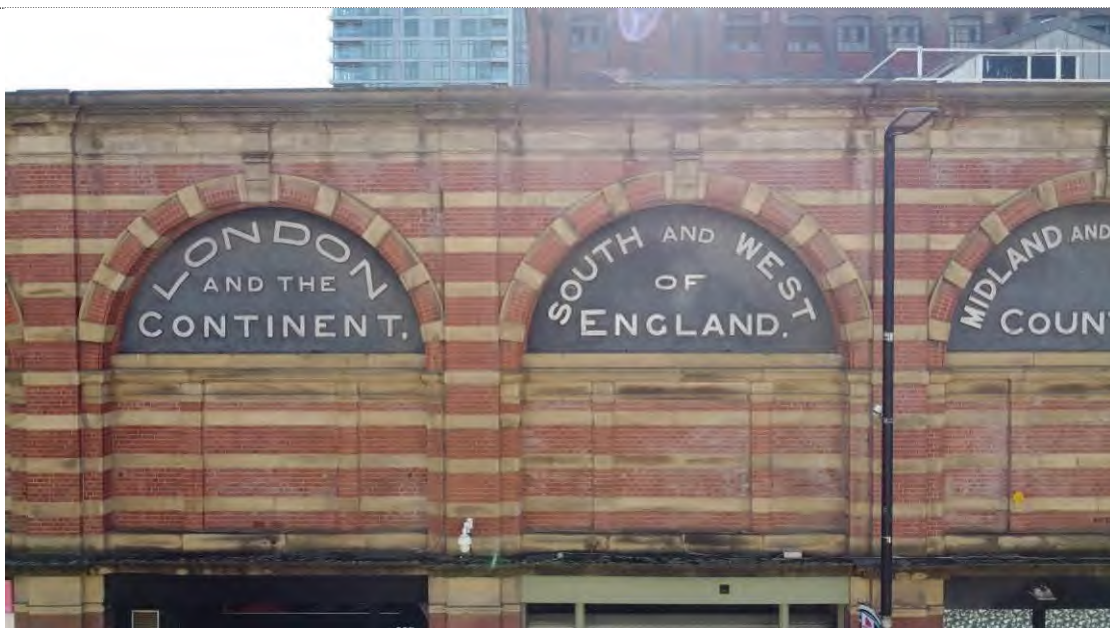
| Photograph: | 8 |

| Description: | Redress spalling stone to a sound surface. Cut out defective stone and replace new matching stone. (West facing) |

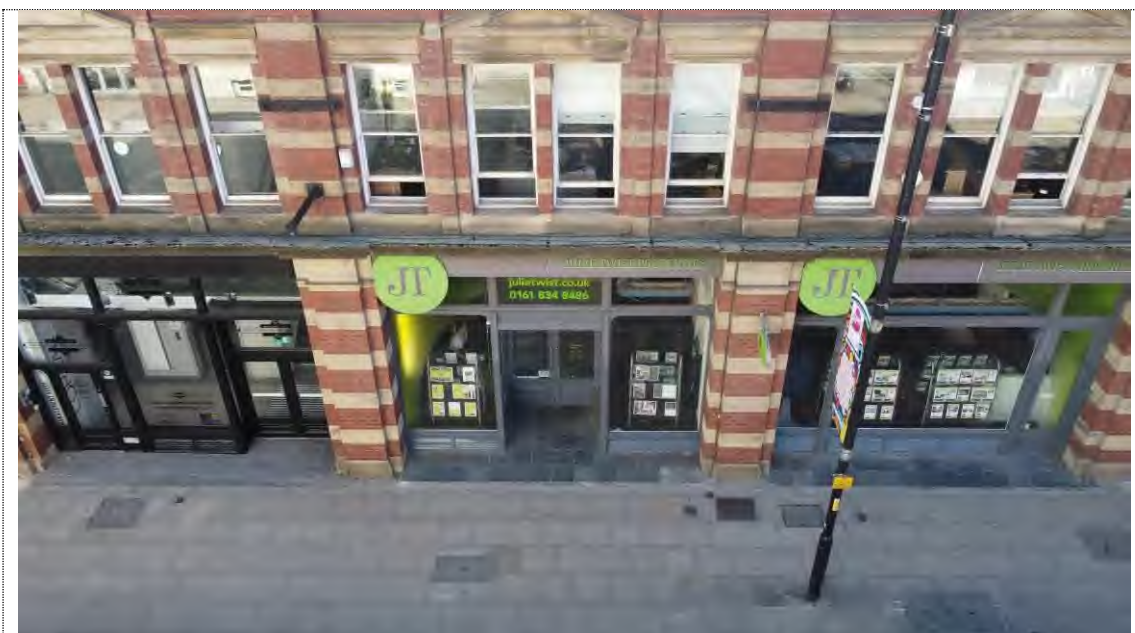
| Photograph: | 11 |

| Description: | Redress spalling stone to a sound surface. Treat CI straps. (West facing) |

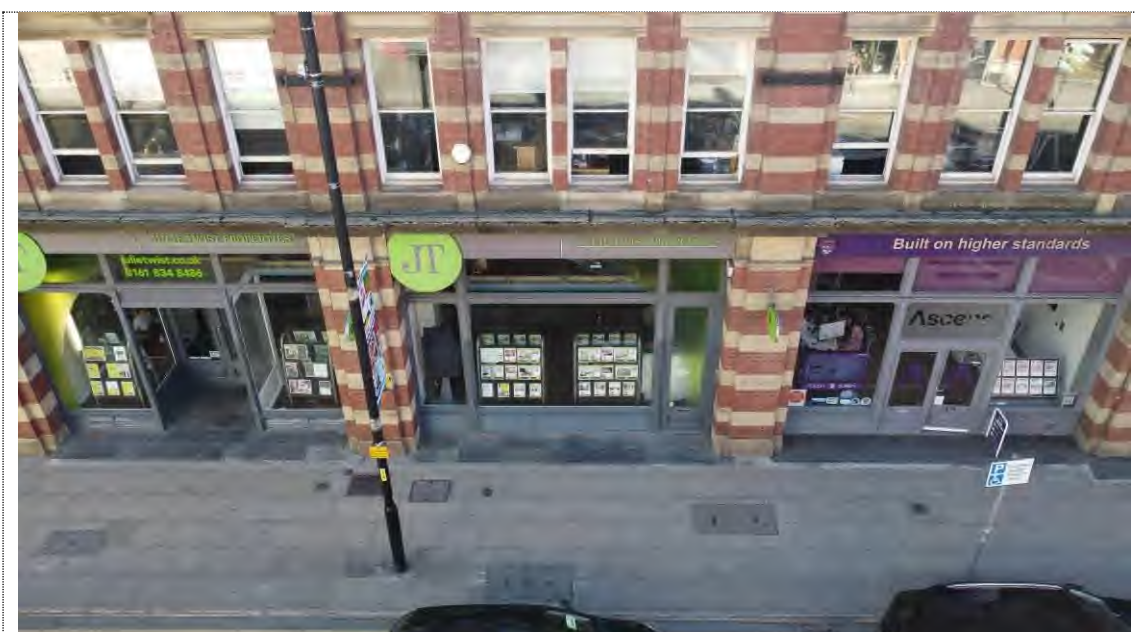
| Photograph: | 12 |

| Description: | Redress spalling stone to a sound surface. Treat CI straps. (West facing) |

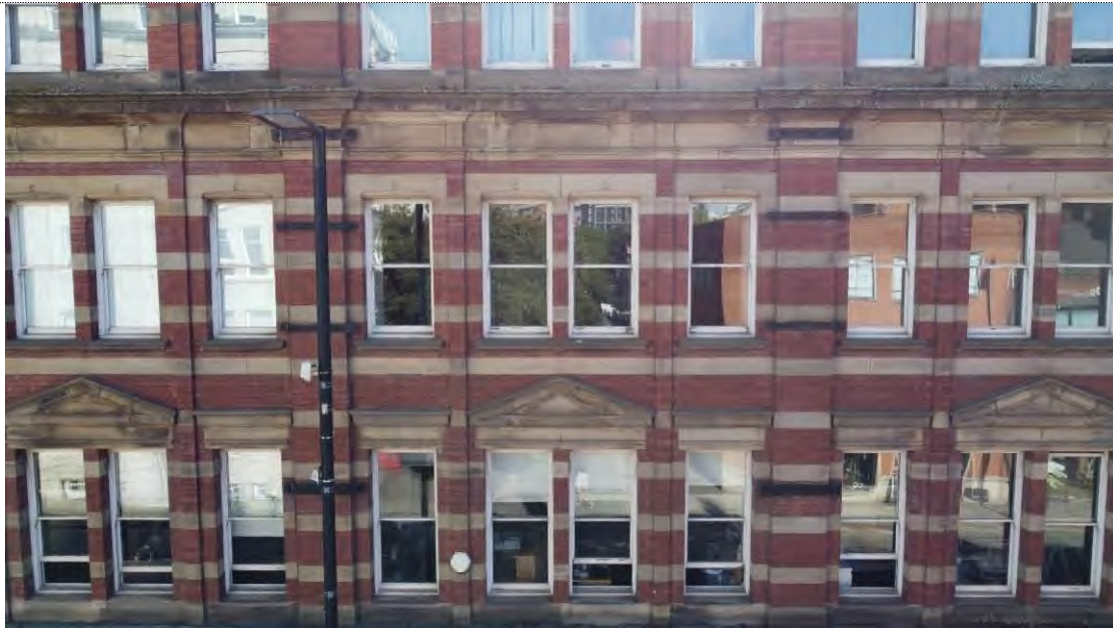
| Photograph: | 13 |

| Description: | Redress spalling stone to a sound surface. Treat CI straps. (West facing) |

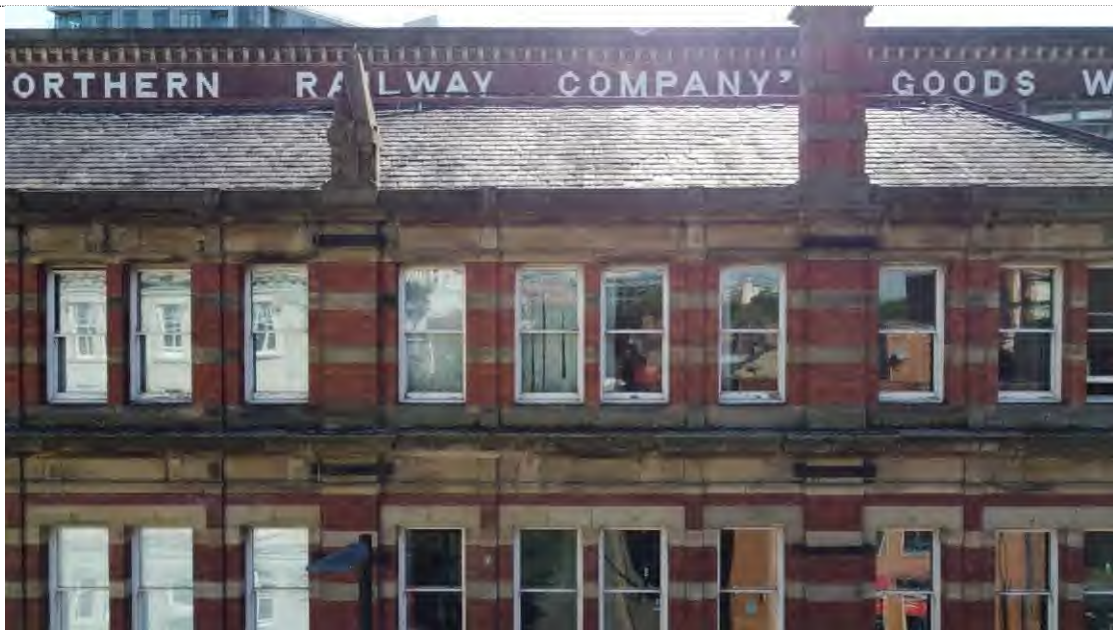
| Photograph: | 14 |

| Description: | Redress spalling stone to a sound surface. Treat CI straps. (West facing) |

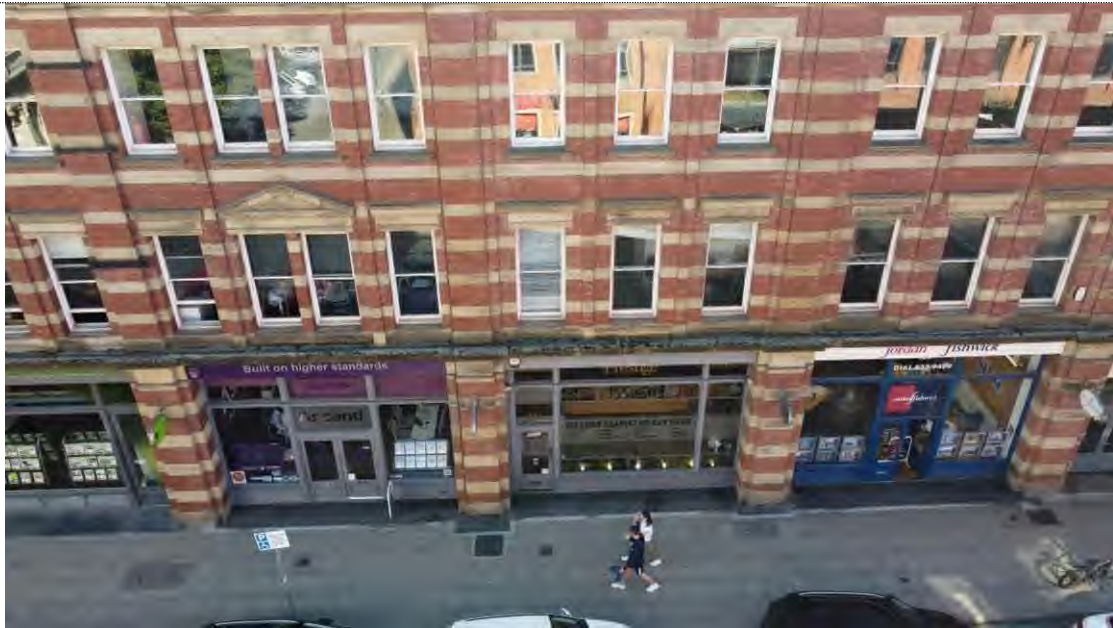
| Photograph: | 15 |

| Description: | Redress spalling stone to a sound surface. Treat CI straps. (West facing) |

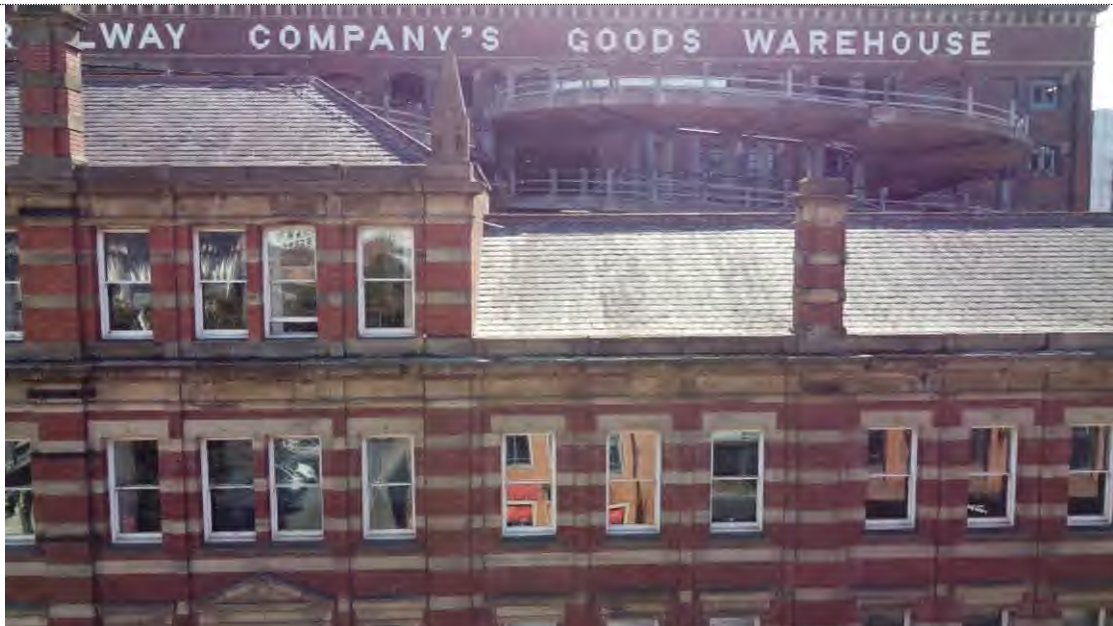
| Photograph: | 16 |

| Description: | Redress spalling stone to a sound surface. Treat CI straps. (West facing) |

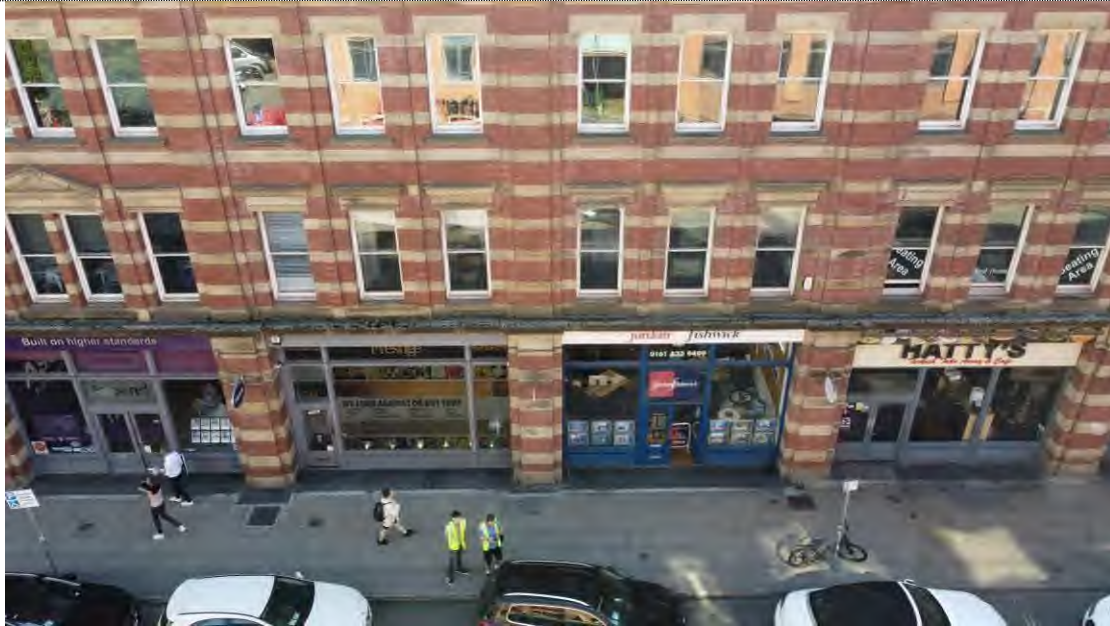
| Photograph: | 17 |

| Description: | Redress spalling stone to a sound surface. Treat CI straps. (West facing) |

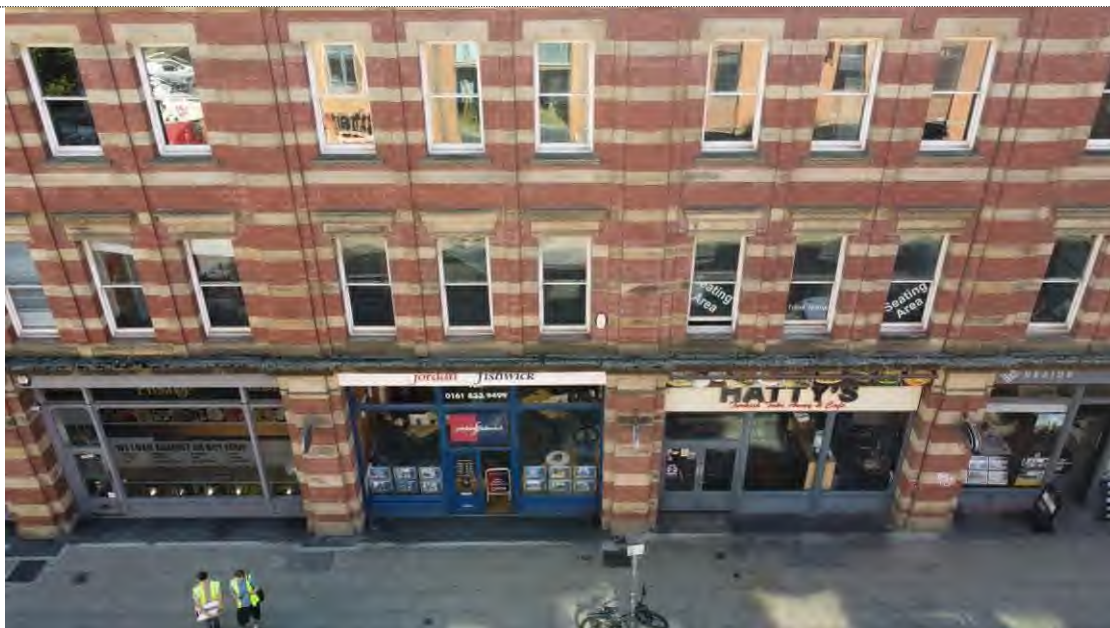
| Photograph: | 18 |

| Description: | Redress spalling stone to a sound surface. Cut out defective stone and replace new matching stone. (West facing) |

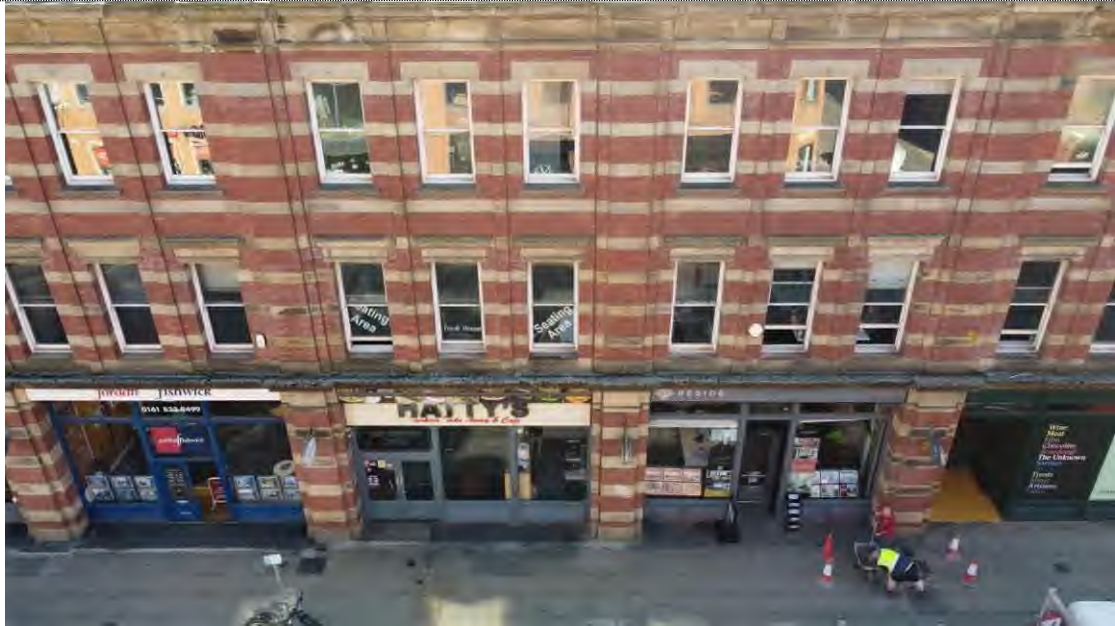
| Photograph: | 19 |

| Description: | Redress spalling stone to a sound surface. Cut out defective stone and replace new matching stone. (West facing) |

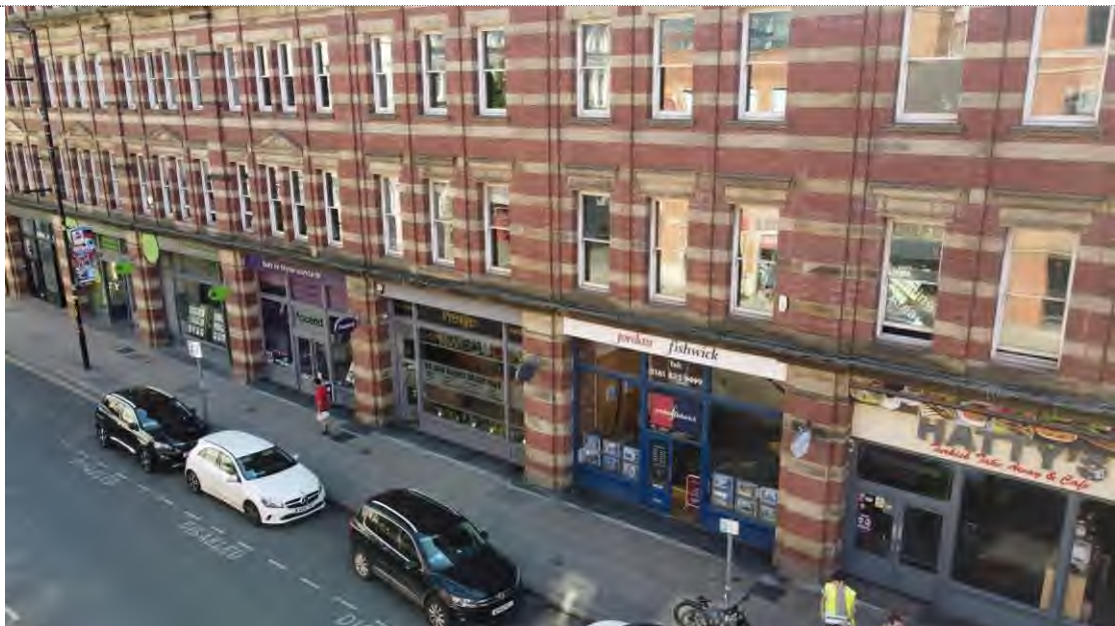
| Photograph: | 20 |

| Description: | Redress spalling stone to a sound surface. Cut out defective stone and replace new matching stone. (West facing) |

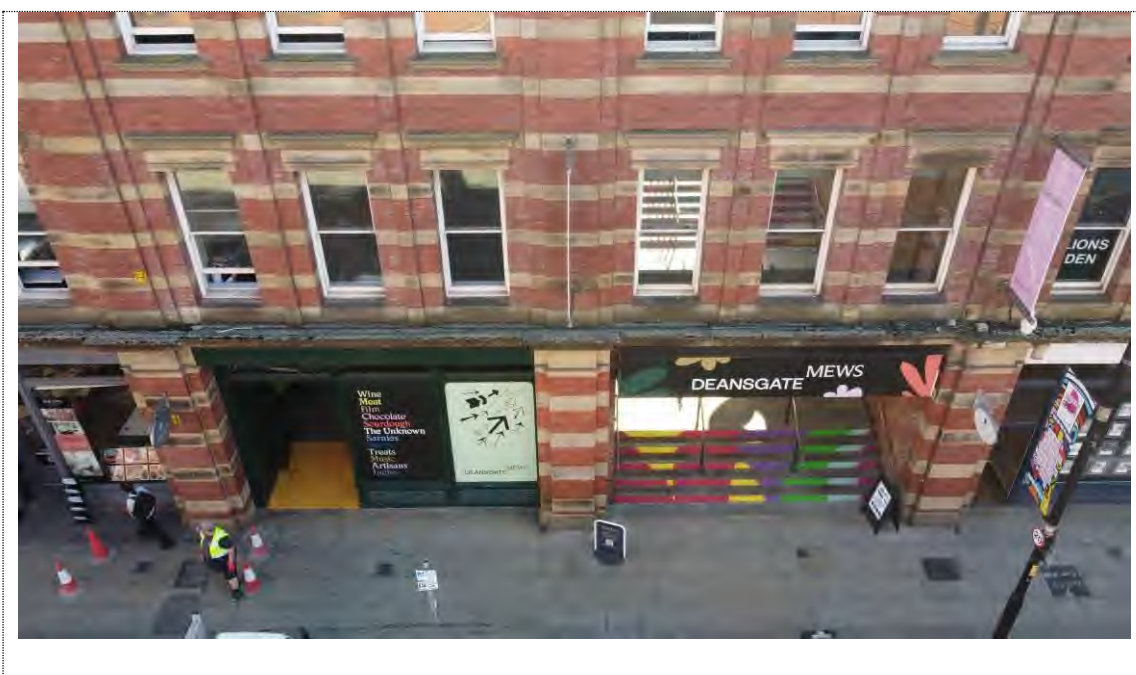
| Photograph: | 24 |

| Description: | Redress spalling stone to a sound surface. Cut out defective stone and replace new matching stone. (West facing) |

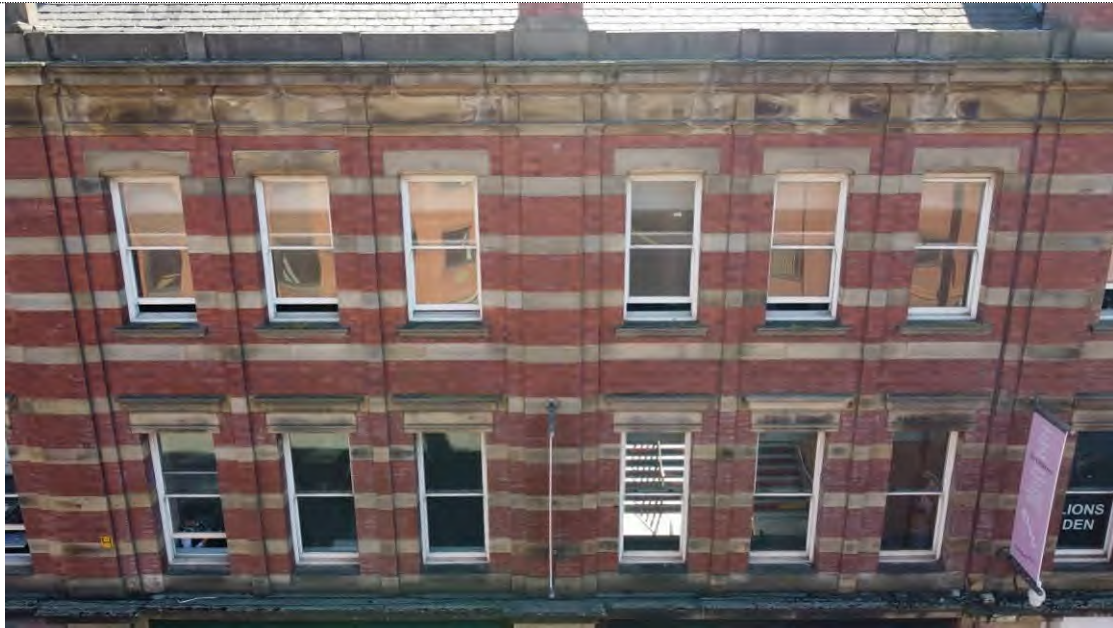
| Photograph: | 25 |

| Description: | Redress spalling stone to a sound surface. Cut out defective stone and replace new matching stone. (West facing) |

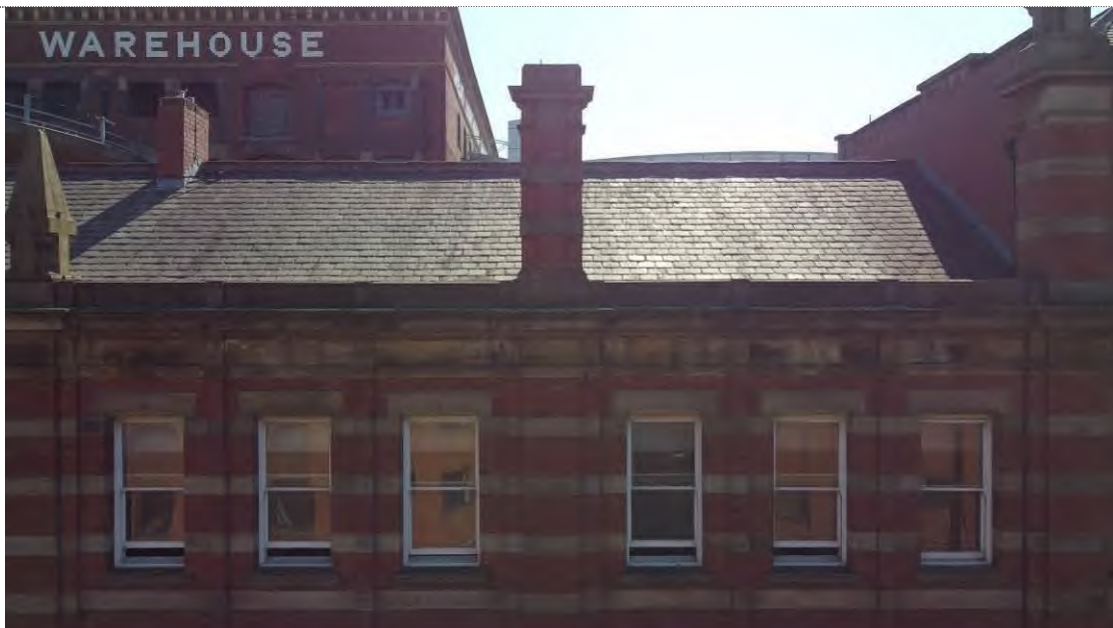
| Photograph: | 26 |

| Description: | Redress spalling stone to a sound surface. Cut out defective stone and replace new matching stone. (West facing) |

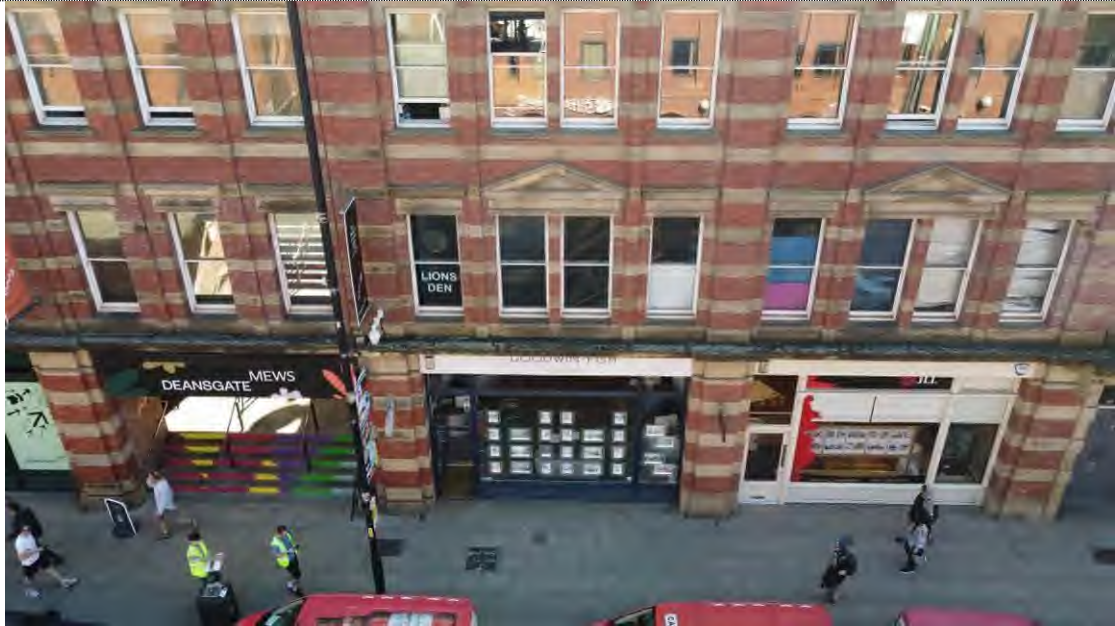
| Photograph: | 27 |

| Description: | Redress spalling stone to a sound surface. Cut out defective stone and replace new matching stone. (West facing) |

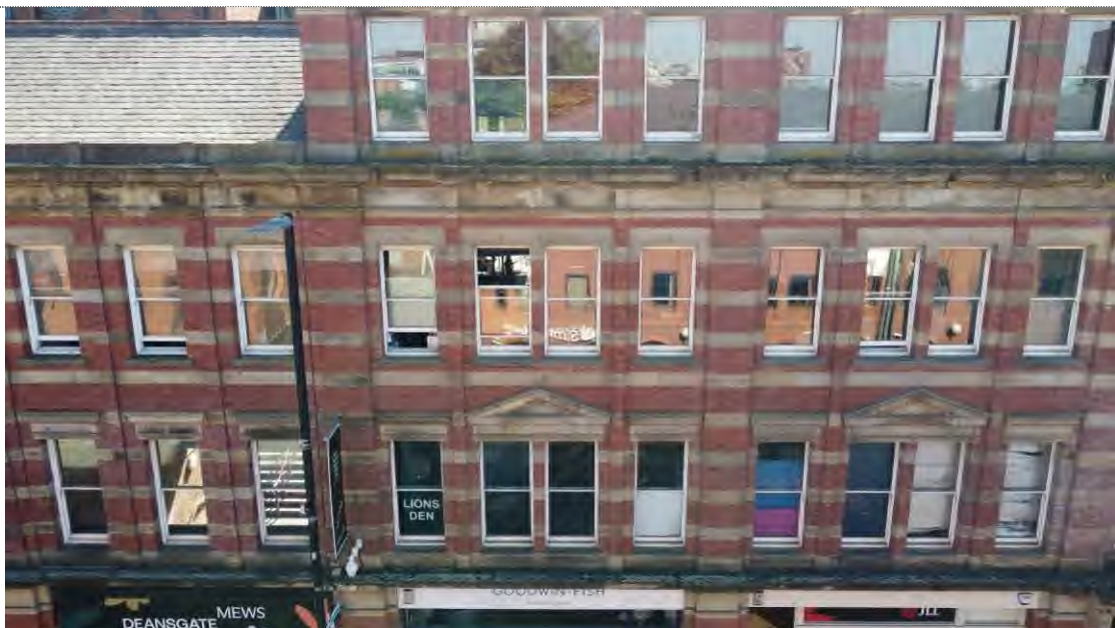
| Photograph: | 28 |

| Description: | Redress spalling stone to a sound surface. Cut out defective stone and replace new matching stone. (West facing) |

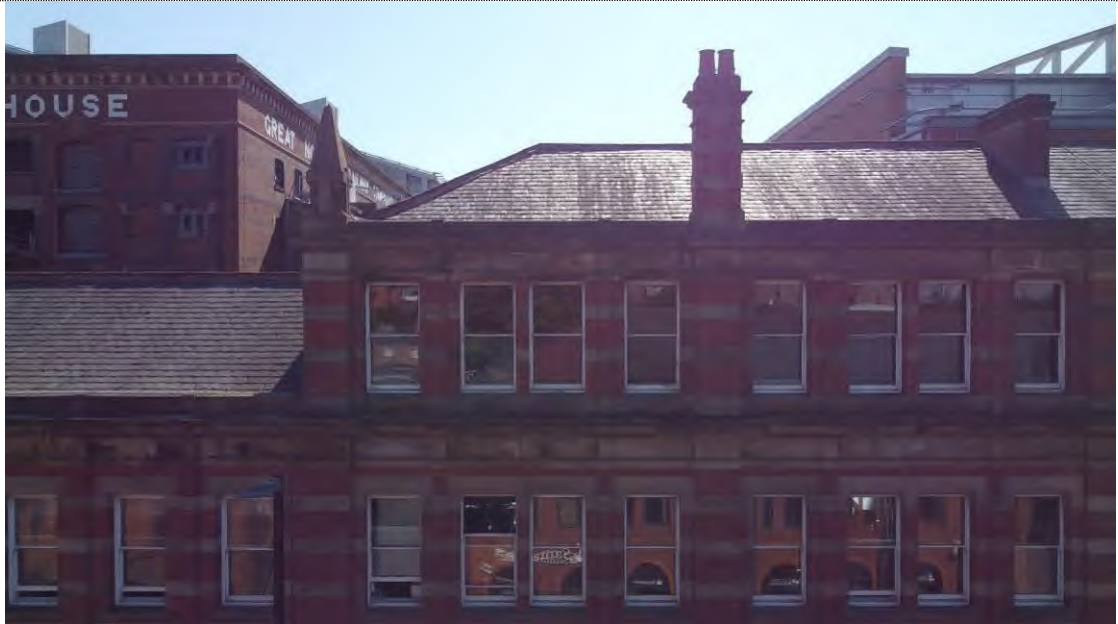
| Photograph: | 29 |

| Description: | Redress spalling stone to a sound surface. Cut out defective stone and replace new matching stone. (West facing) |

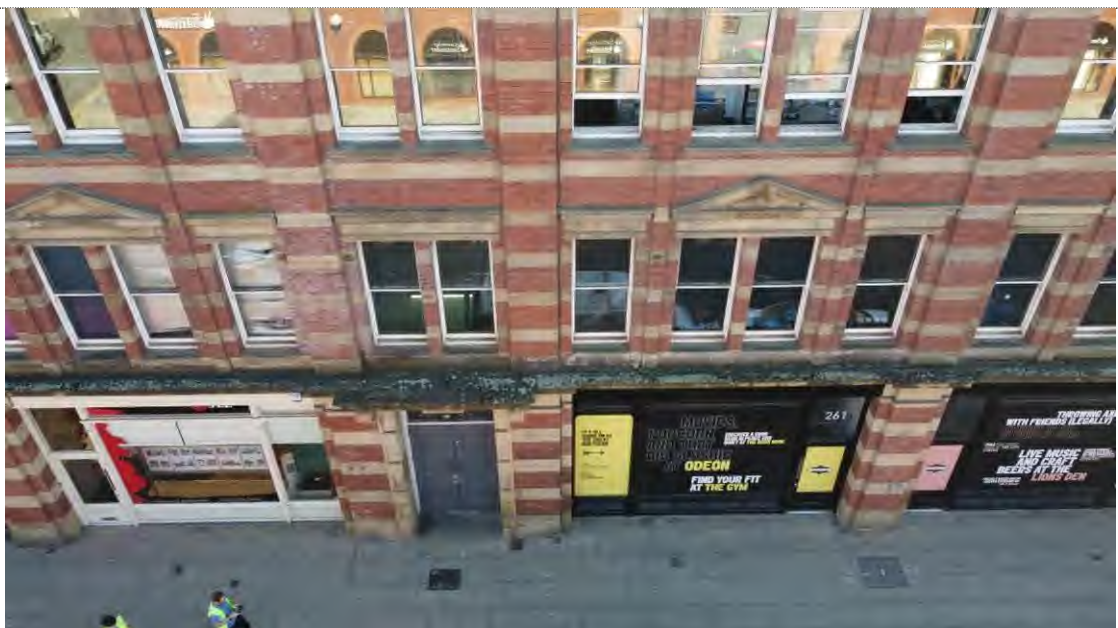
| Photograph: | 30 |

| Description: | Redress spalling stone to a sound surface. Cut out defective stone and replace new matching stone. (West facing) |

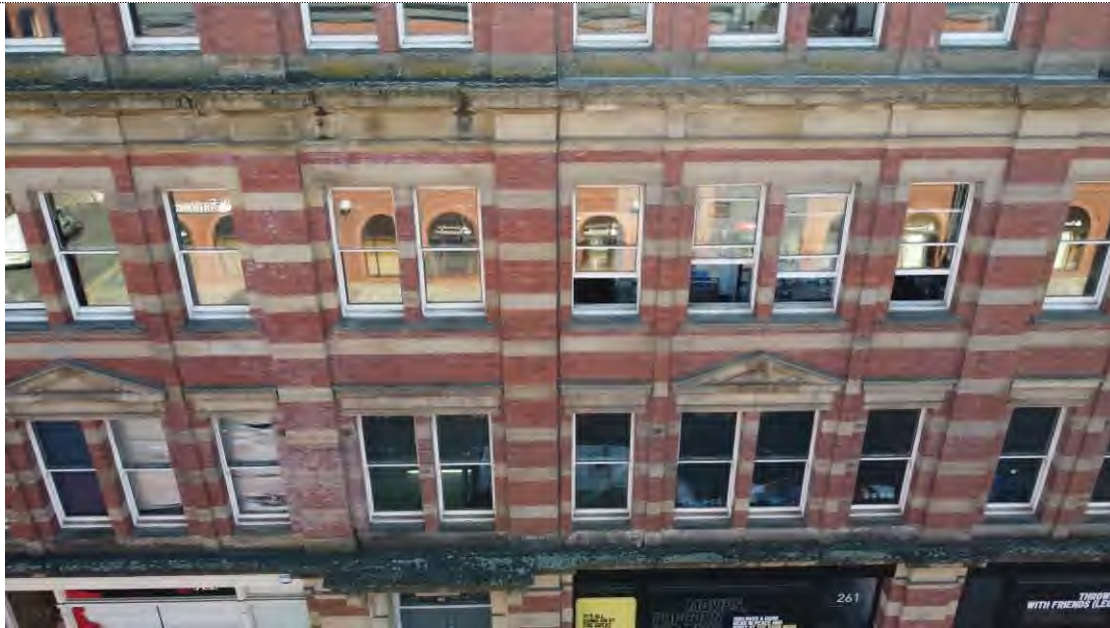
| Photograph: | 31 |

| Description: | Redress spalling stone to a sound surface. Cut out defective stone and replace new matching stone. (West facing) |

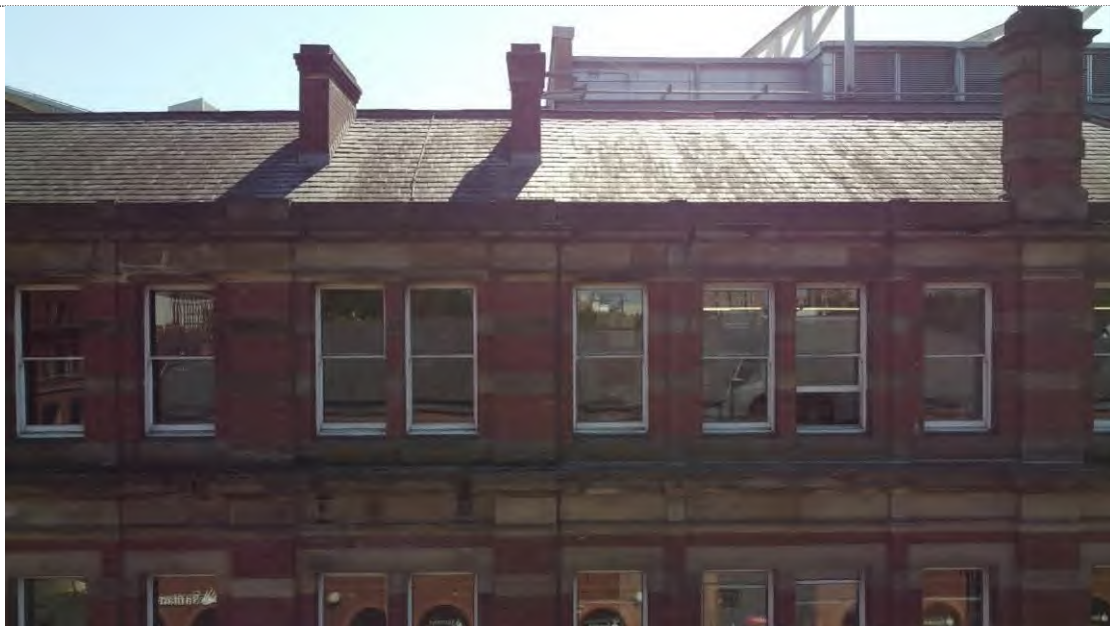
| Photograph: | 32 |

| Description: | Redress spalling stone to a sound surface. Cut out defective stone and replace new matching stone. (West facing) |

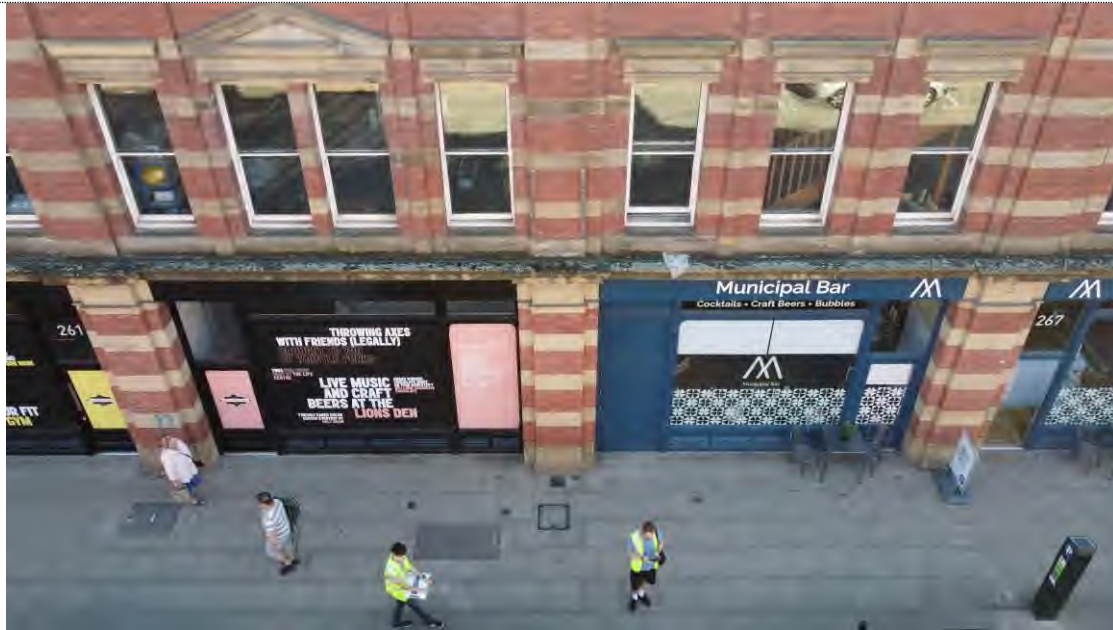
| Photograph: | 33 |

| Description: | Redress spalling stone to a sound surface. Cut out defective stone and replace new matching stone. (West facing) |

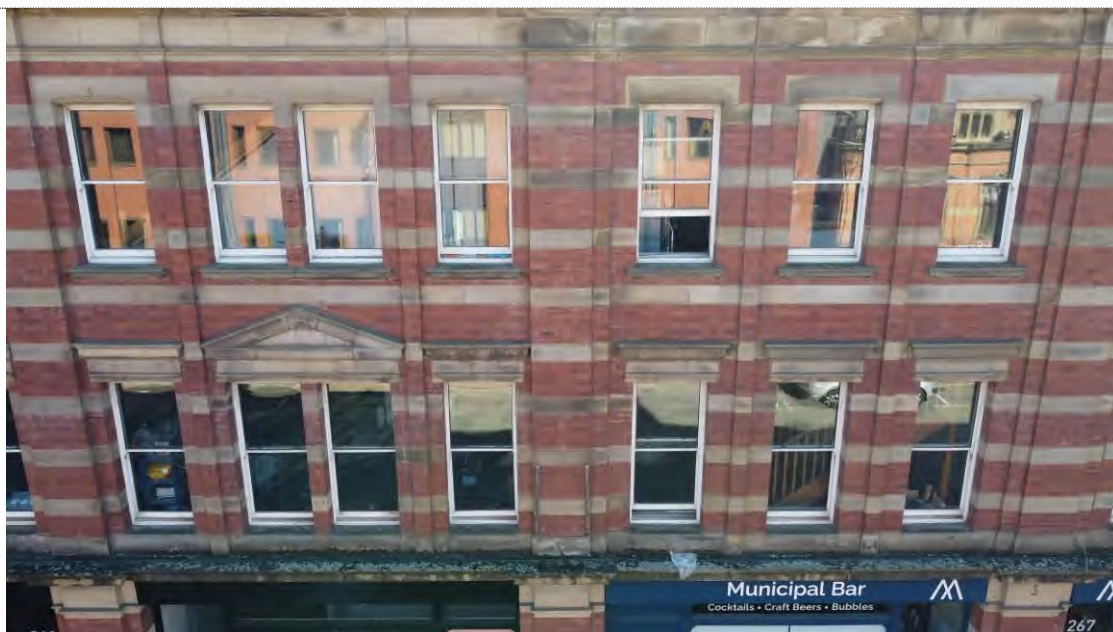
| Photograph: | 34 |

| Description: | Redress spalling stone to a sound surface. Cut out defective stone and replace new matching stone. (West facing) |

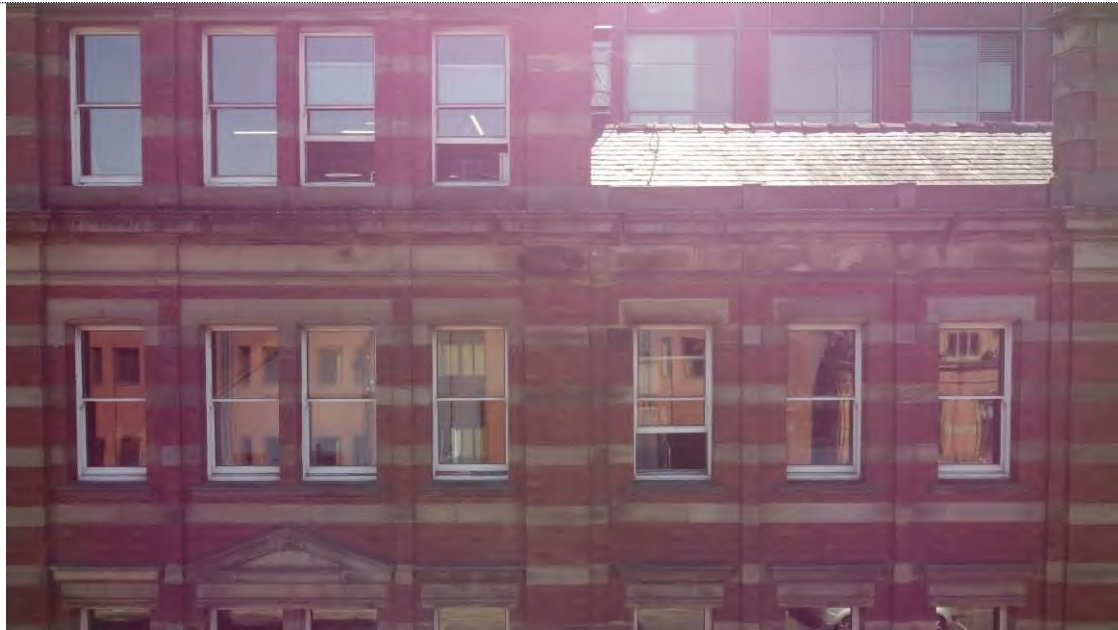
| Photograph: | 35 |

| Description: | Redress spalling stone to a sound surface. Cut out defective stone and replace new matching stone. (West facing) |

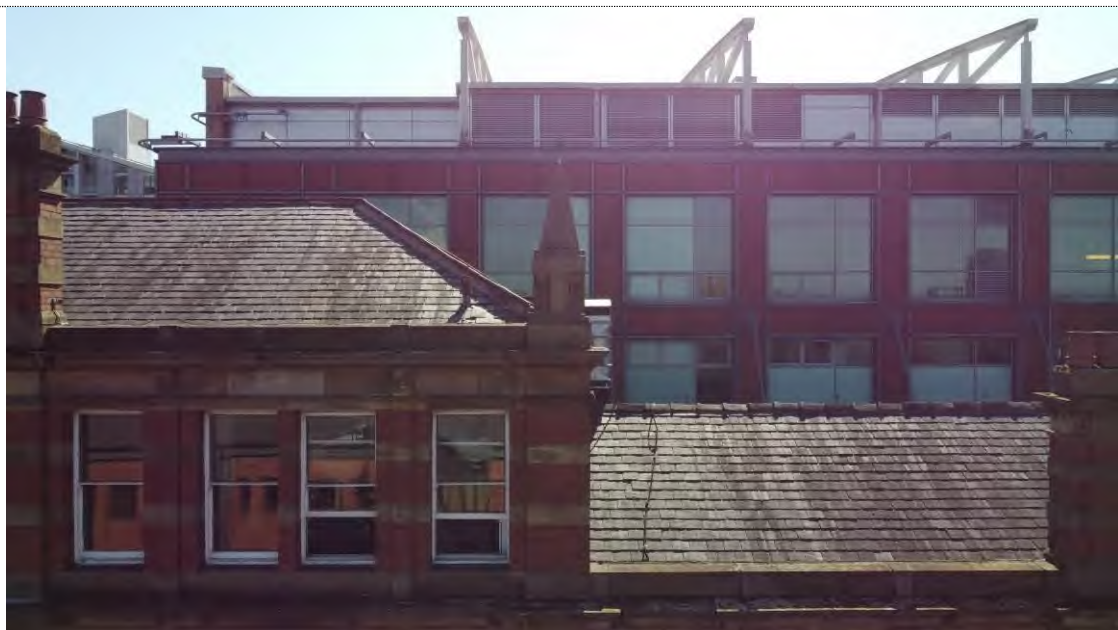
| Photograph: | 36 |

| Description: | Redress spalling stone to a sound surface. Cut out defective stone and replace new matching stone. (West facing) |

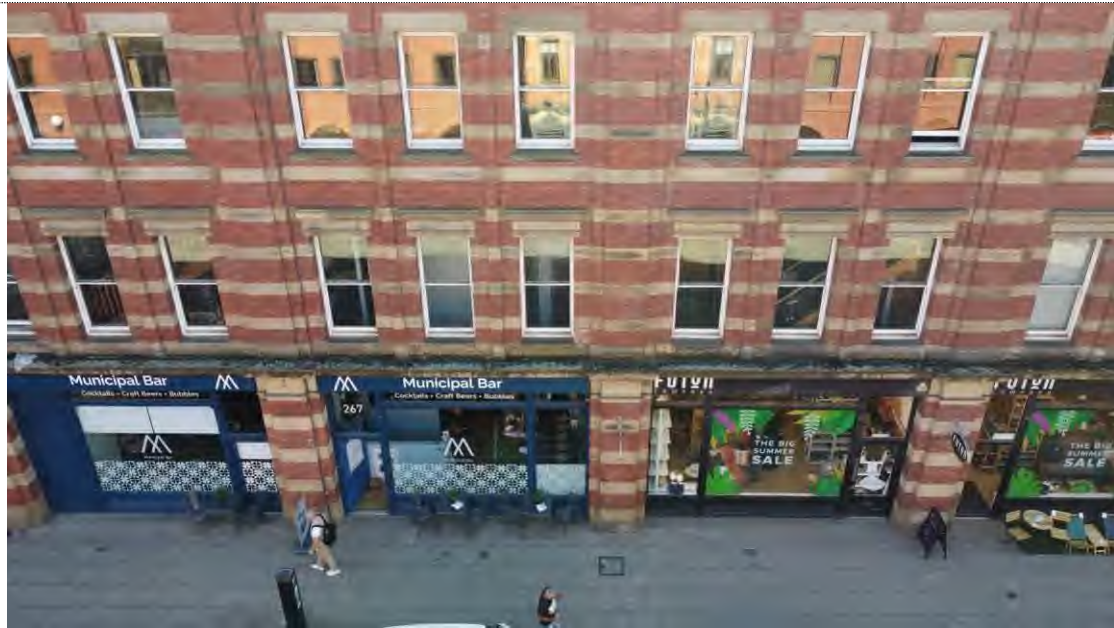
| Photograph: | 37 |

| Description: | Redress spalling stone to a sound surface. Cut out defective stone and replace new matching stone. (West facing) |

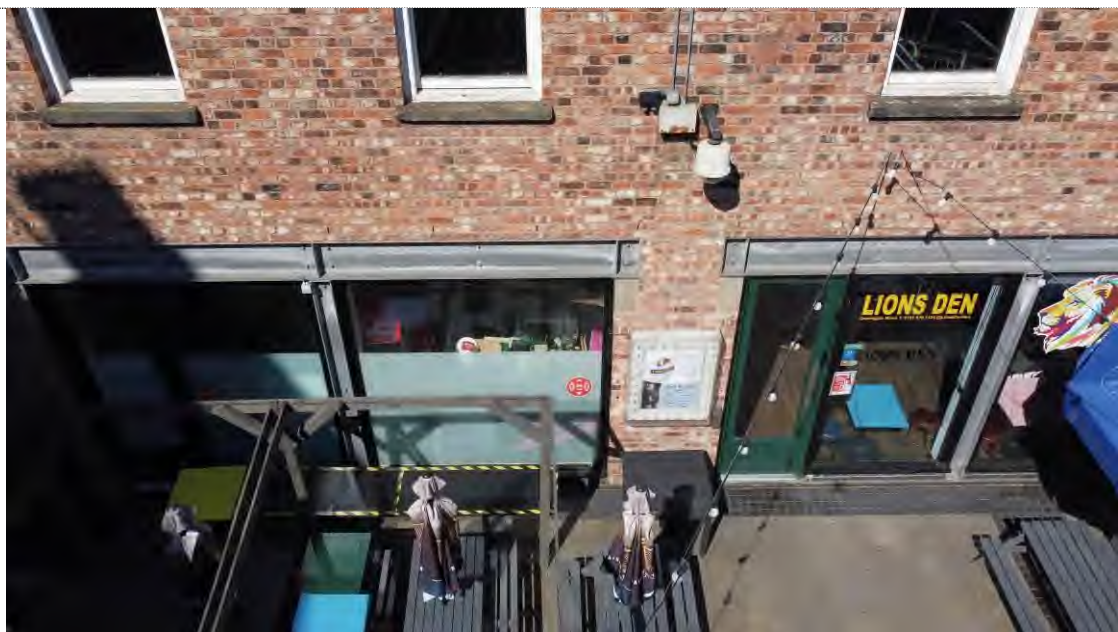
| Photograph: | 111 |

| Description: | Doff clean all areas of brickwork and stonework. Rake out defective and open joints of the brickwork and repoint. Damaged flashing. (East facing) |
