**The Great Northern Warehouse**

**Survey 2022**

**Great Northern Warehouse & Deansgate Terraces, Manchester**

**Condition Survey**

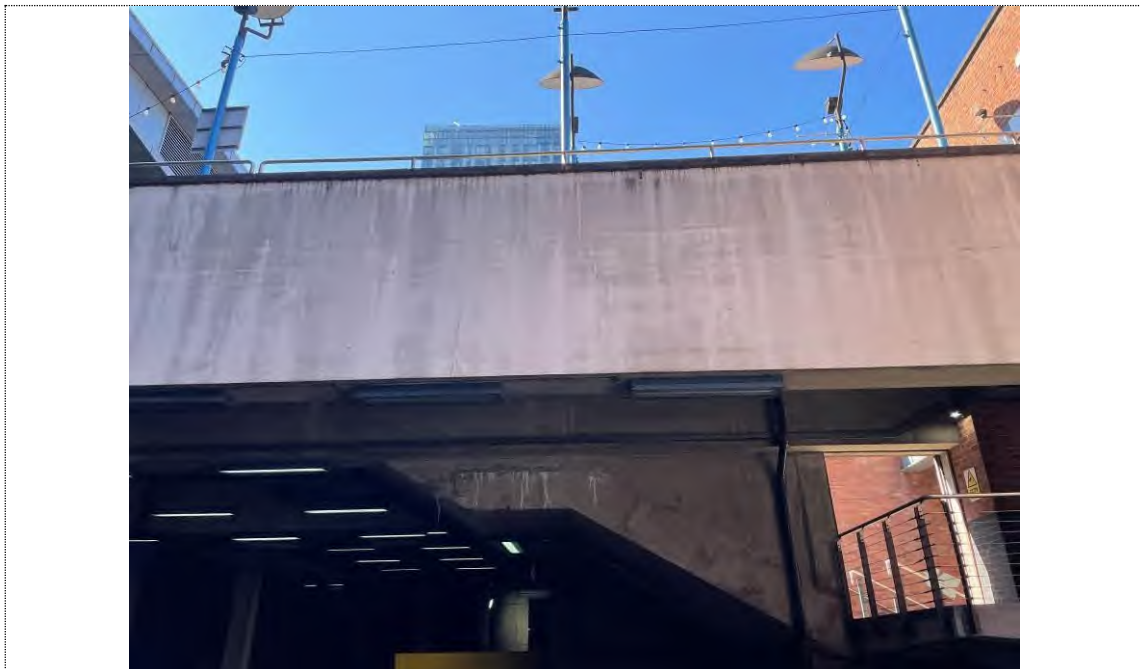
| Photograph: | 126 |

| Description: | Doff clean all areas of brickwork and stonework. (North facing elevation) |

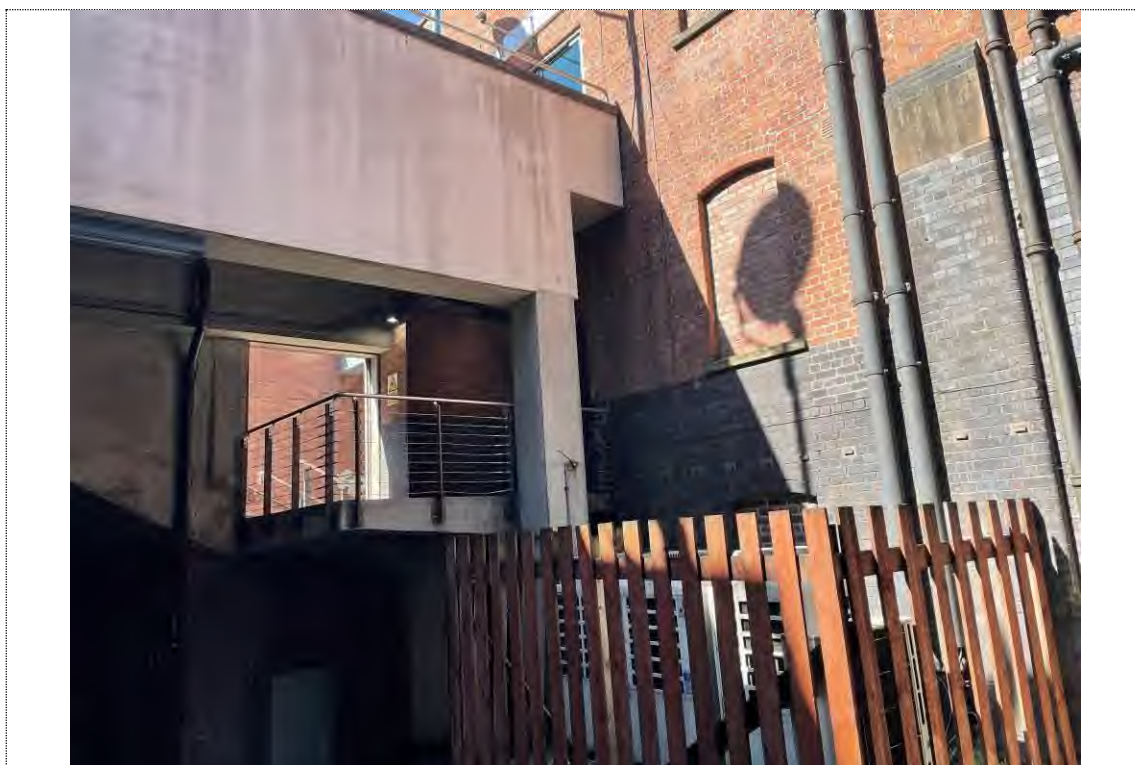
| Photograph: | 127 |

| Description: | Doff clean all areas of brickwork and stonework. (North facing elevation) |

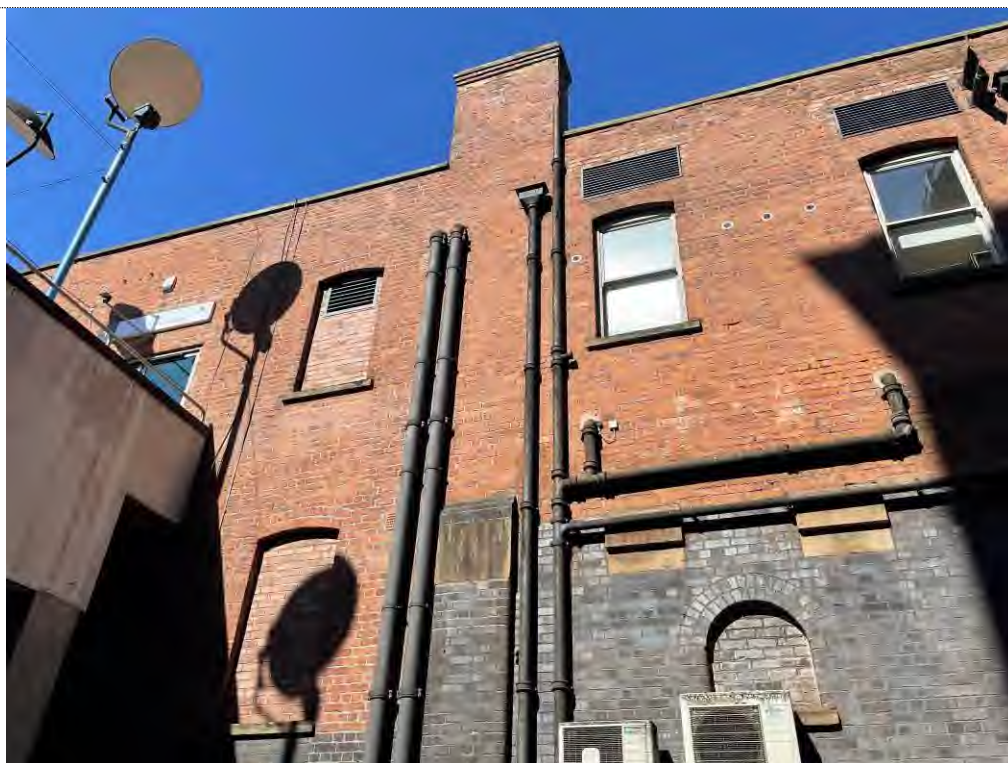
| Photograph: | 131 |

| Description: | Doff clean all areas of brickwork and stonework. Rake out defective and open joints of the brickwork and repoint. (East facing elevation) |

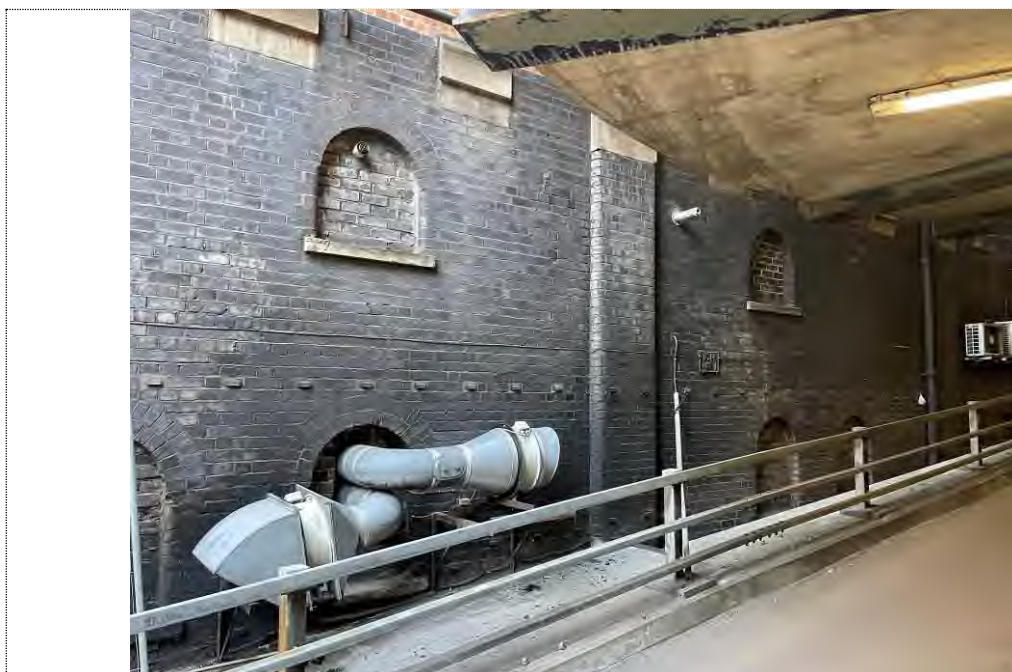
| Photograph: | 132 |

| Description: | Doff clean all areas of brickwork and stonework. Rake out defective and open joints of the brickwork and repoint. (East facing elevation) |

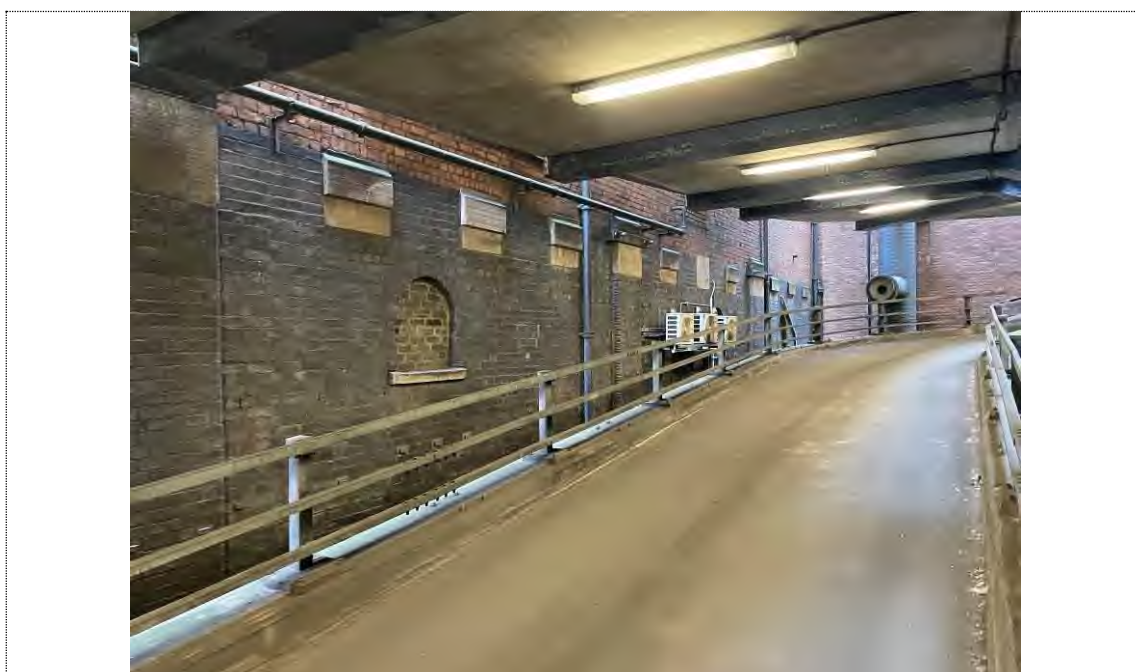
| Photograph: | 134 |

| Description: | General view of the rear elevation. Doff clean all areas of brickwork and stonework. (East facing elevation) |

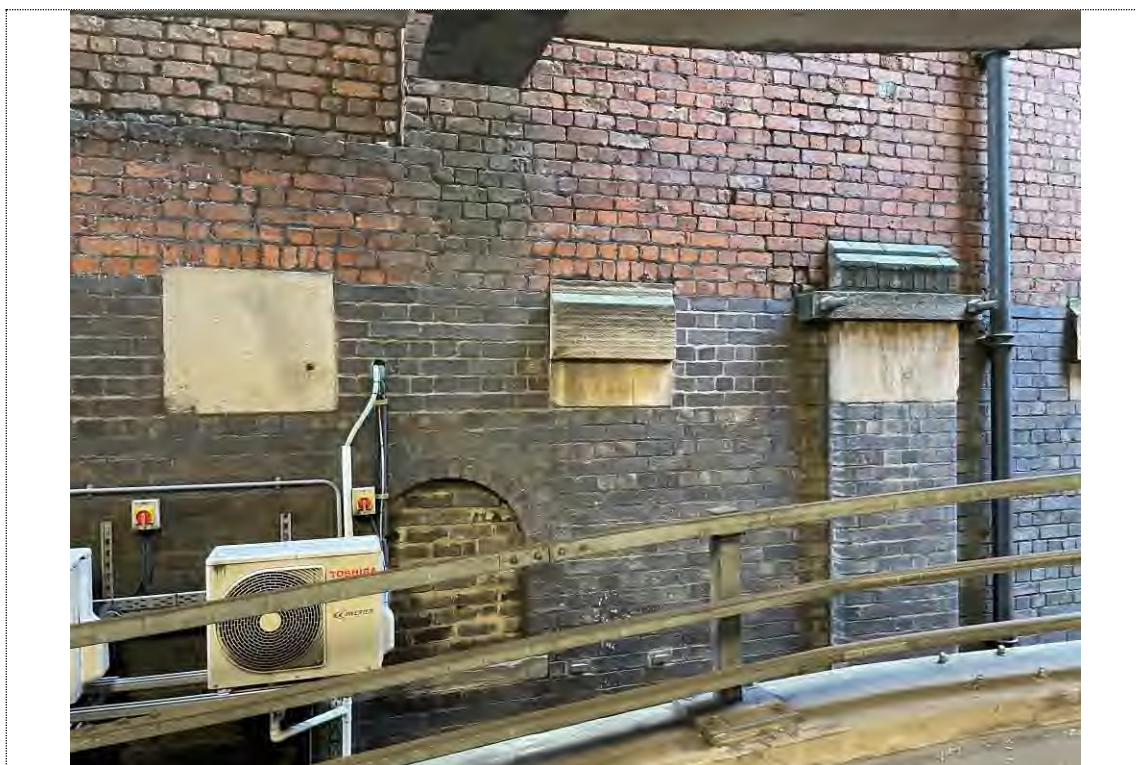
| Photograph: | 135 |

| Description: | Doff clean all areas of brickwork and stonework. (East facing elevation) |

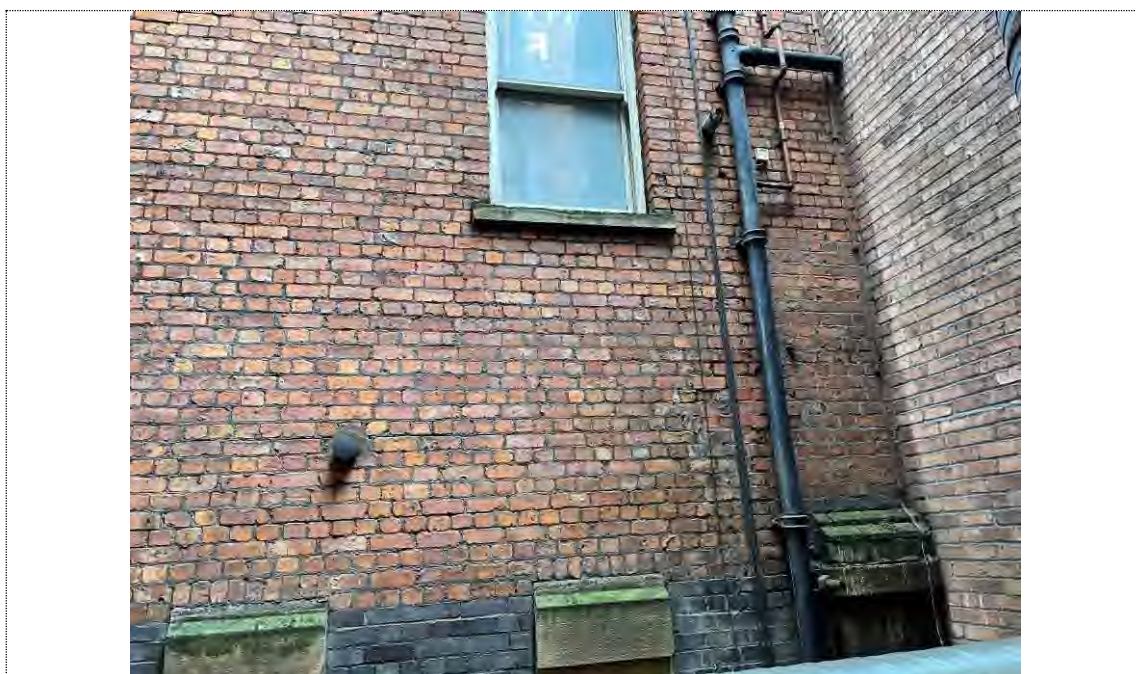
| Photograph: | 136 |

| Description: | Doff clean all areas of brickwork and stonework. (East facing elevation) |

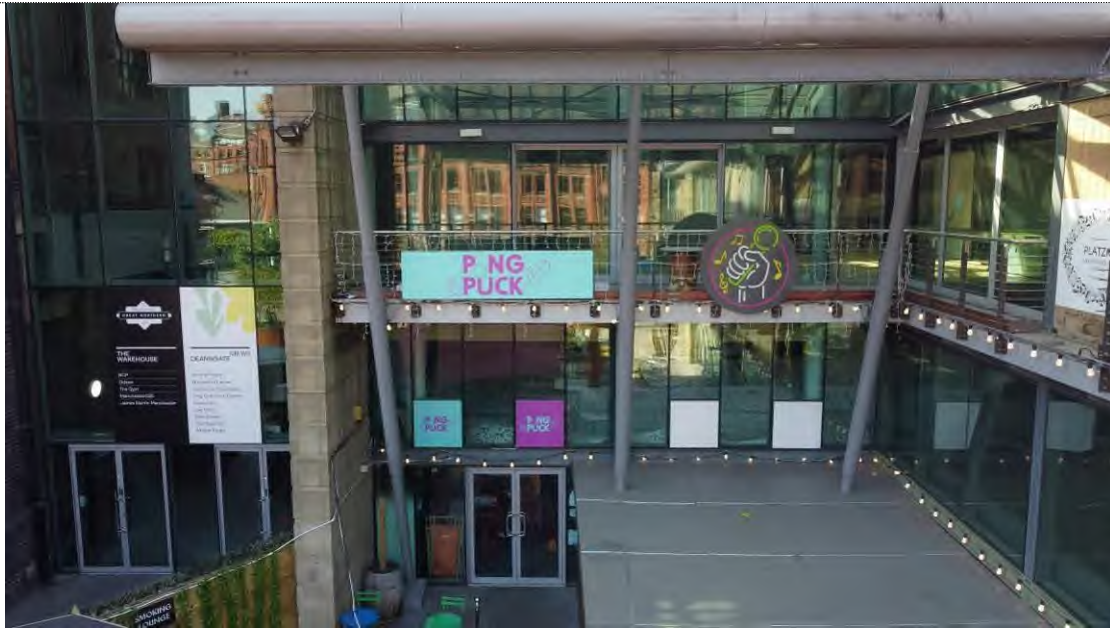
| Photograph: | 137 |

| Description: | Glazed shopfronts generally in good condition. (North facing elevation) |

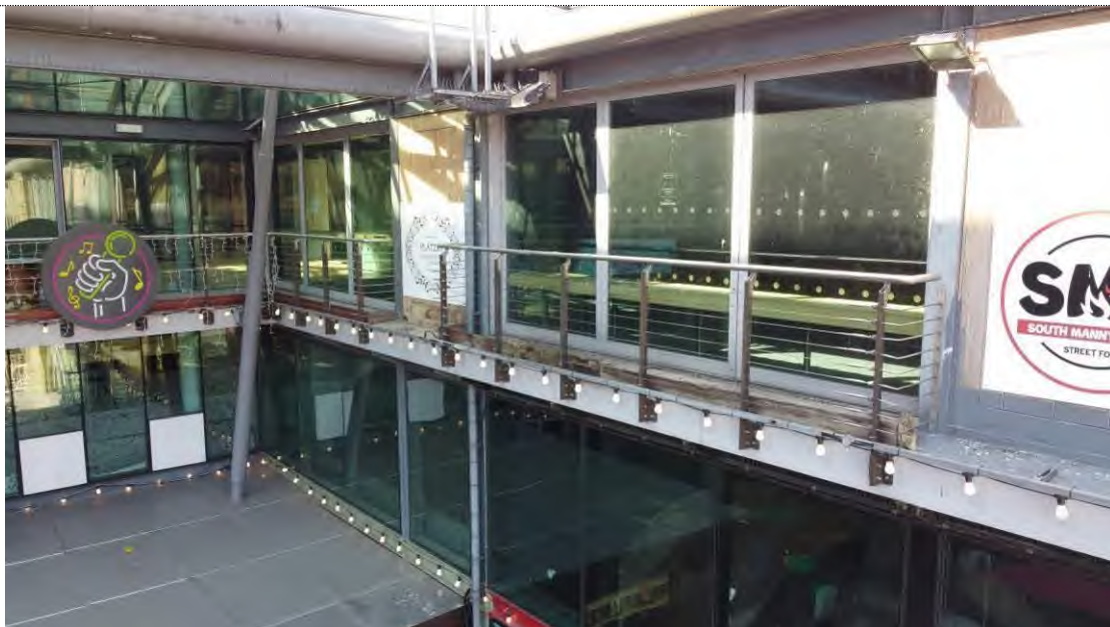
| Photograph: | 138 |

| Description: | Glazed shopfronts generally in good condition. (East facing elevation) |

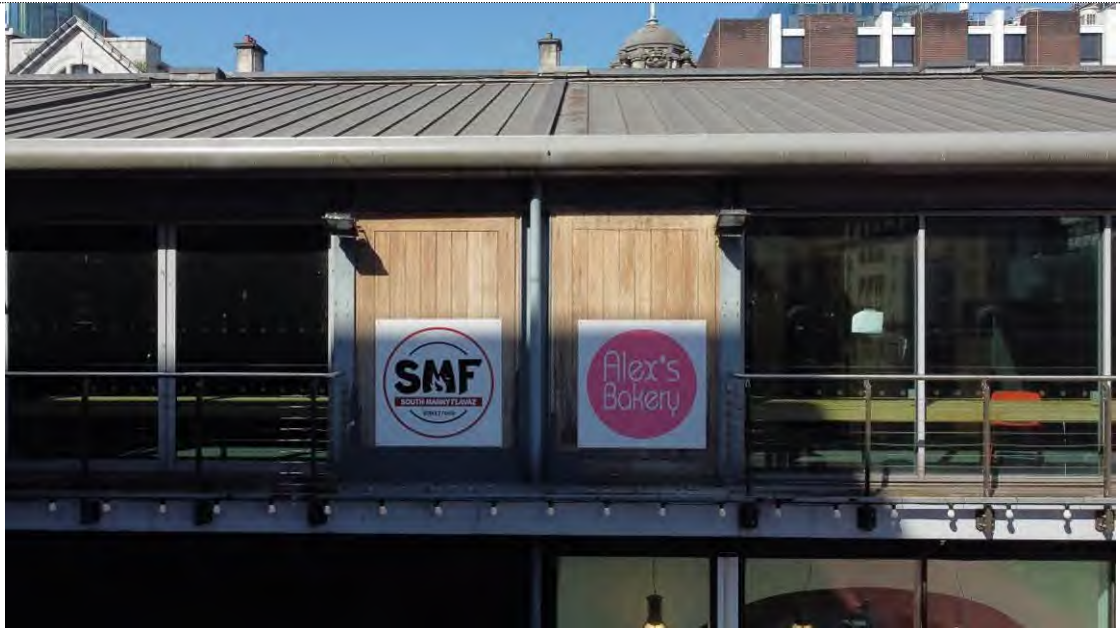
| Photograph: | 139 |

| Description: | Glazed shopfronts generally in good condition. (East facing elevation) |

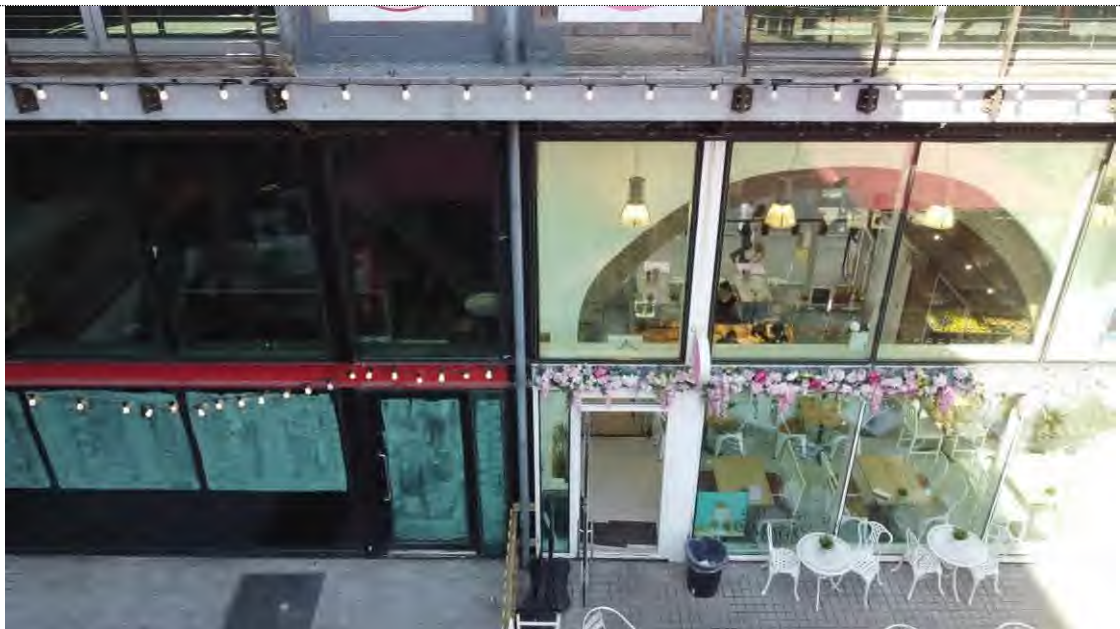
| Photograph: | 140 |

| Description: | Glazed shopfronts generally in good condition. (East facing elevation) |

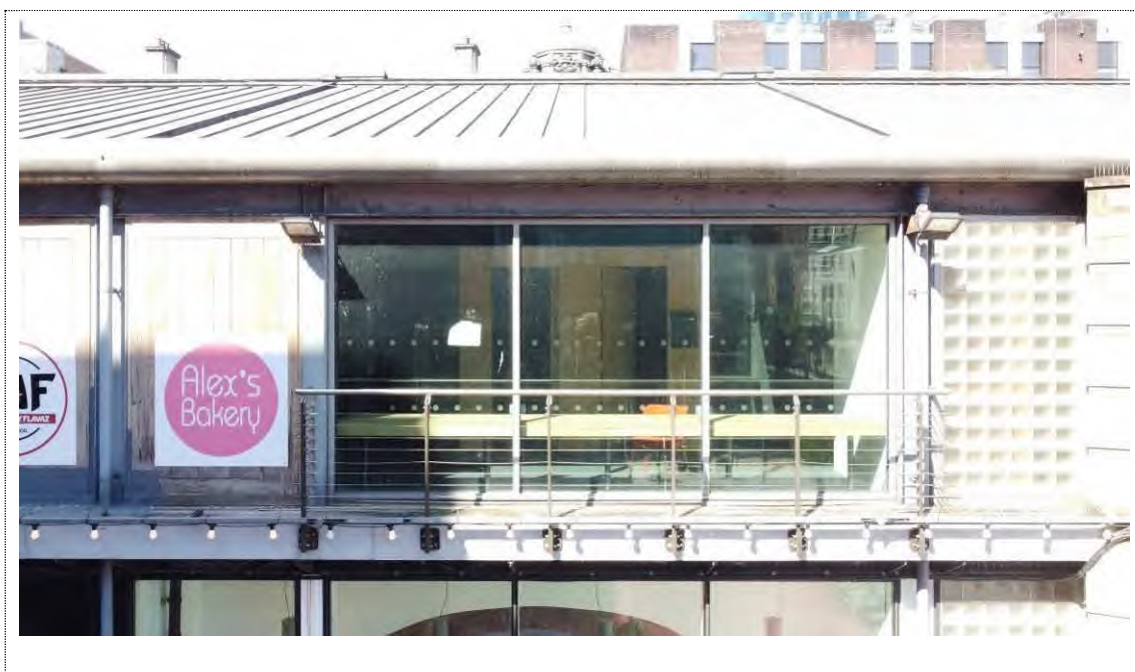
| Photograph: | 142 |

| Description: | Glazed shopfronts generally in good condition. (East facing elevation) |

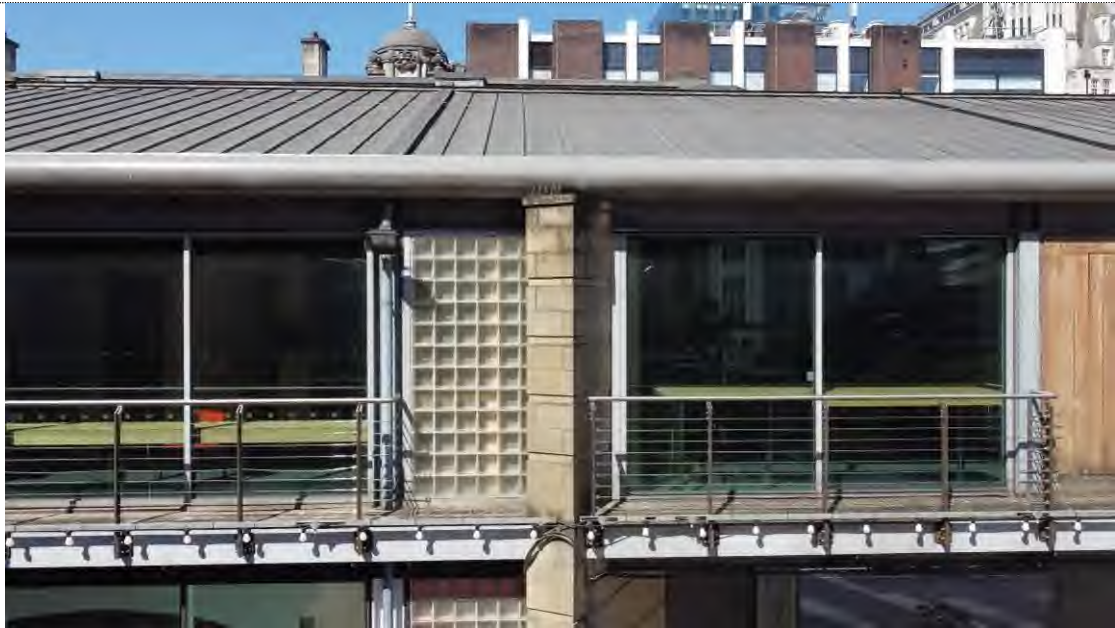
| Photograph: | 143 |

| Description: | Glazed shopfronts generally in good condition. (East facing elevation) |

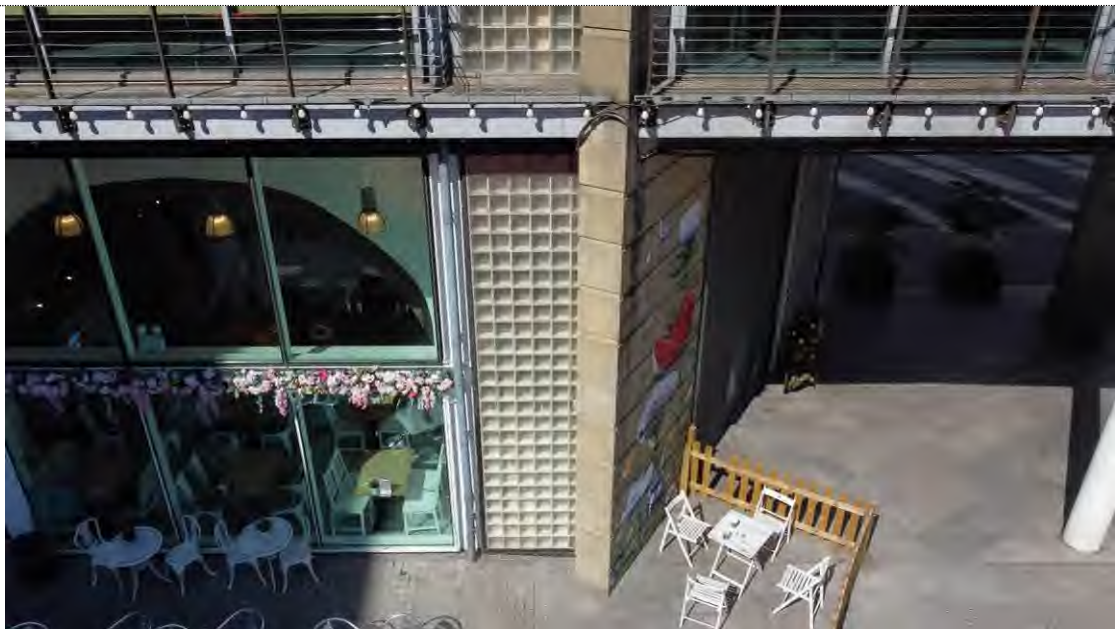
| Photograph: | 144 |

| Description: | Glazed shopfront generally in good condition. (East facing elevation) |

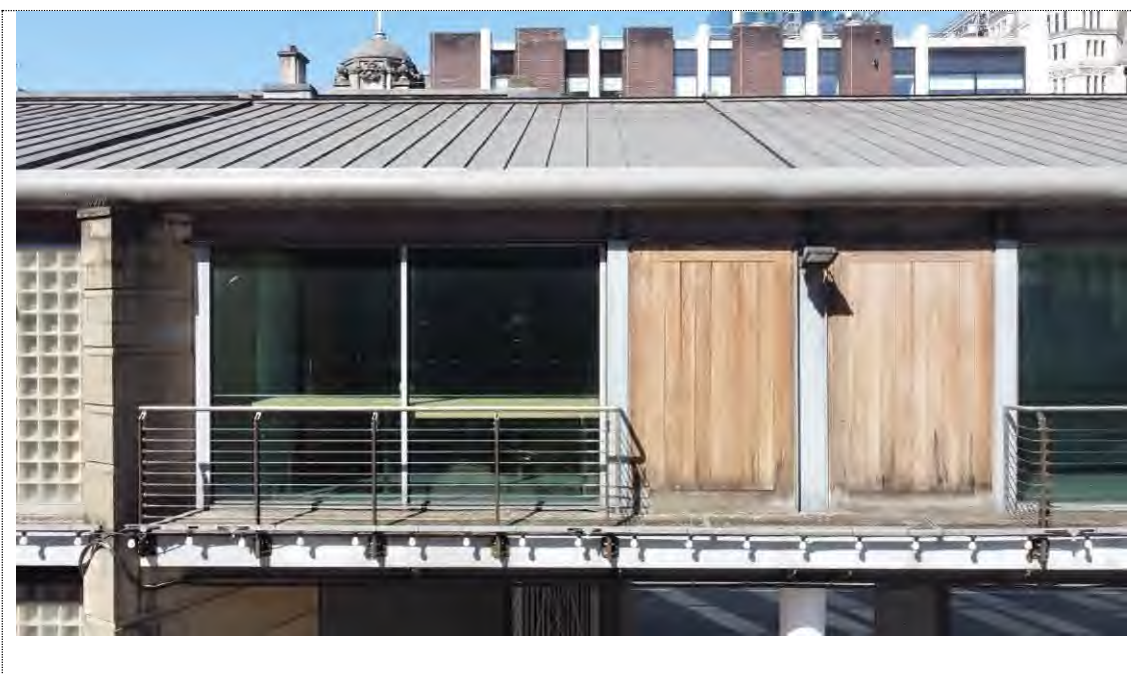
| Photograph: | 146 |

| Description: | Staining to timber cladding. (East facing elevation) |

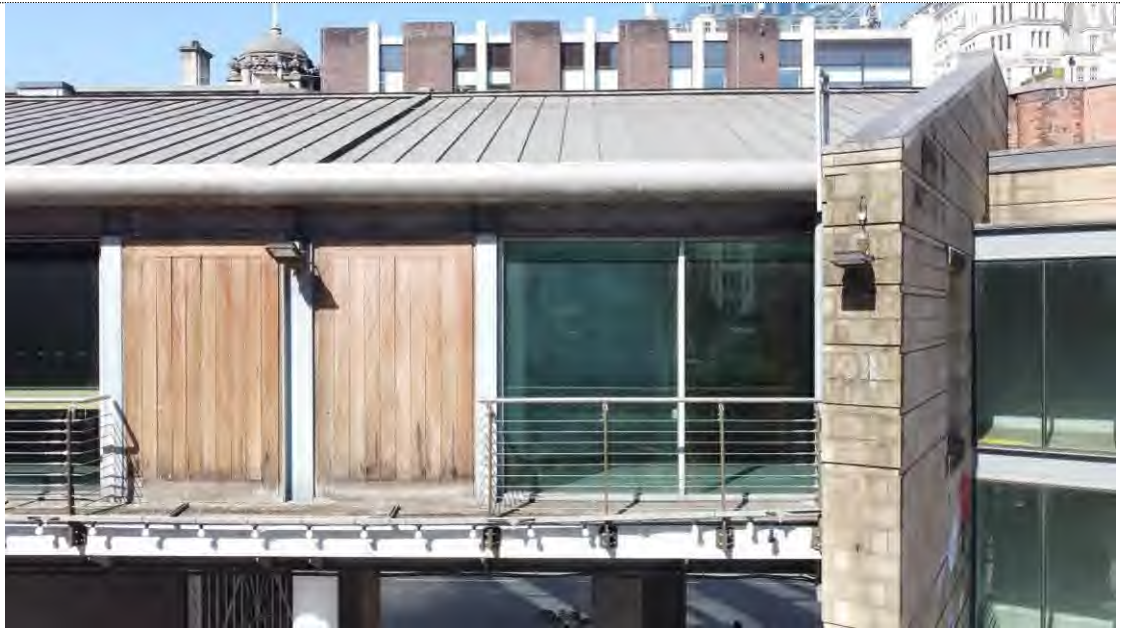
| Photograph: | 147 |

| Description: | Staining to timber cladding (East facing elevation) |

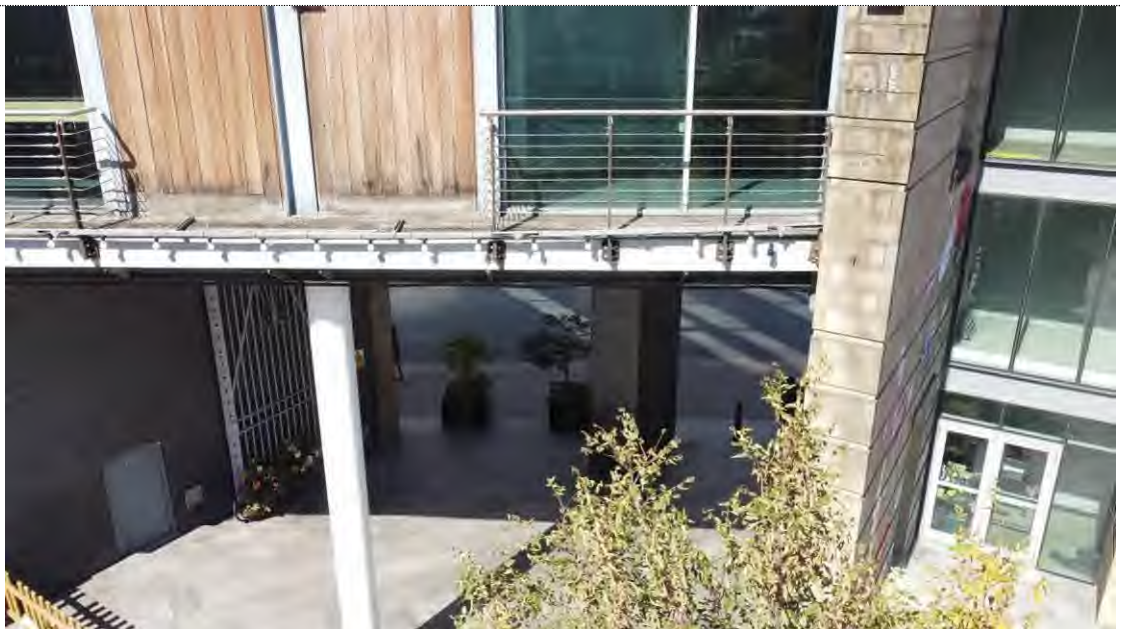
| Photograph: | 148 |

| Description: | Staining to timber cladding. (East facing elevation) |

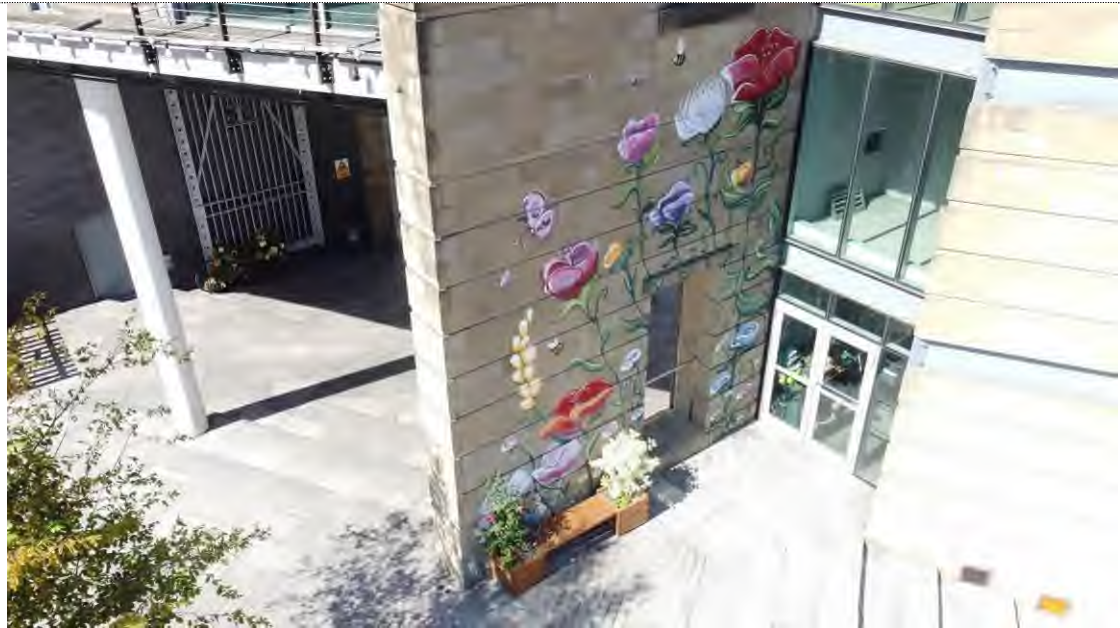
| Photograph: | 149 |

| Description: | Doff clean all areas of brickwork and stonework. (East facing elevation) |

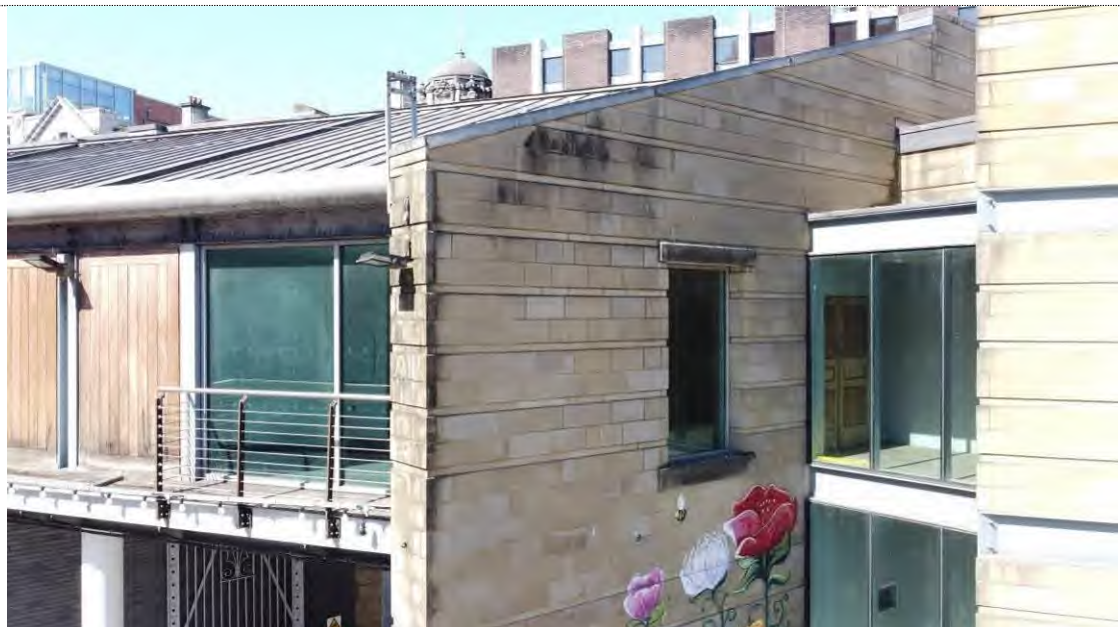
| Photograph: | 150 |

| Description: | Doff clean all areas of brickwork and stonework (East facing elevation) |

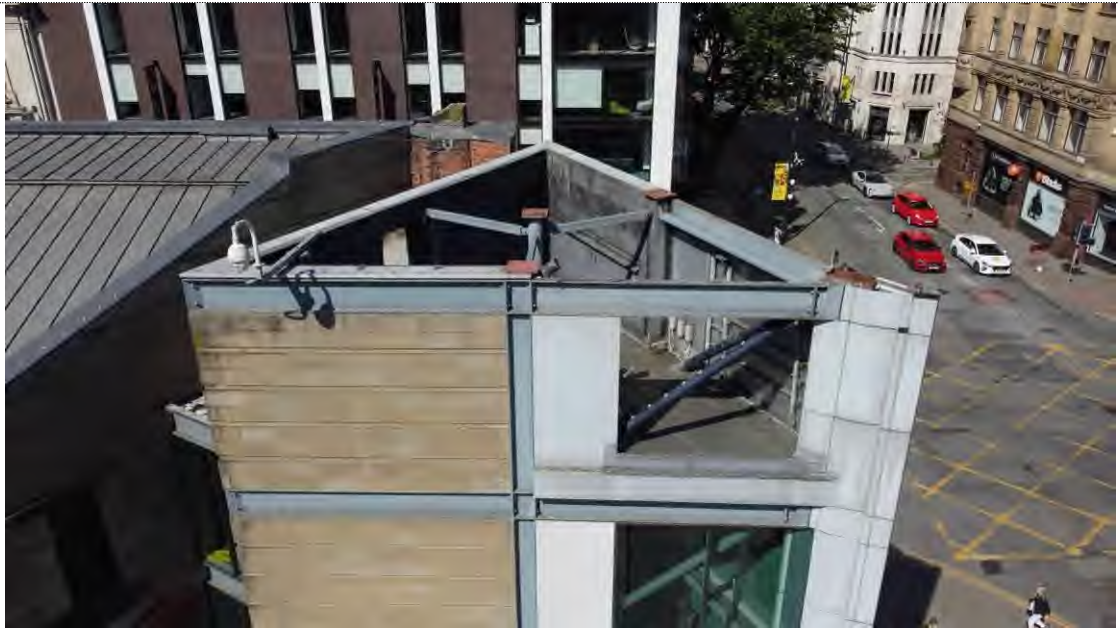
| Photograph: | 151 |

| Description: | Doff clean all areas of brickwork and stonework. (East facing elevation) |

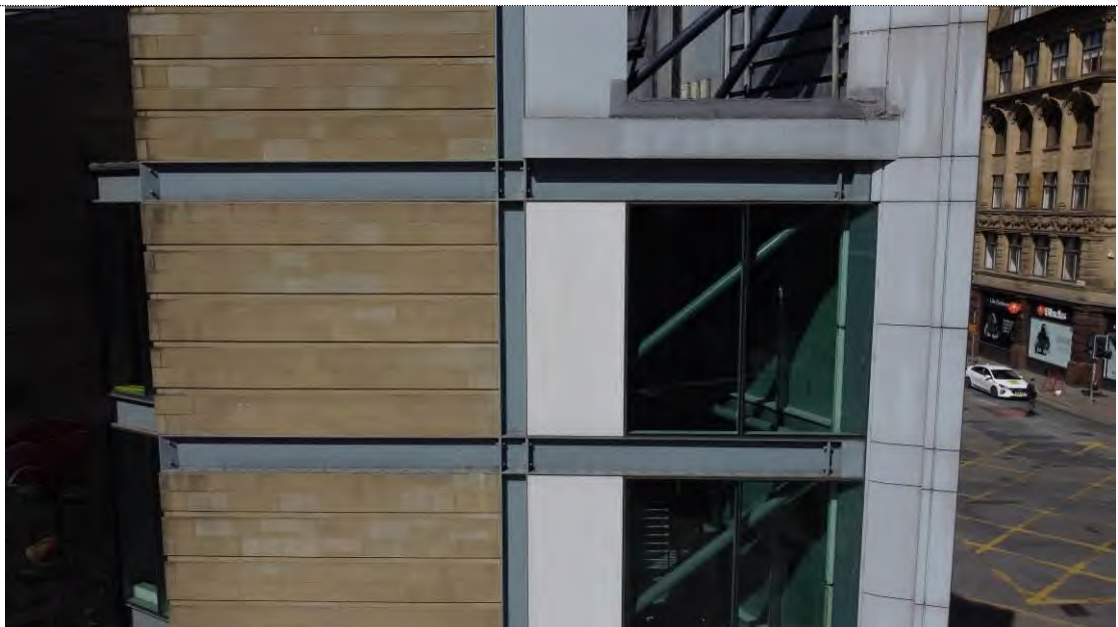
| Photograph: | 152 |

| Description: | Doff clean all areas of brickwork and stonework. (East facing elevation) |

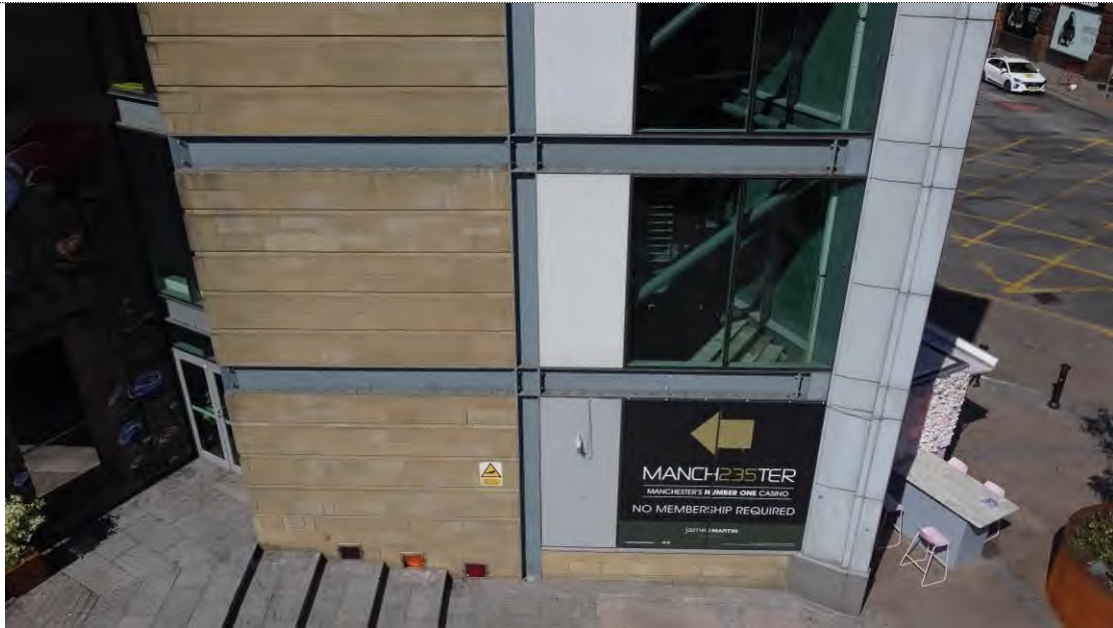
| Photograph: | 153 |

| Description: | Doff clean all areas of brickwork and stonework. (East facing elevation) |

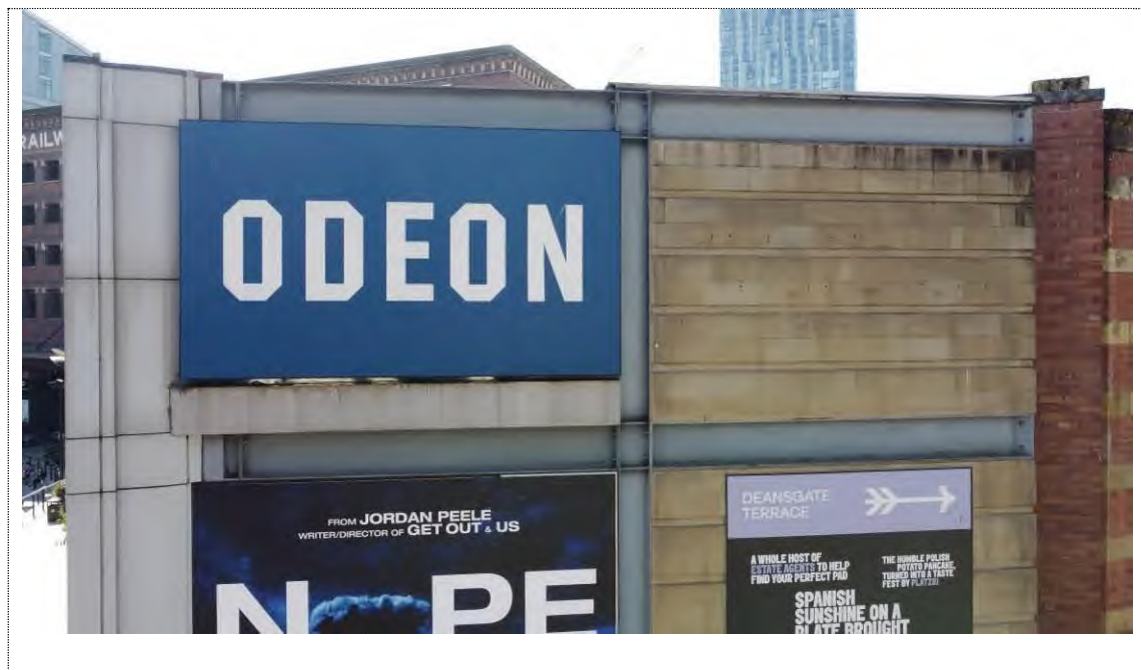
| Photograph: | 154 |

| Description: | Doff clean all areas of brickwork and stonework. (South-west facing elevation) |

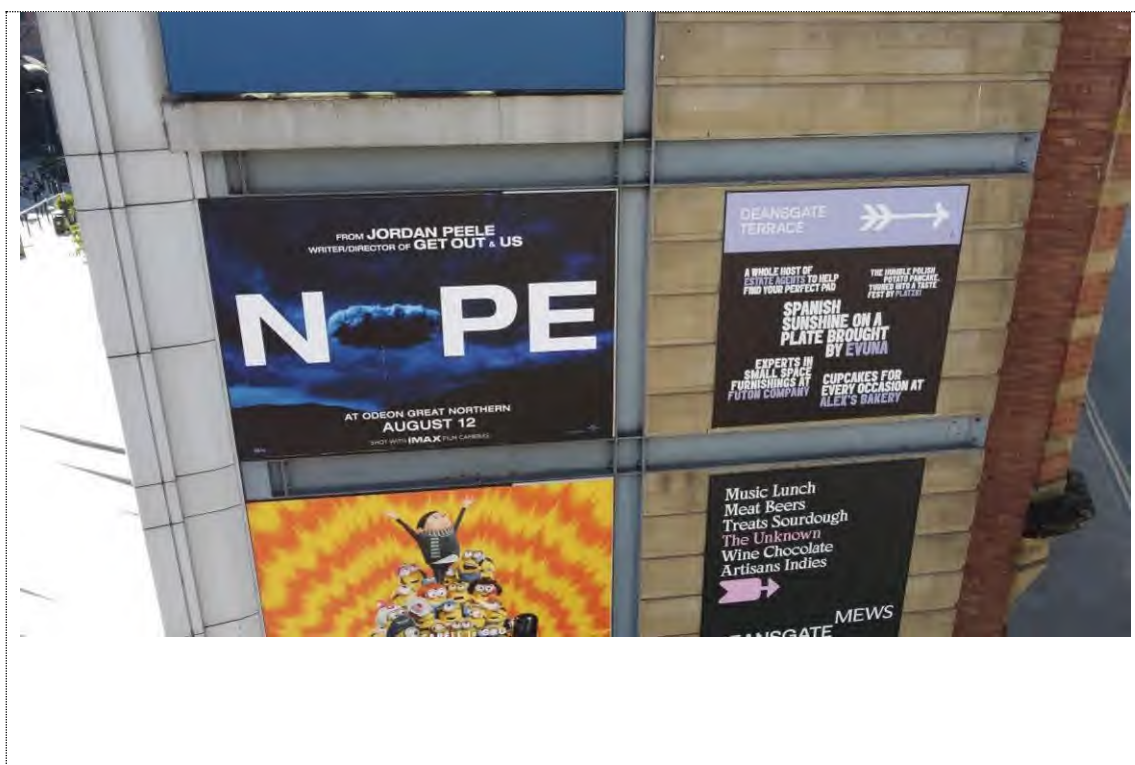
| Photograph: | 155 |

| Description: | Doff clean all areas of brickwork and stonework. (South-west facing elevation) |

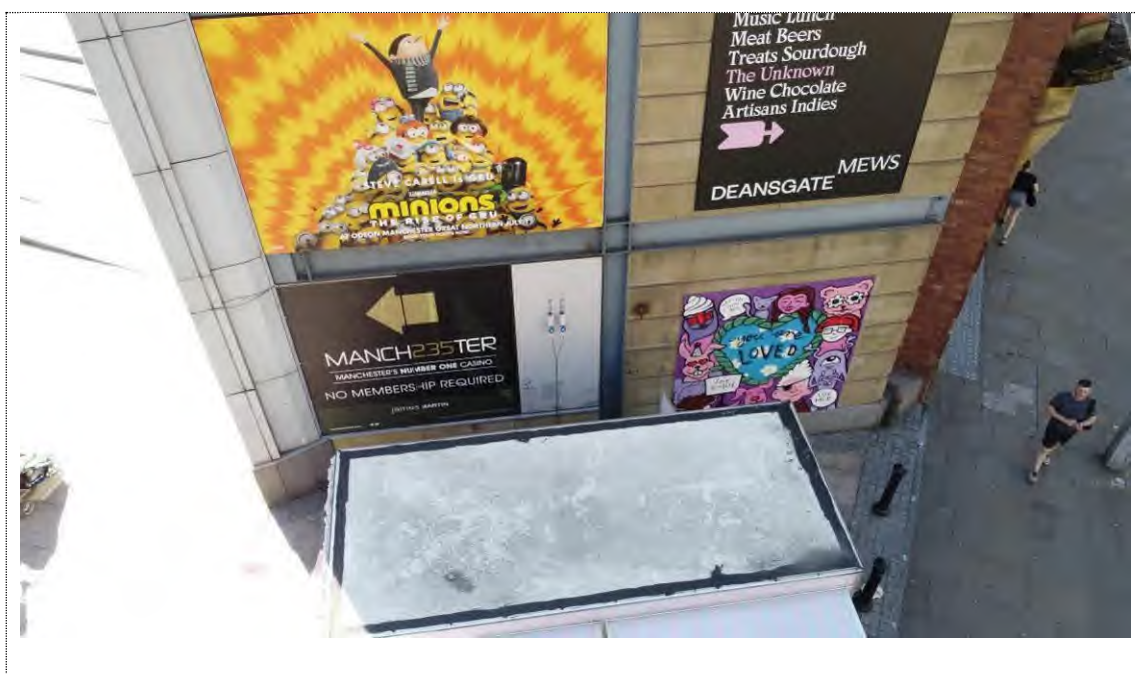
| Photograph: | 156 |

| Description: | Doff clean all areas of brickwork and stonework. (South-west facing elevation) |

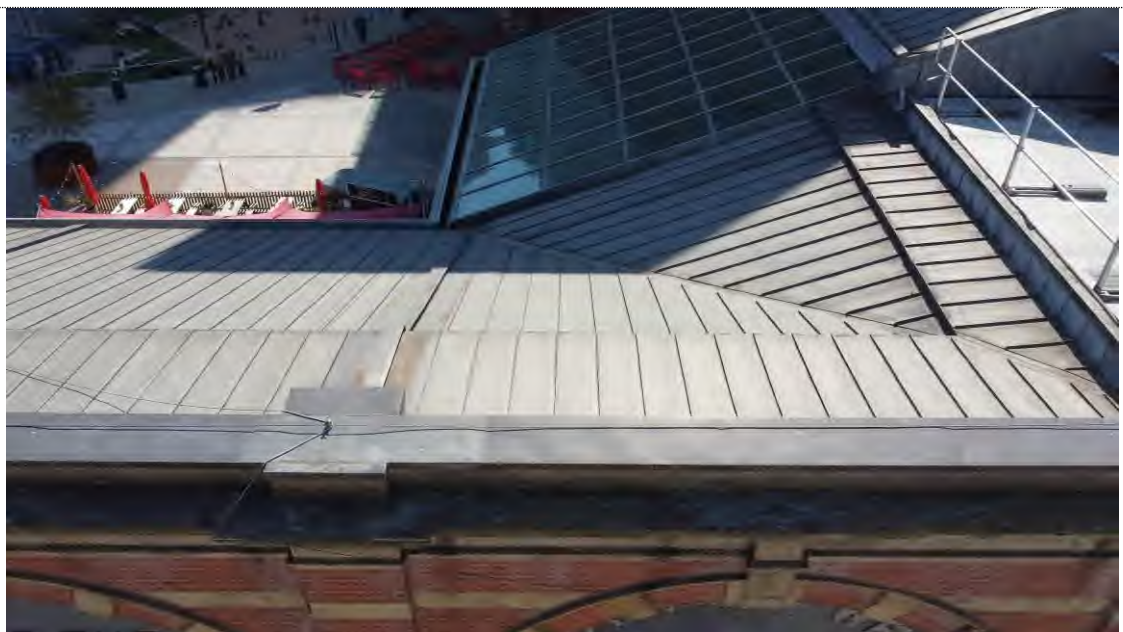
| Photograph: | 158 |

| Description: | General view of the roof. visible corrosion stains. (North facing side) |

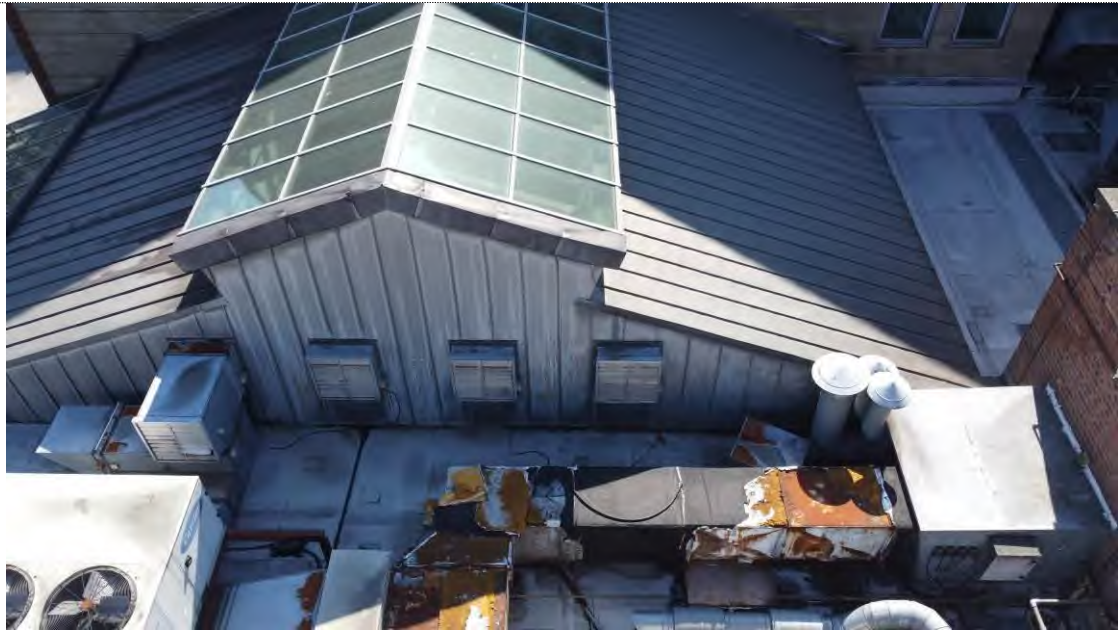
| Photograph: | 161 |

| Description: | General view of the roof. Visible weathering to equipment. |

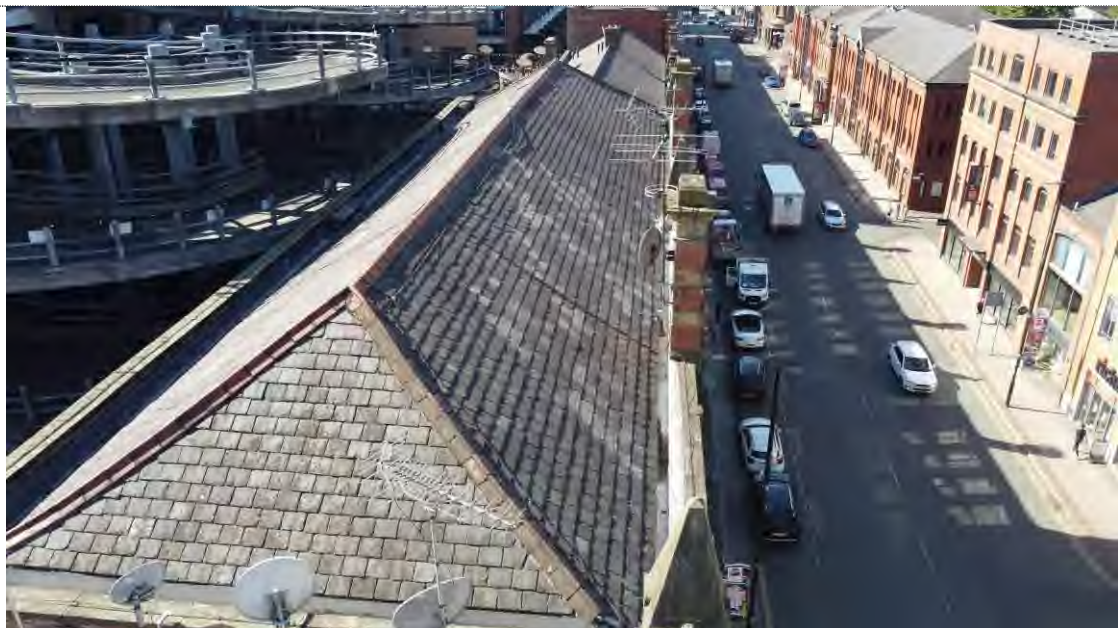
| Photograph: | 162 |

| Description: | General view of the roof. Visible discolouration to select roof slates. |

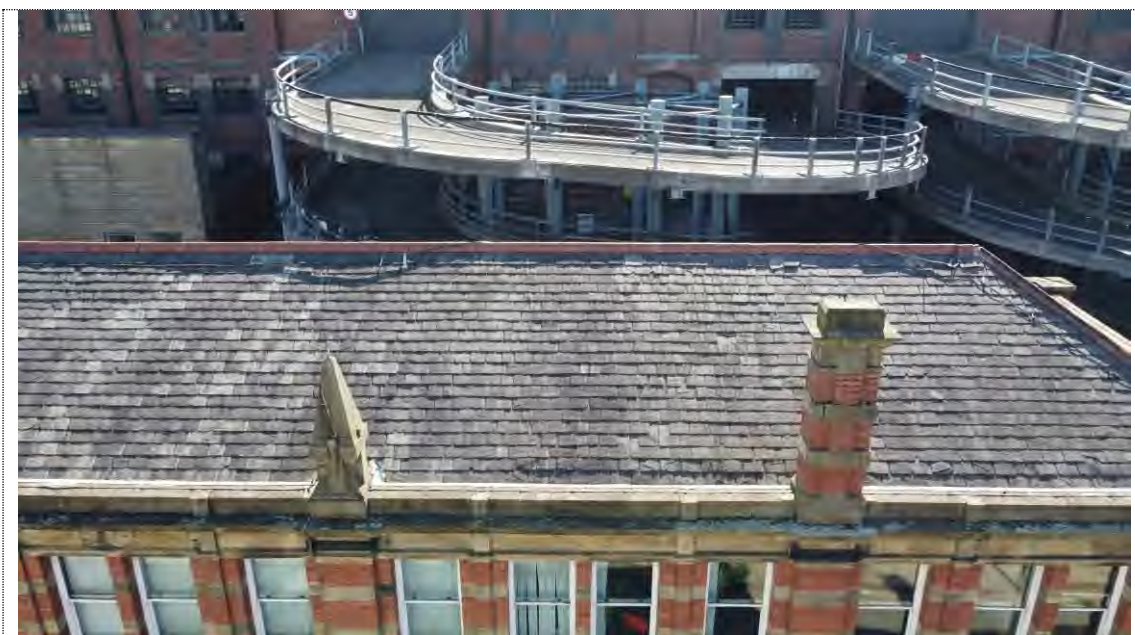
| Photograph: | 163 |

| Description: | Damaged and worn slates. Slipped slates/ridge tiles. |

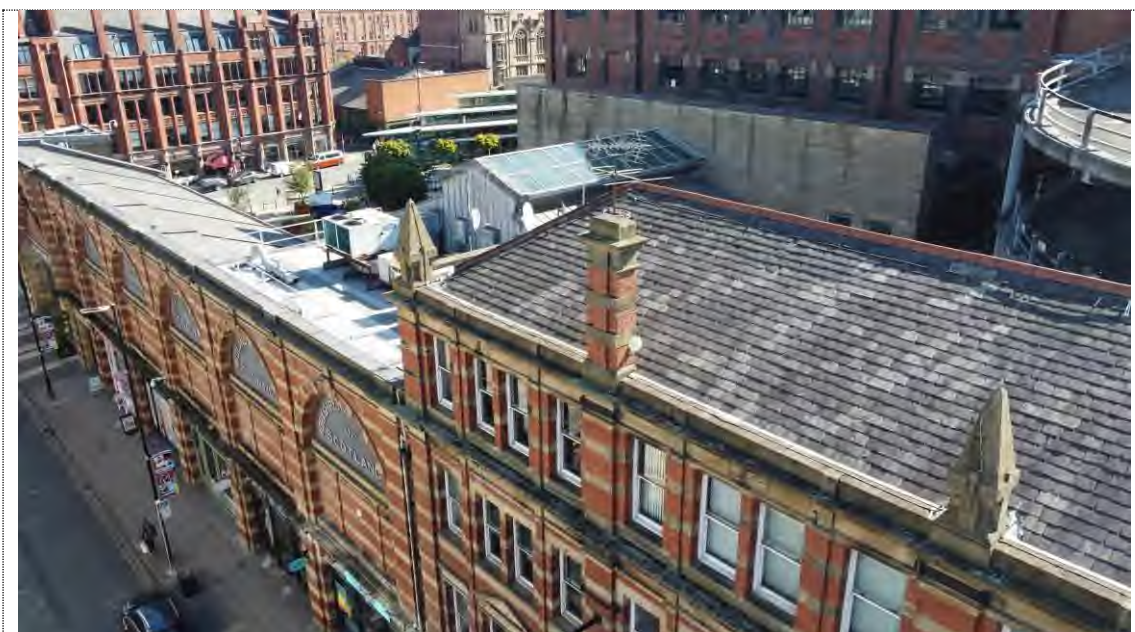
| Photograph: | 164 |

| Description: | General view of the roof. Visible discolouration and weathering to roof slates. |
