**The Great Northern Warehouse**

**Survey 2022**

**Great Northern Warehouse & Deansgate Terraces, Manchester**

**Condition Survey**

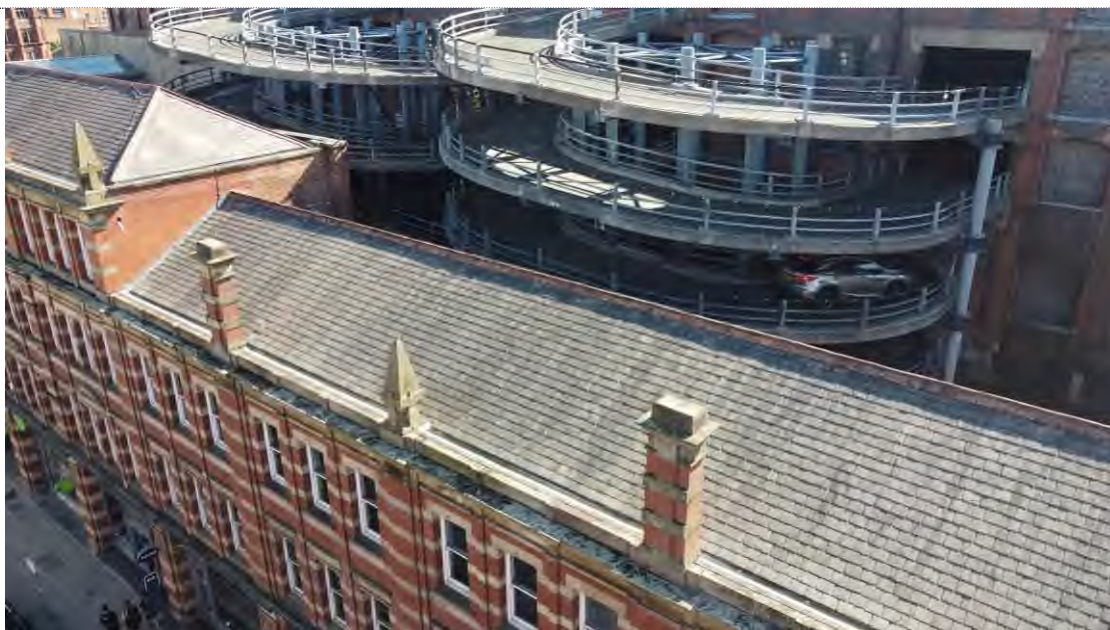
| Photograph: | 166 |

| Description: | General view of the roof. Visible algae growth. |

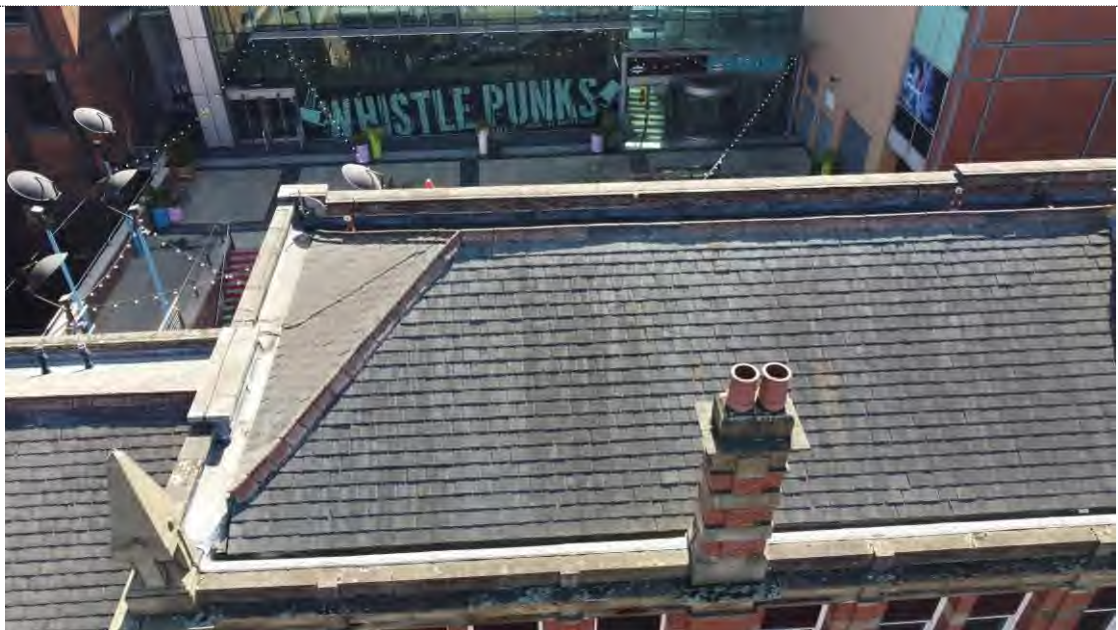
| Photograph: | 168 |

| Description: | General view of the roof. Evidence of replacement ridge tiles. |

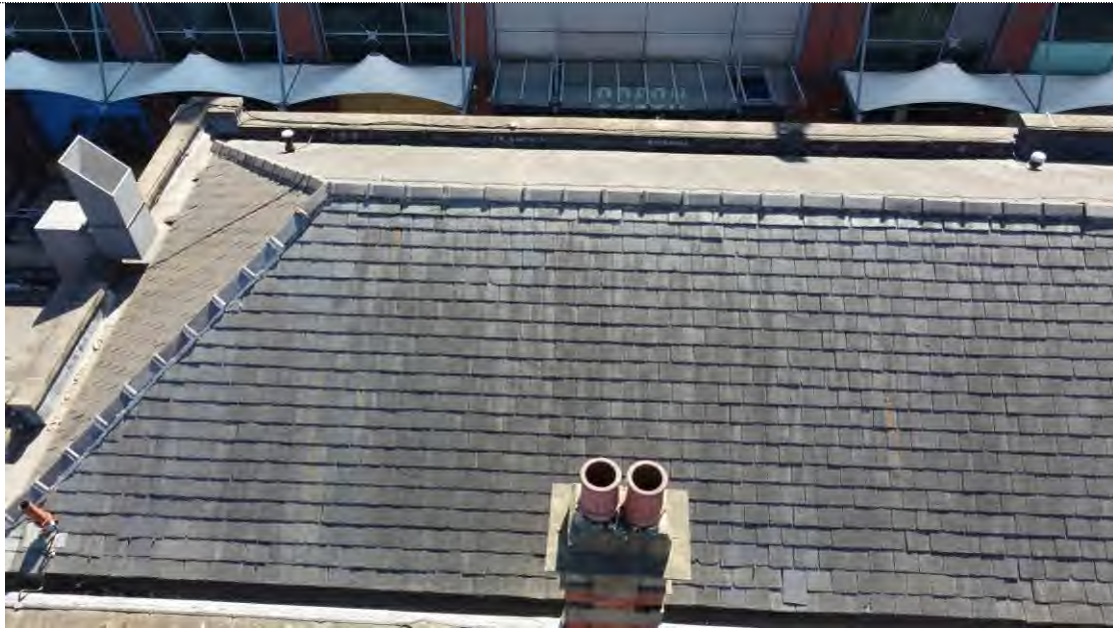
| Photograph: | 171 |

| Description: | Evidence of staining to roof slates. |

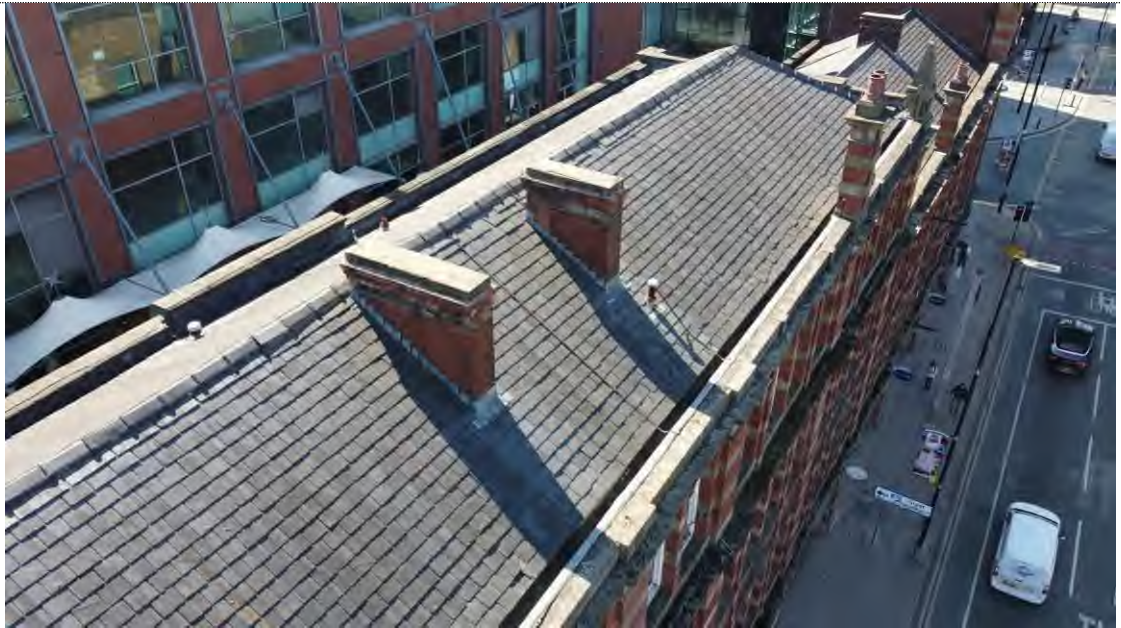
| Photograph: | 172 |

| Description: | General view of the roof. Evidence of newer ridge tiles. |

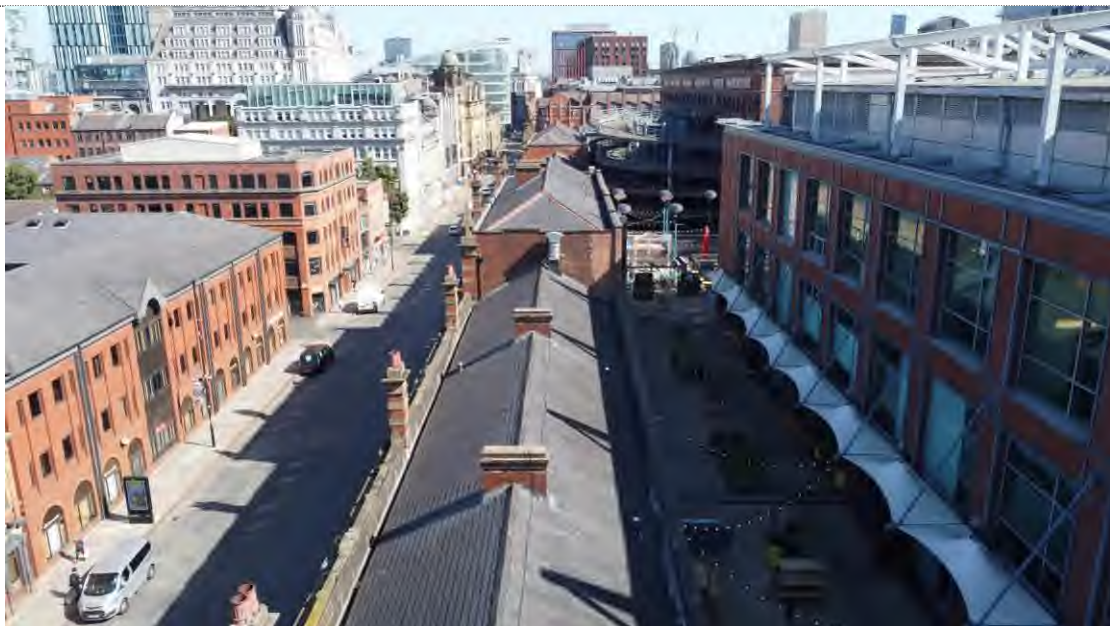
| Photograph: | 173 |

| Description: | General view of the roof. Evidence of newer ridge tiles. Evidence of damage and weathering to roof slates. |

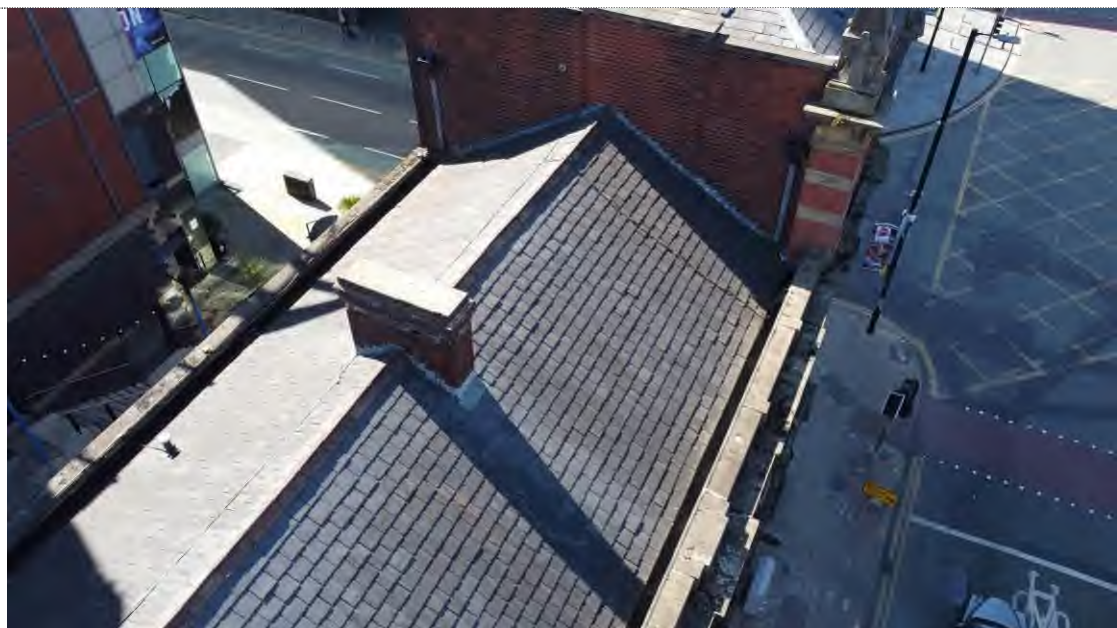
| Photograph: | 175 |

| Description: | General view of the roof. Evidence of newer ridge tiles and weathering to roof slates. |

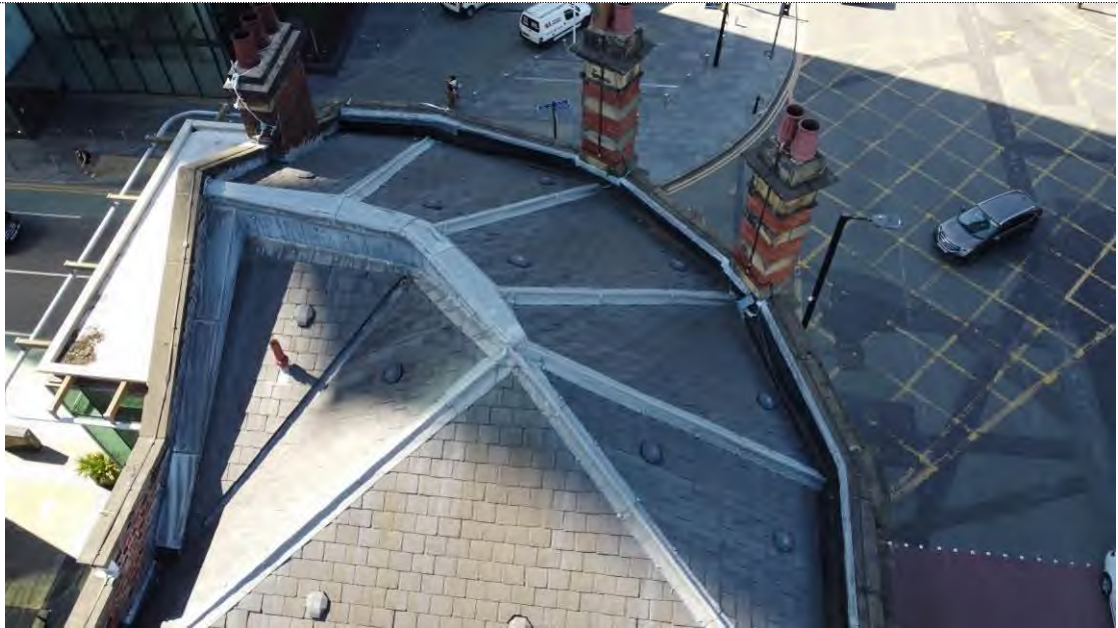
| Photograph: | 176 |

| Description: | General view of the roof. Evidence of staining and weathering to roof tiles. |

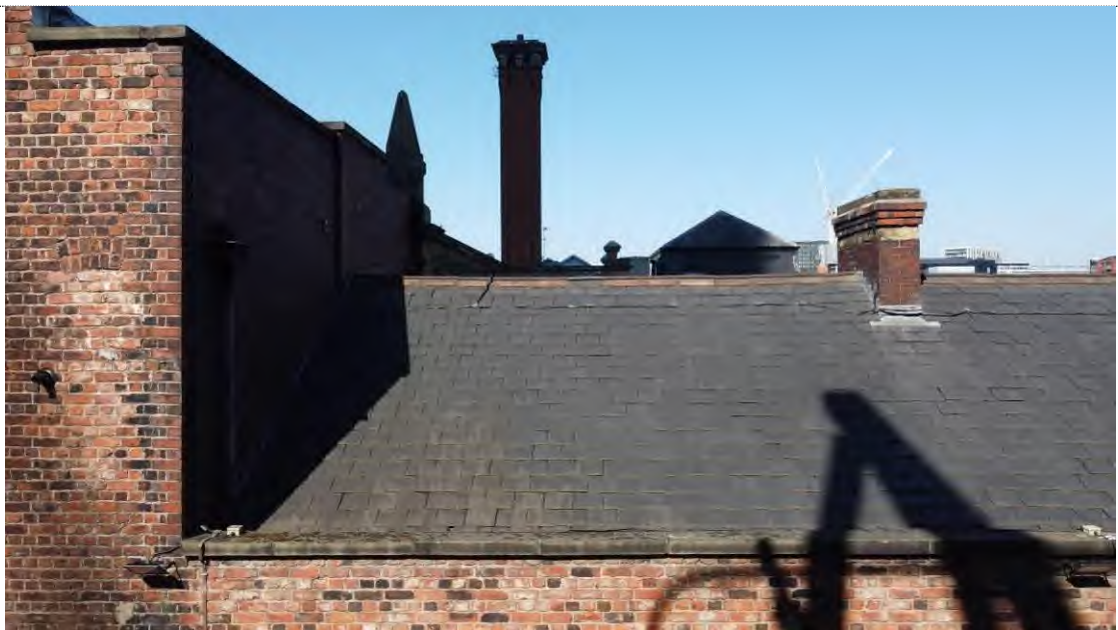
| Photograph: | 179 |

| Description: | General view of the roof. Evidence of ponding water. |

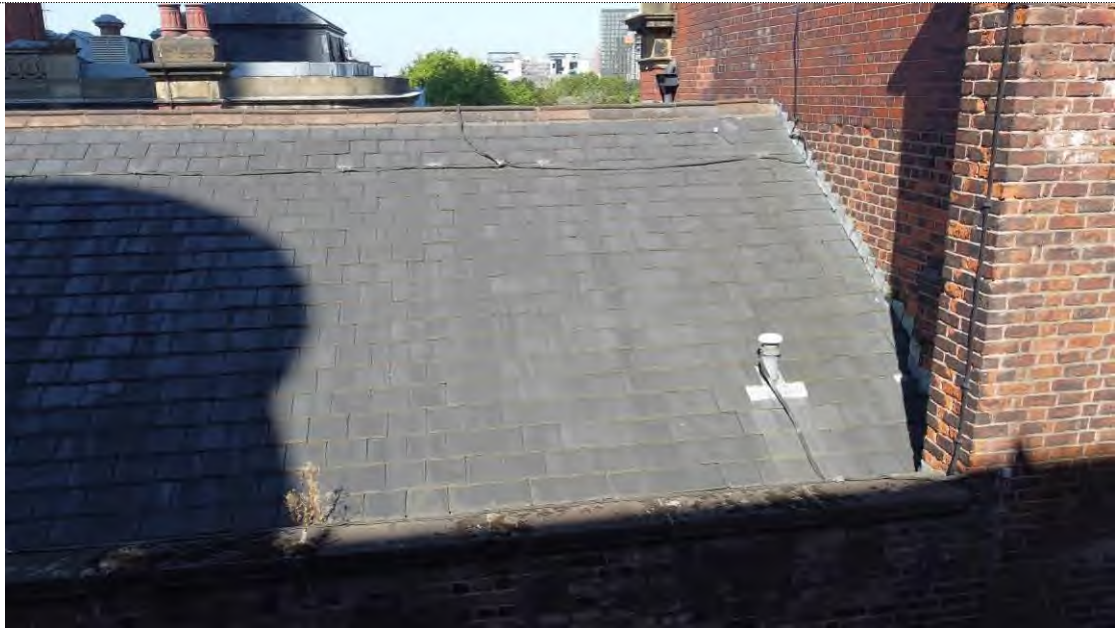
| Photograph: | 180 |

| Description: | General view of the roof. Evidence of weathering and newer ridge tiles. |

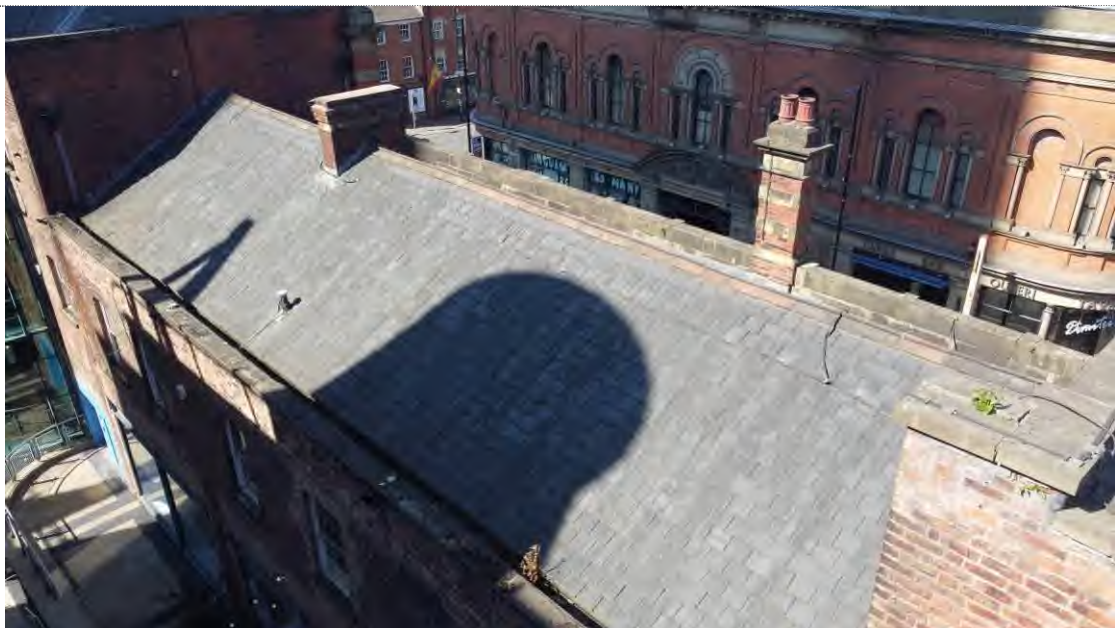
| Photograph: | 181 |

| Description: | General view of the roof. Evidence of damaged roof slates and newer ridge tiles. |

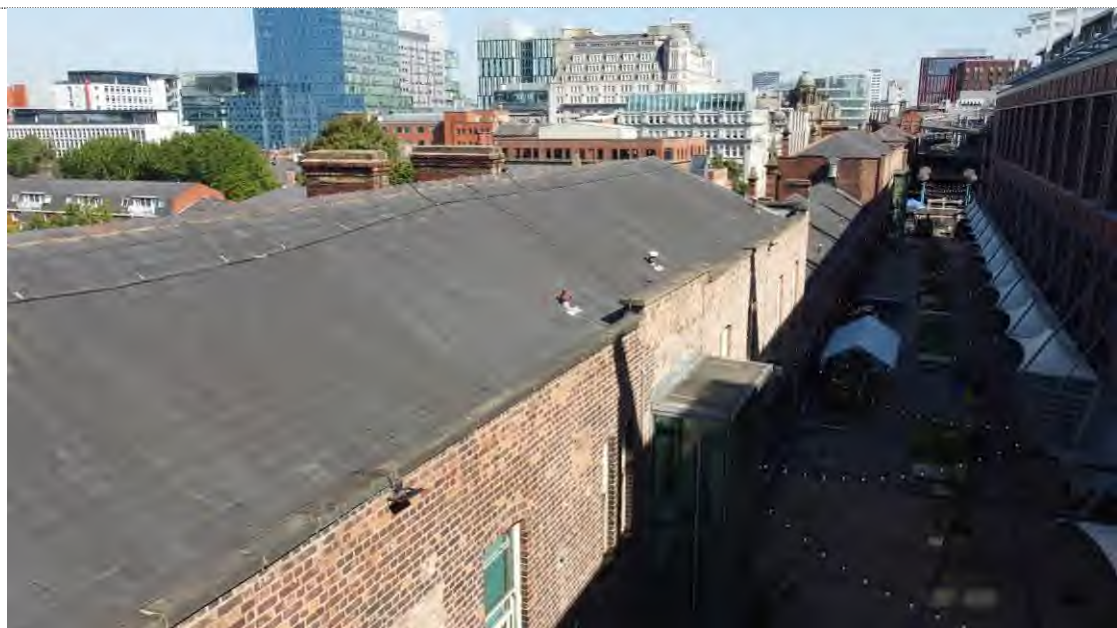
| Photograph: | 183 |

| Description: | General view of the roof. Evidence of slipping to roof slates and weathering/staining. |

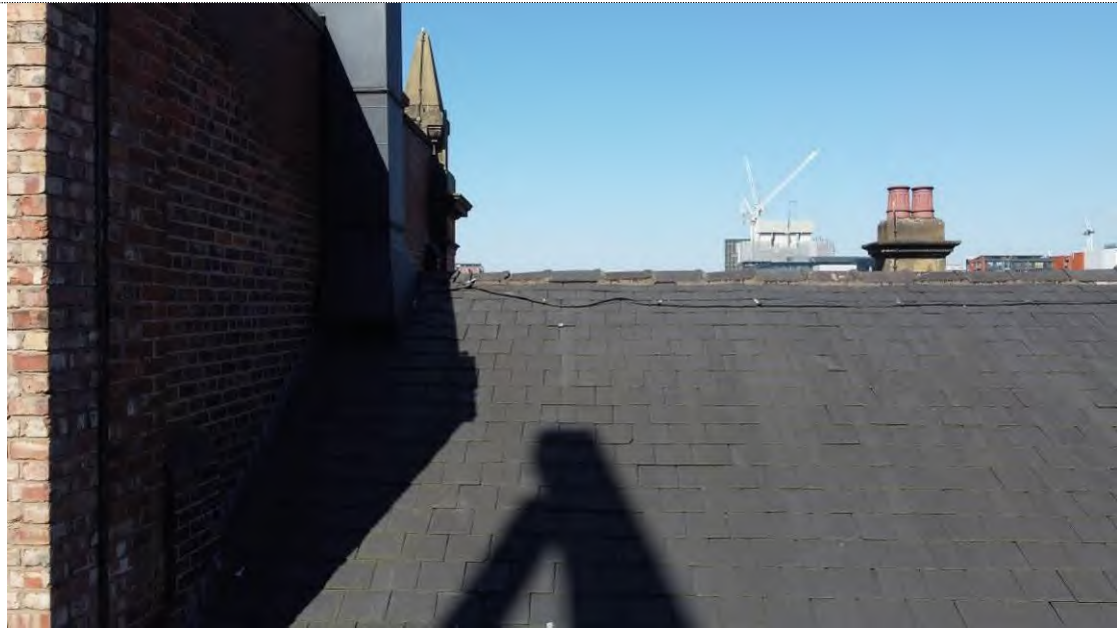
| Photograph: | 184 |

| Description: | General view of the roof. Evidence of weathering. |

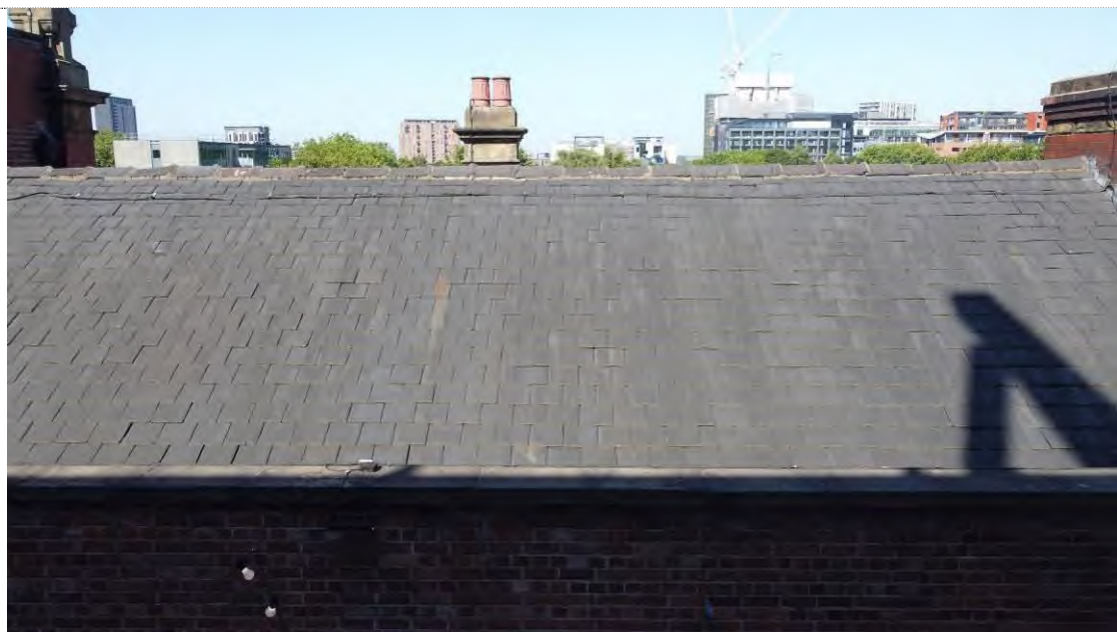
| Photograph: | 185 |

| Description: | Evidence of damage to ridge tiles. |

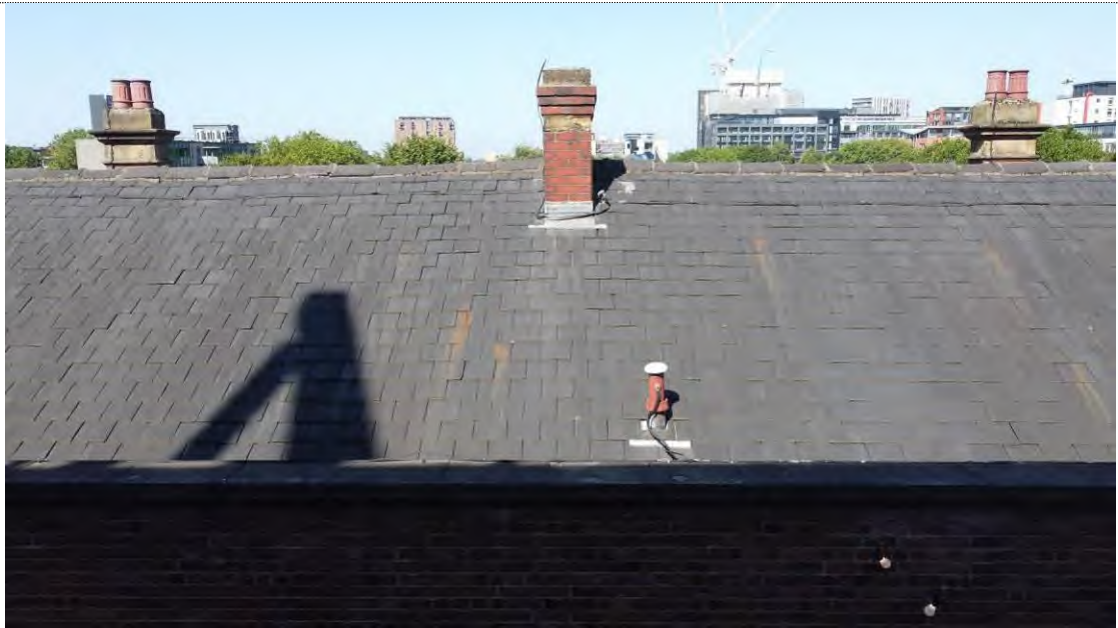
| Photograph: | 186 |

| Description: | General view of the roof. Evidence of staining to roof slates. |

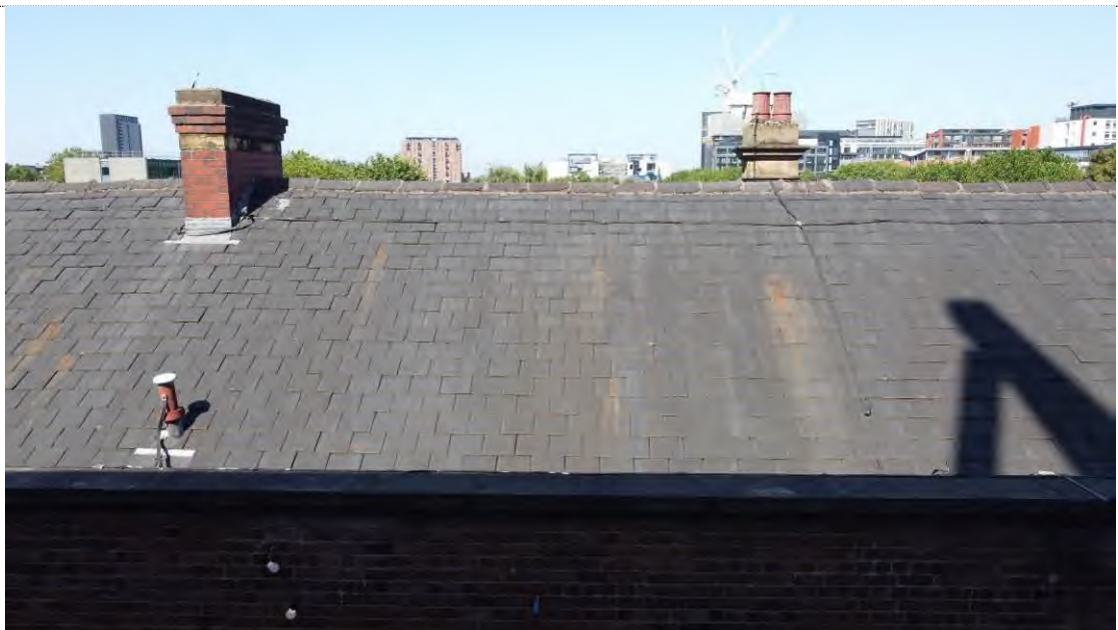
| Photograph: | 187 |

| Description: | General view of the roof. Evidence of staining to roof slates. |

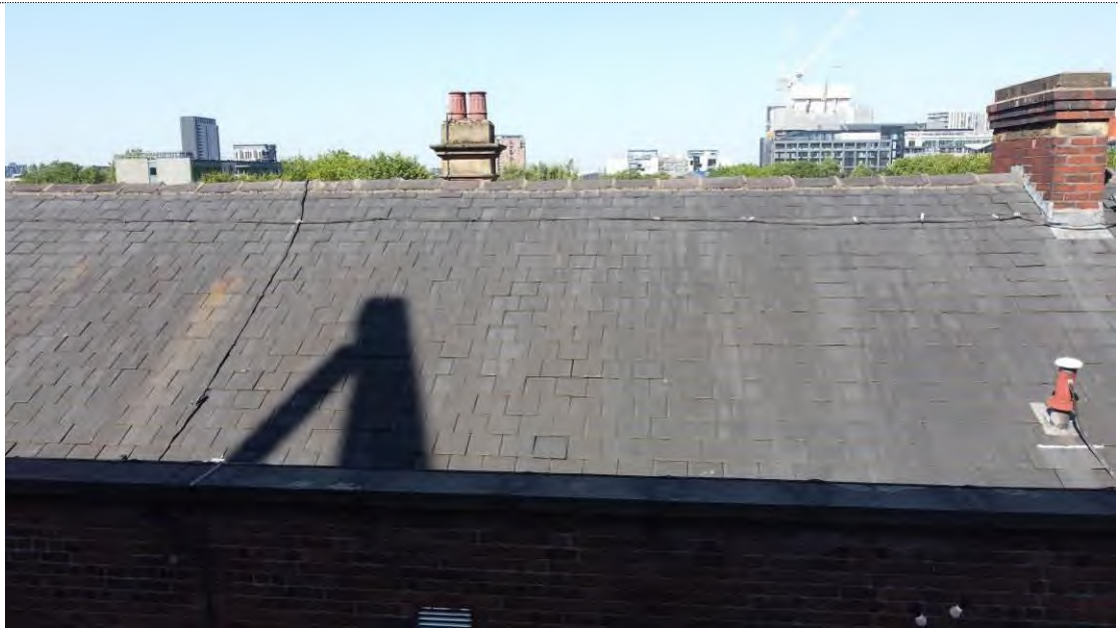
| Photograph: | 188 |

| Description: | General view of the roof. Evidence of staining to roof slates. |

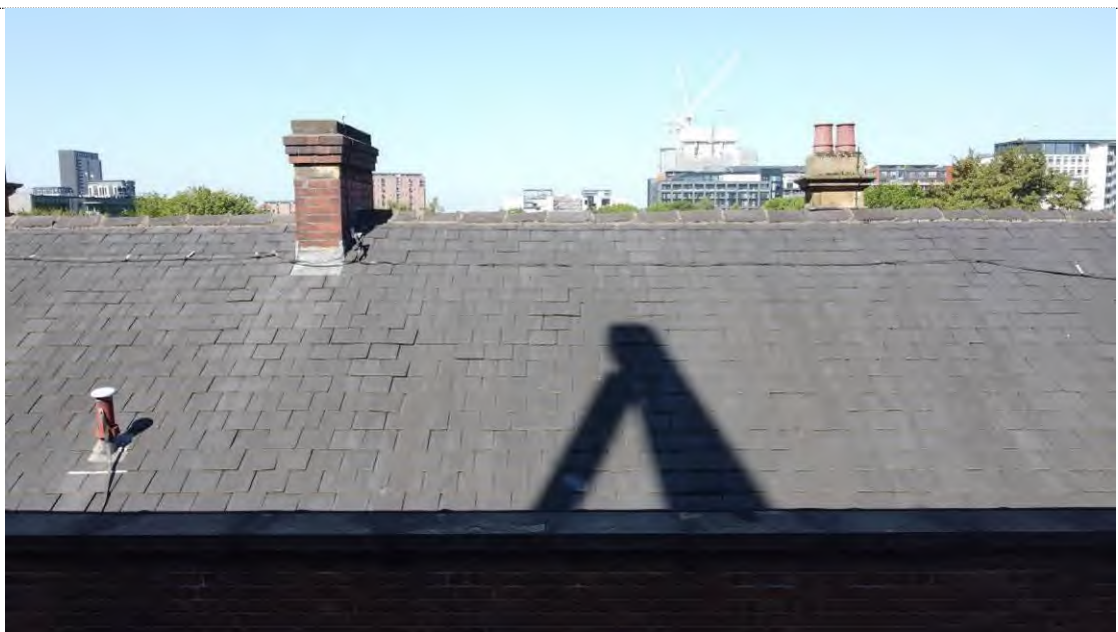
| Photograph: | 189 |

| Description: | General view of the roof. Evidence of staining to roof slates. |

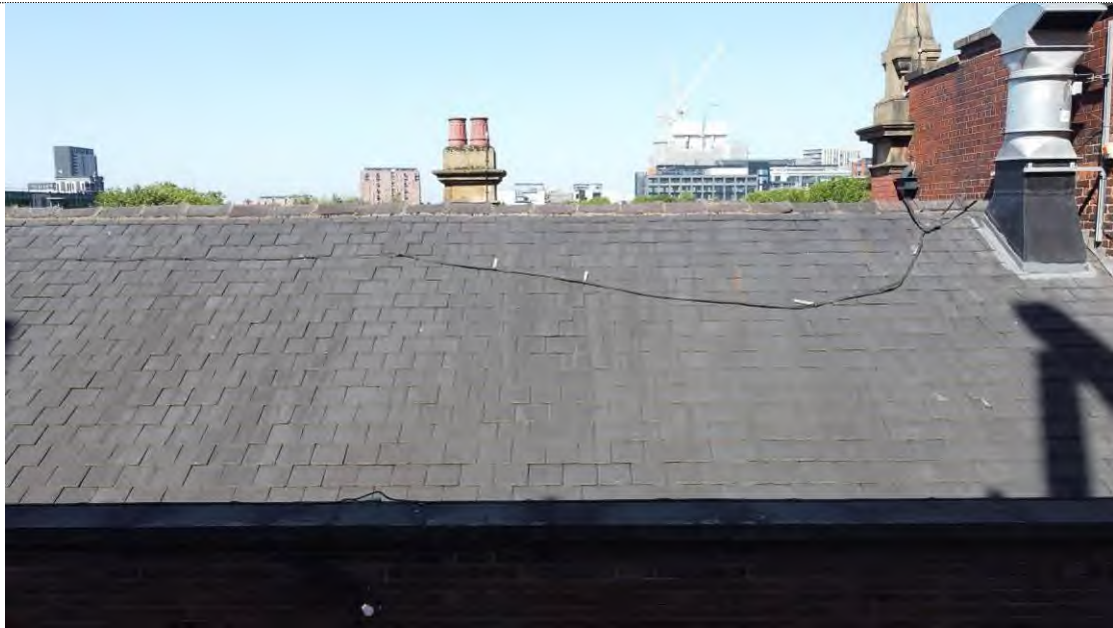
| Photograph: | 190 |

| Description: | General view of the roof. Evidence of weathering and shifting to roof slates. |

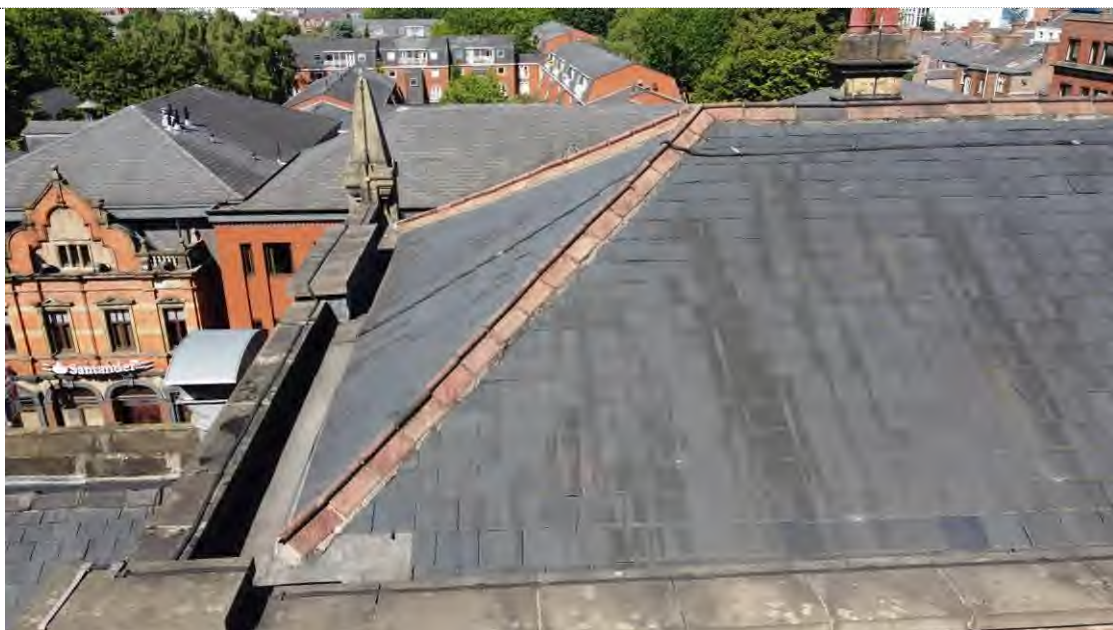
| Photograph: | 191 |

| Description: | General view of the roof. Evidence of weathering to roof slates. |

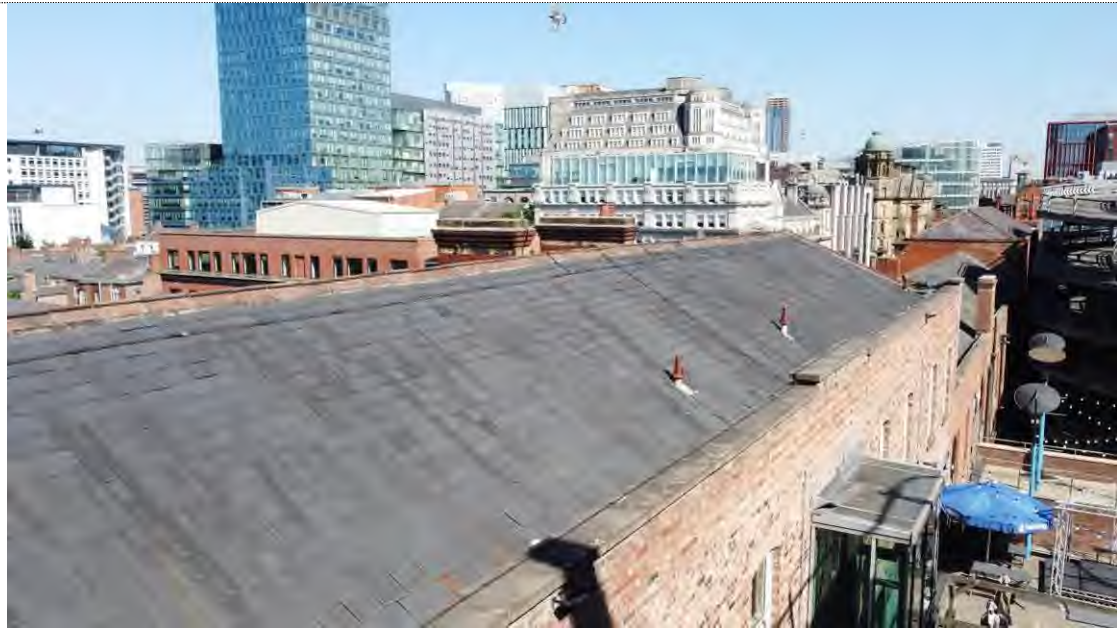
| Photograph: | 192 |

| Description: | Missing and loose roof slates. |

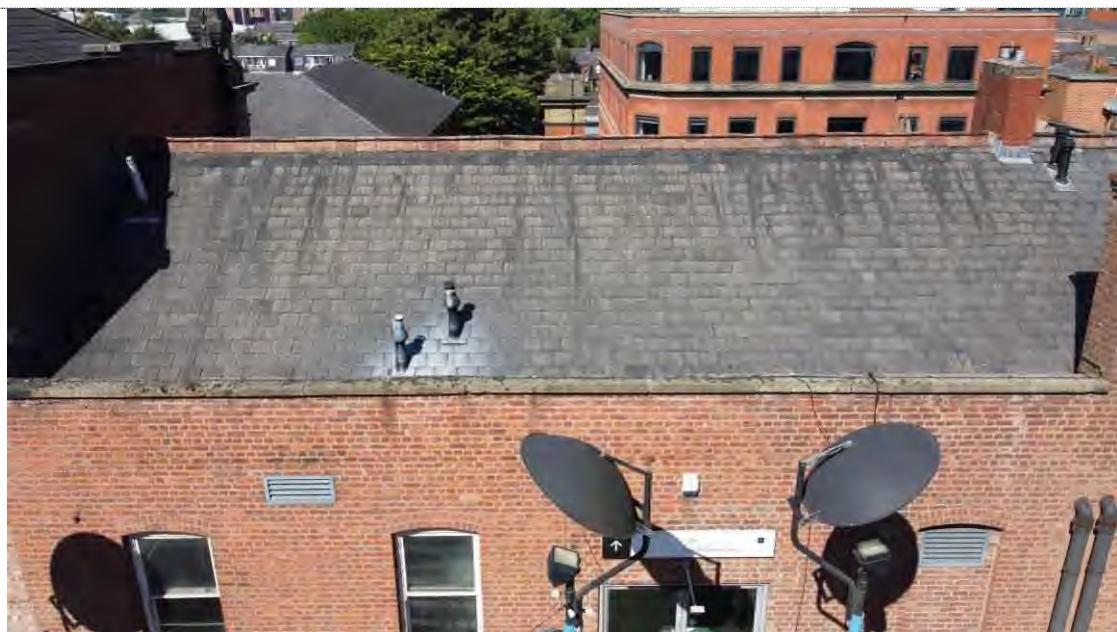
| Photograph: | 193 |

| Description: | General view of the roof. Evidence of staining and shifting to roof slates. |

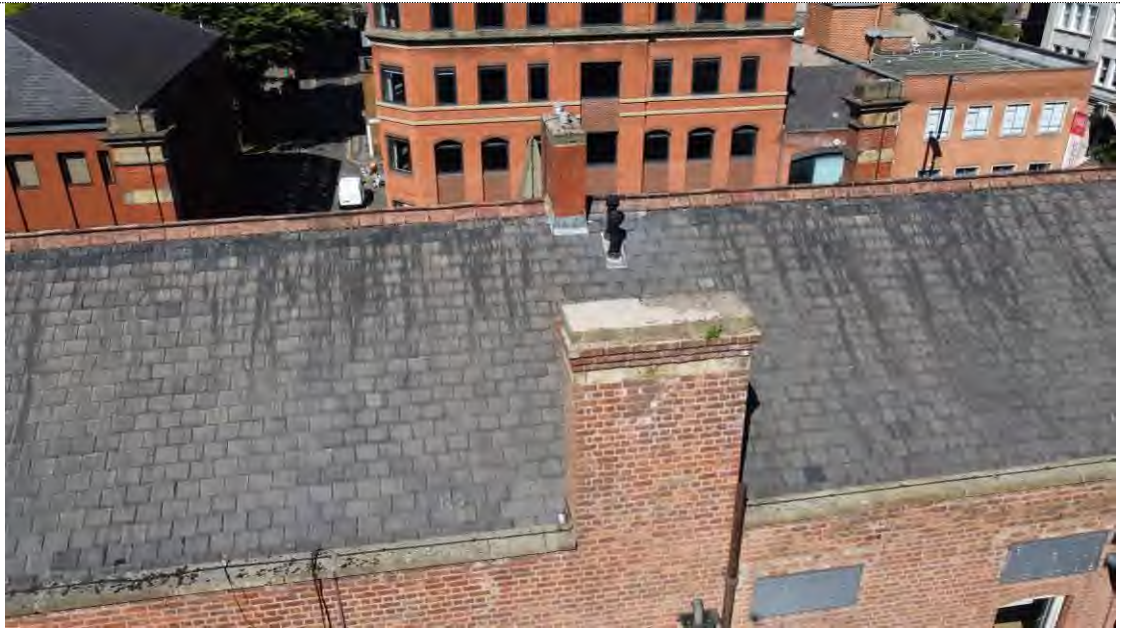
| Photograph: | 194 |

| Description: | General view of the roof. Evidence of staining and weathering to roof slates. |

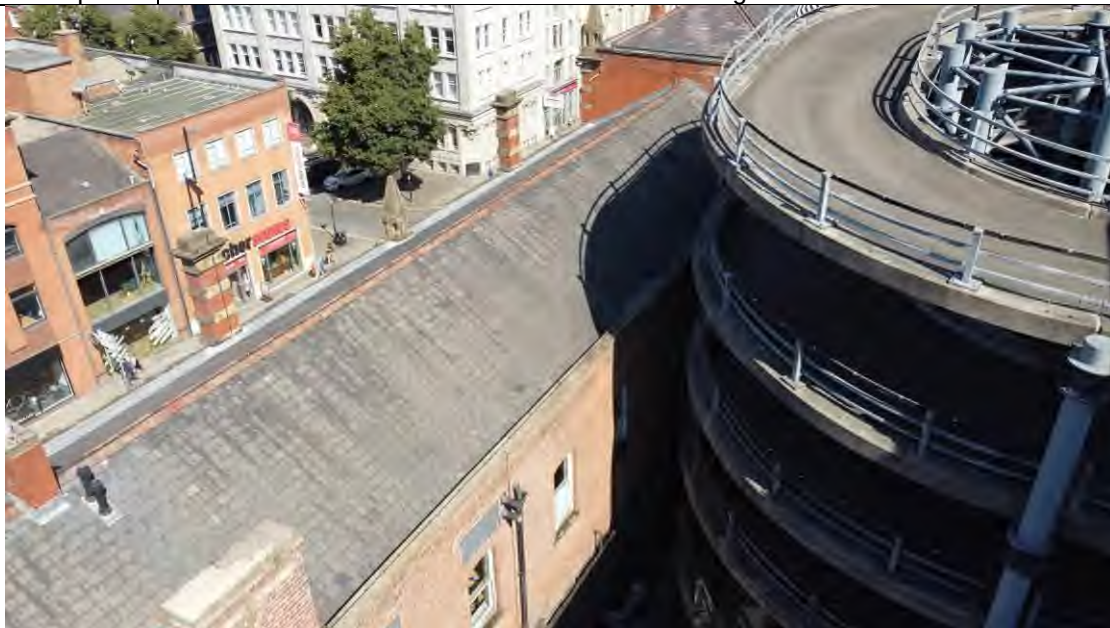
| Photograph: | 195 |

| Description: | General view of the roof. Evidence of weathering to roof slates. |

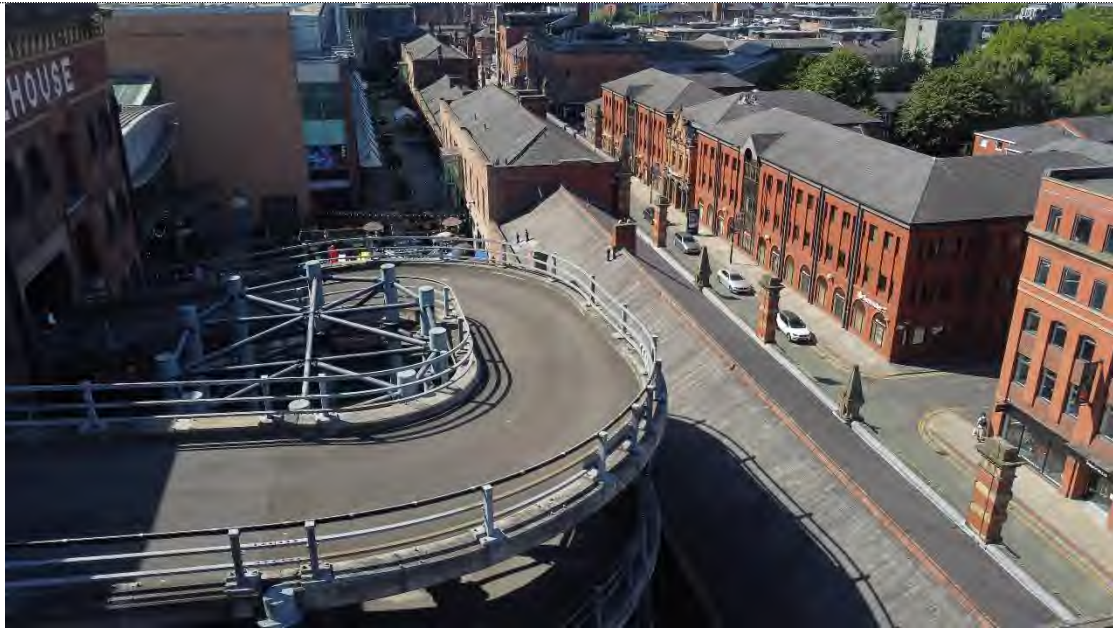
| Photograph: | 196 |

| Description: | General view of the roof. Evidence of weathering to roof slates. |

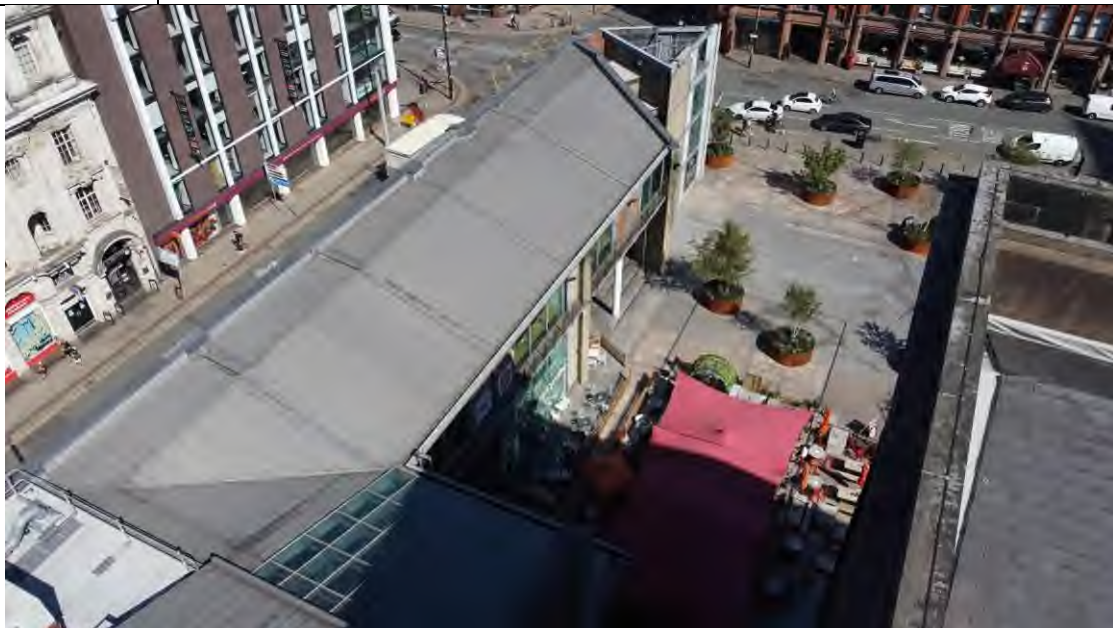
| Photograph: | 197 |

| Description: | General view of the roof. Evidence of weathering to roof slates. |

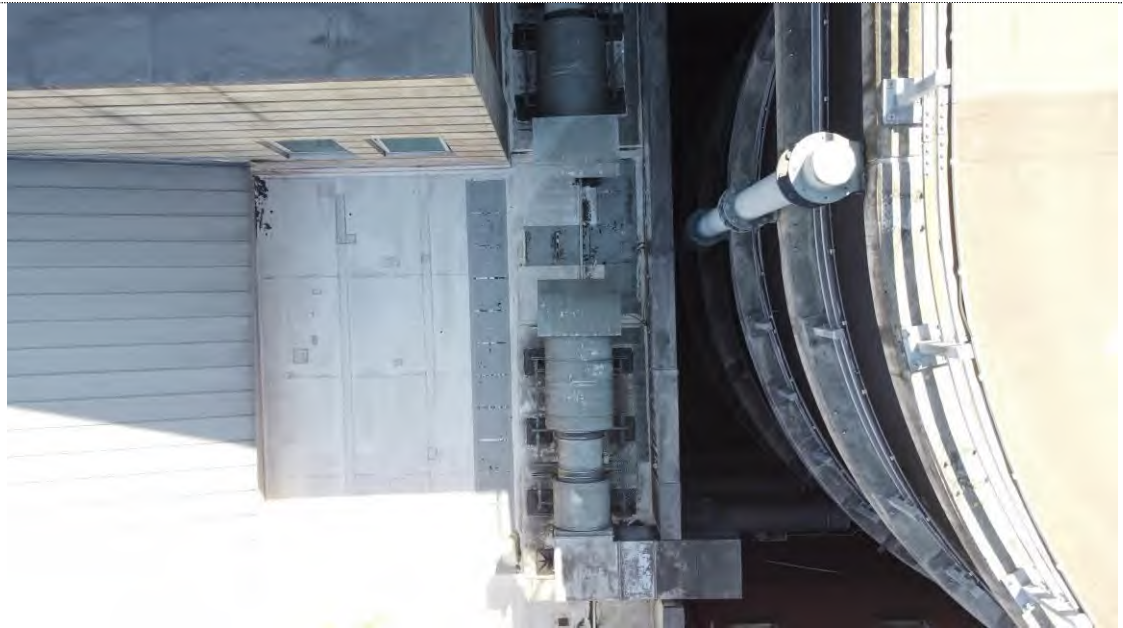
| Photograph: | 198 |

| Description: | General view of the roof. Evidence of weathering and stains to roof panels. |

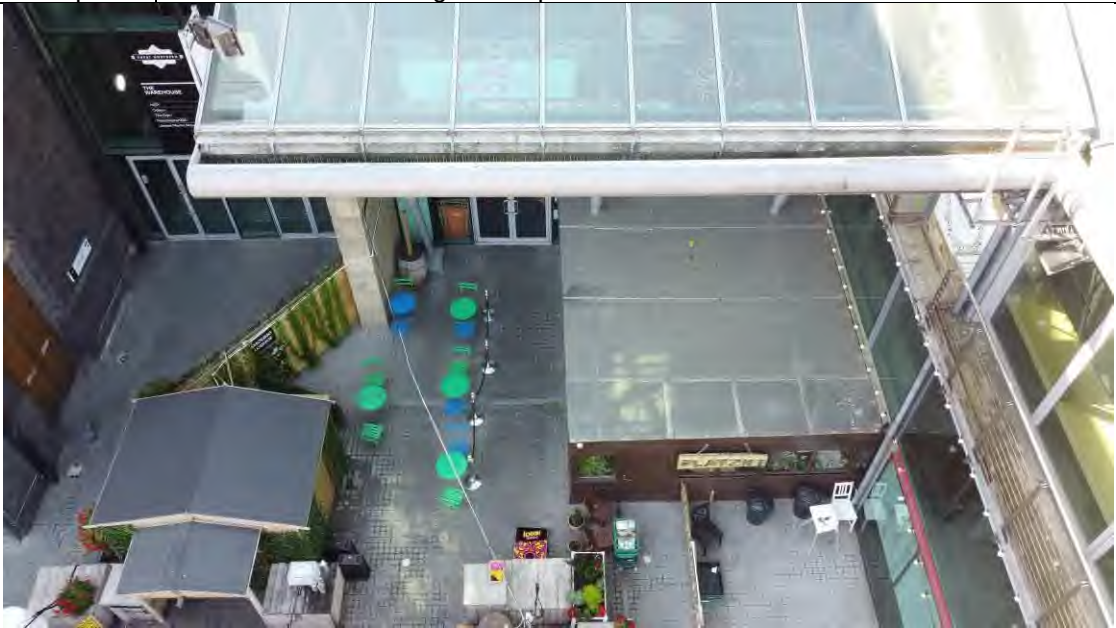
| Photograph: | 201 |

| Description: | Evidence of weathering to roof panels. |

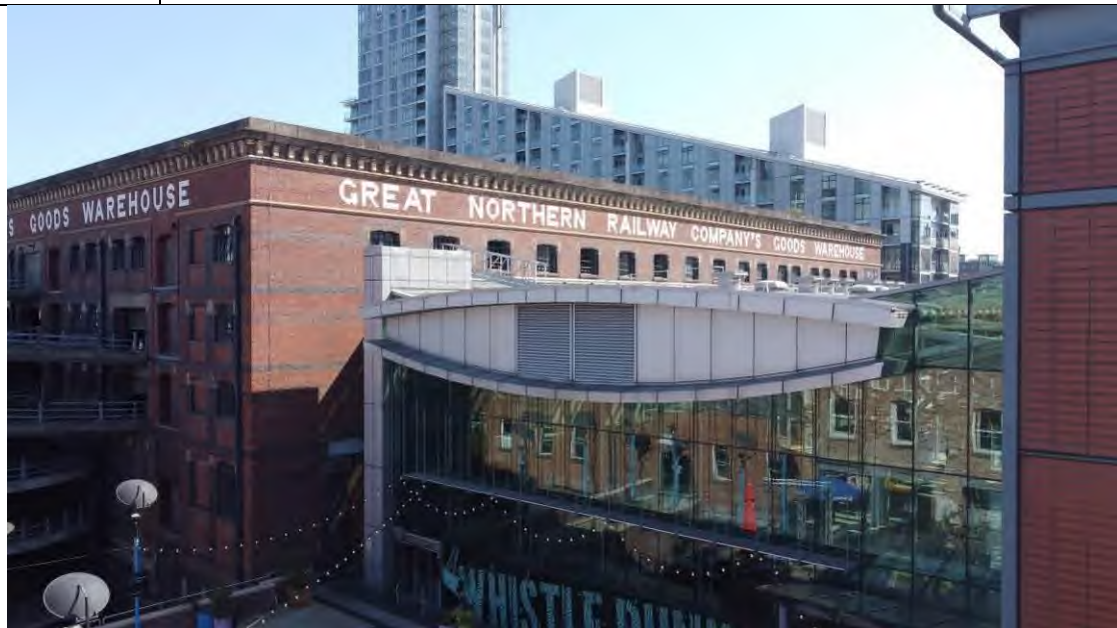
| Photograph: | 9 |

| Description: | Redress spalling stone to a sound surface. (West facing elevation) |

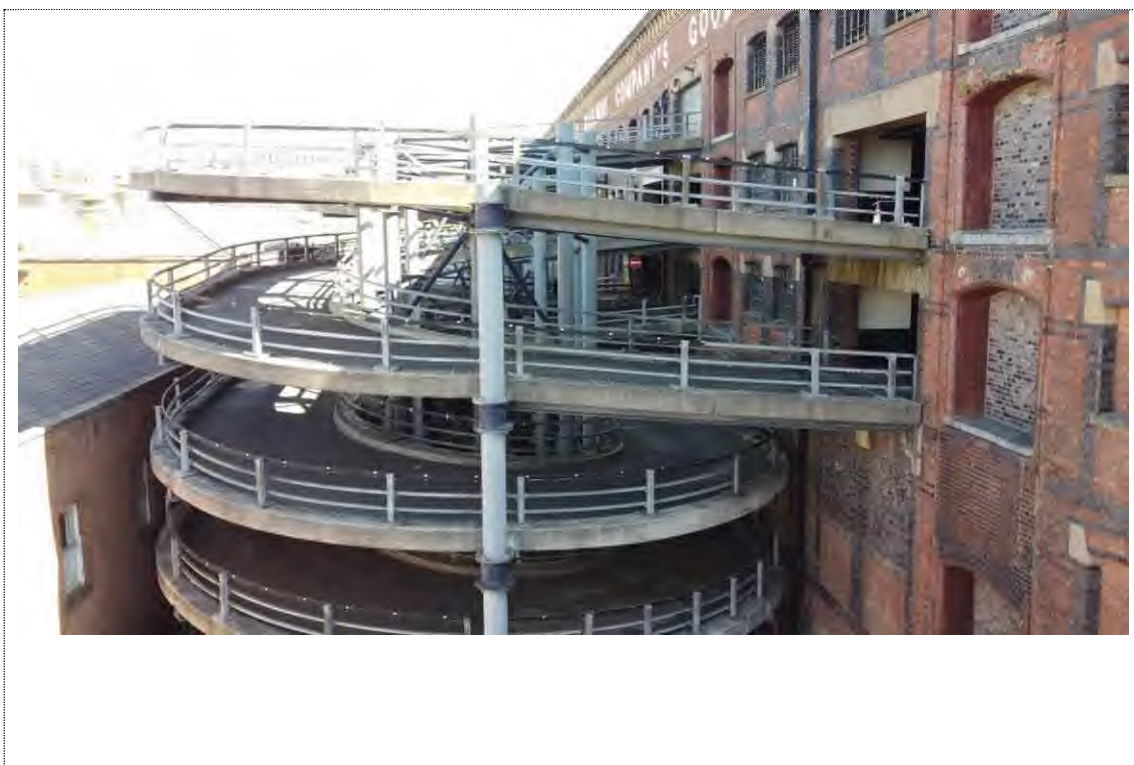
| Photograph: | 10 |

| Description: | Redress spalling stone to a sound surface. (West facing elevation) |

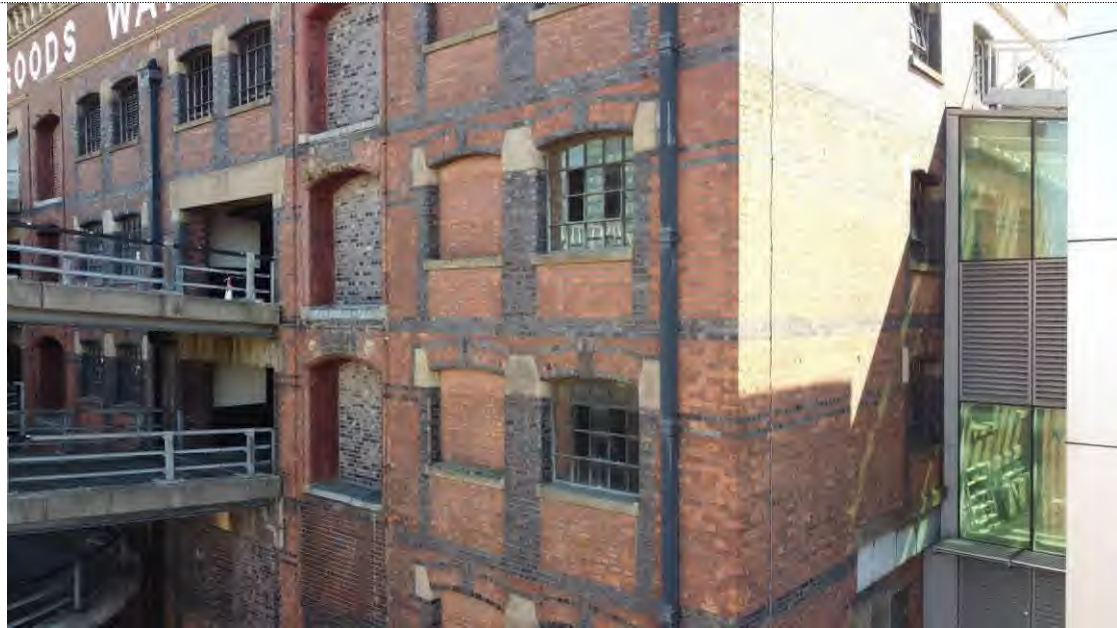
| Photograph: | 12 |

| Description: | Redress spalling stone to a sound surface. (West facing elevation) |

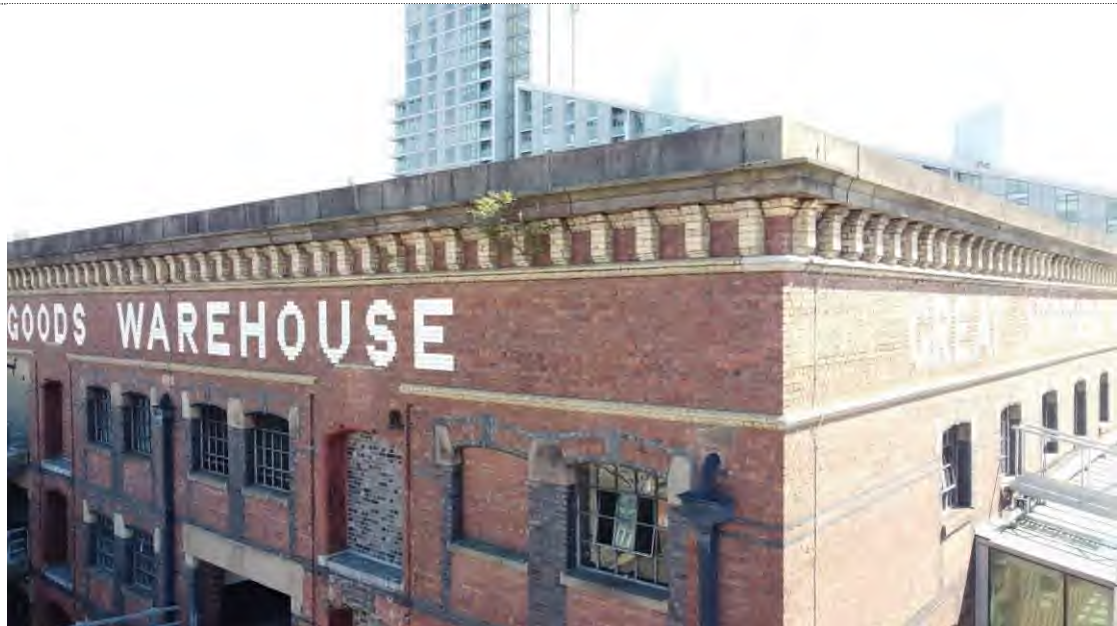
| Photograph: | 13 |

| Description: | Redress spalling stone to a sound surface. (West facing elevation) |
