**The Great Northern Warehouse**

**Survey 2022**

**Great Northern Warehouse & Deansgate Terraces, Manchester**

**Condition Survey**

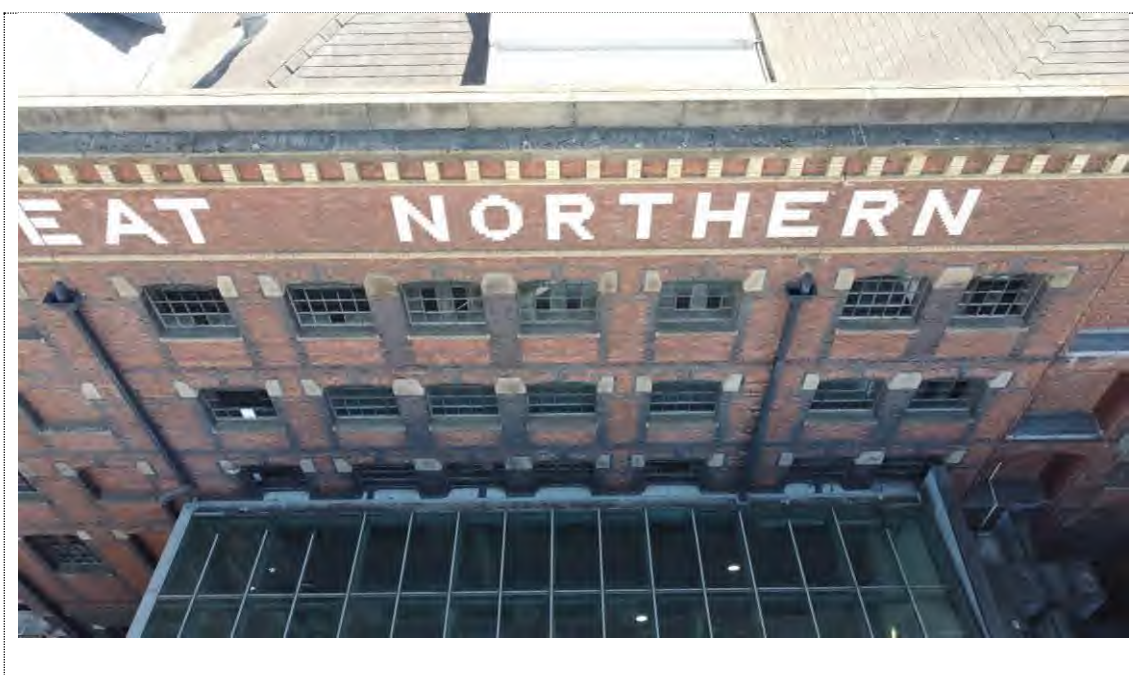
| Photograph: | 15 |

| Description: | Redress spalling stone to a sound surface. (West facing elevation) |

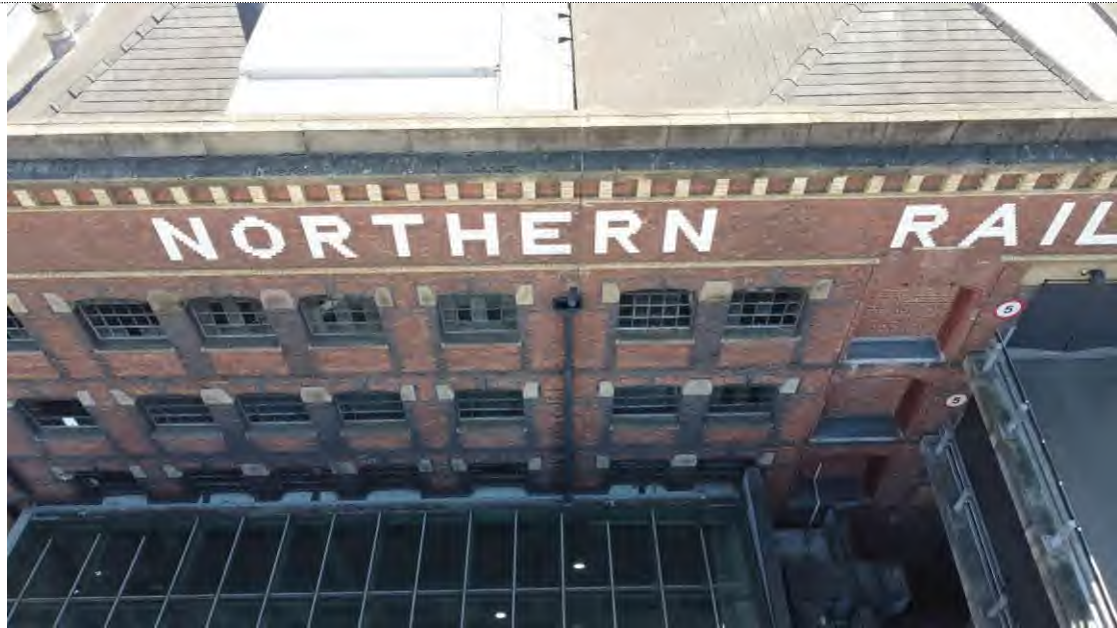
| Photograph: | 16 |

| Description: | Redress spalling stone to a sound surface. (West facing elevation) |

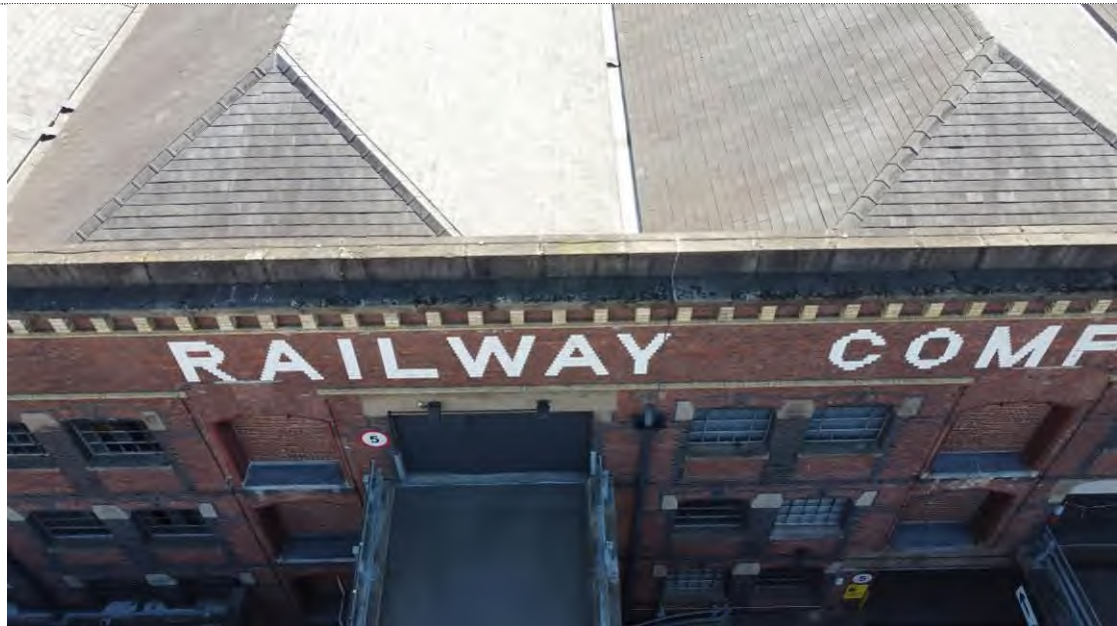
| Photograph: | 17 |

| Description: | Redress spalling stone to a sound surface. (West facing elevation) |

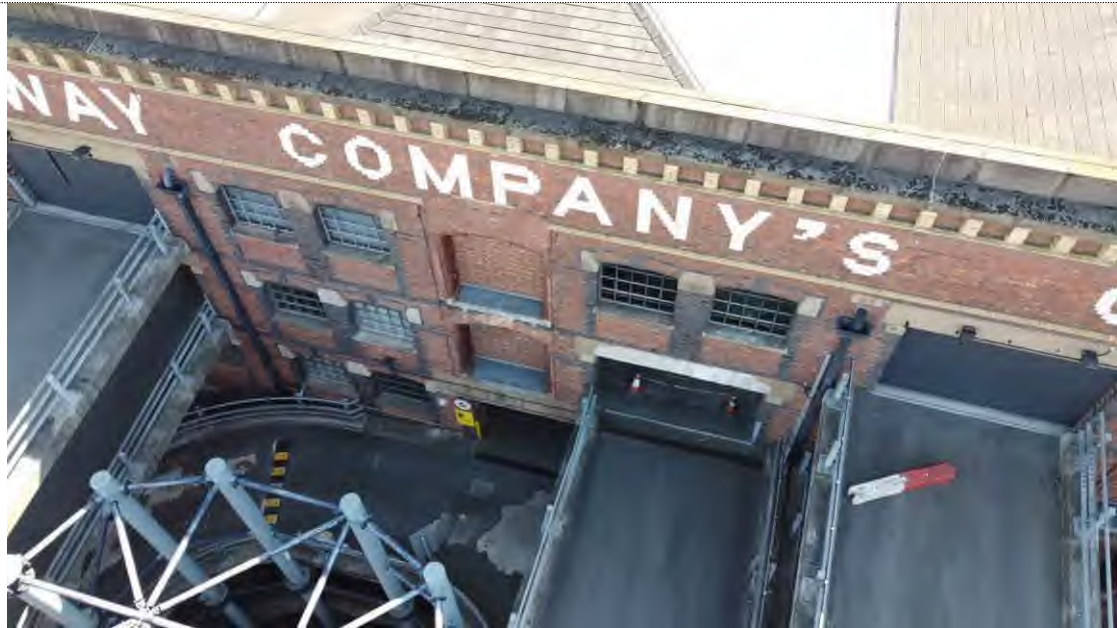
| Photograph: | 18 |

| Description: | Redress spalling stone to a sound surface. (West facing elevation) |

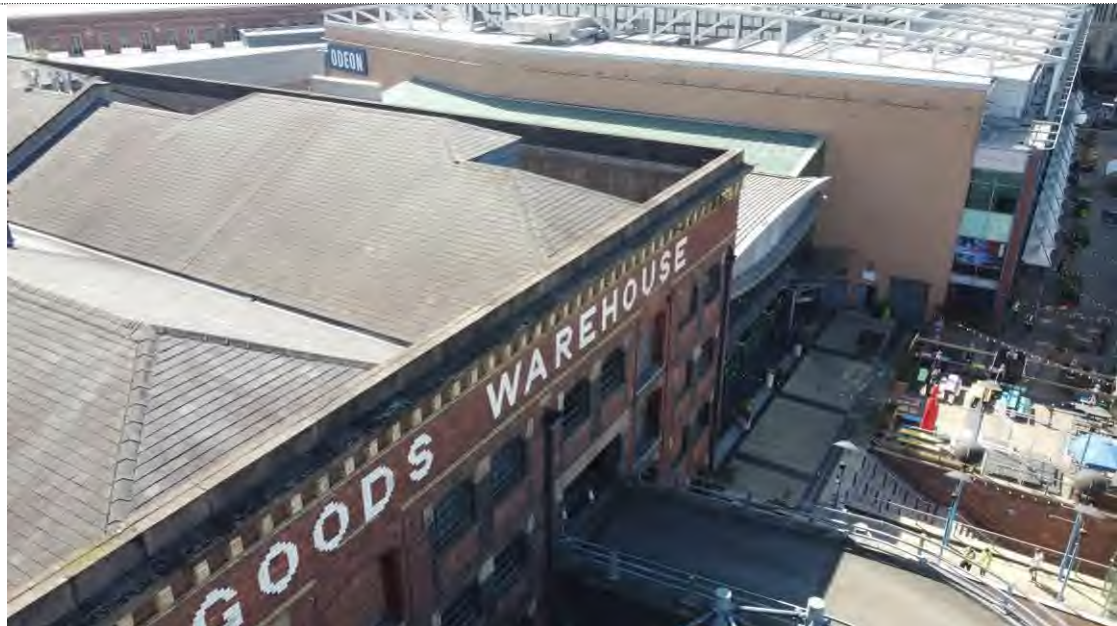
| Photograph: | 19 |

| Description: | Redress spalling stone to a sound surface. (West facing elevation) |

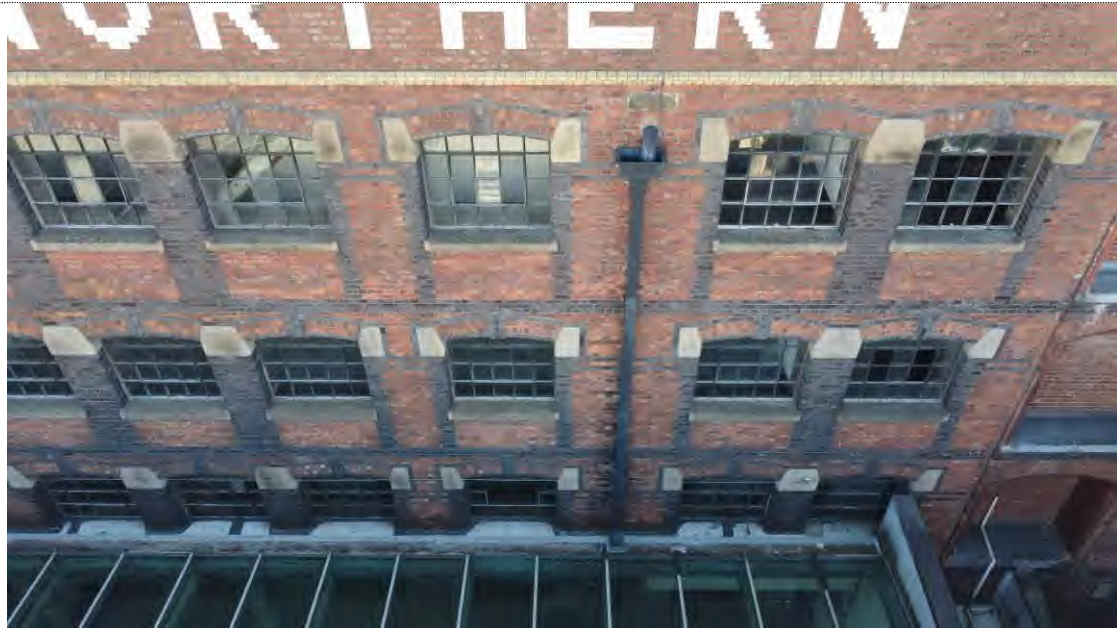
| Photograph: | 20 |

| Description: | Redress spalling stone to a sound surface. (West facing elevation) |

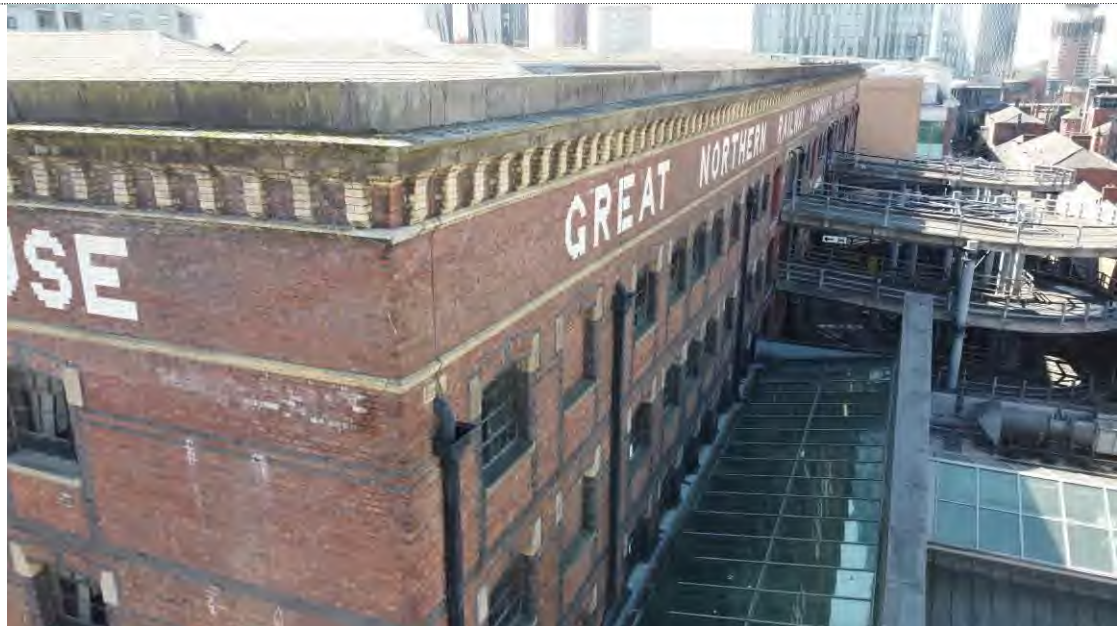
| Photograph: | 21 |

| Description: | Redress spalling stone to a sound surface. (West facing elevation) |

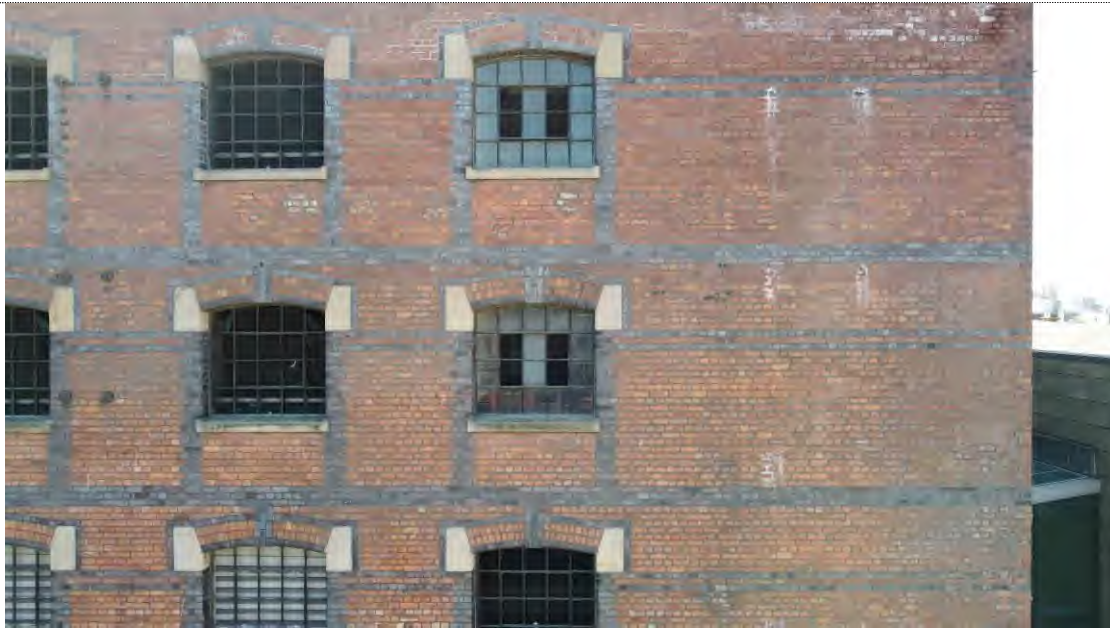
| Photograph: | 24 |

| Description: | Redress spalling stone to a sound surface. Evidence of salt damage to brickwork. |

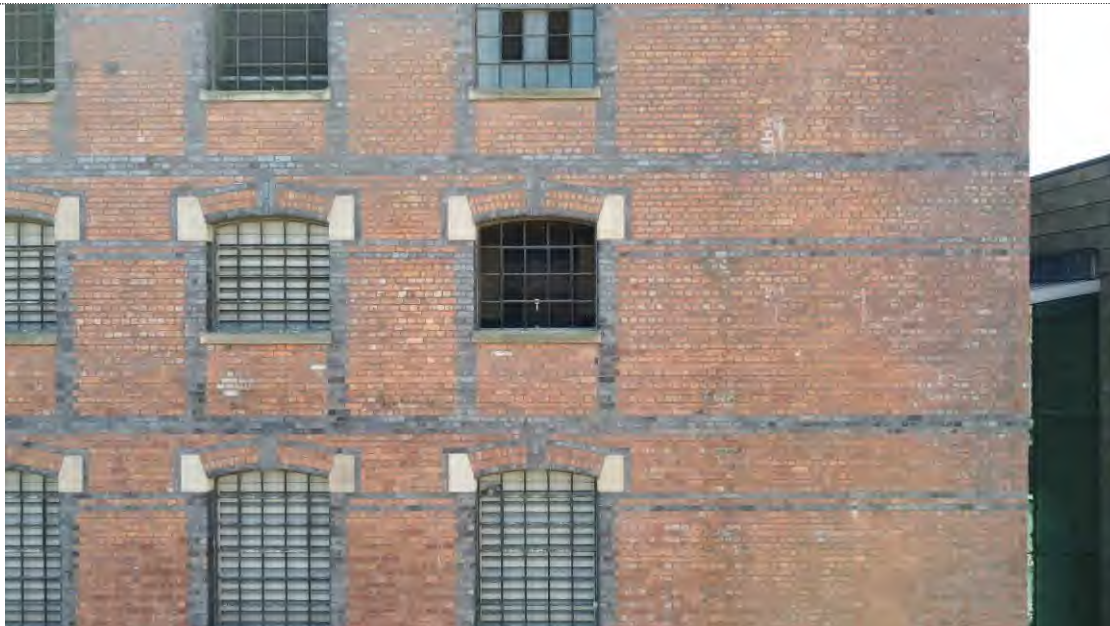
| Photograph: | 25 |

| Description: | General clean and replace of defective brickwork. (North facing elevation) |

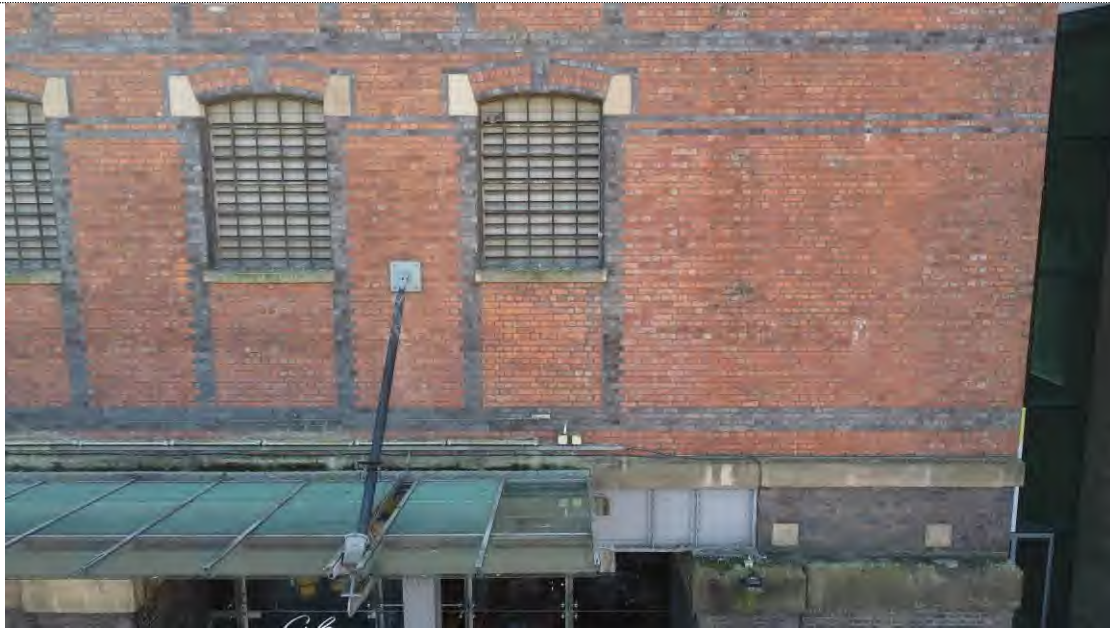
| Photograph: | 26 |

| Description: | General clean and replace of defective brickwork. (North facing elevation) |

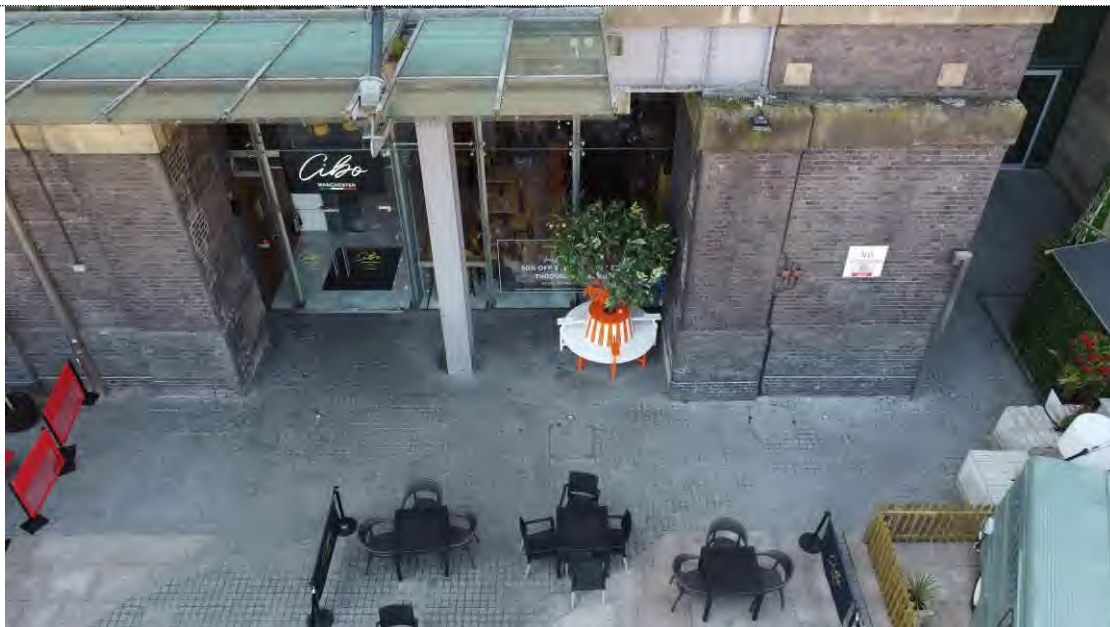
| Photograph: | 27 |

| Description: | General clean and replace of defective brickwork and stonework. (North facing elevation) |

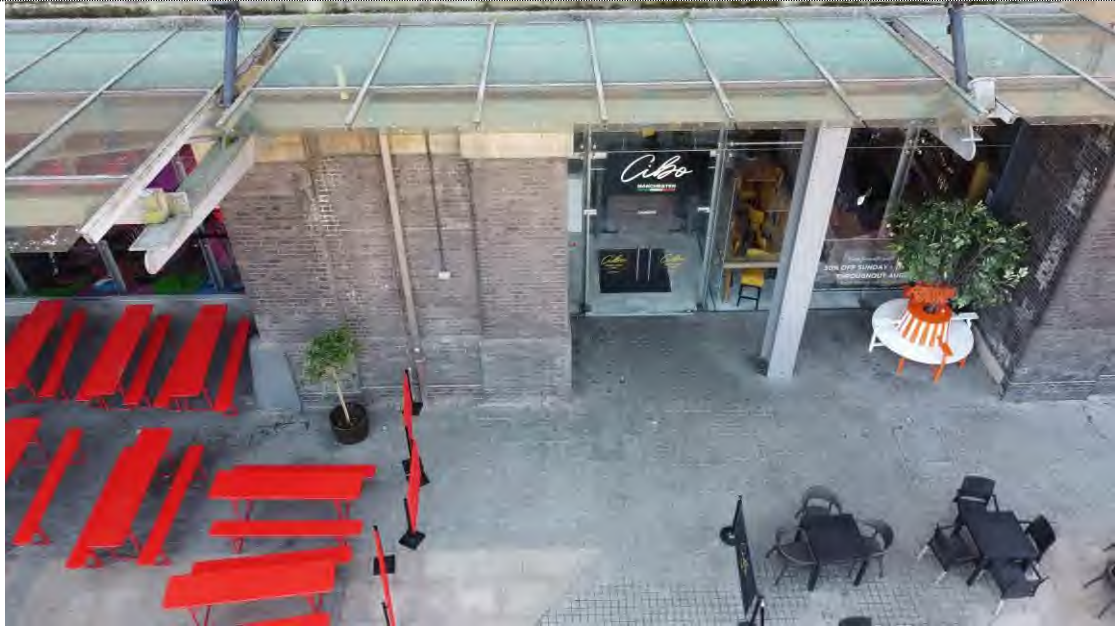
| Photograph: | 28 |

| Description: | General clean and replace of defective brickwork and stonework. (North facing elevation) |

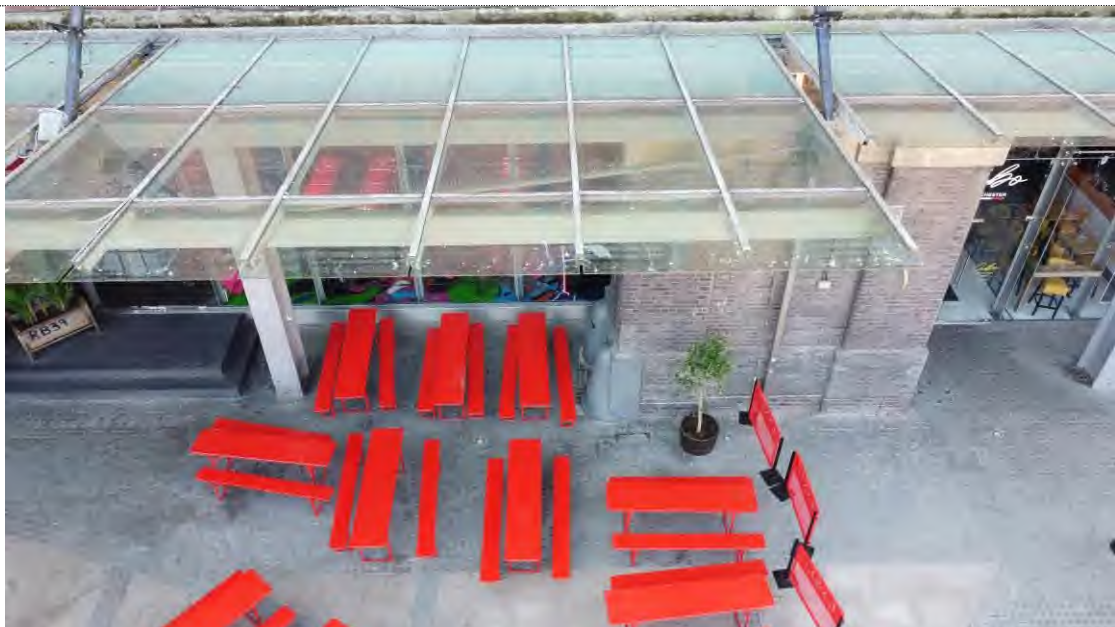
| Photograph: | 29 |

| Description: | General clean and replace of defective brickwork and stonework. (North facing elevation) |

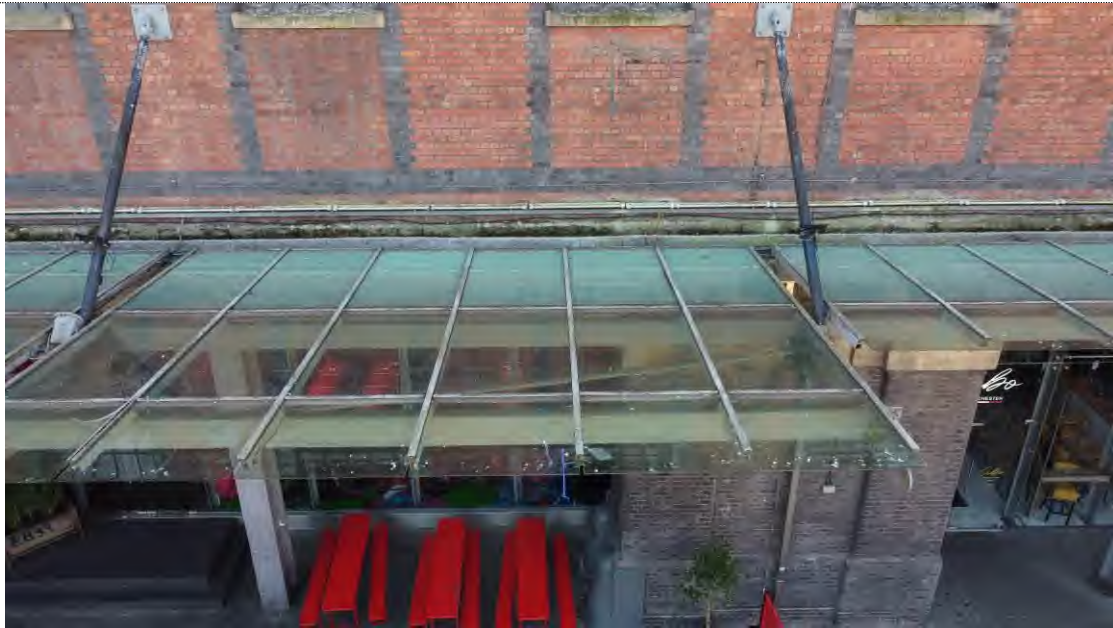
| Photograph: | 30 |

| Description: | Doff clean all areas of brickwork and stonework. (North facing elevation) |

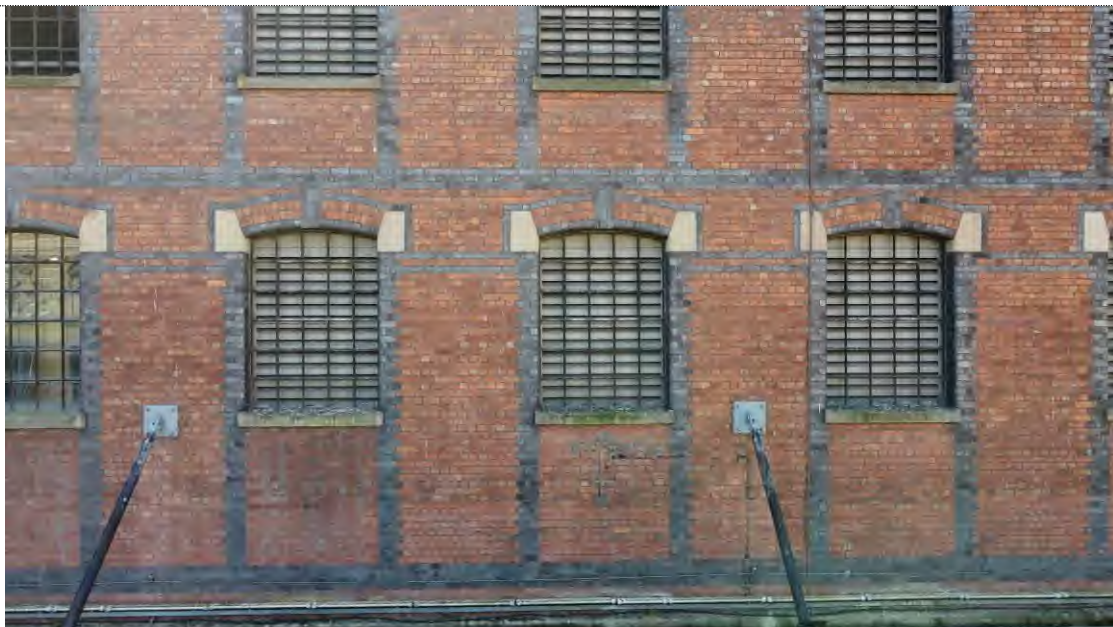
| Photograph: | 31 |

| Description: | General clean and replace of defective brickwork and stonework. (North facing elevation) |

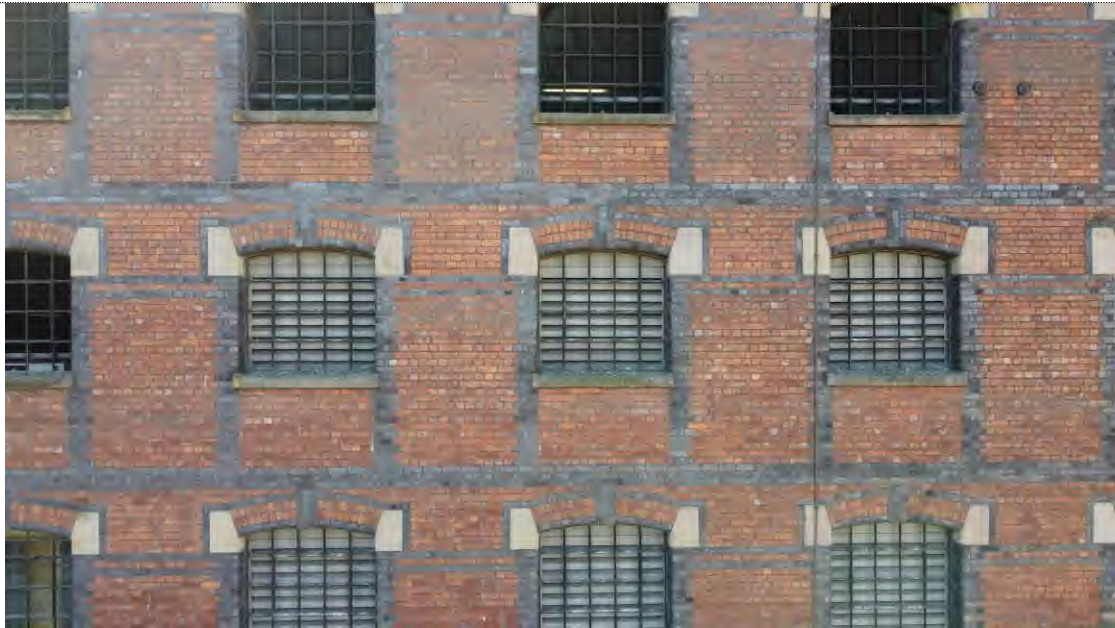
| Photograph: | 32 |

| Description: | General clean and replace of defective brickwork and stonework. (North facing elevation) |

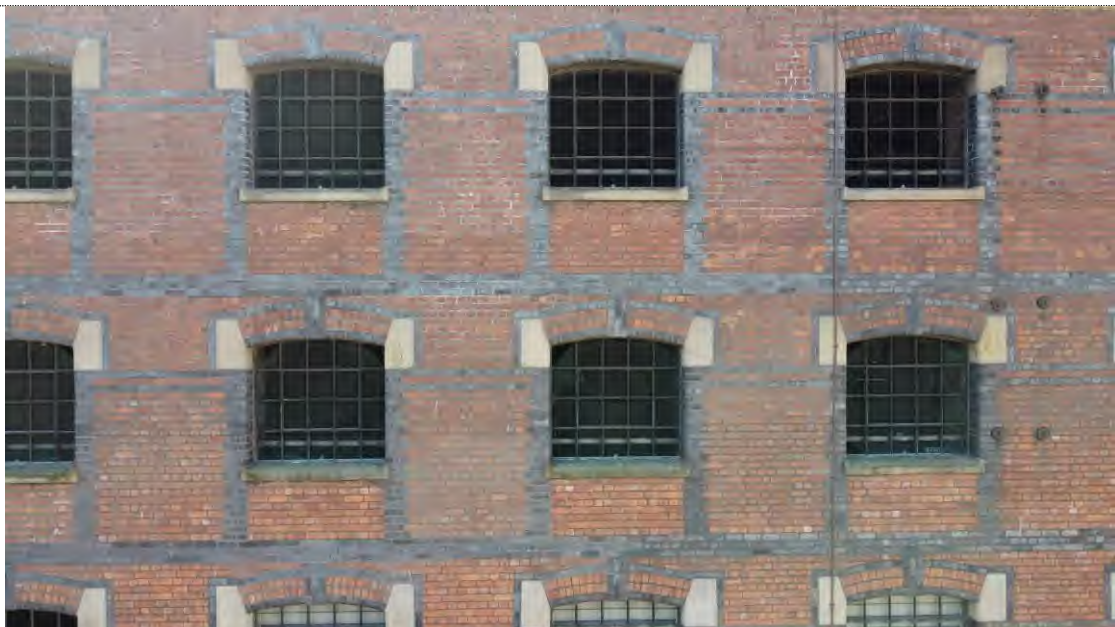
| Photograph: | 33 |

| Description: | General clean and replace of defective brickwork and stonework. (North facing elevation) |

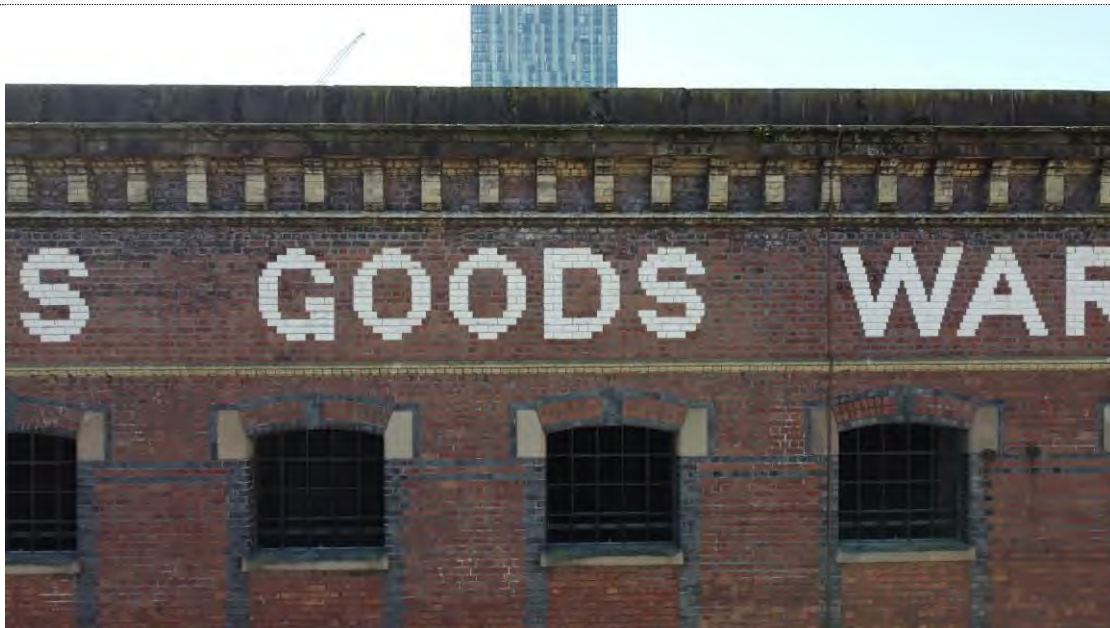
| Photograph: | 34 |

| Description: | General clean and replace of defective brickwork and stonework. (North facing elevation) |

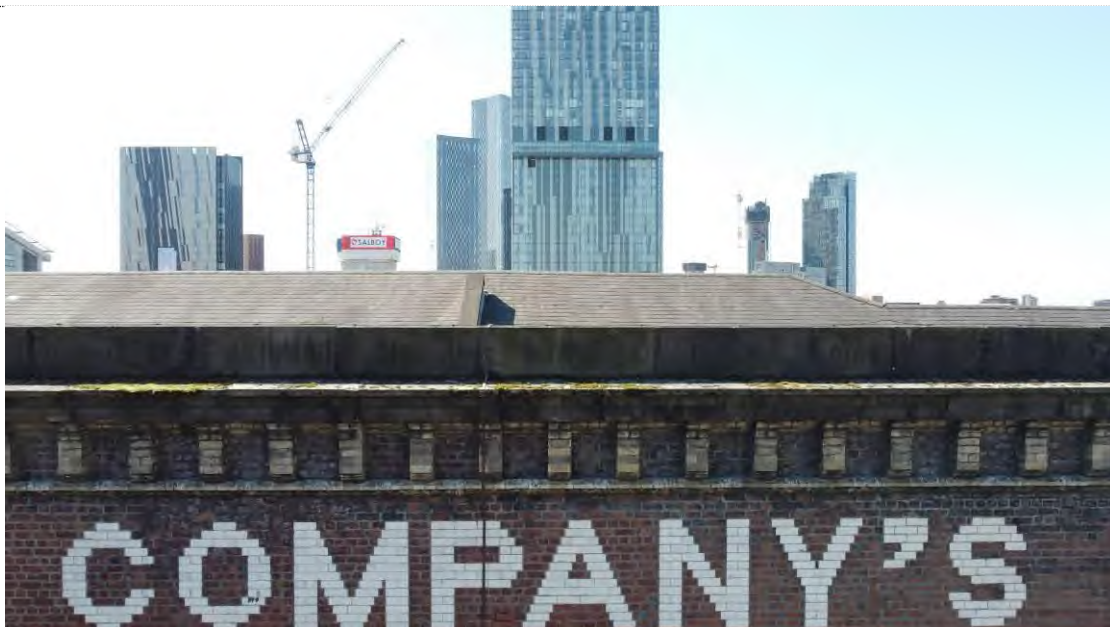
| Photograph: | 35 |

| Description: | General clean and replace of defective brickwork and stonework. (North facing elevation) |

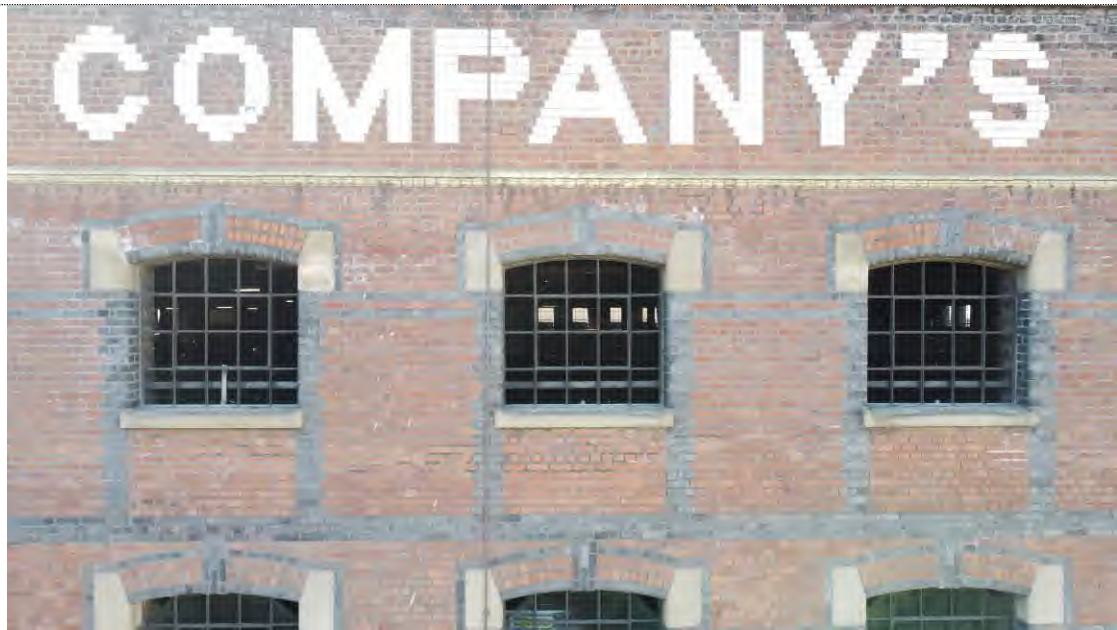
| Photograph: | 36 |

| Description: | General clean and replace of defective brickwork and stonework. (North facing elevation) |

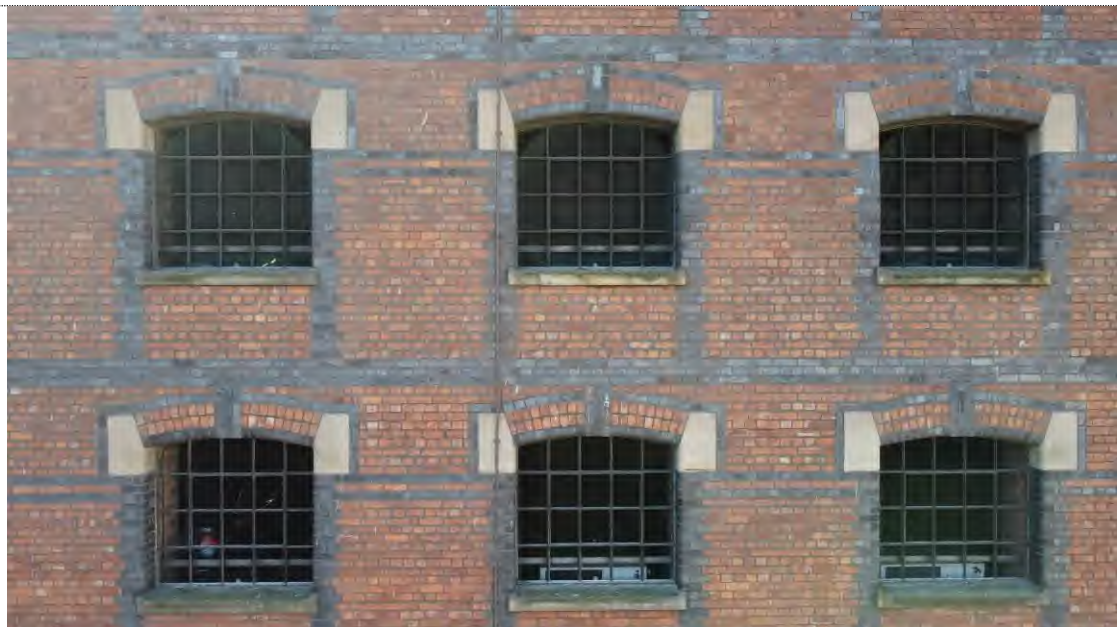
| Photograph: | 37 |

| Description: | General clean and replace of defective brickwork. Evidence of salt damage to brickwork. (North facing elevation) |

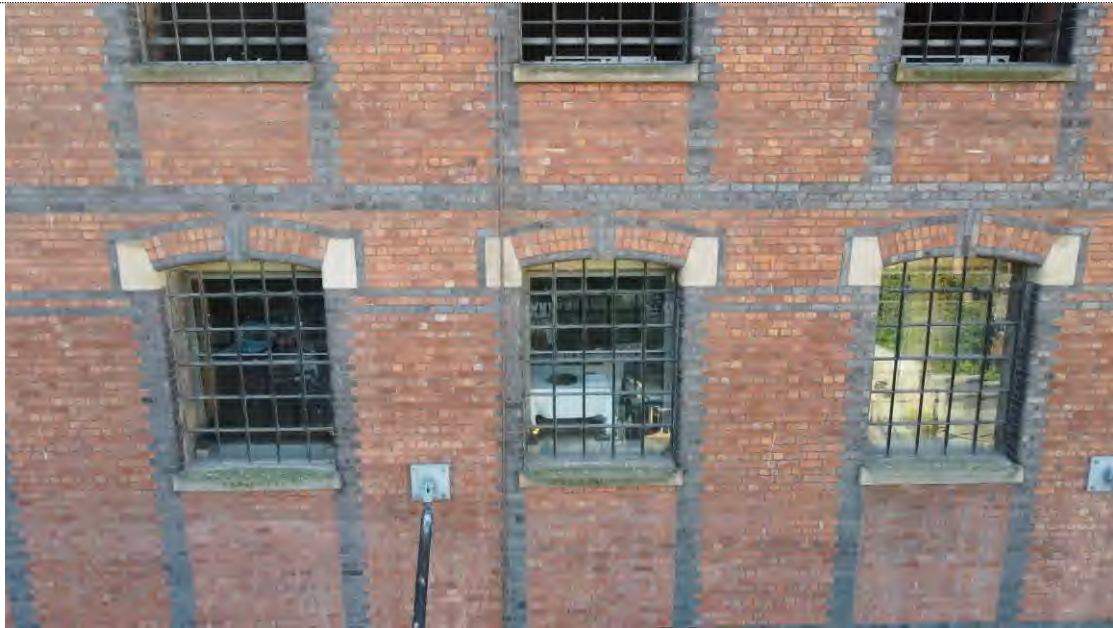
| Photograph: | 38 |

| Description: | General clean and replace of defective brickwork. (North facing elevation) |

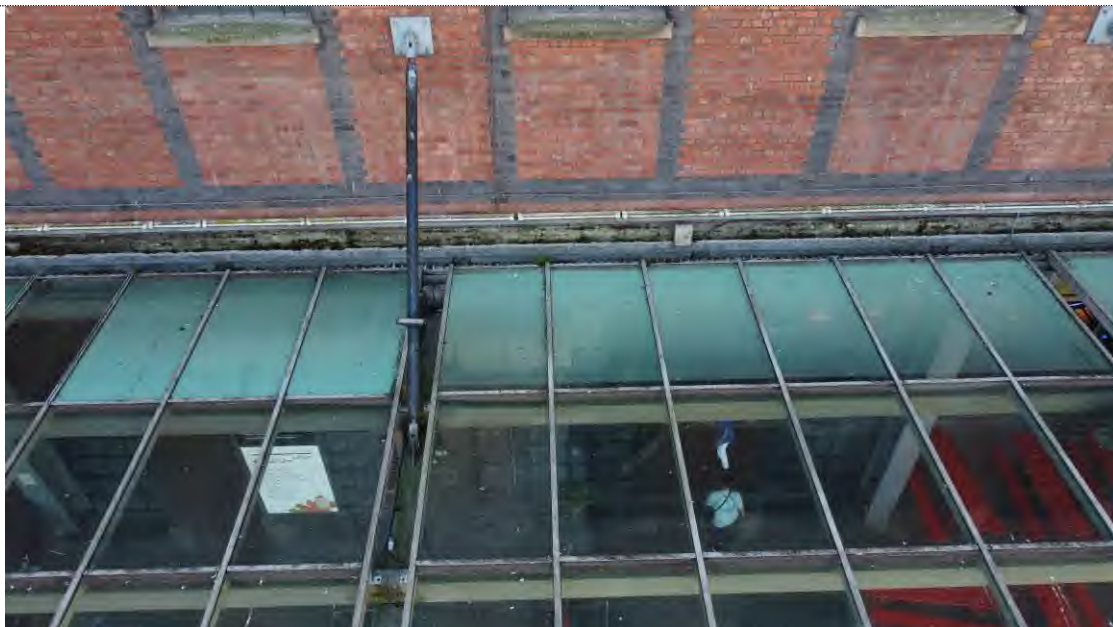
| Photograph: | 39 |

| Description: | General clean and replace of defective brickwork. Aglae growth to stonework. (North facing elevation) |

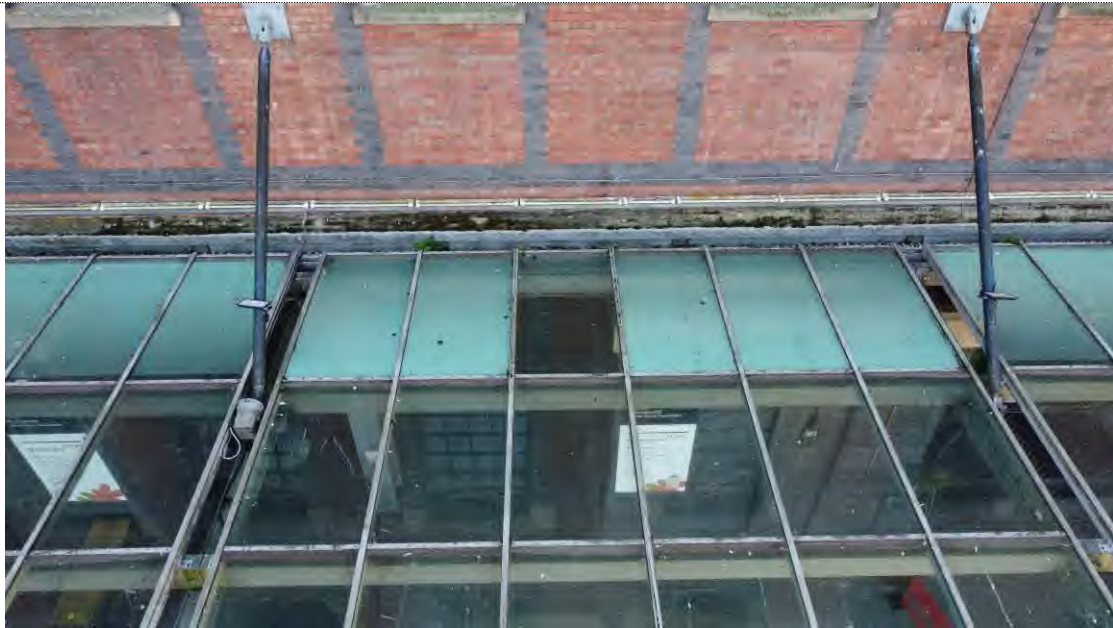
| Photograph: | 40 |

| Description: | Algae growth to stonework. General view of the canopy. |

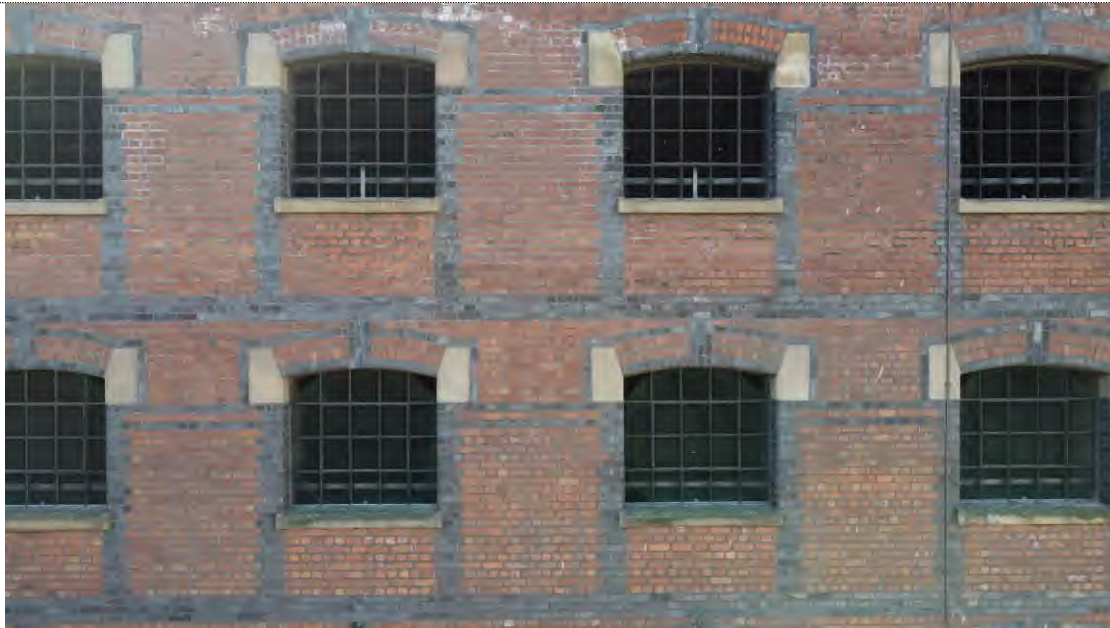
| Photograph: | 42 |

| Description: | General clean and replace of defective brickwork. (North facing elevation) |

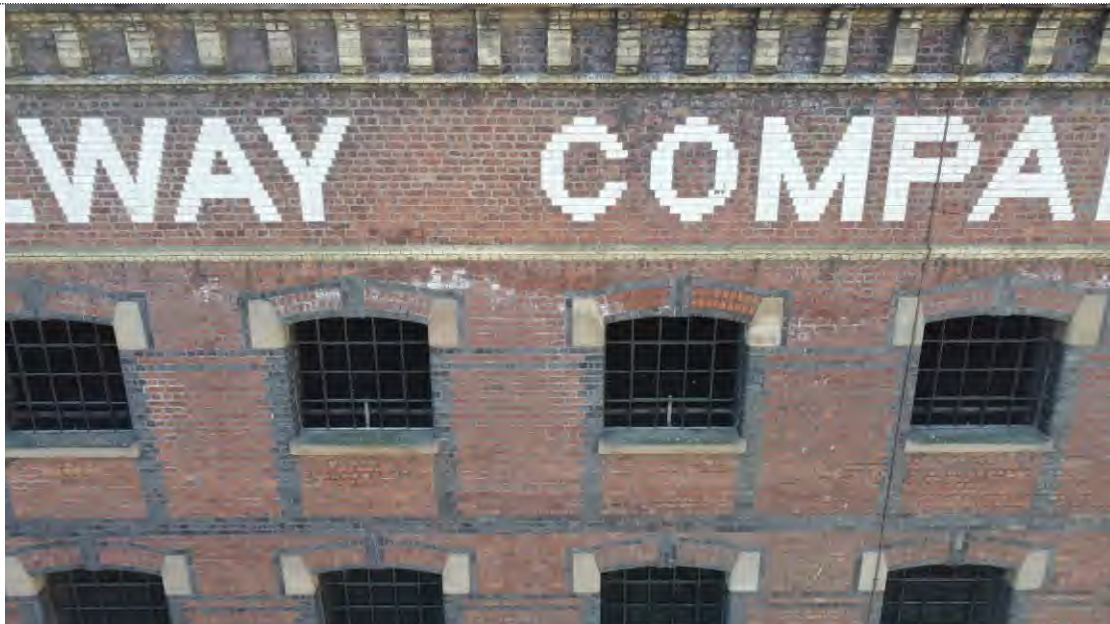
| Photograph: | 43 |

| Description: | General clean and replace of defective brickwork. (North facing elevation) |

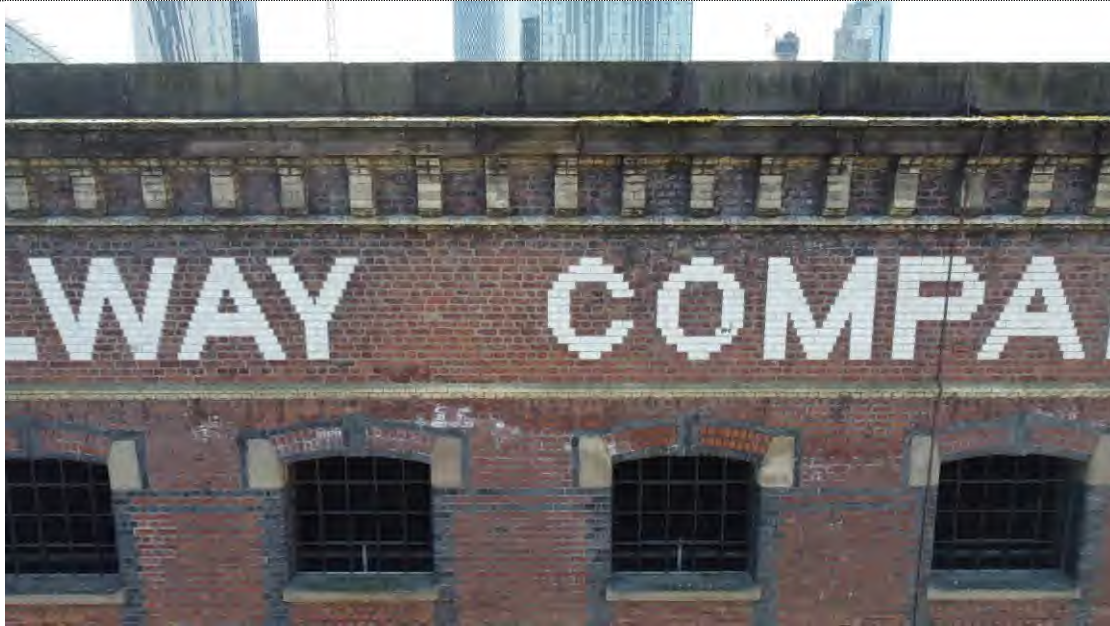
| Photograph: | 44 |

| Description: | General clean and replace of defective brickwork and stonework. (North facing elevation) |

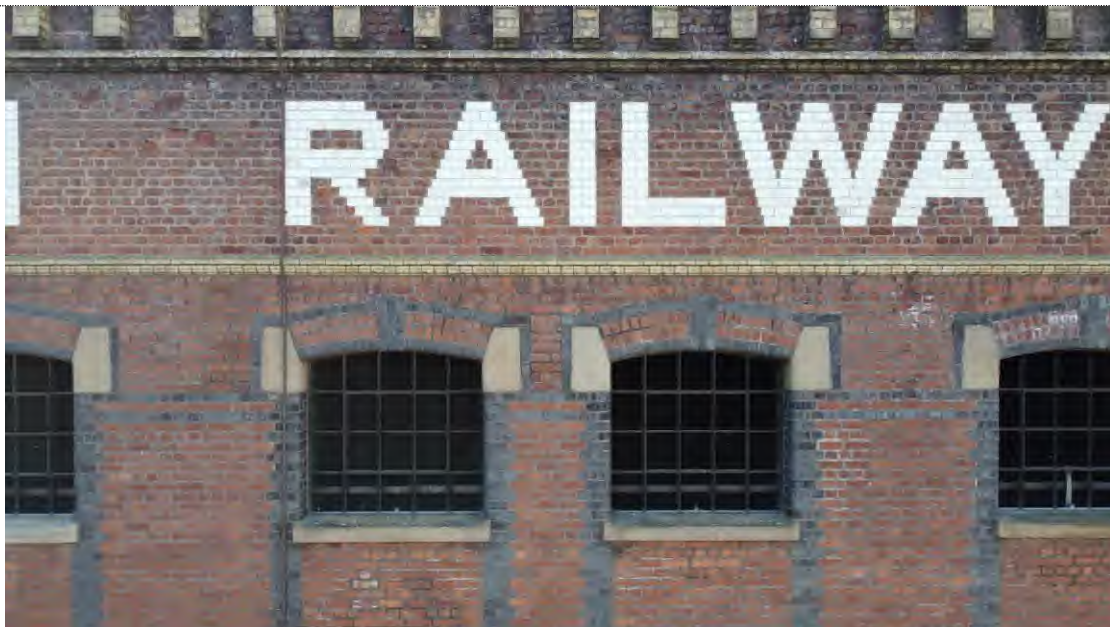
| Photograph: | 45 |

| Description: | General clean and replace of defective brickwork and stonework. (North facing elevation) |

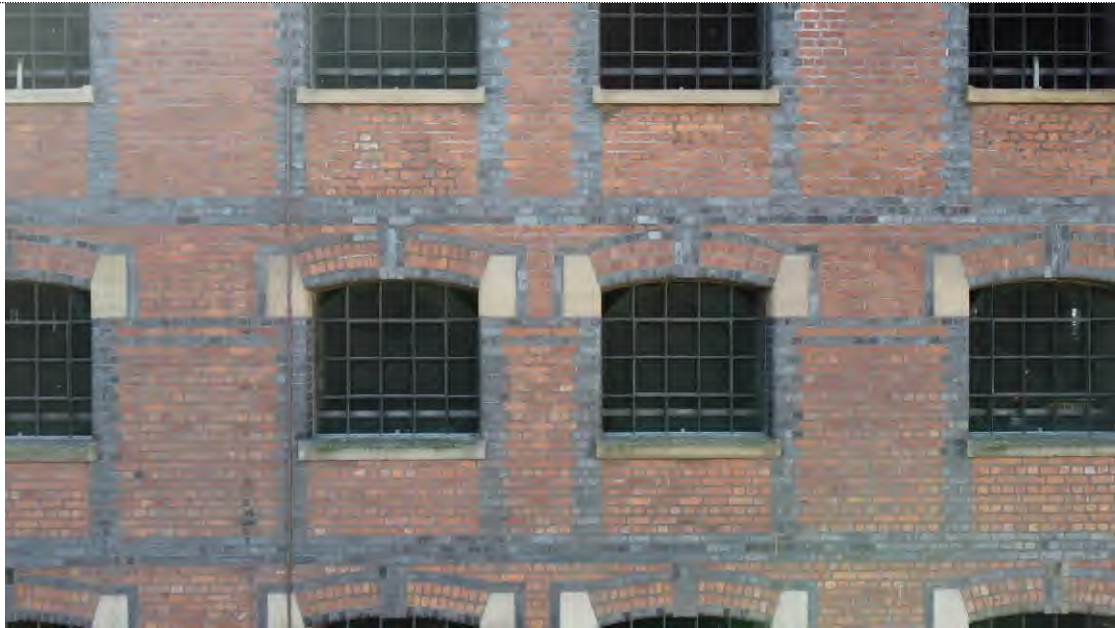
| Photograph: | 46 |

| Description: | General clean and replace of defective brickwork and stonework. (North facing elevation) |

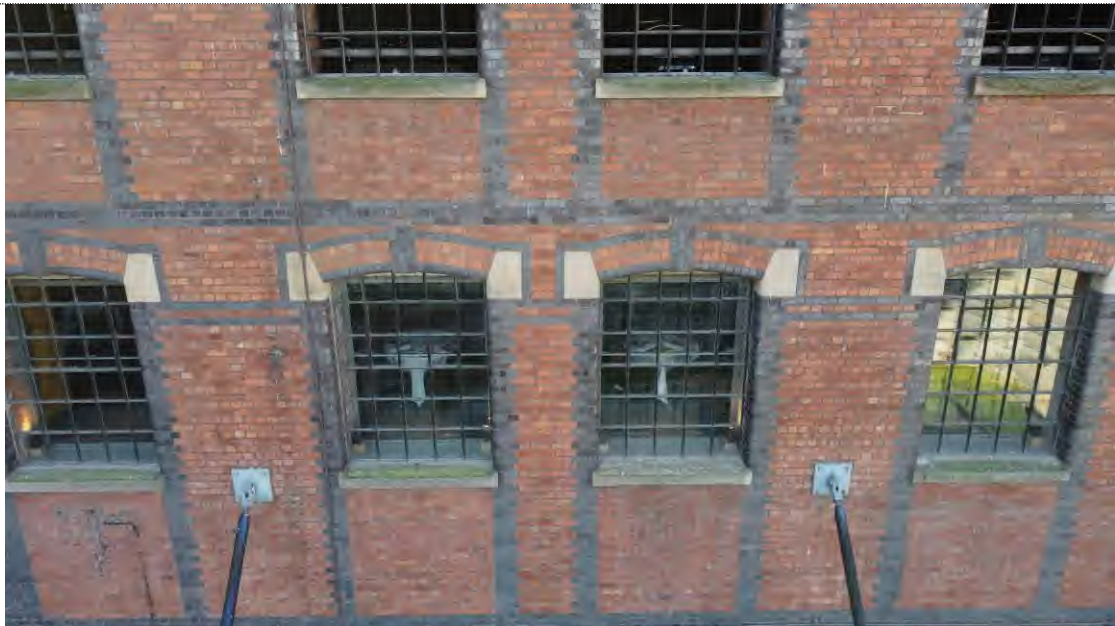
| Photograph: | 47 |

| Description: | General clean and replace of defective brickwork. (North facing elevation) |

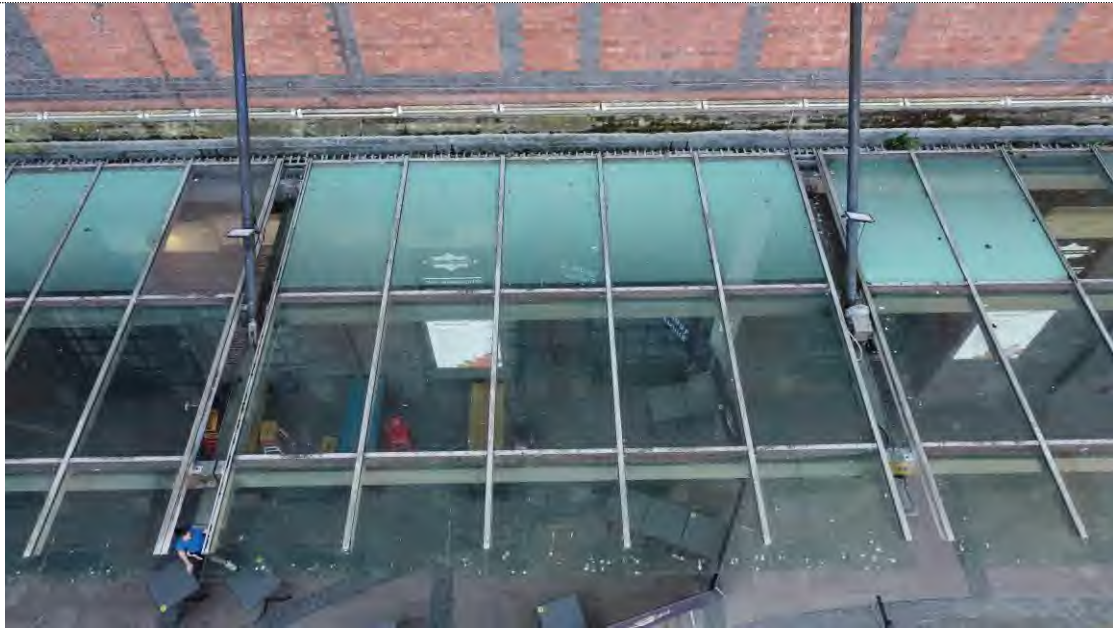
| Photograph: | 48 |

| Description: | General clean and replace of defective brickwork and stonework. (North facing elevation) |
